Environmental Risk Assessment

Site at Greenhills

Kildare County Council

Athy, Co. Kildare

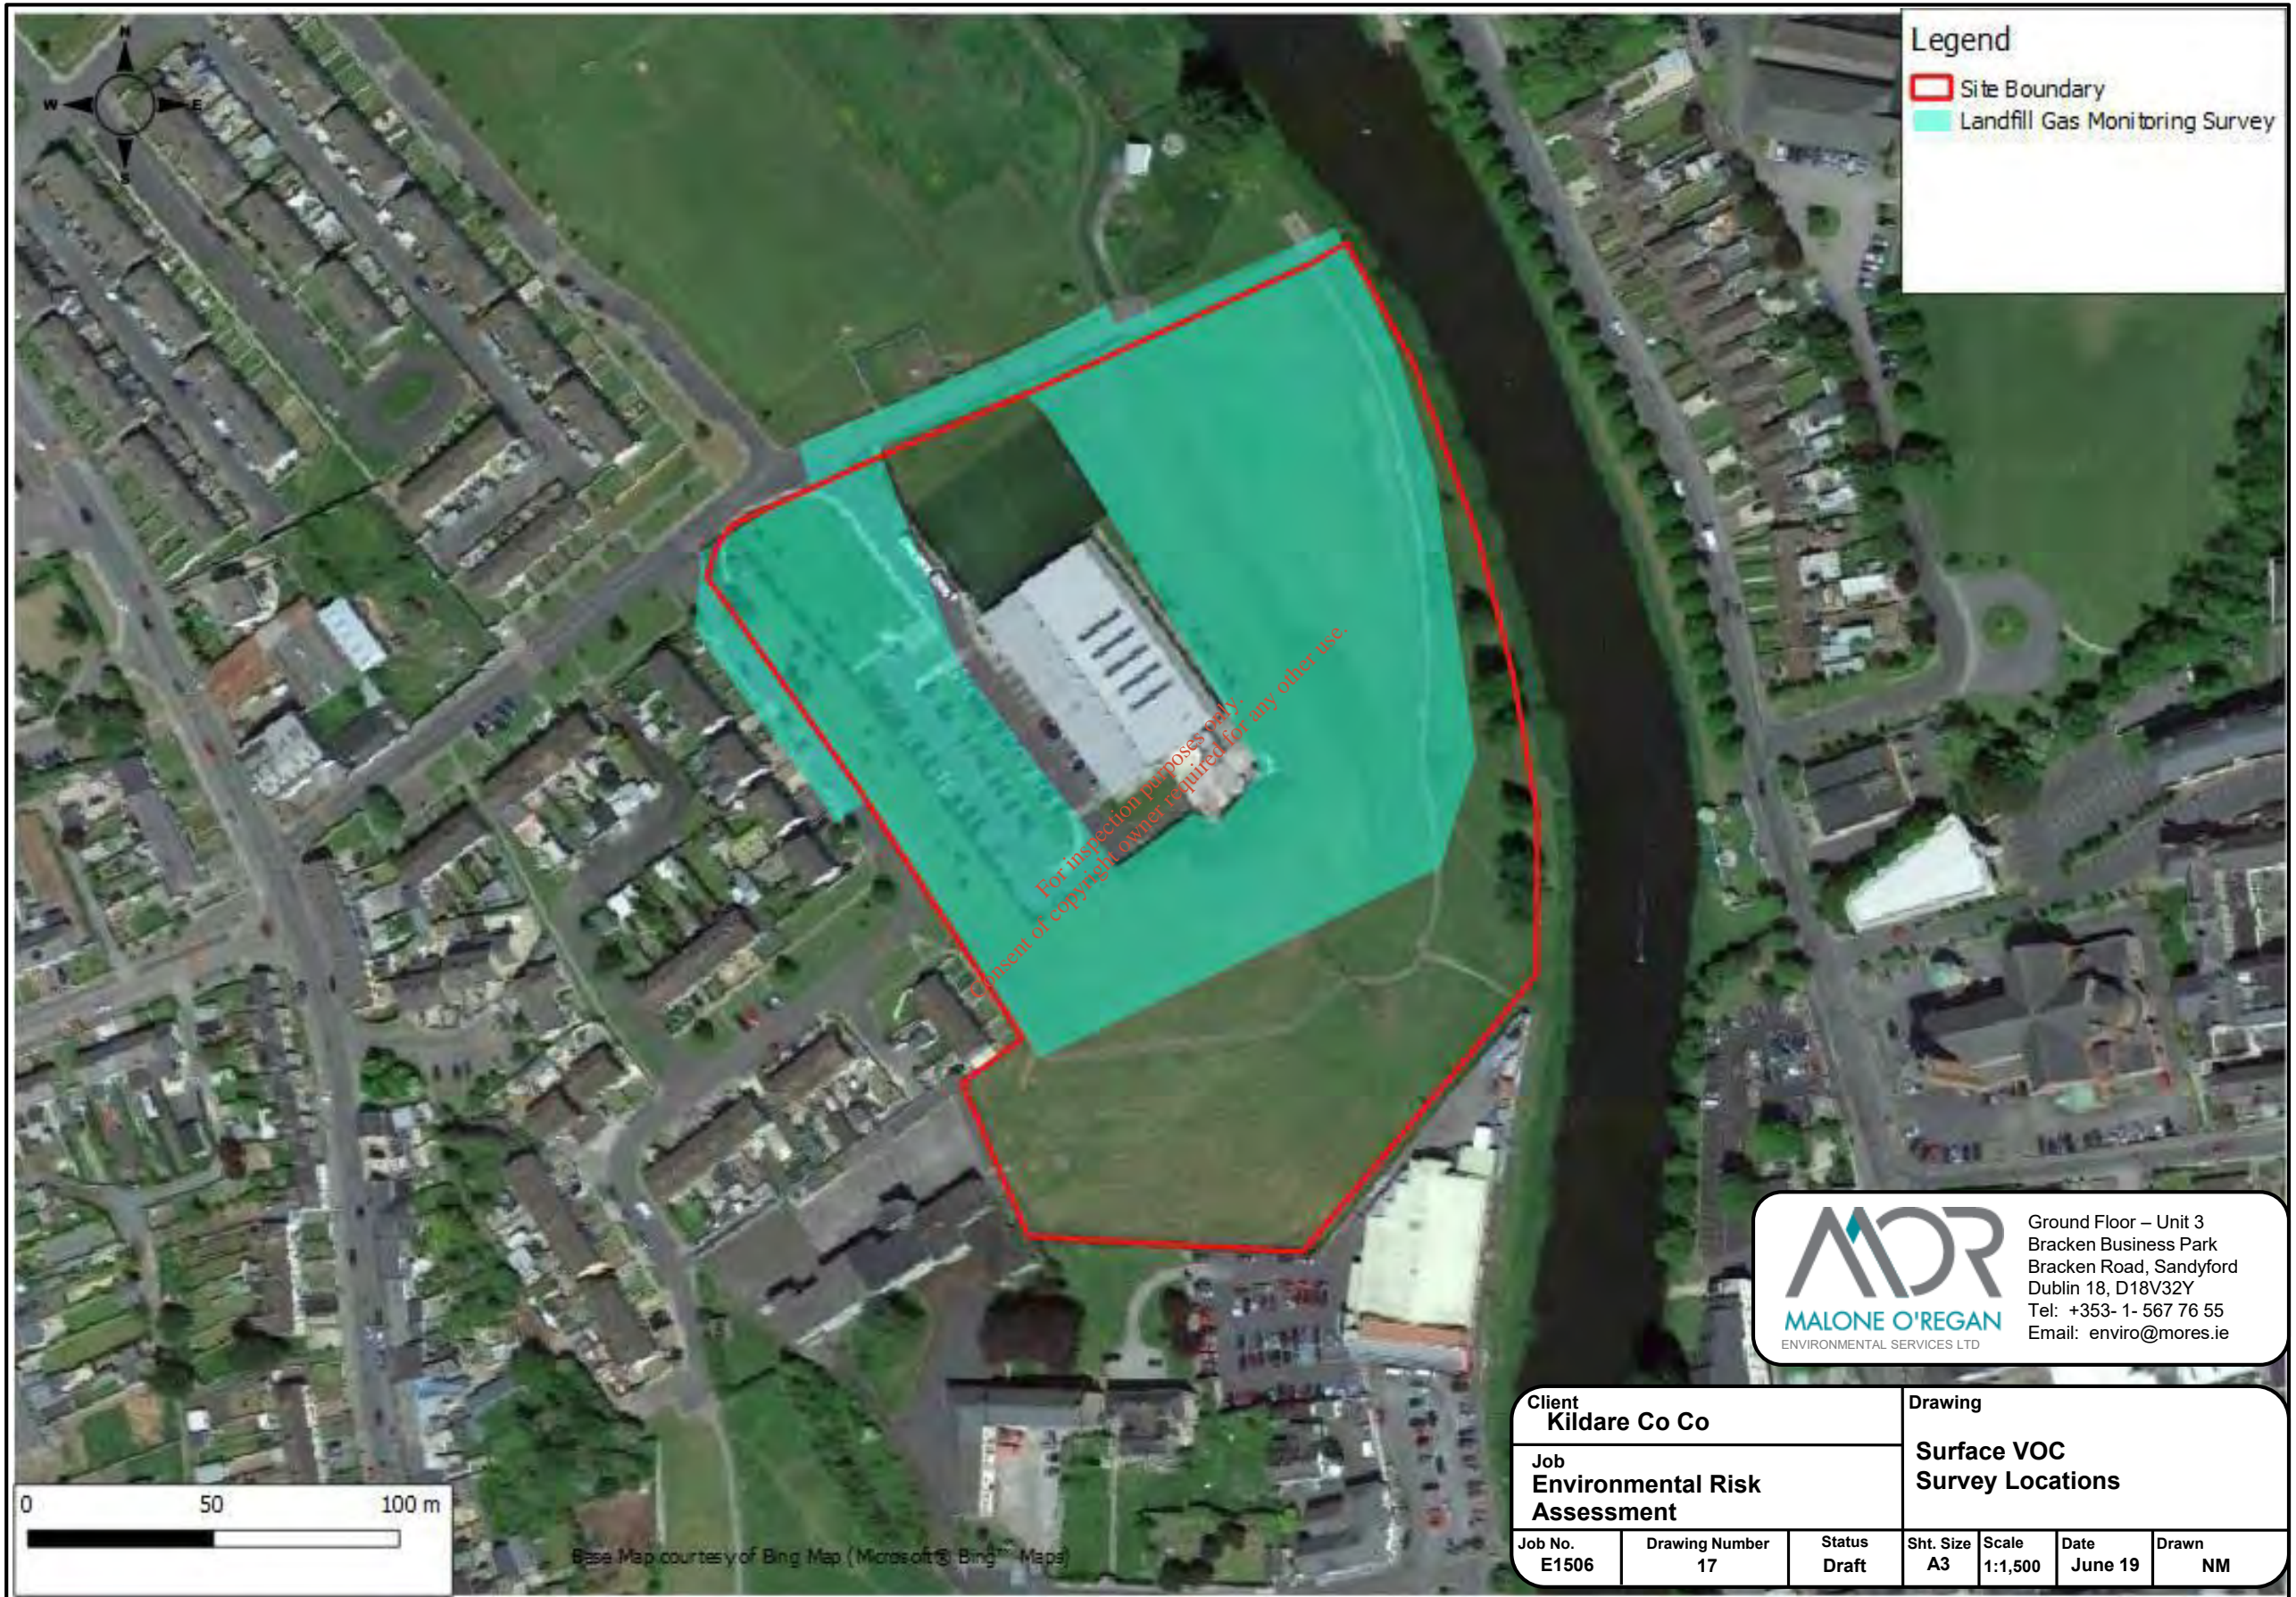
- Site Boundary
- Landfill Gas Monitoring Survey

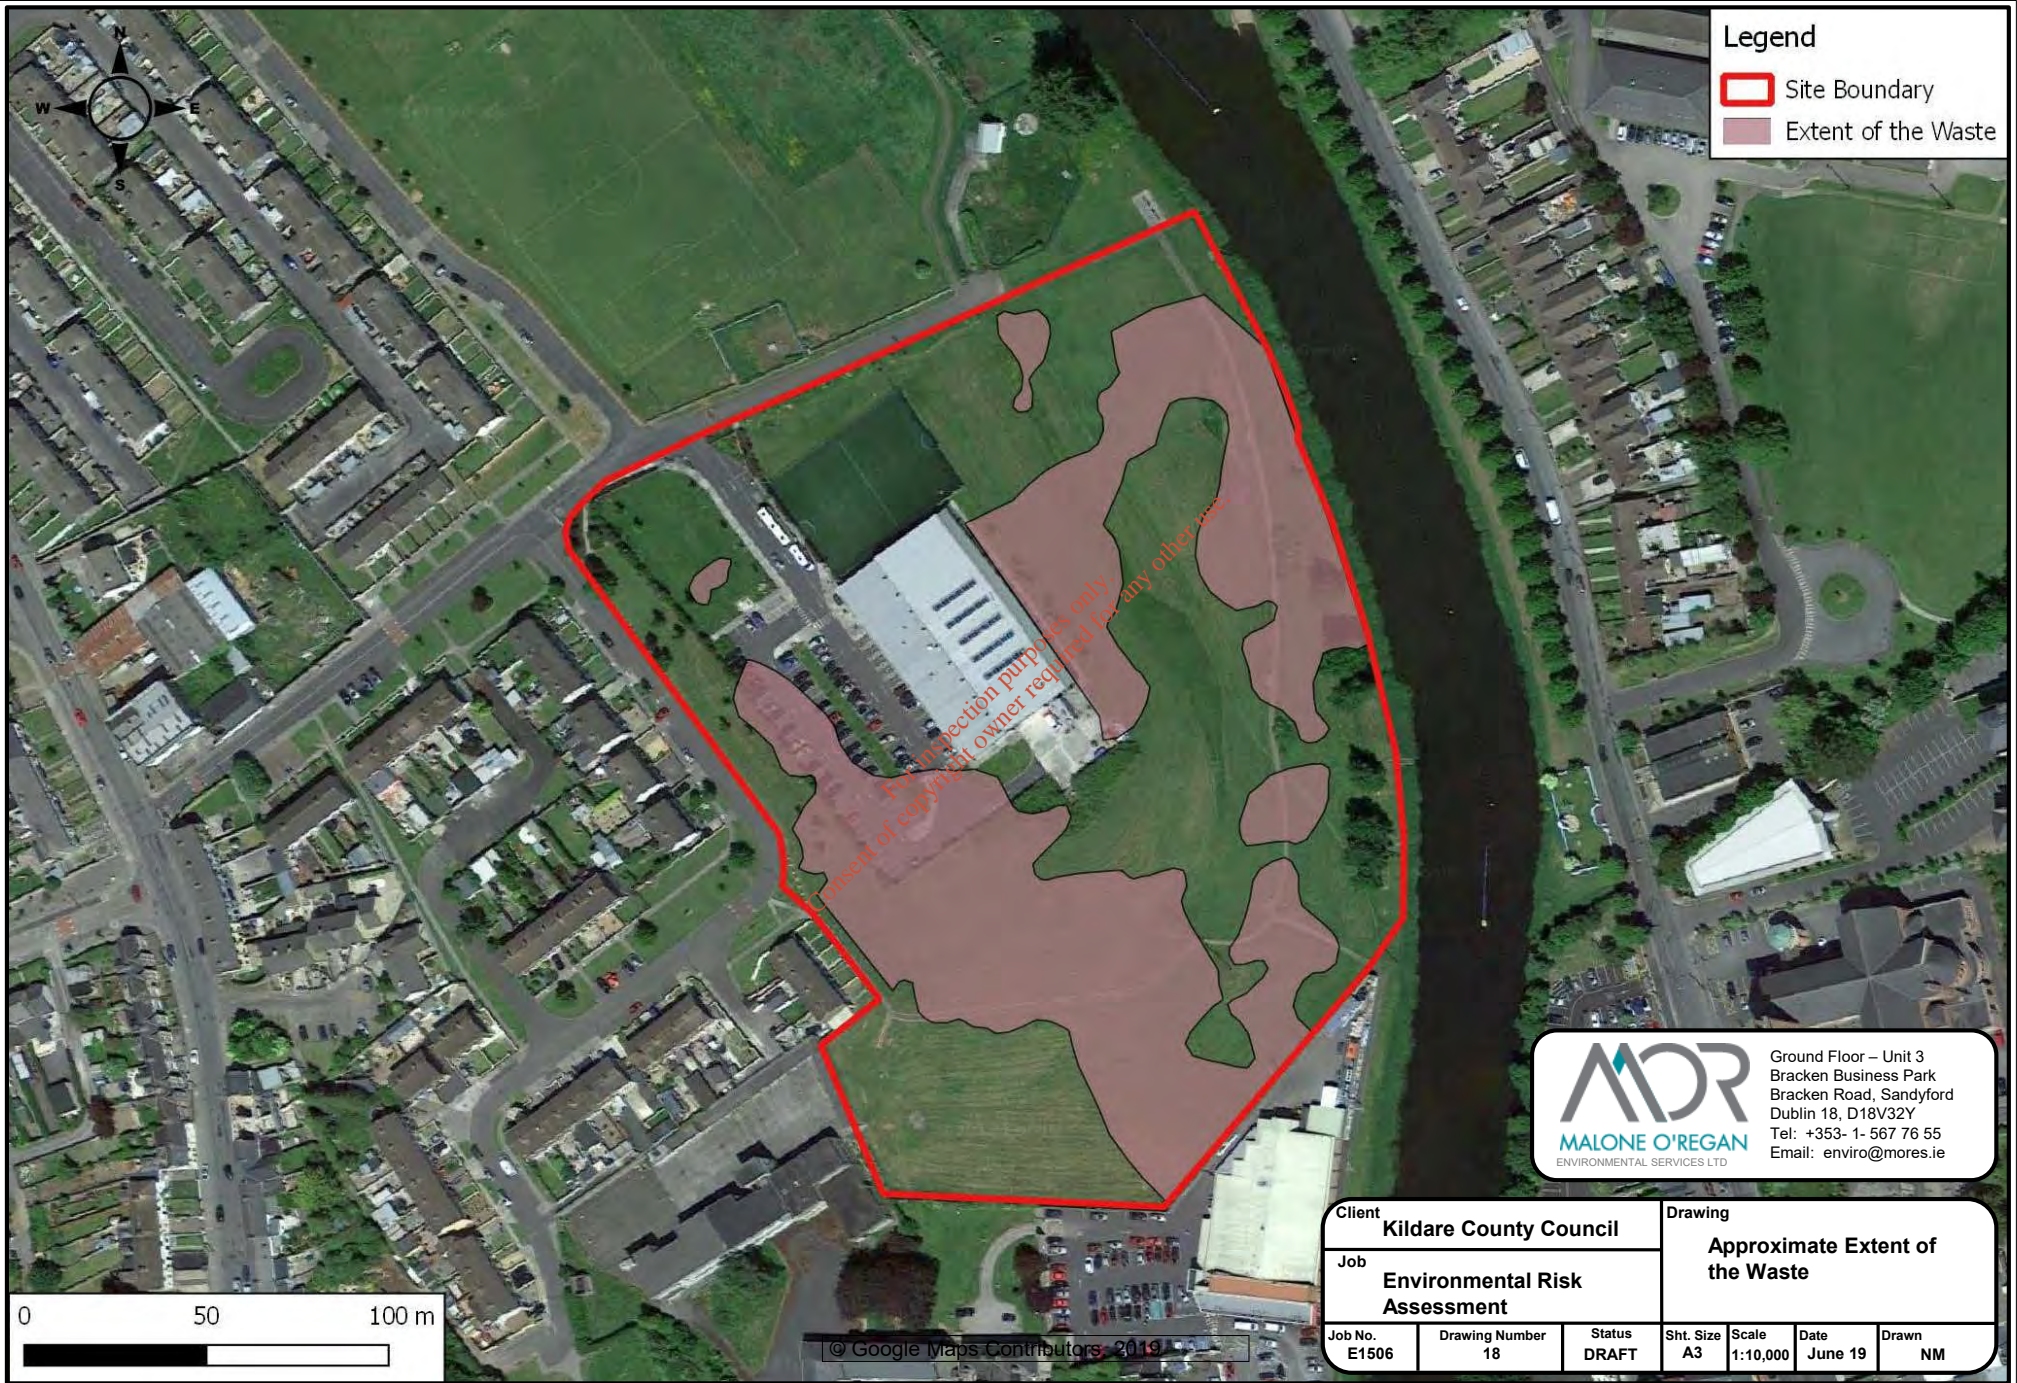
- Site Boundary
- Extent of the Waste

The maximum vertical extent of imported material observed during the trial pitting and borehole installation was 6.7mbgl (L3). The geophysical survey (Apex Geoservices Ltd) indicated a thickness of waste ranging from c. 0.2 to 5.6m, with the thickest areas to the east and south of the main building (sports and leisure facility).
