Environmental Risk Assessment
Site at Prusselstown
Kildare County Council
Athy, Co. Kildare

Title: Environmental Risk Assessment, Site at Prusselstown, Kildare County Council, Athy, Co. Kildare

Job Number: E1506

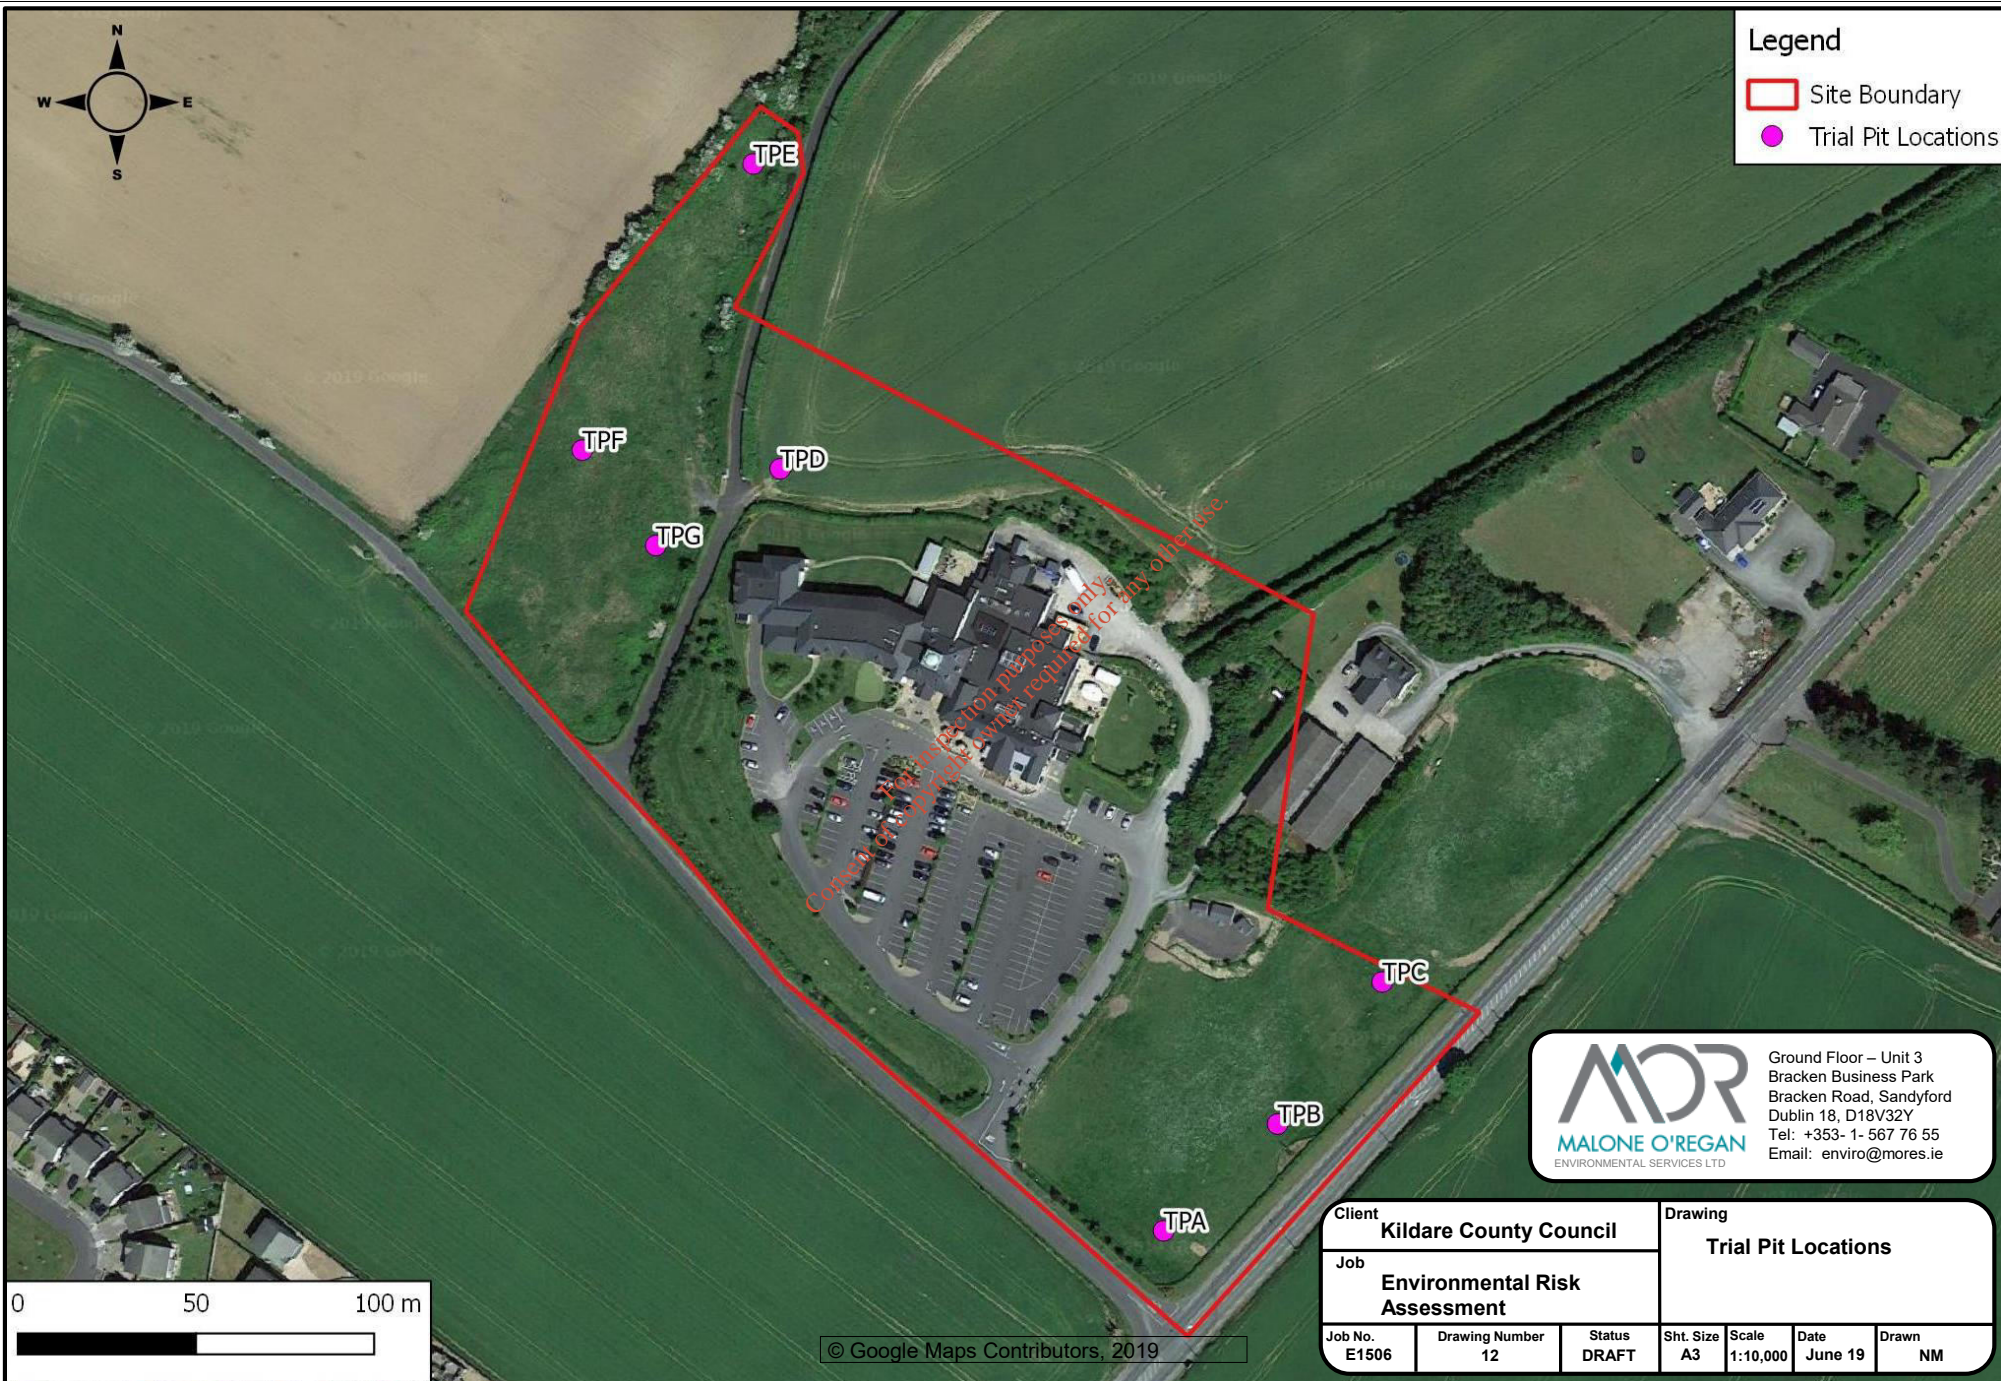
Client Kildare County Council			Drawing Trial Pit Locations			
Job Environmental Risk Assessment						
Job No. E1506	Drawing Number 12	Status DRAFT	Sht. Size A3	Scale 1:10,000	Date June 19	Drawn NM

The excavation of the trial pits to a maximum depth of approximately 5.0mbgl was undertaken using a 13-tonne tracked excavator. Each trial pit was logged in accordance with the BS 5930:2015 standards. Locations for the trial pits were selected based on initial discussions with KCC, findings of the desk-based studies, the site walkover and the results of the geophysical survey. Each trial pit was re-instated to as close to its original condition as possible. Exact locations are shown in Drawing No. 12. Refer to Appendix D for trial pit logs and also for photographic records of all trial pits. Three (3 No) different sub-surface profiles were recorded at the Site;

Sample ID	Final Depth (mbgl)	Waste Depth (mbgl)	Composition of Waste	Comments
TPA	4.1	1.1-4.1	Wood, plastic, glass, metal, concrete, coal, red bricks and cables	Slight odour of burnt material
TPB	5.0	0.6-5.0	Plastic, sacks, glass bottles and car metal parts	Strong decomposition odour & moderate odour of burnt material.
TPC	3.2	-	-	No waste encountered
TPD	3.3	-	-	No waste encountered
TPE	3.1	1.4-3.1	Plastic, red bricks, cloths, glass bottles, oil can, carpet and mattress	Moderate decomposition and hydrocarbon odours
TPF	3.5	1.3-3.5	Plastic, wood, plastic glasses, milk cartons, metal, can (milk formula), metal lids, steel sheeting, supermarket bags, pieces of throw and hard metal	Strong decomposition odour
TPG	4.0	1.0-4.0	Plastic bottles, concrete, glass jars, glass, metal wires and wood	Slight sweet odour and odour of burnt material

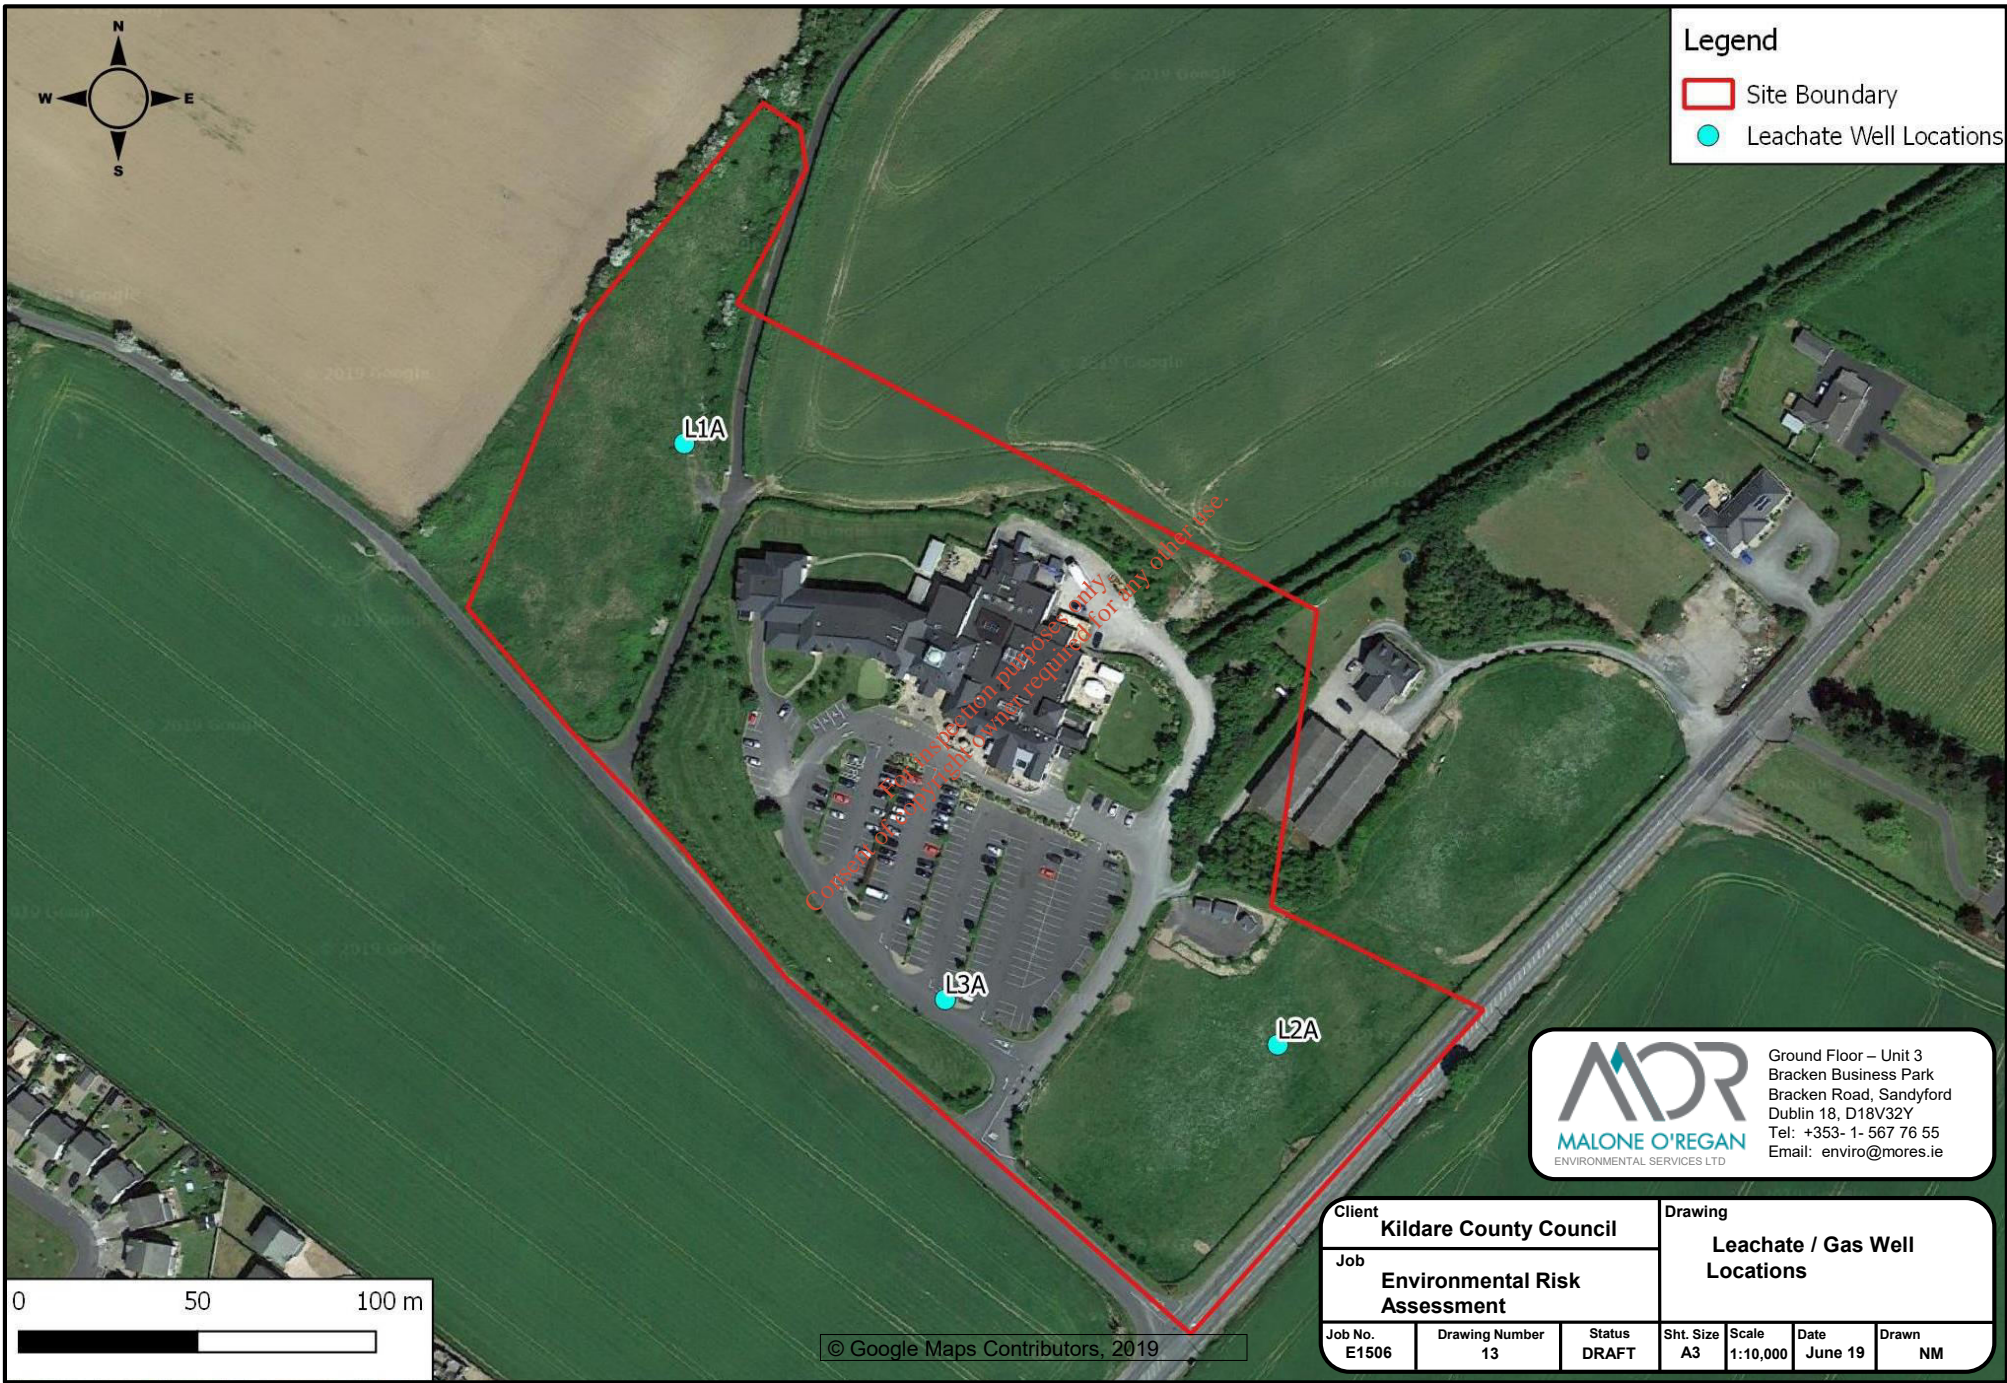
A shell and auger rig were mobilised to the Site from the 9th to the 15th of January 2019 to install shallow leachate/gas wells (L1A to L3A). The three (3 No) combined leachate and gas monitoring wells were installed within the imported material to maximum depths ranging from 5.1 to 8.5mbgl. During the installation works the MOR consultant noted any field evidence of contamination through the soil/lithological profile to ensure that a conduit was not provided to the underlying aquifer. The borehole logs are shown in Appendix E. Refer to Table 5-4 for details on the installation and Drawing No. 13 for leachate borehole locations.

Sample ID	Final Depth (mbgl)	Depth of Waste (mbgl)	Composition of Waste	Leachate (mbgl)
L1A	5.1 - Obstruction	1.8 – 5.1	Plastic, cloths, red bricks, wood, concrete, metal and plastic bottles	1.8
L2A	8.5 - Obstruction	1.5 – 8.5	Hard plastic, clothes, glass, red bricks, wood, lids and burnt tyre	-
L3A	6.5 - Obstruction	1.4 – 6.5	Plastic, glass, red bricks, concrete and hard plastic	-

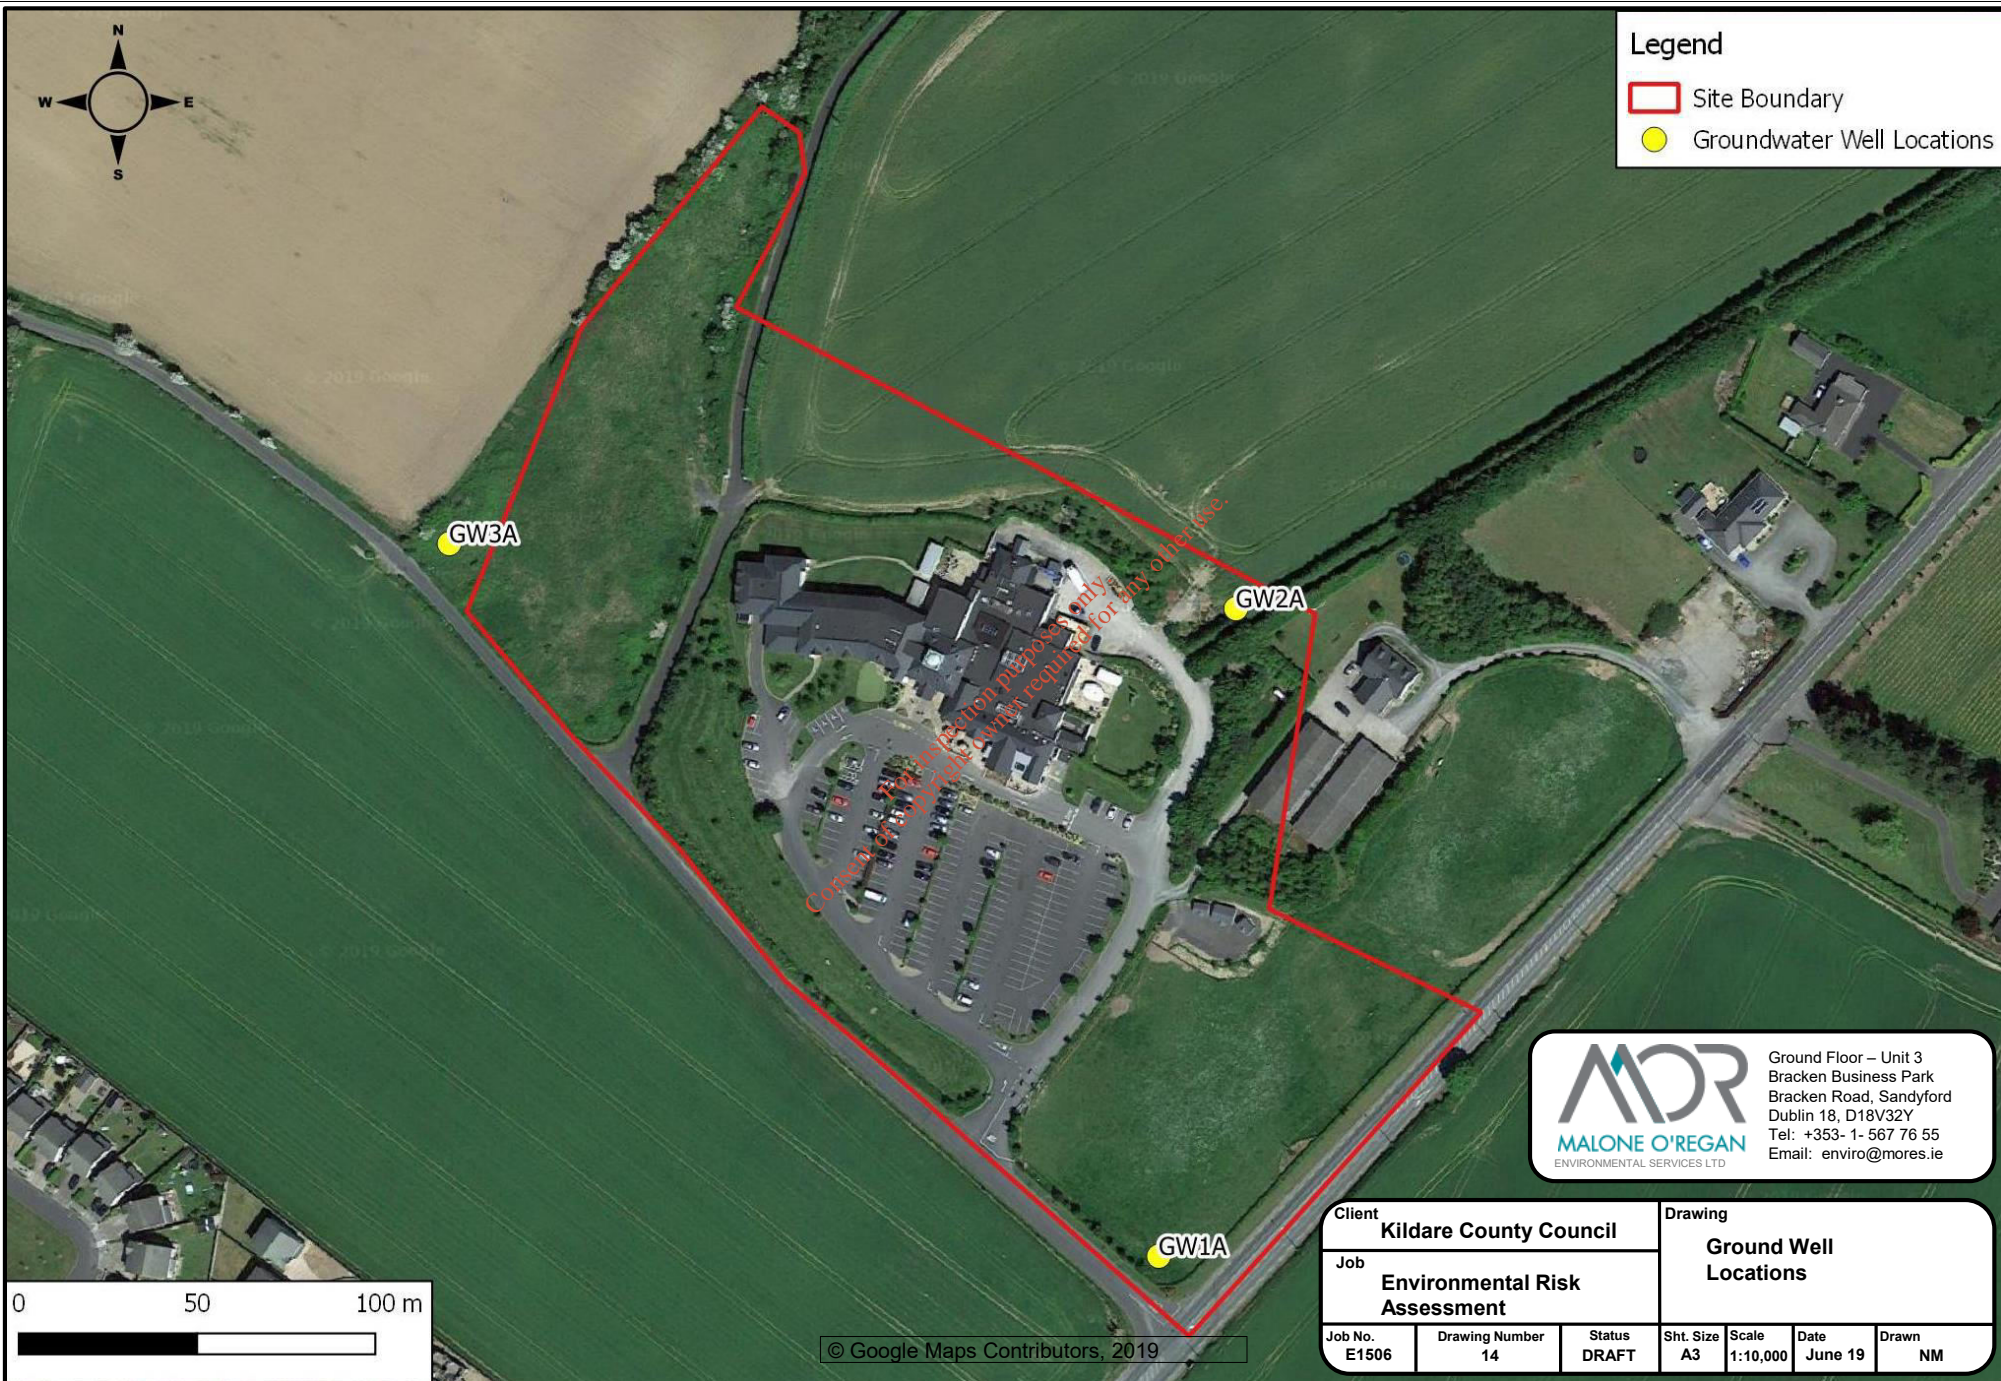
- Site Boundary
- Groundwater Well Locations

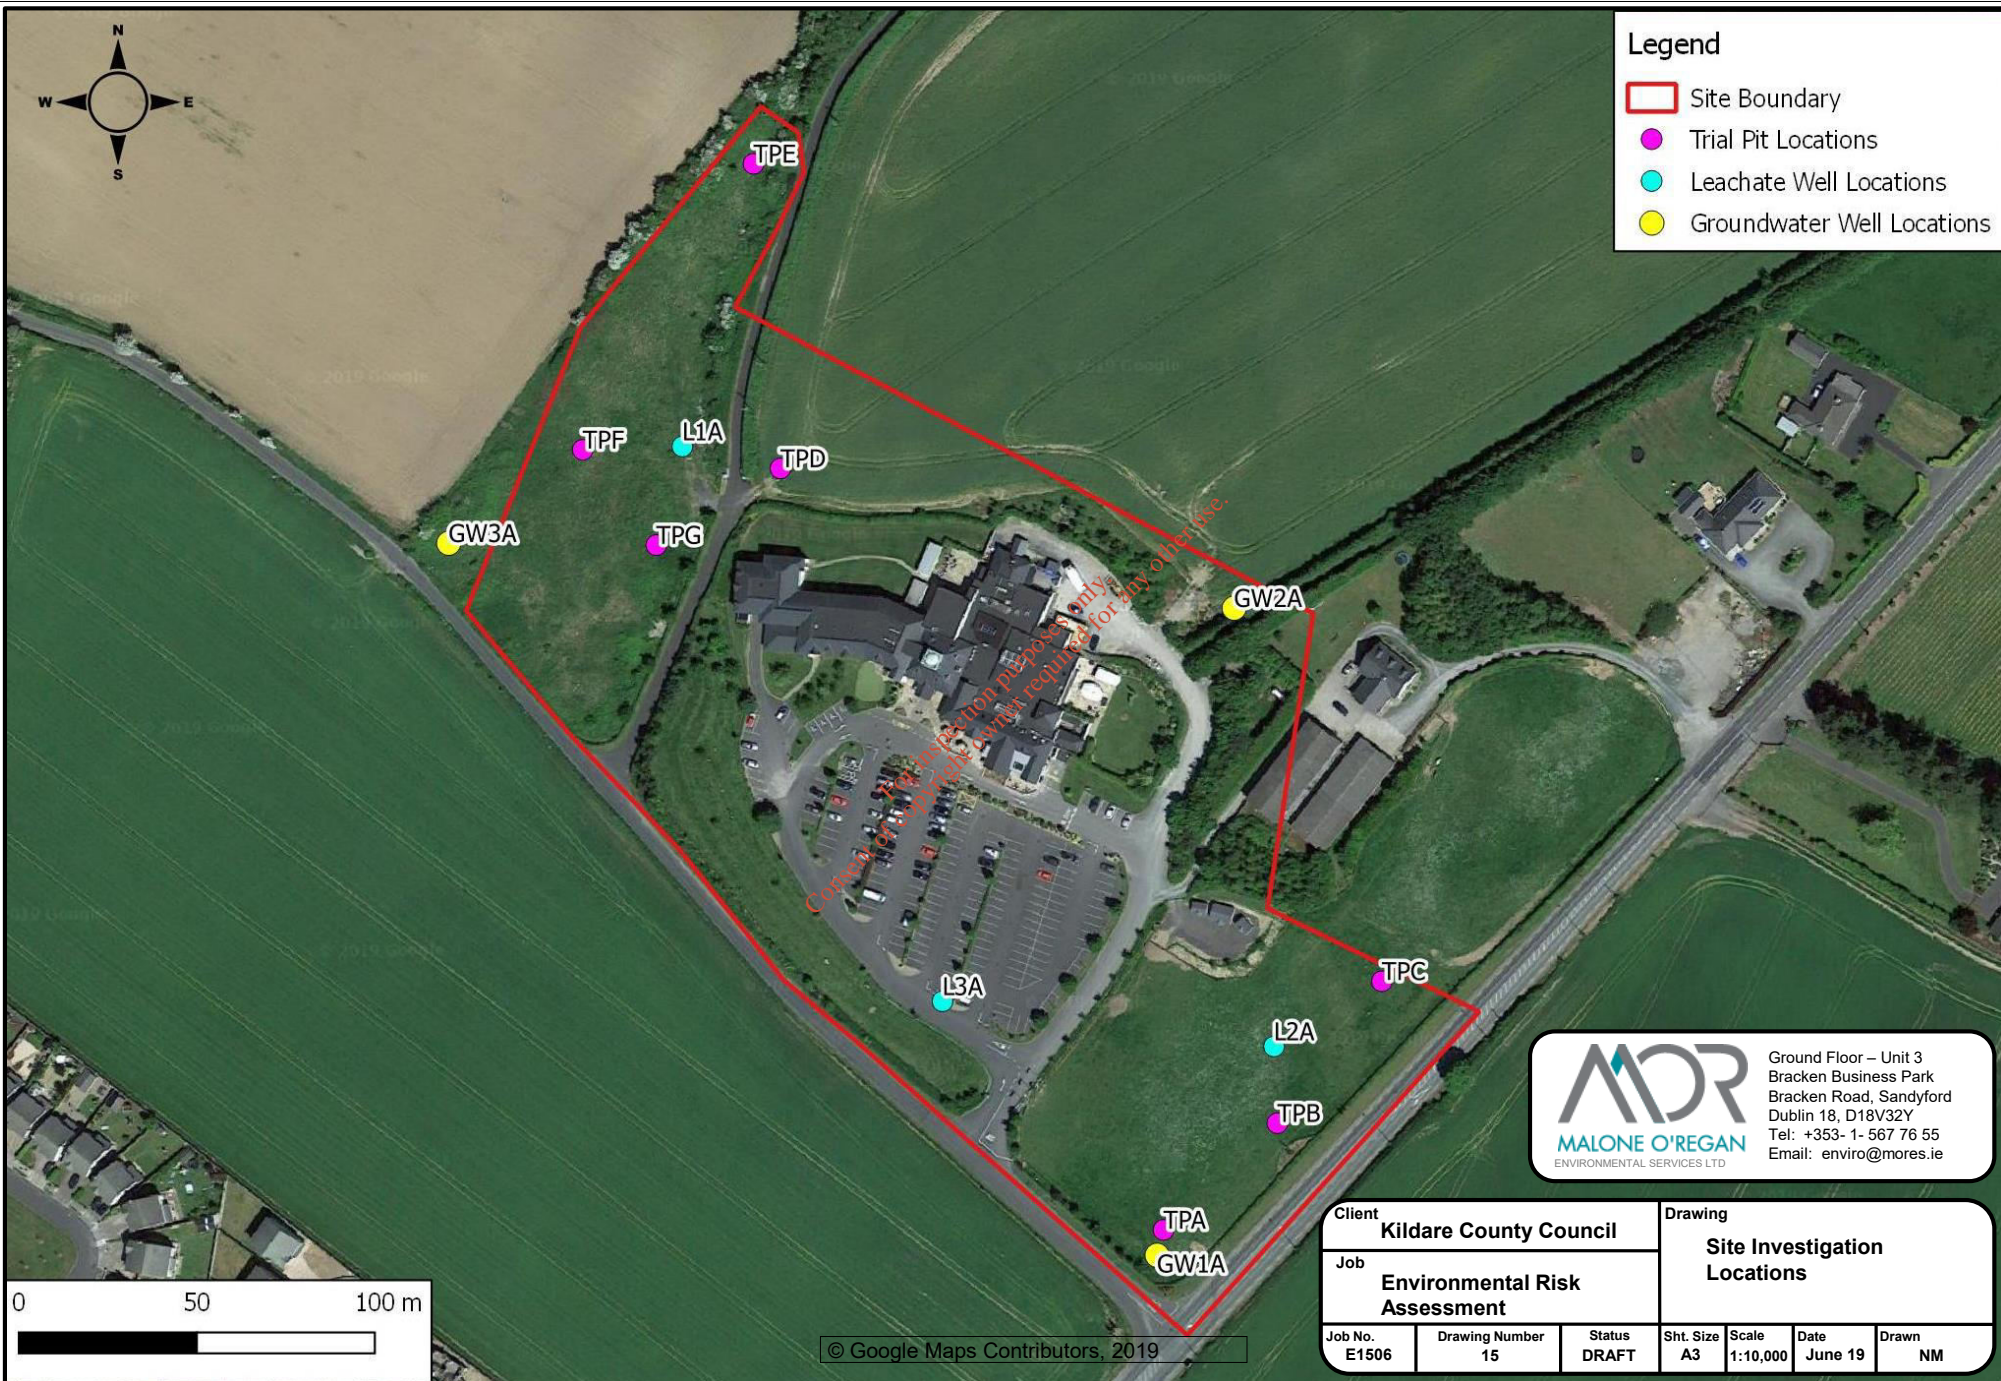
Client Kildare County Council			Drawing Site Investigation Locations			
Job Environmental Risk Assessment						
Job No. E1506	Drawing Number 15	Status DRAFT	Sht. Size A3	Scale 1:10,000	Date June 19	Drawn NM

- Site Boundary
- Trial Pit Locations
- Leachate Well Locations
- Groundwater Well Locations

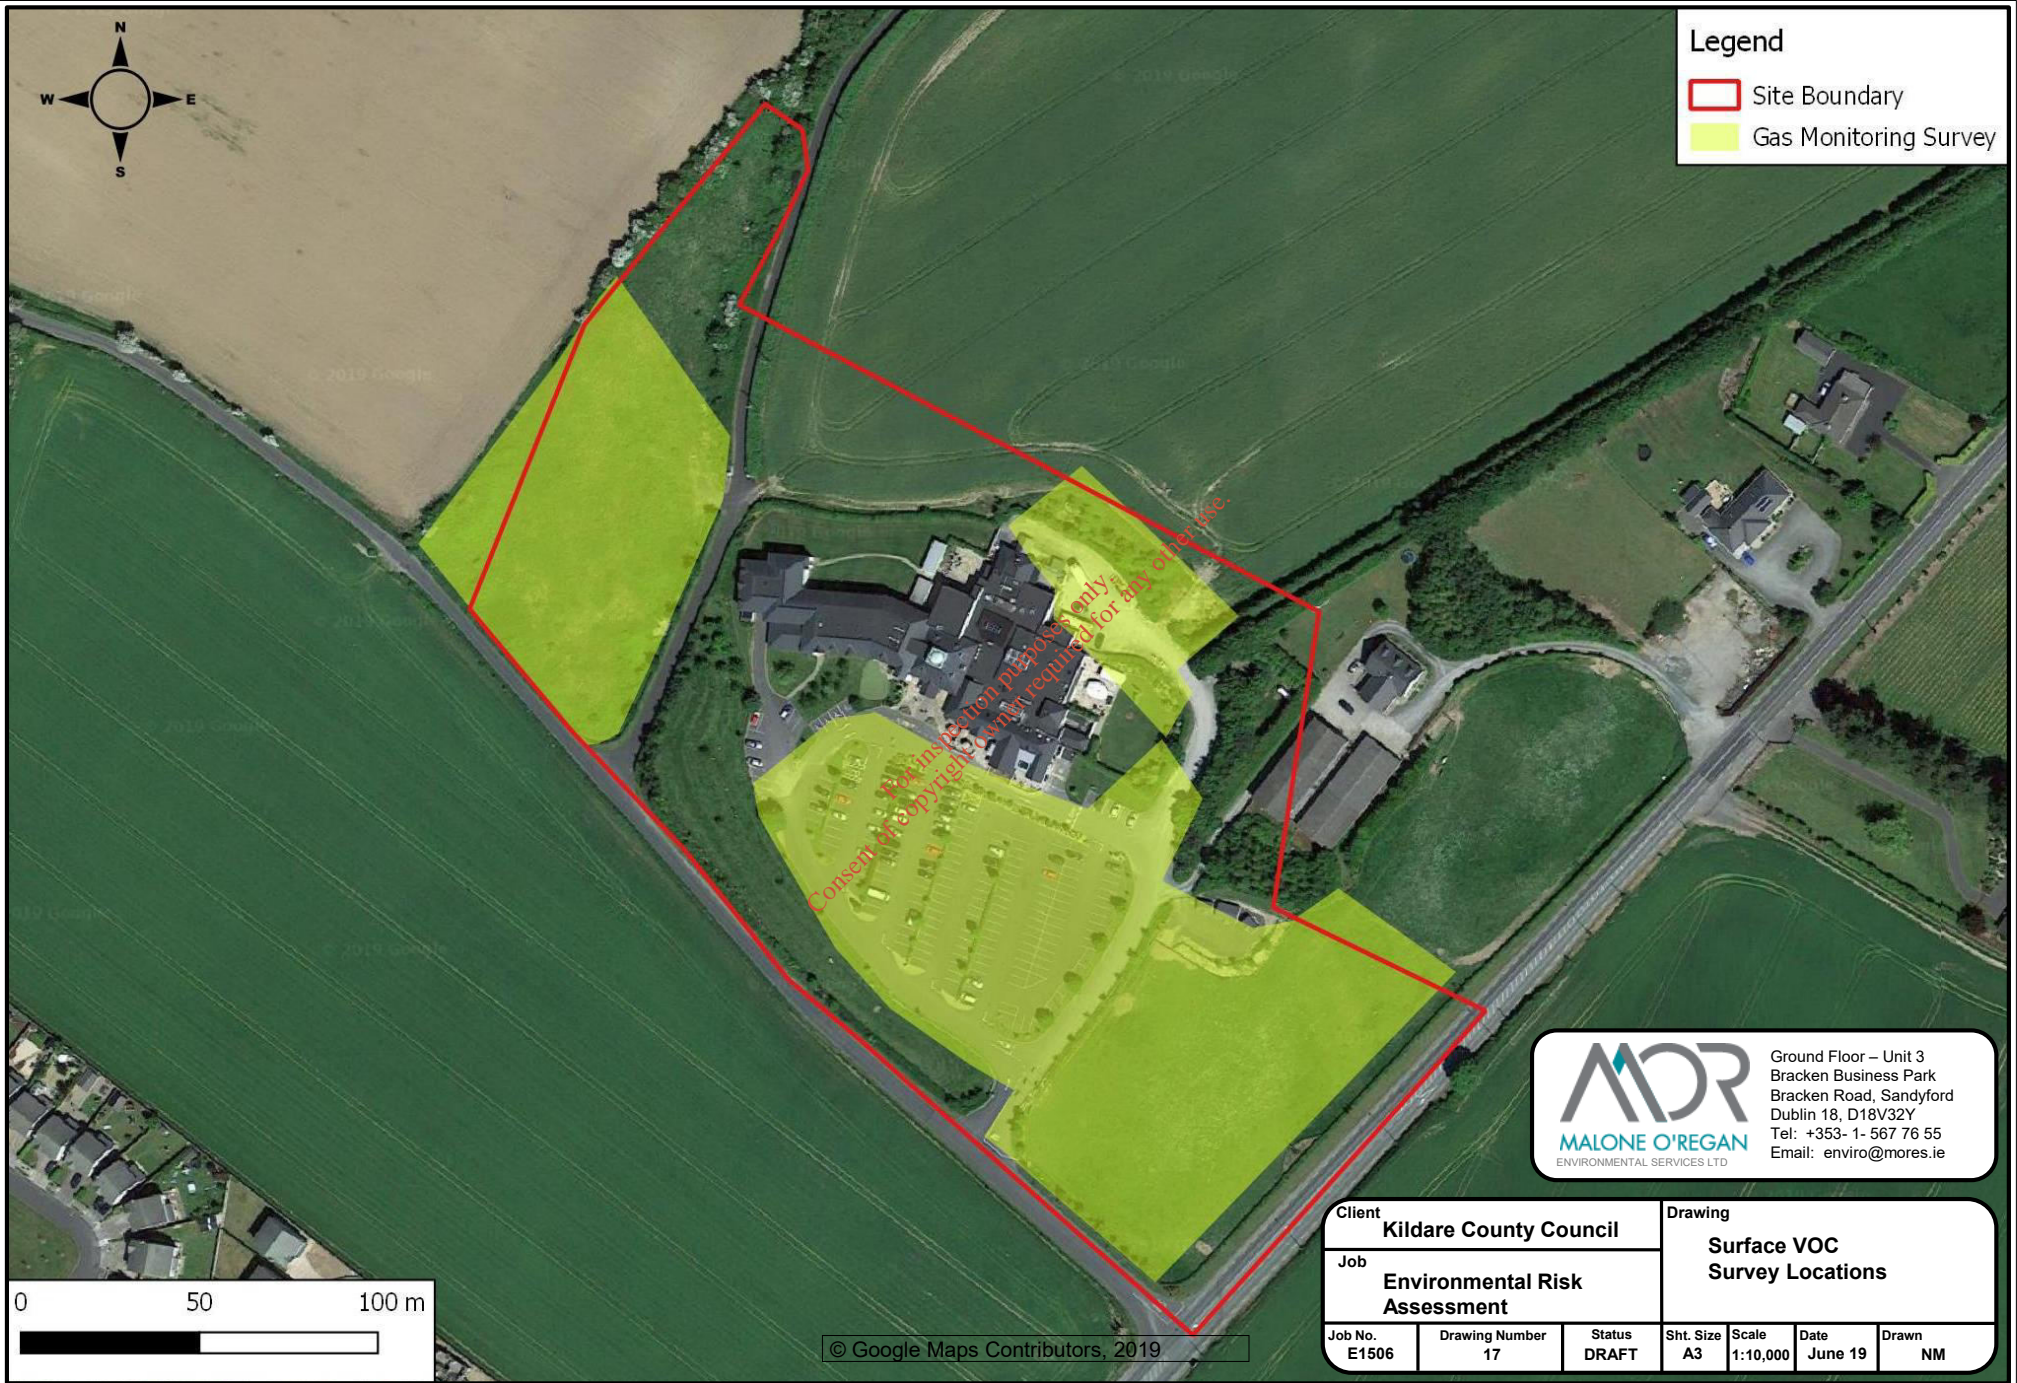
Gas Monitoring Survey

The survey was undertaken at fifty-one (51 No) locations within the Site boundary. All surface locations measured where recorded, if an elevated CH₄ reading was measured the location was noted using a handheld GPS.

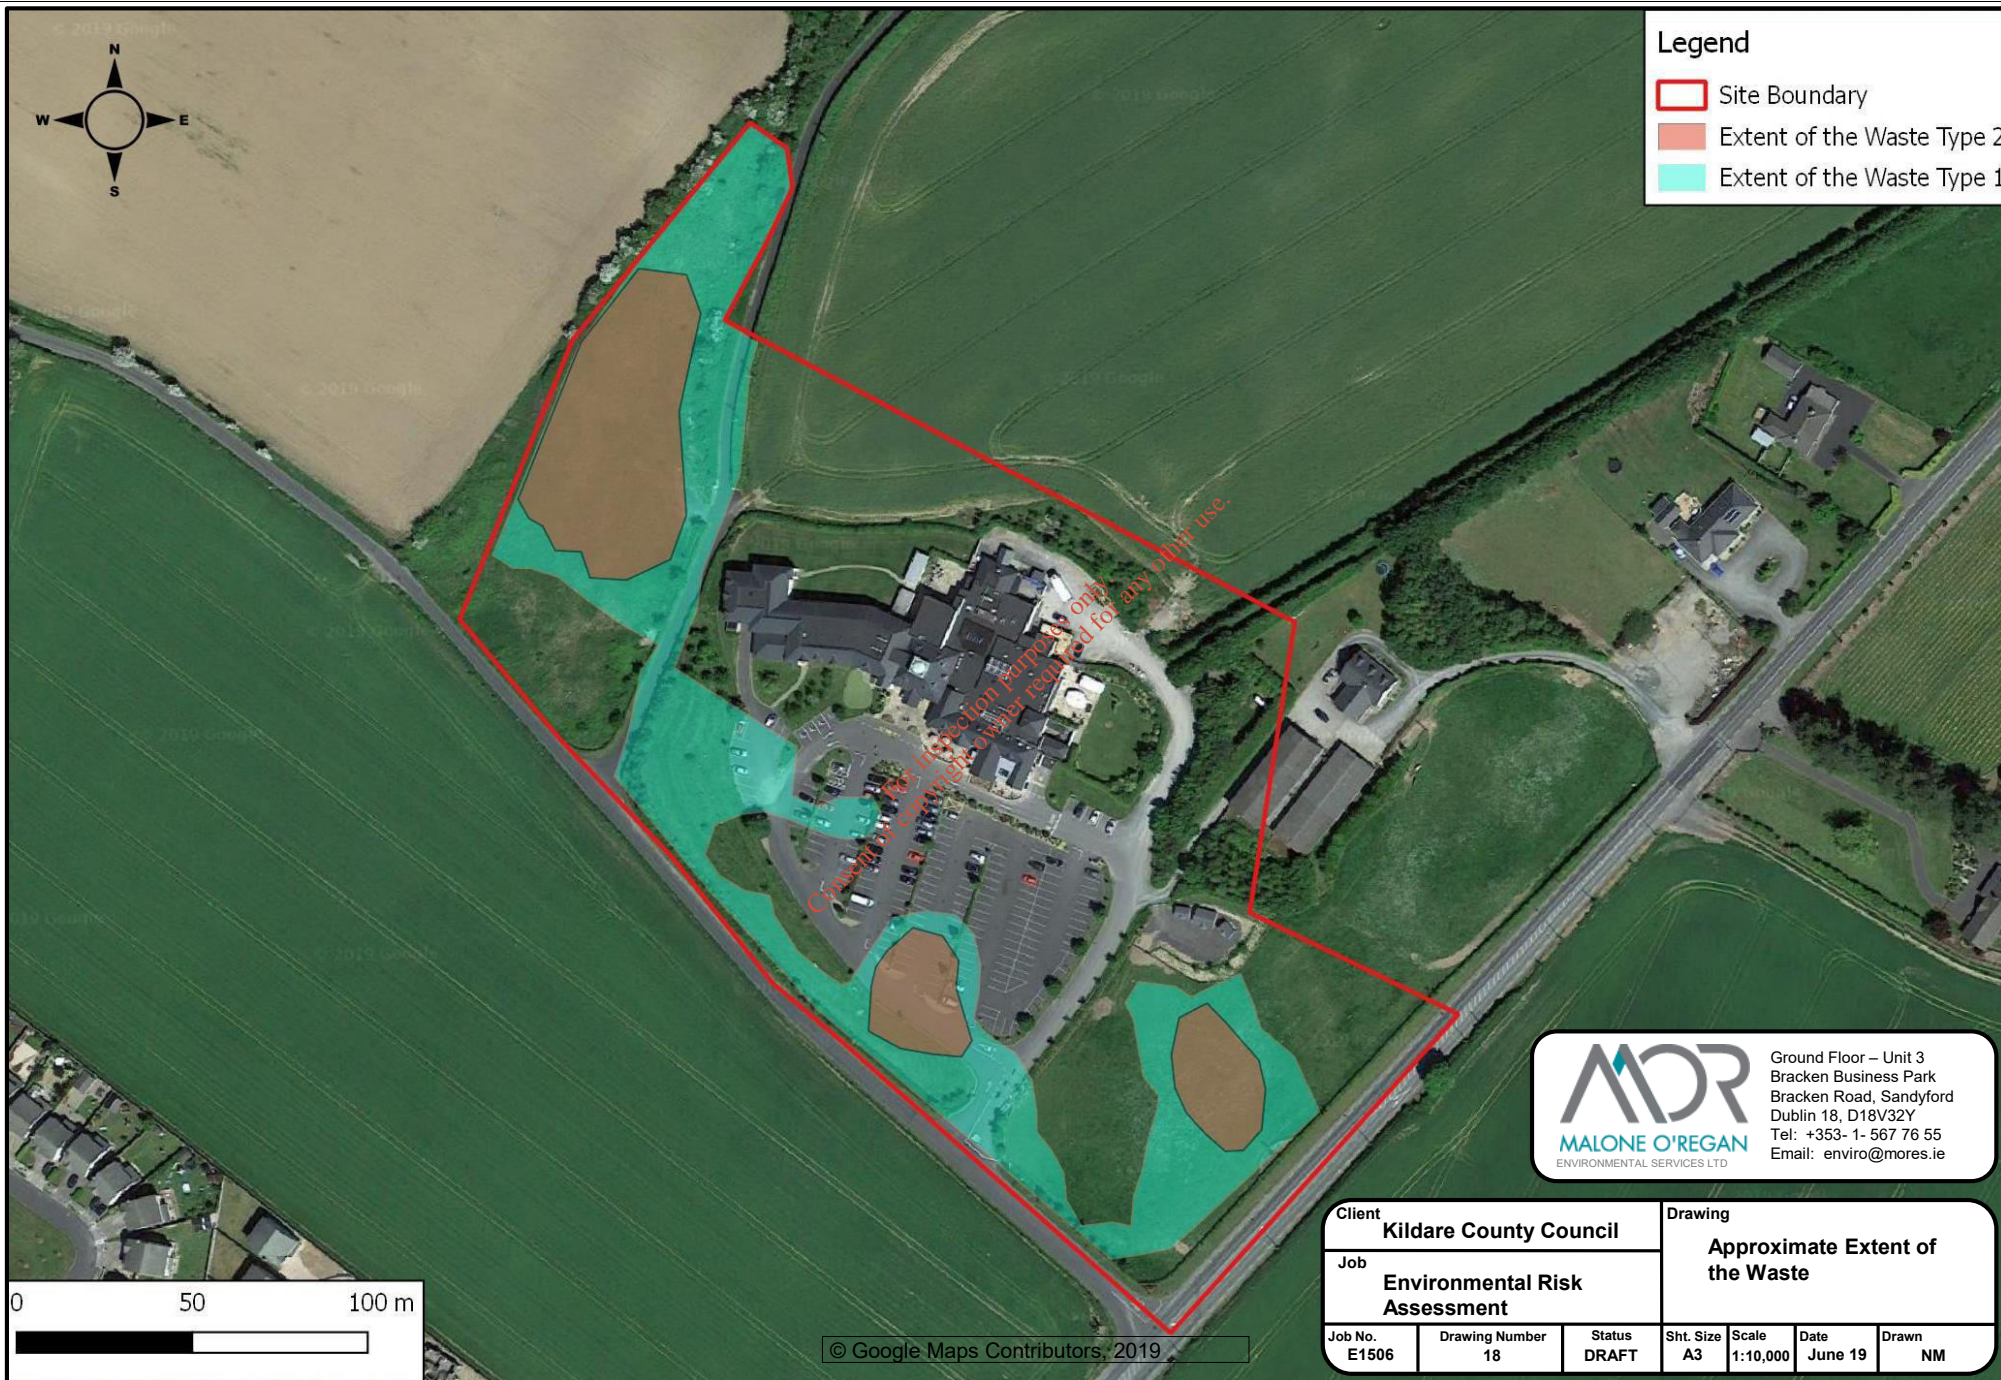
The maximum vertical extent of imported material observed during the trial pitting and borehole installation ranged from 5.1mbgl northwest of the Site to 8.5mbgl southeast of the Site. However, it is believed that the imported material extended beyond those depths. The geophysical survey (Apex Geoservices Ltd) indicated a combined thickness for both types of waste ranging from c. 0.3m in the southwest to 15.6m in the south and northwest of the Site.

- Site Boundary
- Extent of the Waste Type 2
- Extent of the Waste Type 1
