Kildare County Council

Remediation of Legacy Landfill Site at Digby Bridge, Sallins,
Co. Kildare,
Stage 1: Environmental Risk Assessment
and Remediation Plan

Attachment D1- Review of Tier 1 Risk Assessment

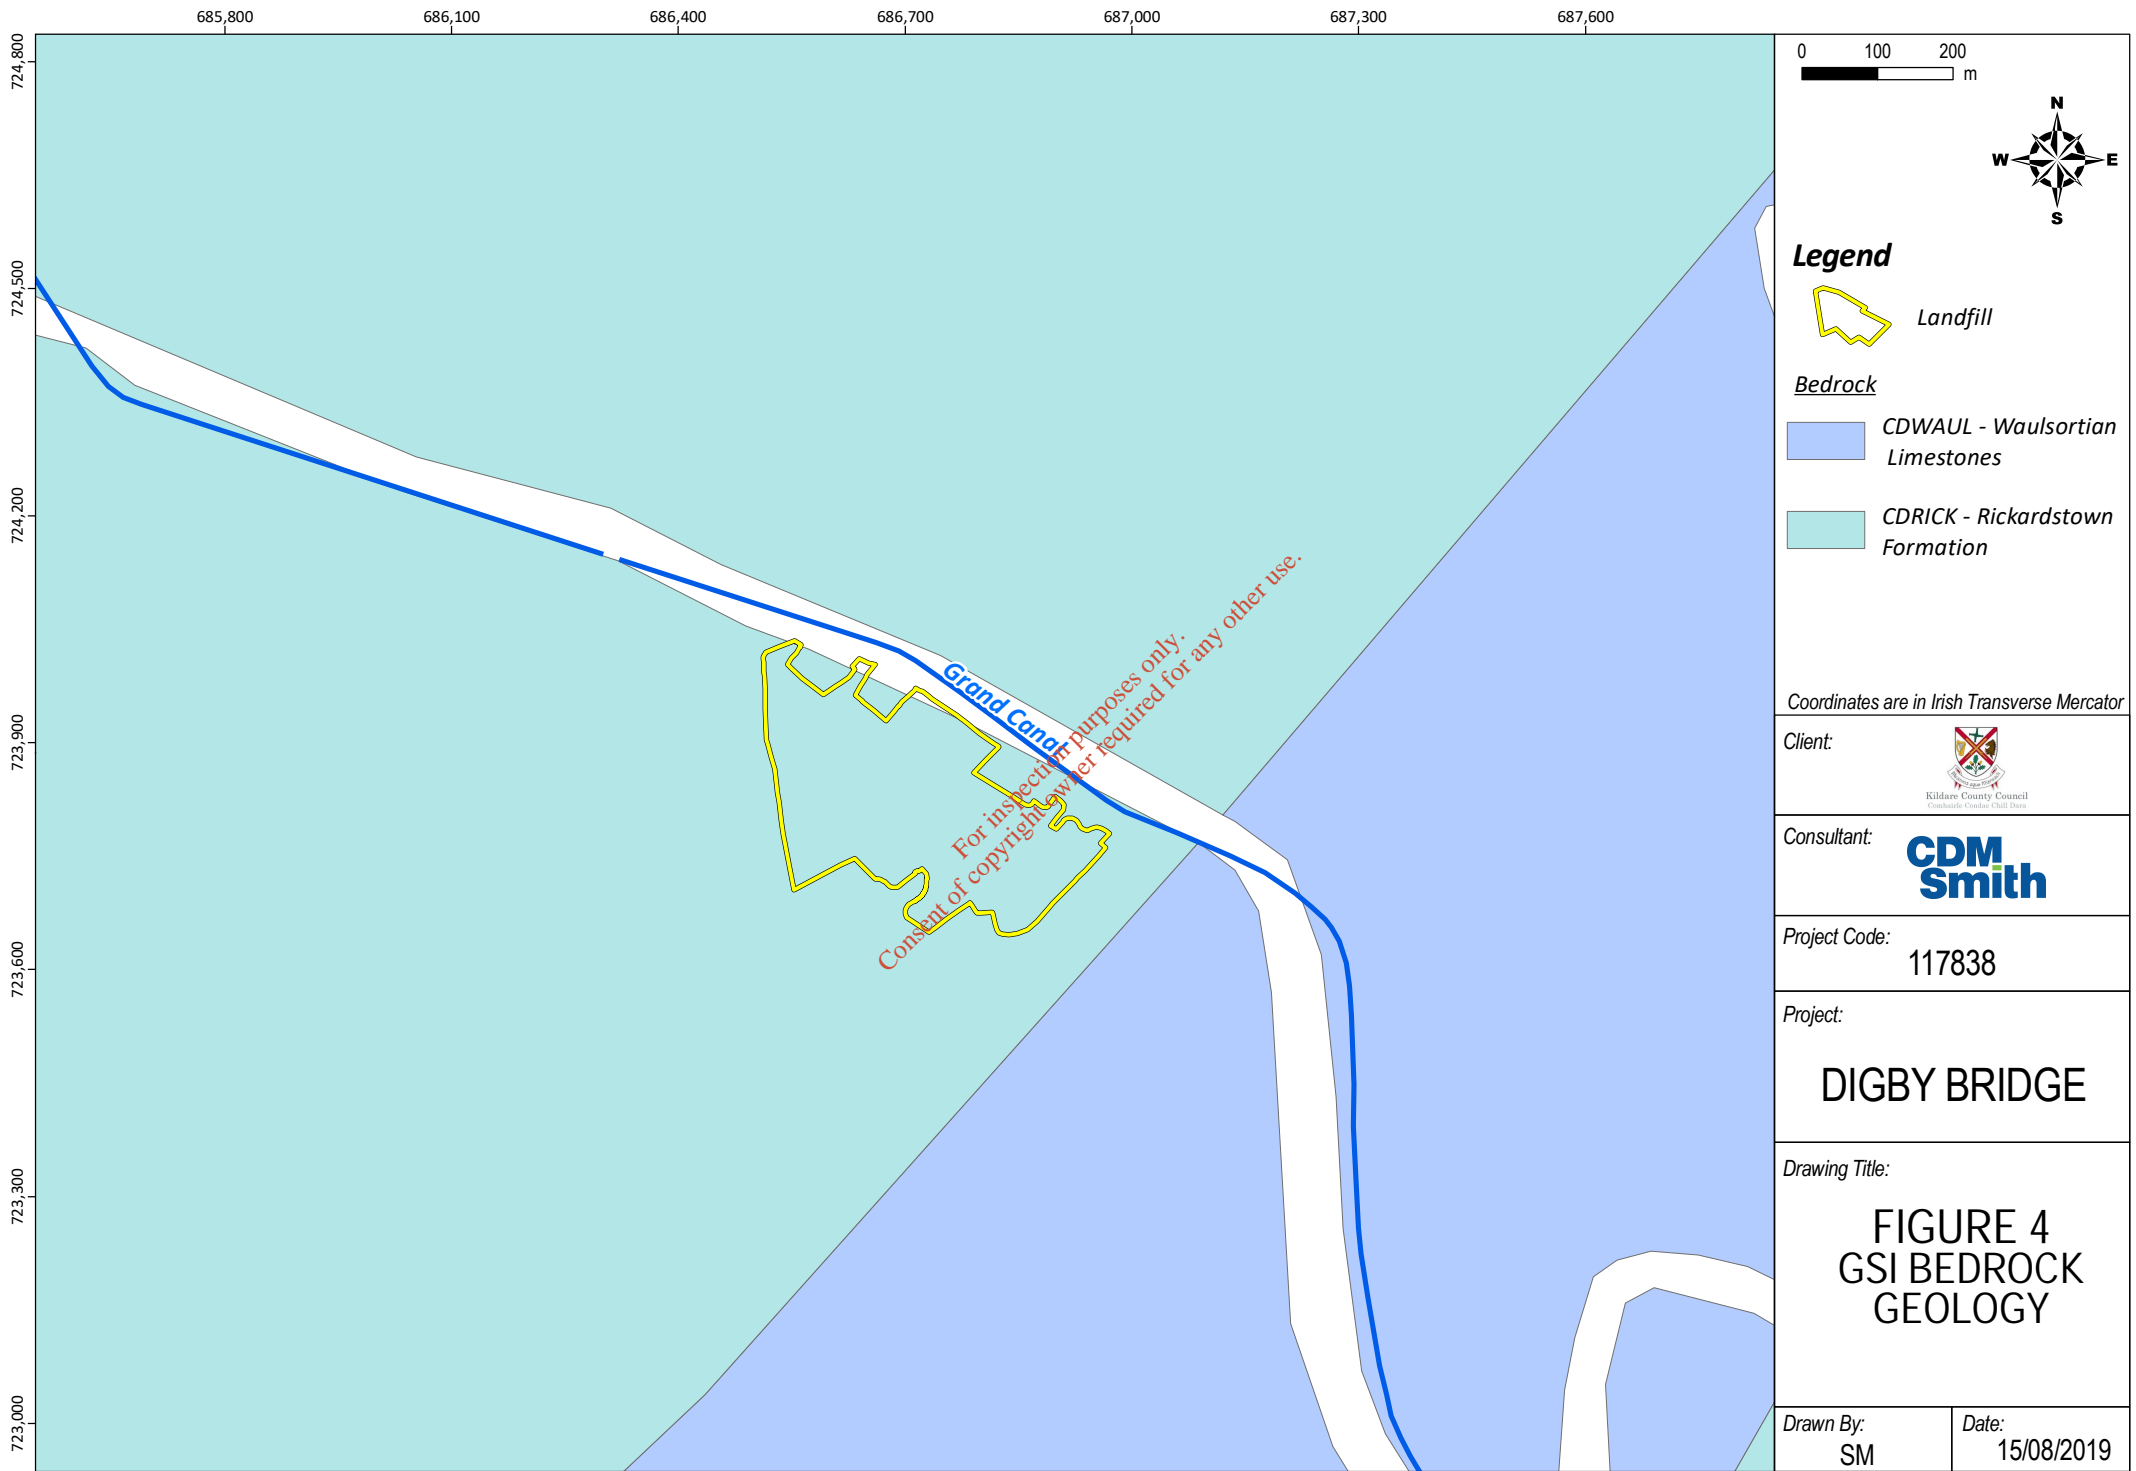
The GSI Bedrock Geology map (scale 1:100,000) shown as Figure 4 indicates the site is underlain by a massive, unbedded, cherty and often dolomitised limestone of the Rickardstown Formation. This formation is Dinantian (Lower Carboniferous), has also been described as a pure bedded limestone and is thought to be more than 100m thick. The formation is mostly surrounded by the Waulsortian limestones. The Waulsortian Limestones are massive, unbedded/crudely bedded lime-mudstones. They are of older Dinantian age and are typically 300m to 500m thick.

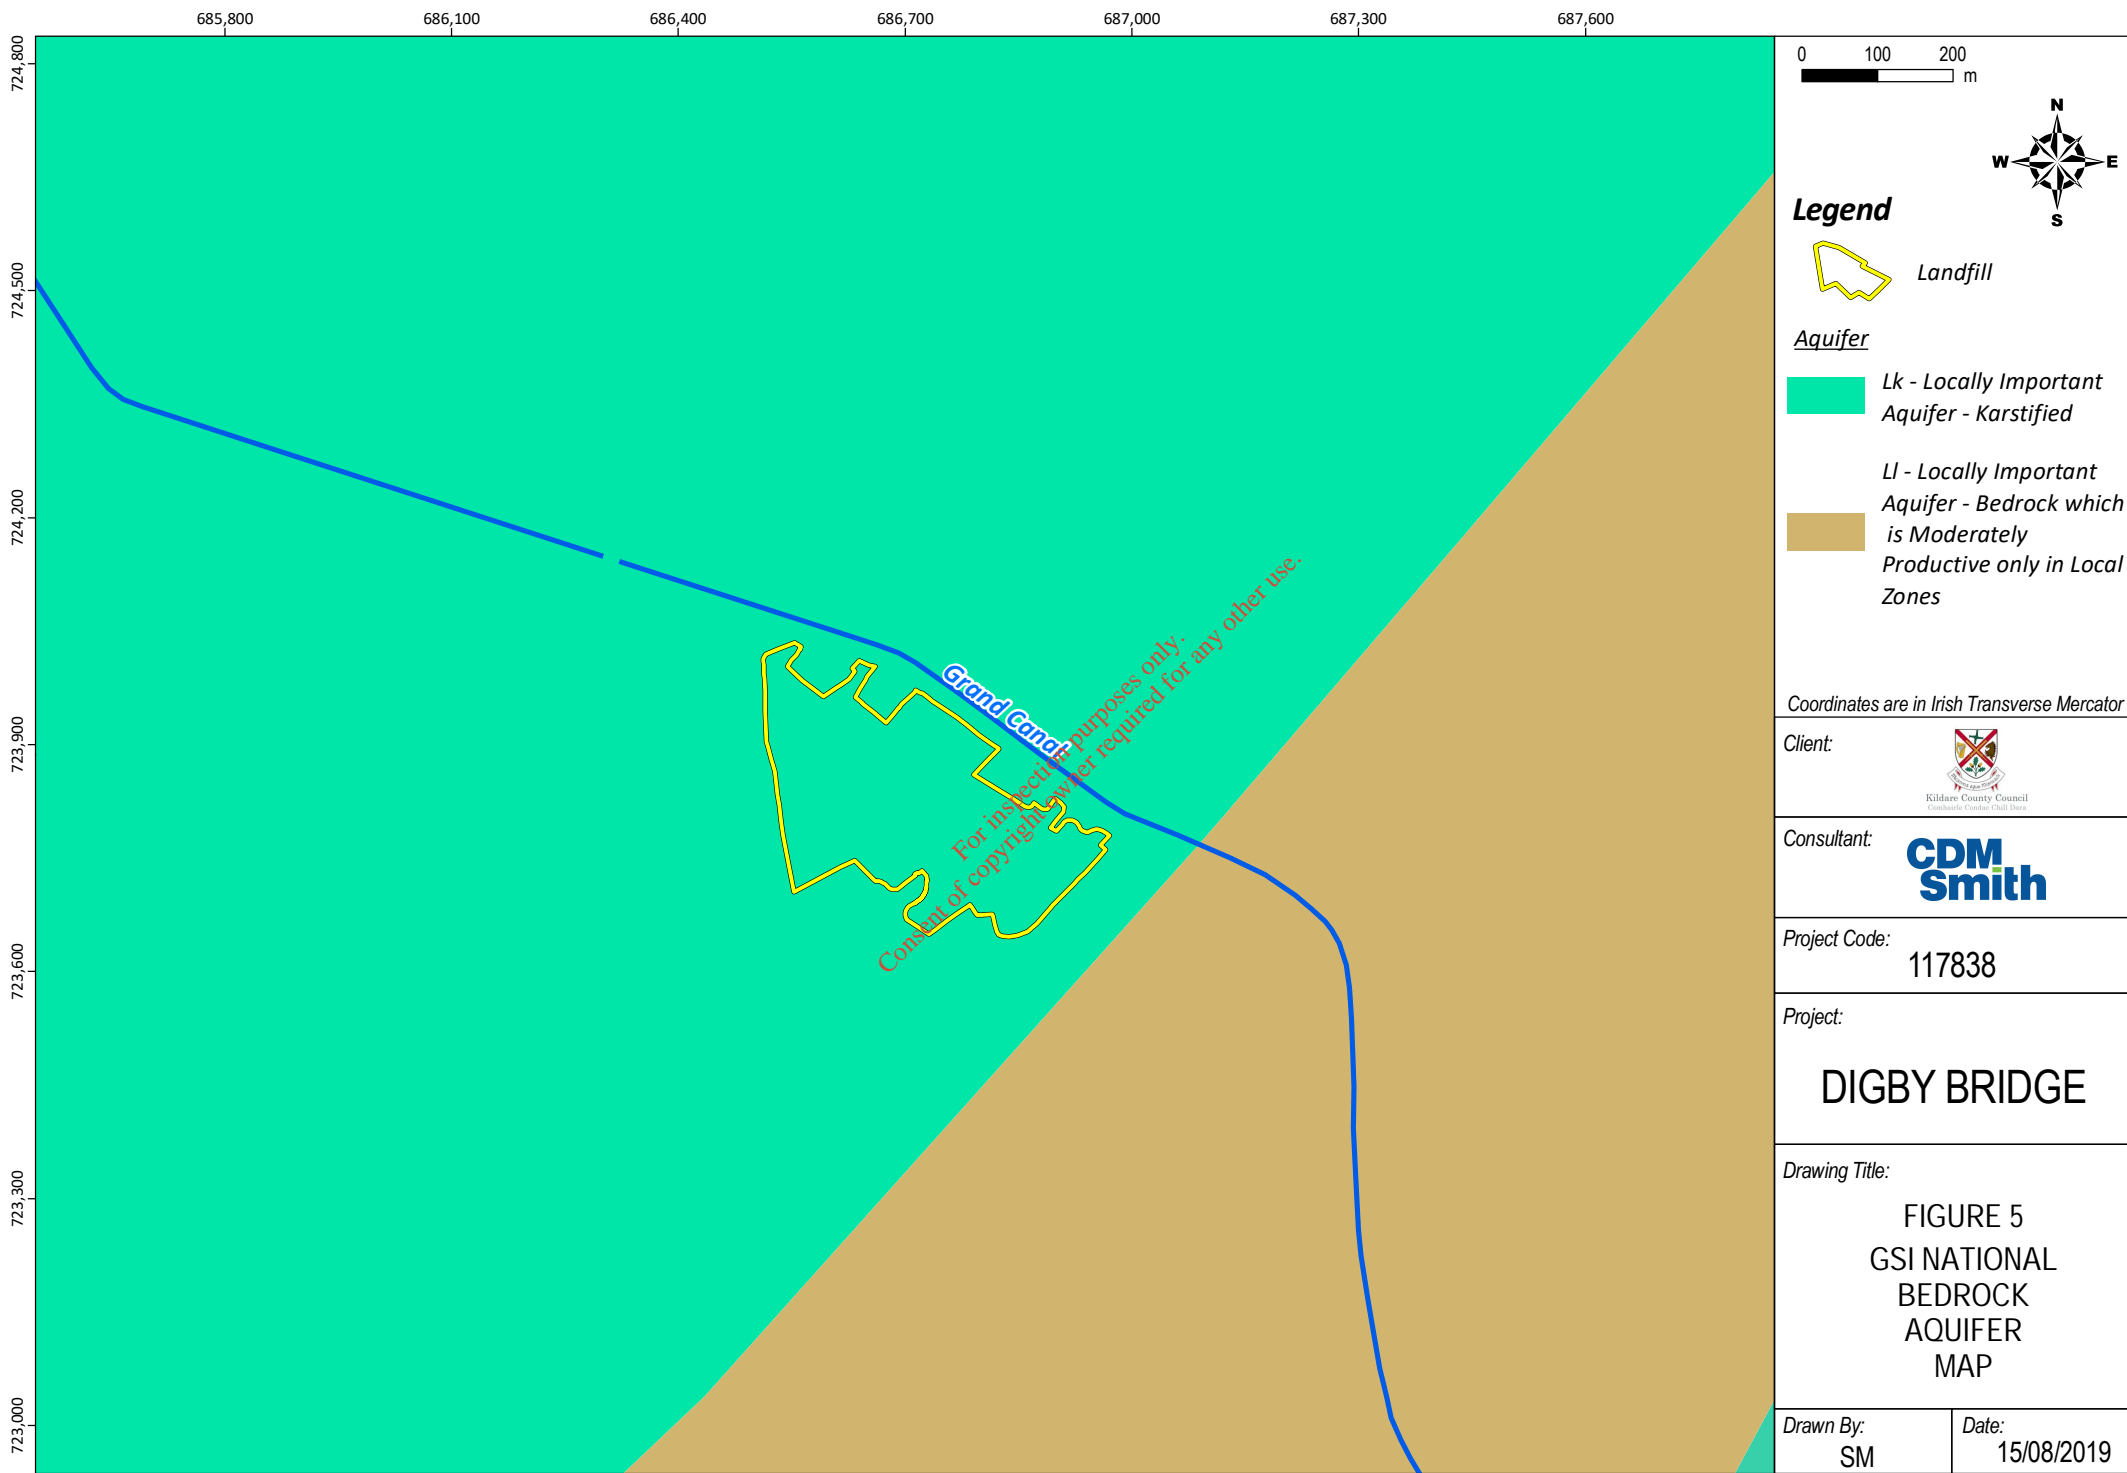
The GSI National Bedrock Aquifer map is shown as Figure 5, this identifies the site as being underlain by a Locally Important Karstified Aquifer (Lk), the Rickardstown Formation. The eastern boundary of the site is a 100 m from the intersection between the Rickardstown Formation (Lk) and the Waulsortian Limestones. The Waulsortian Limestones are classed as a Locally Important Aquifer (LI) and are moderately productive only in local zones. The Rickardstown Formation is commonly very cherty and often dolomitised. In areas where dolomitisation has been intense, groundwater yields are found to be high.

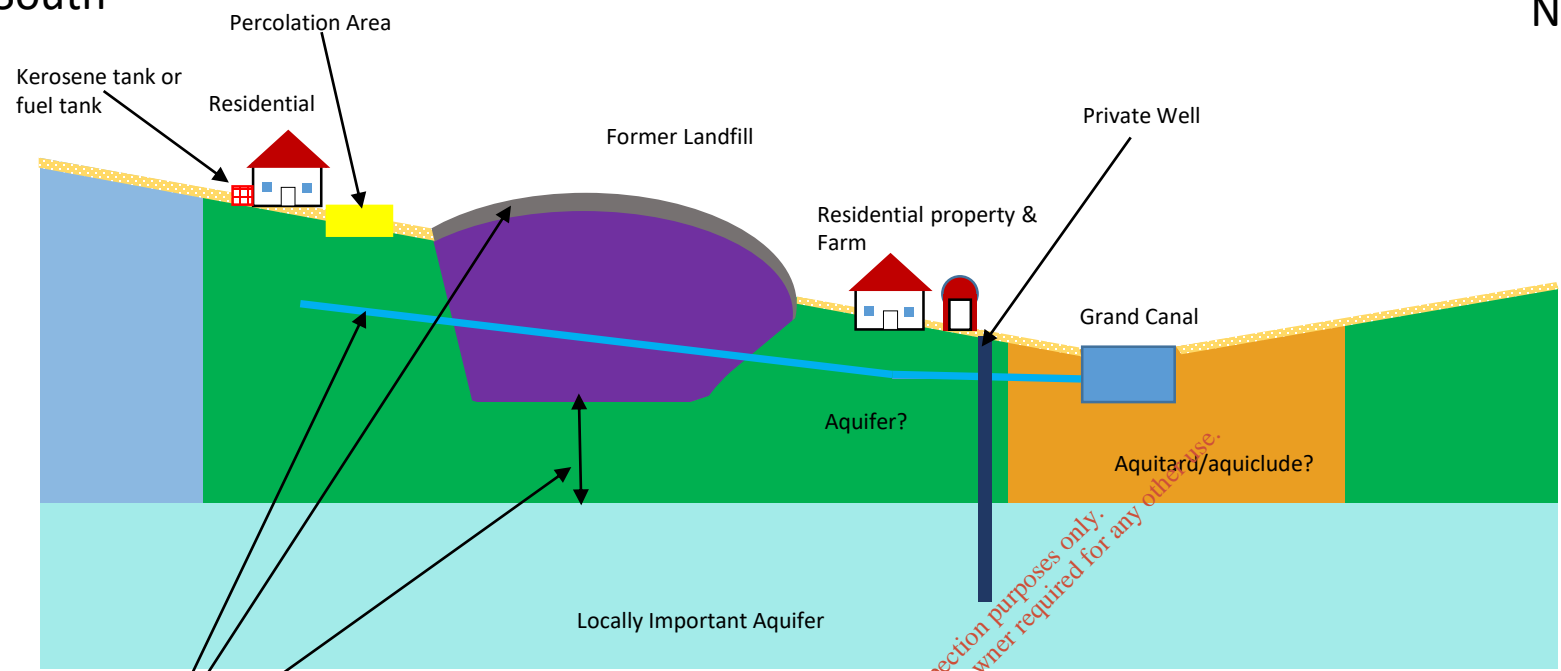
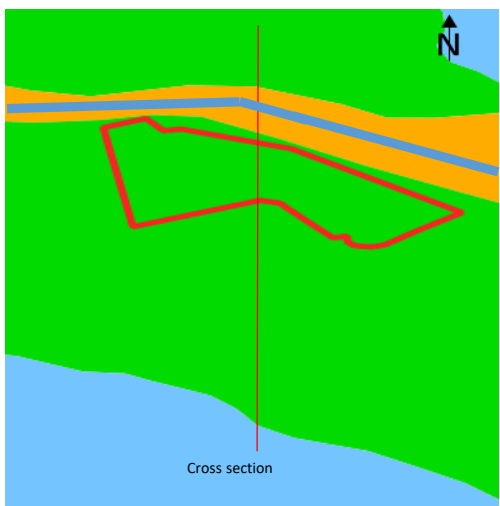
Drawing Number
FIGURE 7

1. Thickness and composition of deposits below the waste mass, is there a confining layer Between gravel deposits and the Rickardstown Formation .
2. Thickness and composition of the landfill cover.
3. The position of the water table, flow direction, connectivity with canal and waste mass.
4. Waste mass extents, composition and presence of leachate.

Title
Preliminary
Site Conceptual Model

An updated preliminary CSM is presented on Figure 7 and Figure 8.
