# Kildare County Council

Remediation of Legacy Landfill Site at Digby Bridge, Sallins,  
Co. Kildare,  
Stage 1: Environmental Risk Assessment  
and Remediation Plan

## Attachment D1-Tier 2 Report Tier 2 Report: Site Investigations and Testing

May 2020

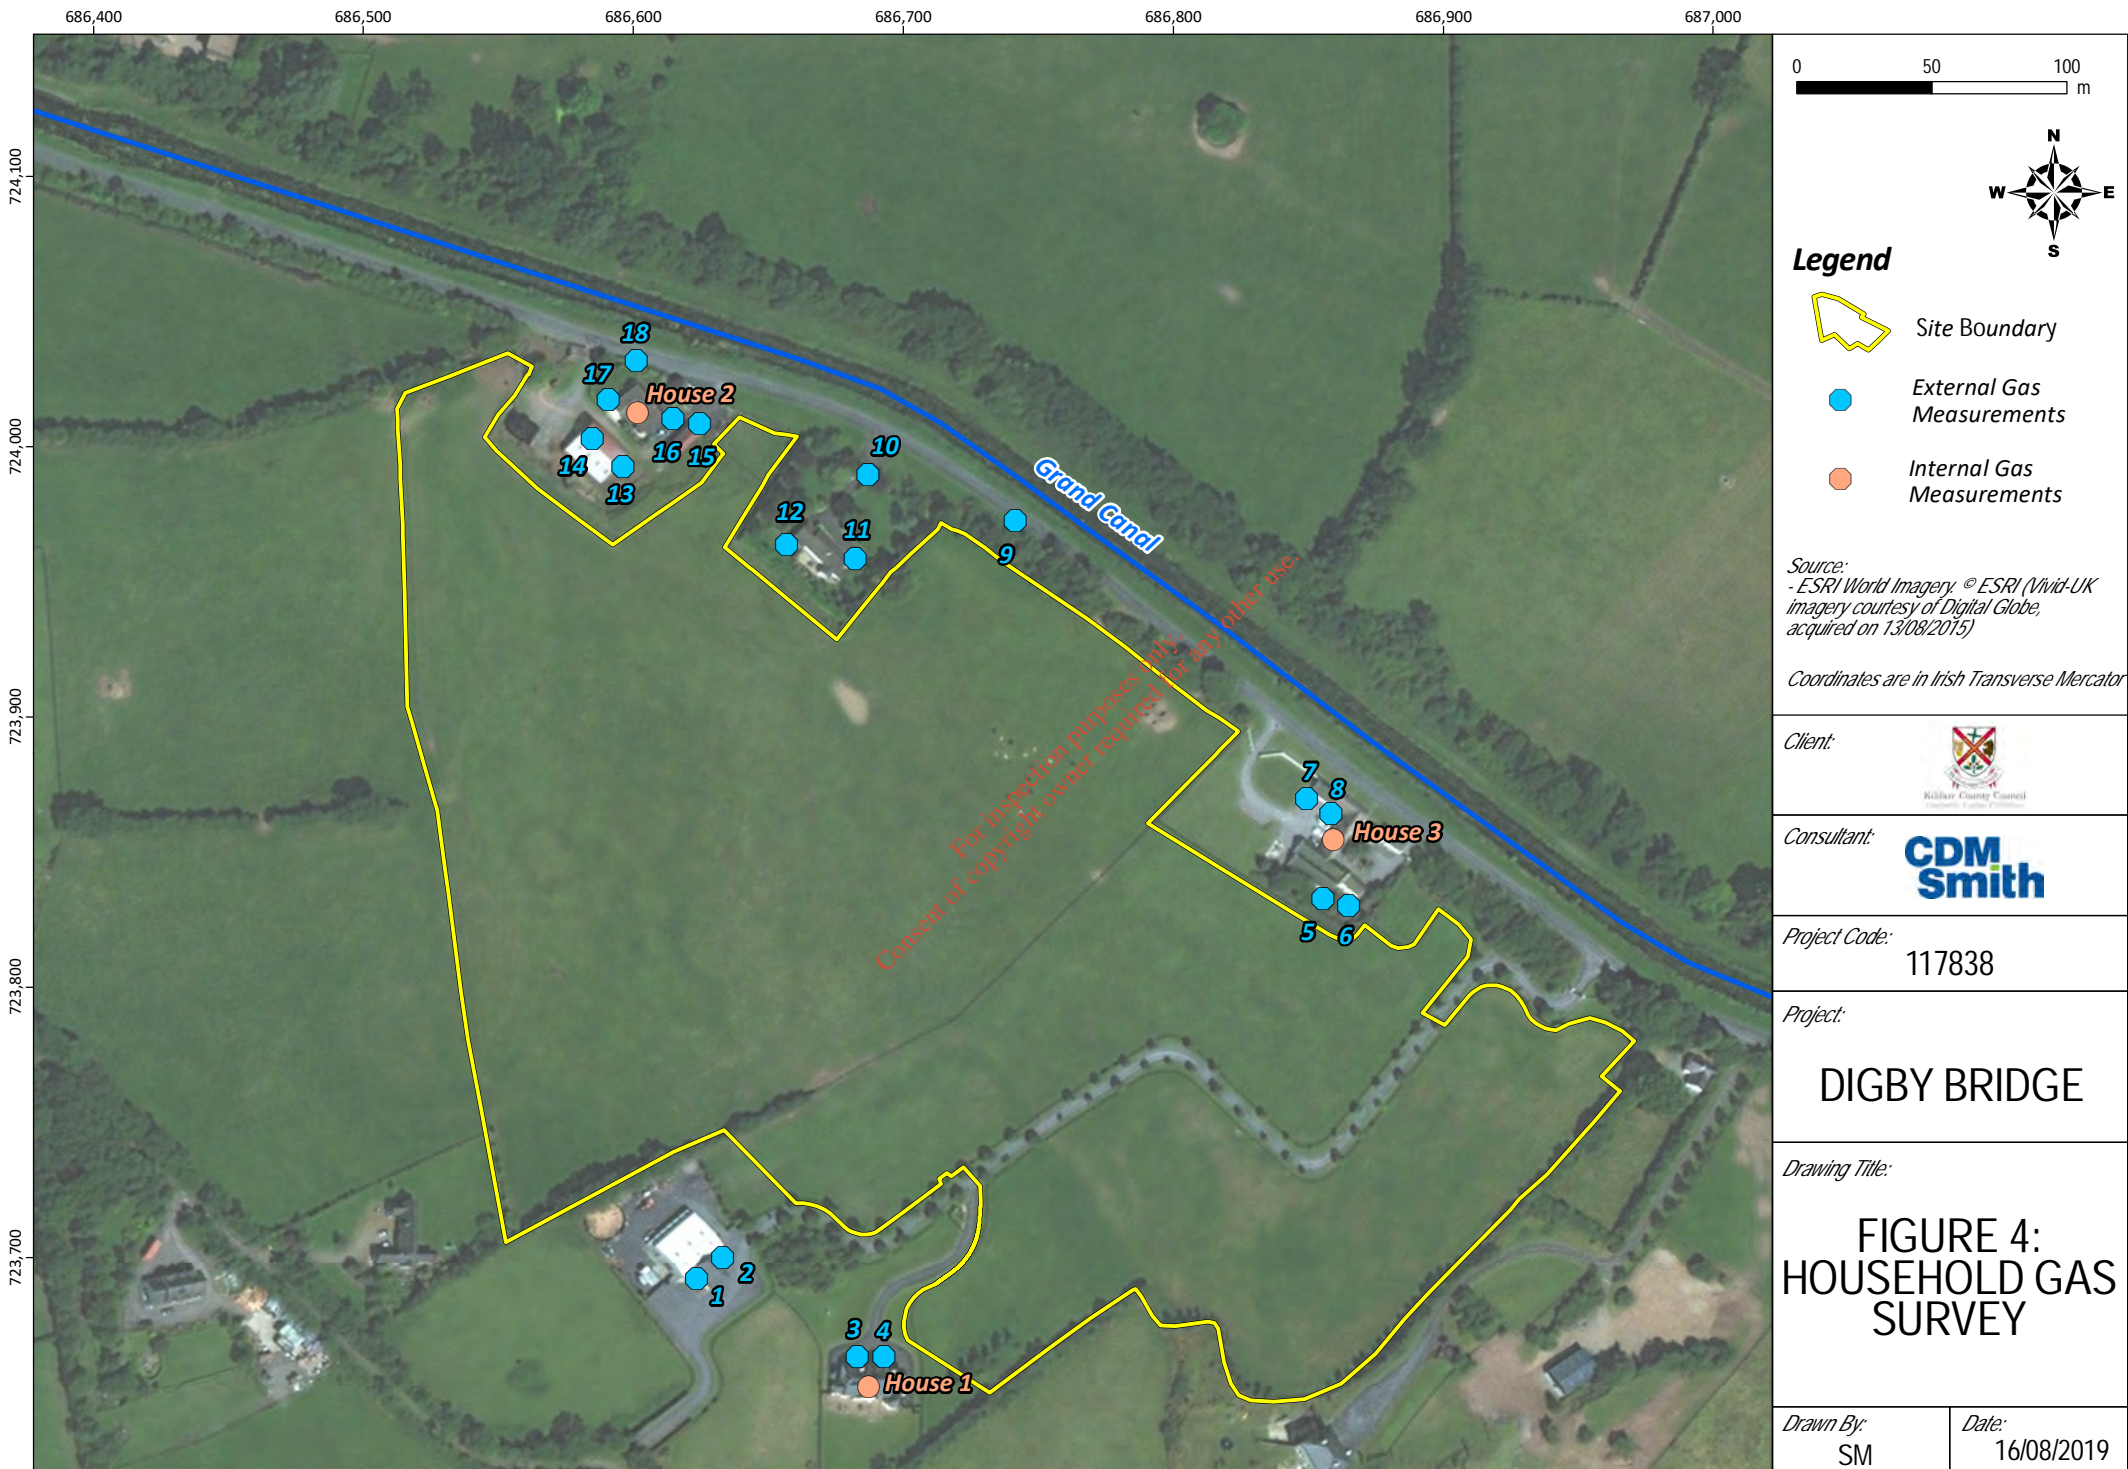
sumps, trenches, cracks and drains in concrete retaining. The locations which were surveyed are shown on Figure 4. The highlighted houses in Figure 4 were entered with householder permission by a CDM Smith employee on 25 June 2019 to obtain readings with a landfill gas (LFG) analyser. Readings were taken from plugholes within the resident's home. The results of the survey are presented in Table 15 and Table 16, and a discussion can be found in Section 3.6.2.

The external gas property survey was conducted between 16 and 18 October 2018 at the locations shown on Figure 4, the results are shown in Table 15. The FID did not detect any gases, measuring zero for the duration of the survey.

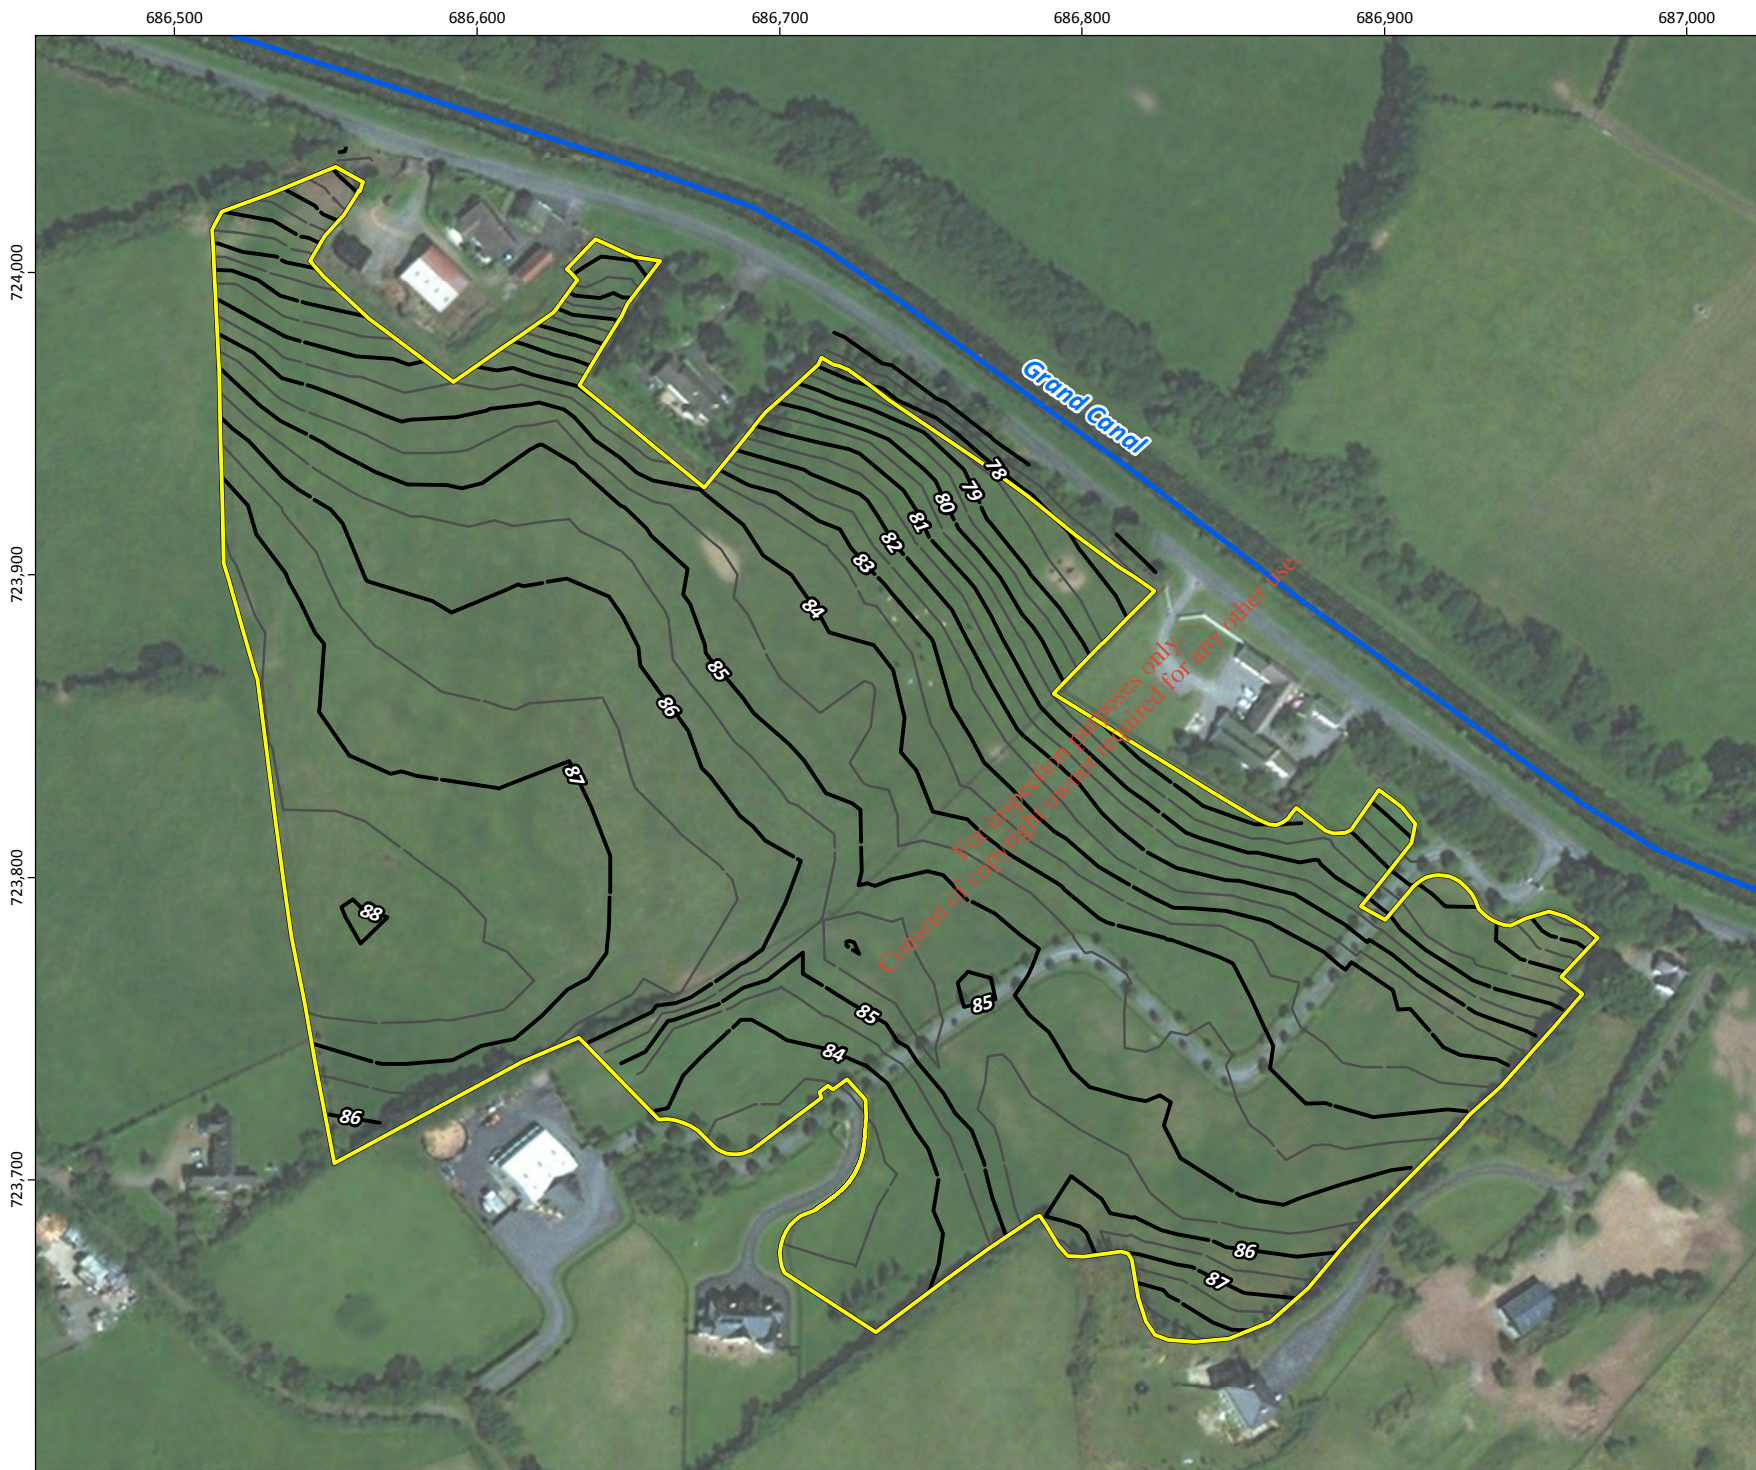
The site is managed for agricultural purposes; the land is cleared of scrub, covered with short grass and gently slopes from south to north as shown in Figure 5. The site is divided by fences delineating field boundaries. There are signs of settlement in places, this occurs within the extents of the waste body footprint on, the settlement may be related to the decomposition of landfill material over time. During high precipitation events several depressions pool with water, this was observed during site visits and monitoring rounds. Suspected consolidated ridges can also be identified on site, which may define the boundary ridges of the waste body. No liners were encountered at the sides or base of the waste mass during the ground investigation. The subsidence and ridges are defined by the waste body outline shown in Figure 2.

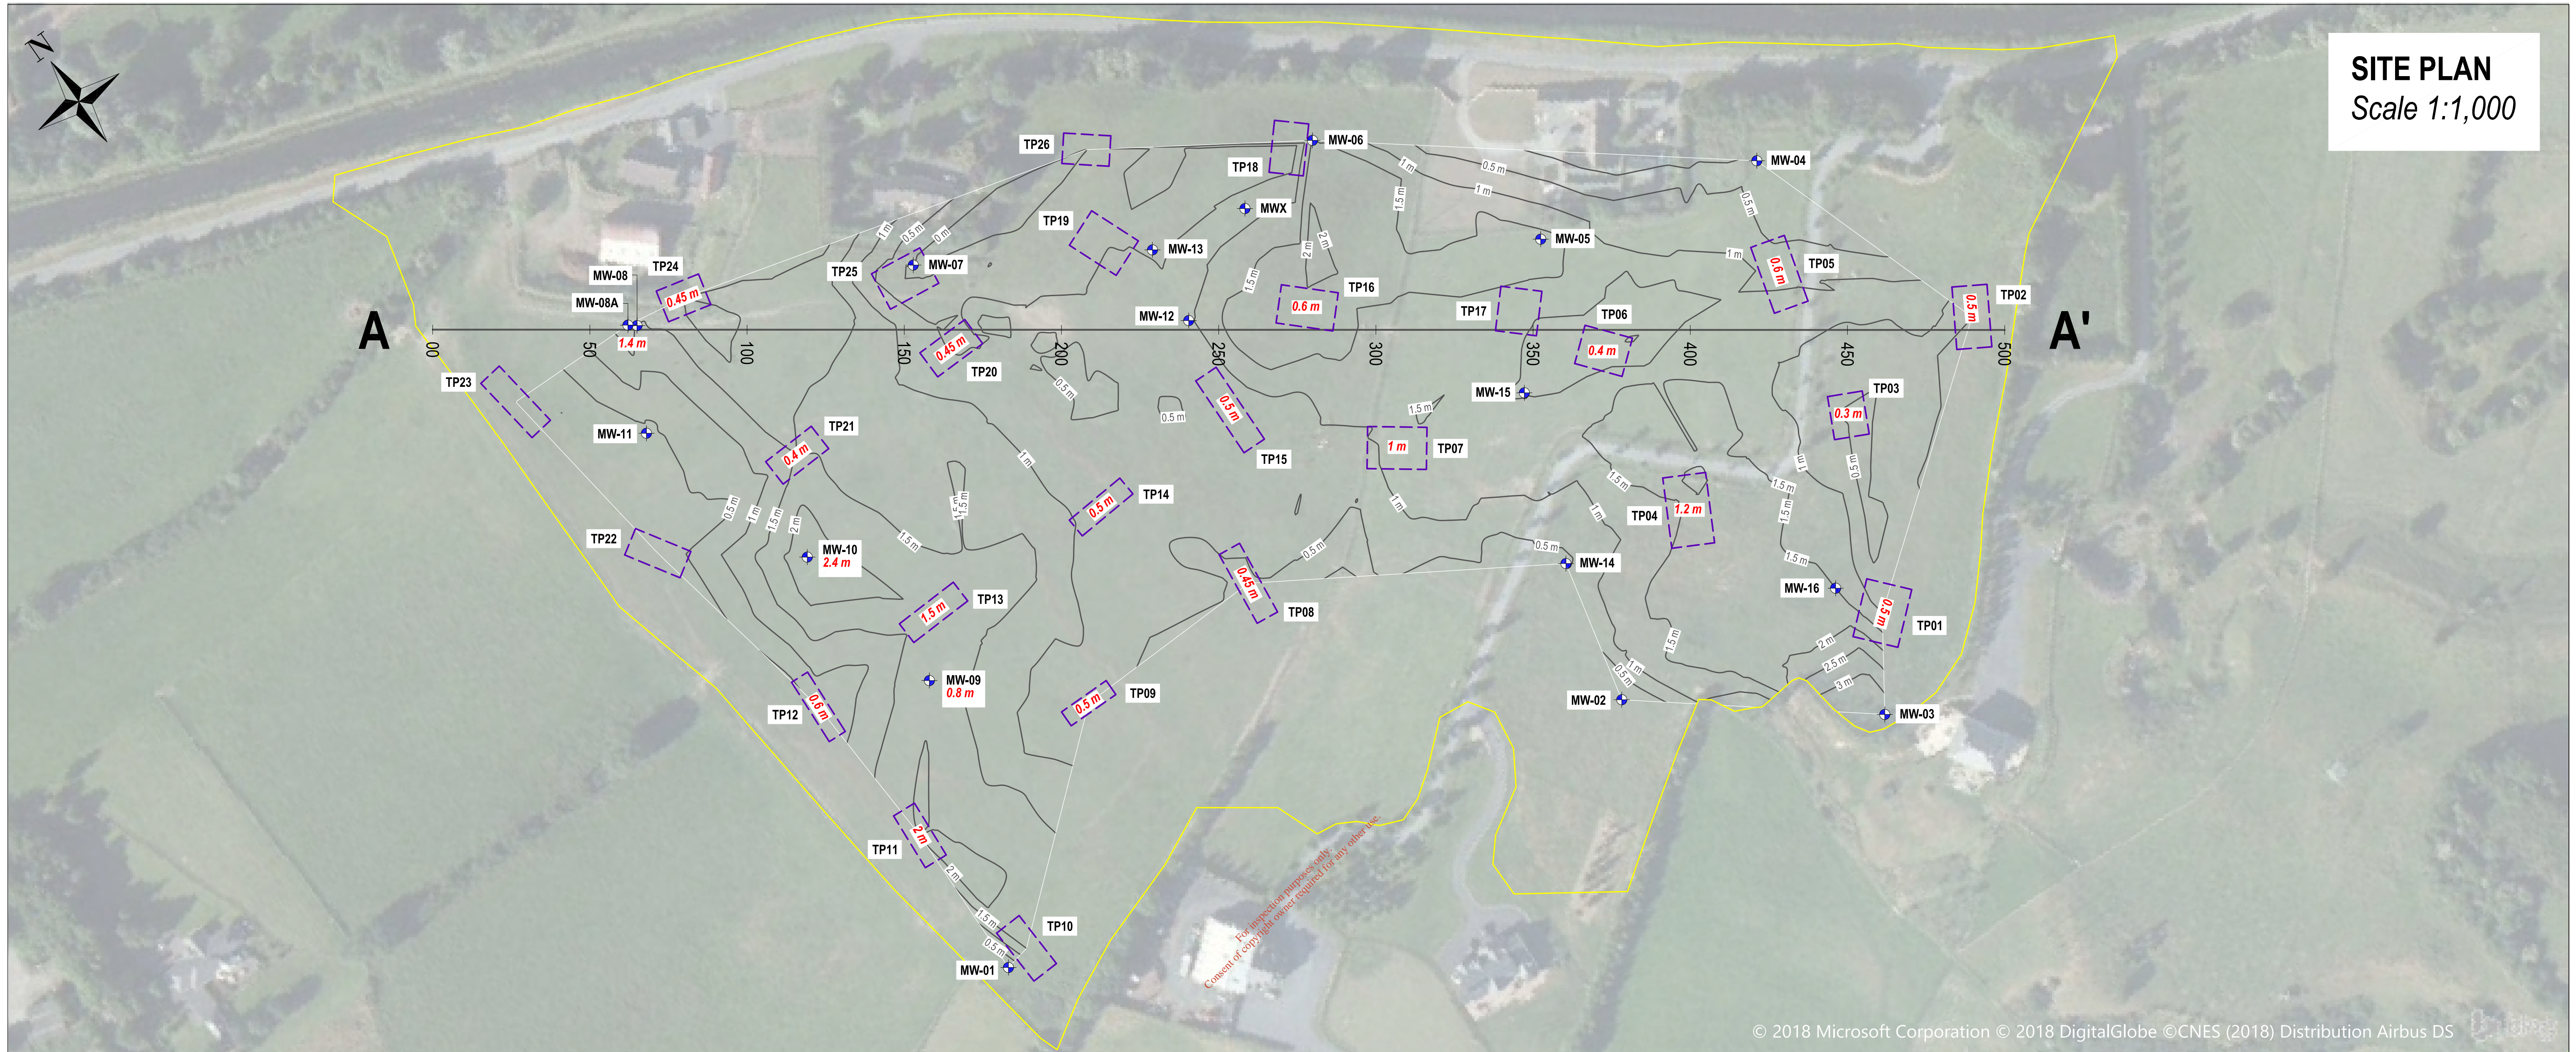
## SECTION A-A'

The geophysical survey was carried out on 1-2 November 2017. The investigation consisted of reconnaissance electromagnetic (EM) ground conductivity mapping with a follow-up of seven lines of electrical resistivity tomography (ERT) and four lines of seismic refraction profiling with associated multi-channel analysis of surface waves (MASW), as shown on Drawing AGL17263\_01

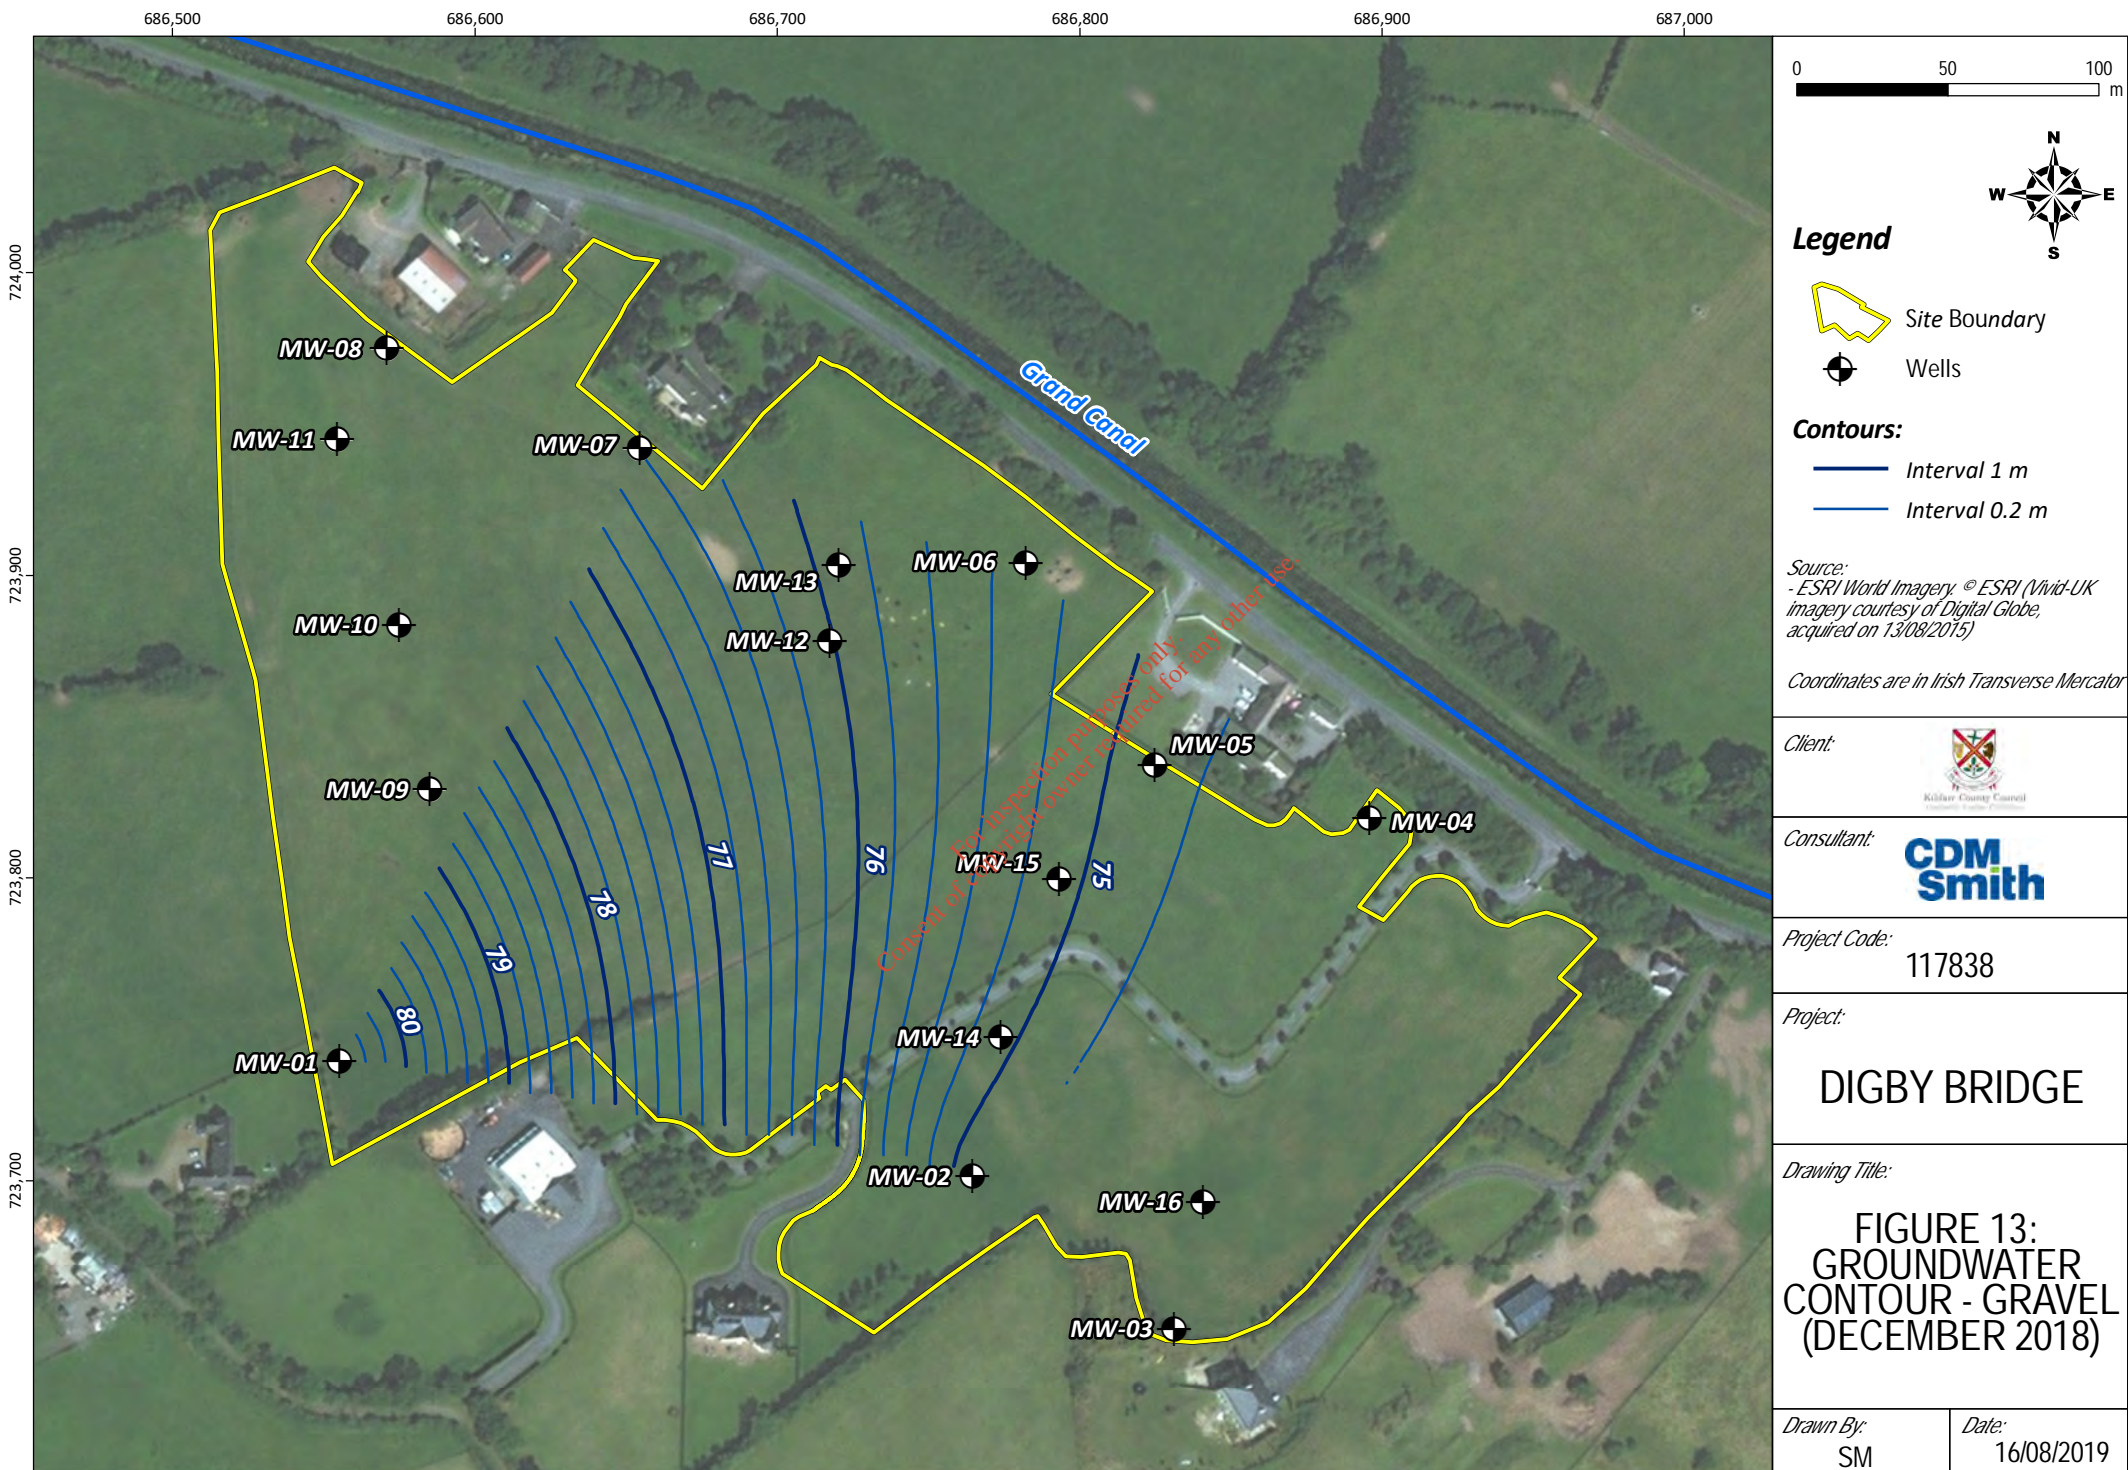
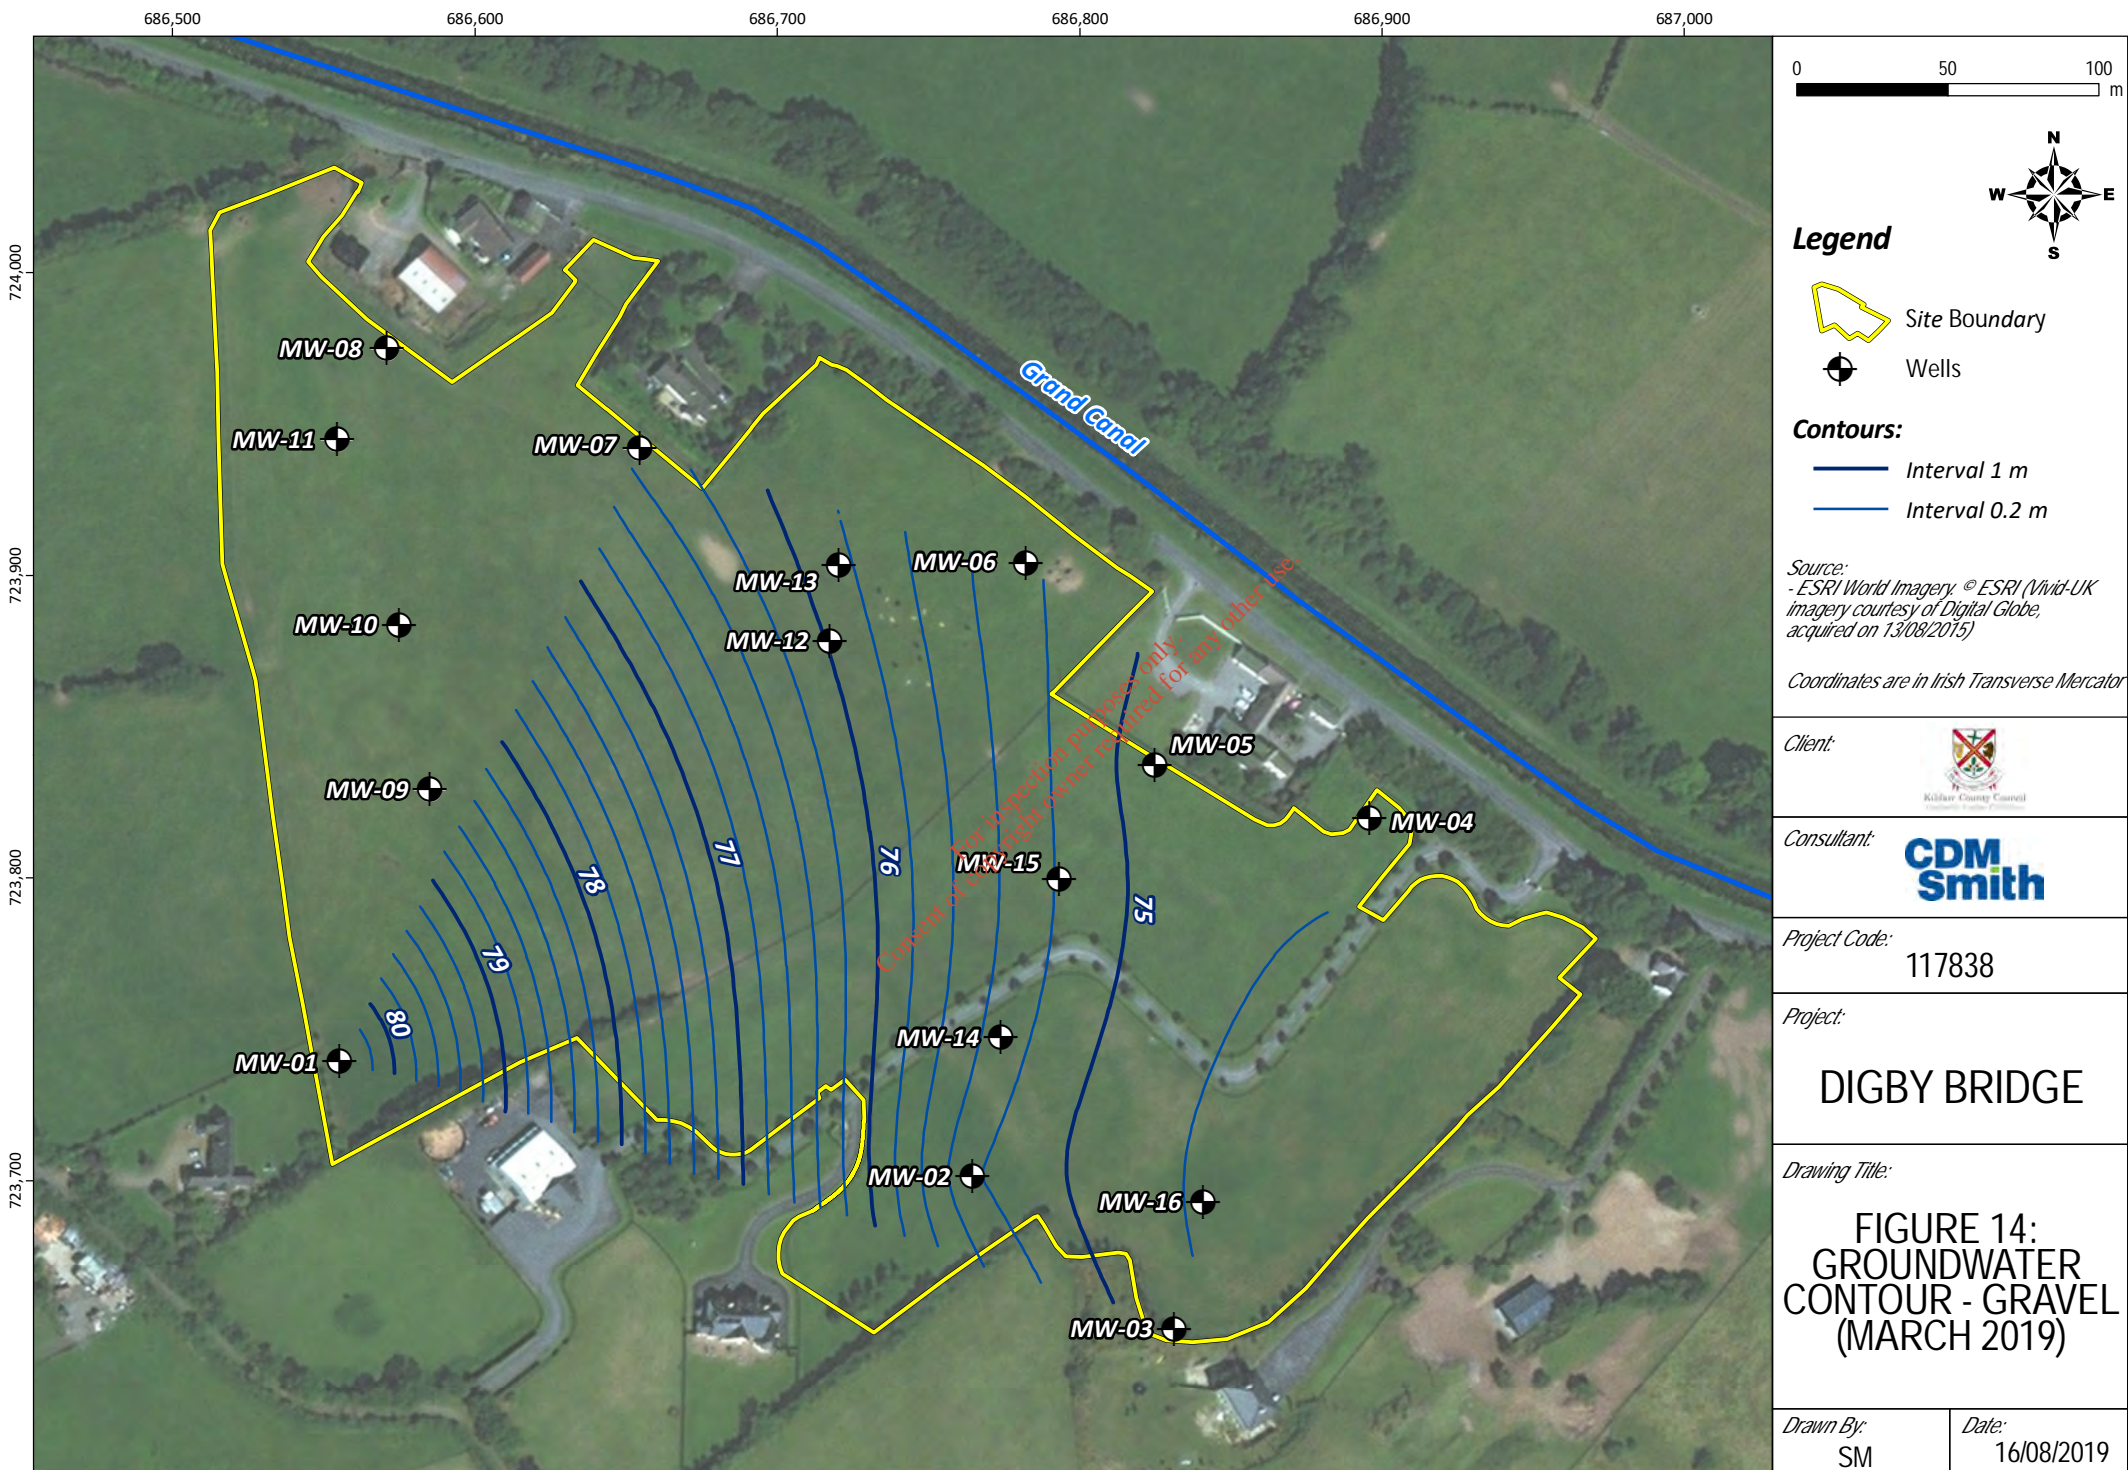
The data from monitoring wells screened in the Gravel Formation was used to produce groundwater contour plots, these are presented on Figure 13, Figure 14 and Figure 15. The contours show that the groundwater flow direction is to the north east, which follows the Gravel Formation and topography, which turns to the south east towards the River Liffey. The Gravel Formation is most likely providing baseflow to the River Liffey. As such the River Liffey is a potential receptor to any potential contaminants in the groundwater of the Gravel Formation.

To complement the water level data from the onsite monitoring wells with a response zone in the Rickardstown Formation (Lk – locally important karstified aquifer), water levels were taken from domestic wells (which were surveyed) near the site. These were used to generate a groundwater contour map shown on Figure 16, which shows the groundwater gradient in the Rickardstown Formation (Lk) moving north east.

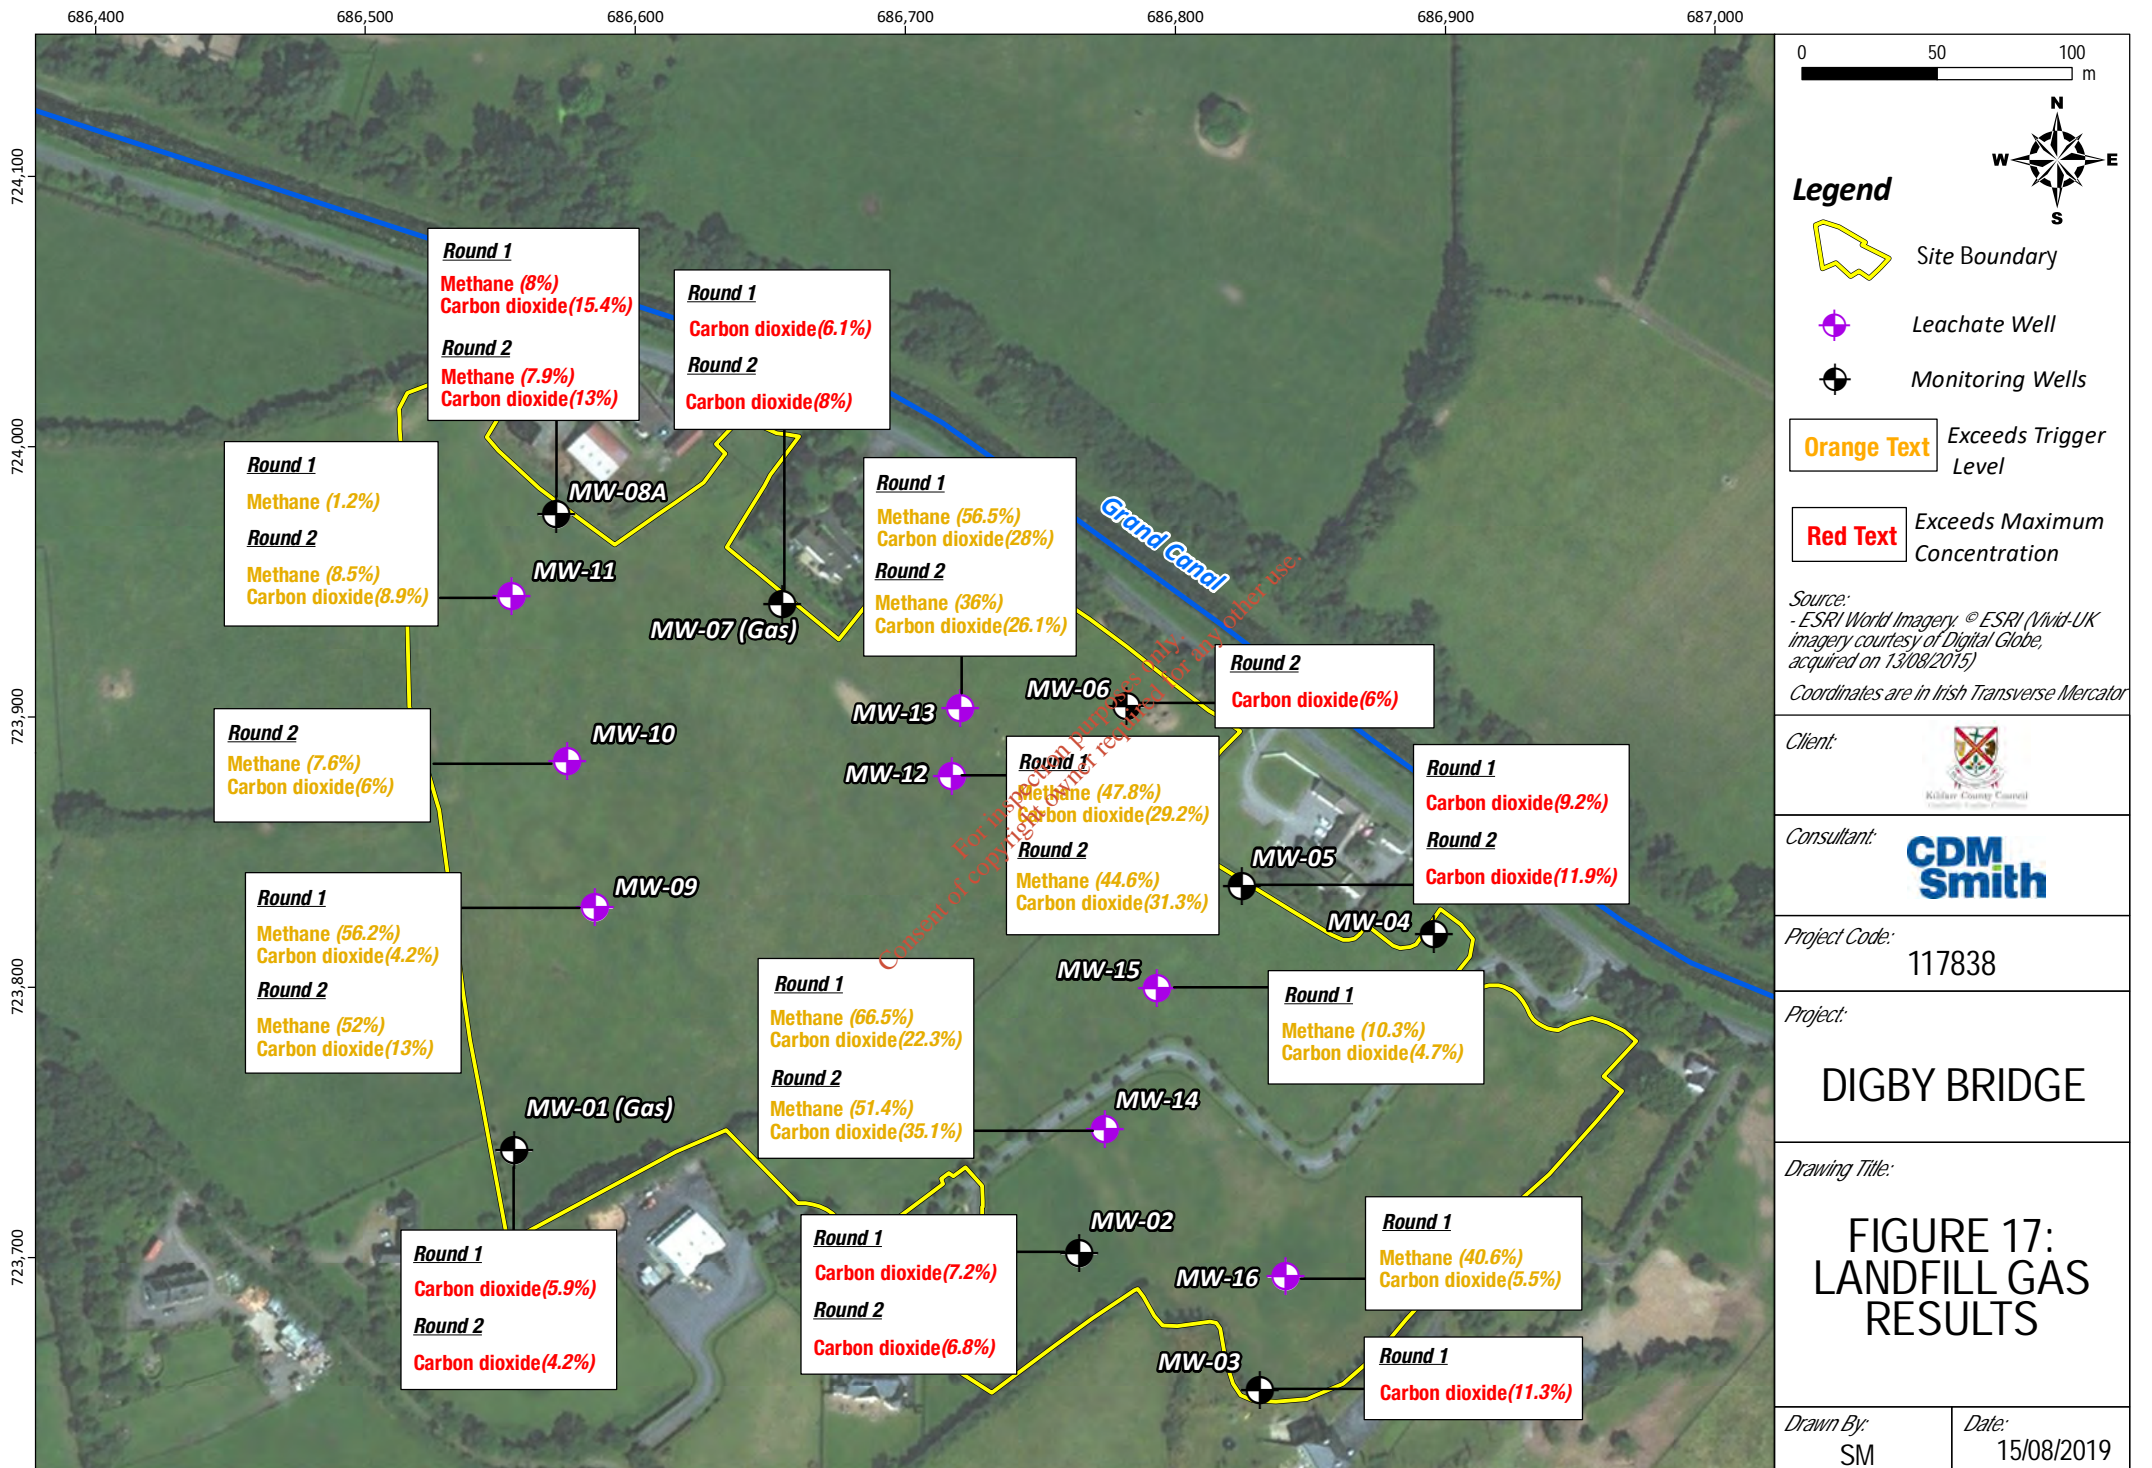
During the first round of LFG monitoring on 4 March 2019, atmospheric pressure rose from 991.4 hPa at 11:30 to 993.6 hPa at 14:00. Within the analysis window for the second round of monitoring on 26 June 2019, atmospheric pressure reduced from 1031 hPa at 13:00 to 1030.8 hPa at 16:00. The annual average of atmospheric pressure in Ireland falls within 1010 and 1020 hPa. A summary description of the results is listed below:

- Trigger level exceedances of CO<sub>2</sub> outside the waste body were detected in all monitoring wells except for MW04, ranging from 4.2 to 15.4% v/v;
- Exceeding concentrations of CO<sub>2</sub> inside the landfill were detected in all leachate wells, ranging from 4.2 to 35.1% v/v;
- A trigger level exceedance of CH<sub>4</sub> outside the waste body was detected in monitoring well MW08A, between 7.9 and 8.0% v/v in each round. An elevated concentration of CH<sub>4</sub> was detected in MW03, at 0.8% v/v; and
- Exceeding concentrations of CH<sub>4</sub> inside the landfill were detected in all leachate wells, ranging from 1.2 to 66.5% v/v.
