## TIER 2 RISK ASSESSMENT

SCOTCH CORNER HISTORIC LANDFILL SITE,  
LETTERBANE, CO. MONAGHAN

# TIER 2 RISK ASSESSMENT

## SCOTCH CORNER HISTORIC LANDFILL SITE, CO. MONAGHAN

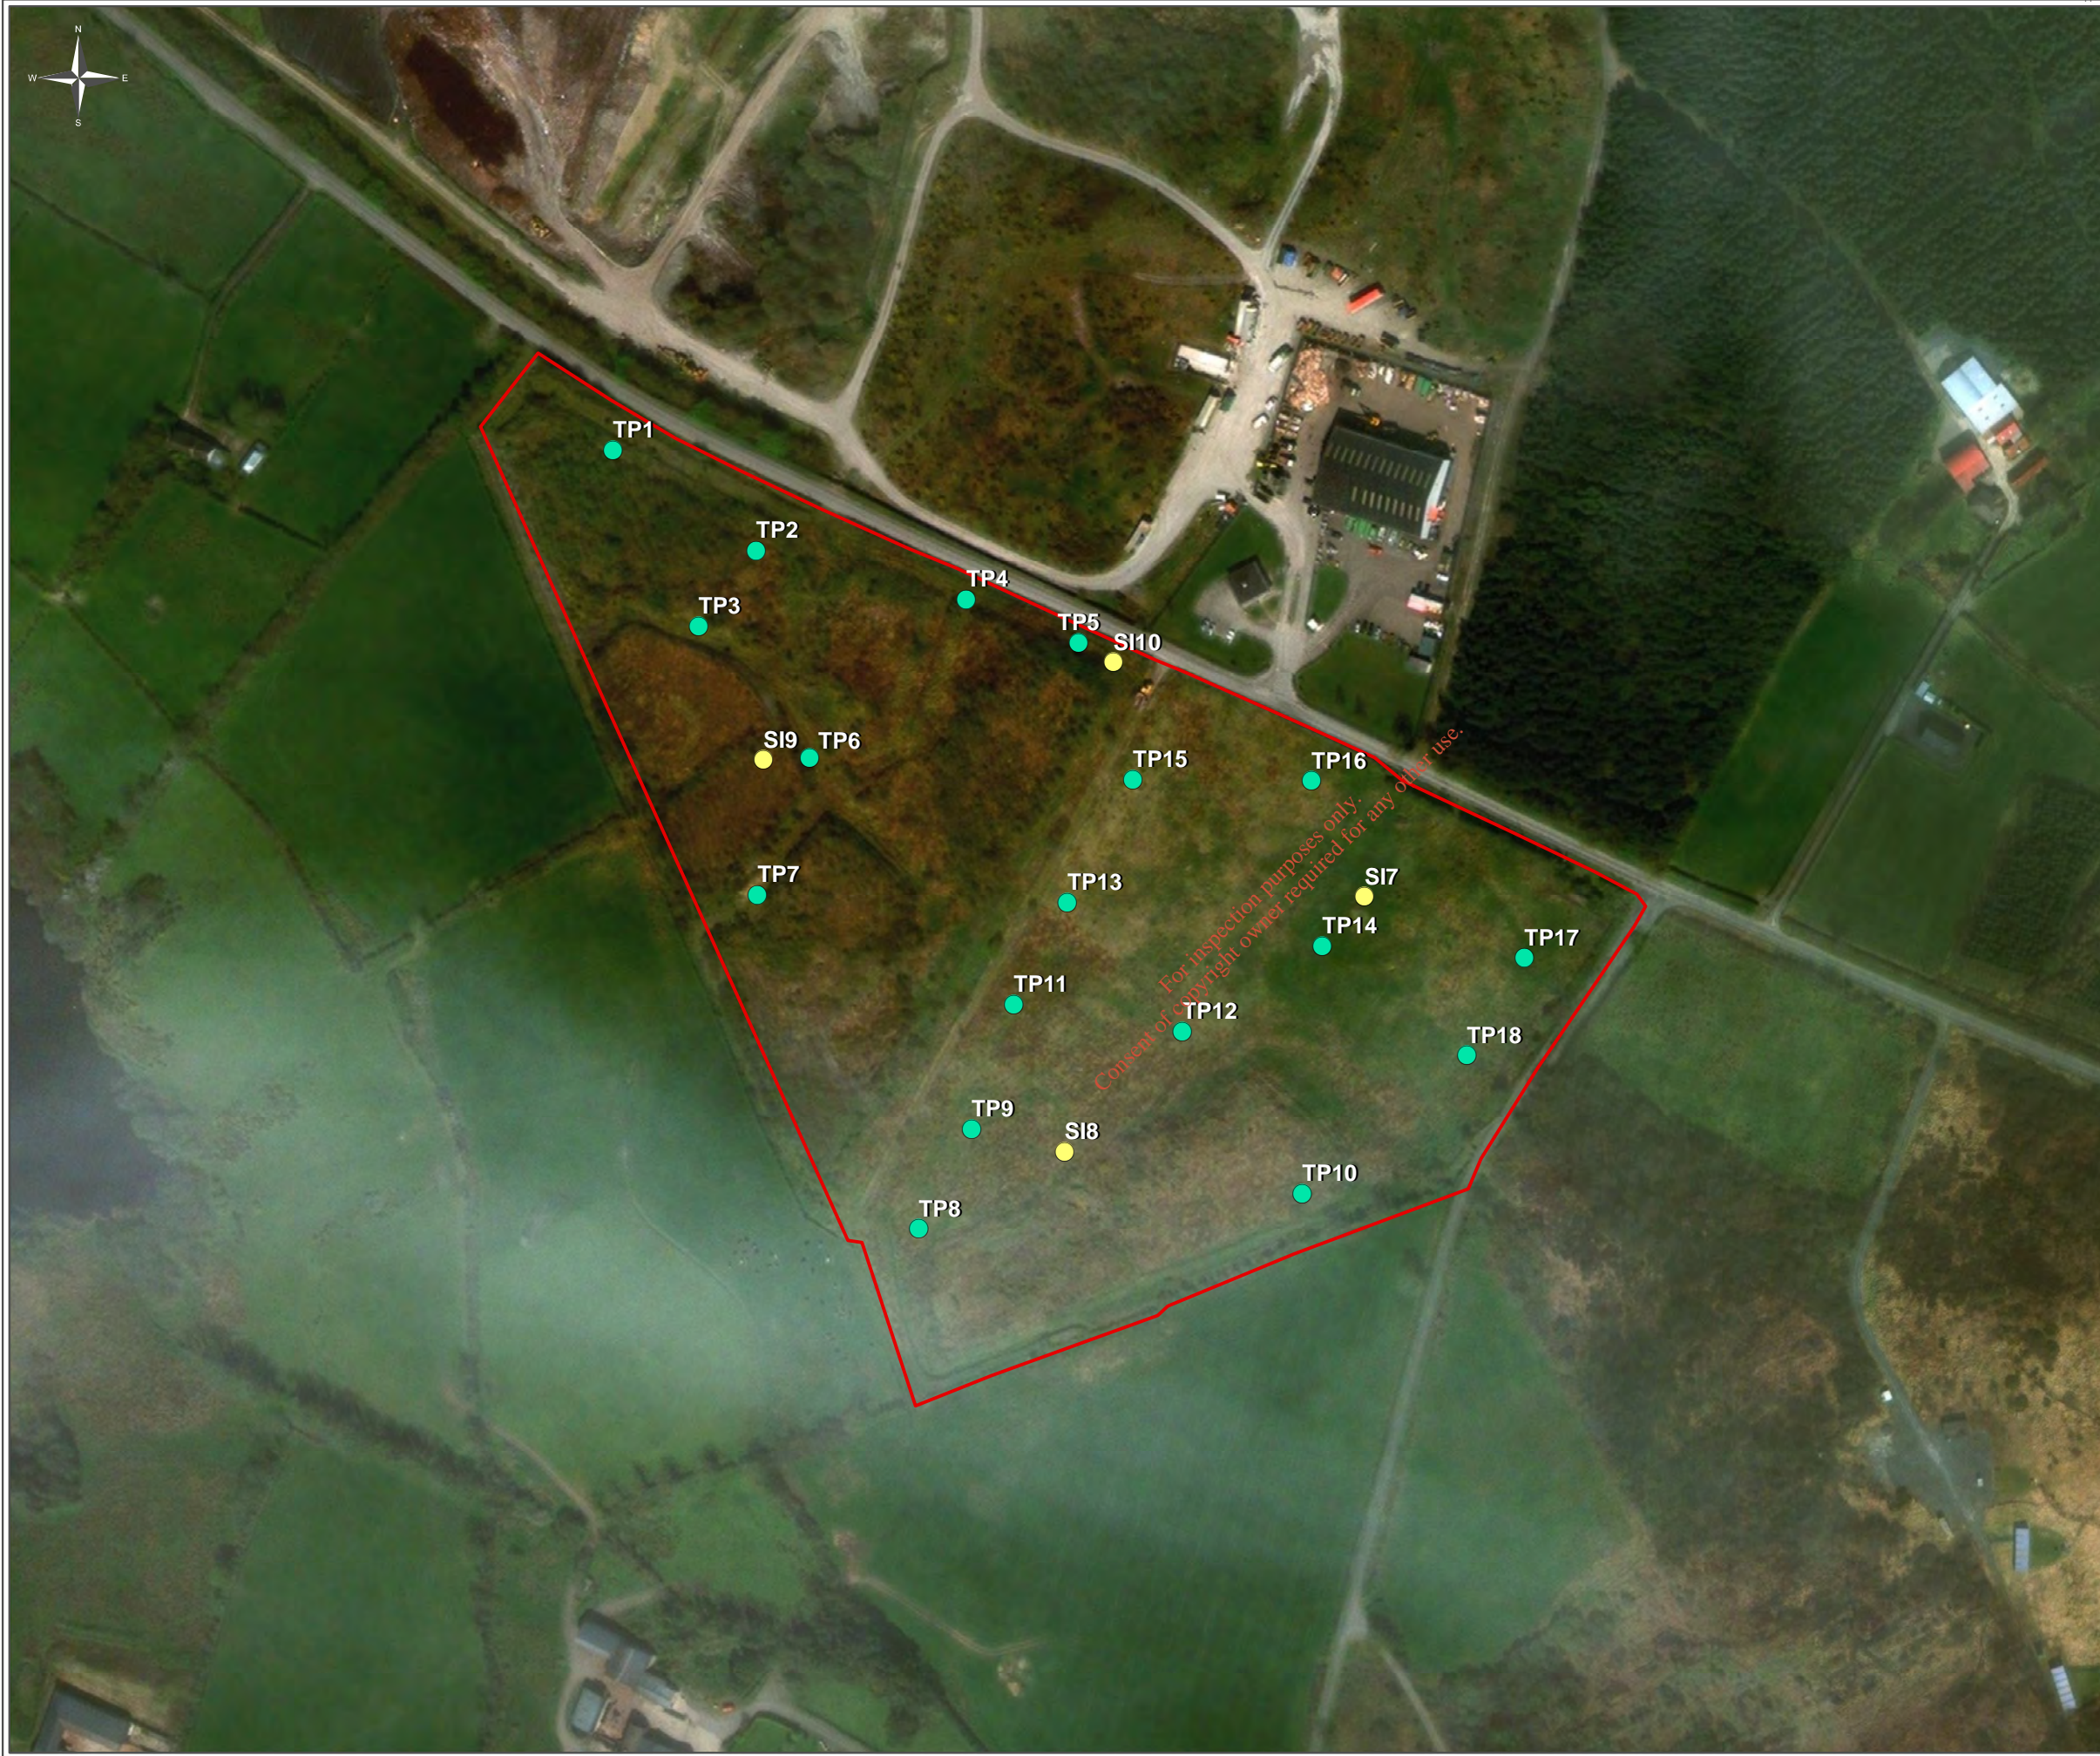
**Figure Title**  
Site Investigation Location Plan

During the site walkover the scope of the investigative works were evaluated based on the findings in the Tier 1 assessment. The locations of the intrusive works undertaken at the site are presented in Figure 3-1.

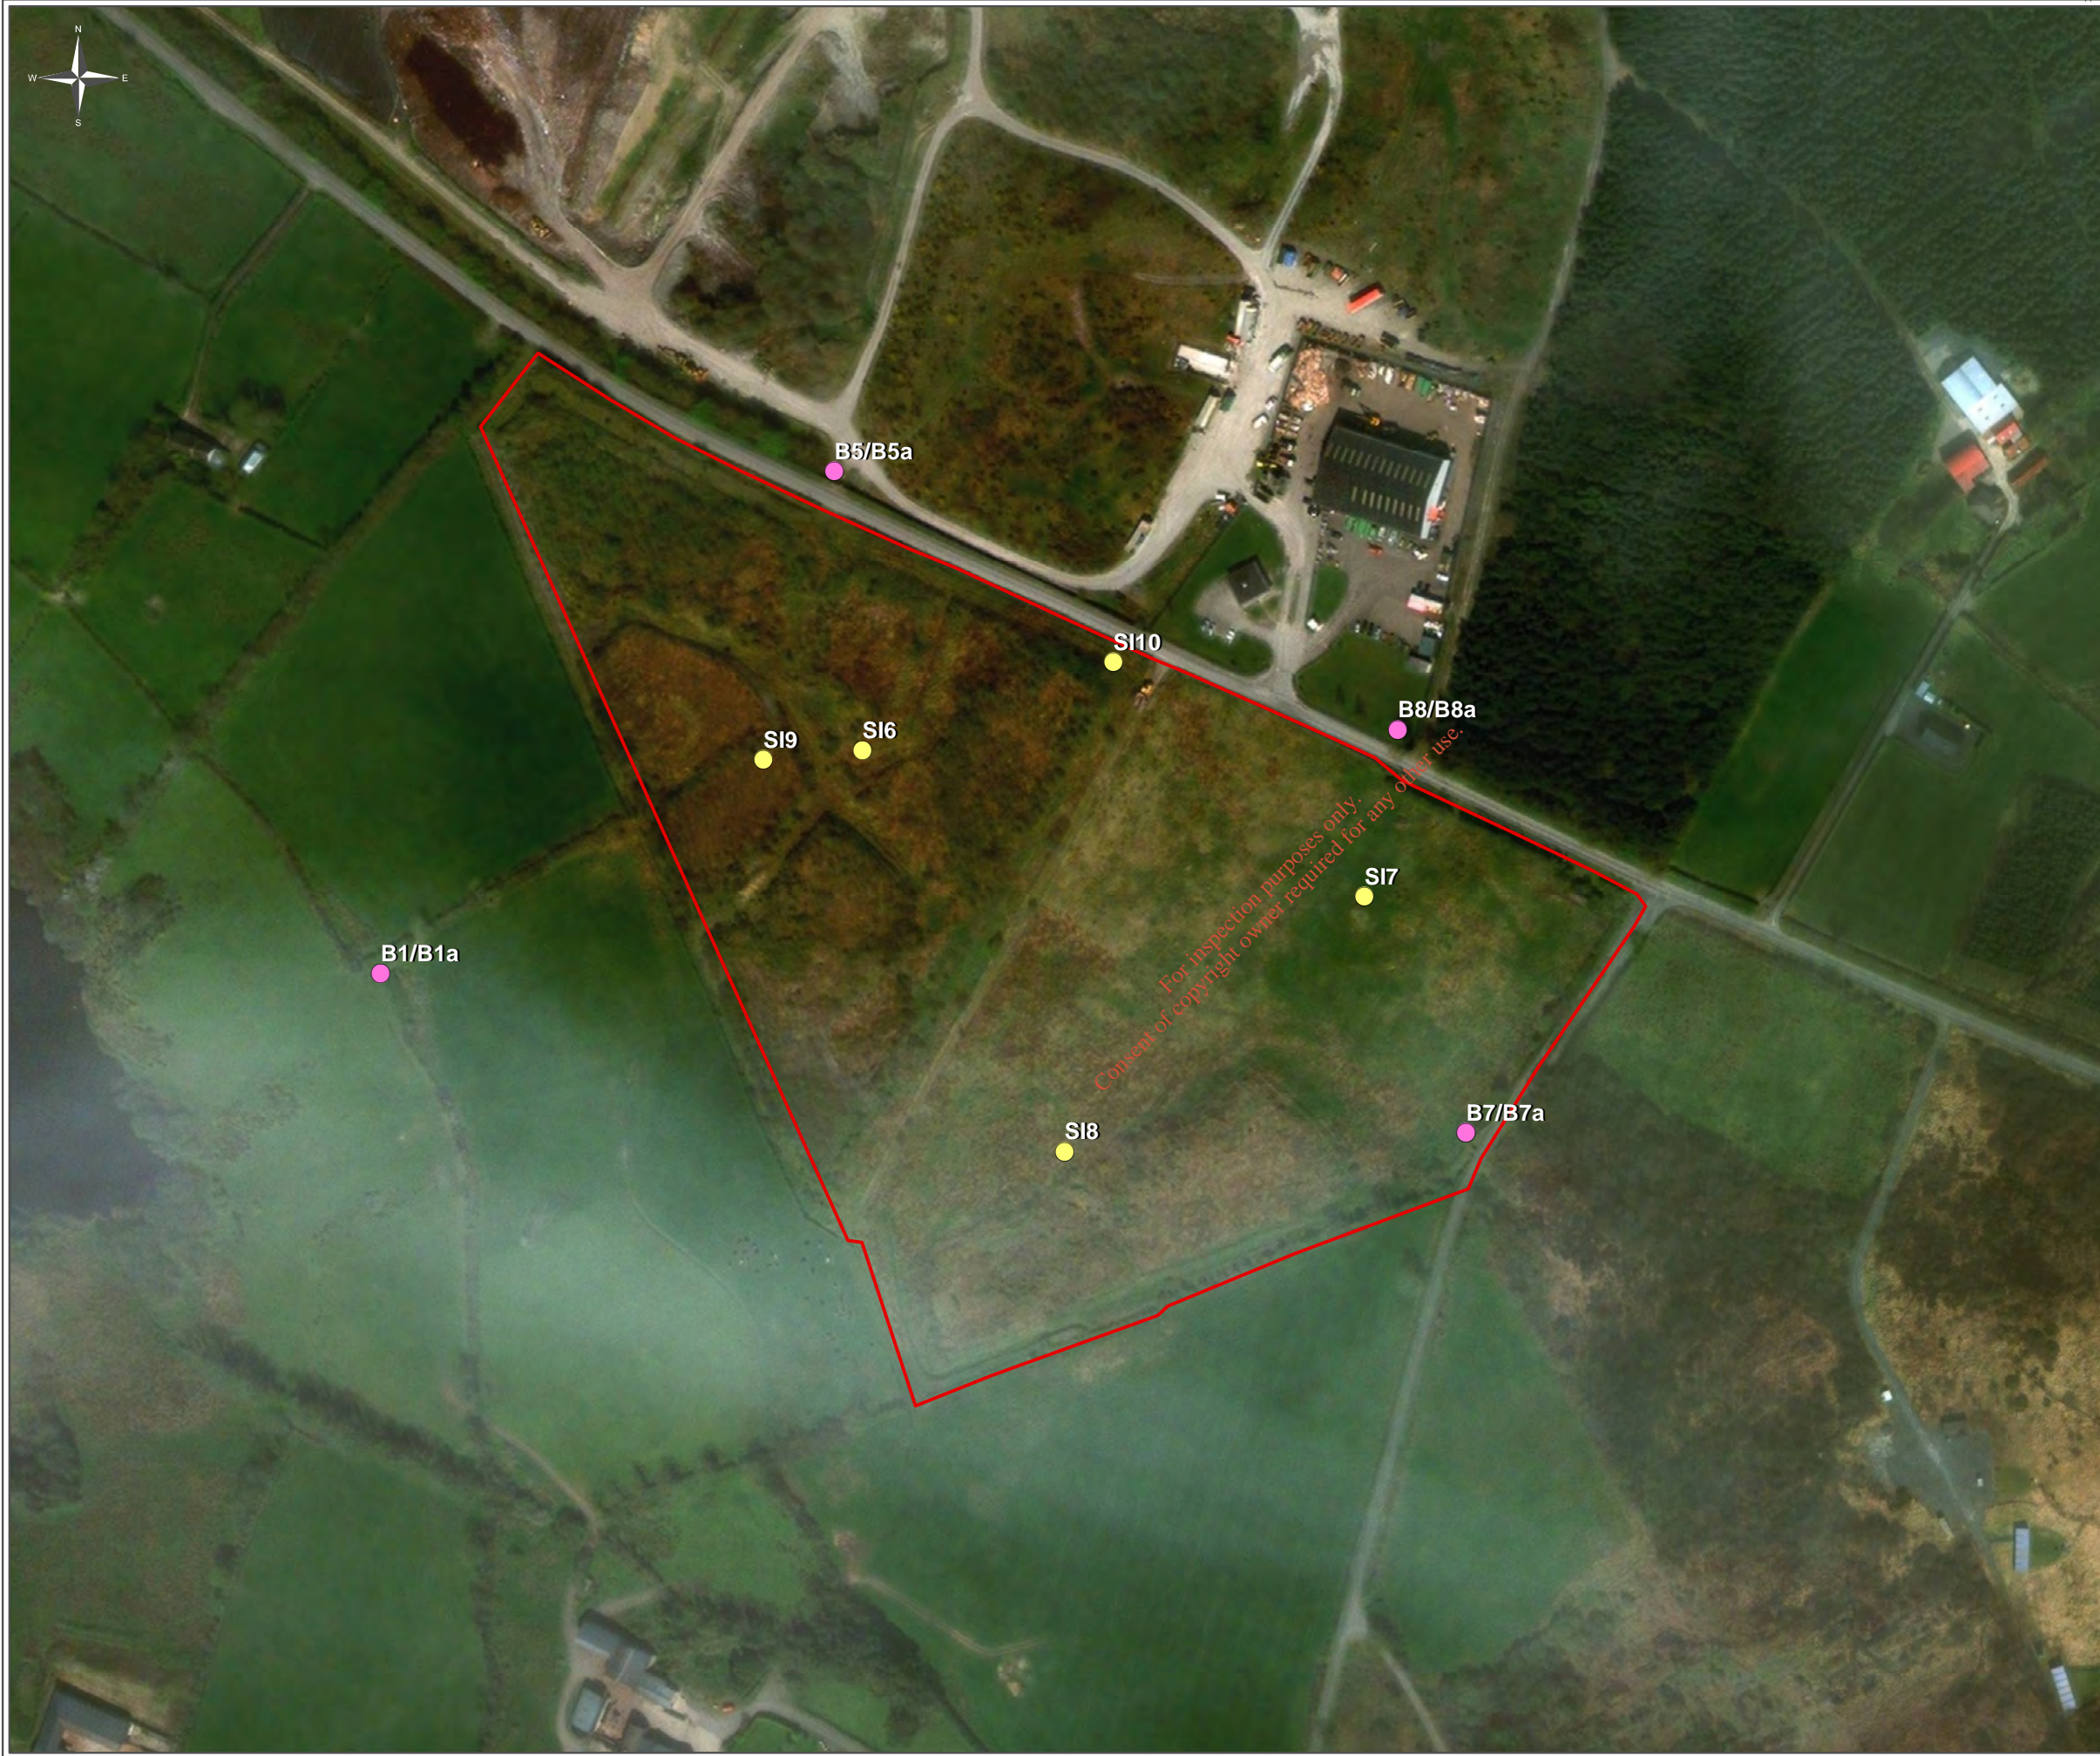
**Figure Title**  
Leachate and Groundwater Monitoring Wells

Previously installed groundwater monitoring boreholes (B1a, B5a, B7a and B8a) were selected for this assessment as suitable perimeter monitoring wells based on their proximity to the landfill. The purpose of these boreholes was to assess the potential for leachate migration beyond the landfill boundary.

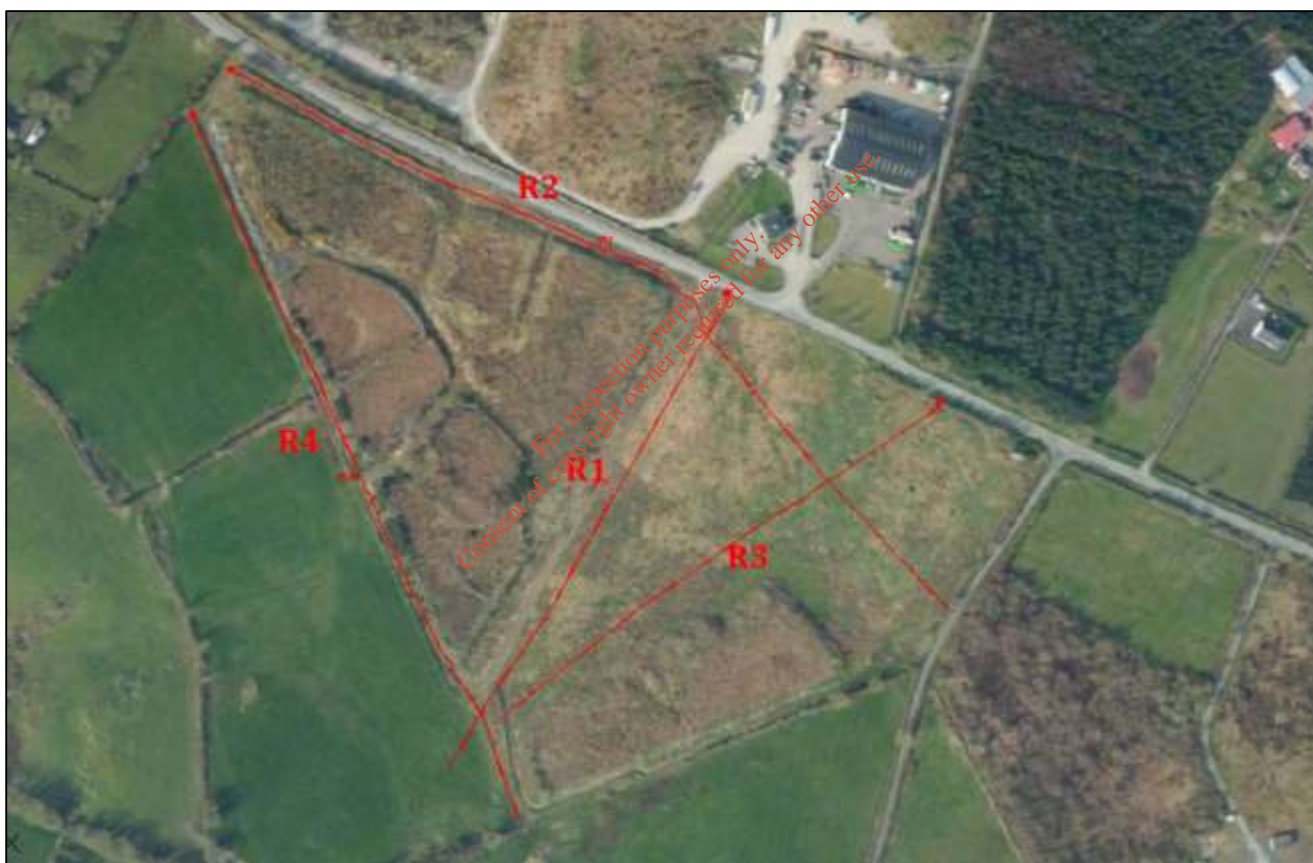
Figure 3-3: Scotch Corner ERT Profiles R1 to R4

PGL recorded 4 no. ERT profiles data along four designated profiles. ERT profiles are named R1 through R4. The location of these profiles is given in Drawing No's P18175\_GP\_D01 to P18175\_GP\_D02 and an interpretation of the results are included below in Figure 3.3 and in the PGL Geophysics Report, Appendix 2.

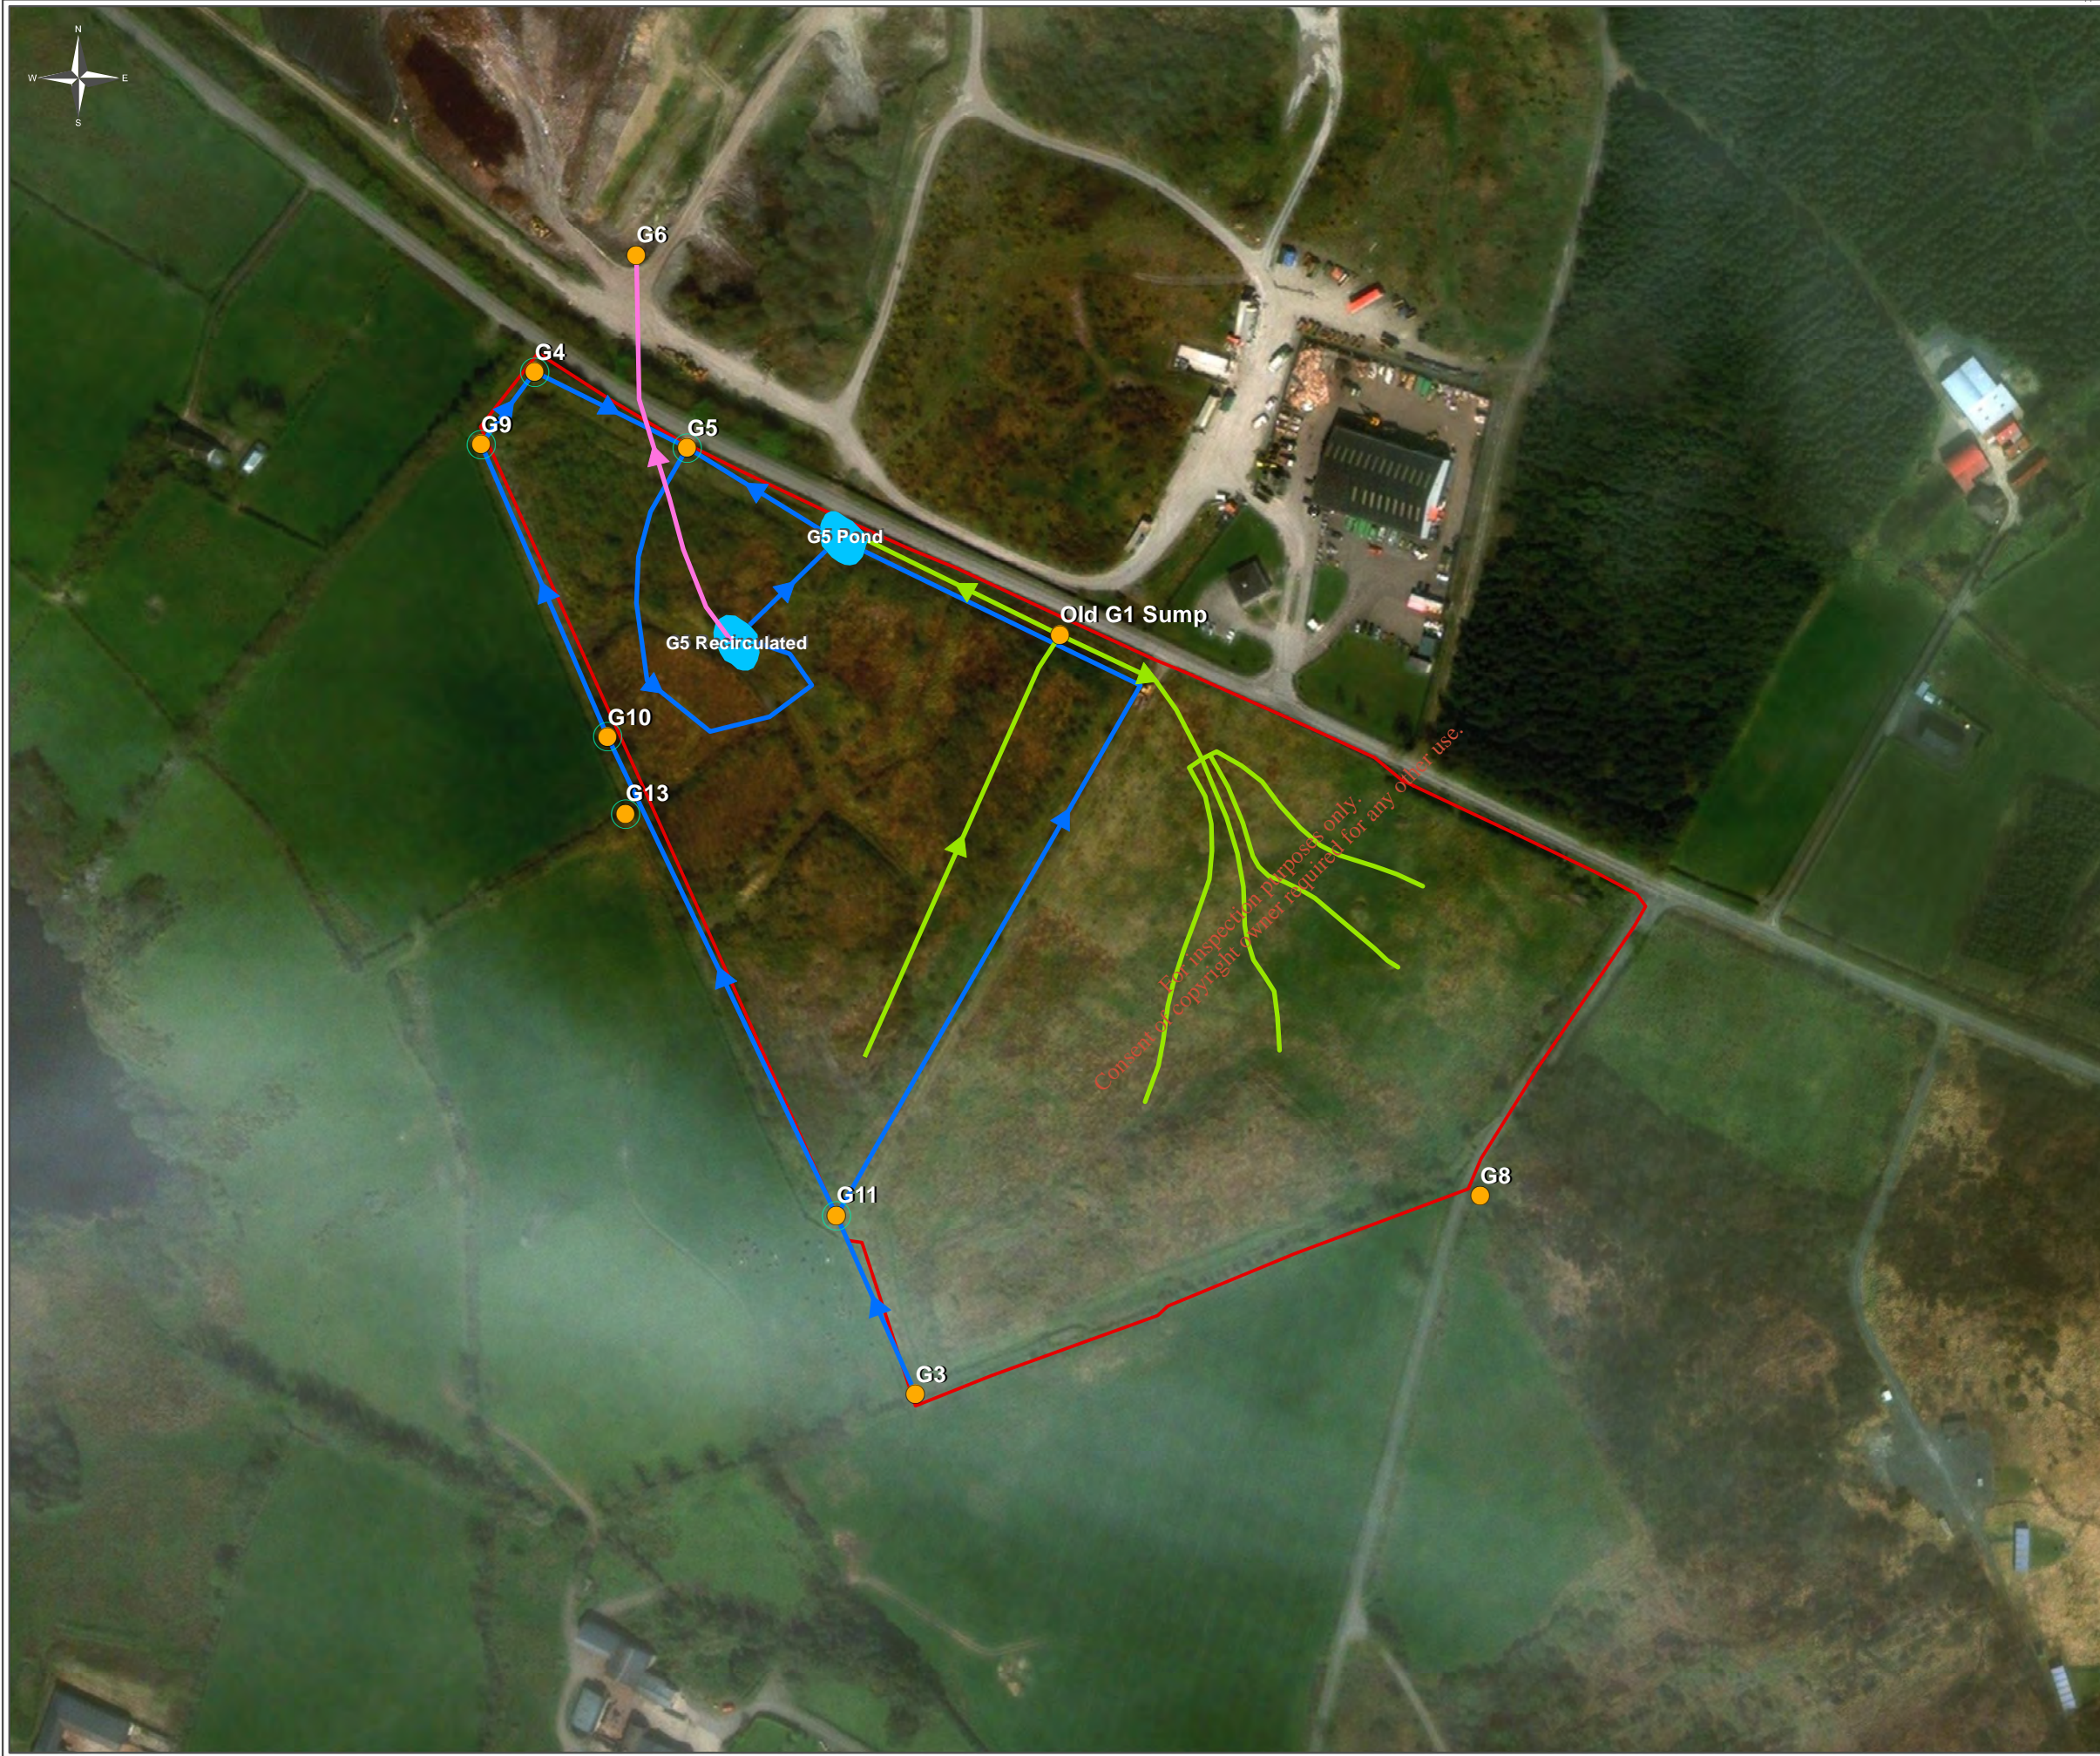
- Legend**
- Surface Water Monitoring Locations
  - Dry Sampling Locations
  - Leachate Pipework
  - Redirected Surface Water Pipeline Directed to G6 (existing landfill)
  - Surface Water Pipework
  - Surface Water Ponds
  - Site Boundary

The remaining results of the surface water laboratory analysis at G3 and G8 as presented in Table 4.5, when assessed against the MAC (1989) and EQS (2009) quality standards were found to be below the guideline values in all assessments.
