TIER 3 RISK ASSESSMENT HISTORIC LANDFILL AT CLAREMORRIS, CO. MAYO

Prepared for: Mayo County Council

Abstract: This report represents the findings of a Tier 3 risk assessment carried out at Claremorris Historic Landfill, Co. Mayo, conducted in accordance with the EPA Code of Practice for unregulated landfill sites.

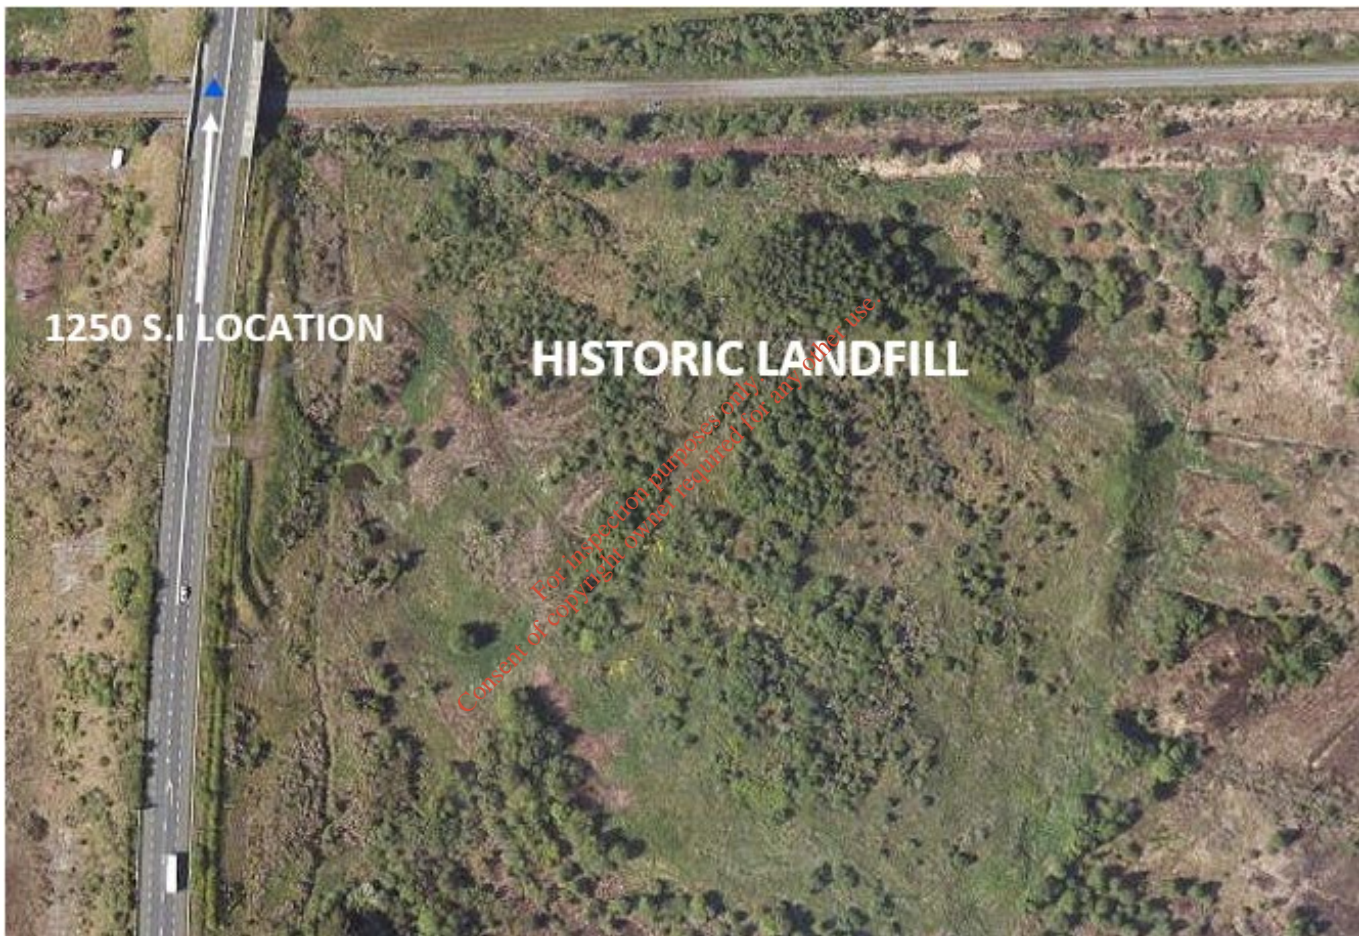
Figure 2-10: GSI Geotechnical Boreholes (Blue Triangle)

The review highlighted two boreholes located close to the site for the then proposed (now existing) railway overbridge. The boreholes are referred to as 1250R and 1250L indicating their chainage location. The approximate location of these boreholes according to the GSI is shown in Figure 2-10 below.

Two holes were bored at this location. In borehole 1250R, 1.00 metres of filling overlies a 2.00 metres peat stratum. Coarse compact gravel was noted from 3.00 to 3.80 metres with Limestone rock found at 3.80 metres.

In Borehole 1250L, fill and peat again occurred to a depth of 1.40 metre, overlying a firm stiff gravelly clay. Gravel was noted from 2.70 to 3.70 metres with refusal (probably rock) at 3.70 metres.

Diamond drilling methods were used to recover NQ (50mm) core at both locations. At 1250R good quality core was recovered from 3.70 metres below ground level to 7.00 metres, while at Borehole 1250L solid rock core was recovered from 4.90 to 6.70 metres. Some weathered rock was noted in Borehole 12501. above the solid horizon.

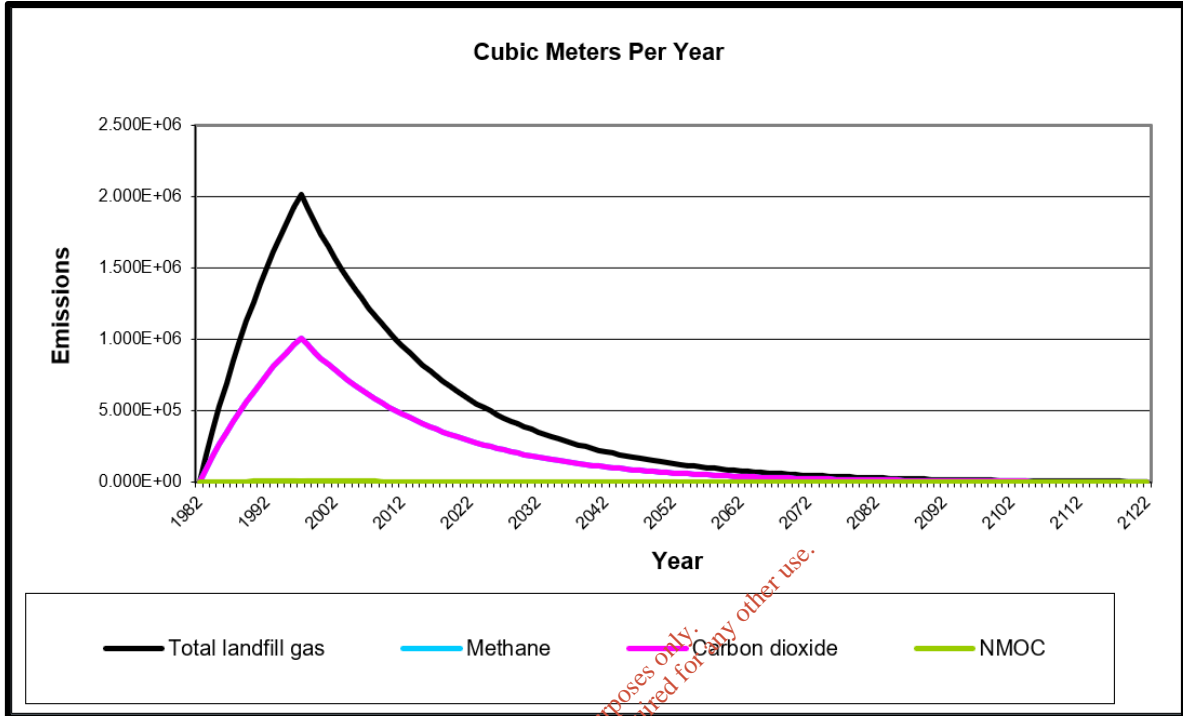
Figure 6-1: LandGEM Landfill Gas Volume Generation Rate (at 168,000 tonnes)

Figure 6-1 and Figure 6-2 below show the estimated landfill gas generation rates per year during the assumed operational phase (c.1982 to 1996) and predicted generation rates from 1996 onwards following closure of the site. It is noted that the model assumes equal production rates for both methane and carbon dioxide and are represented by the pink trendline.

As an output, LandGEM produces a report on the model inputs and outputs. This report is included in Appendix 5 of this report. LandGEM estimates the mass and volume of landfill gases generated both during the operational/filling phase of the landfill and beyond. The estimated quantity of gas generated for the current year (2021) and after 10 years of further degradation (2031) are presented in Table 6-3. The model predicted that the site is currently generating 35 - 58 m³/hr of methane across the entire site area. This will reduce to 21 - 35m³/hr by 2031.
