**APPROPRIATE ASSESSMENT**

**STAGE 1 SCREENING**

**PROPOSED LICENCE ALTERATION**

**KILLARNEY WASTE DISPOSAL**

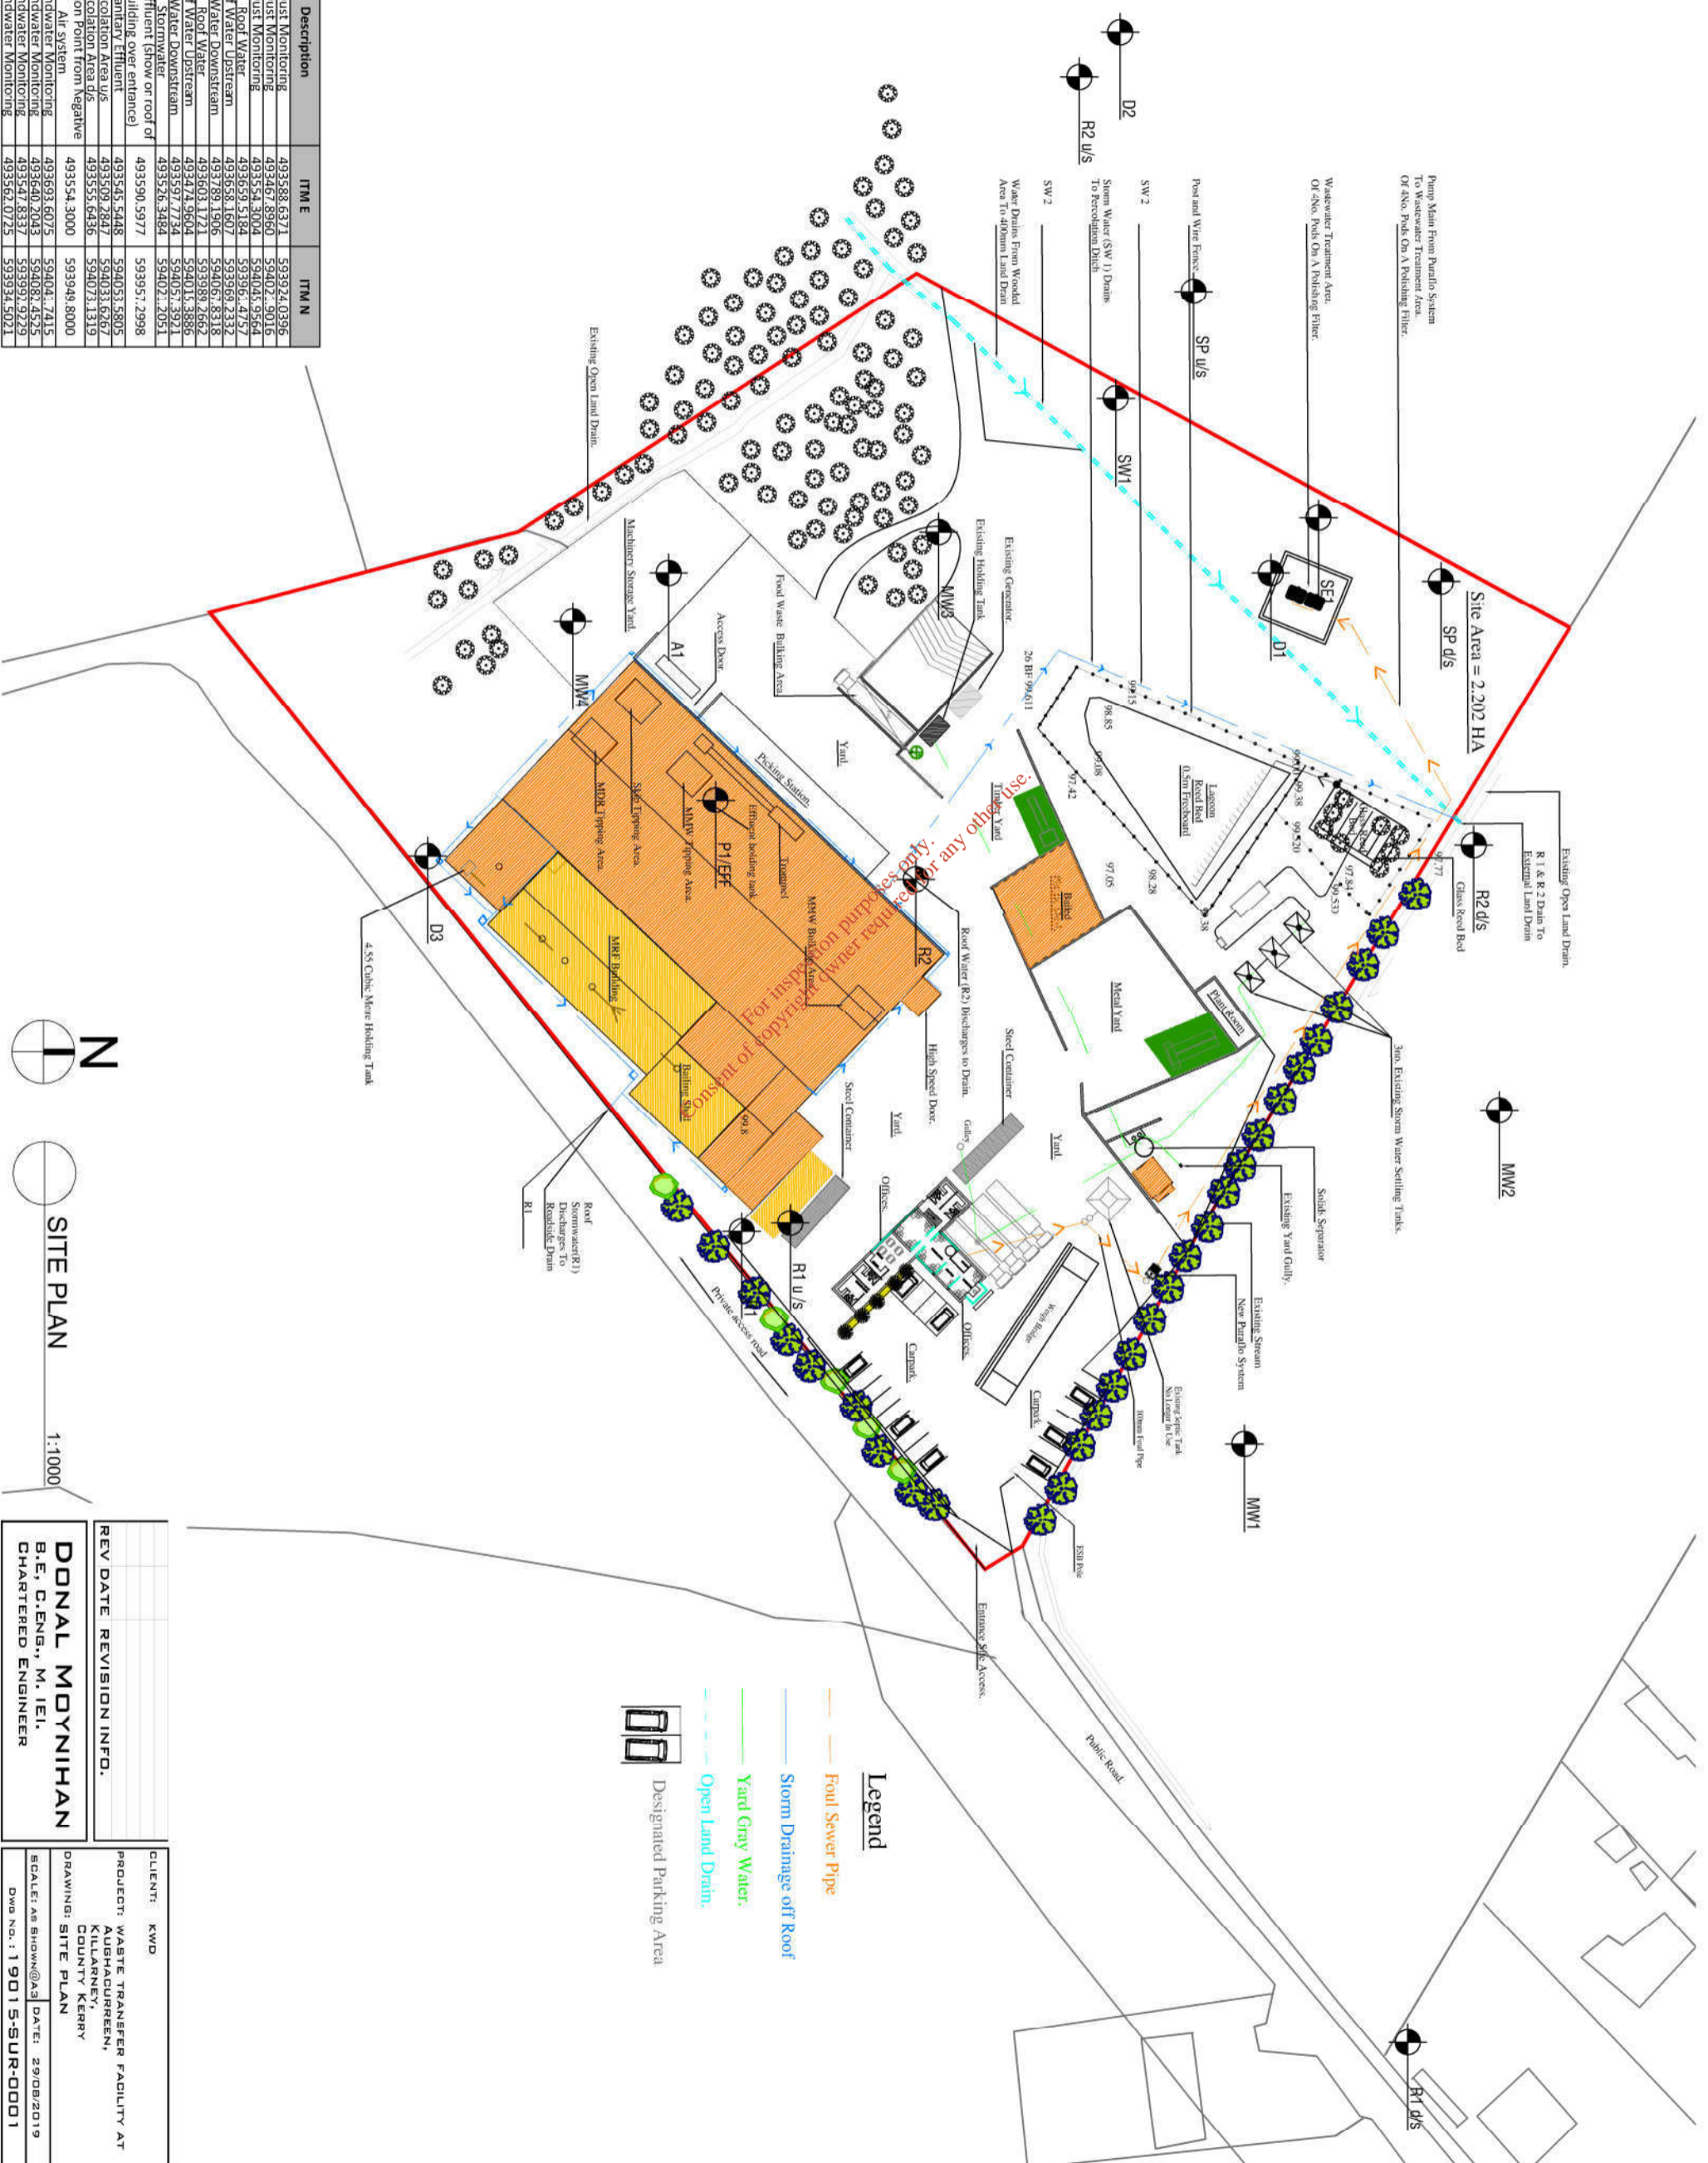
SITE PLAN

Location	Frequency of Sampling and Analysis	Description	ITM E	ITM N
D3	Quarterly	Dust Monitoring	493568.6371	593921.0396
D2	Quarterly	Dust Monitoring	493471.8960	594024.9016
D1	Weekly	Dust Monitoring	493471.8960	594024.9016
R1	Weekly	Roof Water Upstream	493564.5184	593964.4259
R1 u/s	Biannually	Roof Water Upstream	493564.5184	593964.4259
R1 d/s	Biannually	Roof Water Downstream	493789.1906	594067.8318
R2	Weekly	Roof Water Upstream	493603.1221	593989.2662
R2 u/s	Biannually	Roof Water Upstream	493474.9604	594011.3886
R2 d/s	Biannually	Roof Water Downstream	493597.7734	594057.3921
SW1	Weekly	Stormwater	493526.3484	594027.2051
P1/EFF	Annually	Process effluent (show on roof of main building over entrance)	493590.5977	593957.2998
SE1	Biannually	Sanitary Effluent	493545.5448	594051.5805
SP u/s	Biannually	Percolation Area u/s	493509.2847	594031.6267
SP d/s	Biannually	Percolation Area d/s	493555.6436	594073.1319

A1	Quarterly	Air Emission Point from Negative Air system	493554.3000	593948.8000
MW1	Biannually	Groundwater Monitoring	493693.6075	594047.7415
MW2	Biannually	Groundwater Monitoring	493640.2043	594081.4525
MW3	Biannually	Groundwater Monitoring	493547.8337	593991.9729
MW4	Biannually	Groundwater Monitoring	493562.0725	593934.5021

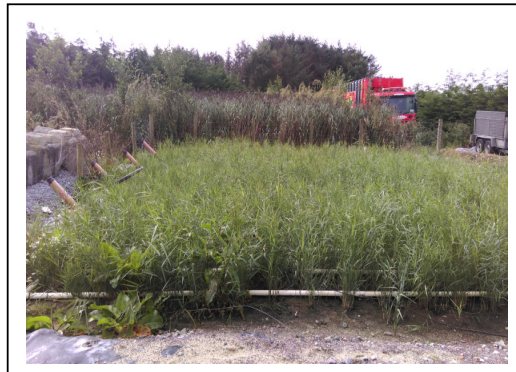
During the course of the summer months, the effluent level in the vertical flow reedbed was maintained at a high level to ensure satisfactory growth of reeds. High water level in a vertical flow reedbed produces a mixture of aerobic and anoxic conditions.

The reeds are now well established, and the water level of the reedbed has been dropped to the design operating (low) level. The system is now operating as a vertical flow reedbed/percolating filter operating under mainly aerobic conditions. The system is very effective at reducing the level of suspended solids and BOD.

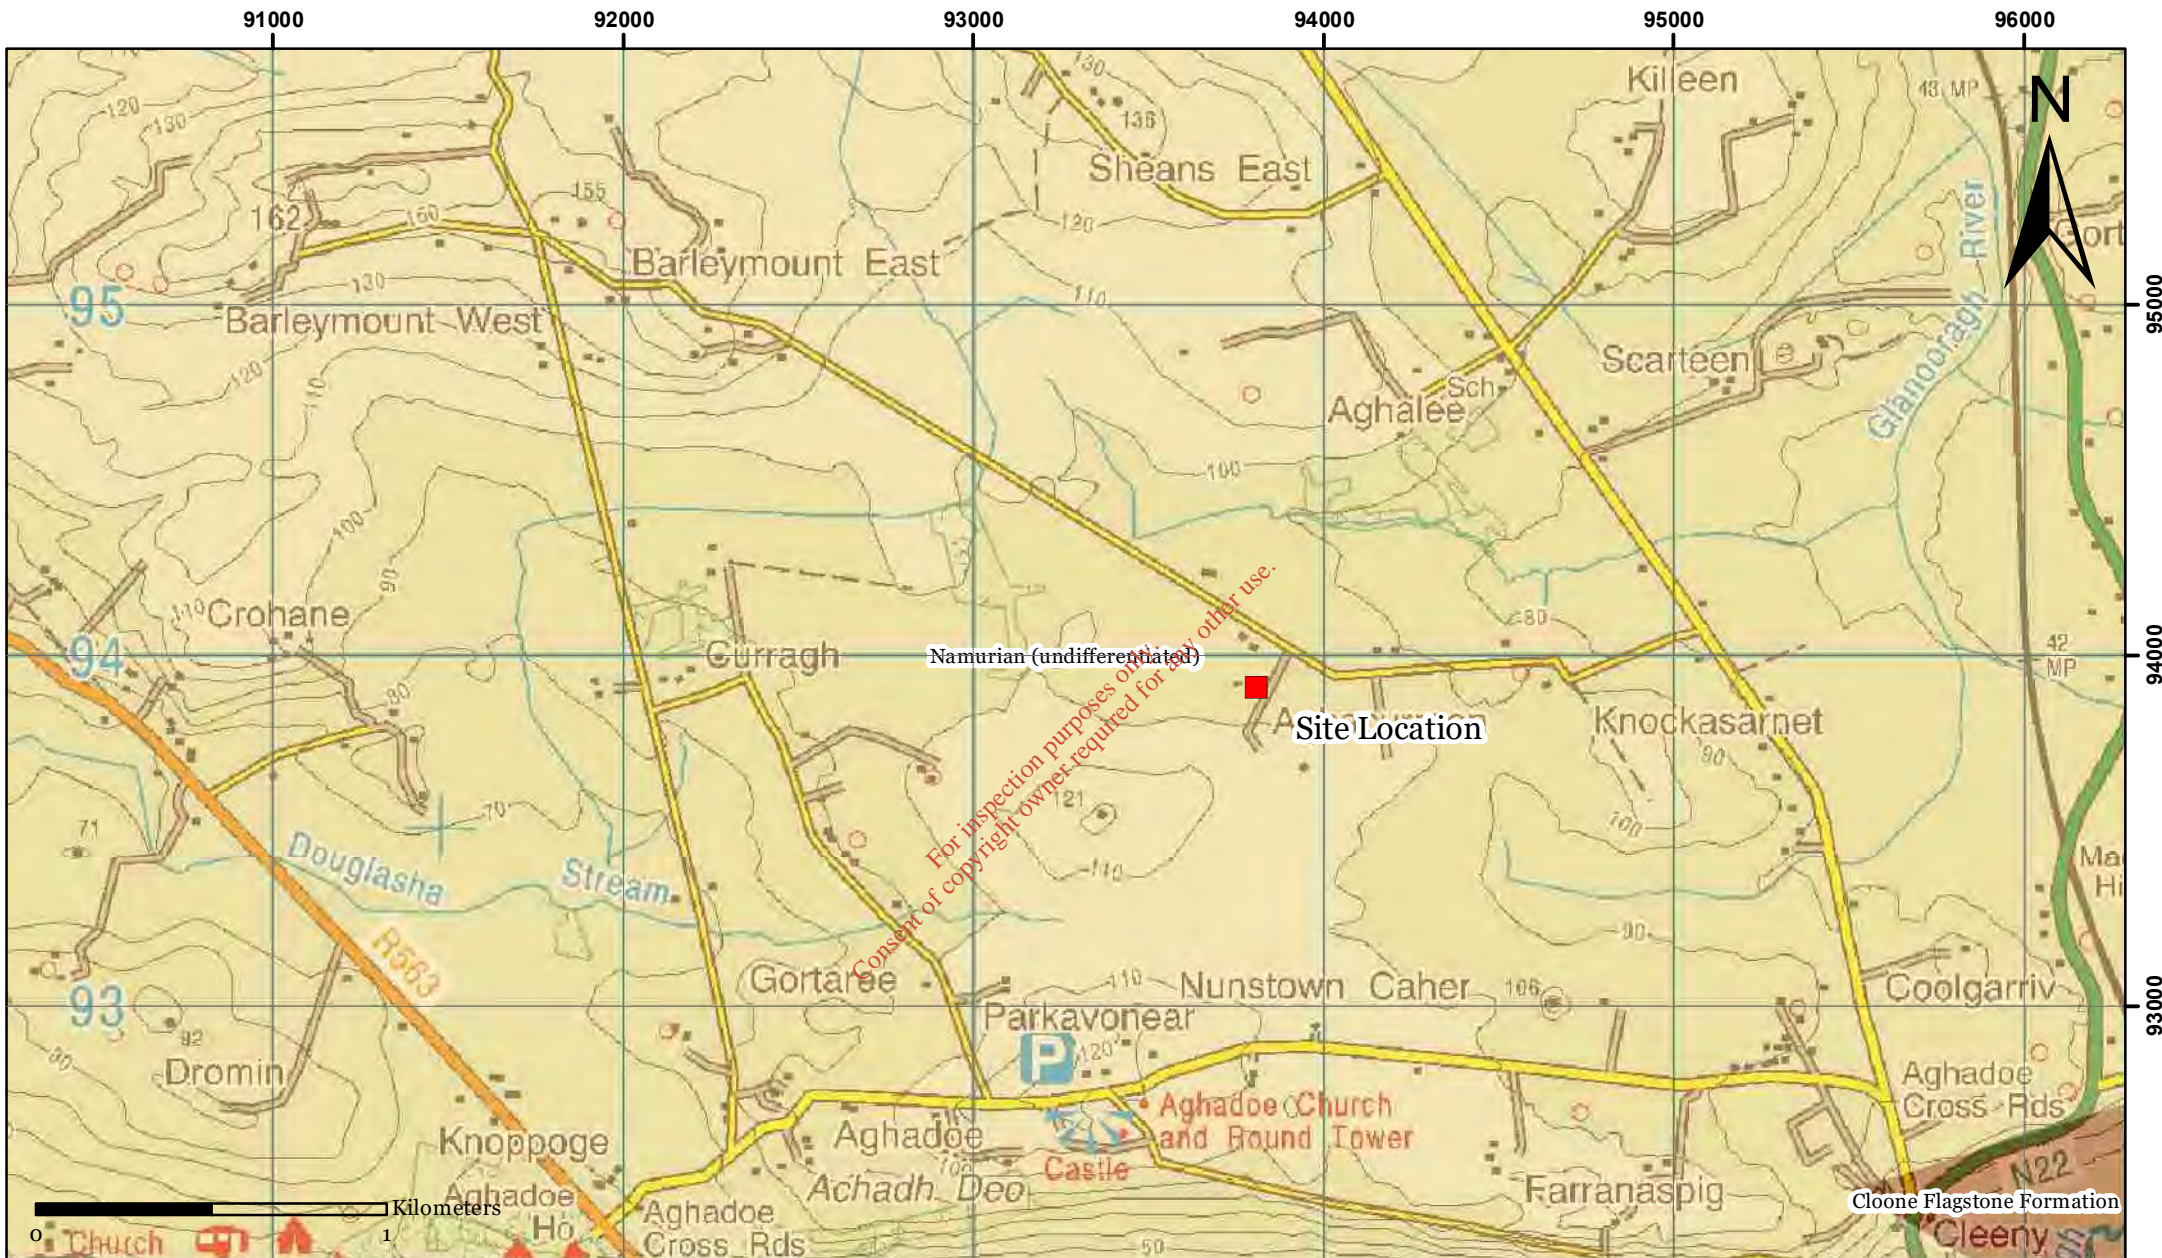
**Figure 2.4**

The Teagasc maps (Figure 2.4) indicate that the subsoils are till derived from Namurian shales and sandstones. The logs of the boreholes installed by OES (refer to Appendix 1) indicate the soils comprise peat overlying tills. The combined thickness ranges from 3m in the east of the site to 5m in the west.

The Teagasc maps (Figure 2.4) indicate that the subsoils are till derived from Namurian shales and sandstones. The logs of the boreholes installed by OES (refer to Appendix 1) indicate the soils comprise peat overlying tills. The combined thickness ranges from 3m in the east of the site to 5m in the west.

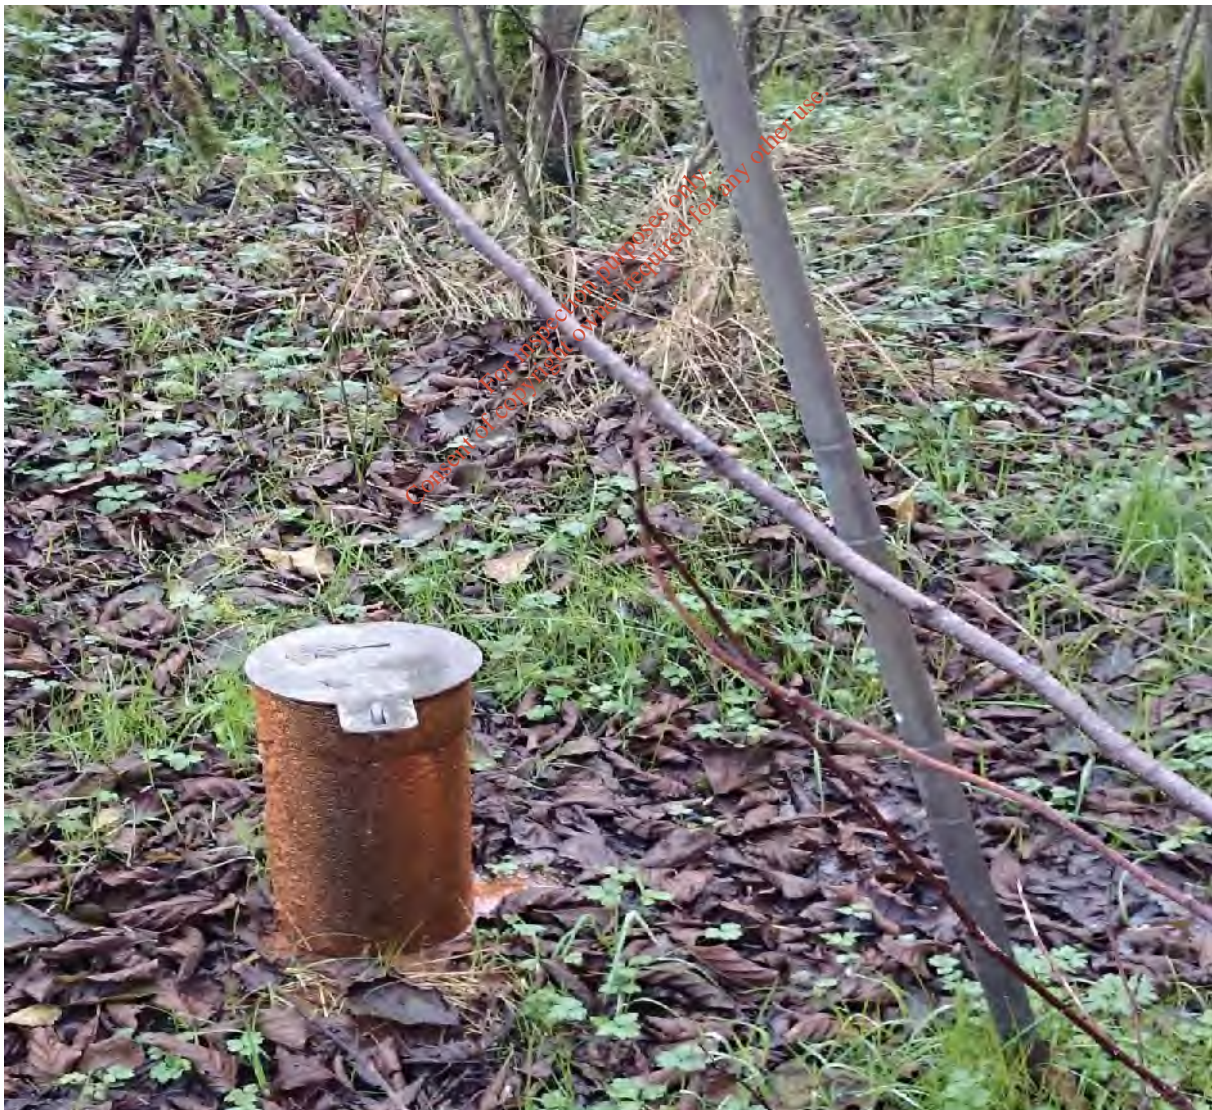
**Photograph 1 MW-1**

The well is located in a wooded area to the north of the drain that flows along the north-eastern boundary. The headworks are intact (Photograph 1) but there is evidence of artesian conditions.

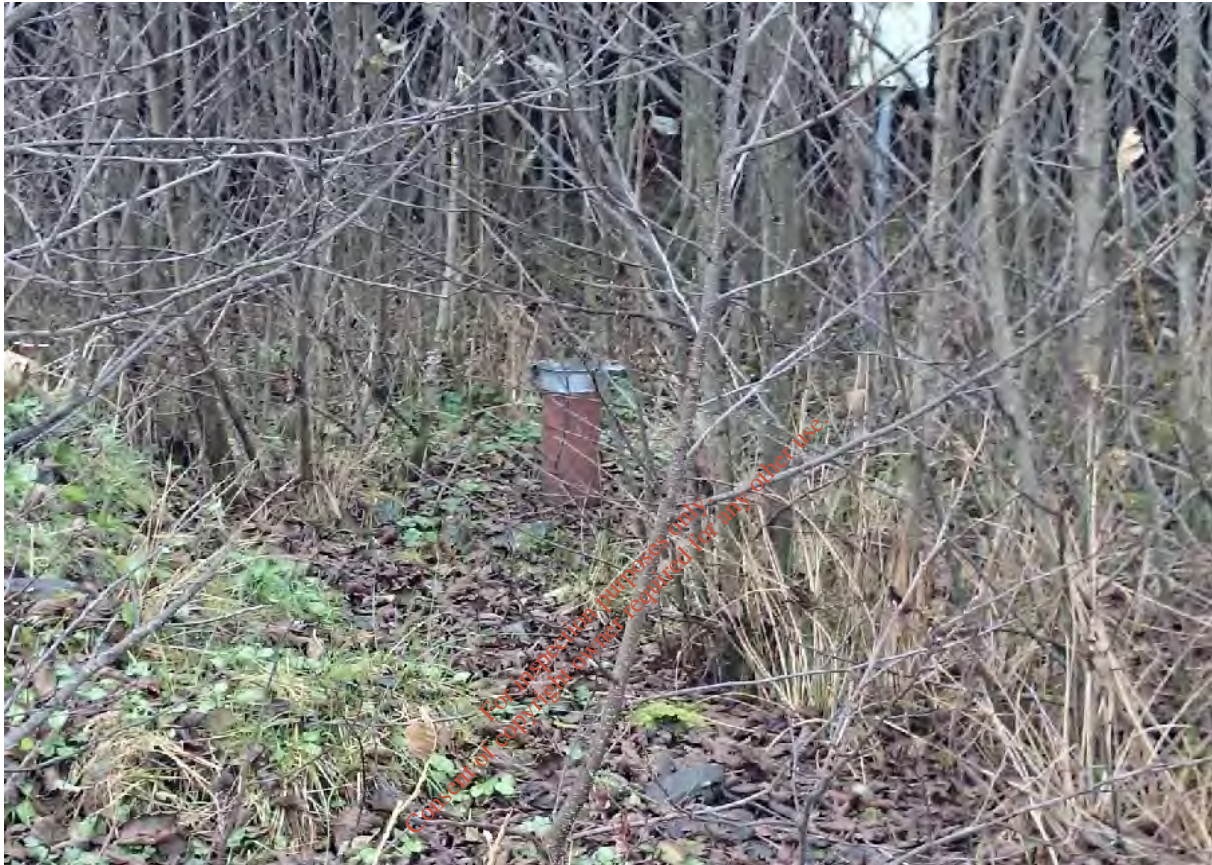
**Photograph 2 MW-2**

At MW-2 there is approximately 1.8m of peat, which is underlain by 1.2 m of till. The top 3m of the bedrock is weathered and the total depth of the well is 24m. A water strike was encountered at 20m below ground level. Slotted well pipe extends from the bottom of the hole to the base of the weathered bedrock, with plain pipe extending from there to above ground level. There is a bentonite seal from ground level to the base of the weathered bedrock. The well construction details indicate the well is screened exclusively in the competent bedrock.

The well is located in a wooded area to the north of the drain that flows along the north-eastern boundary. The headworks are intact.

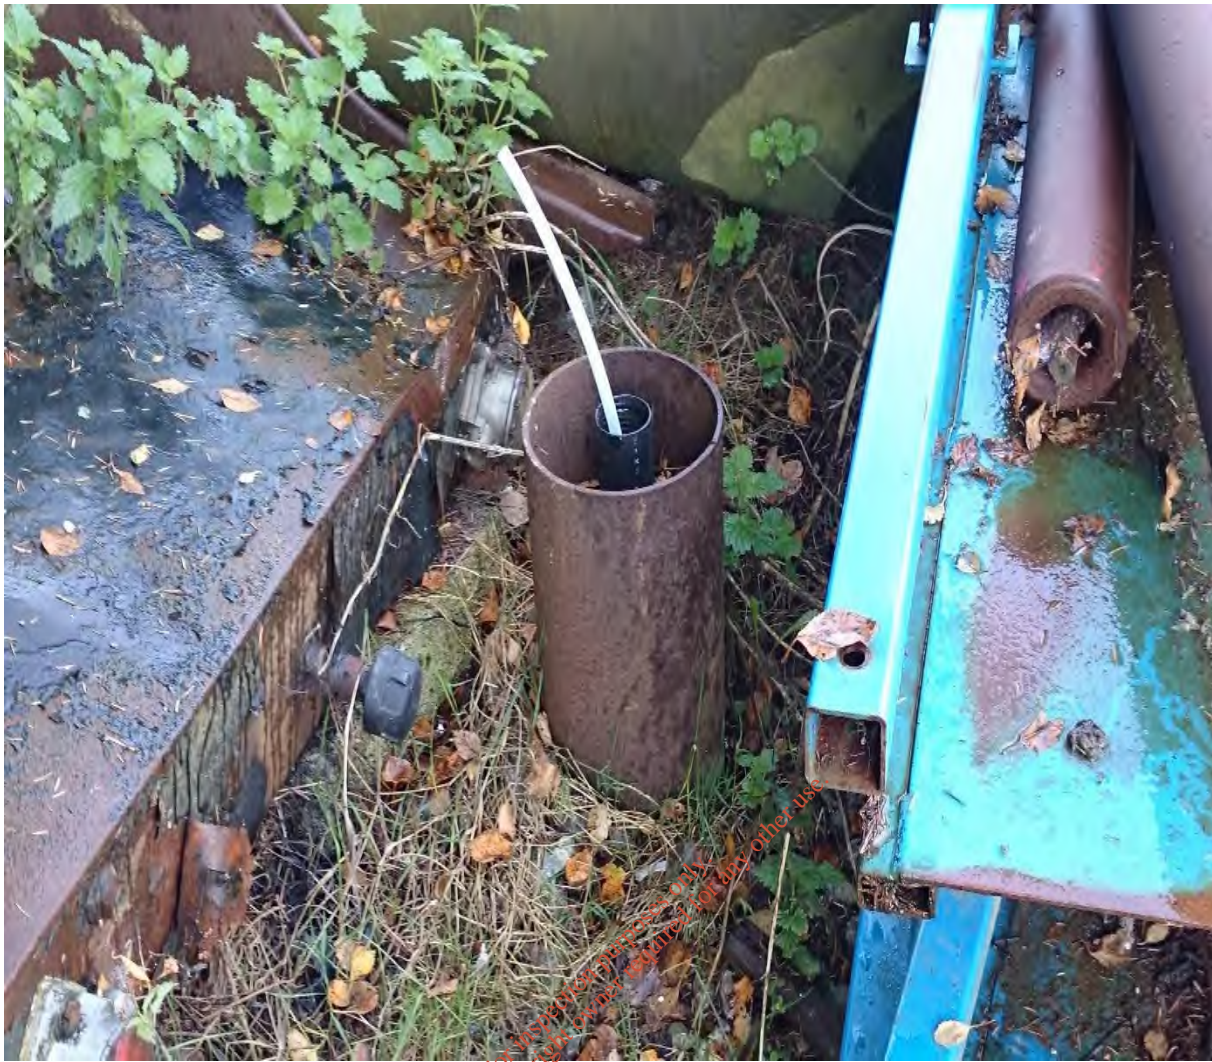
**Photograph 3 MW-3**

At MW-3 there is approximately 1.8m of peat which is underlain by almost 3m of till. The top 3.5m of the bedrock is weathered and the total depth of the well is 18m. A water strike was encountered at 11m below ground level. Slotted well pipe extends from the bottom of the hole into the weathered bedrock, with plain pipe extending from there to above ground level. There is a bentonite seal from ground level to the middle of the weathered bedrock. The well construction details indicate it is possible for water in the weathered zone and the competent rock to enter the well pipe.

The well is located in the south-west of the site. The on the top of the steel casing has been removed and there is no cap on the top of the well pipe.

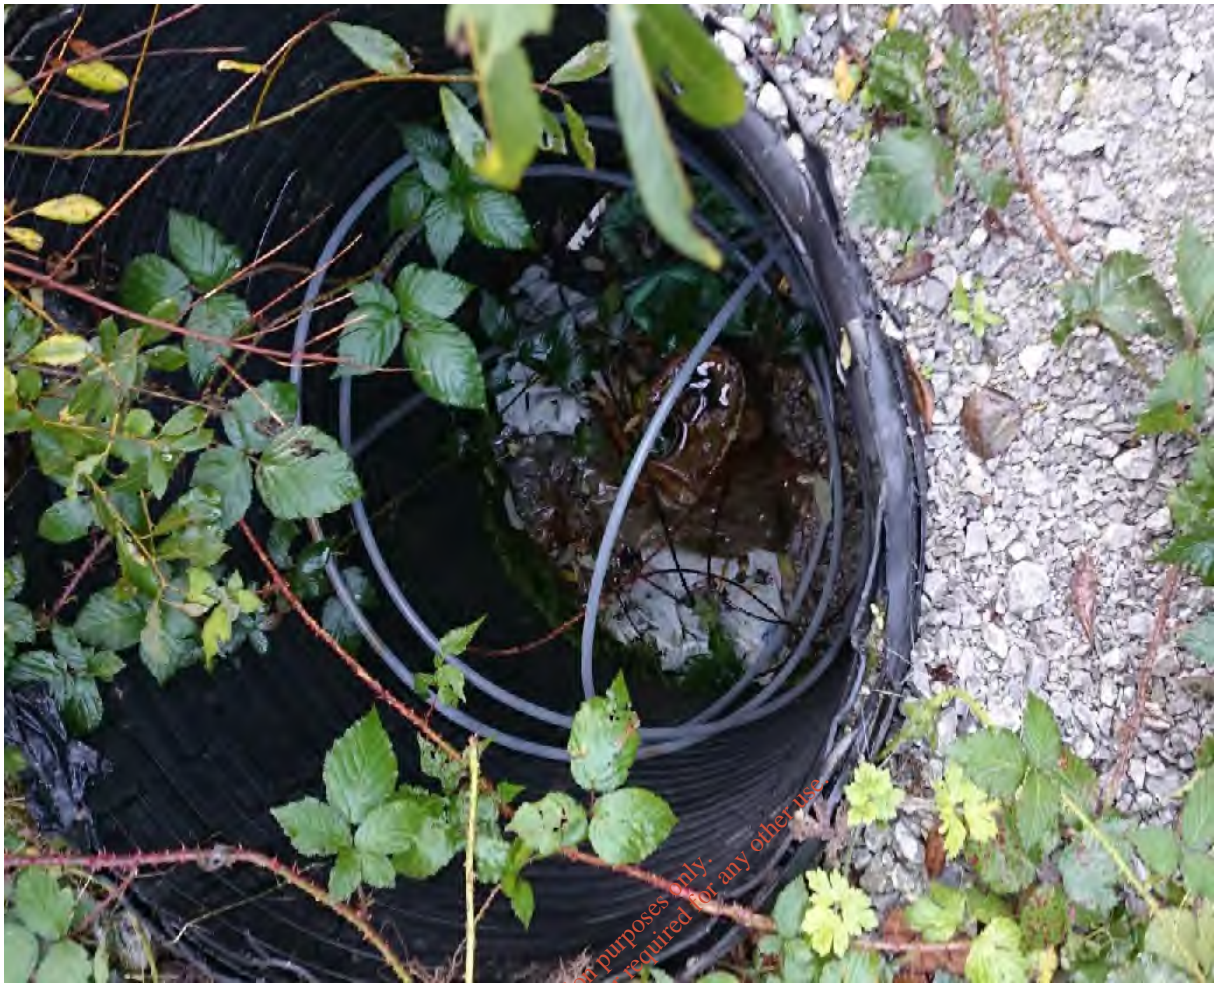
**Photograph 4 MW-4**

At MW-4 there is approximately 1.8m of peat, underlain by almost 1.2m of till. The top 5m of the bedrock is weathered and the total depth of the well was 18m. A water strike was encountered at 11m below ground level. Slotted well pipe extends from the bottom of the hole into the weathered bedrock, with plain pipe extending from there to above ground level. There is a bentonite seal from ground level to the middle of the weathered bedrock. The well construction details indicate it is possible for water in the weathered zone and the competent rock to enter the well pipe.

The well was protected by placing a large diameter plastic pipe on the ground and backfilling around it. However the lid on top of the casing has been removed and there is no well cap. OCM observed water had accumulated in the base of the protective pipe and the level was just below the top of the well pipe and there were leaves and litter around the well pipes. It was not possible to determine if the water in the base was overtopping groundwater or surface water.

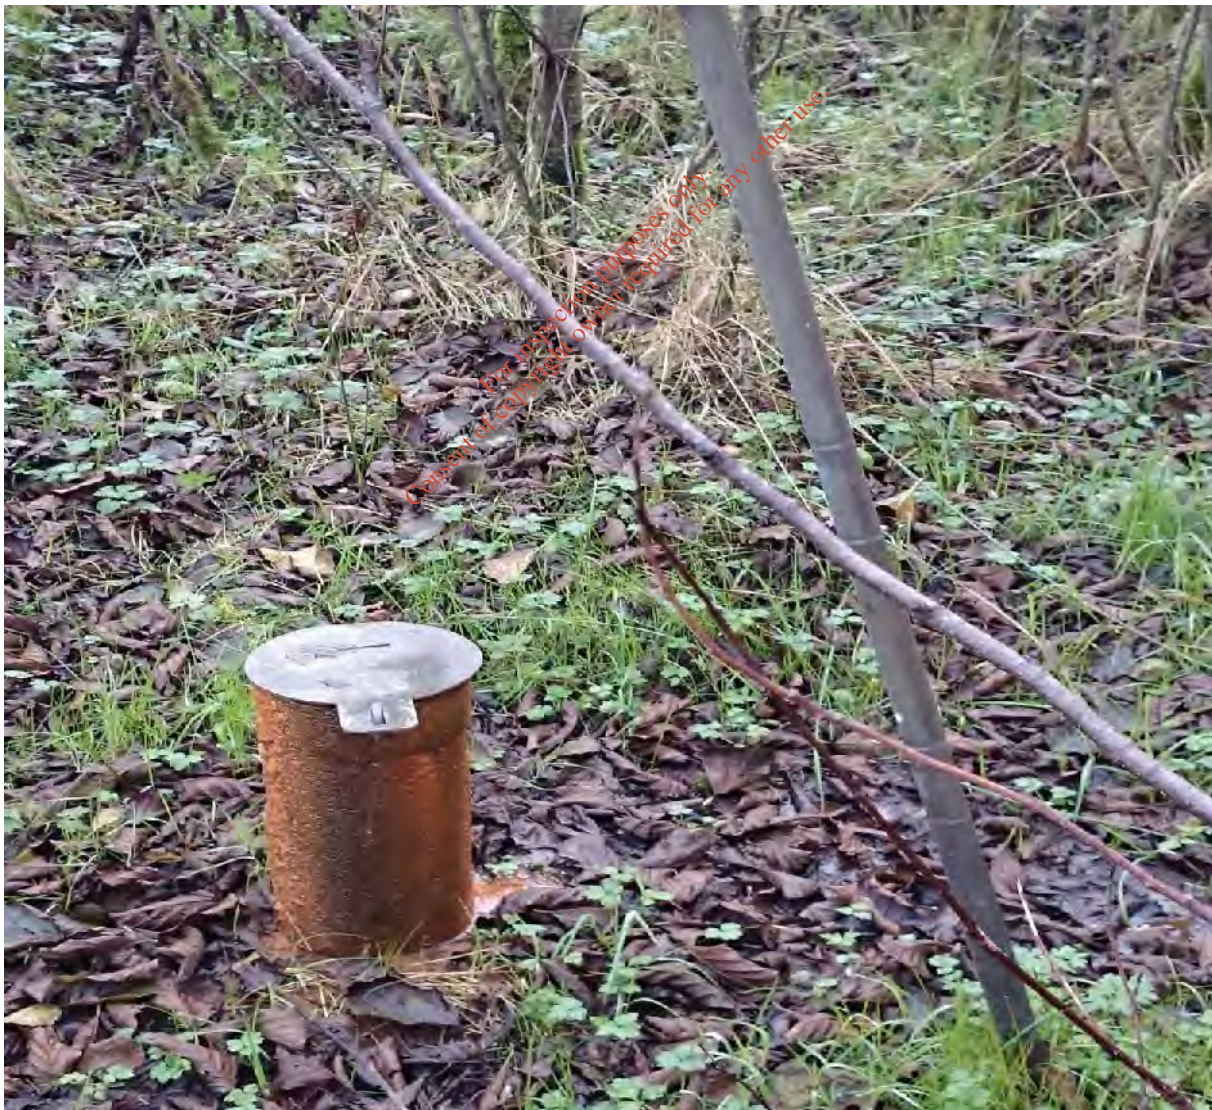
**Photograph 1 MW-1**

The well is located in a wooded area to the north of the drain that flows along the north-eastern boundary. The headworks are intact (Photograph 1) but there is evidence of artesian conditions.

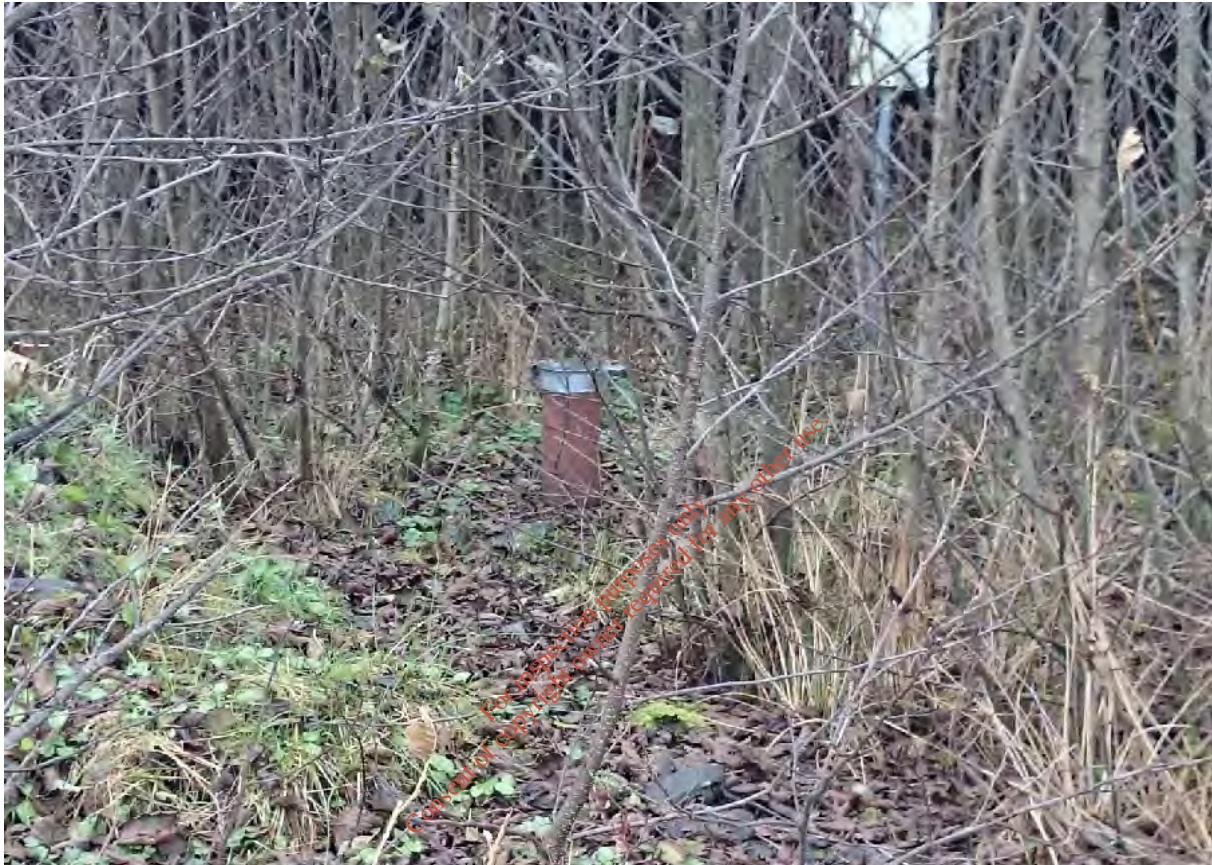
**Photograph 2 MW-2**

At MW-2 there is approximately 1.8m of peat, which is underlain by 1.2 m of till. The top 3m of the bedrock is weathered and the total depth of the well is 24m. A water strike was encountered at 20m below ground level. Slotted well pipe extends from the bottom of the hole to the base of the weathered bedrock, with plain pipe extending from there to above ground level. There is a bentonite seal from ground level to the base of the weathered bedrock. The well construction details indicate the well is screened exclusively in the competent bedrock.

The well is located in a wooded area to the north of the drain that flows along the north-eastern boundary. The headworks are intact.

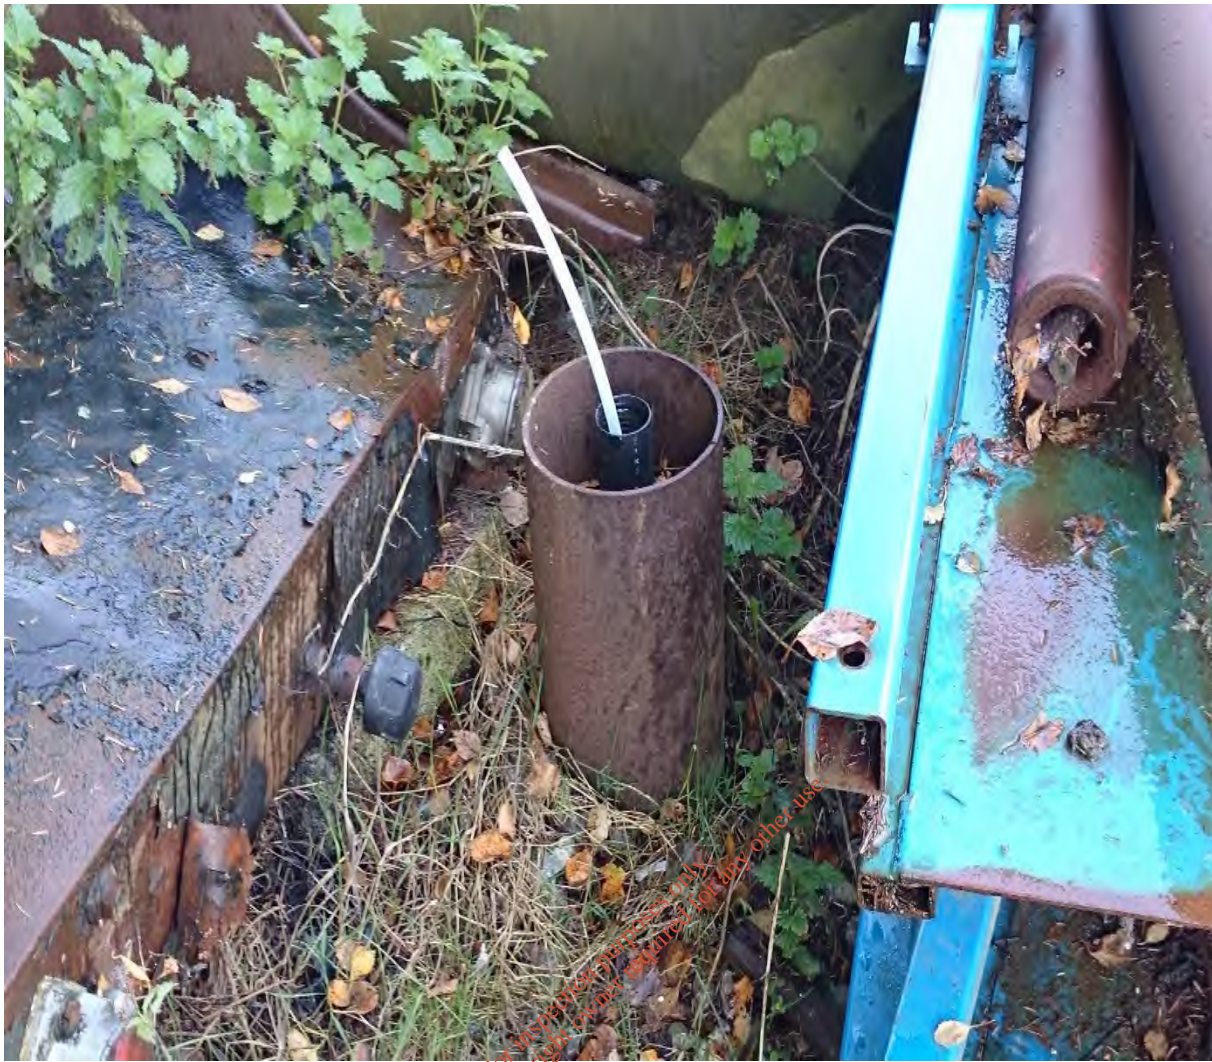
**Photograph 3 MW-3**

At MW-3 there is approximately 1.8m of peat which is underlain by almost 3m of till. The top 3.5m of the bedrock is weathered and the total depth of the well is 18m. A water strike was encountered at 11m below ground level. Slotted well pipe extends from the bottom of the hole into the weathered bedrock, with plain pipe extending from there to above ground level. There is a bentonite seal from ground level to the middle of the weathered bedrock. The well construction details indicate it is possible for water in the weathered zone and the competent rock to enter the well pipe.

The well is located in the south-west of the site. The on the top of the steel casing has been removed and there is no cap on the top of the well pipe.

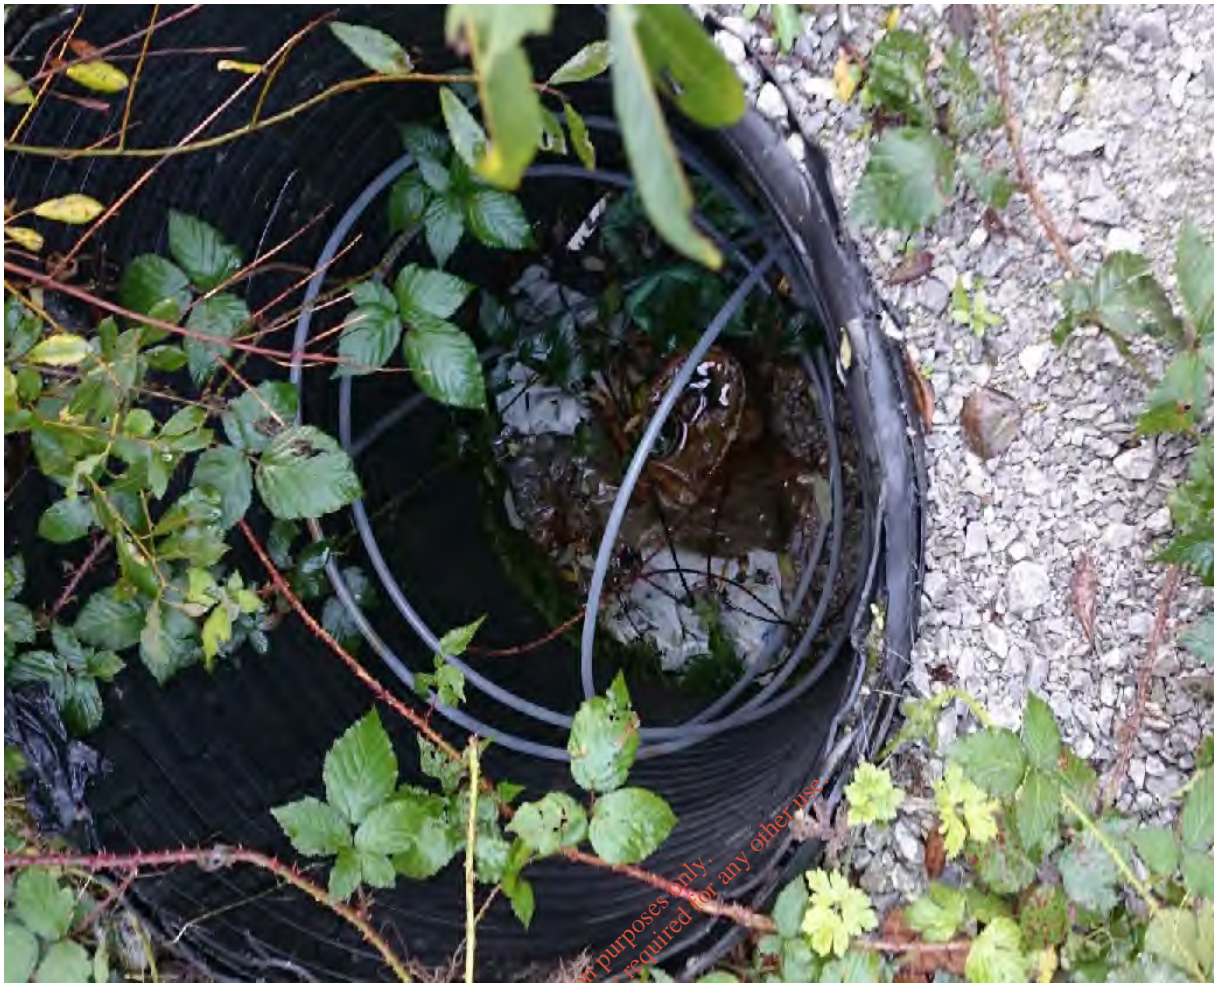
**Photograph 4 MW-4**

At MW-4 there is approximately 1.8m of peat, underlain by almost 1.2m of till. The top 5m of the bedrock is weathered and the total depth of the well was 18m. A water strike was encountered at 11m below ground level. Slotted well pipe extends from the bottom of the hole into the weathered bedrock, with plain pipe extending from there to above ground level. There is a bentonite seal from ground level to the middle of the weathered bedrock. The well construction details indicate it is possible for water in the weathered zone and the competent rock to enter the well pipe.

The well was protected by placing a large diameter plastic pipe on the ground and backfilling around it. However the lid on top of the casing has been removed and there is no well cap. OCM observed water had accumulated in the base of the protective pipe and the level was just below the top of the well pipe and there were leaves and litter around the well pipes. It was not possible to determine if the water in the base was overtopping groundwater or surface water.
