Reg. No. H0209-01

Re: Prusselstown (Former Refuse Depot) Landfill – Notice in accordance with Regulation 7(4) of the Waste Management (Certification of Historic Unlicensed Waste Disposal and Recovery Activity) Regulations, 2008

Client Kildare Co Co			Drawing			
Job Environmental Risk Assessment			Site Investigation Locations – REV A			
Job No. E1506	Drawing Number 15 – REV A	Status DRAFT	Sht. Size A3	Scale 1:10,000	Date June 19	Drawn NM

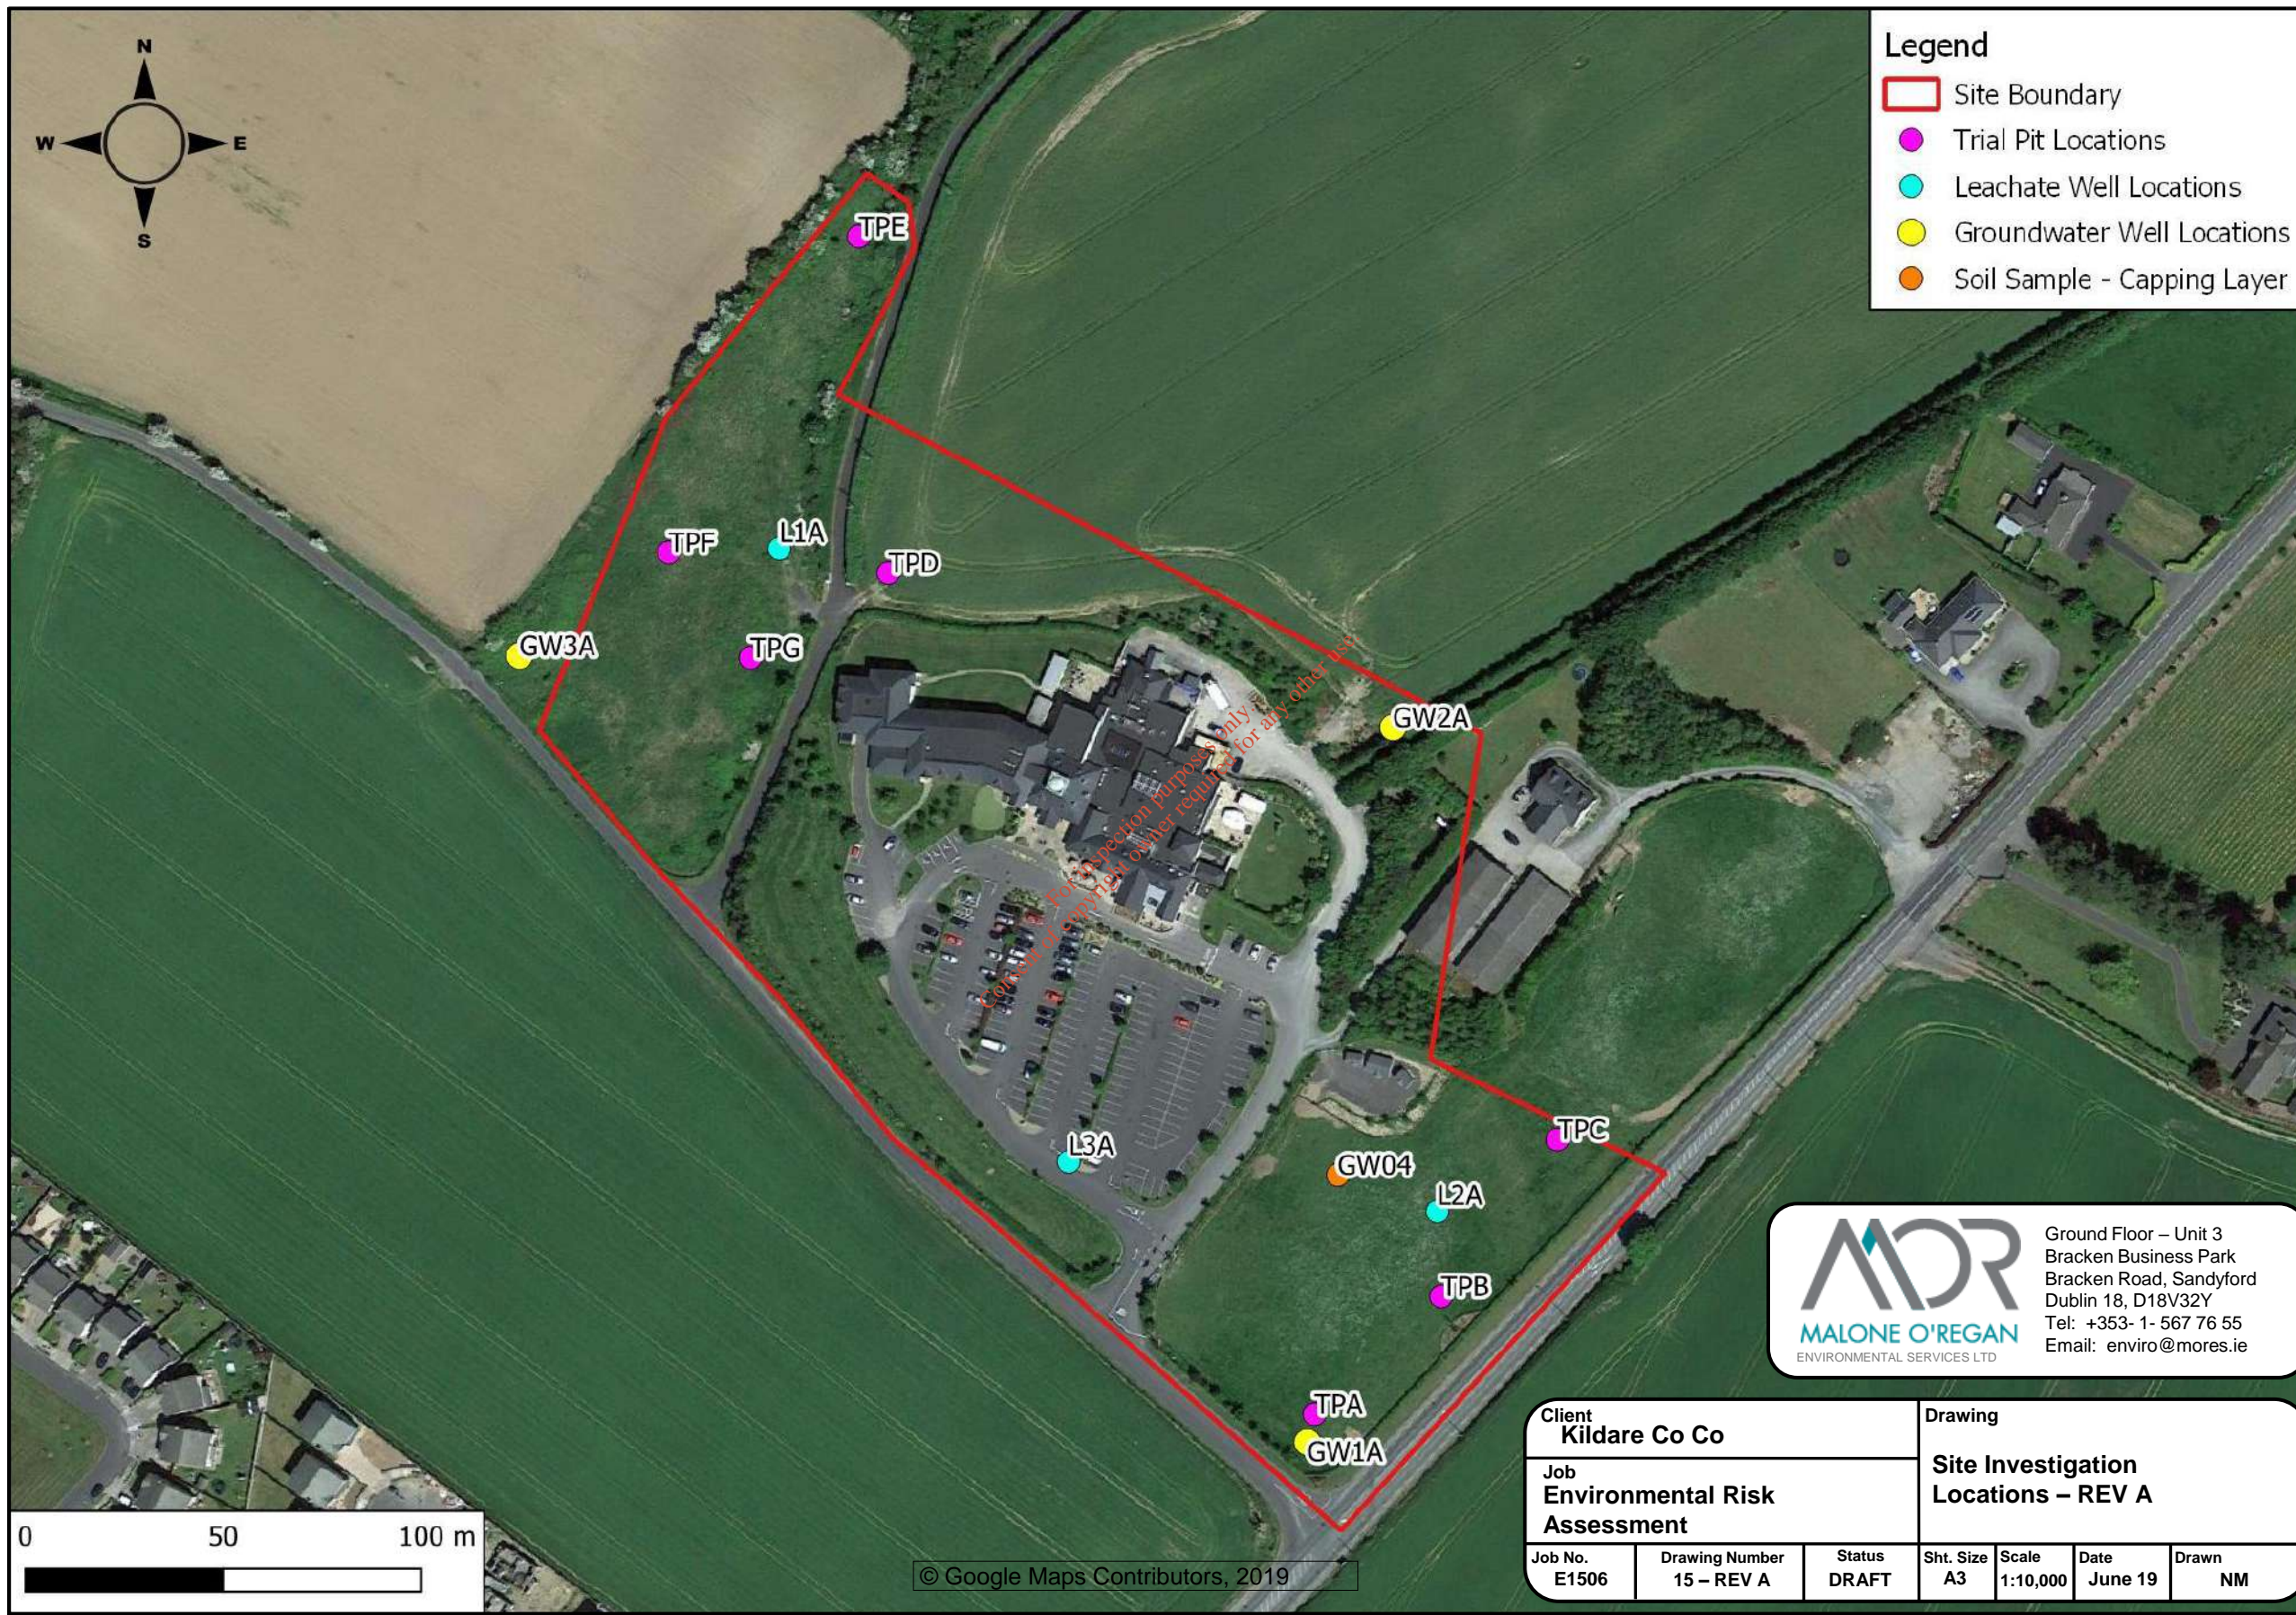
8. Please see attached updated Drawing No. 15 Rev A titled 'Site Investigation Locations – REV A' showing the location of soil permeability sample GW04.

3. Drawing No. 15 shows the boundary of the whole site as per the Tier 1 risk assessment.
4. Drawing No. 15 shows the correct site boundary.
5. The gas monitoring events indicated no flow. As stated in Section 7.5 of the Environmental Assessment:
The flow rate indicates the level of gas movement through the permeable layers. The purpose of measuring gas flow rates is to predict surface emissions and from these deduce the potential for gas ingress into buildings (CIRIA, 2007). The flow rate indicates the level of gas movement through the permeable layers. Furthermore, surface emission rate measures the potential for gas to escape from a particular area on the ground. The very low flow rates observed, and the results of the VOC monitoring surveys, on and off-Site and within the hotel building, demonstrated that the imported material is not actively generating landfill gas and it is therefore not migrating vertically or laterally. Therefore, it would not affect any potential receptors (on or off-site).
