C.4. Land Use

Table C5.1 Breakdown of Old Waste Landfilled at Shore Road Historic Landfill from 1920s to 1960s and Recent Construction and Demoliation Waste Landfilled in 2018

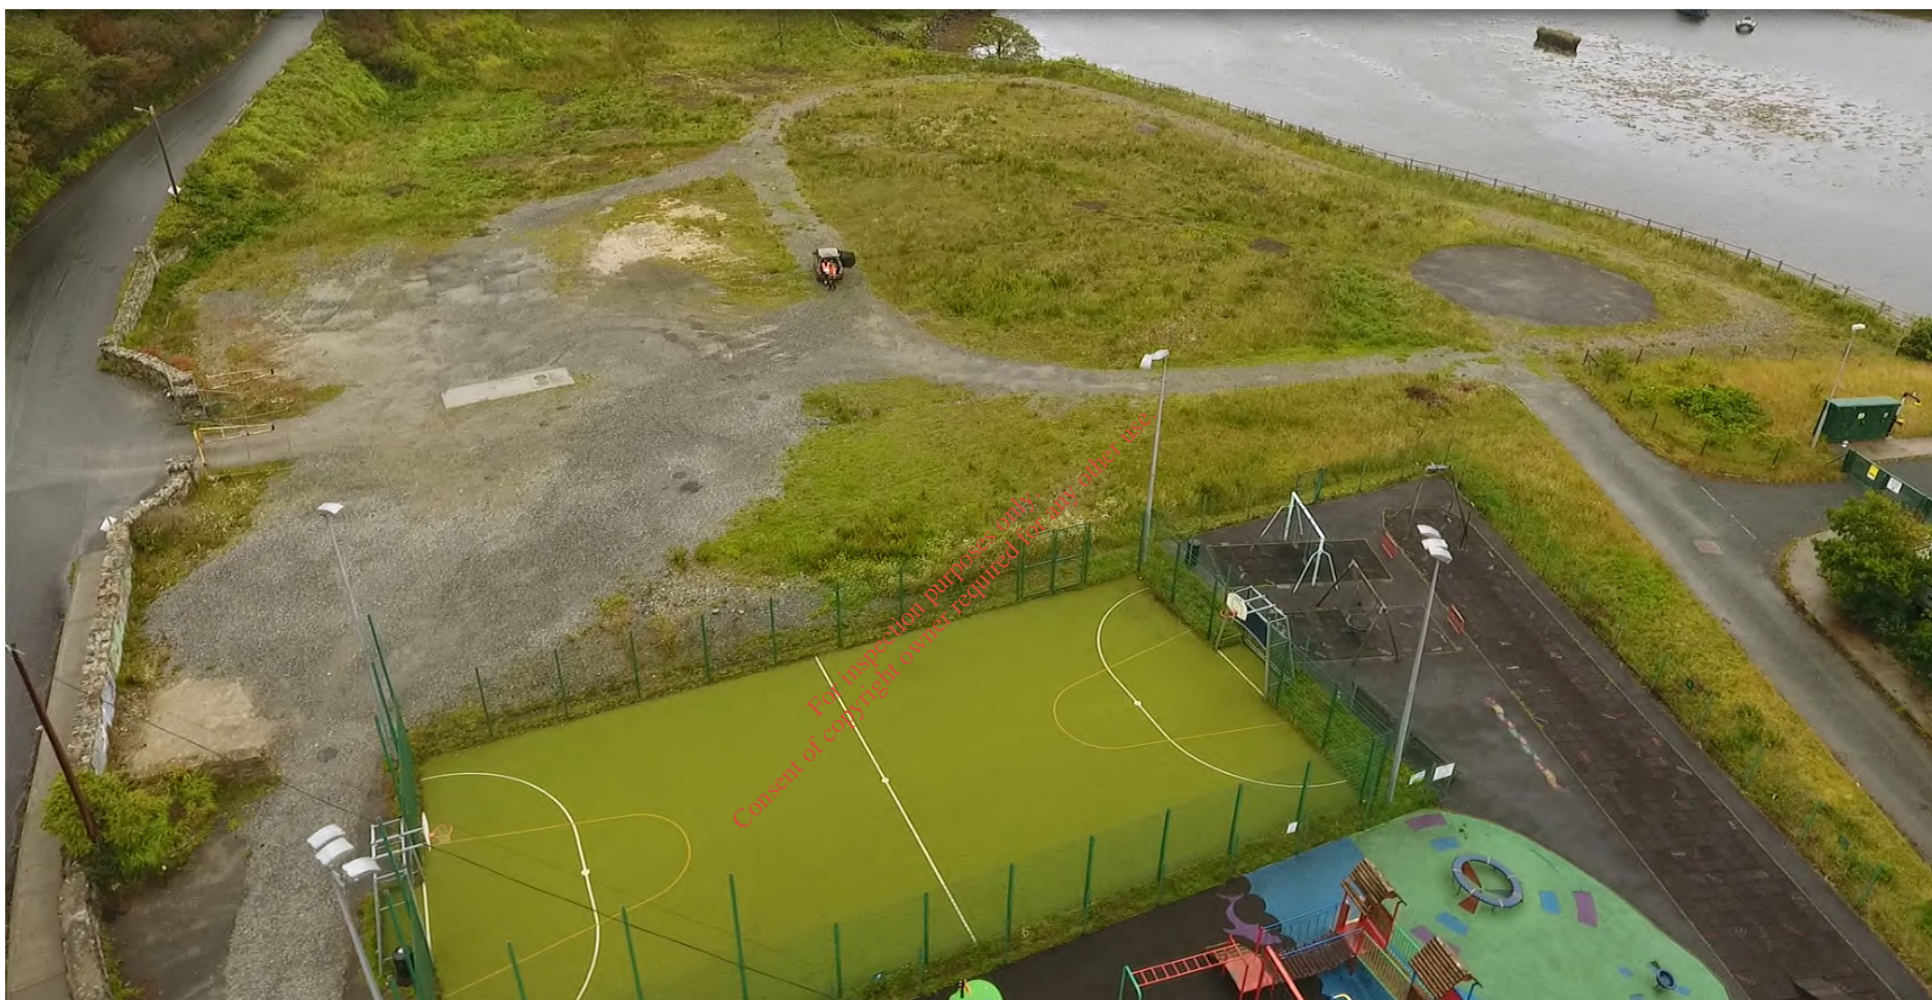
Plate C4.1. Aerial photograph taken on the 29th June, 2020 of the Former Shore Road Historic Landfill taken at 30m elevation from the western end of the site facing eastwards showing the public basketball court, playground and wastewater pumping station in the foreground.

See attached Plate C4.1 which shows an aerial photograph taken on 29th June, 2020 of the Former Shore Road Landfill taken at 30m elevation from the western end of the site facing eastwards showing the basketball court, public playground and wastewater pumping station in the foreground (i.e. to the west of the site). It is proposed to convert the site to a public park for Clifden Town.
