**SHORE ROAD HISTORIC LANDFILL,  
CLIFDEN, CO. GALWAY**

**VOLUME III. SECTION D - PART C  
TIER 3 FURTHER SITE INVESTIGATION &  
UPDATED RISK ASSESSMENT OF FORMER  
SHORE ROAD LANDFILL (24<sup>th</sup> March 2021)  
(VOLUME III - APPENDICES)**

**TIER 3 FURTHER SITE INVESTIGATION &**  
**UPDATED RISK ASSESSMENT OF FORMER**  
**SHORE ROAD LANDFILL**

**VOLUME III. APPENDICES**

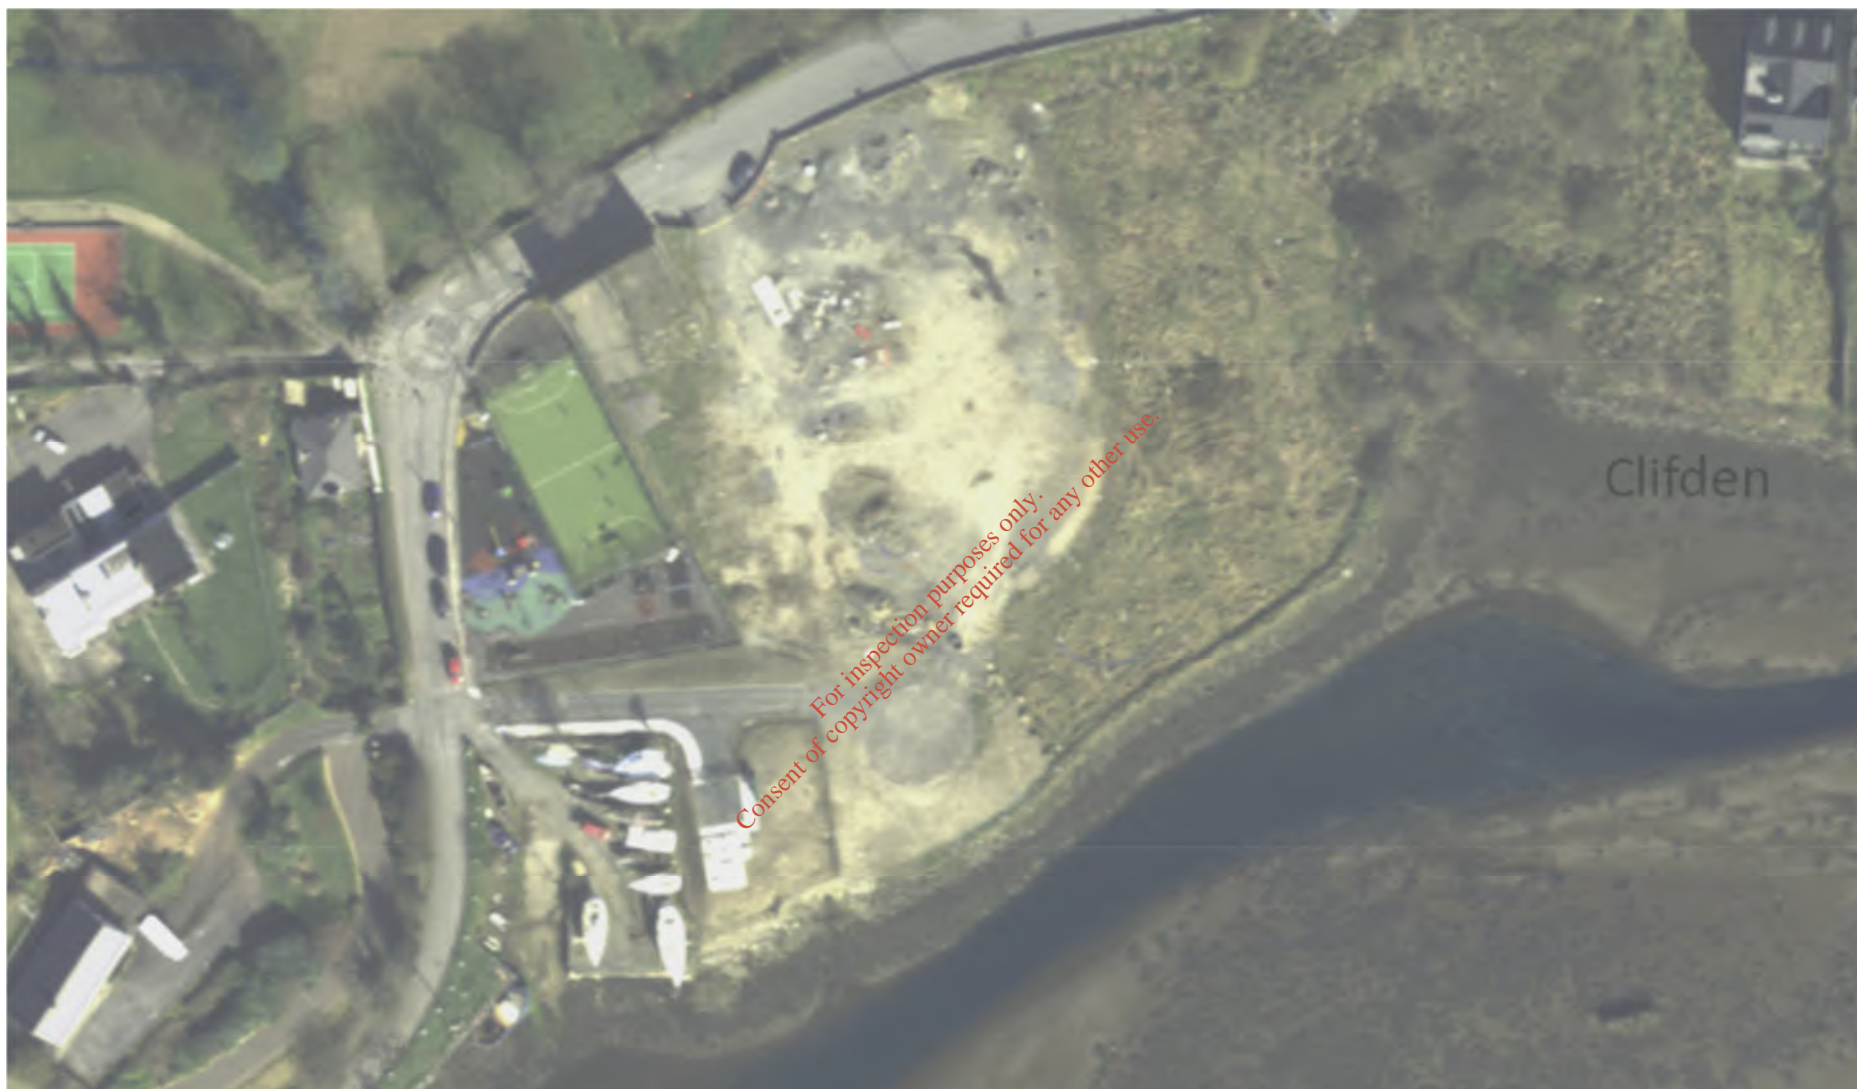
**AERIAL PHOTOGRAPH TAKEN FROM ORDNANCE SURVEY IRELAND SHOWING SITE BEFORE THE DEMOLITION OF THE HANDBALL ALLEY (POSSIBLY TAKEN IN LATE 2017). GROUNDWORKS ON THE INSTALLATION OF NEW SEWERAGE DRAINAGE INFRASTRUCTURE IS VISIBLE.**

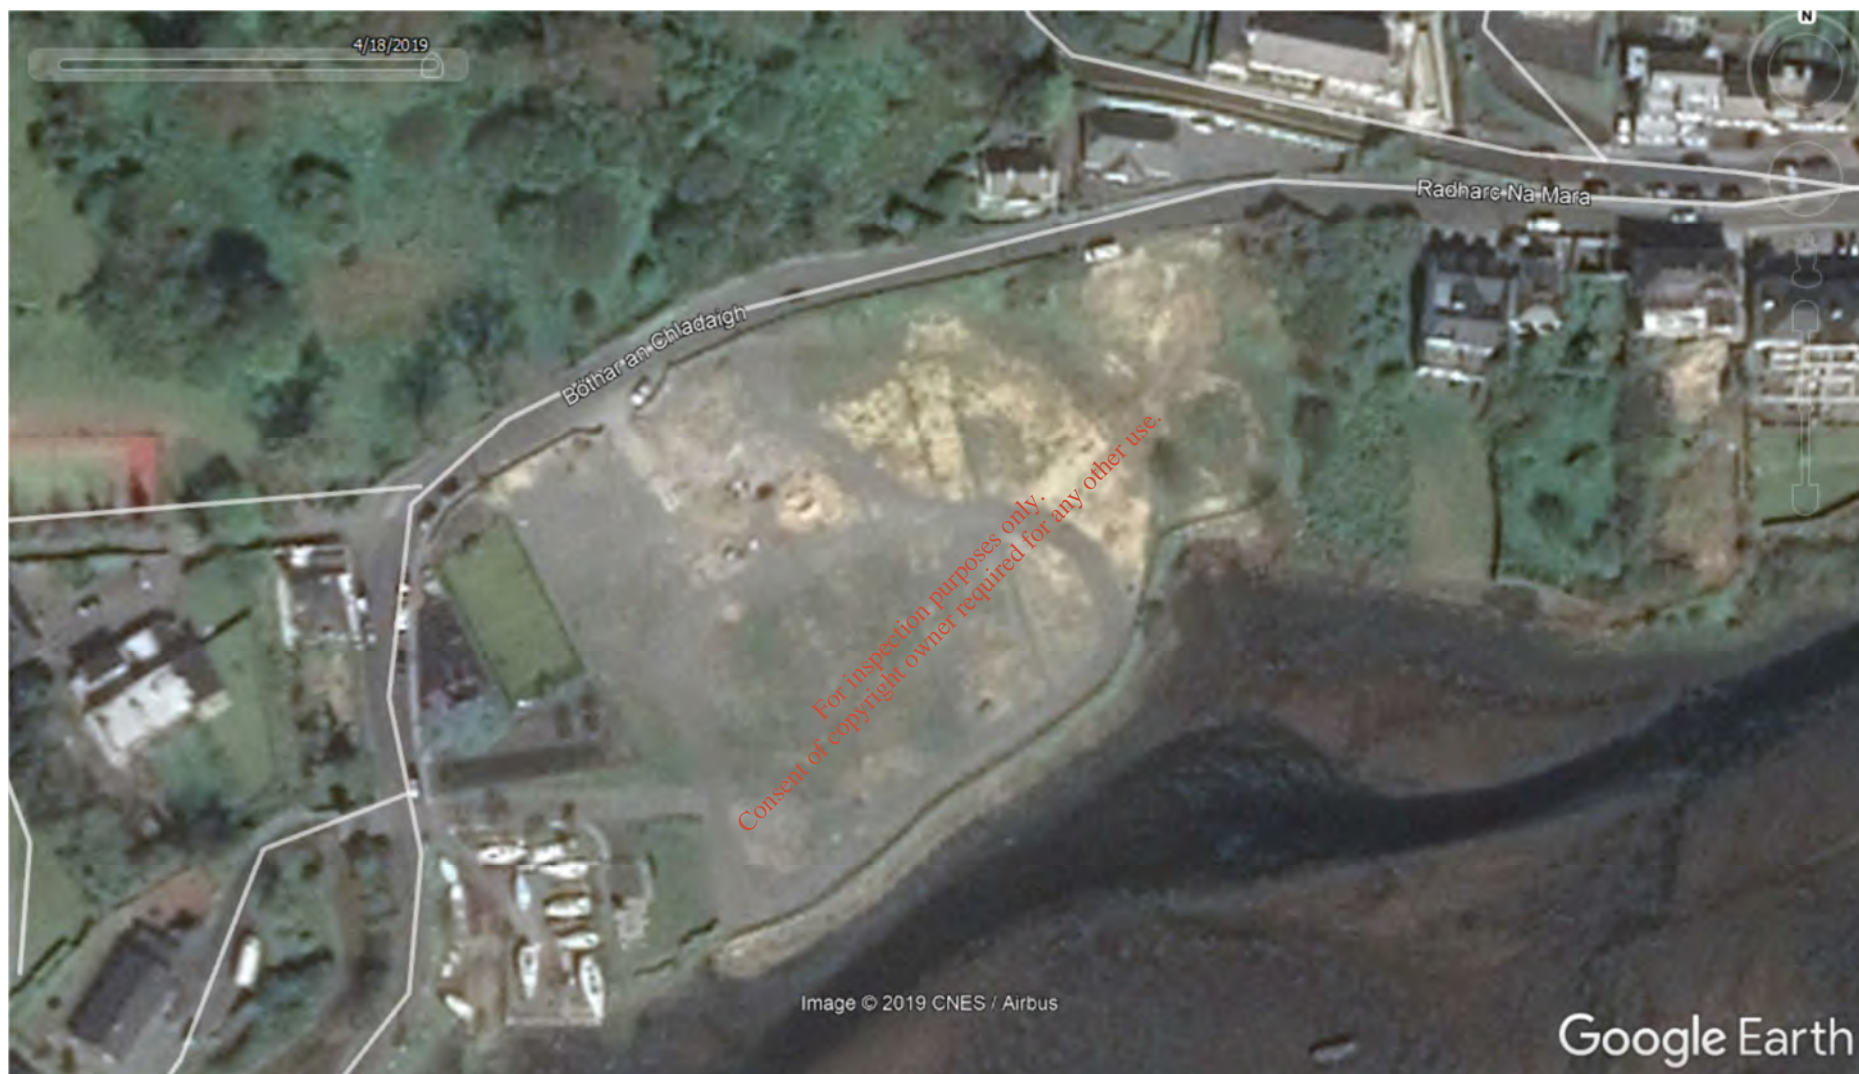
**AERIAL PHOTOGRAPH TAKEN FROM GOOGLE EARTH SHOWING SITE AFTER THE DEMOLITION OF THE HANDBALL ALLEY, THE IMPORTATION OF C&D WASTE AND THE INSTALLATION OF THE 5 LAND DRAINS (MOST LIKELY TAKEN IN 2019)**

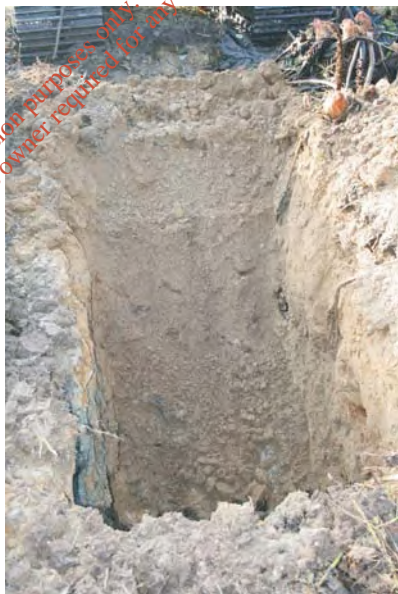
DESCRIPTION	COMMENTS	
			0	Soft light brown sandy SILT	Green color on wall of pit	0
			0.5	Soft yellow/light brown sandy gravelly CLAY with boulders and cobbles	No evidence of contamination Indigenous	0.5
			1.0	indigenous soil	Mottling	1.0
			1.5	Gray/ white coarse sandy GRAVEL with cobbles	Water ingress at 1.5m bgl	1.5
			2.0	Terminated at 1.55m bgl - hit weathered bedrock		2.0
			2.5

<p><u>LOCATION / NOTES:</u></p> <p>NE corner.</p> <p>Some inflow of ponded water top of pit.</p> <p>Water rose to approximately 1m bgl.</p>	<p><u>LEGEND</u></p> <ul style="list-style-type: none"> <li><input checked="" type="checkbox"/> Disturbed Sample</li> <li><input type="checkbox"/> Undisturbed Sample</li> <li>* Headspace Analysis</li> <li>† Down Borehole Analysis</li> <li>▽ Groundwater Table</li> <li>▽ Perched Water Table</li> </ul>	<b>TRIALPIT LOG</b>	
		JOB TITLE	SHORE ROAD SITE INVESTIGATION
		LOCATION	CLIFDEN, CO. GALWAY
		CLIENT	GALWAY C.C.

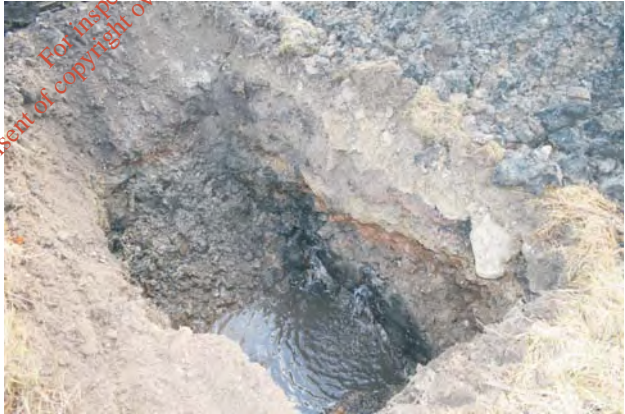
DEPTH (m)	DESCRIPTION	COMMENTS	
				0	Soft dark brown sandy CLAY (MADE GROUND/LANDFILL CAP)		0
				0.5	Yellow/ light brown gravelly CLAY (MADE GROUND) with boulders and cobbles- rounded, sub rounded and sub-angular		0.5
				1.0	Some timber, occasional pods of peat		1.0
				1.5	Loose clayey gravelly COBBLES/ BOULDERS (MADE GROUND)	Possible stone drain	1.5
				2.0	Terminated at 1.82m bgl - hit weathered bedrock	At 1.5m bgl very strong inflow of clean water	2.0
				2.5			2.5
				3.0			3.0
				3.5			3.5
				4.0			4.0
				4.5			4.5
				5.0			5.0

<u>LOCATION / NOTES:</u> Located at the edge of the car park.	<u>LEGEND</u> <input checked="" type="checkbox"/> Disturbed Sample <input type="checkbox"/> Undisturbed Sample * Headspace Analysis † Down Borehole Analysis Groundwater Table Perched Water Table	<b>TRIALPIT LOG</b>	
		JOB TITLE	SHORE ROAD SITE INVESTIGATION
		LOCATION	CLIFDEN, CO. GALWAY
		CLIENT	GALWAY C.C.

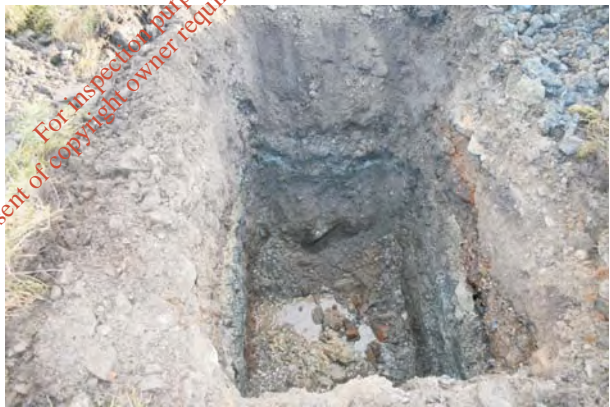
DESCRIPTION	COMMENTS	
		Soft light brown sandy CLAY (MADE GROUND/LANDFILL CAP)		0
		Soft yellow/ light brown gravelly CLAY with boulders and cobbles (rounded)	Iron mottling, black staining	0.5
		Loose angular clayey COBBLES (MADE GROUND) with boulders	Strong water inflow at 0.8m bgl	1.0
		clayey GRAVEL with cobbles		1.5
		Terminated at 2.10m bgl - hit weathered bedrock		2.0

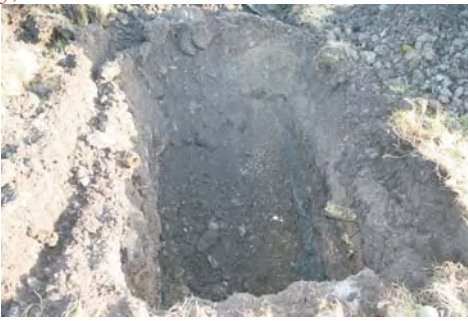
DEPTH (m)	GEOLOGY	DESCRIPTION	COMMENTS	
				0		Soft light brown sandy CLAY (MADE GROUND/LANDFILL CAP)		0
				0.5		yellow/light brown gravelly CLAY with boulders and cobbles. Rounded, sub-rounded, sub-angular etc	No evidence of contamination Drainage pipe Layers become stratified over time	0.5
				1.0		some builders blocks	Water ingress at 1.5m bgl	1.0
				1.5				1.5
				2.0		soft light gray gravelly CLAY with cobbles (rounded)		2.0
				2.5		Terminated at 2.4m bgl - hit weathered bedrock		2.5
				3.0				3.0
				3.5				3.5
				4.0				4.0
				4.5				4.5
				5.0				5.0

<u>LOCATION / NOTES:</u>  South east of handball alley	<u>LEGEND</u> <input checked="" type="checkbox"/> Disturbed Sample <input type="checkbox"/> Undisturbed Sample * Headspace Analysis † Down Borehole Analysis ▼ Groundwater Table ▽ Perched Water Table	<b>TRIALPIT LOG</b>	
		JOB TITLE	SHORE ROAD SITE INVESTIGATION
		LOCATION	CLIFDEN, CO. GALWAY
		CLIENT	GALWAY C.C.

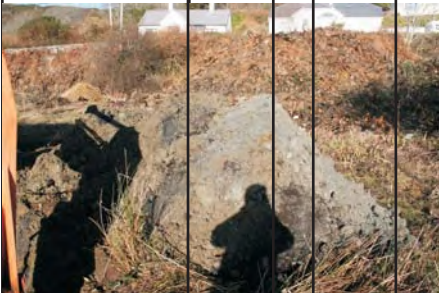
0		Soft light brown sandy CLAY (MADE GROUND/LANDFILL CAP)		0
				0.5		Soft light gravelly CLAY (MADE GROUND) with boulders	Trapped clay pipe with water	0.5
				1.0		Soft/firm yellow brown gravelly CLAY		1.0
				1.5		Soft gray gravelly CLAY with cobbles/boulders interspersed	No evidence of contamination Mottling	1.5
				2.0				2.0
				2.5		Soft gray sandy gravelly SILT with rounded boulders and cobbles	Collapsing sides	2.5
				3.0				3.0
				3.5		Coarse gray sandy GRAVEL with boulders and cobbles	Water ingress at 3.5m bgl	3.5
				4.0				4.0
				4.5		Terminated at 3.9m bgl- hit weathered bedrock		4.5
				5.0				5.0

<b>LOCATION / NOTES:</b> Near shallow land drain. Noticeable drop off in depth to bedrock.	<b>LEGEND</b>

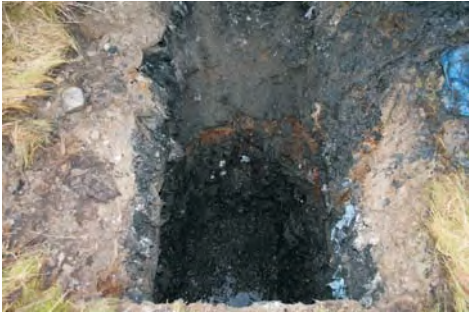
DEPTH (m)	GEOLOGY	DESCRIPTION	COMMENTS	
				0		Soft light brown sandy CLAY (MADE GROUND/LANDFILL CAP)		0
				0.5		soft yellow/light brown gravelly CLAY with boulders and cobbles- rounded, sub-rounded, sub-angular etc some builders blocks		0.5
				1.0				1.0
				1.5				1.5
				2.0				2.0
				2.5		soft black/dark gray gravelly sandy SILT with boulders	Sulphide odor/brackish smell  Strong water ingress	2.5
				3.0				3.0
				3.5		End of hole at 3.5m bgl - hit weathered bedrock		3.5
				4.0

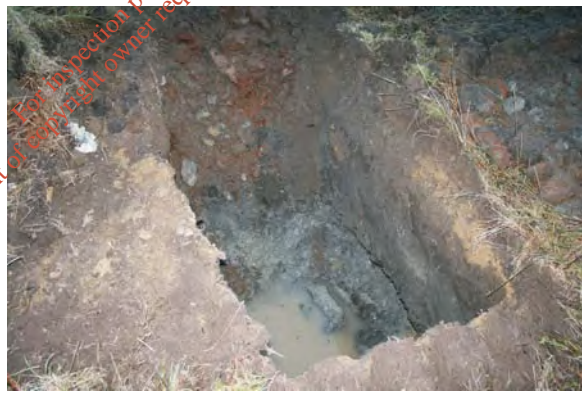
Drainage pipe at 0.5m bgl  Strong inflow	0.5
			1.0	Mixed WASTE (DOMESTIC/COMMERCIAL/C&D)	Slight Sulphide odor	1.0
			1.5	Black plastic bin bag waste/ plastics, skip waste, residential renovation waste, electric cables, timer shards, plastic & glass bottles, ash and cinder, rubber hosing, car parts, inflow from perched water table into overlying plastic sheeting.		1.5
			2.0			2.0
			2.5			2.5
			3.0		Collapsing pit walls	3.0
			3.5		No sheen on water.	3.5
			3.9		Strong inflow	3.9
			4.0	Terminated at 3.9m bgl - hit weathered bedrock or very large boulder.		4.0
			4.5			4.5
			5.0			5.0

LOCATION / NOTES: East of helepad	<b>LEGEND</b>

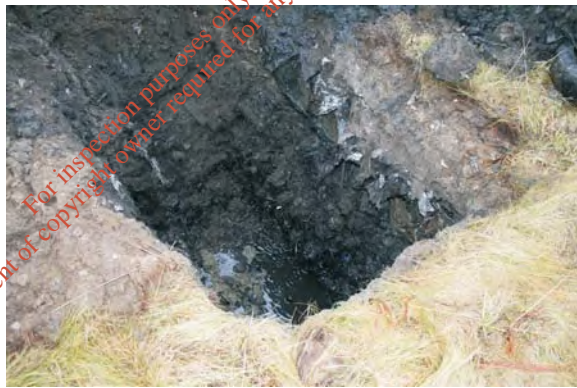
DEPTH (m)	GEOLOGY	DESCRIPTION	COMMENTS	
				0		Soft light brown sandy CLAY (MADE GROUND/LANDFILL CAP)		0
				0.5				0.5
				1.0				1.0
				1.5		Mixed WASTE (DOMESTIC/COMMERCIAL/C&D) skip waste, residential renovation waste, electric cables, timer shards, masonry, plastic & glass bottles, ash and cinder, rubber hosing, car parts, inflow from perched water table into overlying plastic sheeting.	No evidence of Contamination	1.5
				2.0				2.0
				2.5				2.5
				3.0				3.0
				3.5				3.5
				4.0		Terminated at 3.95m bgl - hit weathered bedrock.		4.0
				4.5				4.5
				5.0				5.0

East of helipad

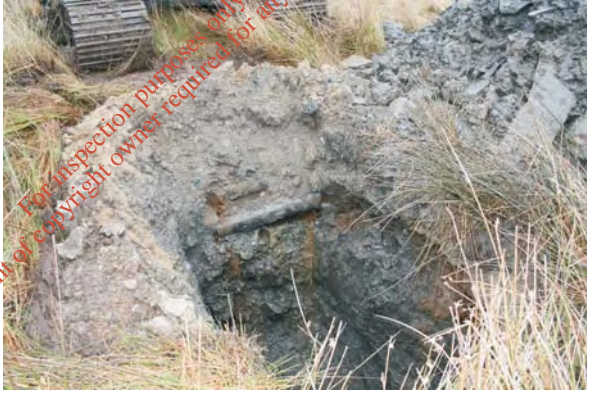
Inflow from pipe, possibly an old foul sewer	0.5
			1.0	Large amount of boulders and rubble		1.0
			1.5	Some pipes		1.5
			2.0	Pockets of Peat, low percentage domestic waste		2.0
			2.5

Collapsing sides	2.5
			3.0			3.0
			3.5			3.5
			4.0	Terminated at 3.75m bgl - hit weathered bedrock		4.0
			4.5			4.5
			5.0			5.0

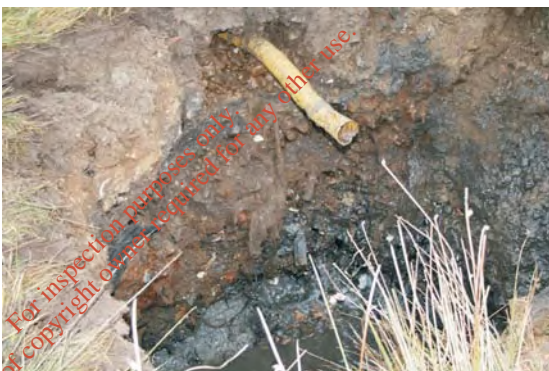
Land Drain	0
				0.5		Soft light brown/green gravelly CLAY		0.5
				1.0		C&D WASTE (MADE GROUND)	No odor	1.0
				1.5		Boulders, bricks, blocks, ash, timber, some glass, metal, some plastics	Strong inflow from N face and S face	1.5
				2.0		Mottling around waste		2.0
				2.5

2.5
				3.0				
				3.5		soft brown gravelly CLAY with cobbles	Indigenous	3.5
				4.0		Terminated at 3.85m bgl - hit weathered bedrock		4.0
				4.5				4.5
				5.0				5.0

<u>LOCATION / NOTES:</u> Located beside helipad.	<u>LEGEND</u>
