**OFFICE OF ENVIRONMENTAL  
SUSTAINABILITY**

**INSPECTOR'S REPORT ON AN APPLICATION  
FOR A CERTIFICATE OF AUTHORISATION  
FOR A CLOSED LANDFILL**

<b>TO:</b>	Eimear Cotter, Director
<b>FROM:</b>	Ewa Babiarczyk, Inspector, Environmental Licensing Programme
<b>DATE:</b>	4 <sup>th</sup> May 2021
<b>RE:</b>	Application by <b>Kildare County Council</b> for a Certificate of Authorisation for a closed landfill at <b>Greenhills, Athy, County Kildare</b> . Certificate of Authorisation Register Number <b>H0208-01</b> .

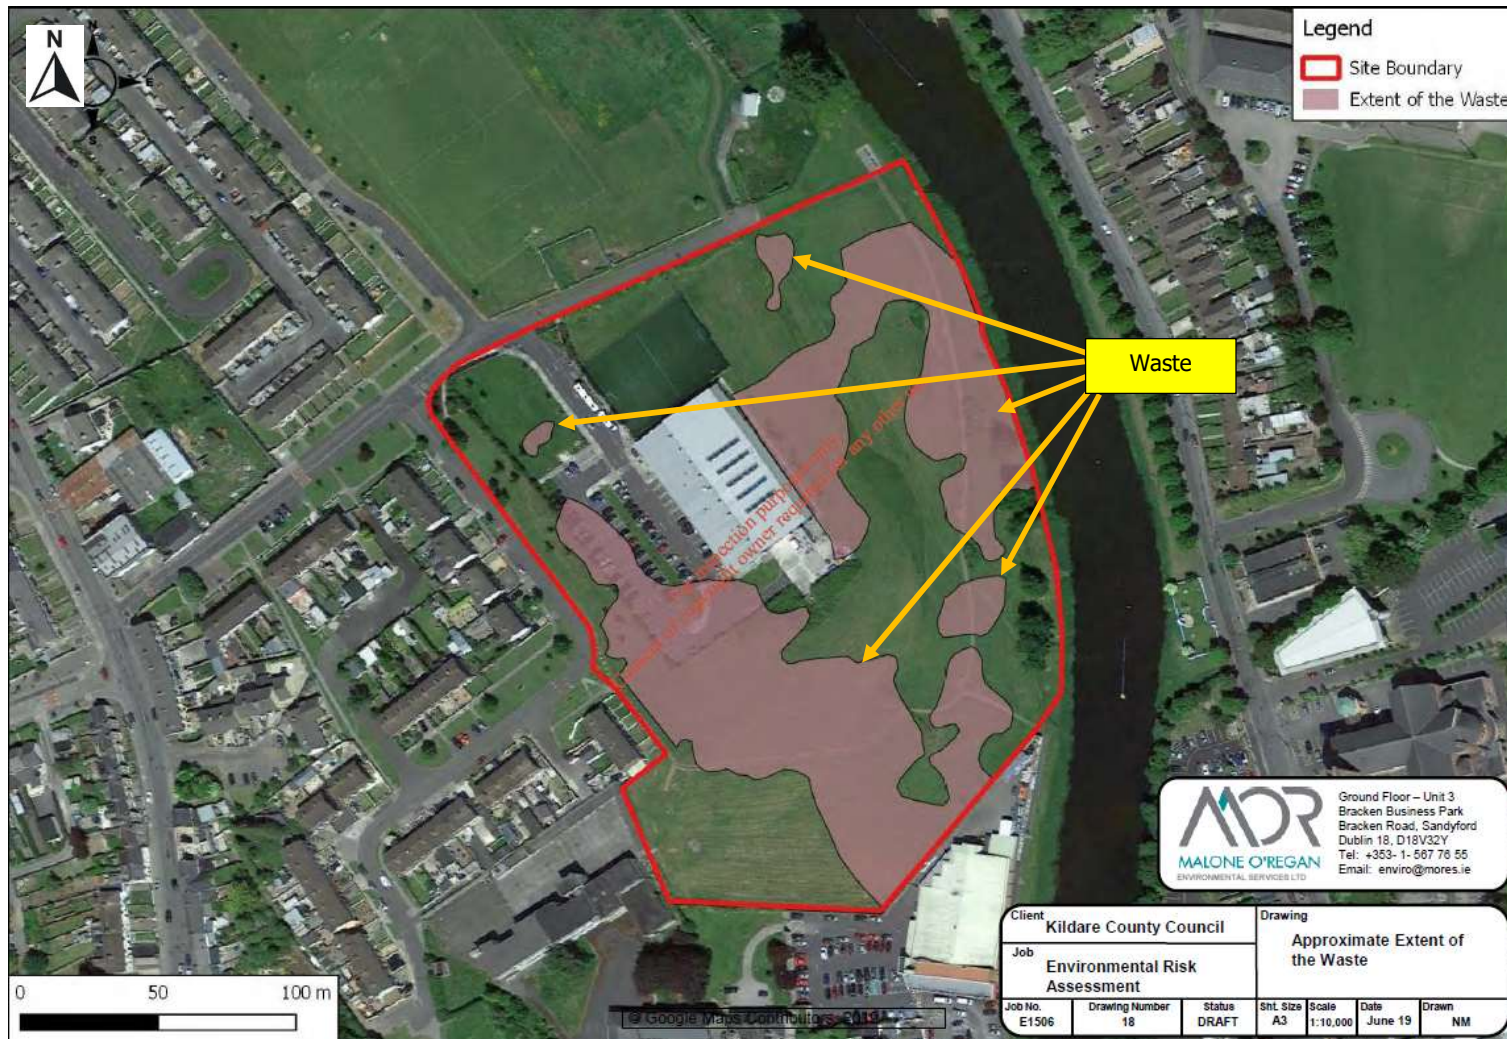
**Figure 3: Approximate extent of deposited waste**

Location of facility	The closed landfill is located in the centre of Athy town, County Kildare, 150m north of the N78 road.  The location of the landfill site is shown in Figure 1.
Period of landfilling	1980 to 1985.
Surrounding area	There are residential properties immediately adjacent to the western boundary of the site, as shown in Figure 2. The closest property is located 15m from the site boundary. A field with football pitches is located to the north of the site. The Barrow River flows immediately adjacent to the eastern boundary of the site. On the eastern bank of the Barrow River are residential properties and a school. A shopping centre and a car park adjoins the south-eastern boundary of the site.
Area of the closed landfill	The site covers an area of 4.1 ha.
Quantity of waste at the facility	Approximately 68,040 tonnes. 48,600 m <sup>3</sup>
Characterisation of waste deposited	The waste comprises municipal waste, construction & demolition (C&D) waste, commercial waste and industrial waste. The deposited waste includes brown gravelly clay / brown clay mixed with wood, concrete, cloths, black fibres, tiles, terram geotextile materials, bricks, metal, plastic, rubber plastic, bitumen, glass and styrofoam. Asbestos fibre bundles were also detected, as outlined below in Section titled <i>Leachate and water quality</i> .  The extent of the waste body is 1.62 ha. The waste was deposited in a few areas across the site as shown in Figure 3.

located at the north-eastern corner of the site and the waste was mainly deposited in other parts of the site, as shown in Figure 3. Therefore, it is considered that the monitoring results from GW1 are not fully representative of groundwater conditions downgradient of the site. Accordingly, Condition 3.1(d) requires installation of at least one additional groundwater monitoring well downgradient of the waste body.

However, due to the fact that leachate is being generated, it is considered that the rainwater ingress is not prevented by the existing cover material and therefore, a cover material of a lesser permeability is required. Accordingly, Condition 3.1(b) requires a landfill cap that comprises of a minimum 1m thick mineral layer having a hydraulic conductivity of less than or equal to  $1 \times 10^{-9} \text{m/s}$  or a 1mm thick geomembrane, or equivalent, to achieve the hydraulic conductivity of  $1 \times 10^{-9} \text{m/s}$ . In addition, Condition 3.1(b) requires that the cap is placed over all areas where waste is deposited with the exception of the hardstanding areas.

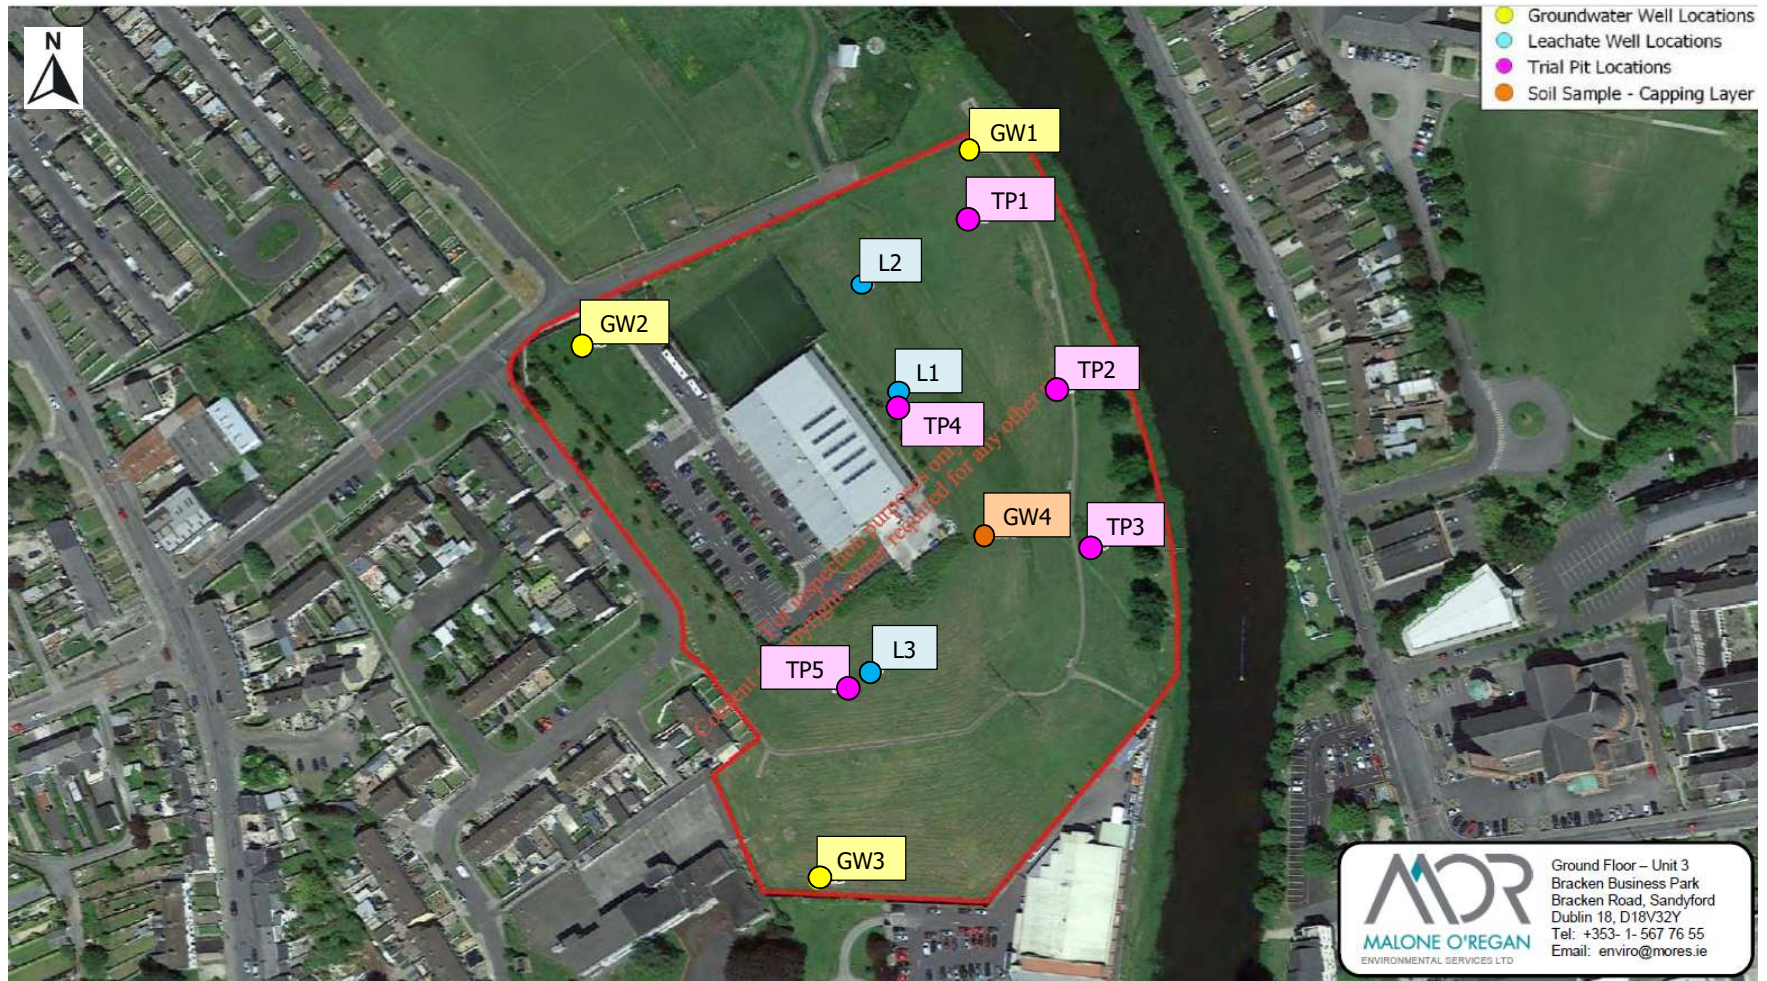
**Figure 6: Groundwater well (GW), trial pit (TP) and leachate (L) monitoring locations**

<p>Leachate and water quality:</p>	<p><u>Trial pit investigation</u></p> <p>Five trial pits TP1 to TP5 were excavated on 16<sup>th</sup> January 2019, as shown in Figure 6. Waste was encountered in all five trial pits. The sub-surface profile encountered in the trial pits consisted of a cover material comprised of brown gravelly clay / brown clay, with a thickness ranging from 0.5m to 1.1m overlaying a 1.1 to 4.4m thick layer of brown gravelly clay/ brown clay mixed with plastic, metal, terram geotextile materials, bricks, clothes and wood.</p> <p><u>Soil sampling</u></p> <p>Soil samples were collected from the trial pits TP3, TP4 and TP5. The sampling detected the presence of total organic carbon (TOC), sulphide and elemental sulphur, metals, polycyclic aromatic hydrocarbons (PAHs), mineral oil, petroleum hydrocarbons, polychlorinated biphenyls (PCBs) and phenols. The sampling also detected chrysotile (white asbestos) fibre bundles at concentrations of less than 0.001% in samples from trial pits TP4 and TP5. The Tier 3 Assessment states that asbestos in such low concentrations poses no risk to human health or the surrounding environment considering the use of site. The soil sampling further showed that the relevant parameters, which include TOC, BTEX (benzene, toluene, ethylbenzene and xylenes), PCBs (7 congeners), mineral oil (C10-C40) and PAH 17 Total, were within the inert waste limit values, as set in the <i>Waste Acceptance Criteria set out in Council Decision of 19 December 2002 establishing criteria and procedures for the acceptance of waste at landfills pursuant to Article 16 of and Annex II to Directive 1999/31/EC</i>.</p> <p><u>Leachate</u></p> <p>The applicant carried out leachate testing on the soil samples from trial pits TP3, TP4 and TP5 on 16<sup>th</sup> January 2019. The testing included dissolved antimony, arsenic, barium, boron, cadmium, chromium, copper, lead, molybdenum, nickel, selenium, zinc and mercury, total phenols, fluoride, ammoniacal nitrogen, sulphate, chloride, dissolved organic carbon and total dissolved solids. The leachate testing result showed that the concentrations of the tested parameters were within the leaching limit values for inert waste, as set out in the above Waste Acceptance Criteria. Accordingly, the landfill leachate is typical of leachate generated in an inert landfill.</p> <p>Leachate monitoring was carried out at combined monitoring wells L1, L2 and L3 within the waste body, as shown in Figure 6, on 23<sup>rd</sup> April 2019 and 8<sup>th</sup> May 2019. The monitoring well L2 was dry during both monitoring events therefore, leachate samples were only retrieved from wells L1 and L3. It is also noted that monitoring well L2 is not located within the waste body when Figure 3, which shows the waste locations, is cross-referenced with the monitoring well locations in Figure 6. Accordingly, Condition 3.7 requires a drawing showing, among other elements, the interpolated extent of the waste body and all monitoring points.</p> <p>Table below shows the parameter concentrations which exceed the relevant standards.</p>

Groundwater monitoring was carried out at three groundwater monitoring wells GW1, GW2 and GW3, as shown in Figure 6, on 23<sup>rd</sup> April 2019 and 8<sup>th</sup> May 2019.

Considering that groundwater flows towards east/ north-east, it is noted that only one of the monitoring wells (GW1) is located downgradient of the waste body. It is noted however, that GW1 is

<p>Condition 3.8(e) requires monitoring on a quarterly basis of groundwater from the existing wells and at least one additional groundwater monitoring well, which shall be downgradient of the waste body. Also, Condition 3.8(f) requires that the sensitivity of the monitoring methods utilised shall have an appropriate limit of detection to allow for comparison of pollutant concentrations against the relevant trigger levels and/or standard reference values.</p>																												
<p>Landfill gas:</p>	<p>There is a risk of landfill gas migration to on-site and off-site buildings. The most likely pathway for the migration of the landfill gas is through the underlying bedrock and existing landfill cover material.</p> <p>Gas monitoring was carried out on 23<sup>rd</sup> April 2019, 25<sup>th</sup> April 2019, 8<sup>th</sup> May 2019 and 29<sup>th</sup> May 2019. In total six wells L1, L2, L3 and GW1, GW2 and GW3, as shown in Figure 6, were monitored. The monitored parameters were methane (CH<sub>4</sub>), carbon dioxide (CO<sub>2</sub>), oxygen (O<sub>2</sub>), carbon monoxide (CO) and hydrogen sulphide (H<sub>2</sub>S). Also, gas flow rate was measured.</p> <p>The below table shows the maximum concentrations of methane and carbon dioxide measured at on-site locations shown in Figure 6. For ease of reading, the monitoring locations outside the waste body are highlighted orange.</p>
