DROGHEDA LANDFILL SITE

Drogheda Licence Review Article 12

IBR1237
Final
09 June 2021

REPORT

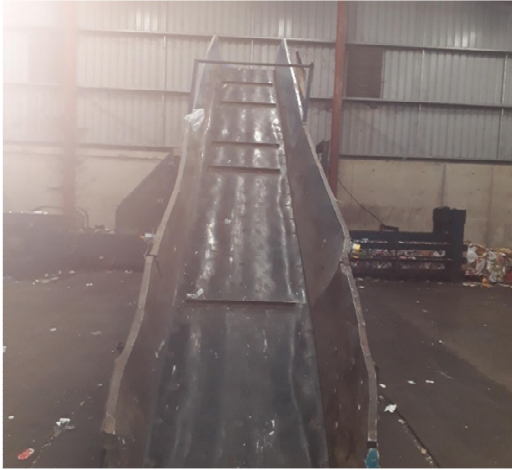
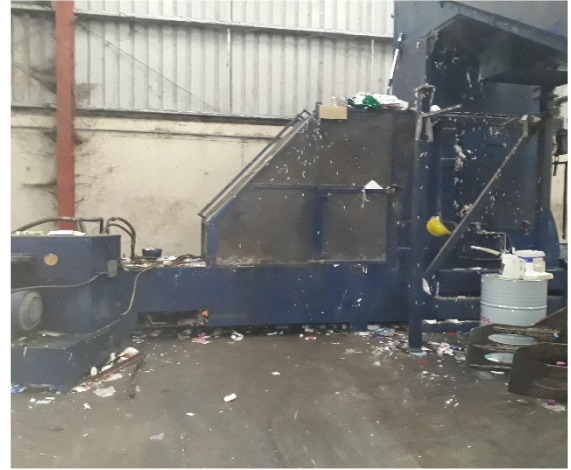
Picture 1 Plant at the Civic Waste Facility

The following plant is used at the Civic Waste Facility:

- A compactor is used to reduce and compress waste
- A baler is used to transform waste into solid blocks of recyclable material
- Conveyor is used for sorting of waste materials.

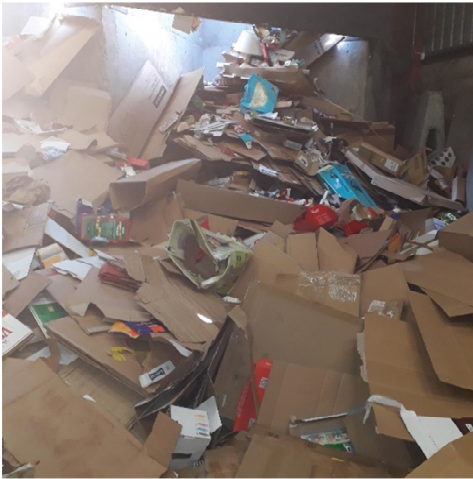
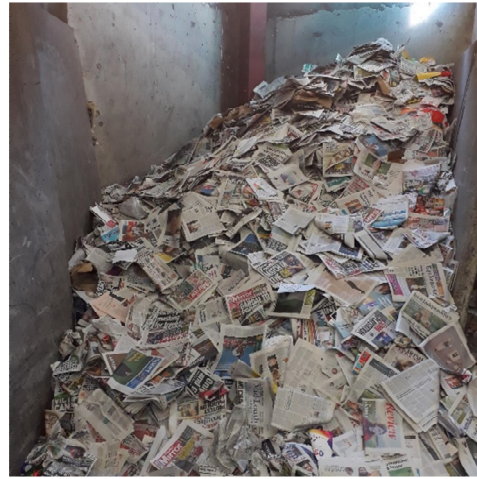
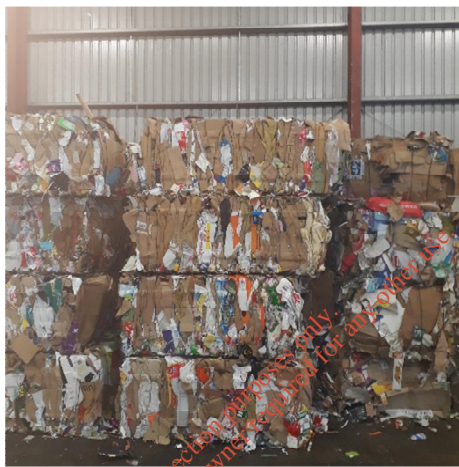
Picture 2 Cardboard, Magazines accepted at the Civic Waste Facility

Cardboard, magazines, books, newspaper, and paper materials are deposited into individual and clearly signed receptacles. These are monitored by staff to ensure only correct material is deposited. Once deposited into the receptacles the material is directed to separate bay areas via chutes. Material in these bay areas are checked to ensure no contamination; material is then loaded onto a conveyor and from there into a baling machine. The bales are stored onsite inside a weatherproof shed and transported offsite to the facility; Peute Europe in loads ranging from 20 to 25 tonnes.

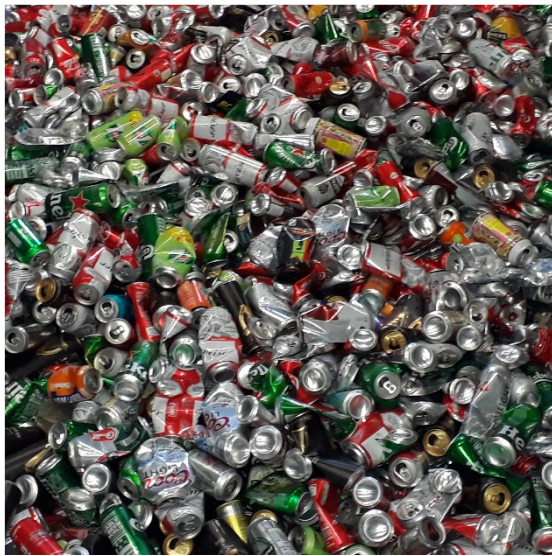
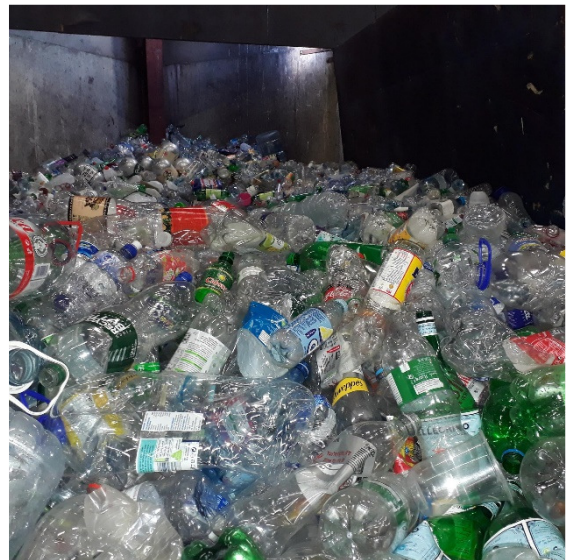
Picture 3 Aluminium cans and plastics accepted at the Civic Waste Facility

- Aluminum Cans – Tinnelly NI CN 09/10,
- Plastic Milk Bottles – Sharba Plastics MN 080,022-01,
- Plastic Bottles – Sharba Plastics MN 080,022-01,
- Plastic Bag/Film – Sharba Plastics MN 080022-01.

Footwear and clothing material are checked, stored in heavy duty bags, and periodically given to charity.

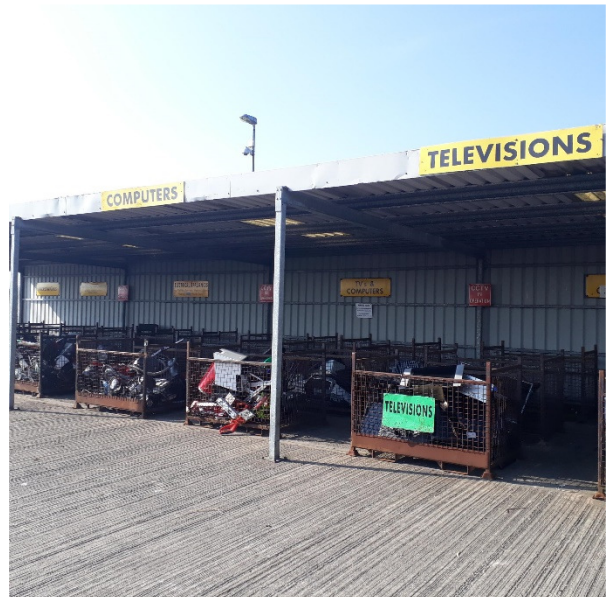
Picture 4 Electrical Goods accepted at the Civic Waste Facility

Items are deposited by the public in a weatherproof area into various cages and receptacles which are clearly labelled, specifying the materials to be deposited. Materials being deposited are monitored by staff to ensure no non-electrical items are deposited. The area consists of 18 4m³ cages. When the cages are full, the material is transported off site by a permitted contractor. Transport off site occurs twice per week and empty cages are left in place. Annually 650 to 600 tonnes of electrical goods are transported off site to an authorised site (Radcliffe- Waste Management Services).

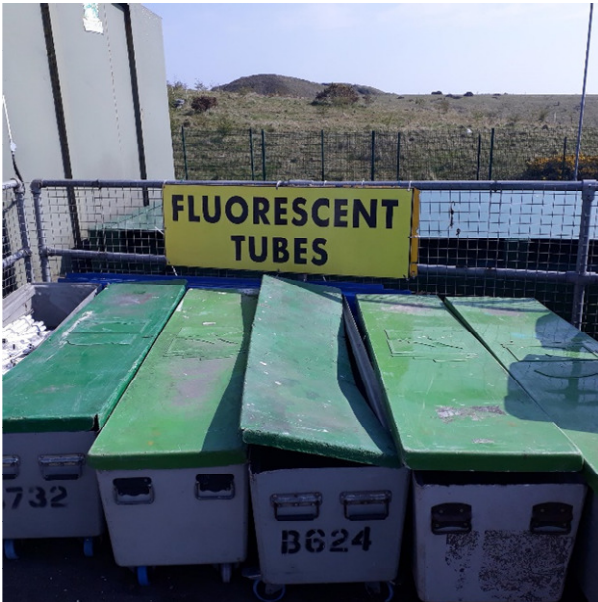
Picture 5 Fluorescent Bulbs accepted at the Civic Waste Facility

Fluorescent bulbs are deposited into closed containers and monitored by staff. When capacity is reached, empty containers are put in place and the full containers are transported to Irish Lamp Recycling by a permitted contractor. Annual quantities transported off site are approximately 500kg.

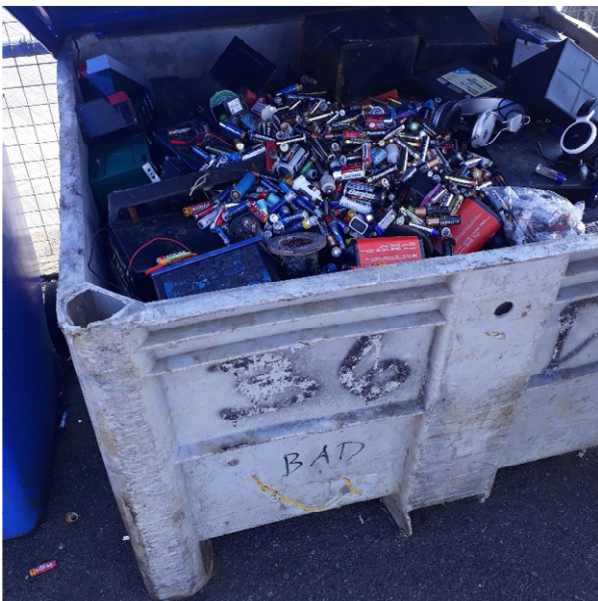
Picture 6 Household Batteries accepted at the Civic Waste Facility

Household Batteries are deposited in sealed containers and when full collection is arranged and transported by a permitted contractor to Enva Ireland. Monitoring is carried out to ensure only household batteries are deposited. Quantities removed off site are approximately 2 tonnes per annum.

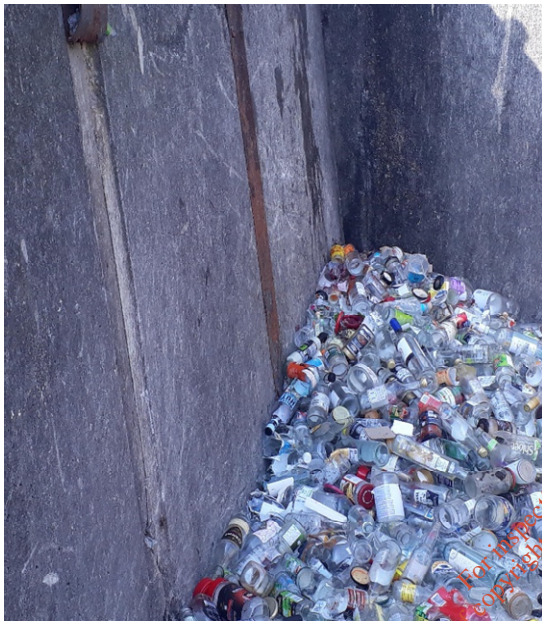
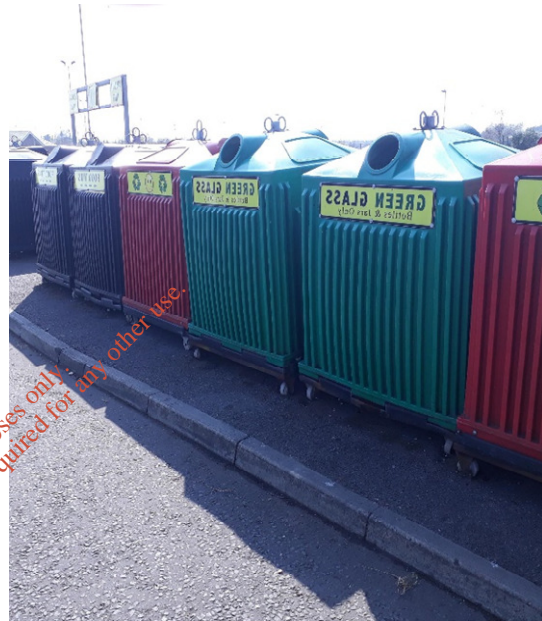
Picture 7 Glass accepted at the Civic Waste Facility

The facility accepts blue, clear, green and brown glass. They are deposited into clearly marked and colour coded receptacles which lead to separated bays. The material is monitored to ensure that non-glass items are not deposited and that the correct glass colour receptacle is used. Each bay area for each glass colour has the capacity for 20 tonnes. Material in these bays is transported off site to the following facility Glasdon NILN 06-08. Material is transported off site in 20 tonne individual coloured glass loads.

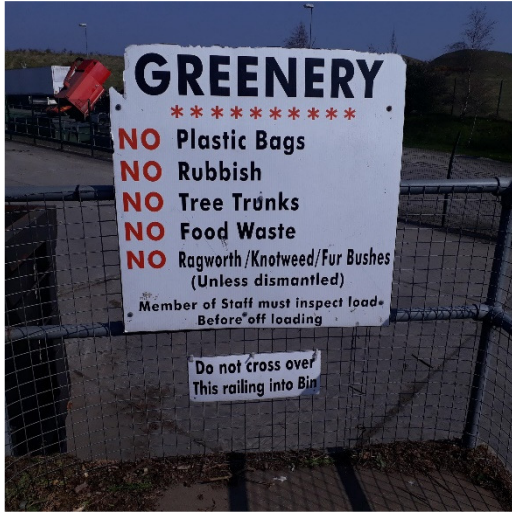
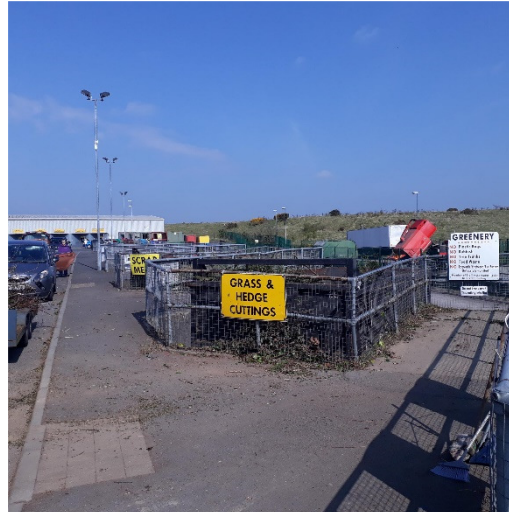
Picture 8 Green waste accepted at the Civic Waste Facility

Green waste material consisting of grass, hedge and shrub cuttings is deposited into 30m³ containers. When full the material is transported to V and W recycling centre in Dundalk and is used in the composting process which is licensed under EPA licence W0034-02. This type of material is seasonal and the number of containers collected on a weekly basis can range from 1 to 3 containers. Material is only stored for a short period in the yard area prior to transport to Dundalk. Monitoring of materials deposited is carried out to ensure only authorized green waste is deposited.

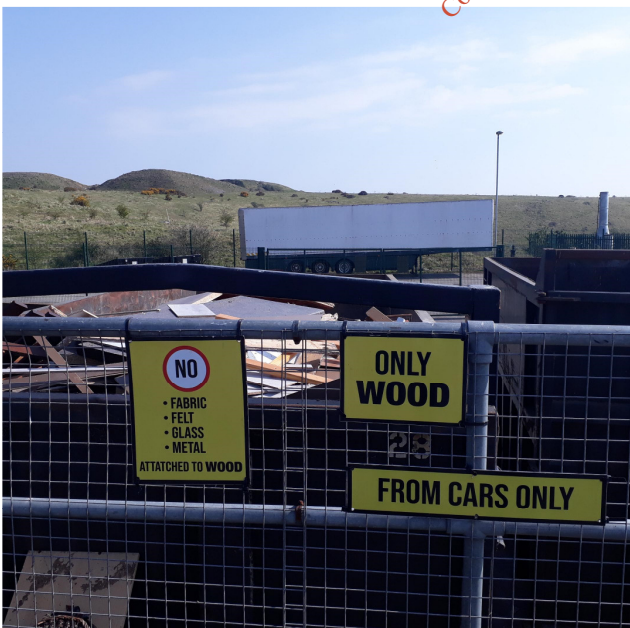
Picture 9 Wood accepted at the Civic Waste Facility

Wood material is deposited in 20 to 30 m³ containers. There is signage in place and supervision to ensure that non wood items are not placed in the container. When the containers are full, they are stored in the general yard area for a short period, prior to transport by a permitted handler to Thorntons W0195-02. An empty container is put in place and the process continues. 1 to 2 containers of wood are collected on a weekly basis.

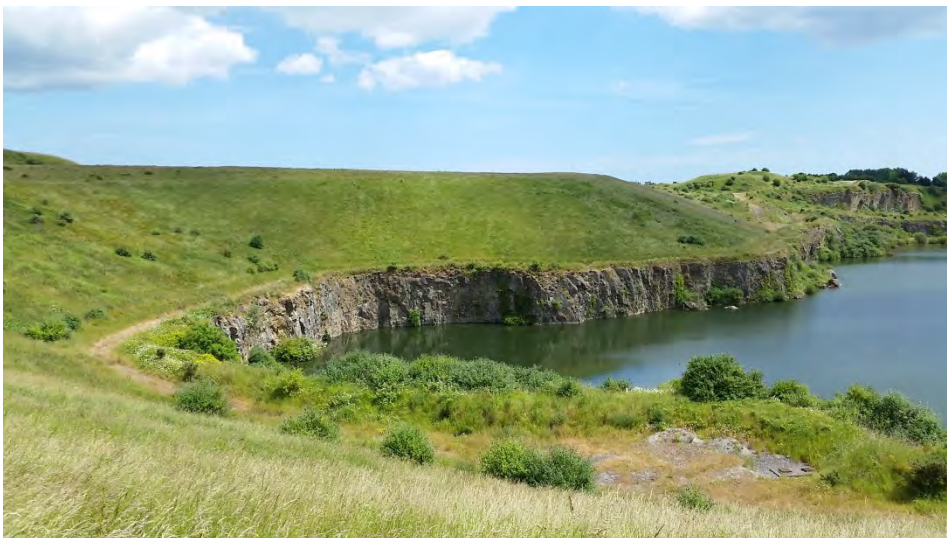
Photo 1 View of Exposed Limestone under the waste material

The thickness and depth of this waste material is currently unclear. However, a geophysical survey undertaken by BMA Geoservices in June 2005 suggests a thickness of waste ranging between 5 and 35 mbgl¹. A suggested cross section of the site is provided in **Figure 3** and **Figure 4**.

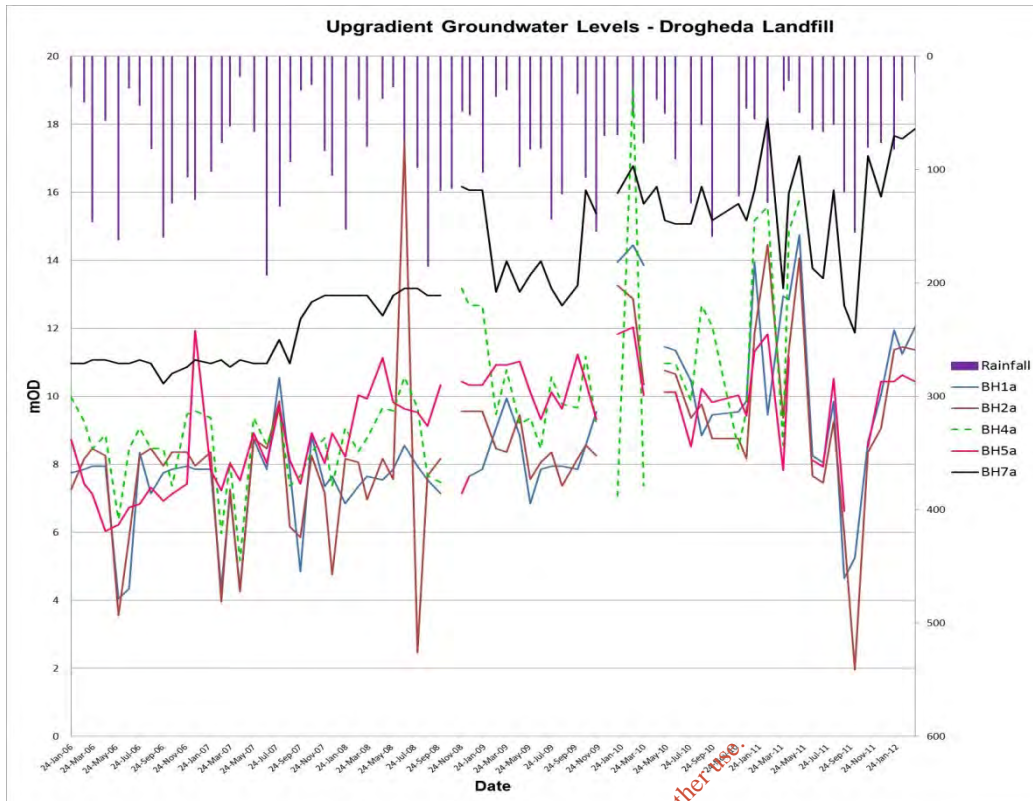
Graph 6.1 Upgradient Groundwater Levels

- Given the variability of groundwater levels and interpreted groundwater flow directions in the northern region of the site and the proximity of the waste body to these wells, it appears that the monitoring wells along the northern boundary of the site *i.e.* BH1A, BH2A, BH4A and BH5A do not fully represent upgradient conditions. It appears that BH1A and BH2A are upgradient of the waste body at particular times of the year and possibly downgradient at other times. In addition, the locations of BH4A and BH5A appear to be too close to the waste body to be representative of upgradient conditions.

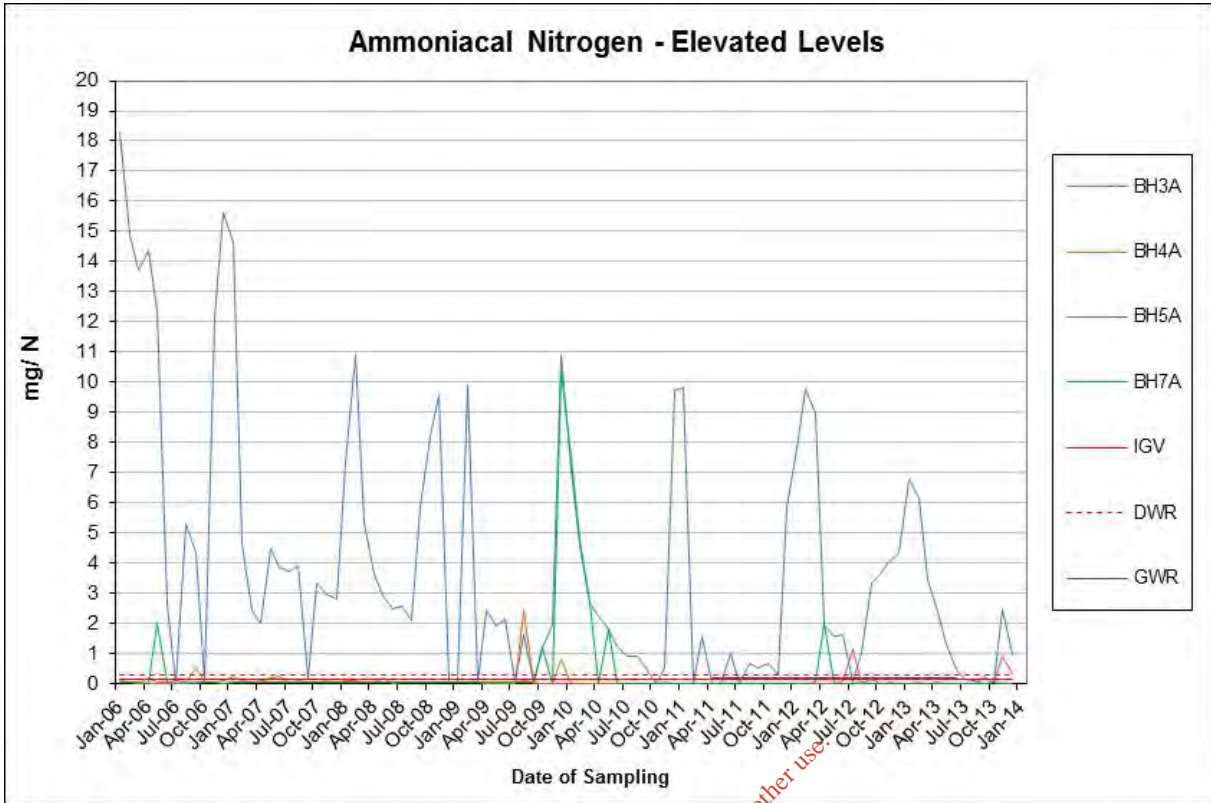
Graph 8.1 Ammonia - Higher Concentrations

In summary, the Ammonia concentrations have significantly reduced over time with occasionally slightly elevated concentrations being detected. Elevated levels were consistently noted in **BH5A** with only recent detected elevated levels recorded in **BH3A**. No correlation with rainfall events was observed. Ammonia concentrations are significantly higher in the northern region of the site in proximity to the waste body in comparison to the locations to the south of the waste body. No notable impact to the water within the former quarry void has been recorded to-date. In addition, no notable flux of Ammonia is evident discharging downgradient from the site to the south and southwest of the open void.

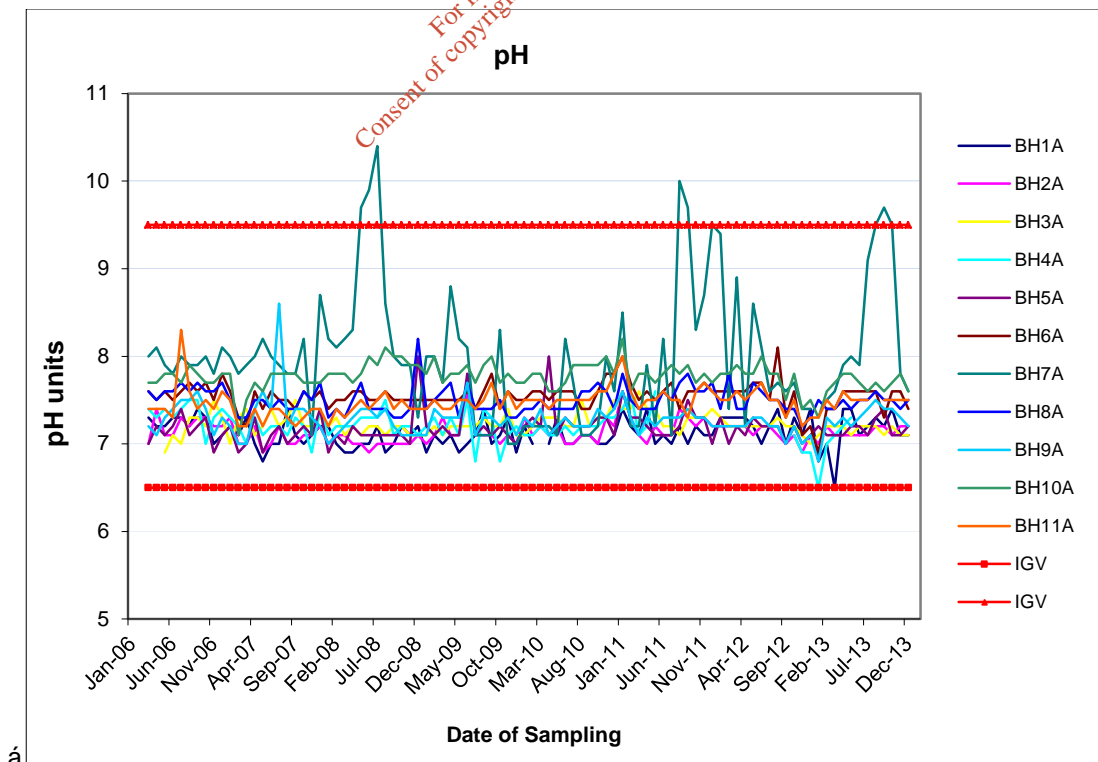
Graph 8.4 pH Levels

The pH levels typically ranged between the 6.5-9.5 pH threshold range (see **Graph 8.4**). Elevated levels of pH were recorded within borehole **BH7A** ranging between 9.7 and 10.4 (the highest level was recorded in July 2008).

Given the proximity of BH7A to the adjacent former quarry and the historical cement works at this site, the elevated levels of pH in this area may be attributed to the historical workings on this site.

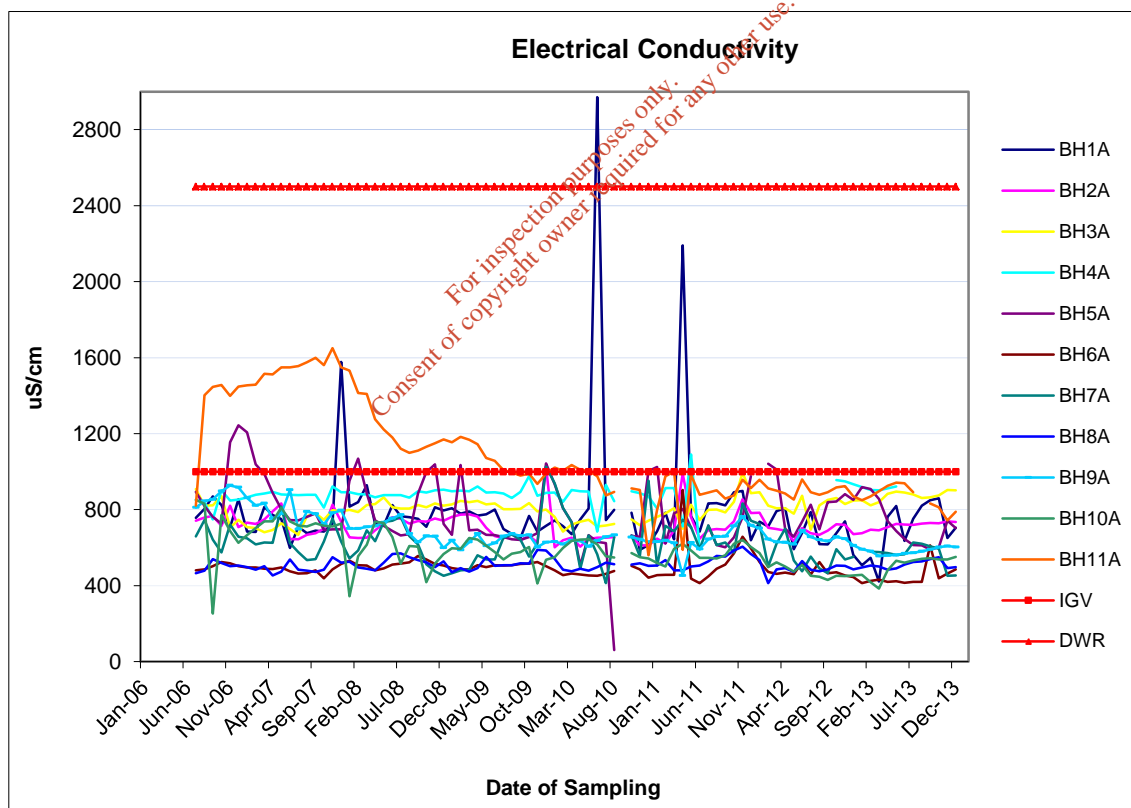
Graph 8.5 Electrical Conductivity Levels

In summary, the EC levels recorded suggest an historical impact from the waste body within **BH5A** and **BH11A** only. However, no elevated levels have been recorded across the site since March 2012.

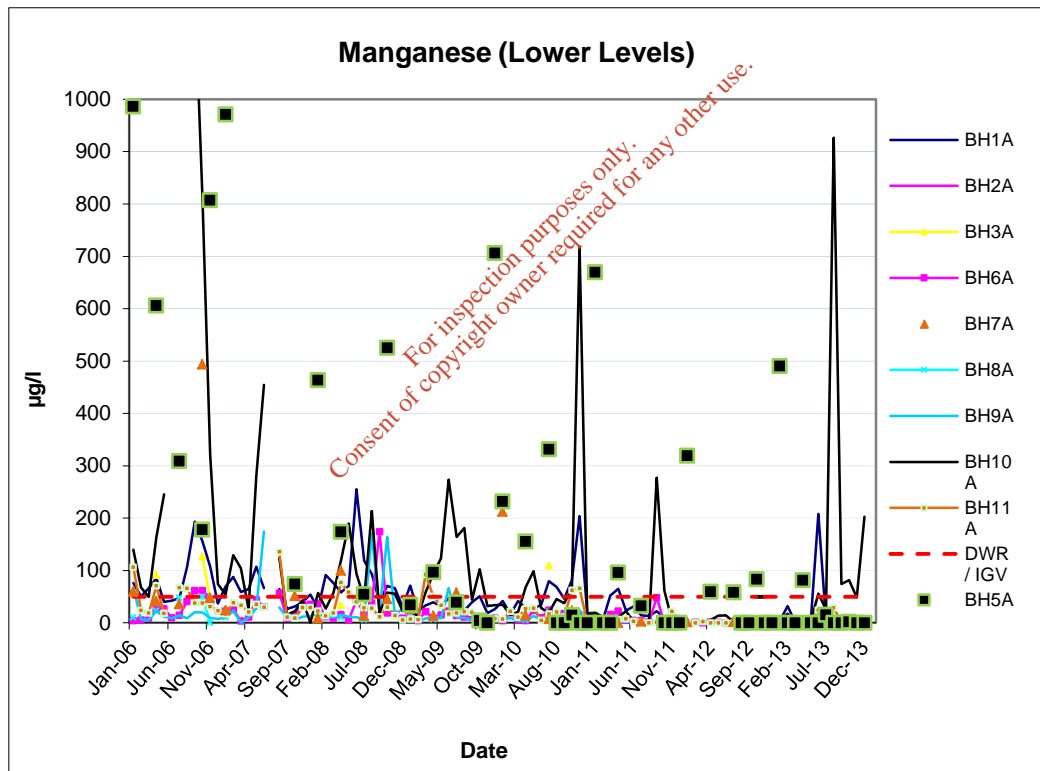
Graph 8.6 Manganese - Lower Concentrations

In summary, elevated concentrations of Manganese were observed within the northern region of the landfill with significantly reduced levels downgradient and within the former quarry void. The levels generally appear to be reducing over time within BH10A. The levels within BH5A have reduced over time but remain significantly above the IGV. The elevated levels recorded in BH4A and BH5A suggest an impact by landfill leachate; however it is unclear as to the source of the elevated levels in BH10A. A natural source is most likely given the low levels detected in the surrounding boreholes.

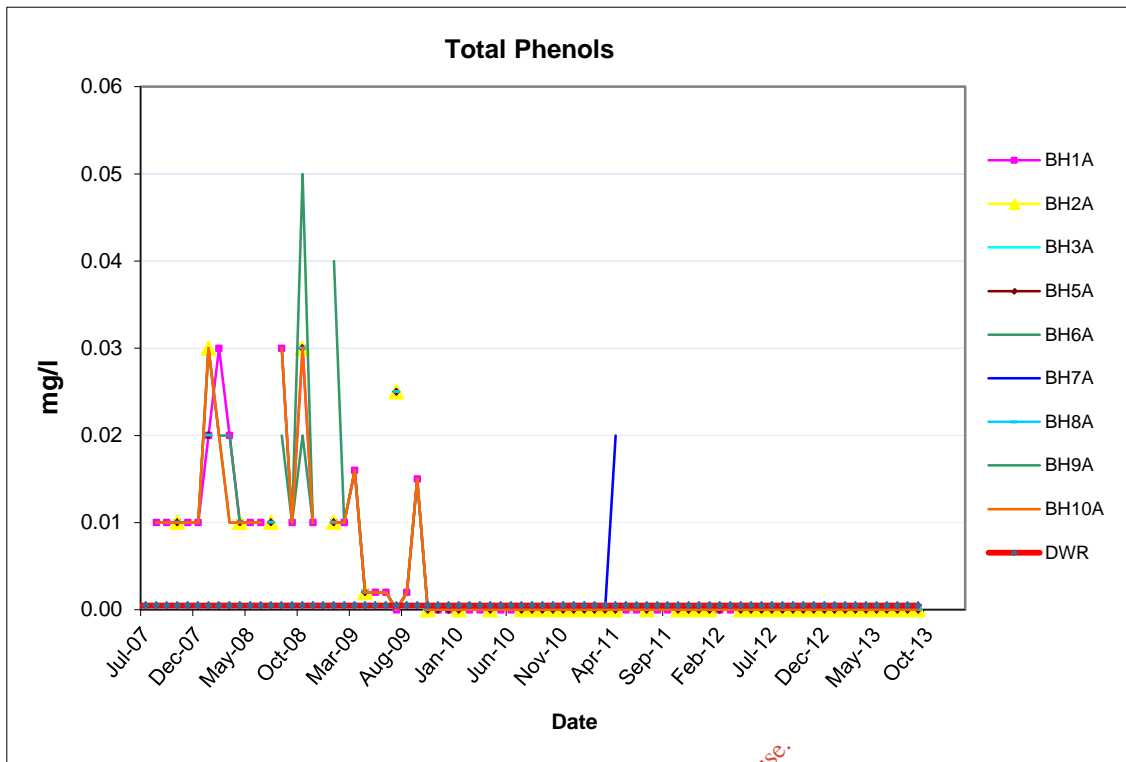
Graph 8.6 Phenol Concentrations

It is noted that the IGW for Total Phenol is 0.0005mg/l which is below the current laboratory limits of detection for phenol. Future analysis should ensure that the limits of detection are reported at or below the EPA IGW.

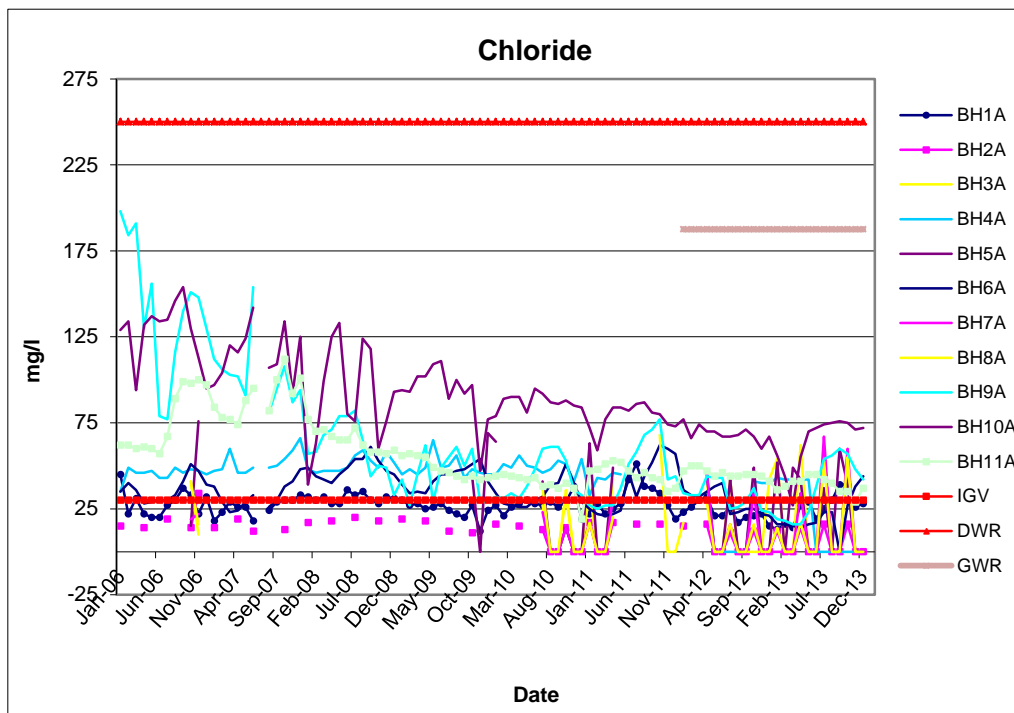
Graph 8.7 Chloride - Higher Concentrations

Since completion of the capping works in 2007, all monitoring locations with slightly elevated concentrations of chloride (*i.e.* above the EPA IGW only of 30 mg/l) generally demonstrate a downward trend over time. The remaining locations demonstrate concentrations typical of background concentrations with no evidence of an impact from landfill leachate.

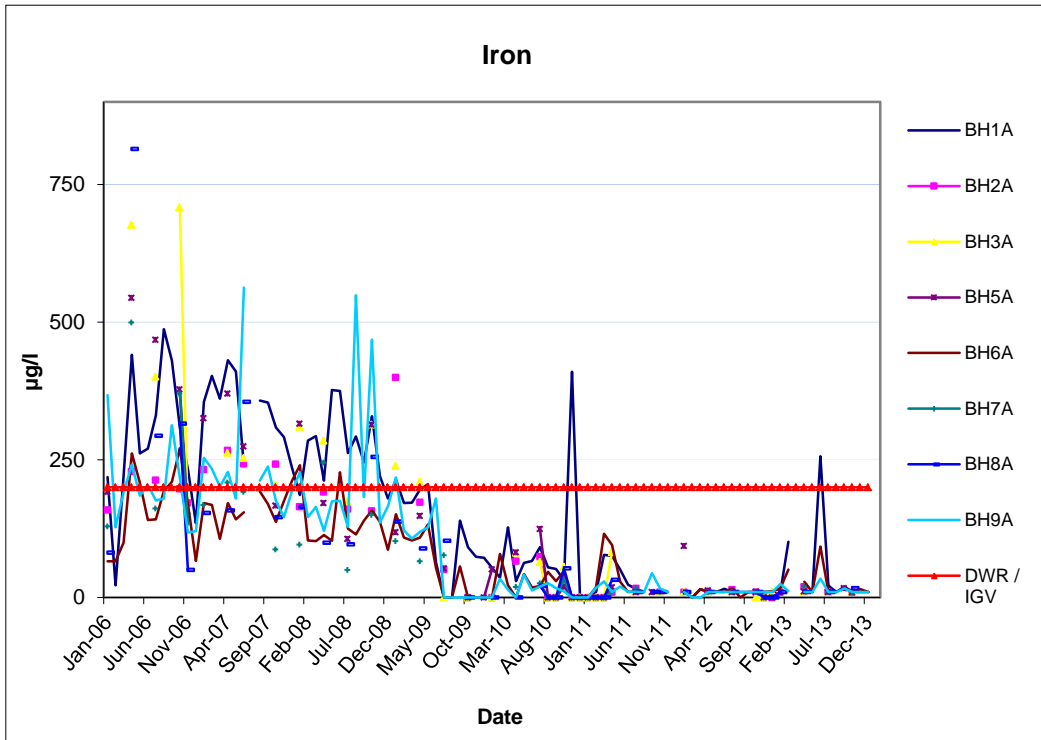
Graph 8.8 Iron - Lower Concentrations

In summary, the presence of elevated levels of Iron in BH4A pre-2013 suggests an impact from the waste body or from a possible upgradient source at this time.

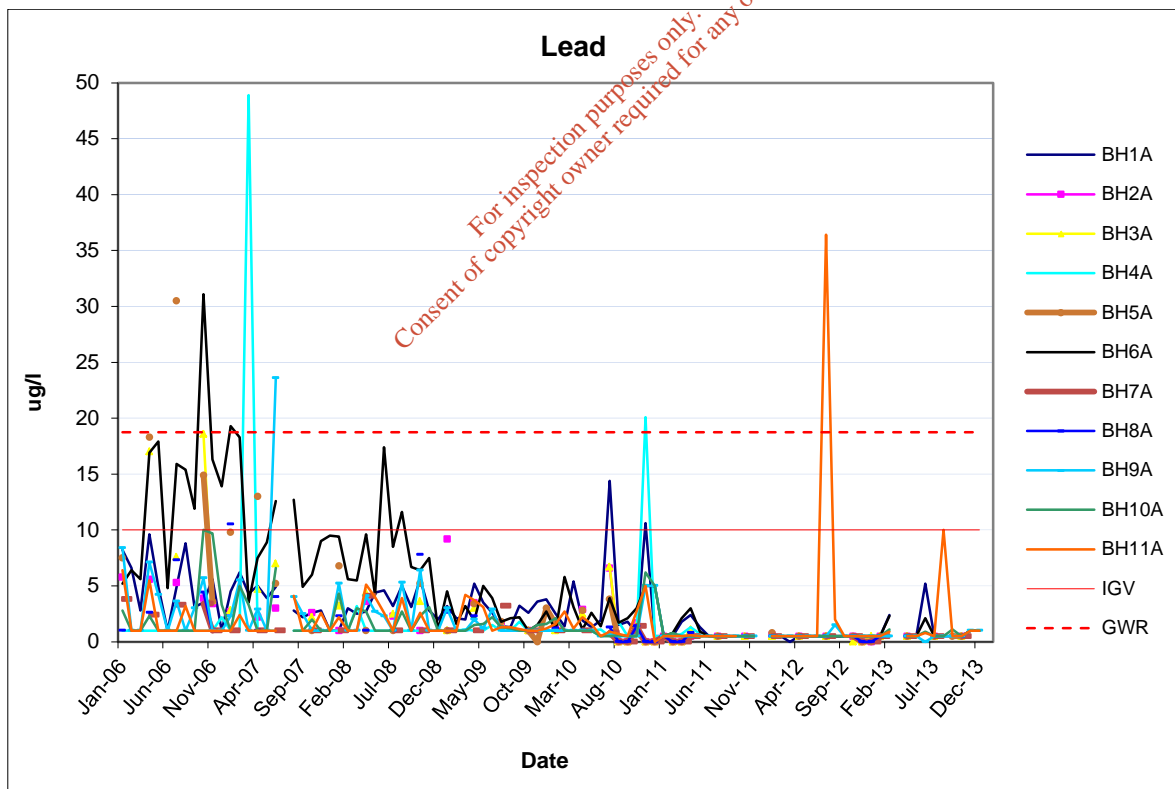
Graph 8.10 Lead Concentrations

The concentrations recorded within **BH6A** display an obvious downward trend since 2006. This is likely to be attributed to the construction of the landfill cap. The elevated concentrations recorded within the remaining monitoring boreholes are considered to be occasional occurrences and not considered representative of an impact from the waste body on groundwater conditions over time.

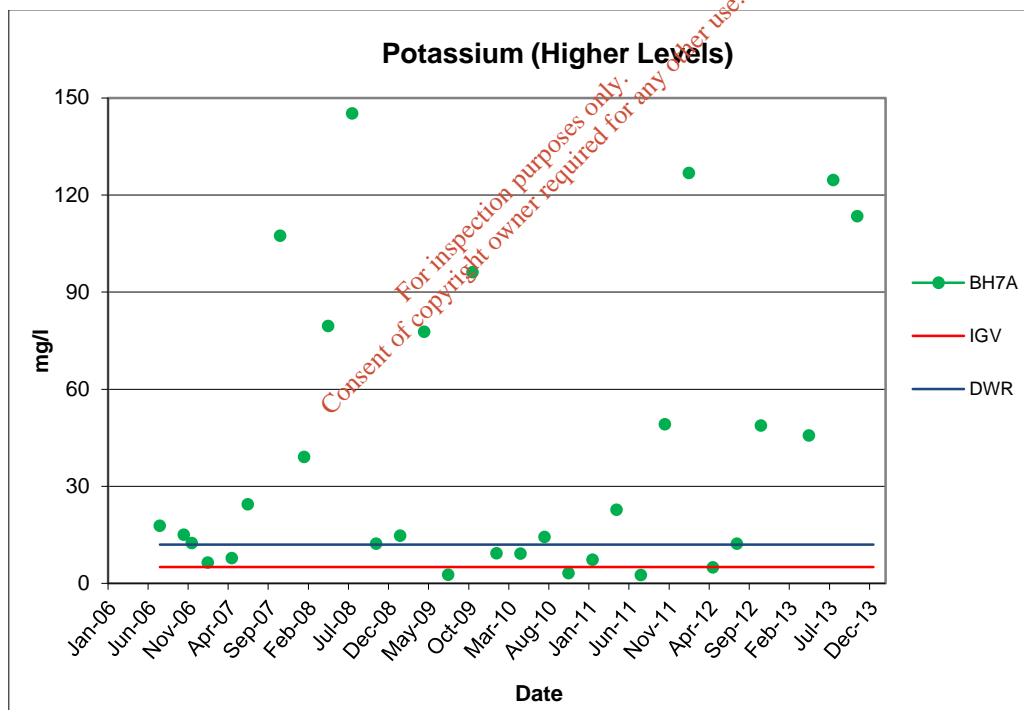
Graph 8.11 Potassium - Higher Concentrations

In summary, the concentrations of potassium recorded appear to be attributable to background levels rather than impacts from the landfill waste body. No obvious downward trend in concentrations at these locations was observed with the exception of BH10A and BH11A (see **Graph 8.12**).

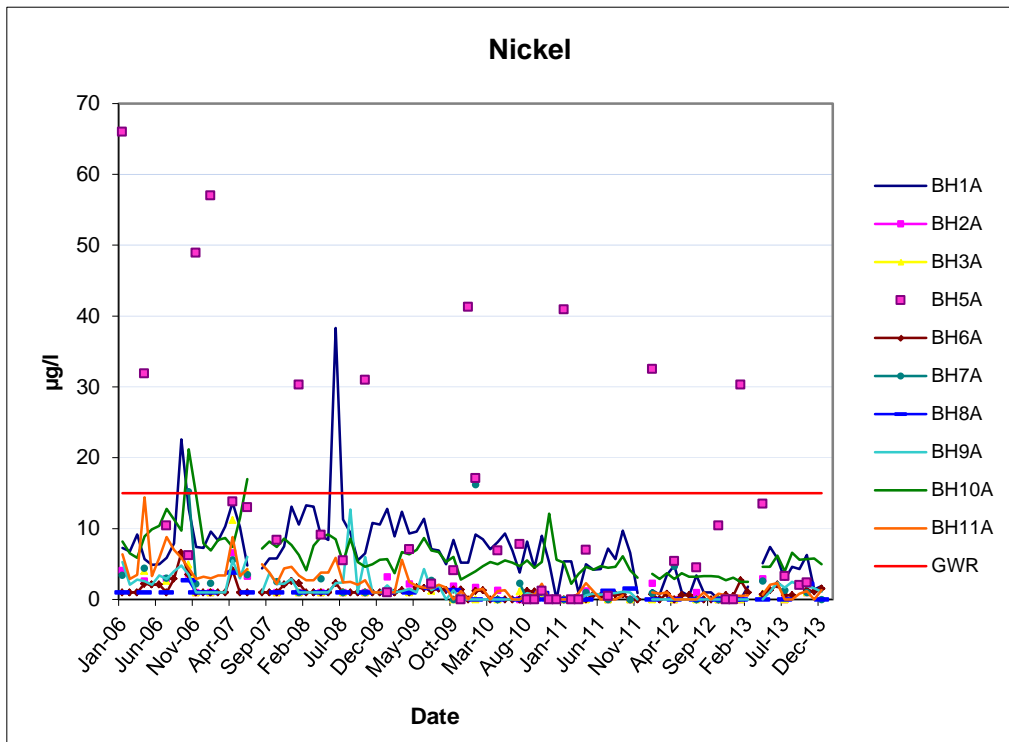
Graph 8.13 Nickel- Lower Concentrations

The levels detected suggest a possible impact of the waste body on the underlying groundwater body in the northern region of the site with no obvious elevated flux of nickel discharging from the site.

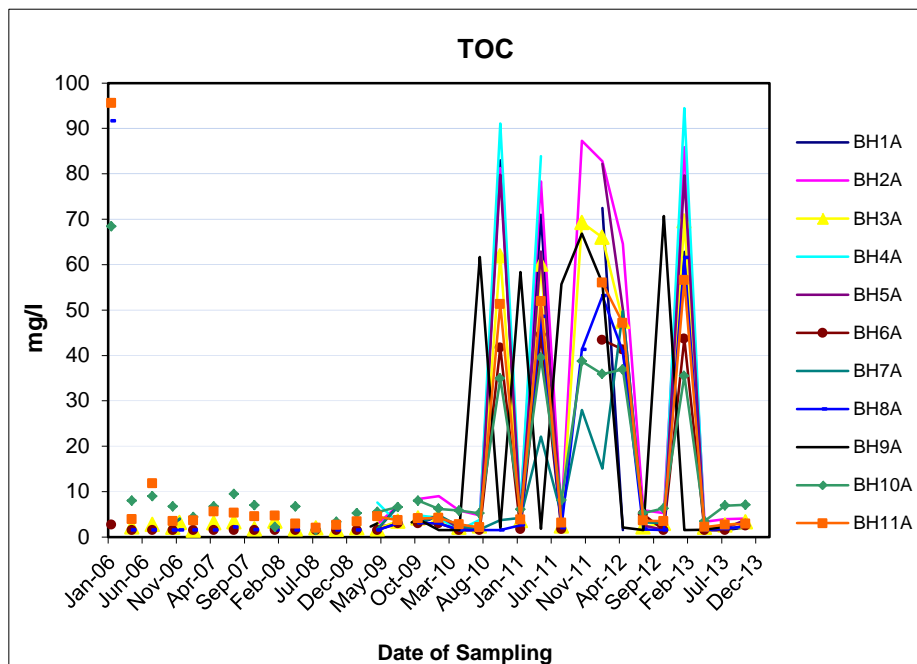
Graph 8.14 TOC Concentrations

A sudden and marked increase in levels within all boreholes were recorded from April 2010 to April 2013 (see **Graph 8.14**) before returning to levels less than 10 mg/l (*i.e.* background levels). The source of this increase is unclear but may be related to a combination of landfill settlement effects or upgradient impacts from agricultural activities.
