INSPECTOR'S REPORT ON AN APPLICATION FOR A CERTIFICATE OF AUTHORISATION FOR A CLOSED LANDFILL

TO:	Mr Tom Ryan, Director	
FROM:	Ewa Babiarczyk, Inspector,	Environmental Licensing Programme
DATE:	10 th June 2021	
RE:	Application by Mayo County Council for a Certificate of Authorisation for a closed landfill at Kilbeg, Claremorris, County Mayo . Certificate of Authorisation Register Number H0319-01 .

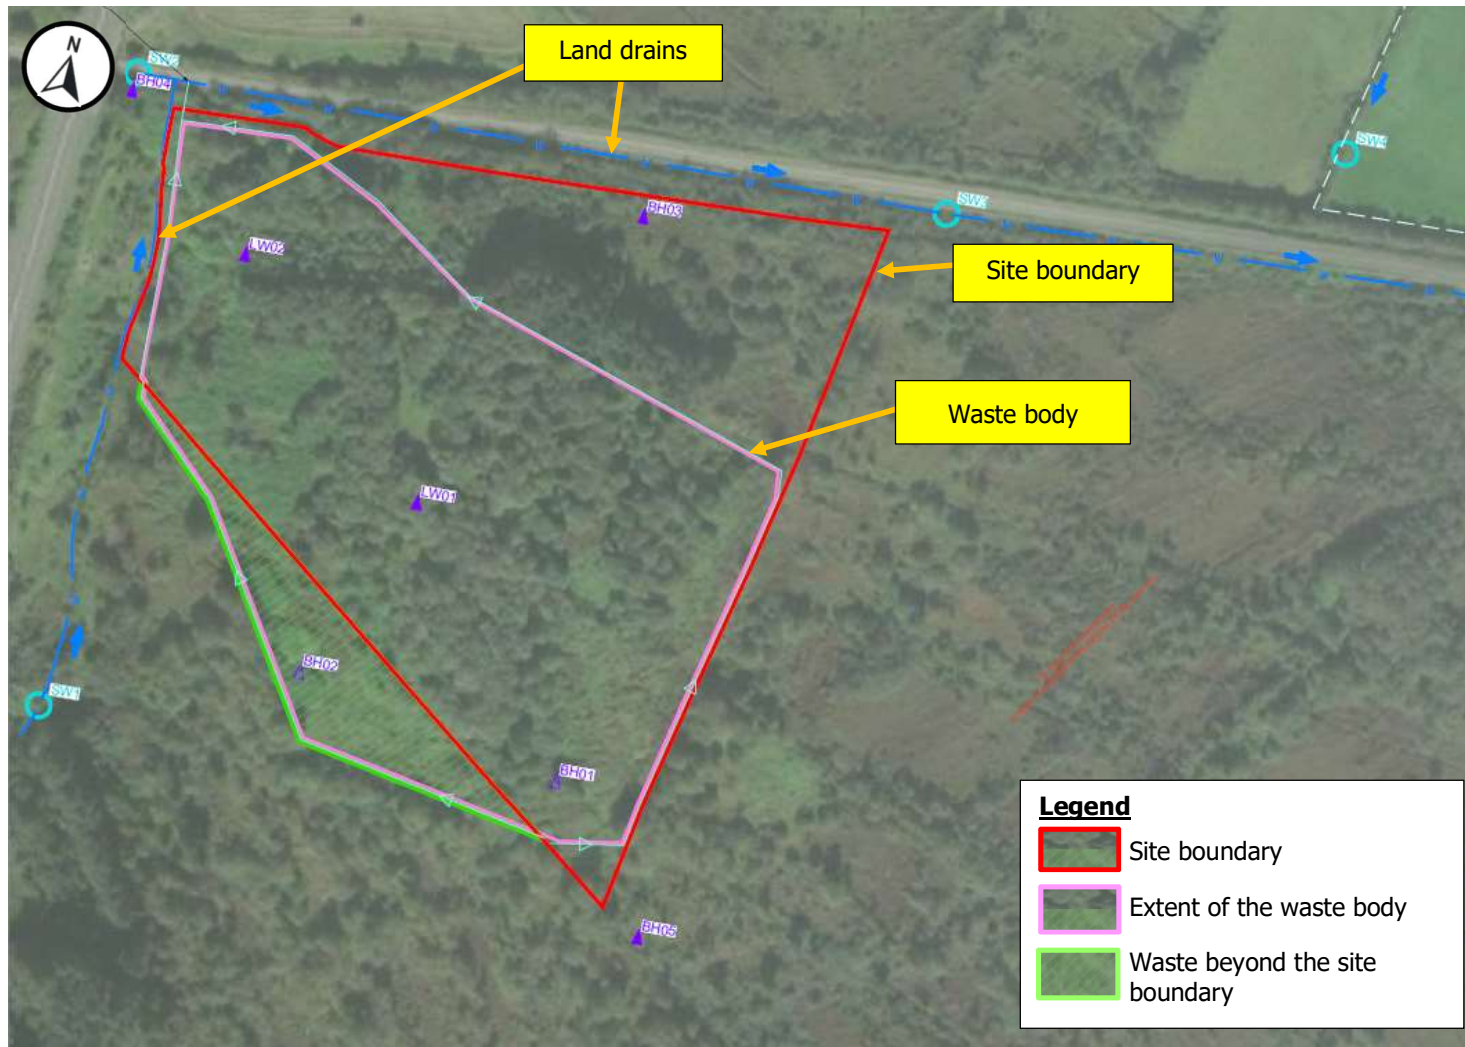
Figure 2: Site layout and the extent of deposited waste

Area of the closed landfill	The site covers an area of approximately 6 ha. The waste body extends beyond the site boundary into privately owned land, as shown in Figure 2. The applicant proposes to cap the waste body, including the waste beyond the site boundary, as outlined in Section: <i>Proposed Remedial Actions</i> of this Inspector's Report. It is noted that the site boundaries shown in Figure 1 and Figure 6 of this report are different to the site boundary shown in Figure 2 and Figure 5. The applicant revised the site boundary, as shown in Figures 2 and 5, in the correspondence received on 23 rd February 2021.
Quantity of waste at the facility	Approximately 279,623 tonnes (199,731 m ³)
Characterisation of waste deposited	The waste comprises municipal waste and construction & demolition (C&D) waste. The encountered waste includes peat mixed with domestic waste, plastic, paper and concrete insulation. The extent of the waste body is 3.8 ha, as shown in Figure 2.

<p>Proposed remedial actions:</p>	<p>Tier 3 Assessment recommends the following remedial measures as the feasible options:</p> <p>1. Landfill cap</p> <p>The Tier 3 Assessment recommends that the landfill capping covers the entire waste body, as shown in Figure 2, and comprises of the following elements, or equivalent:</p> <ul style="list-style-type: none"> (i) 200mm topsoil layer; (ii) 800mm subsoil layer; (iii) 0.5m thick drainage layer of a hydraulic conductivity of a minimum 1×10^{-4} m/s, or equivalent such as a geocomposite; (iv) 1mm LLDPE barrier layer, or equivalent; and (v) landfill gas collection geocomposite. <p>The Tier 3 Assessment also states that the cap will be required to support any on-site solar farm infrastructure, providing a suitable base for the solar panel array.</p> <p>It is noted that the purpose of the landfill cap as specified in the Certificate of Authorisation is to limit the ingress of rainwater and generation of landfill leachate, the integrity of which should not be</p>

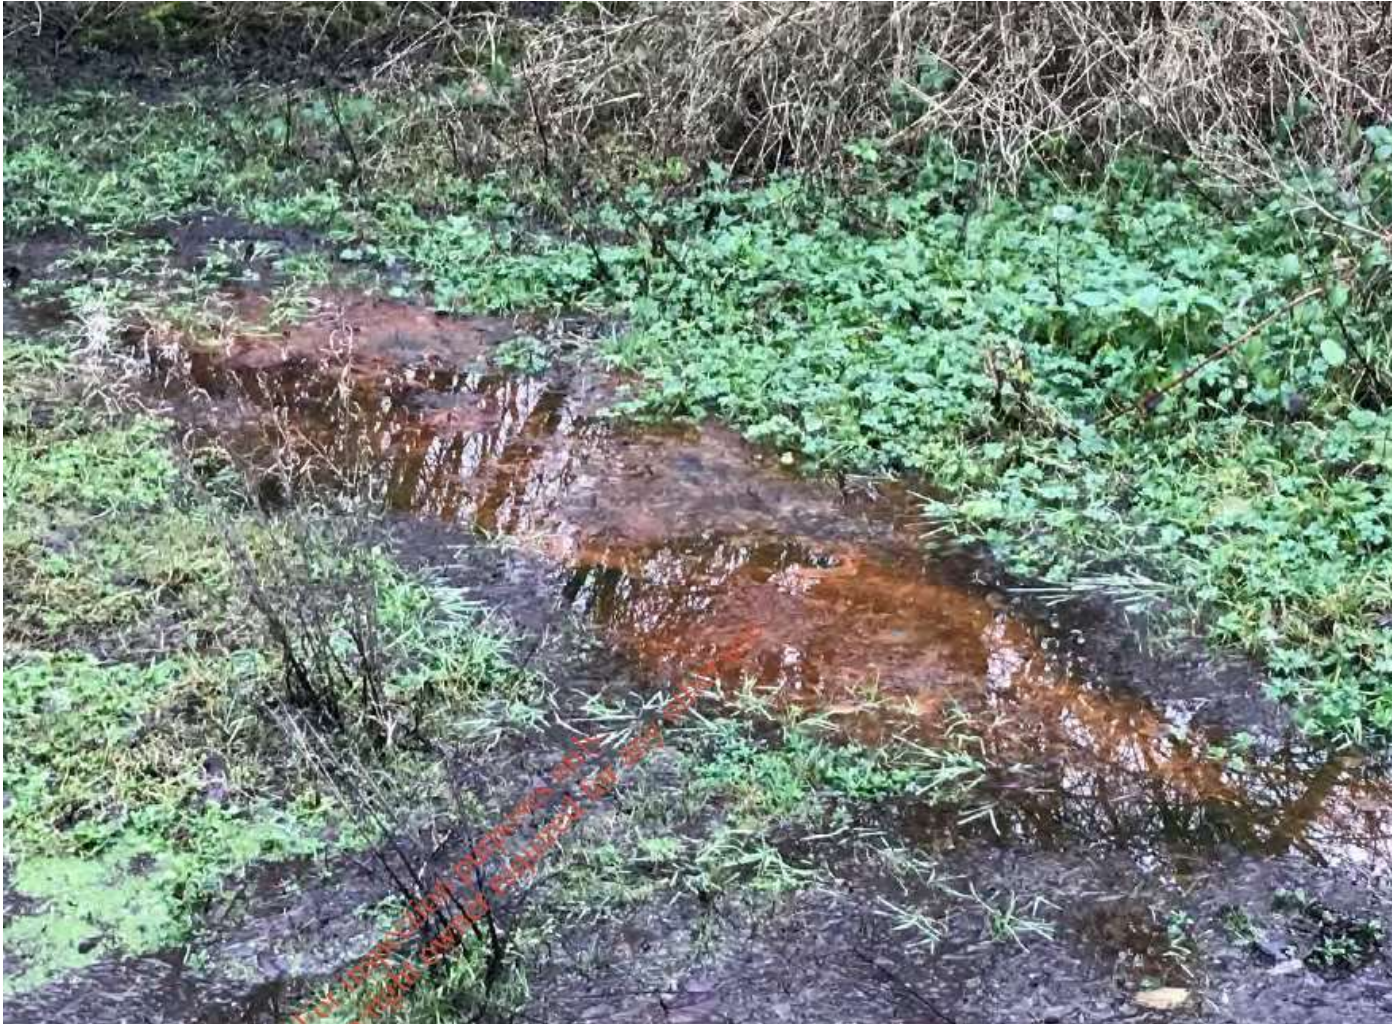
Figure 3: Leachate seepage

<p>Current condition and appearance of closed landfill:</p>	<p>The site topography falls from south to north and west to east. The Corine Land Cover 2018 classification for the site is mostly inland wetlands (peat bogs). Leachate seepage was observed during the site walkover survey on 16th January 2020, as shown in Figure 3. Condition 3.1(d) requires a cap to be put in place over the full extent of the waste body, which will reduce leachate generation. Also, waste on the surface of the landfill was observed, as shown in Figure 4. Condition 3.1(b) requires that the local authority removes this waste for disposal or recovery at an appropriate facility.</p> <p>The Tier 3 Assessment also states that invasive plant species, Japanese Knotweed, is present on site. Condition 3.18 requires an Invasive Species Prevention and Eradication Plan.</p>
<p>Site investigations</p>	<p>The site investigations carried out as part of Tier 1, 2 and 3 assessments established the following facts:</p> <ul style="list-style-type: none"> • The waste body is covered with a layer of 0.3m-0.9m thick soil; • The base of the waste body was not reached and exceeded the depth of 6.5m at four out of seven trial pits; • Natural black peat till was detected to depths of 5.9m and 4m below ground level (bgl) in monitoring boreholes BH01 and BH02; • No bedrock was encountered during the trial pit excavation or installation of boreholes BH01 and BH02; • Landfill leachate is being generated; and • Landfill gas is being generated.

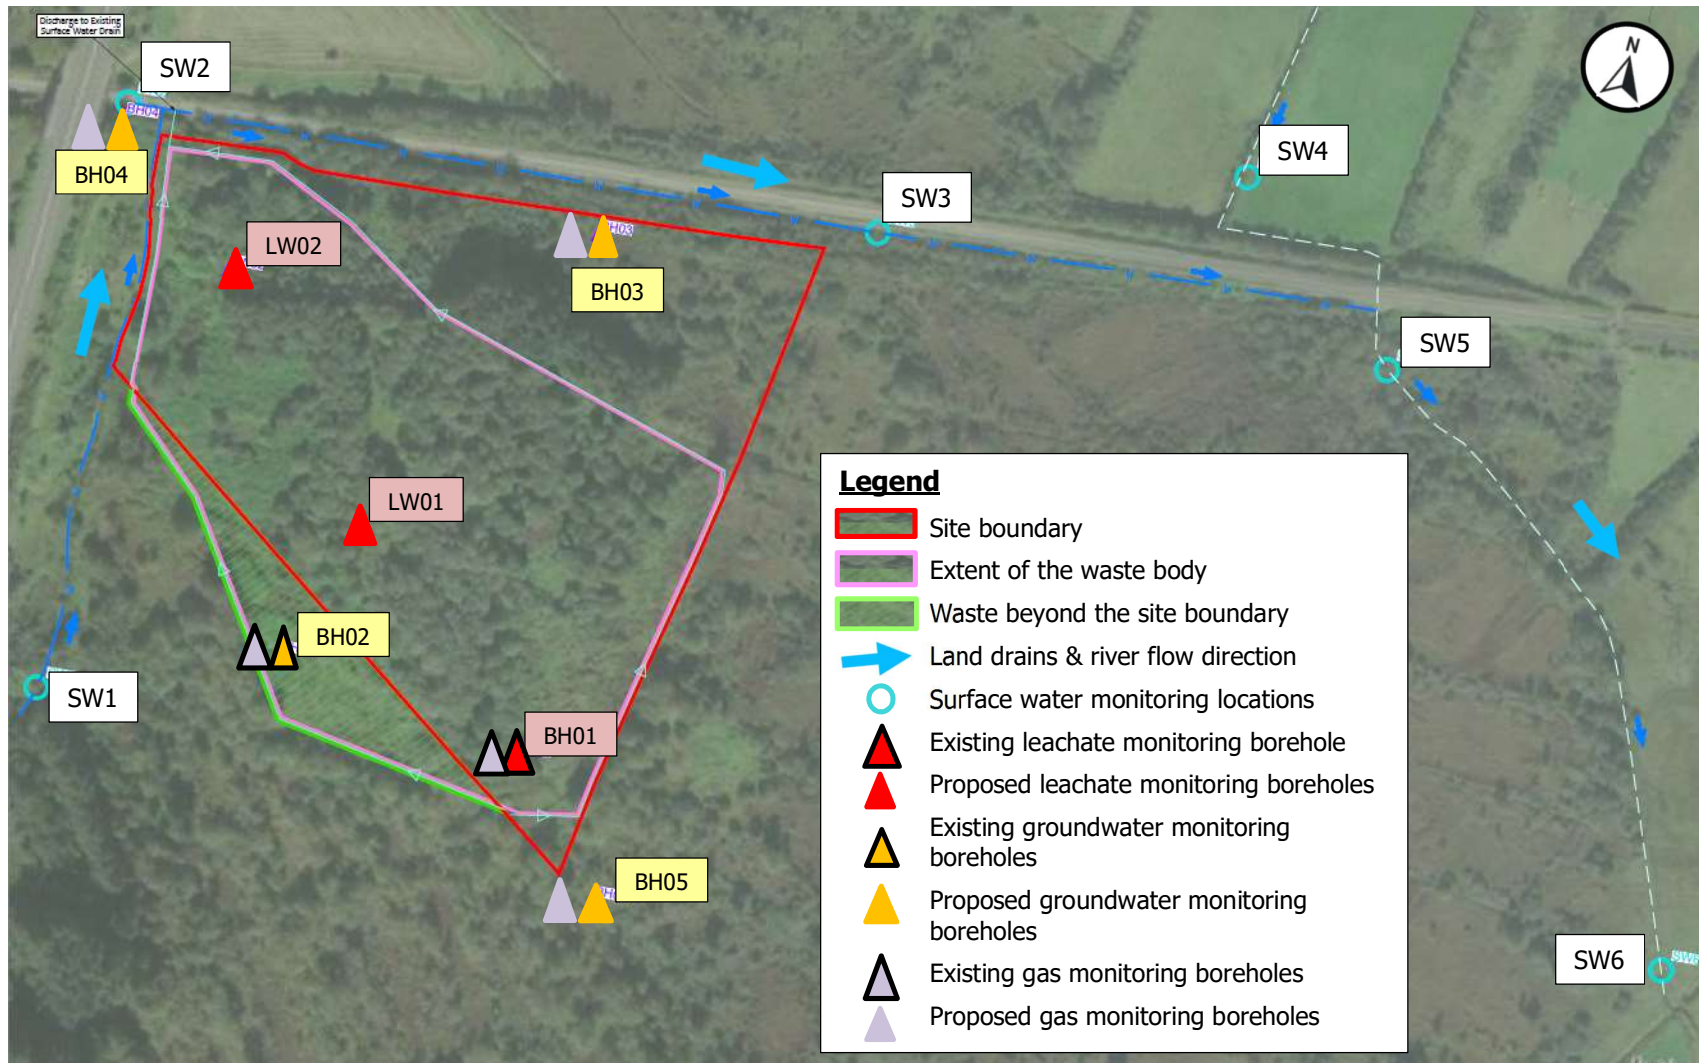
Figure 5: Surface water, leachate, groundwater and gas monitoring boreholes

2010 and 27th November 2020, as shown in Figure 5, and that groundwater monitoring was carried out at combined monitoring borehole BH02 on the same dates. It is noted however that BH02 is located within the waste body, close to the southern edge, as shown in Figure 5. Tier 3 Assessment states that waste appears to be tapering to 0.80m at BH02 and that groundwater level was present at 0.785m below the surface. The Tier 3 Assessment further states that it can be assumed that groundwater intersects the waste body further upgradient.

The Tier 3 Assessment recommends surface water monitoring at six locations SW1, SW2, SW3, SW4, SW5 and SW6, as shown in Figure 5. Additionally, as outlined in Section: *Hydrology* above, one additional monitoring location is required on the Lisduff River (monitoring location south-east of the closed landfill (SW7)).

The Tier 3 Assessment recommends monitoring of leachate at the locations LW01 and LW02 within the waste body, as shown in Figure 5. Condition 3.9(b) reflects this recommendation and, in addition, requires leachate monitoring at the existing monitoring location within the waste body BH01.

The Tier 3 Assessment recommends monitoring of landfill gas at the existing boreholes BH01 and BH02 within the waste body and the three proposed monitoring boreholes BH03, BH04 and BH05 outside the waste body, as shown in Figure 5. Accordingly, Condition 3.1(f) requires installation of the additional gas monitoring locations BH03, BH04 and BH05. Condition 3.9(d) requires a quarterly monitoring to detect the presence and concentration of landfill gas at BH01, BH02 and the three proposed boreholes.

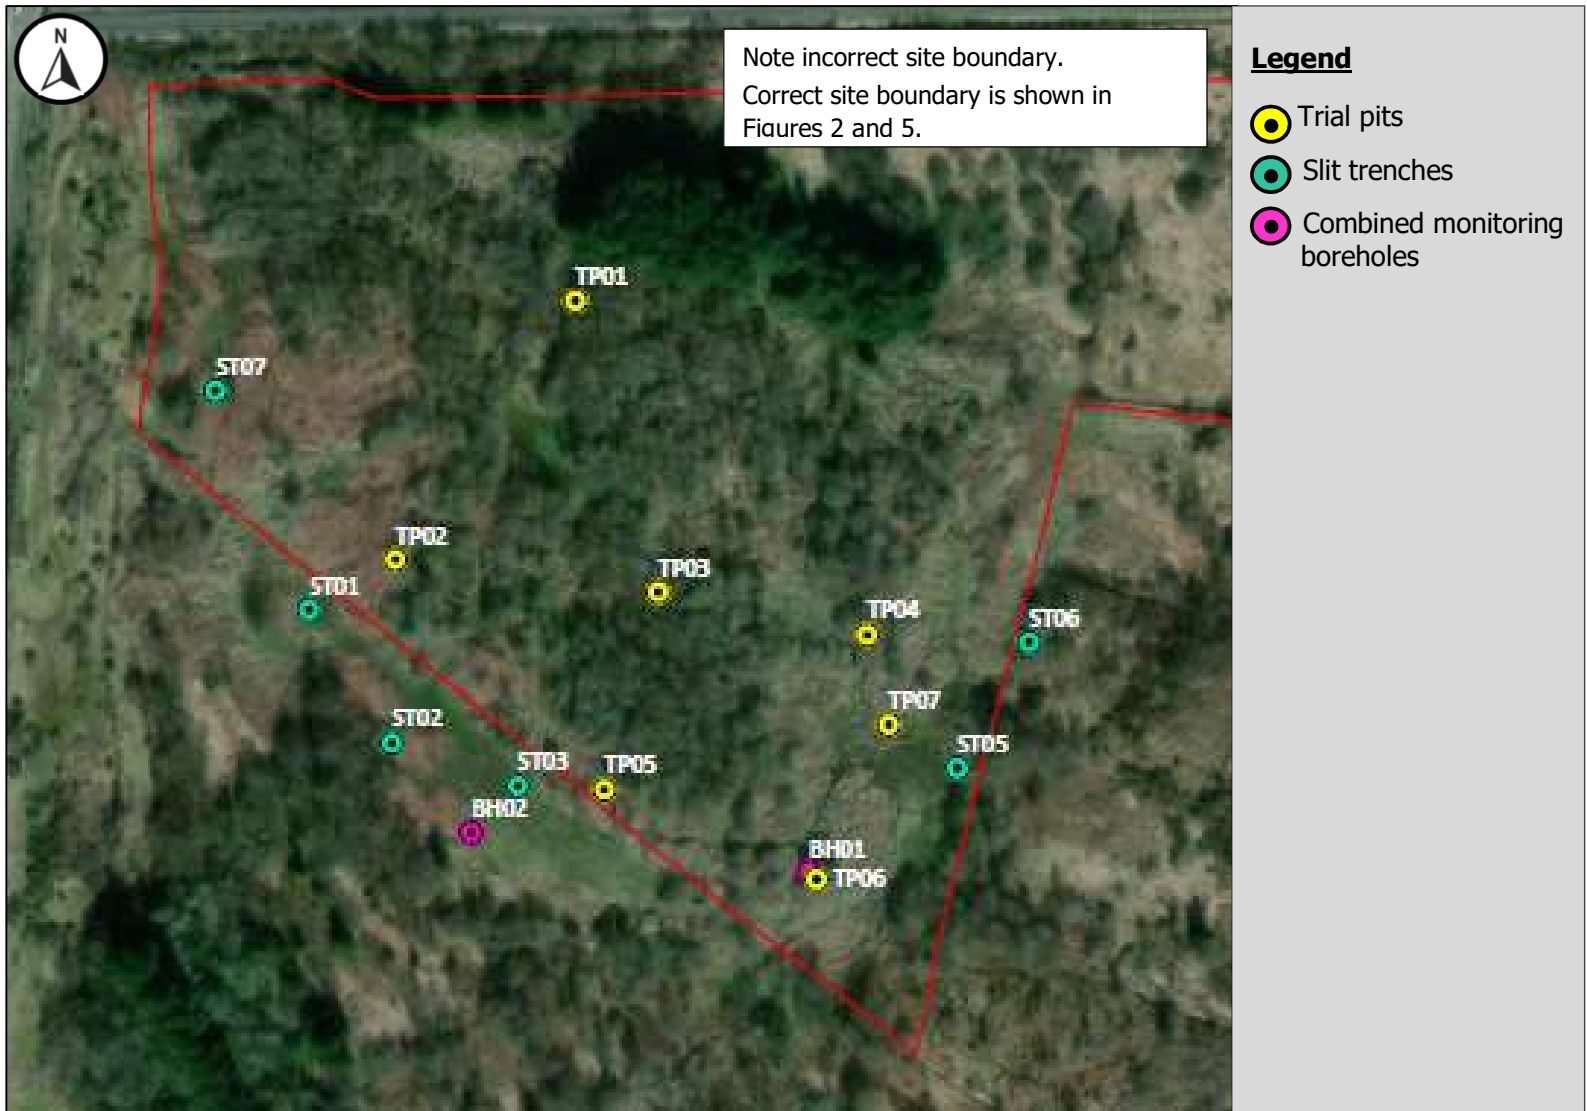
Figure 6: Trial pit (TP), slit trench (ST) and combined monitoring boreholes (BH)

Leachate and water quality:	<p><u>Trial pit investigation</u></p> <p>Seven trial pits TP01 to TP07 were excavated on 25th November 2010, as shown in Figure 6. The maximum depth of the trial pits was 6.5m bgl. Waste material was encountered between 0.0m – 6.5m in all trial pits from TP01 to TP07 however, the base of the waste body was reached at only three trial pits: TP03, TP05 and TP07. Leachate at the depth from 3.7m to 6m bgl and strong pungent odour were encountered in each trial pit.</p> <p><u>Slit Trenches</u></p> <p>Six slit trenches ST01, ST02, ST03, ST04, ST05, ST06 and ST07 were excavated on 26th November 2010 to determine the lateral extent of the waste body, as shown in Figure 6. The edge of the waste body was encountered in ST01, ST02, ST05 and ST06.</p> <p><u>Waste sampling</u></p> <p>Six waste samples were collected from trial pits TP01 to TP06 and analysed against the waste limit values, as set out in the Waste Acceptance Criteria (WAC) set out in <i>Council Decision of 19 December 2002 establishing criteria and procedures for the acceptance of waste at landfills pursuant to Article 16 of and Annex II to Directive 1999/31/EC</i>. The analysis shows that a number of parameter concentrations exceeded either the inert, non-hazardous or hazardous waste criteria, as shown in</p>

Landfill gas monitoring was carried out at seven trial pits TP01 to TP07, two boreholes BH01 and BH02 and six slit trenches ST01 to ST03 and ST05 to ST07 in November 2010, as shown in Figure 6. Additionally, one location, BH01, was monitored on 27th November 2020. The monitored parameters were methane (CH₄), carbon dioxide (CO₂) and oxygen (O₂).

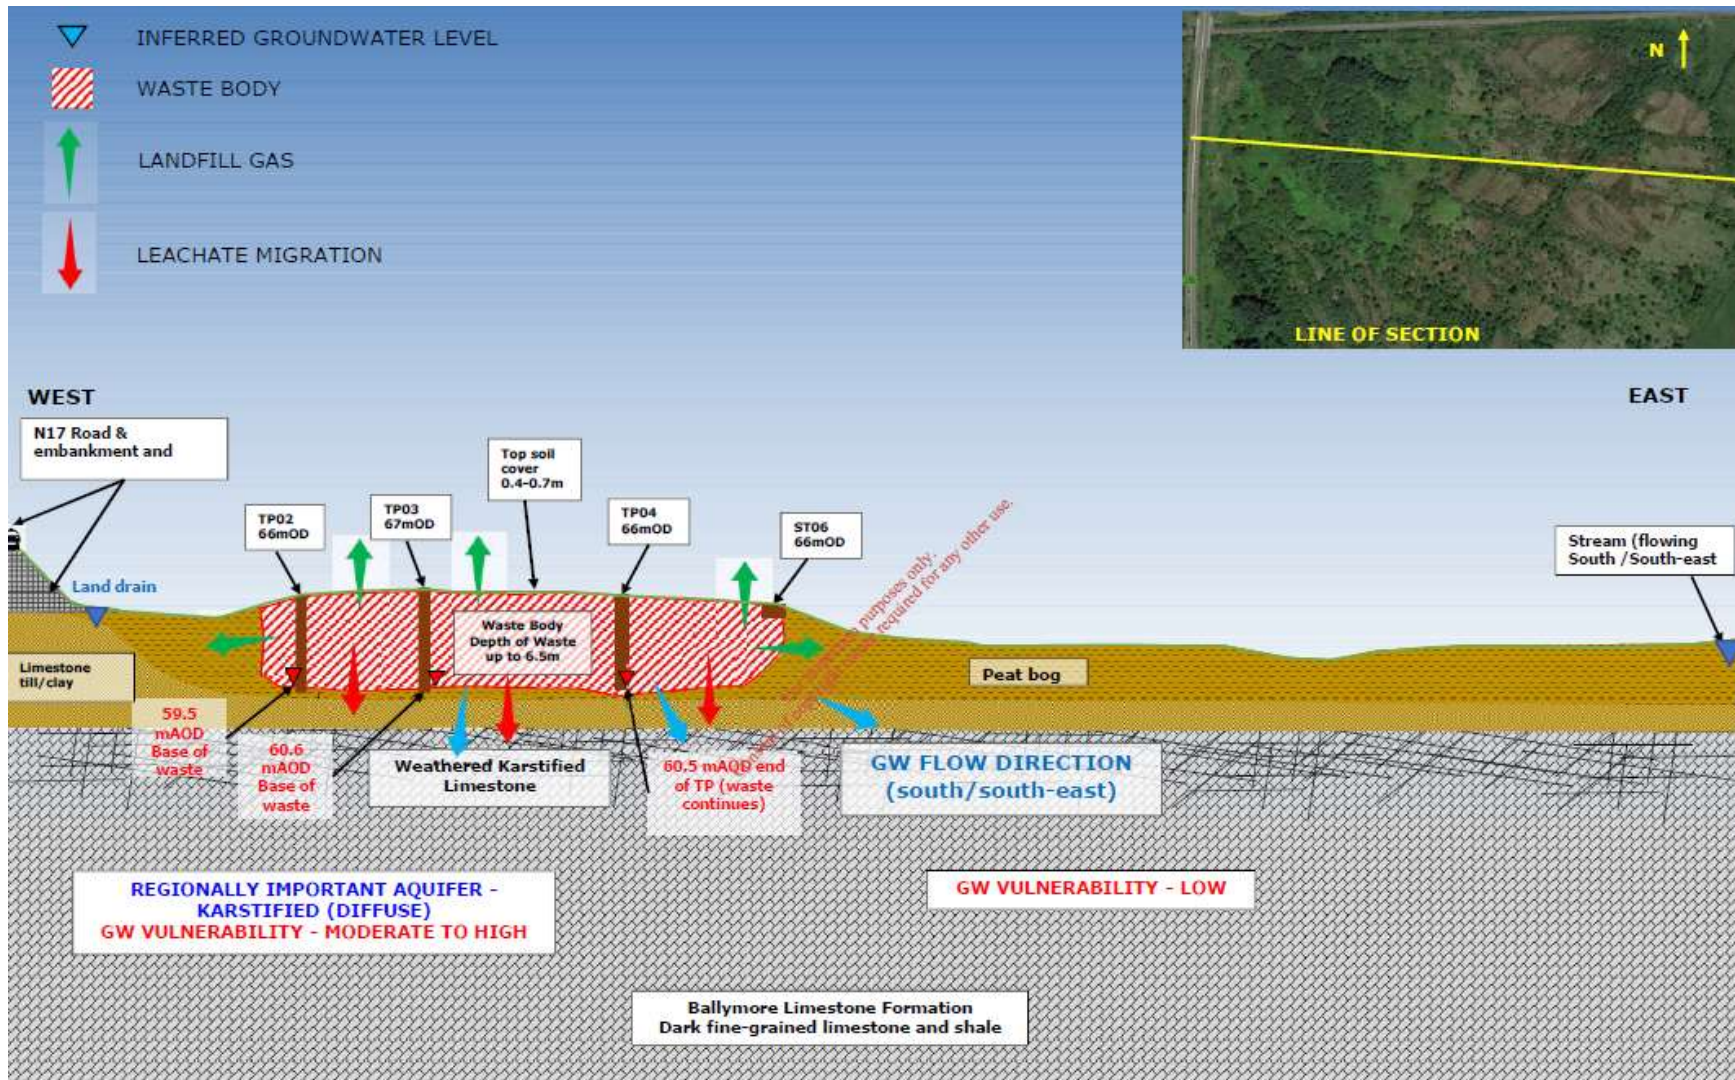
Figure 7: Conceptual site model for Claremorris Historic Landfill

Conceptual site model:	<p>Tier 1 and 2 Assessment determined that the overall risk score for the closed landfill was Moderate (Class B) due to leachate migration into the underlying aquifer and, via groundwater, to human receptors and surface waters.</p> <p>Tier 2 and Tier 3 Assessments confirmed this classification due to leachate migration into the underlying aquifer.</p> <p>The conceptual site model is shown in Figure 7.</p>
