# **Exploratory Site Investigation Waterstown**

**South Dublin County Council**

Title: Waterstown Landfill - Exploratory Site Investigation

Job Number: E0937

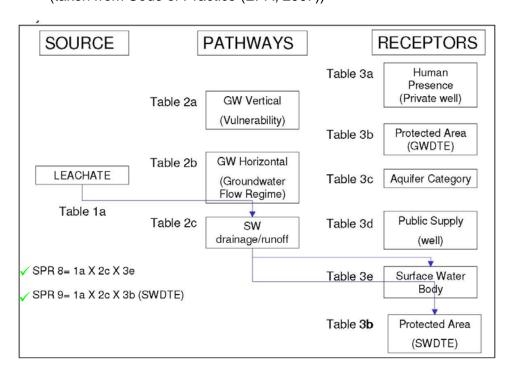
**Table 5:** Network Diagram for Leachate Migration through surface water pathway (taken from Code of Practice (EPA, 2007))

All of the SPR linkages identified in Table 5 have been included within this assessment.

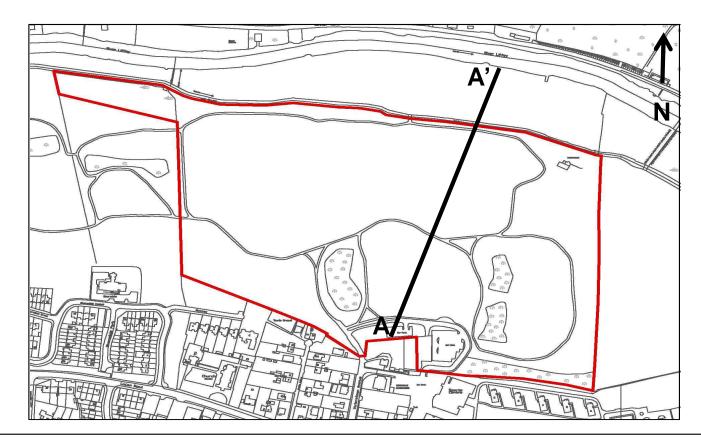
Job Number
LOSS SECTION OF THE SITE

## Section A-A' A A' MIII Raco River Liffey

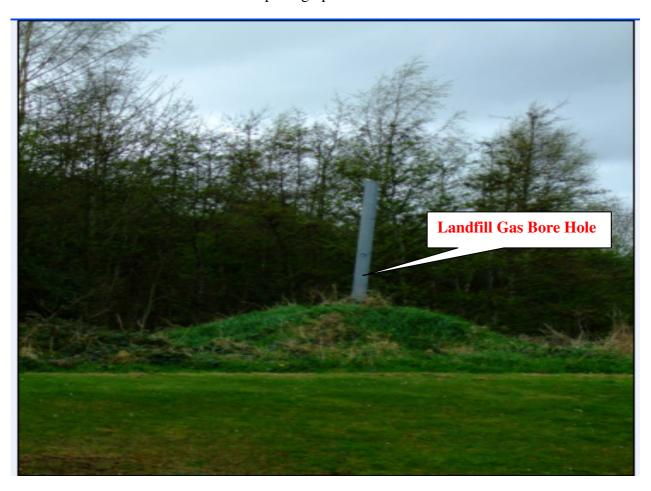
The residents also confirmed that there was once an explosion in a 40ft container on site which was used by Council for storage 15 years ago . This was due to a build up of methane gas in the container. After this explosion, Council constructed some landfill gas boreholes to release the Methane gas. Evidence of this landfill gas borehole could be seen on site as shown in the photograph below.

The boundary between the landfill and residential houses is indicated by the trees shown behind the landfill borehole.

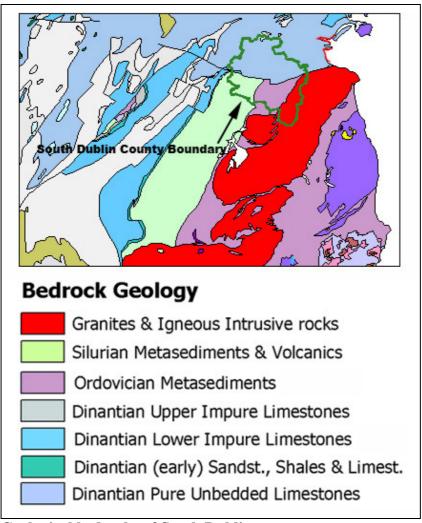
Geological bedrocks of South Dublin

The geology of South Dublin is comprised mainly of limestone with section of Granites and Igneous Intrusive Rocks and Silurian and Ordovician Meta-sediments. This is shown below. Waterstown landfill in particular is underlain by Calp bed rock. In terms of geological timescale it is a Dinantian Pure Unbedded Limestones. It is important to note that the Geological Survey of Ireland has identified M50/N4 Interchange and Liffey Valley Centre Road Sections as geologically sensitive and important. These areas are in closed proximity to Waterstown landfill and they all lie in the same geological formation. According to South Dublin County Development Plan these areas are classified as potential Natural Heritage Area. Hence Waterstown Landfill is in closed proximity to potential Natural Heritage Area. This has an important bearing on risk assessment.

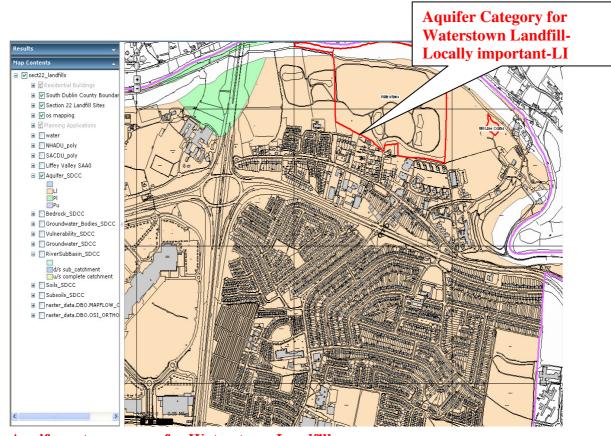
Aquifer category map for Waterstown Landfill.

Waterstown landfill site is underlain by Locally Important Sand/Gravel Aquifers (LI). This is shown below in the aquifer category map. This actually means that the sand and gravel subsoil is water bearing unconsolidated material from which groundwater can be extracted using water well. It also means that the waste was deposited above sand and gravel aquifer which is an important source of groundwater but this will be confirmed by further site investigation. The sand /gravel subsoil exhibits an intragranular permeability which means that it is highly permeable. This has an important bearing on contaminant movement and attenuation and groundwater vulnerability. It is also important to note that during the quarrying operation there most have been excessive dewatering. This may have led to the lowering of the groundwater table. It is also possible that this may have induced some groundwater flow towards the surface water body like the Liffey River or some flow from the Liffey River to the Quarry. The topography of the area is such that the land slopes steeply towards the low lying area through which Liffey River flows. Hence the flow direction of groundwater is in the southerly direction towards the Liffey River.

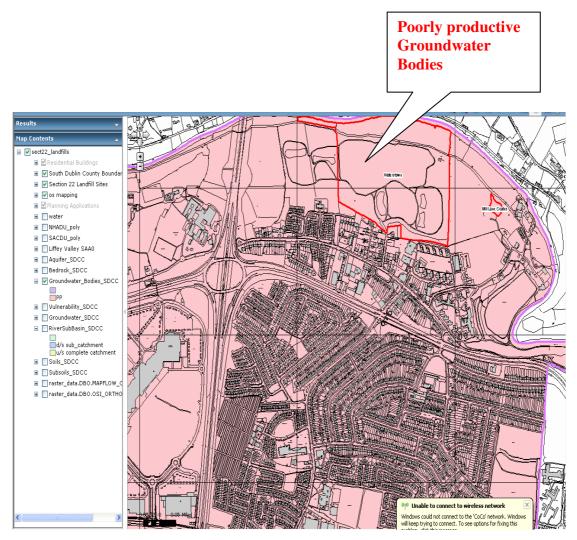
**Groundwater Bodies Map for Waterstown**

The site is also characterised by poorly productive groundwater bodies as shown below. According to the Environmental Protection Agency (EPA) Code of Practice for Environmental Risk Assessment for Unregulated Waste Disposal Site, the flow regime associated with poorly productive bedrock groundwater bodies indicates shallow fissure flow, low transmissivity, and low base flow contribution to streams, high surface water drainage density and general short groundwater flow paths. Hence it is possible that the pathway through which the contaminant in this case the leachate

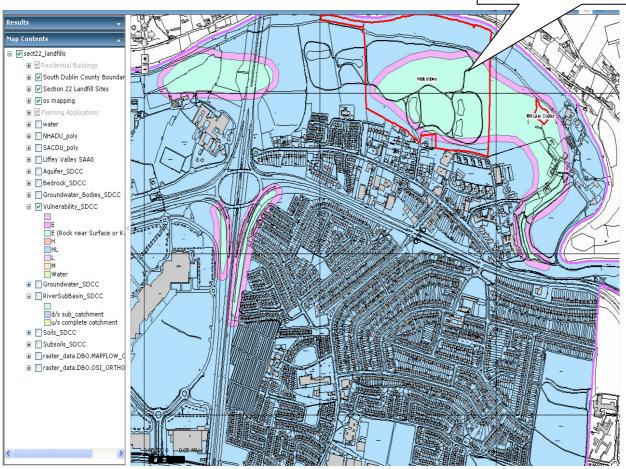
Aquifer Vulnerability map Showing Extremely Vulnerable Aquifer for Waterstown (E)

The aquifer vulnerability of this site shown in the map below is rated by Geological Survey Ireland as extremely high. This is further confirmed by the geology of the area which shows that the waste is placed directly on the Calp bedrock. The quarry operation led to the loss of any protective subsoil. The subsoil in the area is sand and gravel and this is highly permeable. Due to the groundwater vulnerability being very high, there is every possibility for the contaminant to migrate vertically to the aquifer. This aspect has an important bearing on the risk assessment.

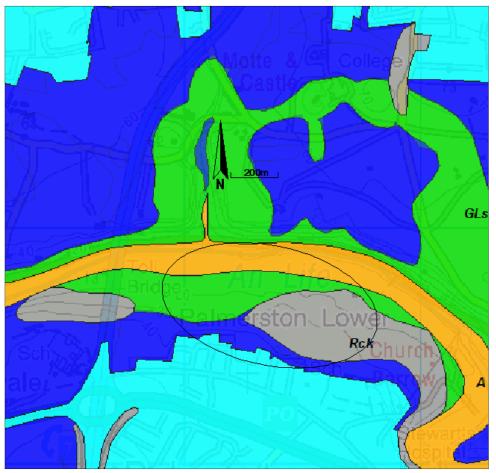
The Teagasc soils map (Fig.2.3) shows that the survey area comprises alluvium along the bank of the river, followed by sand and gravel, bedrock and limestone till to the south.

Fig. 2.3. Soils map for the site, with alluvium in orange, glaciofluvial sands and gravels in green, outcrop in grey, limestone till in blue and made ground in cyan.

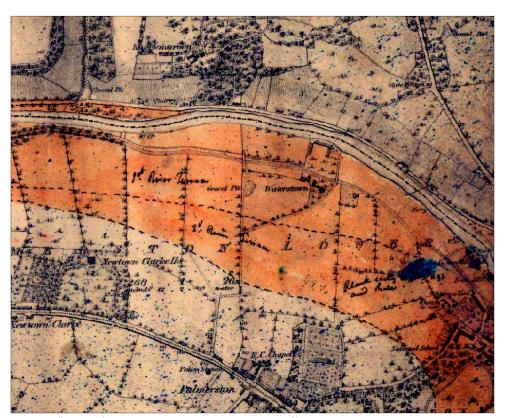
Fig.2.4. 6" Sheet for the survey area, between the Liffey and the Lucan Road to the south.

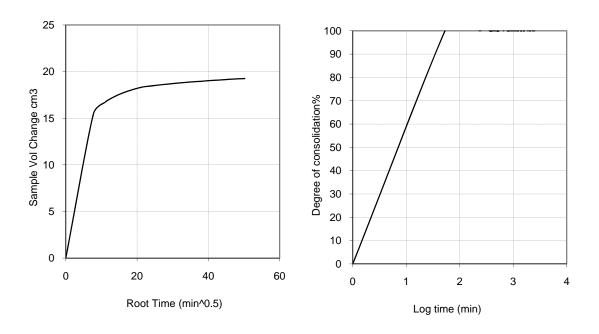
Figure 1 Volume Change Vs Root Time and degree of consolidation vs log time (Consolidation Stage)

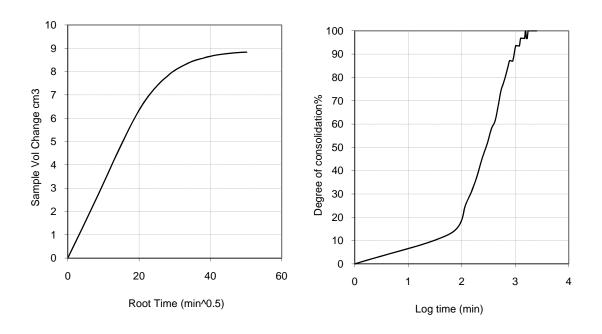
Figure 1 Volume Change Vs Root Time and degree of consolidation vs log time (Consolidation Stage)
