BASELINE ASSESSMENT REPORT
STARRUS ECO HOLDINGS LIMITED
BALLYBEG
LITTLETON
COUNTY TIPPERARY

Project	Baseline Assessment Report Ballybeg, Littleton			
Client	Starrus Eco Holdings Ltd			
Report No	Date	Status	Prepared By	Reviewed By
	13/01/2021	Draft	Billy Hamilton MSc	Jim O'Callaghan MSc
	22/06/2021	Final	Billy Hamilton MSc	Jim O'Callaghan MSc

**SOILS, GEOLOGY AND WATER SECTION OF AN EIS FOR A PROPOSED
COMPOSTING FACILITY AT BALLYBEG LITTLETON, CO. TIPPERARY**

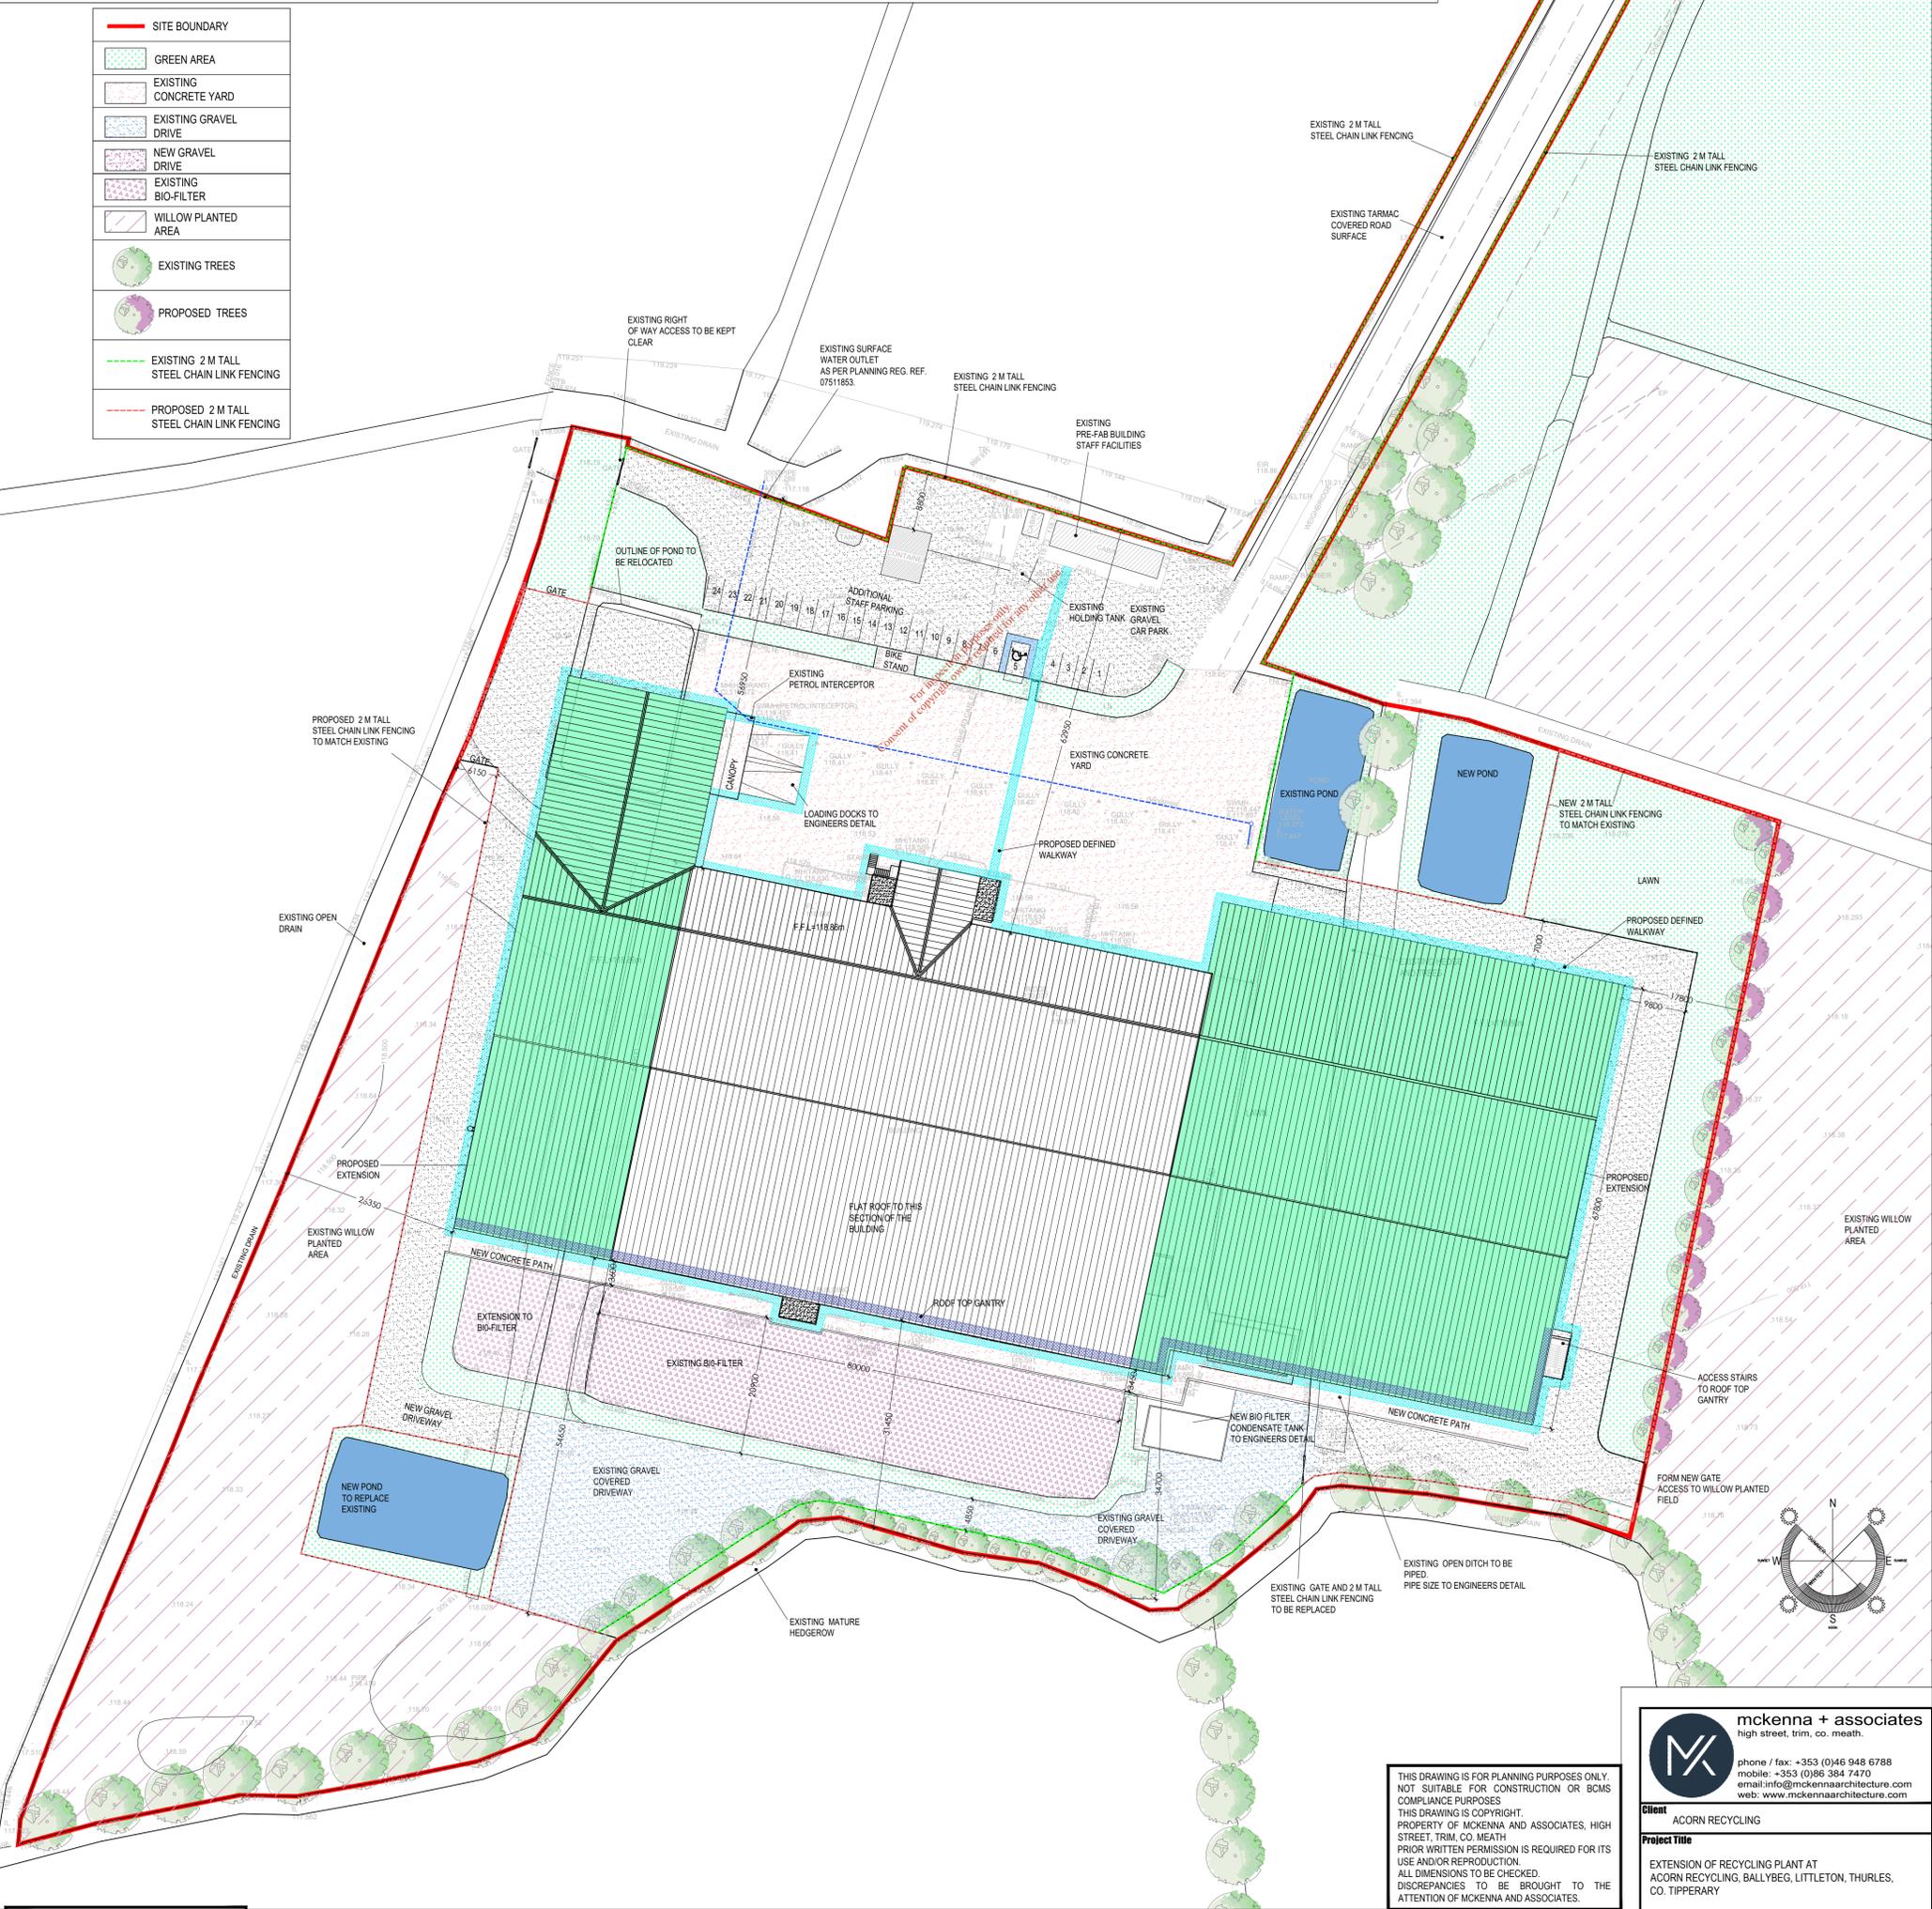
PROPOSED SITE LAYOUT PLAN 1:500
SITE AREA BOUND IN RED: 3.58 HECTARES

The site layout, when fully developed is shown on Drawing No. 18-173-300. The licence boundary encompasses 3.58 ha and includes the access road off the L4101; a weighbridge; the composting building (4,864 m²); an annex on the northern elevation of the building that houses a fuel store, main control room, a mezzanine office and electrical substation; an odour control unit (biofilter) to the south of the building; a condensate holding tank bund; portakabin offices and welfare facilities at the northern boundary; a firewater reservoir lagoon; a firewater retention lagoon, paved yards and unpaved access roads. The licensed area is surrounded by a stock proof security fence as required by the DAFM Animal By-Product Approval.

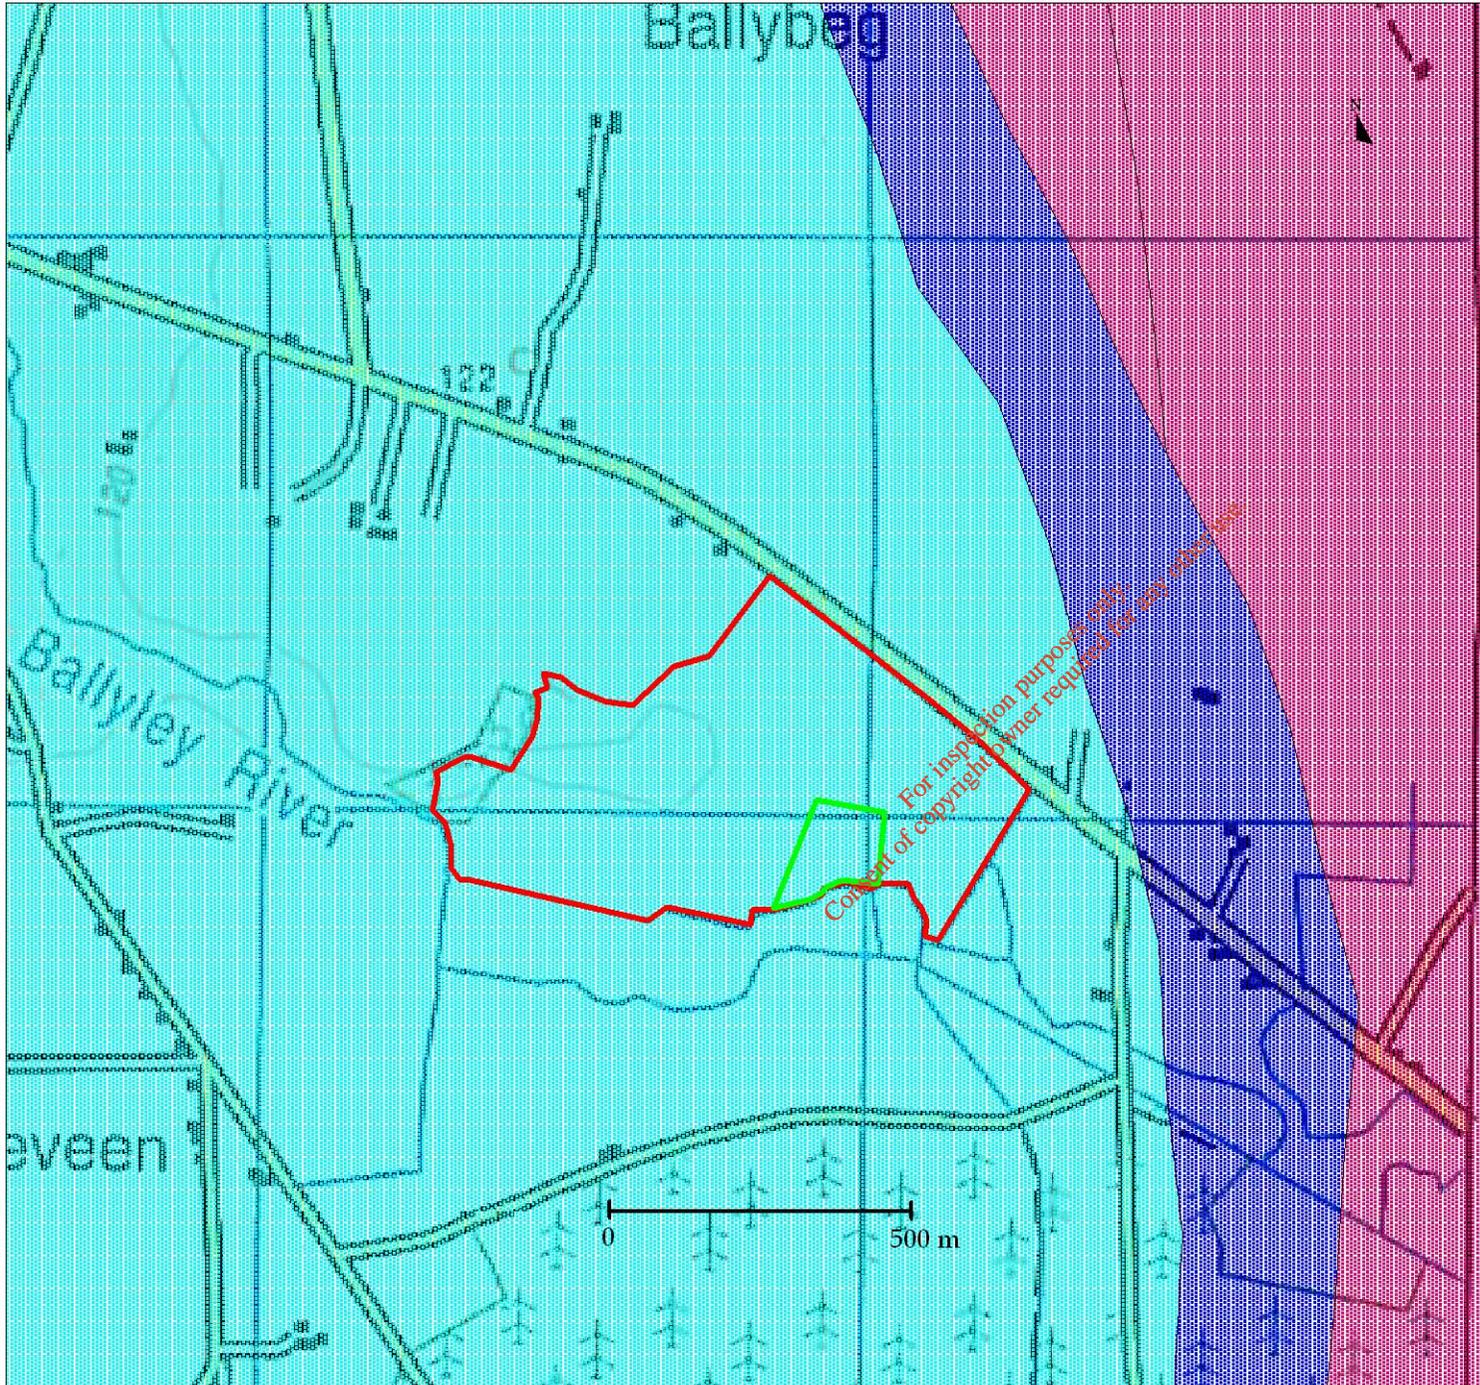
Author: KH/AW **Figure no:** 2

Crosspatrick Formation
Lm: Productive Fissured Aquifer
-

the site is the Crosspatrick Formation, of Dinantian Pure Bedded Limestone, which has been categorised as a Productive Fissured Aquifer (category Lm: Locally moderately productive). A further 300m to the east are the Wausortian Limestones, which are Dinantian Pure Unbedded Limestones and are categorised as a Poorly Productive Bedrock Aquifer (category Ll Locally important, moderately productive only in local zones). Aquifer categories are shown together with bedrock geology information in *Figure No. 2*.

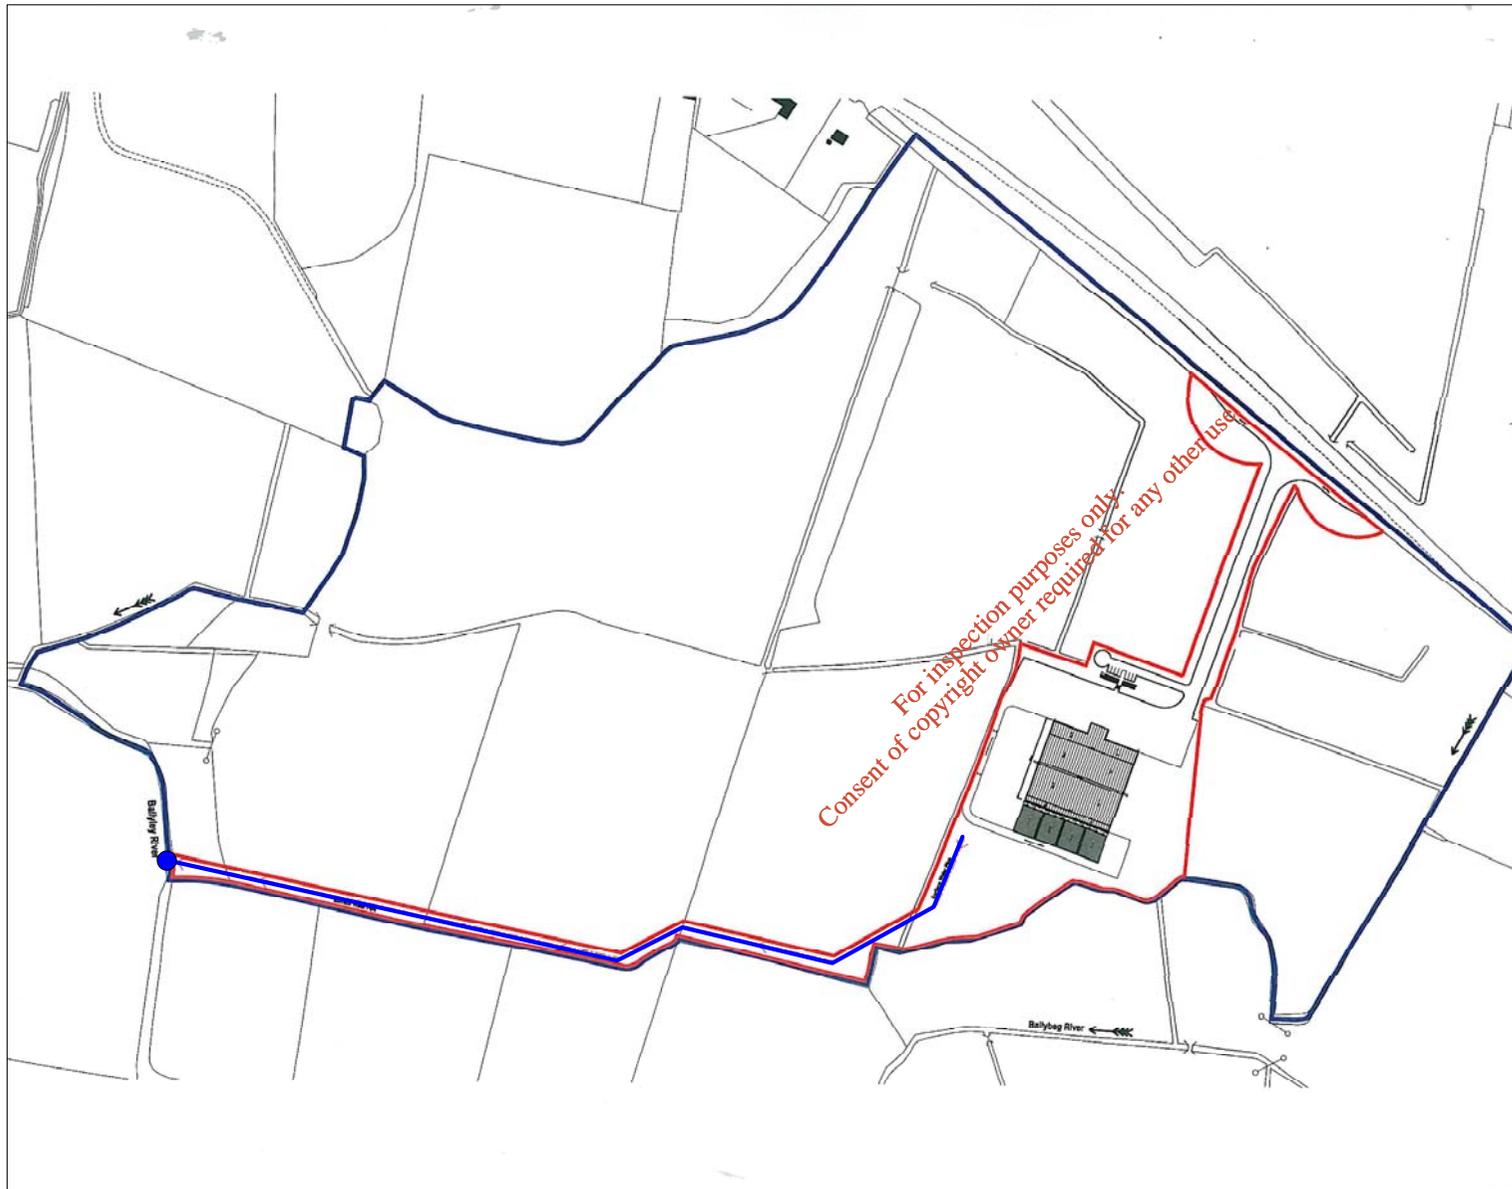
Point of Discharge to Ballybeg River

The above calculations show that the estimated discharge from the site during heavy rainfall events would not contribute a significant amount of the overall flow of the Ballyley River (0.1% of the total flow). Therefore, in OGE's opinion discharging runoff water directly to the river would not increase the flood risk of the river and is the most suitable option for managing storm water. A 150mm pipe is recommended to transfer the runoff to the river. The proposed locations of the discharge pipe and discharge point to the Ballyley River are presented in *Figure No. 6*.
