**A DESK STUDY INVESTIGATION OF POTENTIAL
ECOLOGICAL IMPACTS FROM THE WHITEGATE
LANDFILL, COUNTY CLARE, ON THE CONSERVATION
STATUS OF SPECIES AND HABITATS IN THE SLIEVE
AUGHTY MOUNTAINS SPECIAL PROTECTION AREA**

December 2009

**CONSERVATION SERVICES
&
BIOSPHERE ENVIRONMENTAL SERVICES**

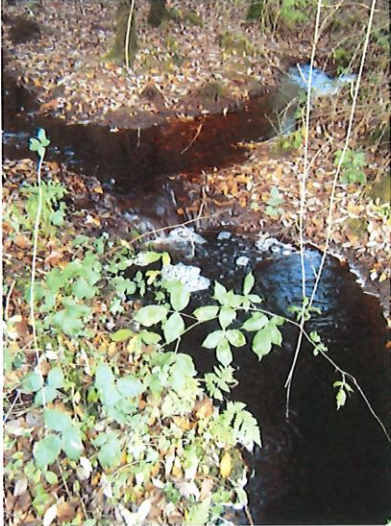
1. Upstream of Landfill and downstream from Crooked Lough: SW6

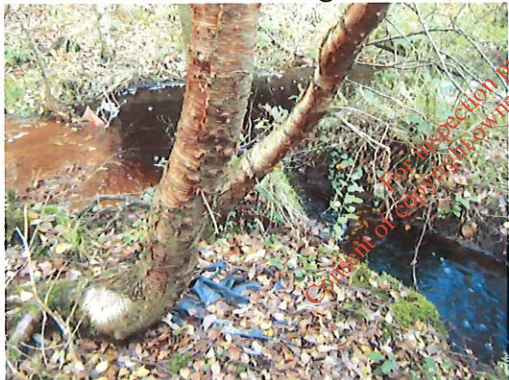
2. D/S on Crooked Lough Stream, down-gradient of Landfill site: SW7

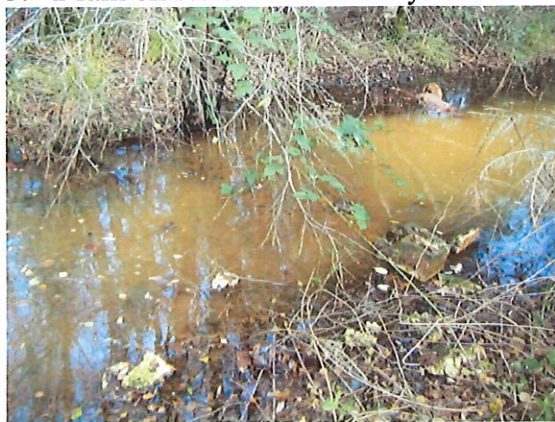
3. Drain on Northern Boundary: SW4

- *“The northern boundary drain, which appears to be very slow moving, with max depth of 1 metre and maximum width 1.5m. The water in the drain was orange, and appeared to be impacted by leachate. This drain flows in a west to east direction along the line of the landfill site. This drain appears to be the main surface water connected with the water table and leachate in the main waste body.”*

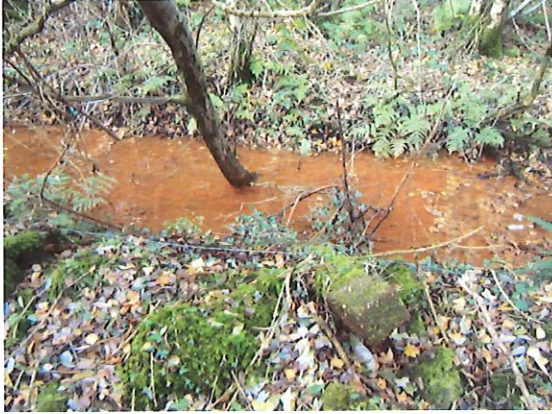
4. Approx 100m downstream of SW4, down-gradient of landfill site and downstream of where land drain (along south boundary) joins stream: SW3

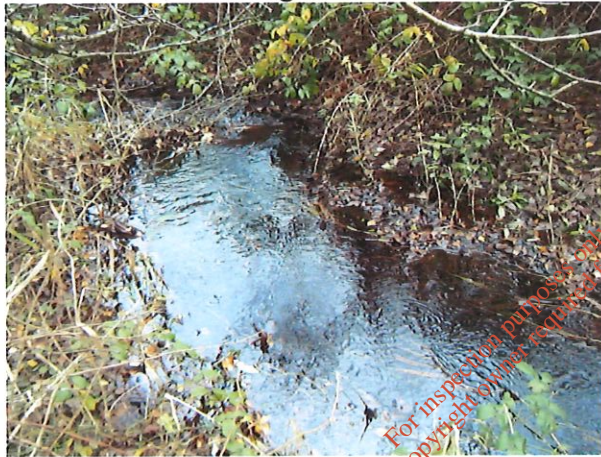
5. Downstream along stream travelling in eastern direction: SW1

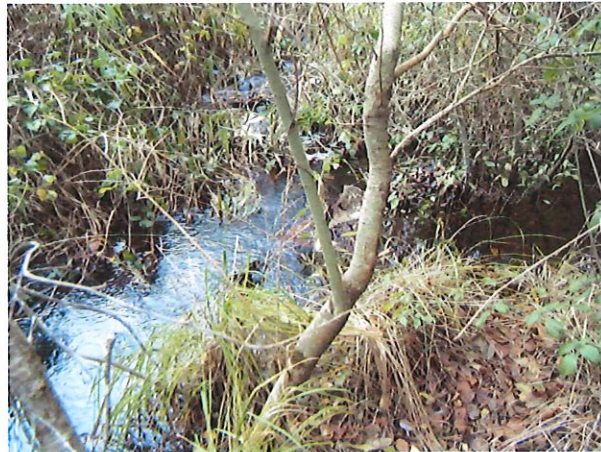
6. Stream from northern direction: SW5

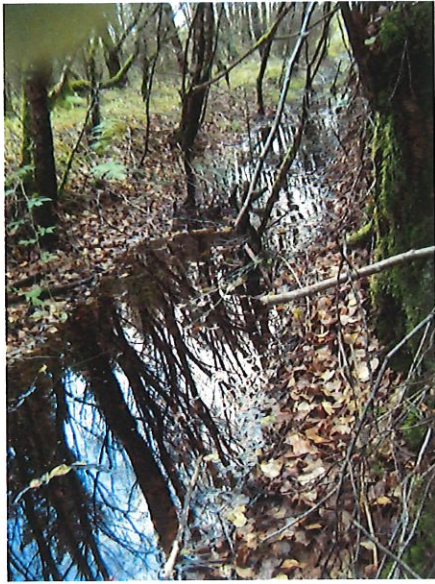
7. Furthest downstream: SW2

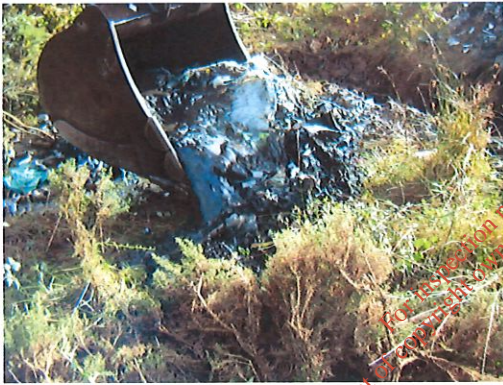
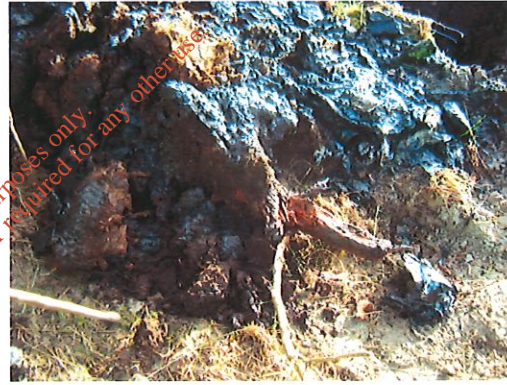
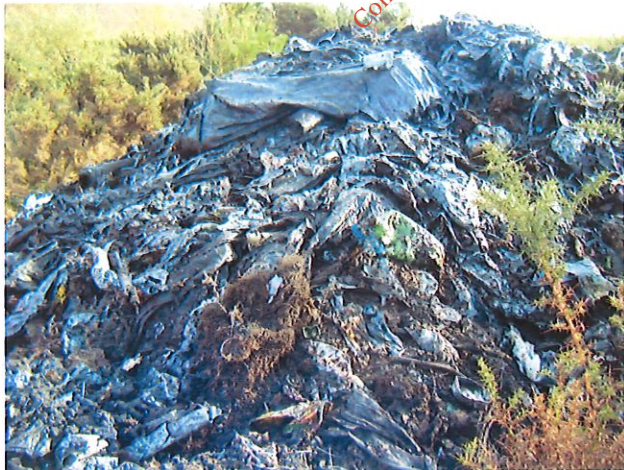
11. Trial Hole 4

Vegetative matter
evident, similar to
surrounding Gorse.

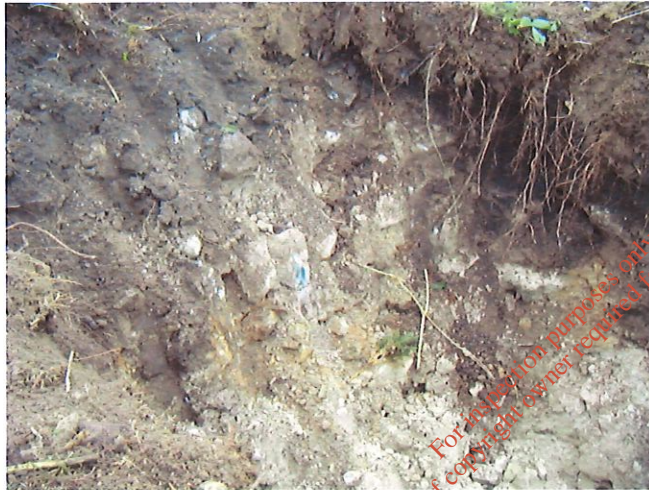
13. Trial Hole 6

Clean Trial Hole

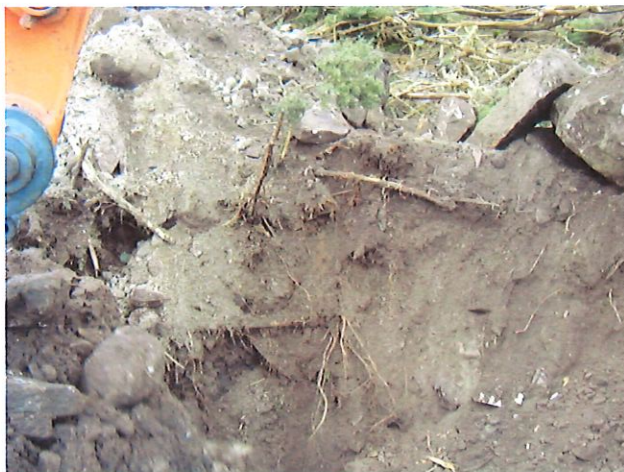
14. Trial Hole 7

Clean Trial Hole

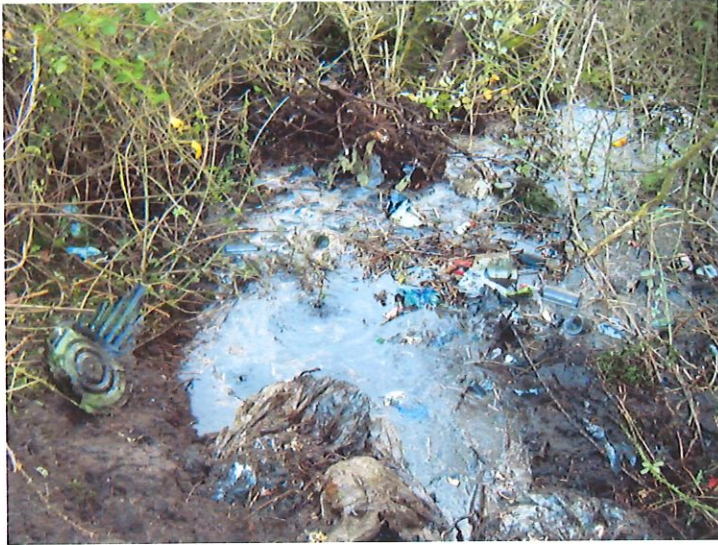
Ponding on site, at eastern side

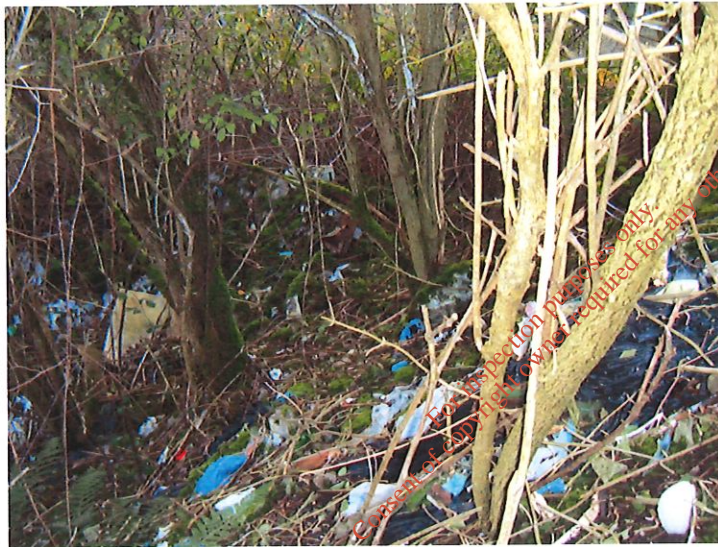
Windblown waste at the eastern part of site

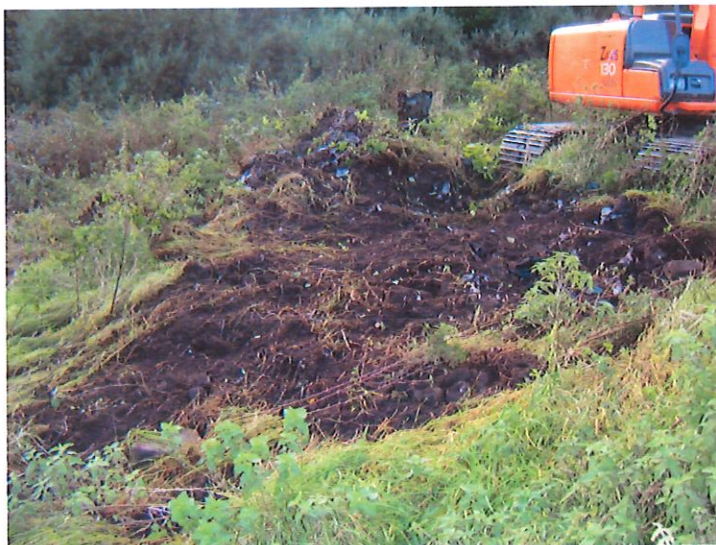
Peat soils evident
