TIER 2 RISK ASSESSMENT

CARTRON BIG HISTORIC LANDFILL SITE, CO. LONGFORD

NOVEMBER 2018

Client: Longford County Council

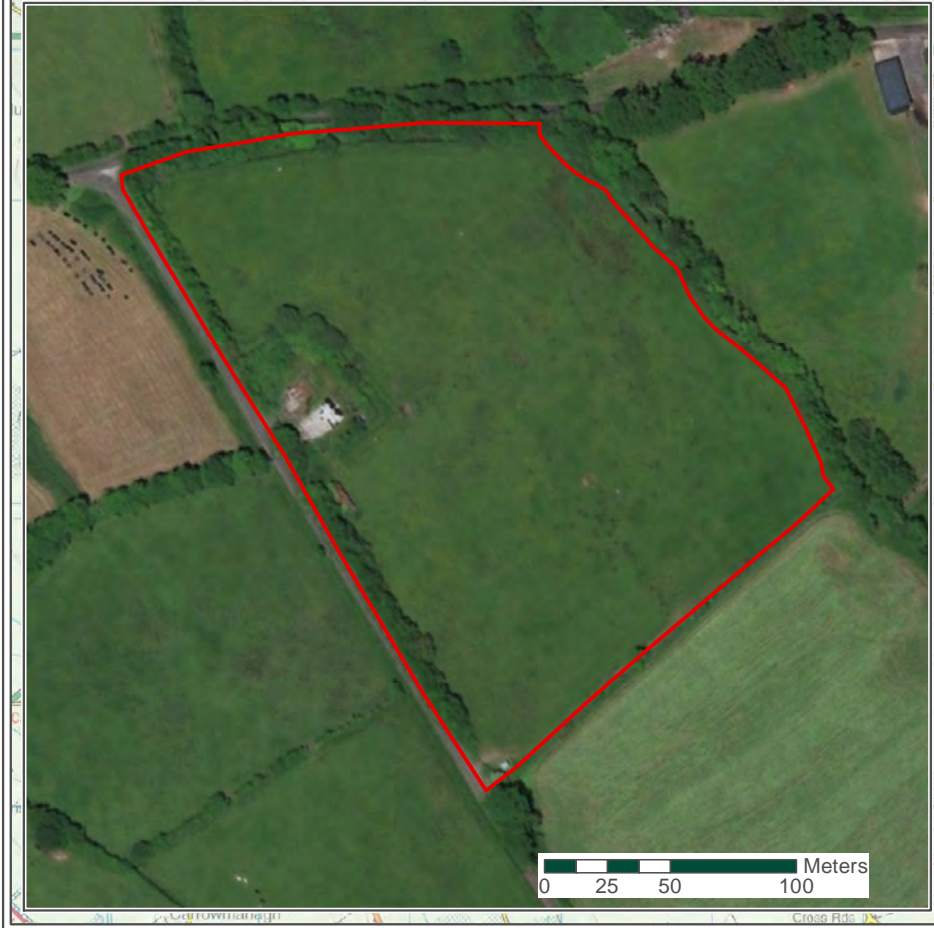
Figure Title	Site Location Plan and Aerial View
Figure No.	2.1
Project	Historical Landfills: Cartron Big
Client	Longford County Council
Scale	1:50,000
Page Size	A3
Revision	A
Date	29/08/2018

An aerial photograph of the site is shown in Figure 2.1, overleaf.

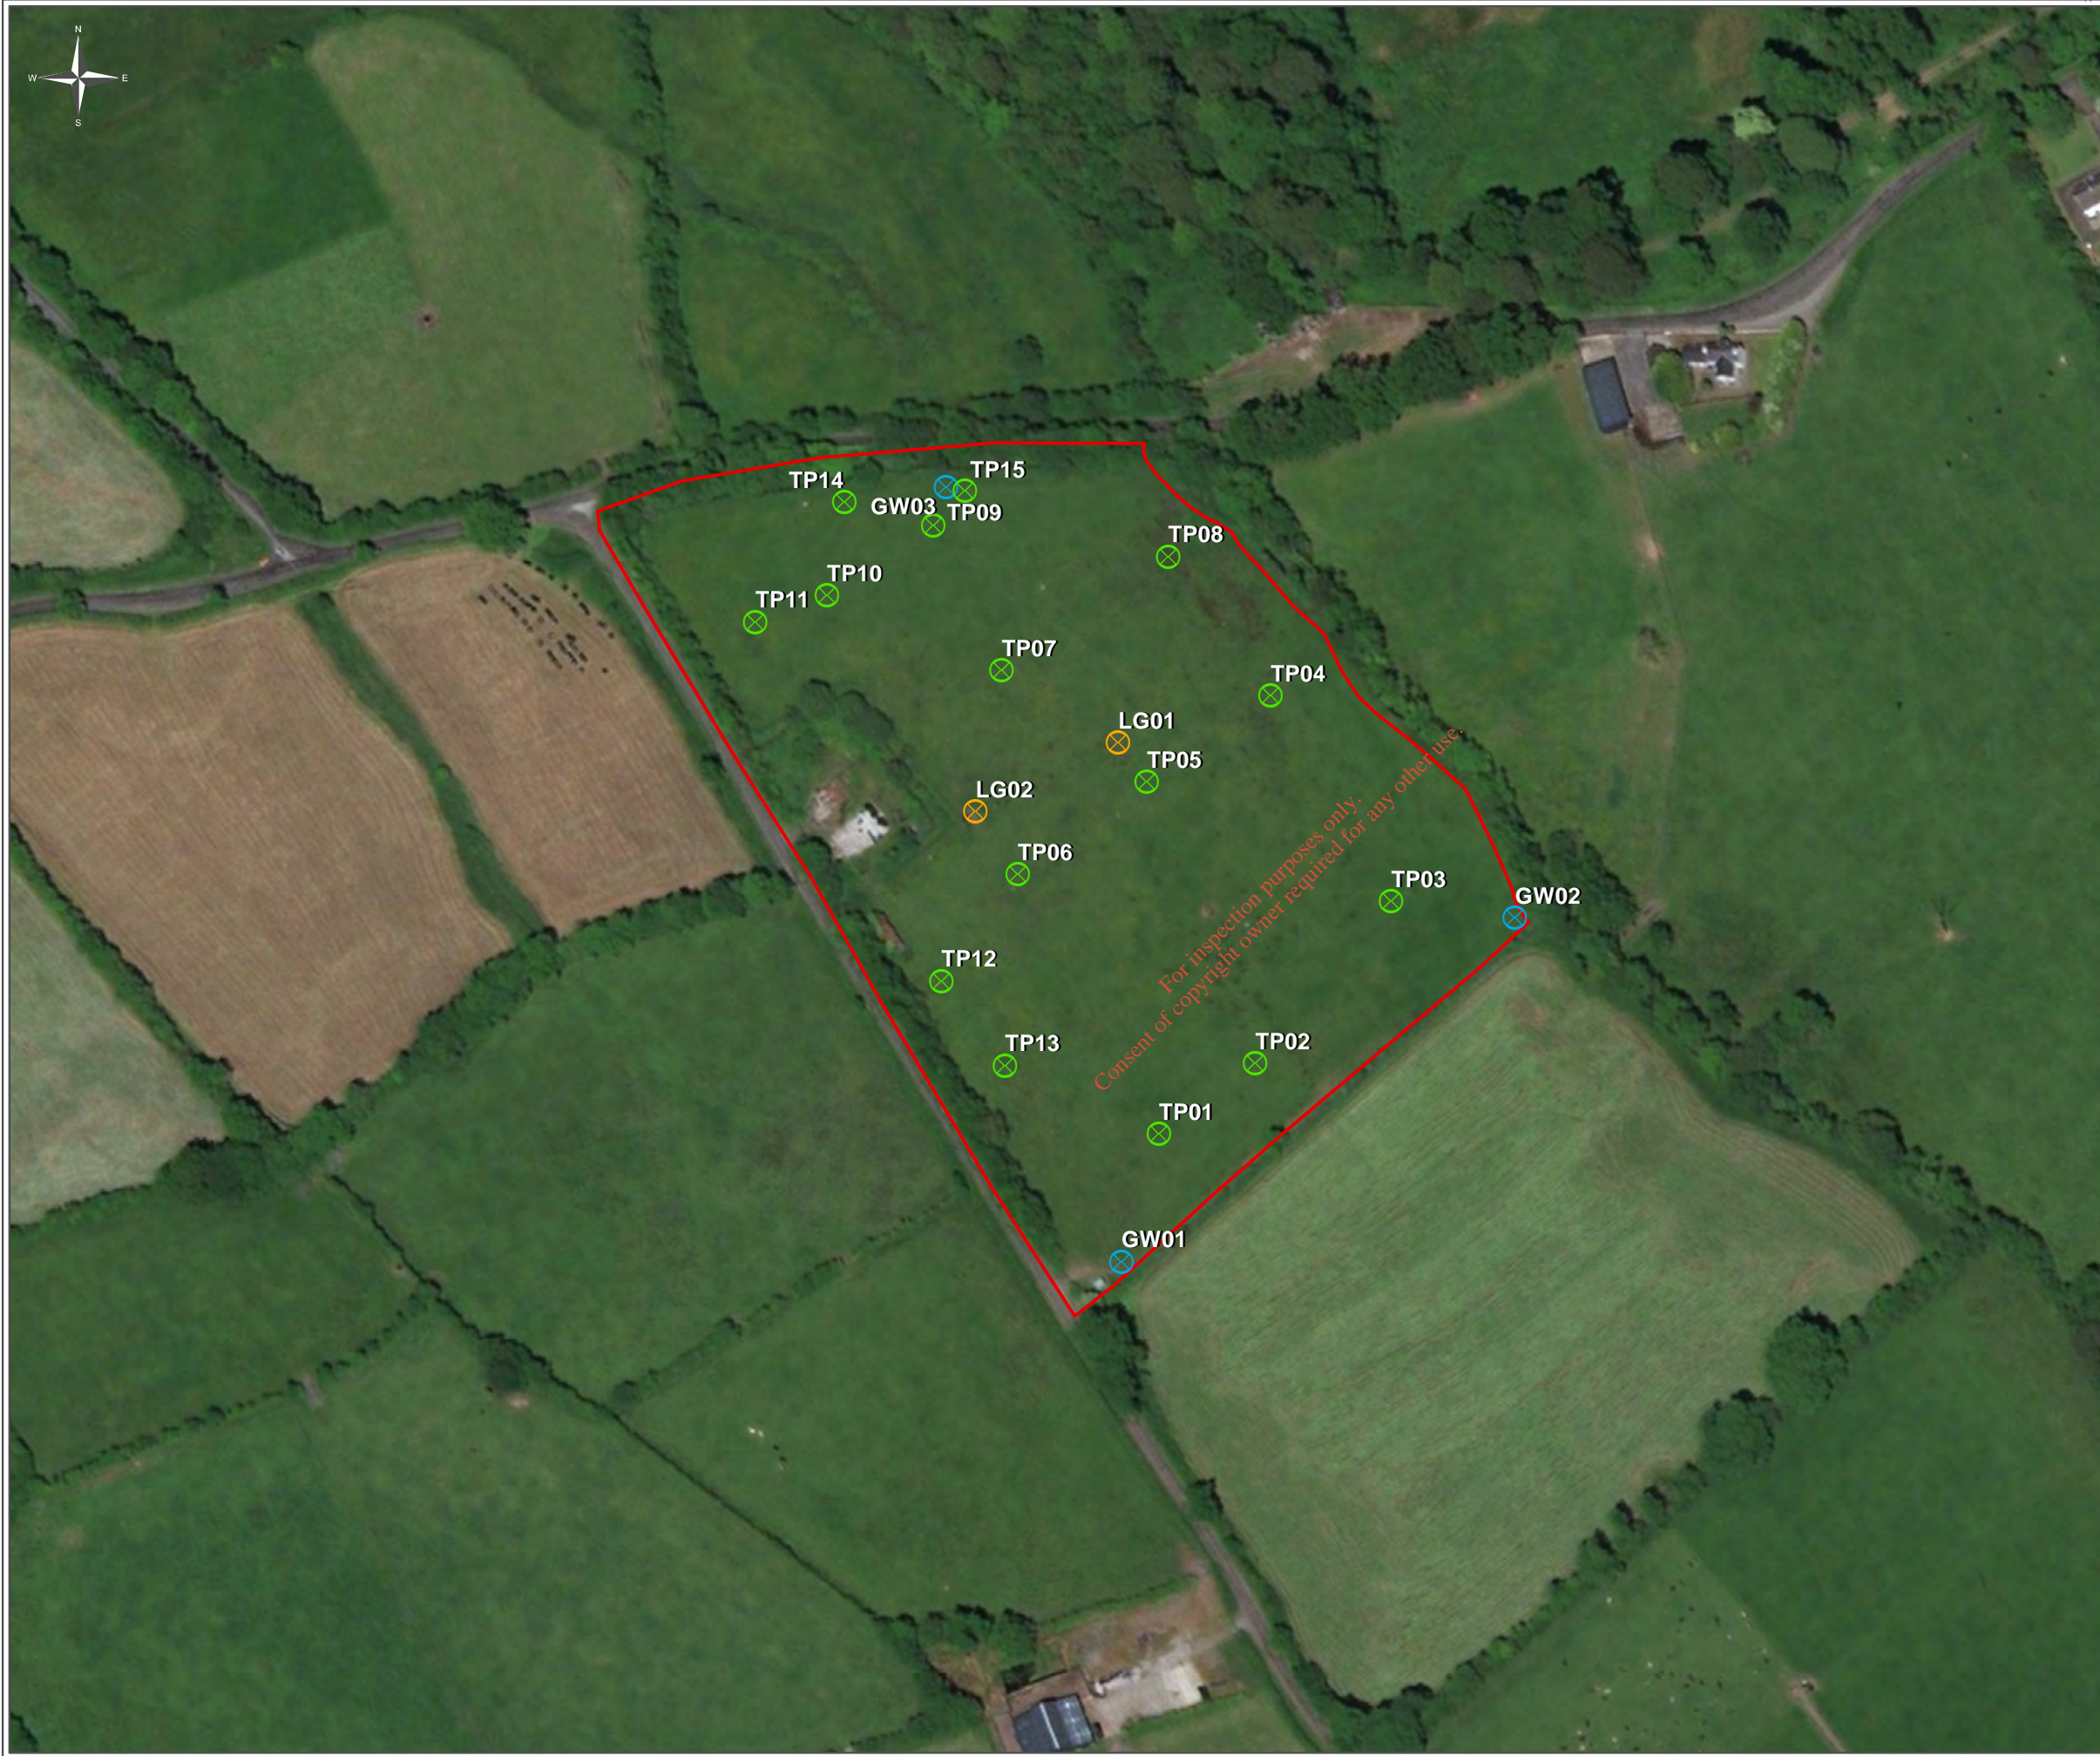
The locations of the intrusive works at the site are presented in Figure 3.1.

- Groundwater Well
- Leachate Well
- Trial Pit
- Site Boundary

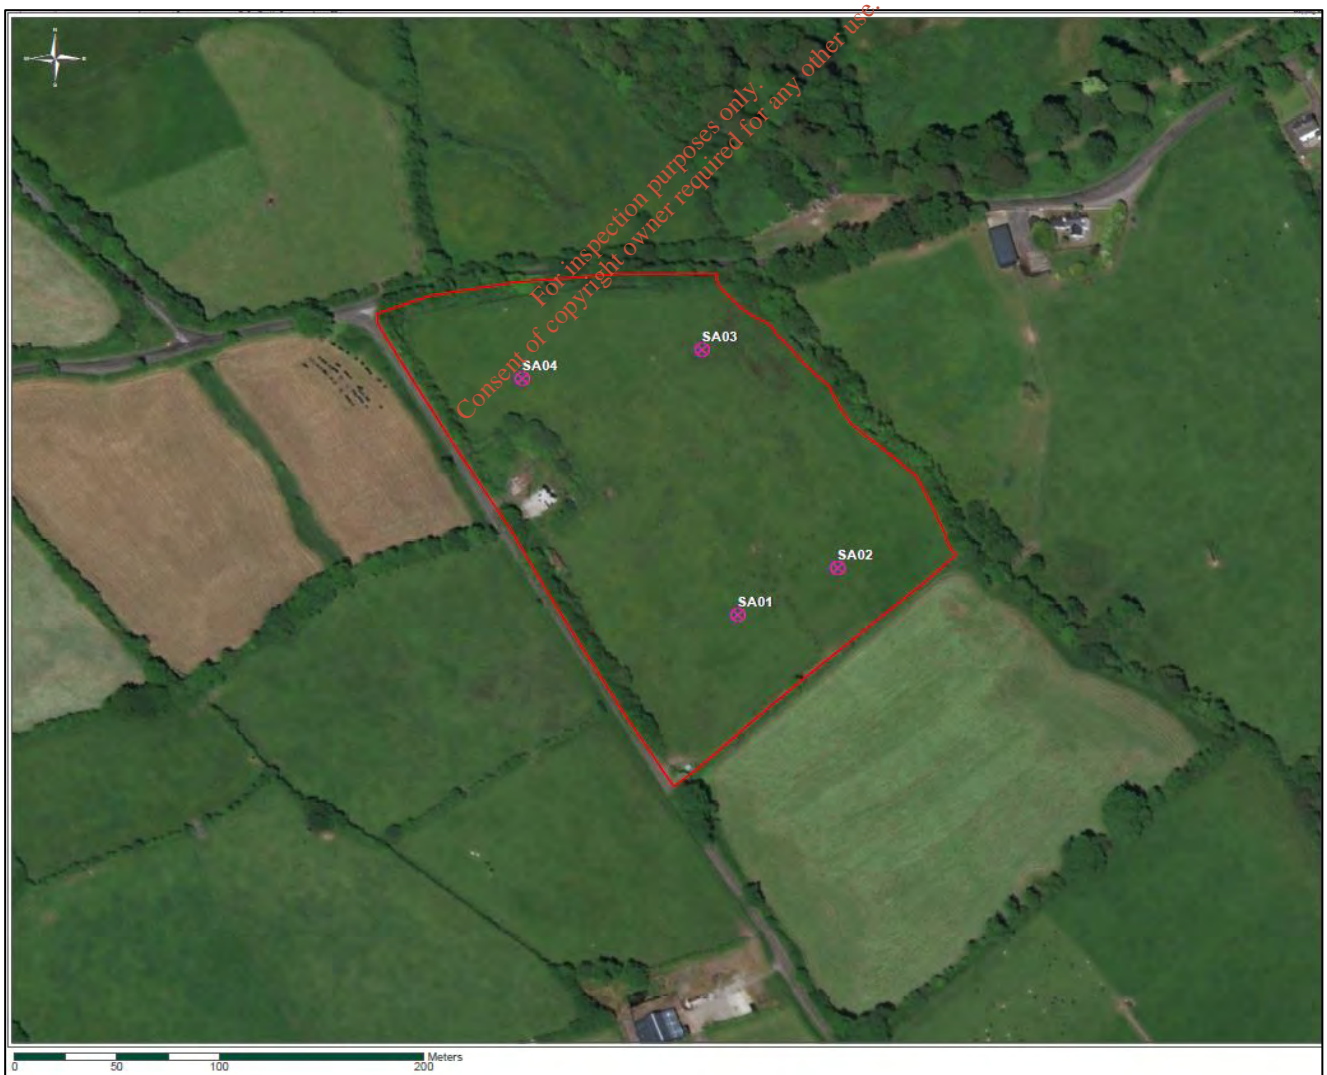
Figure 3.2: Capping Infiltration Testing Locations

Four infiltration tests were carried out in general accordance with the BRE Digest 365, 2007 Soakaway Design Standards. Single and double cycles of infiltration / drainage were undertaken. The soakaway pits failed to drain in full over the test durations of 60 minutes to 120 minutes. The calculated infiltration rates (f) for each test are presented in Table 3.2.

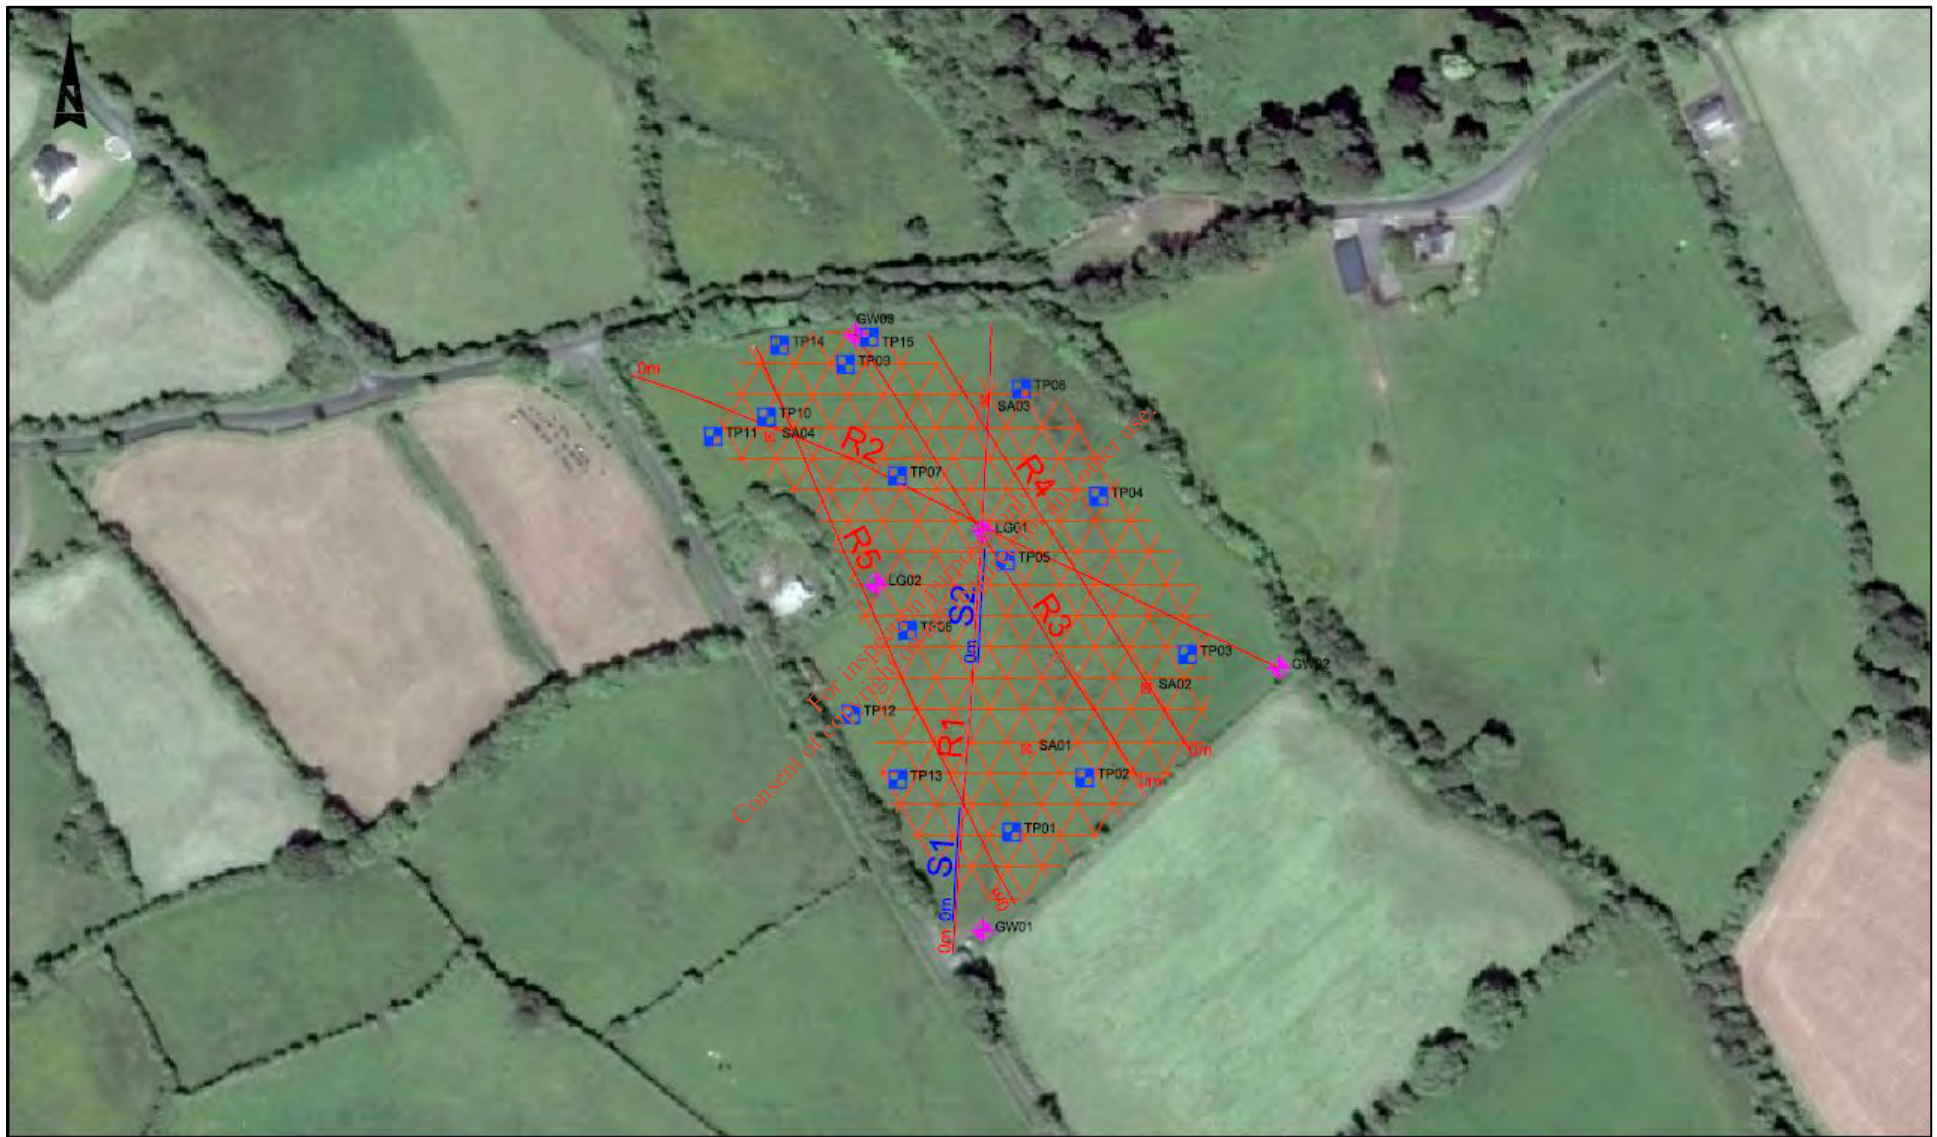
Figure 3.8: Maximum Anticipated Waste Footprint

AI volume calculation was conducted based on the surveyed surface profiles for the existing ground level and the base of waste as interpreted, preliminary estimates indicate an interred waste volume of approximately 206,000 m³ at the site.

The findings of the intrusive works suggest the waste material is deposited in a single infill area tending north-west to south-east and is between 210m in length and 140m in width. Based on this interpretation, the maximum waste footprint is calculated to be 5.80 acres or 2.35 hectares.

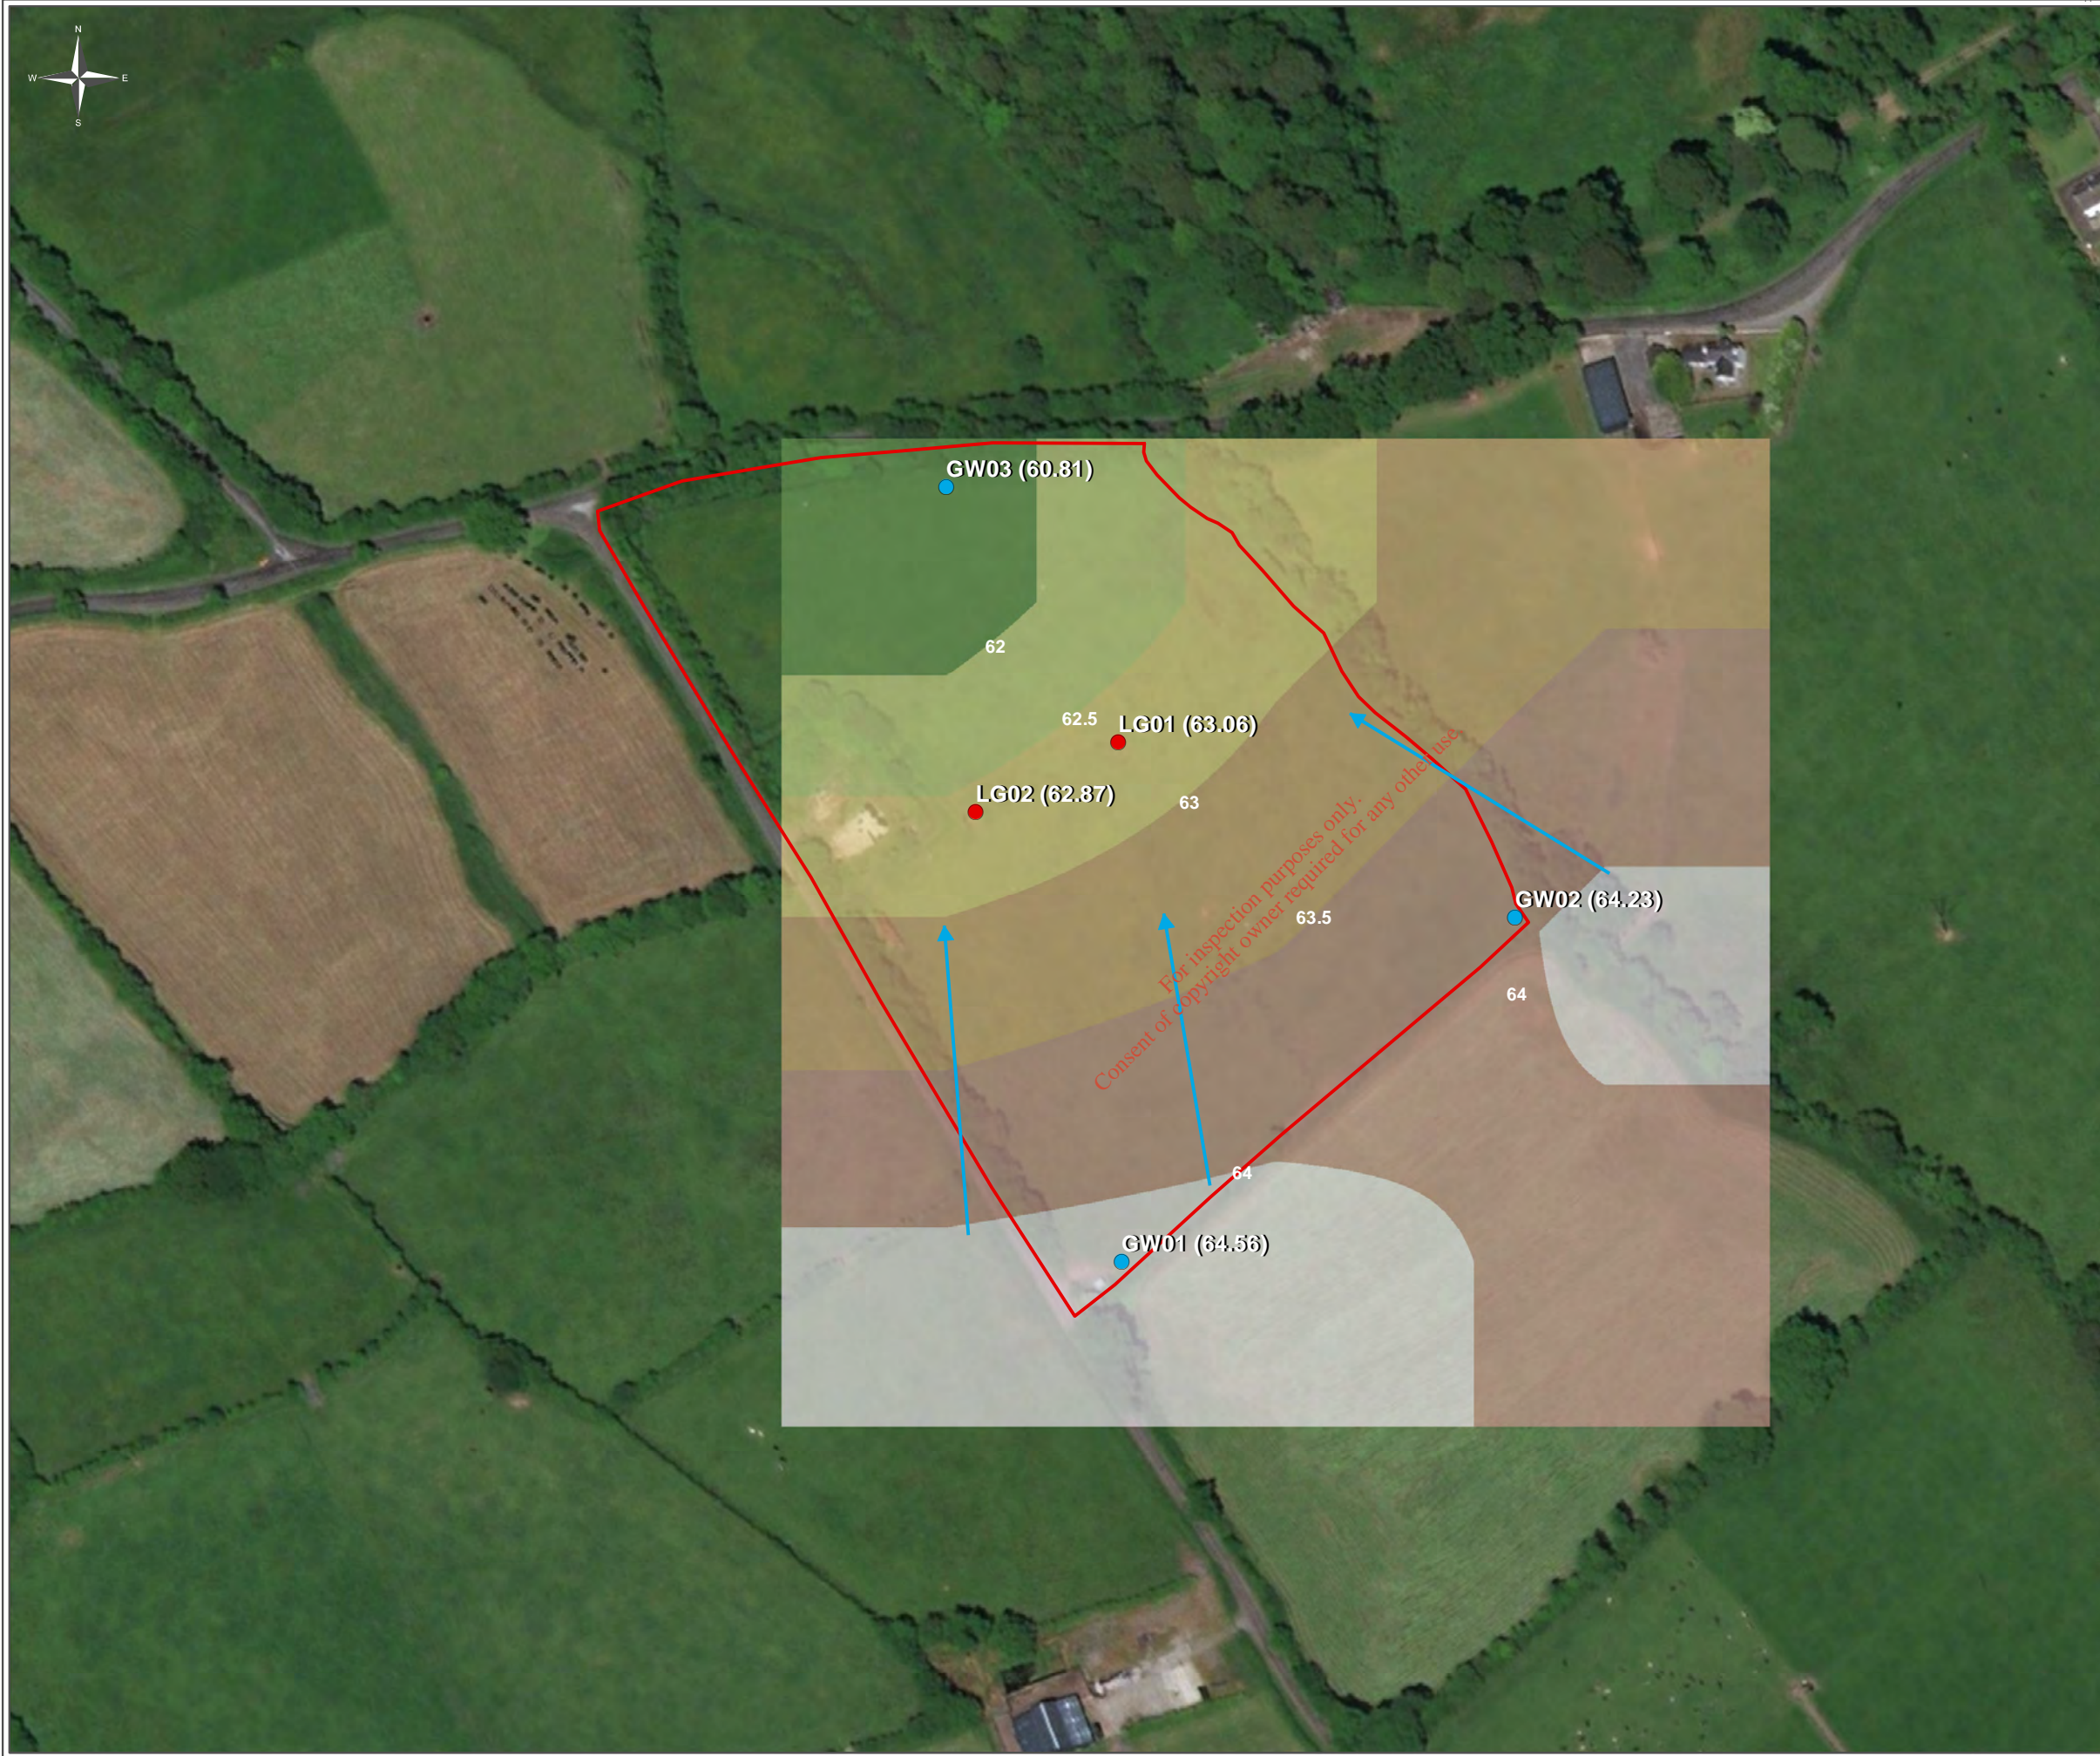
- Legend**
- Dipped Water Level (mAOD)
 - Dipped Leachate Level (mAOD)
 - Groundwater Flow Direction
 - Site Boundary

Interpolated Dipped Water Level (mAOD)
