TIER 2 RISK ASSESSMENT

BALLYMULVEY HISTORIC LANDFILL SITE, BALLYMAHON, CO. LONGFORD

NOVEMBER 2018

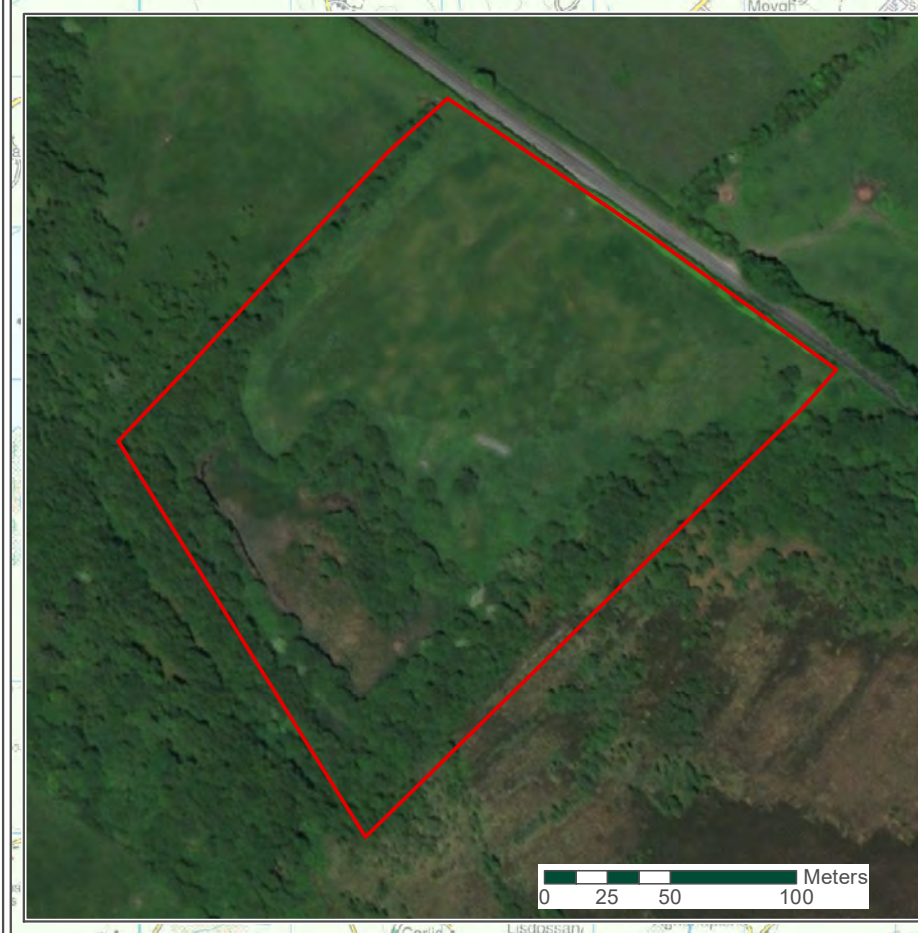
Figure Title	Site Location Plan and Aerial View		
Figure No.	2.1		
Project	Historical Landfills: Ballymulvey		
Client	Longford County Council		
Scale	1:50,000	Page Size	A3
Revision	A	Date	29/08/2018

An aerial photograph of the site is shown in Figure 2.1, overleaf.

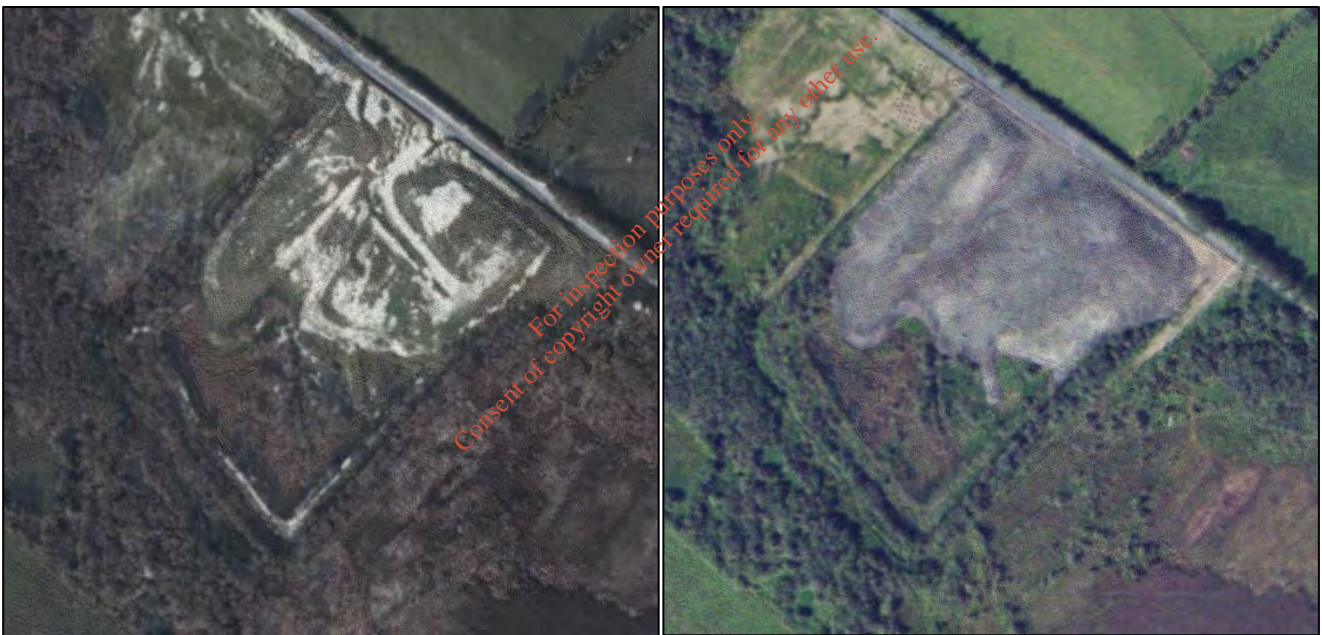
Plate 1-1: OSi Aerial 1995

Aerial photograph from 2000 (see Plate-1 and Plate-2) shows the site is in the process of being capped and profiled, remediation works at the site are likely to have commenced sometime between 1998 and 2000.

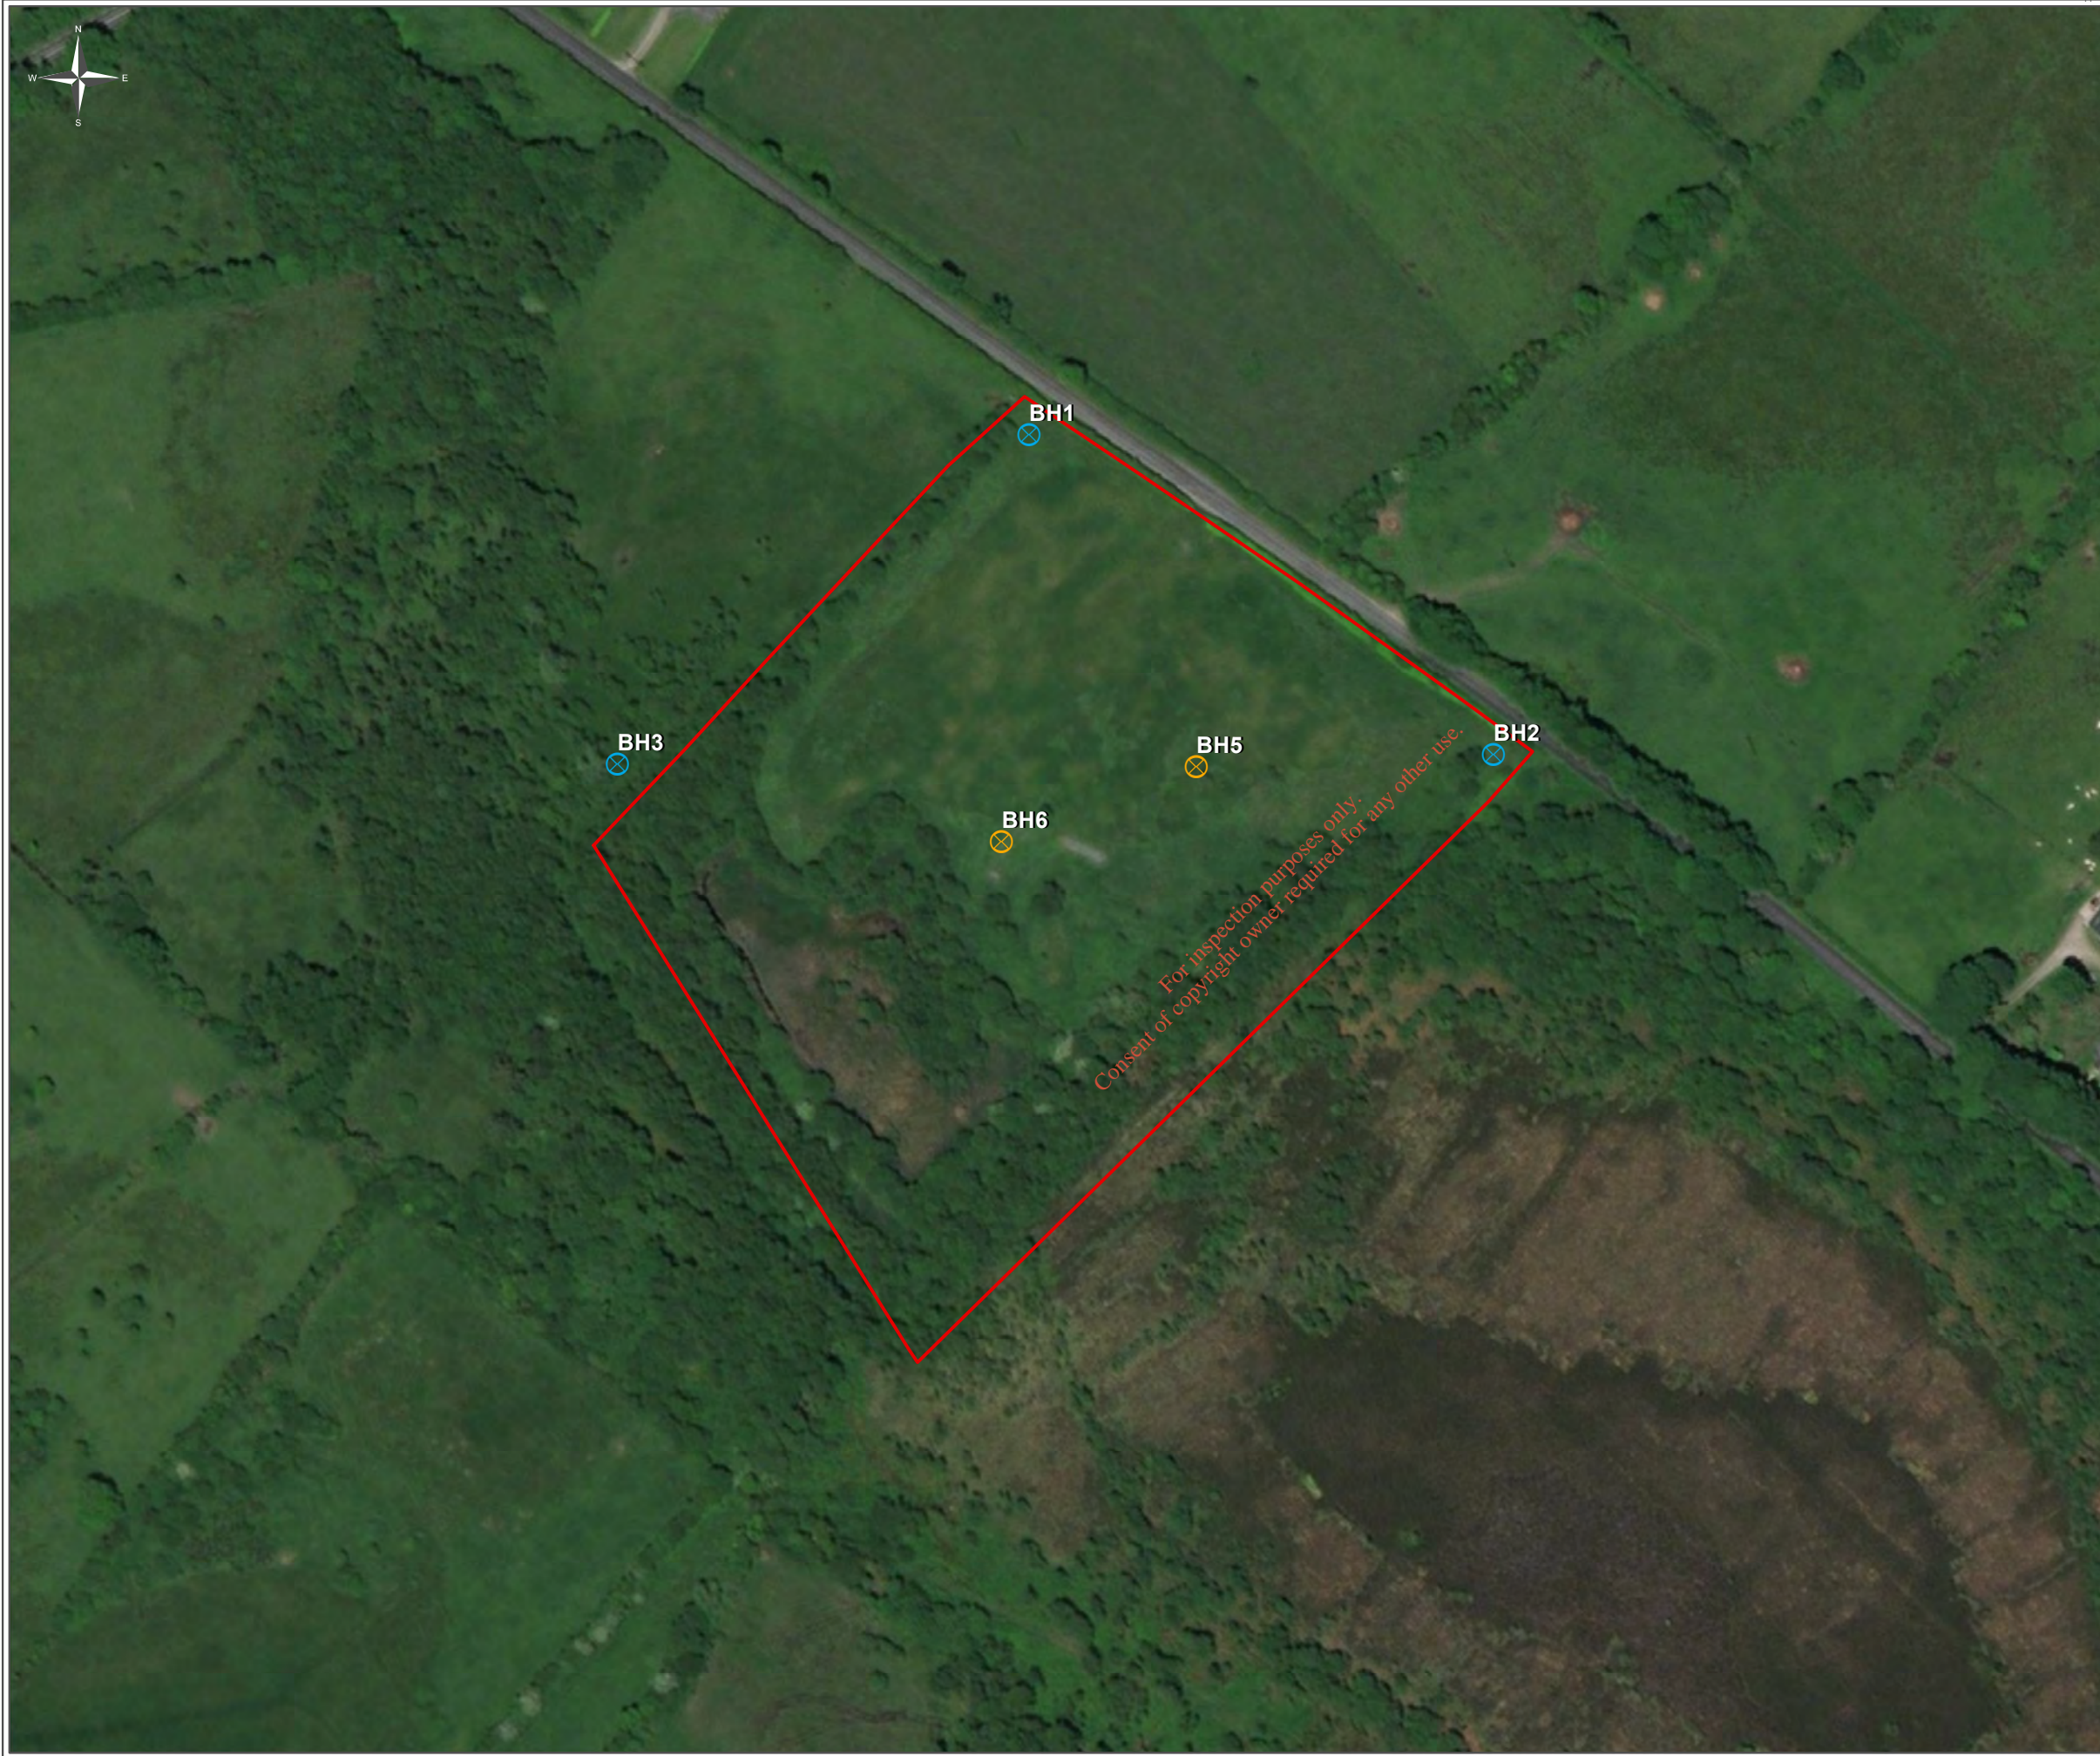
Figure Title	Site Investigation Location Plan		
Figure No.	3.1		
Project	Historical Landfills: Ballymulvey		
Client	Longford County Council		
Scale	1:2,000	Page Size	A3
Revision	A	Date	09/10/2018

The scope was agreed based on the site walkover assessment, "as built" drawings and other information received by LCC. The locations of the intrusive works at the site are presented in Figure 3.1.

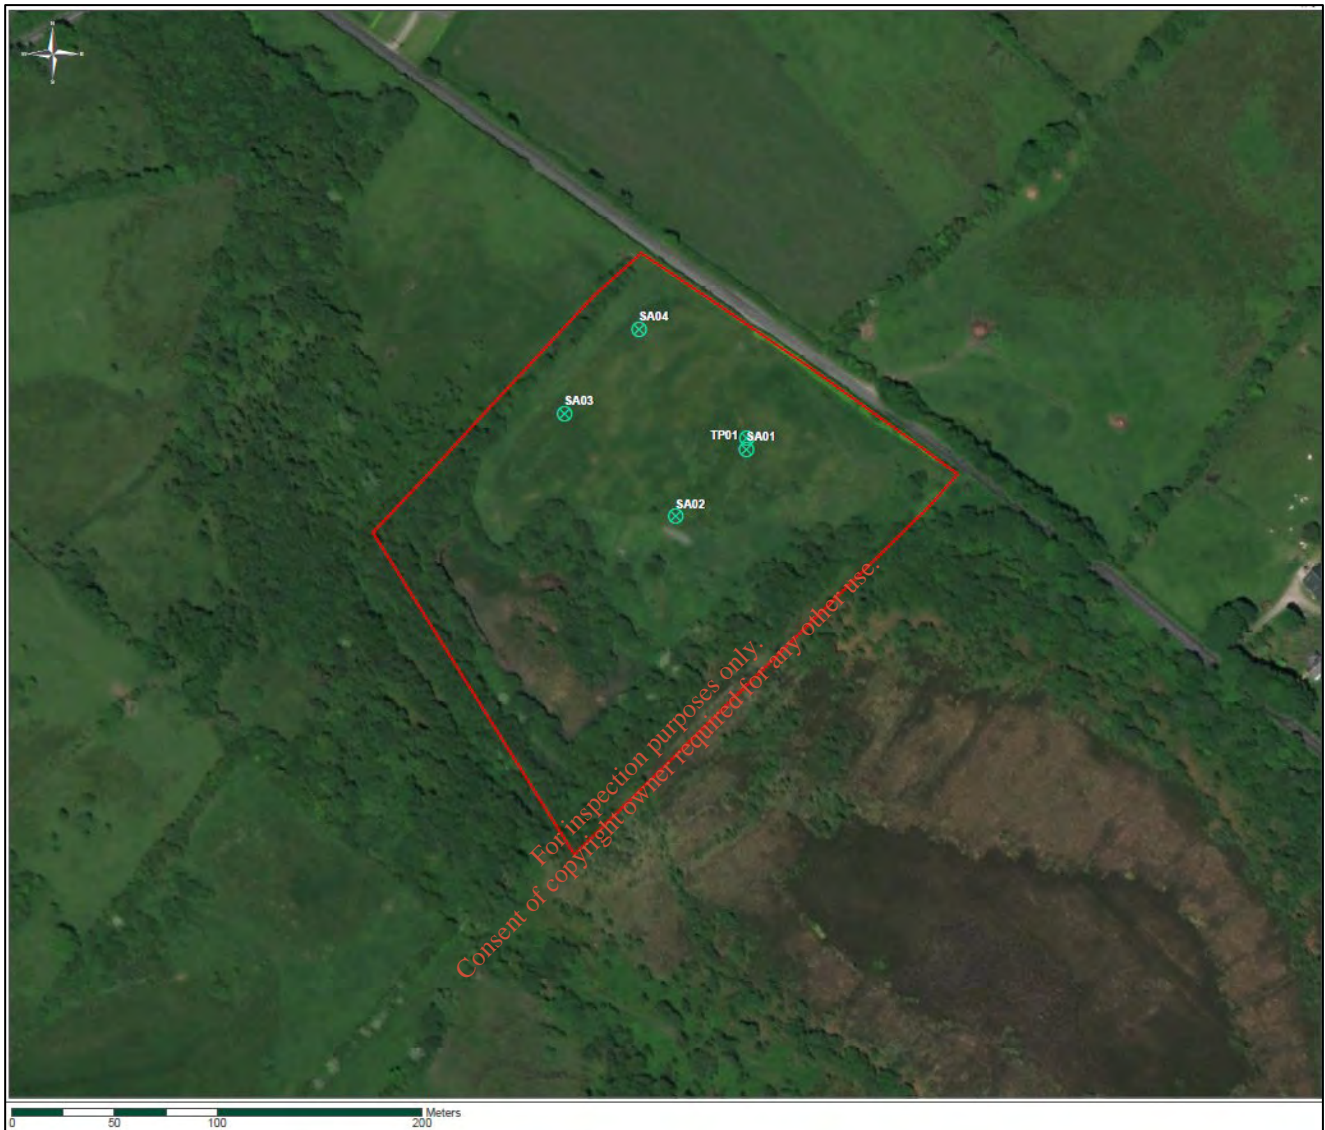
Figure 3.2: Capping Infiltration Testing Locations

Four infiltration tests were carried out in general accordance with the BRE Digest 365, 2007 Soakaway Design Standards. Single cycles of infiltration / drainage were undertaken. The soakaway pits failed to drain in full over the test durations of 180 minutes. The calculated infiltration values (f) for each test are presented in Table 3.2.

The low infiltration results presented in Table 3.2 suggest that rapid vertical leachate migration into the waste body and bedrock aquifer is being prevented by the low permeability of the fly ash cover. Therefore, the low permeability capping on the waste body is suitable to minimise leachate generation within the waste body.

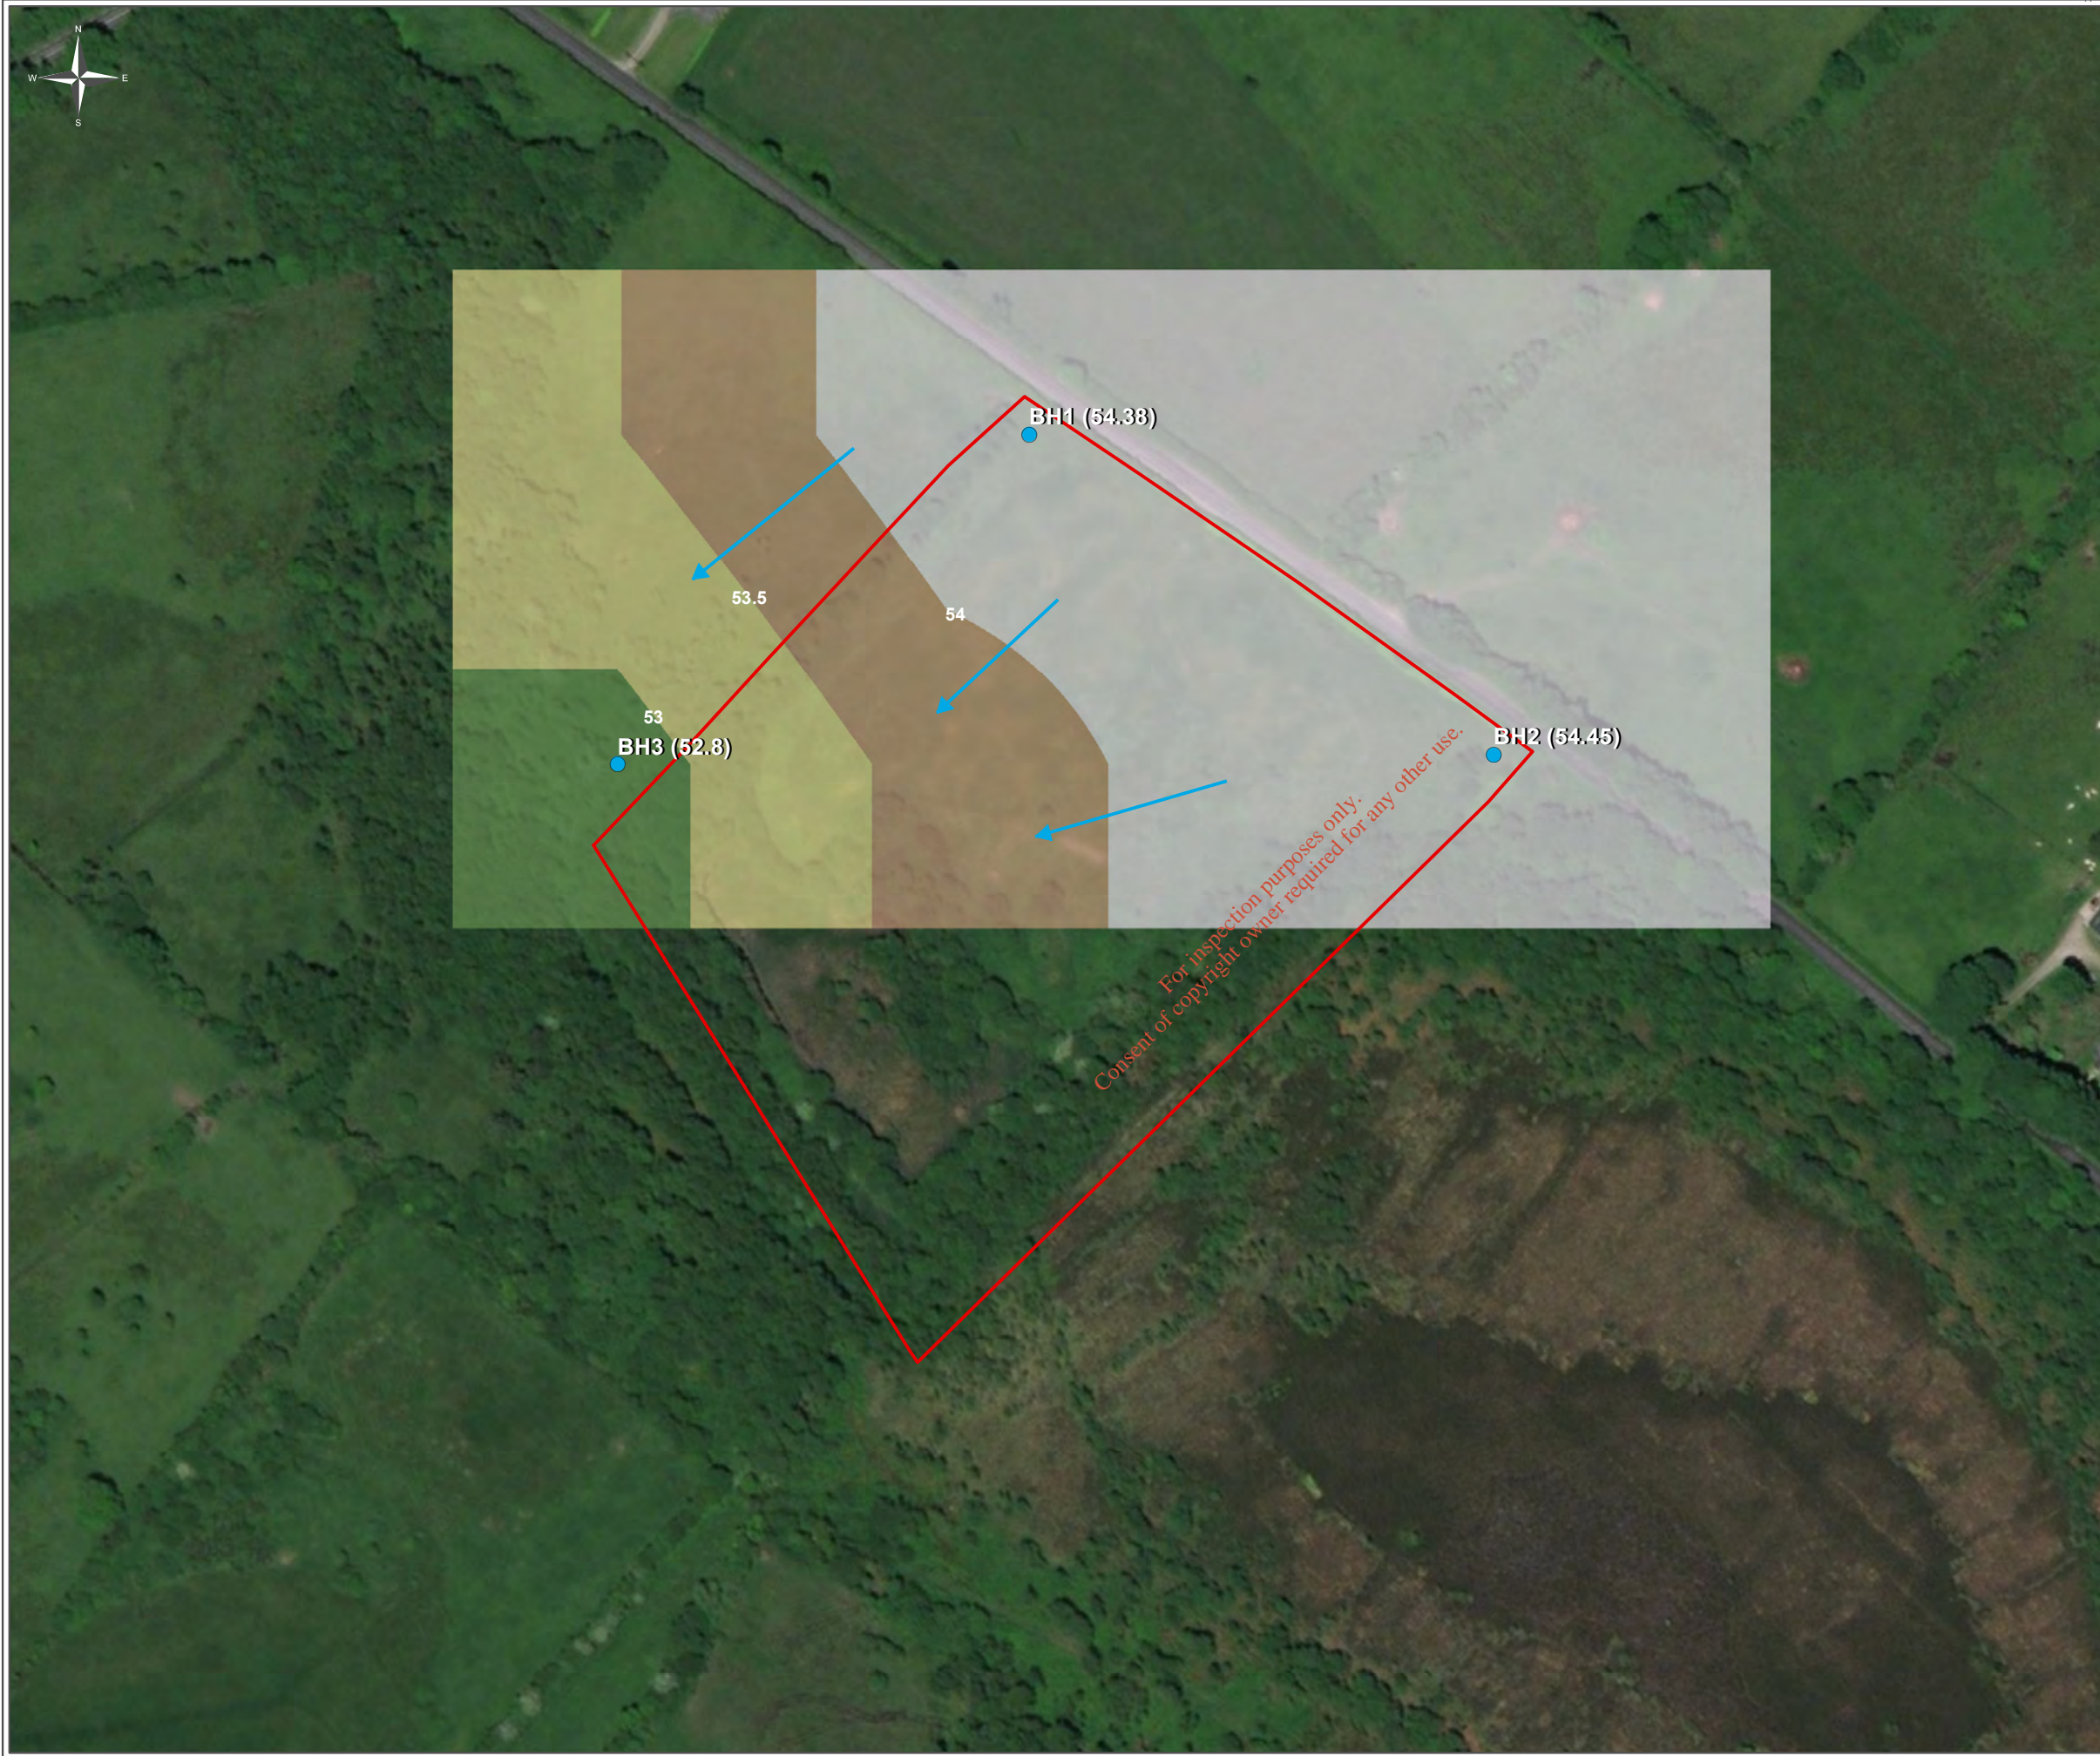
- Legend**
- Dipped Water Level (mAOD)
 - Groundwater Flow Direction
 - Site Boundary
- Interpolated Dipped Water Level (mAOD)*
- 52.5 - 53
 - 53.1 - 53.5
 - 53.6 - 54
 - 54.1 - 54.5

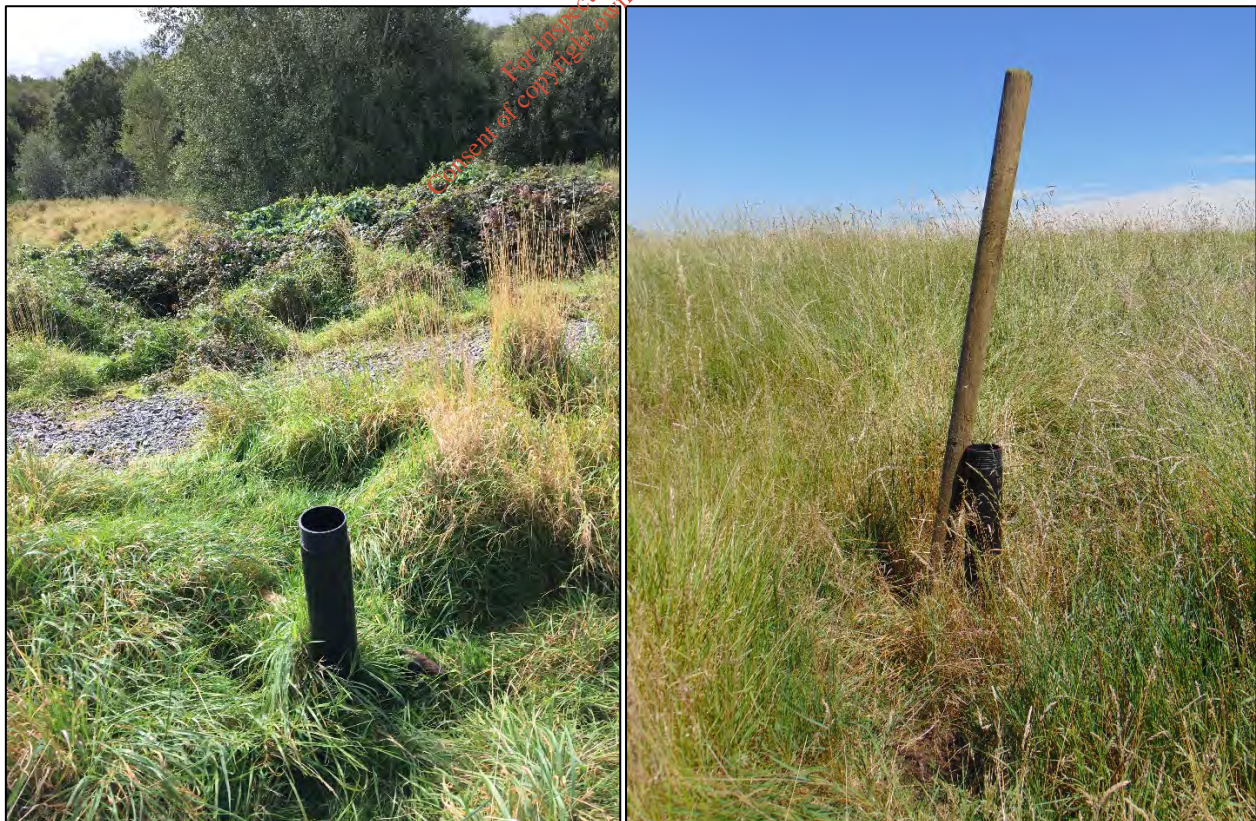
Figure 4.2: Leachate Monitoring Boreholes BH5 and BH6

It is noted that both leachate boreholes BH5 and BH6 are not fitted with gas bungs with sampling valves (see Figure 4.2). Therefore, gas monitoring results at these locations may not be representative of landfill gas concentrations within the waste body.

FT further recommended that further groundwater, leachate surface water monitoring and landfill gas monitoring and analysis be undertaken at each monitoring location GW01 to GW03; BH5, BH6 and all surface water locations (where possible) inclusive. Monitoring should be undertaken on a quarterly basis, subject to any future recommendations of the Tier III report or Certificate of Authorisation. Landfill gas monitoring points should be fully capped in advance of monitoring works to prevent venting.

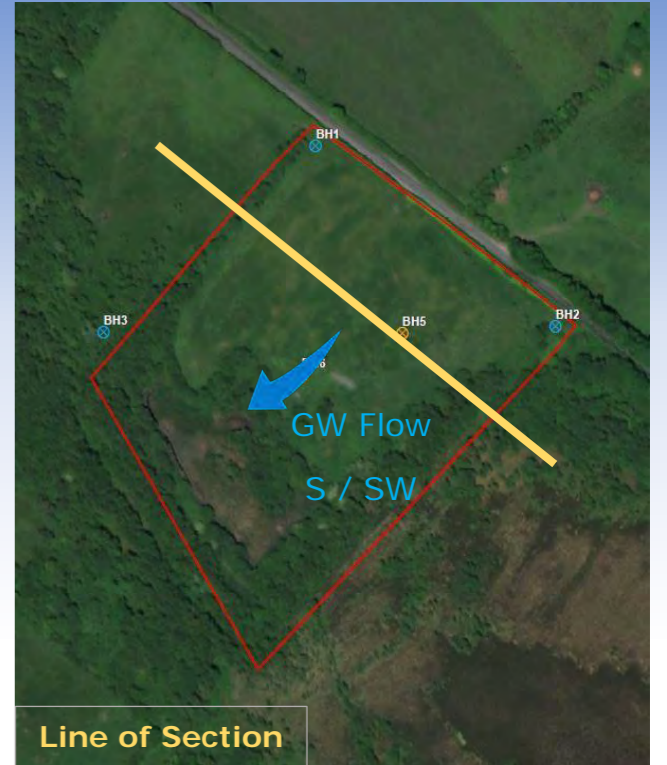
LEACHATE MIGRATION
-   Waste – Typically Municipal and Industrial
-   Measured Groundwater Level
