Causeway Geotechnical Reports

Historical Landfills in North Kerry - Ahascra

Report No.: 18-1068b

Date: September 2019

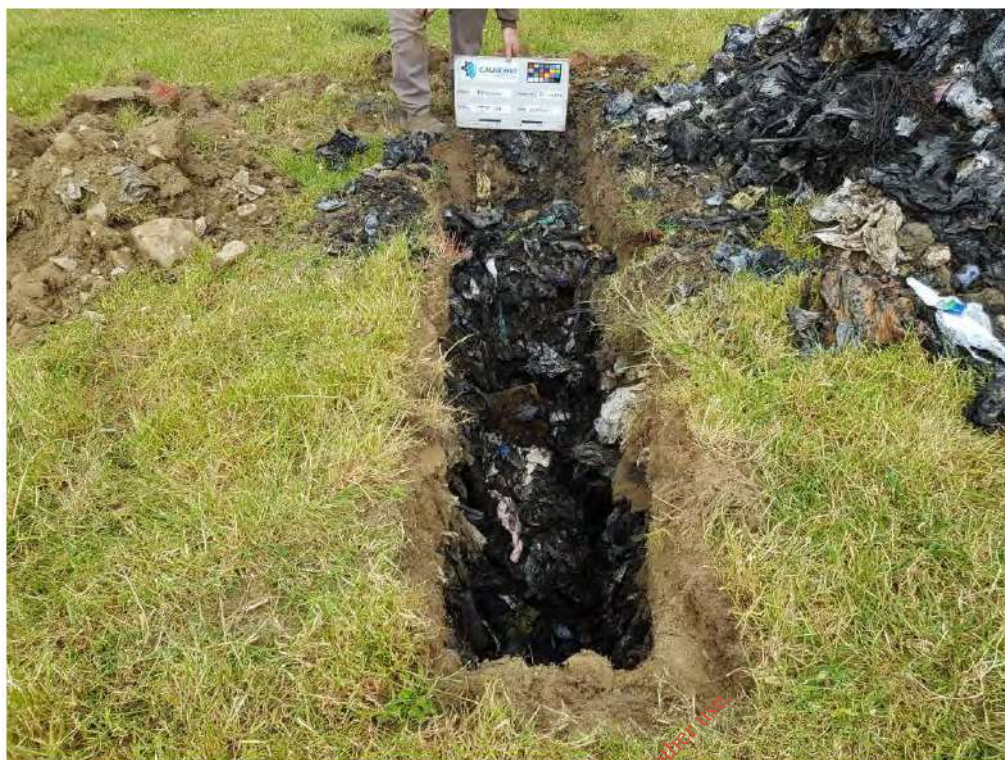
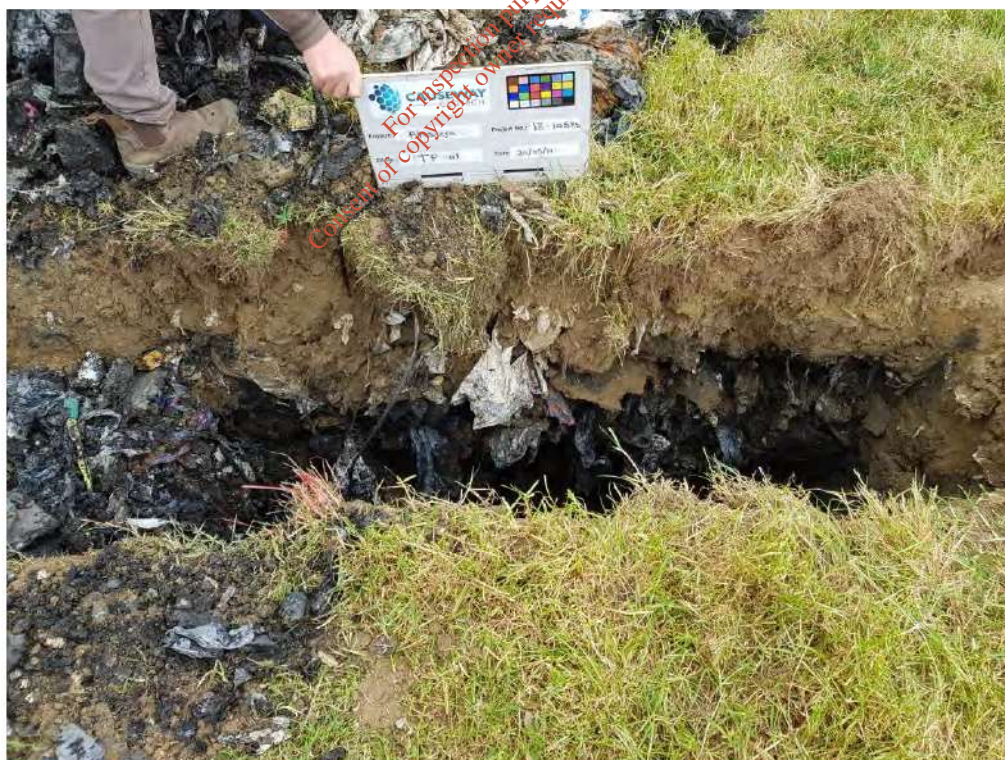
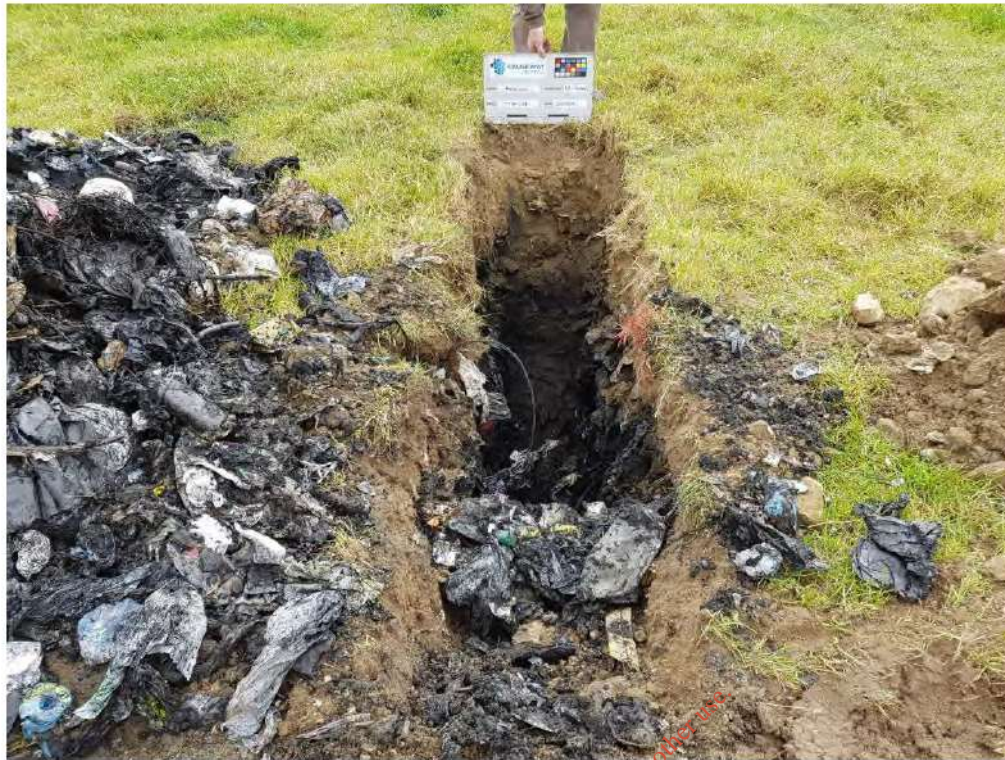
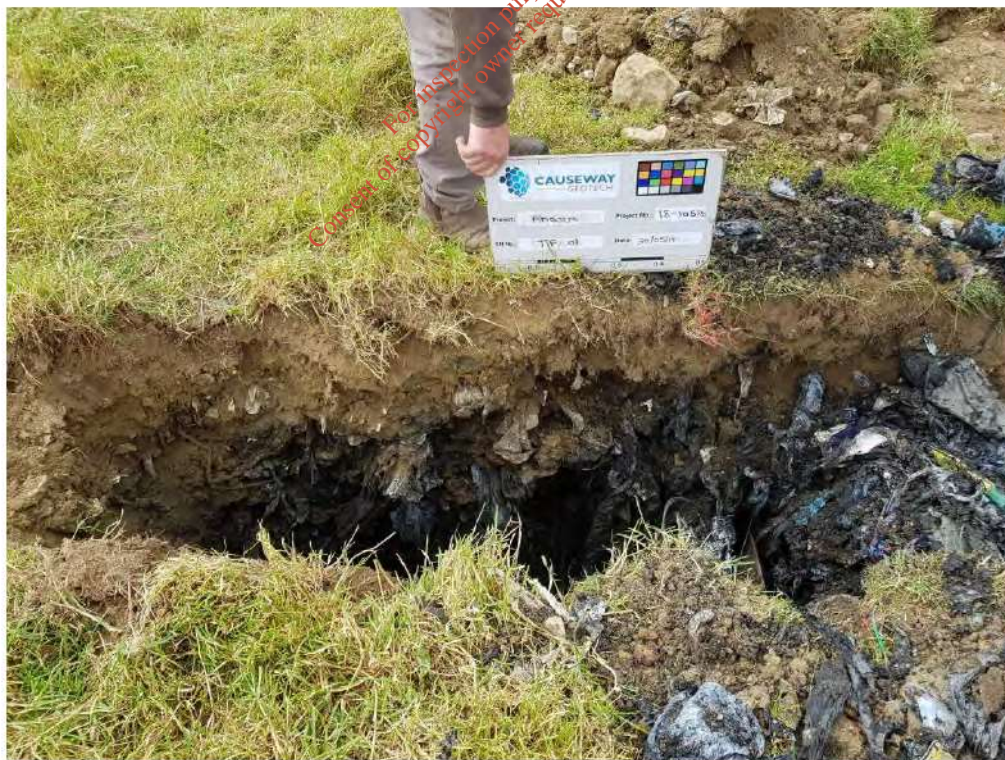
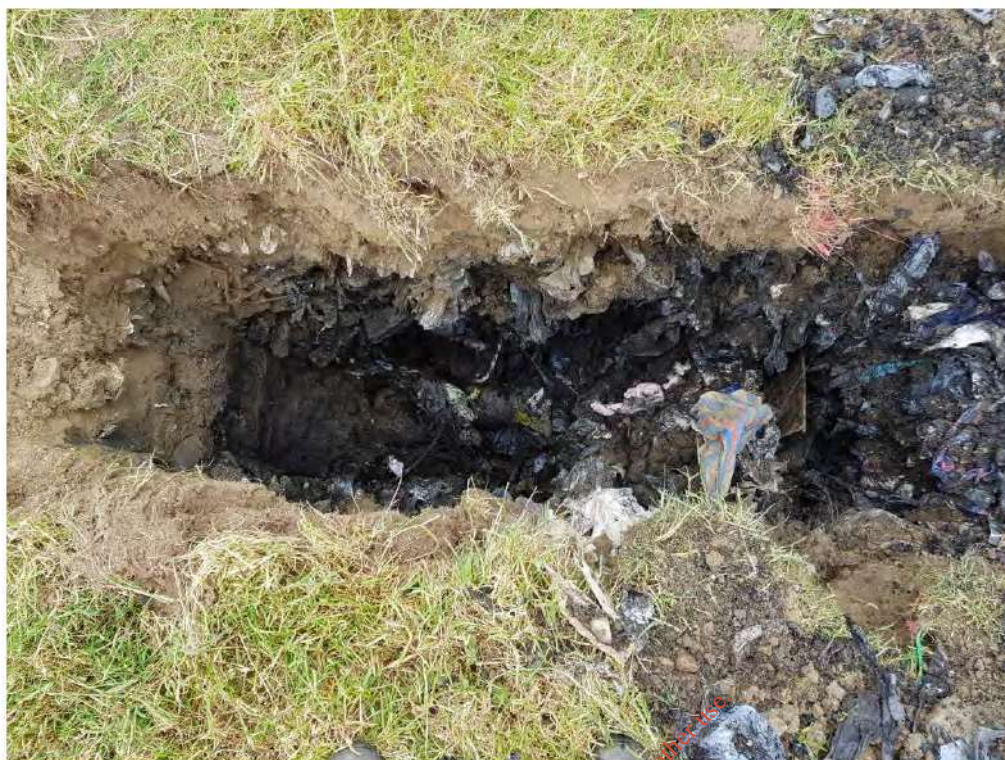
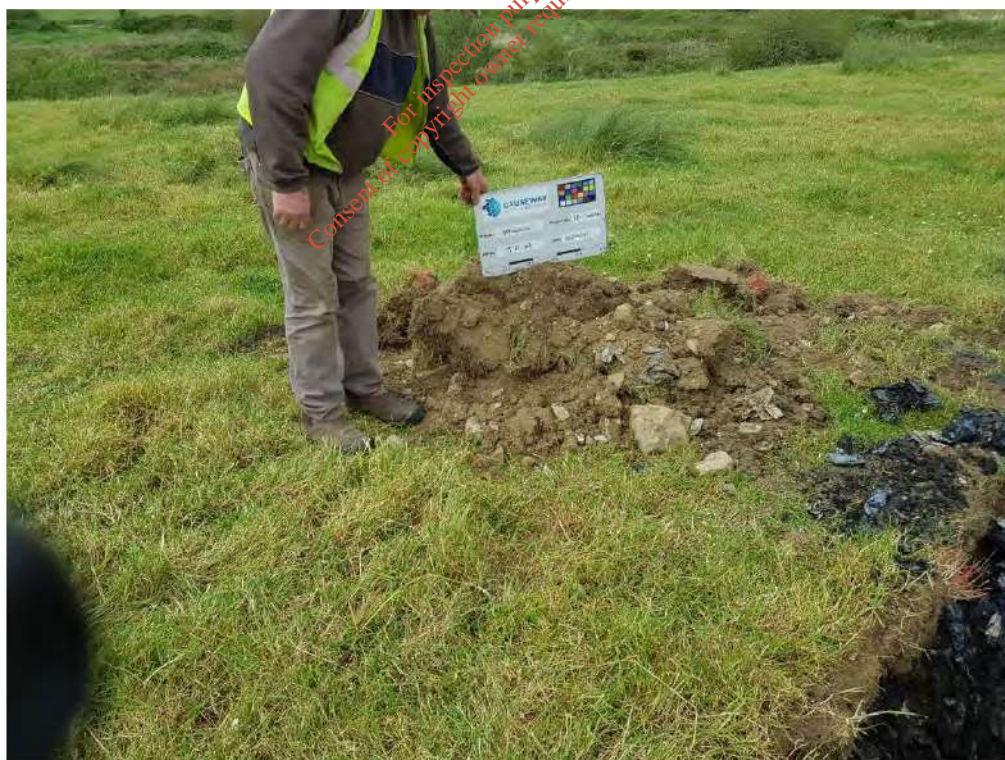
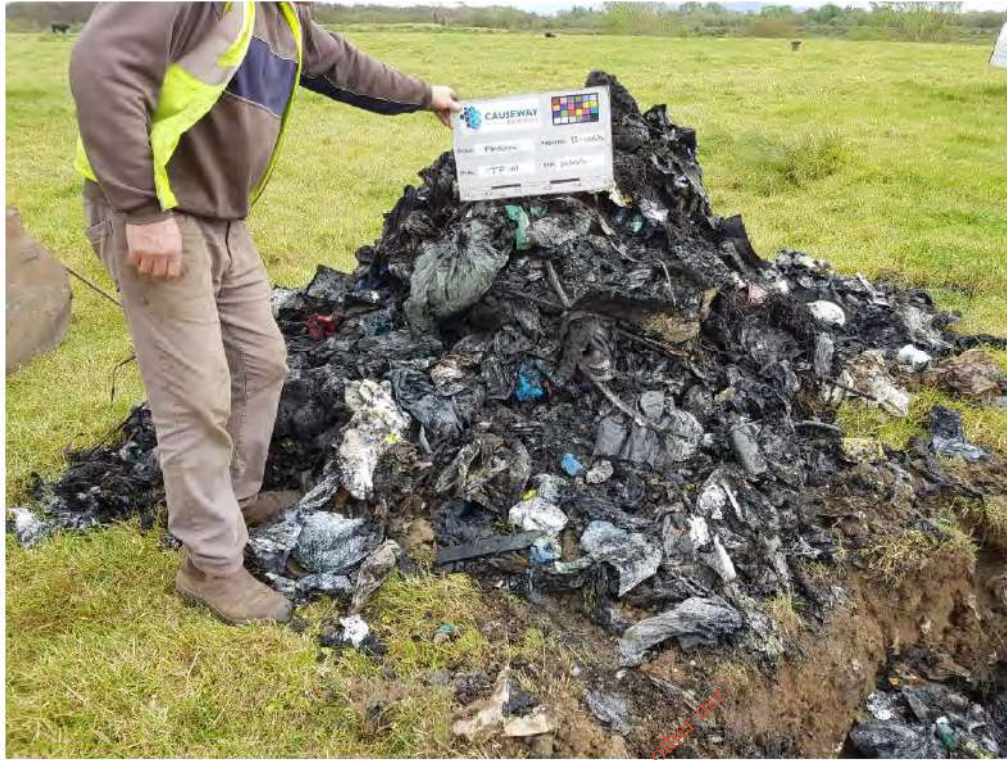
TP01 - NE Face

Remarks No groundwater encountered. Terminated due to >1.50m landfill material present.	Water Strikes:		Stability:
	Struck at (m):	Remarks:	Slightly unstable
			Width: 0.70
		Length: 2.90

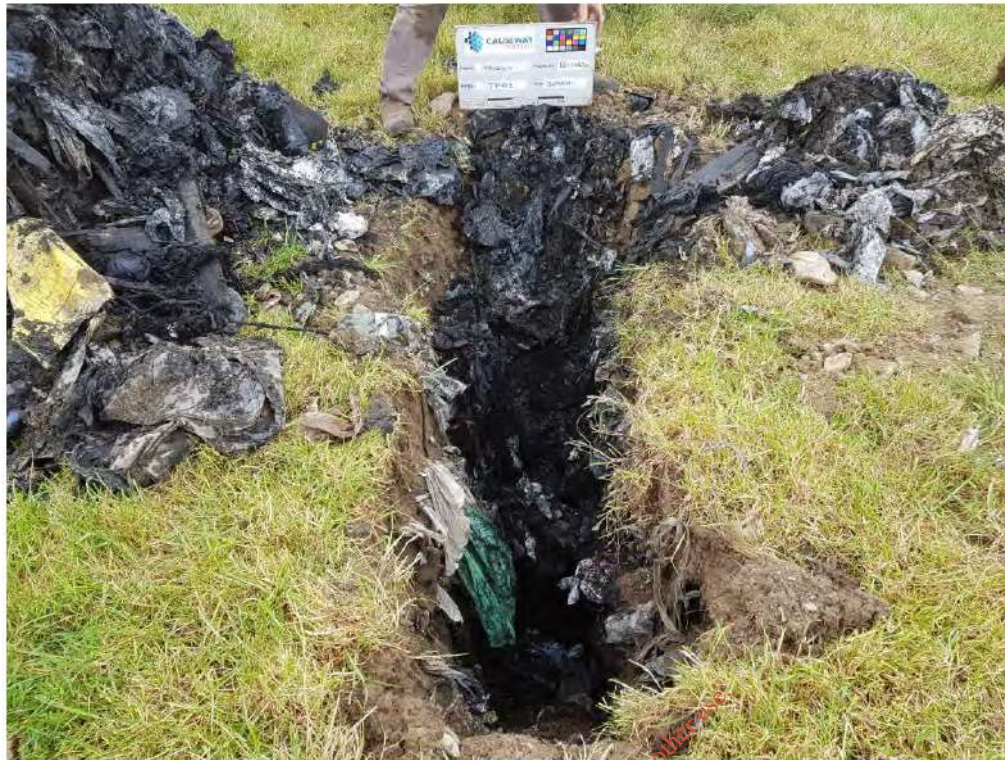
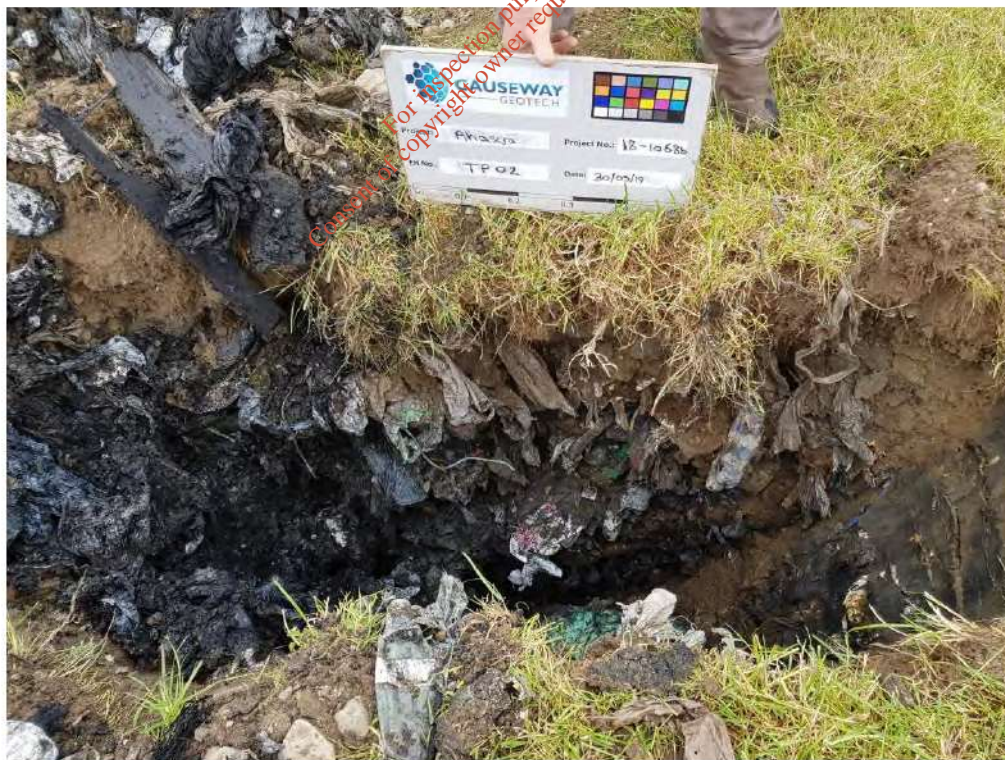
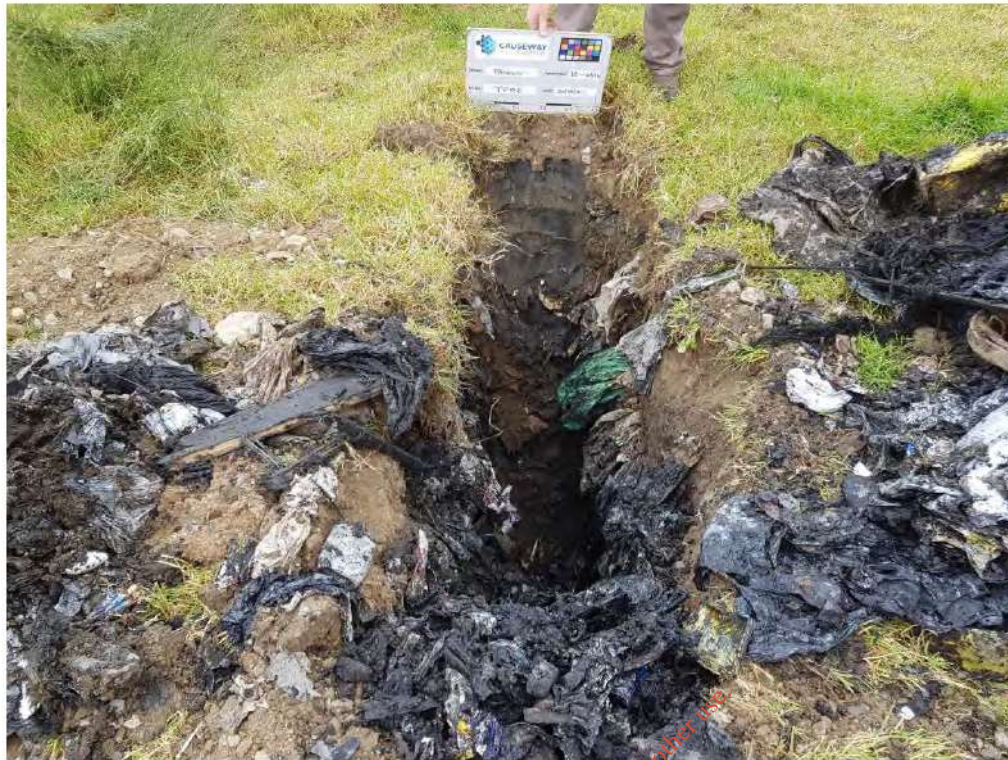
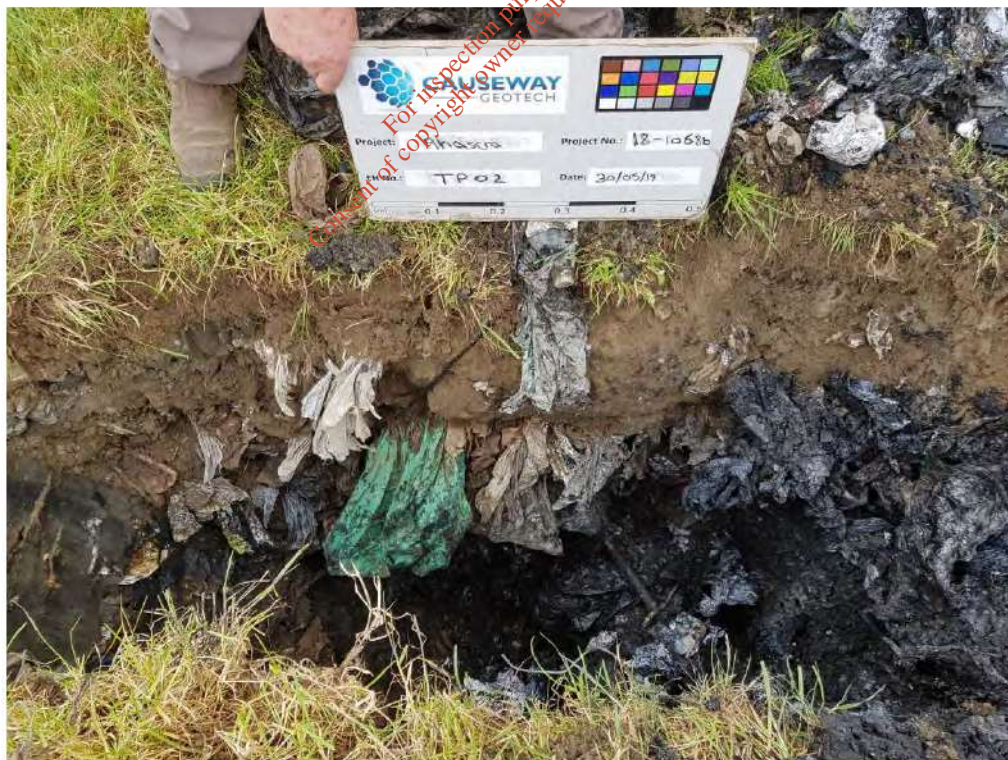
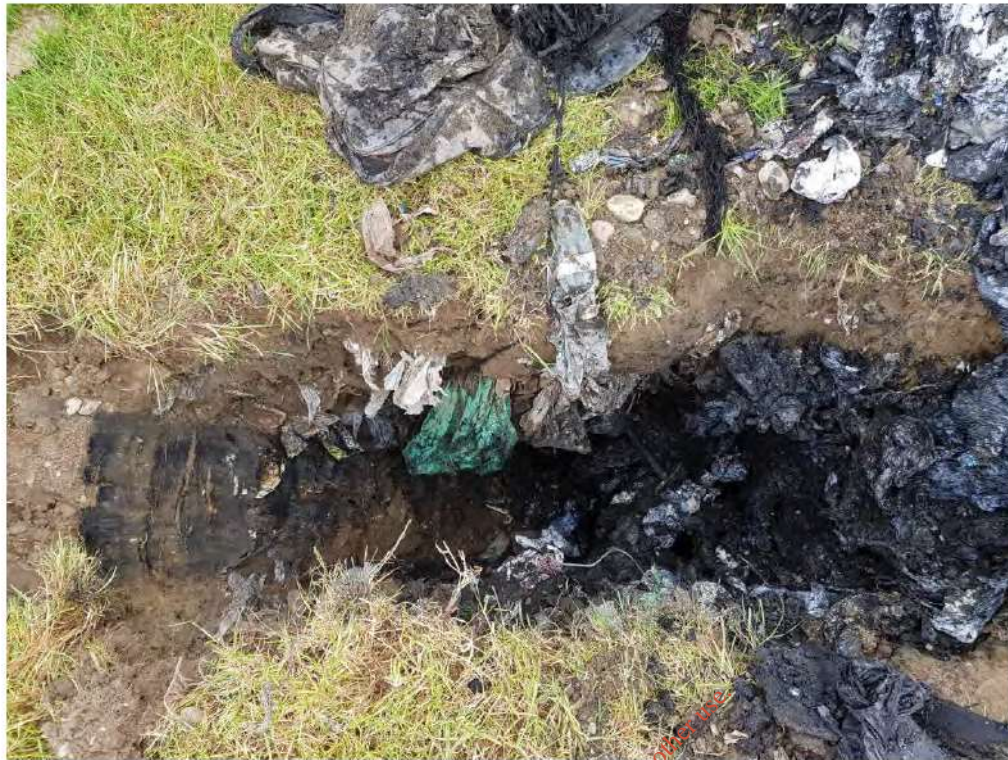
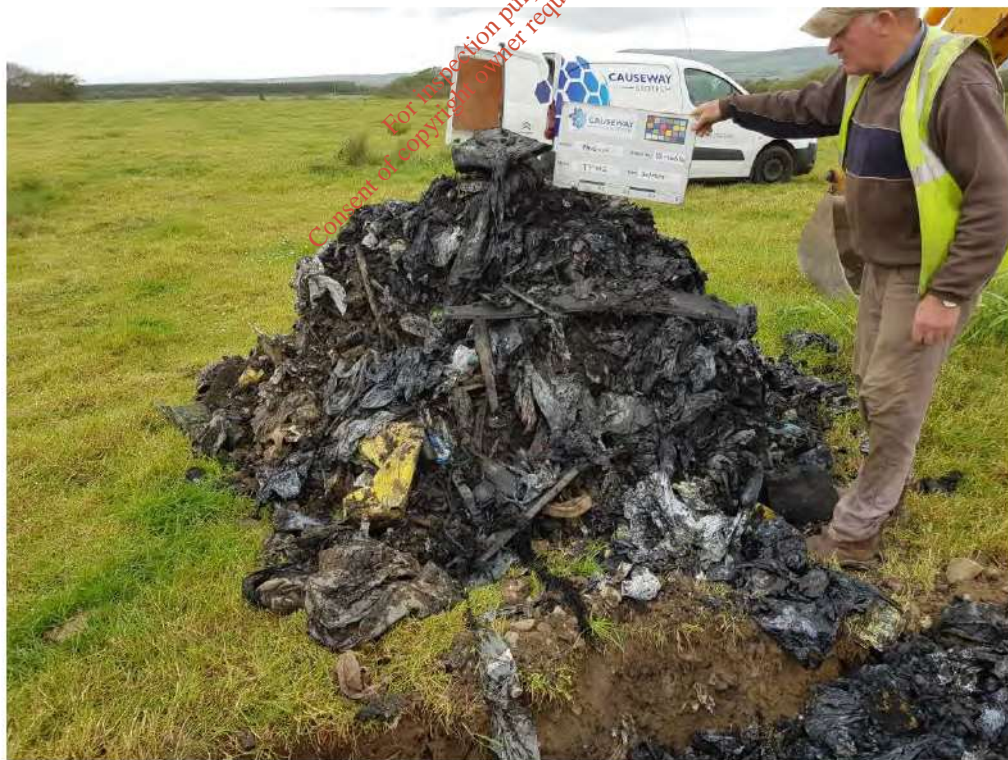
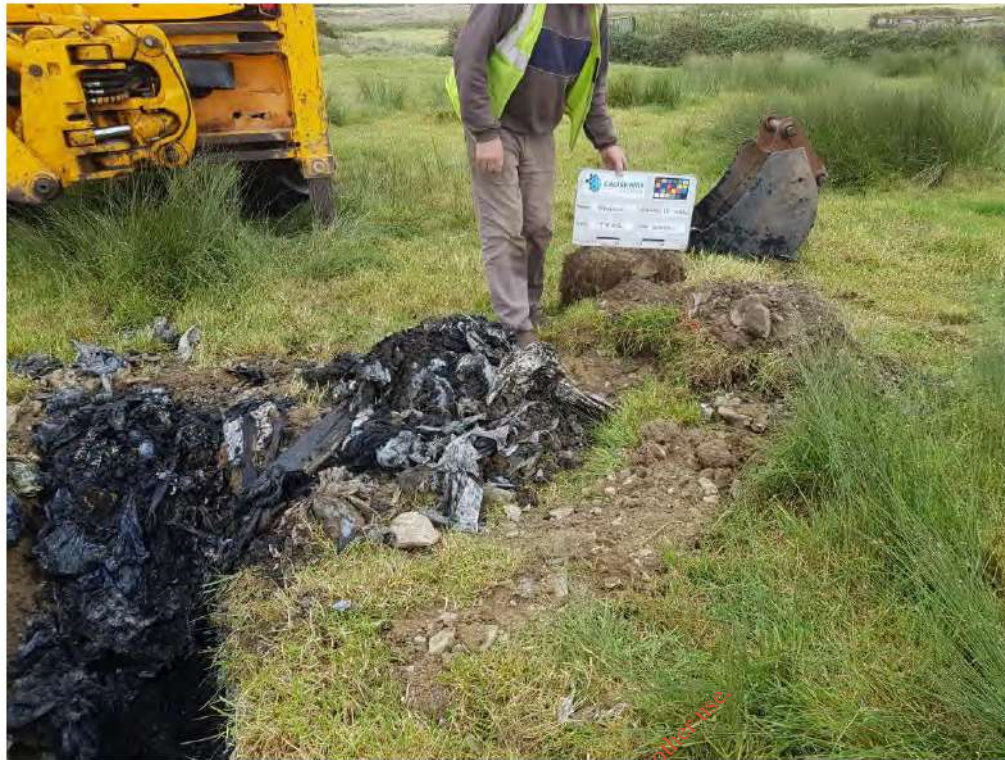
TP02 – ENE Face

Remarks No groundwater encountered. Terminated due to >1.50m landfill material present.	Water Strikes:		Stability: Stable
	Struck at (m):	Remarks:	
			Width: 0.80 Length: 2.20

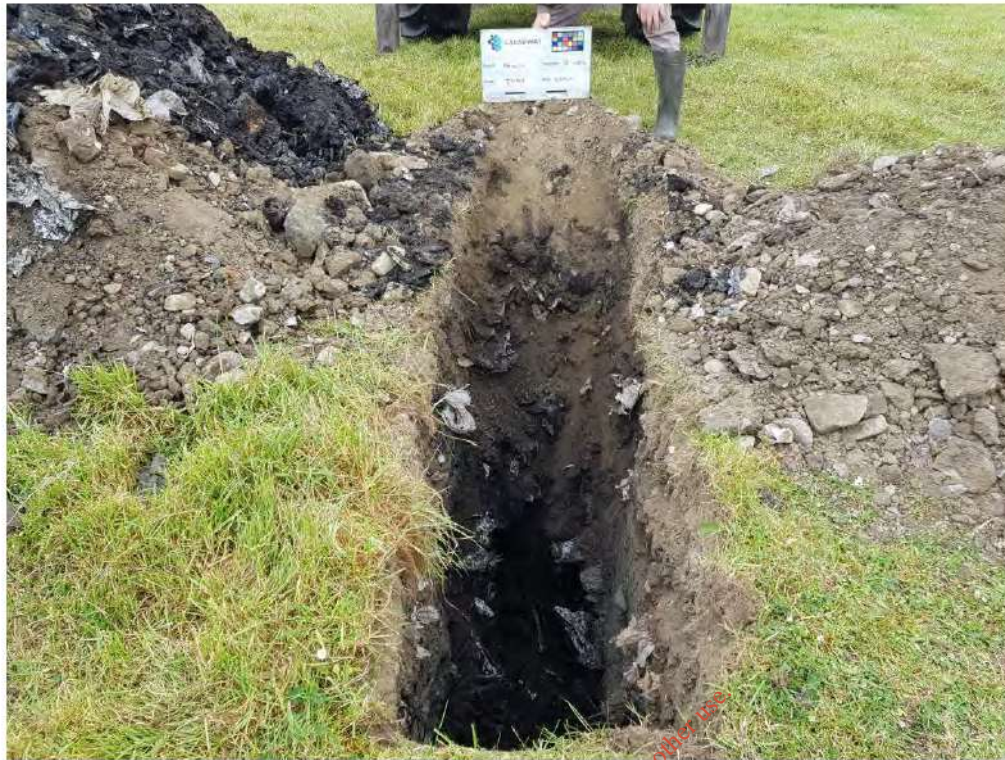
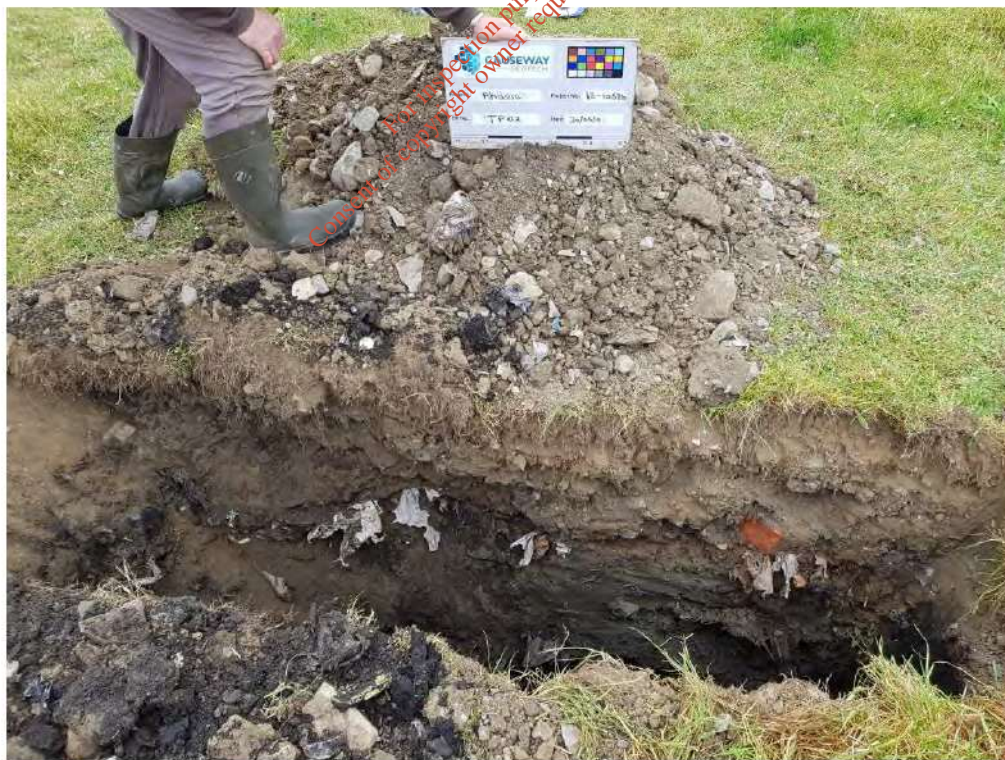
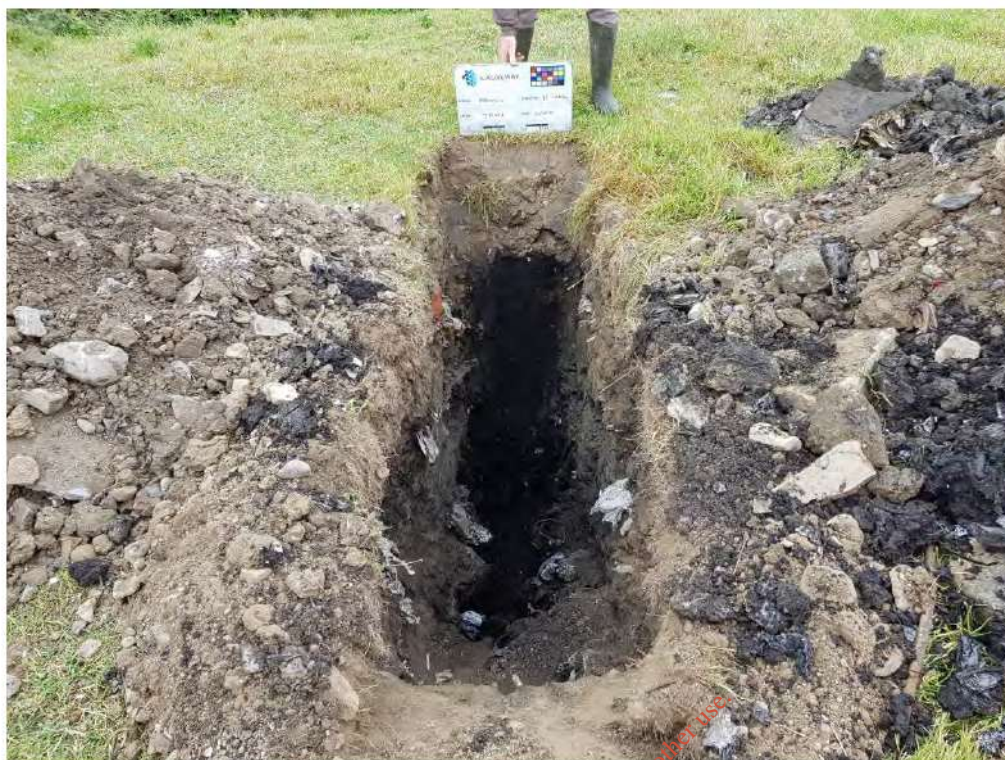
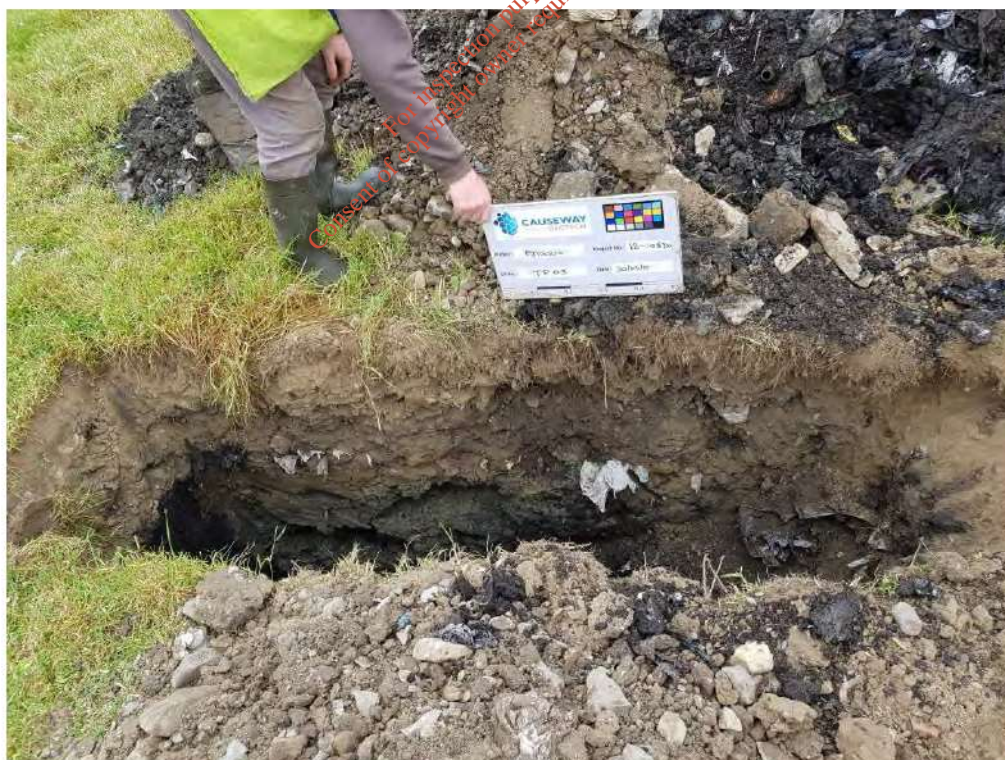
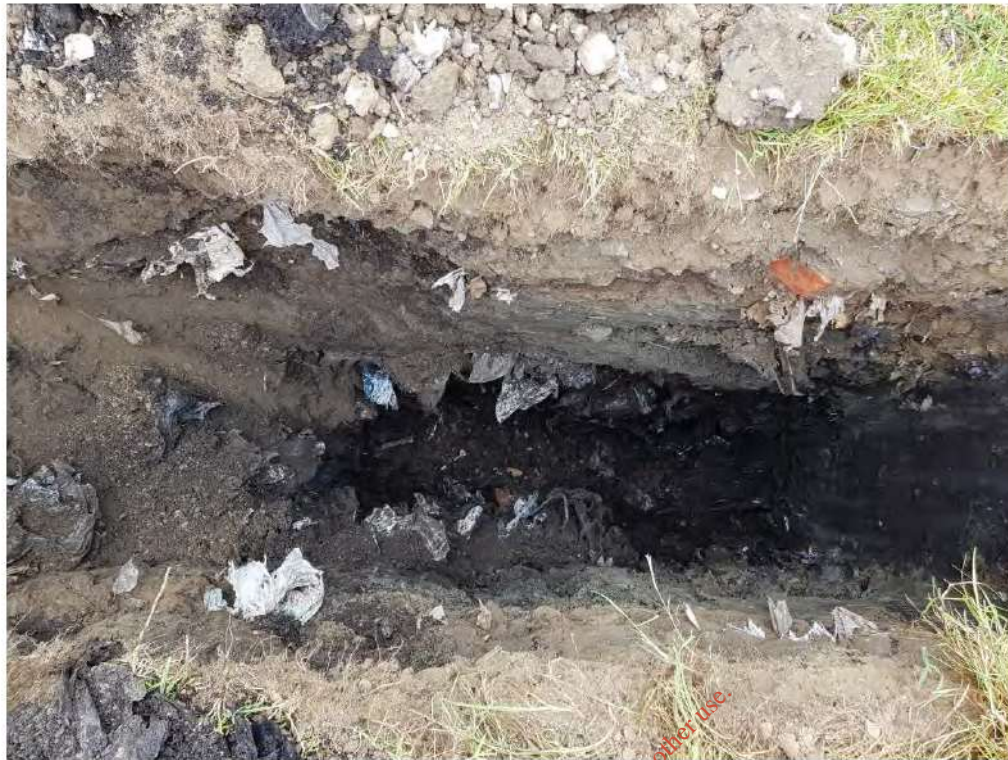
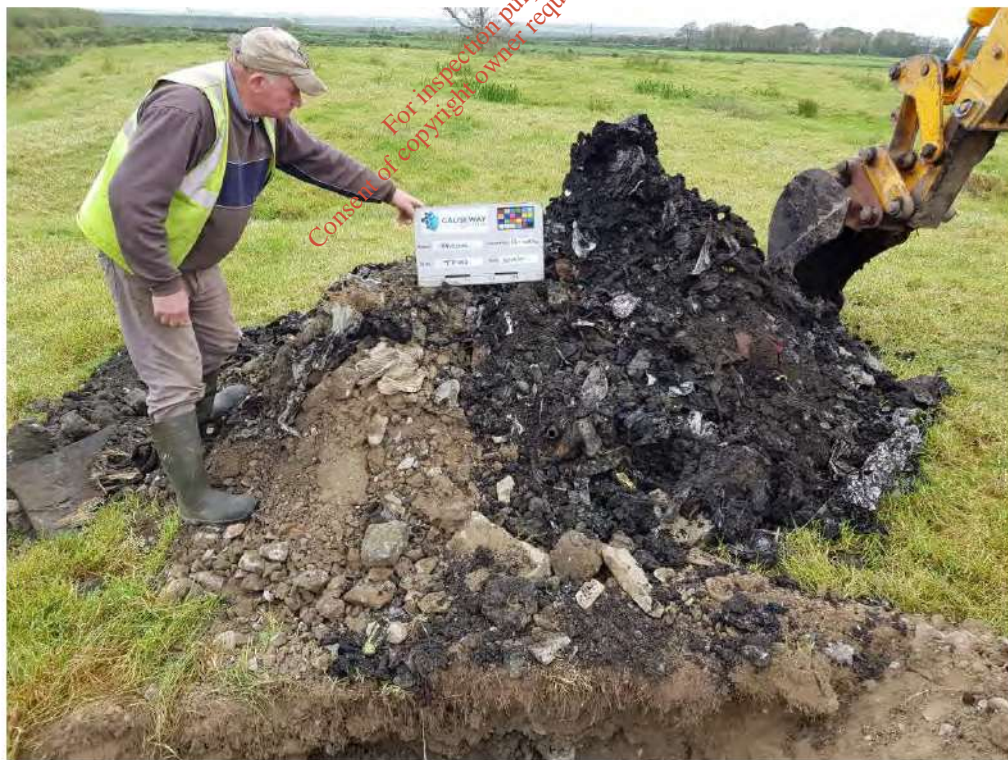
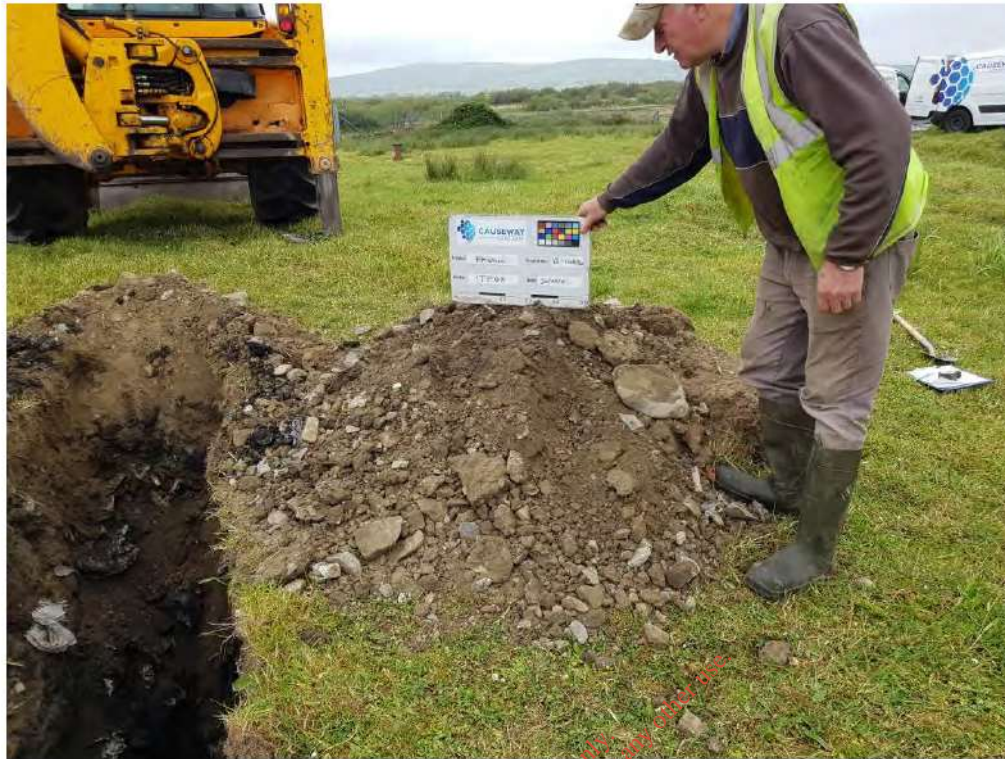
TP03 – NNW Face

Remarks No groundwater encountered. Terminated due to >1.50m landfill material present.	Water Strikes:		Stability: Stable
	Struck at (m):	Remarks:	
			Width: 0.80 Length: 2.80

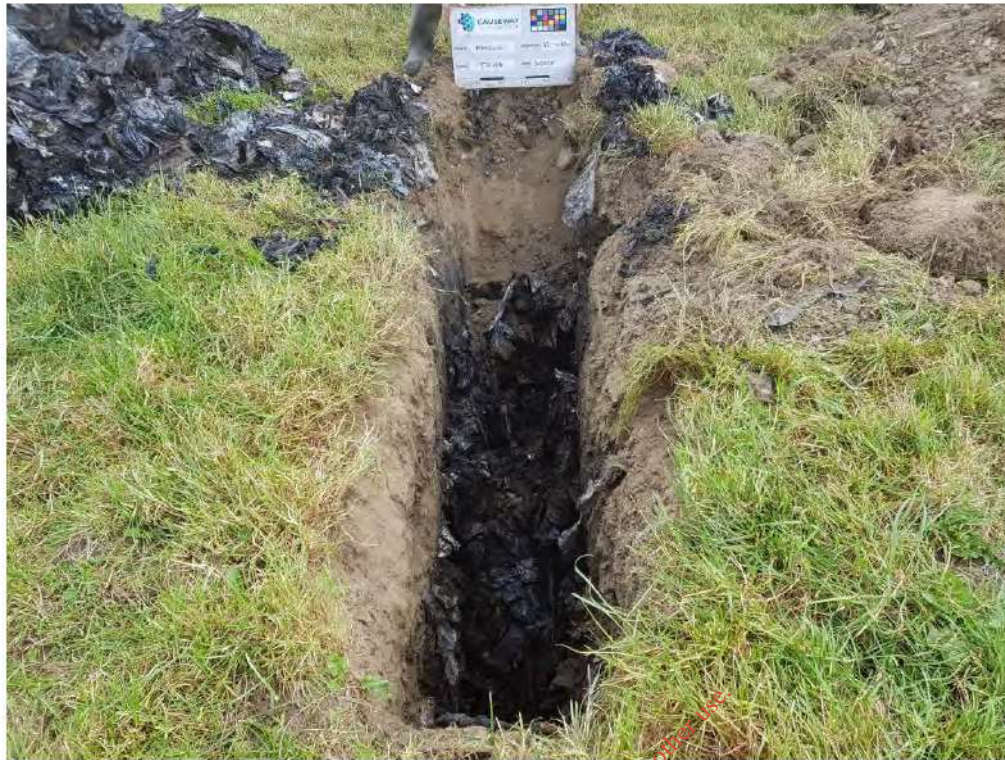
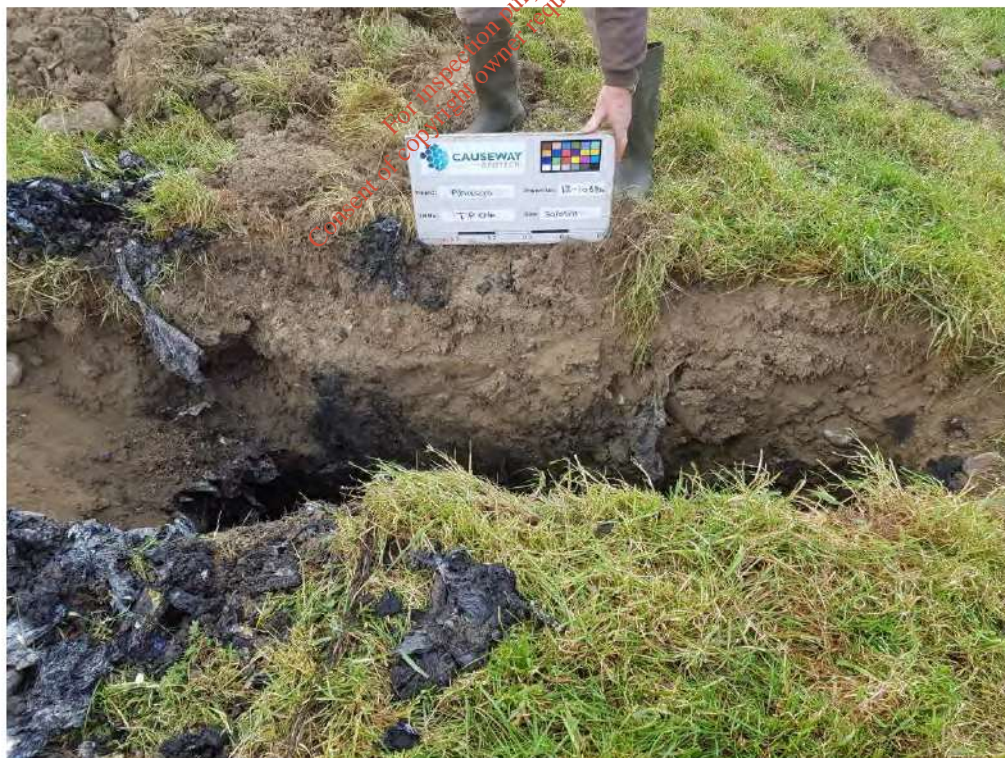
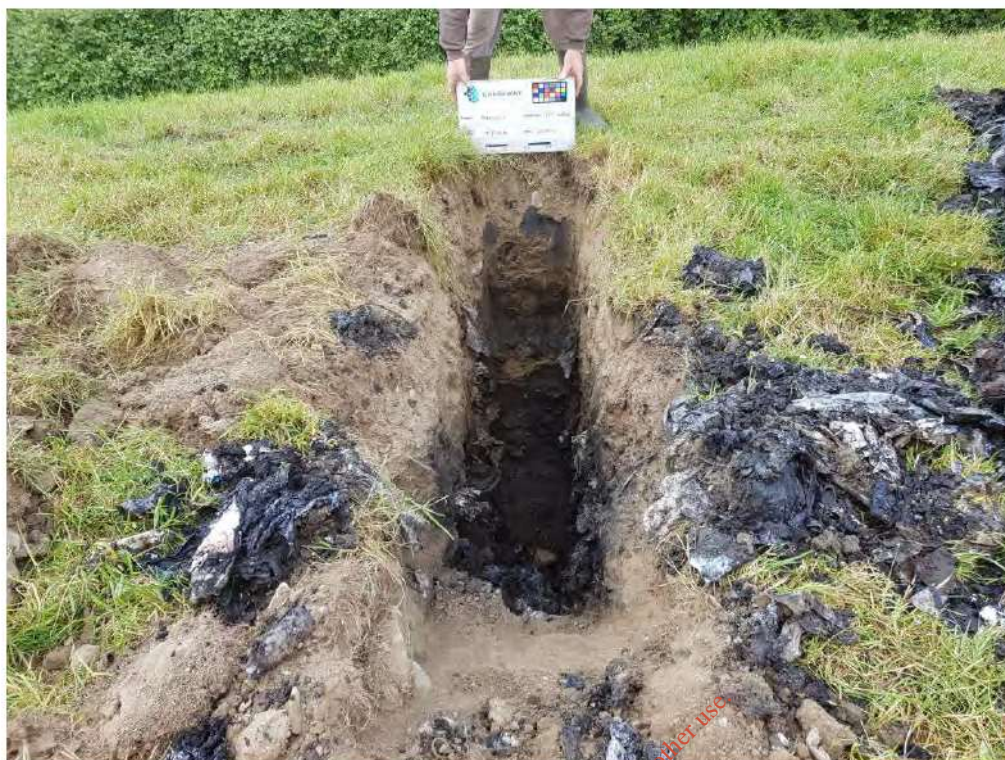
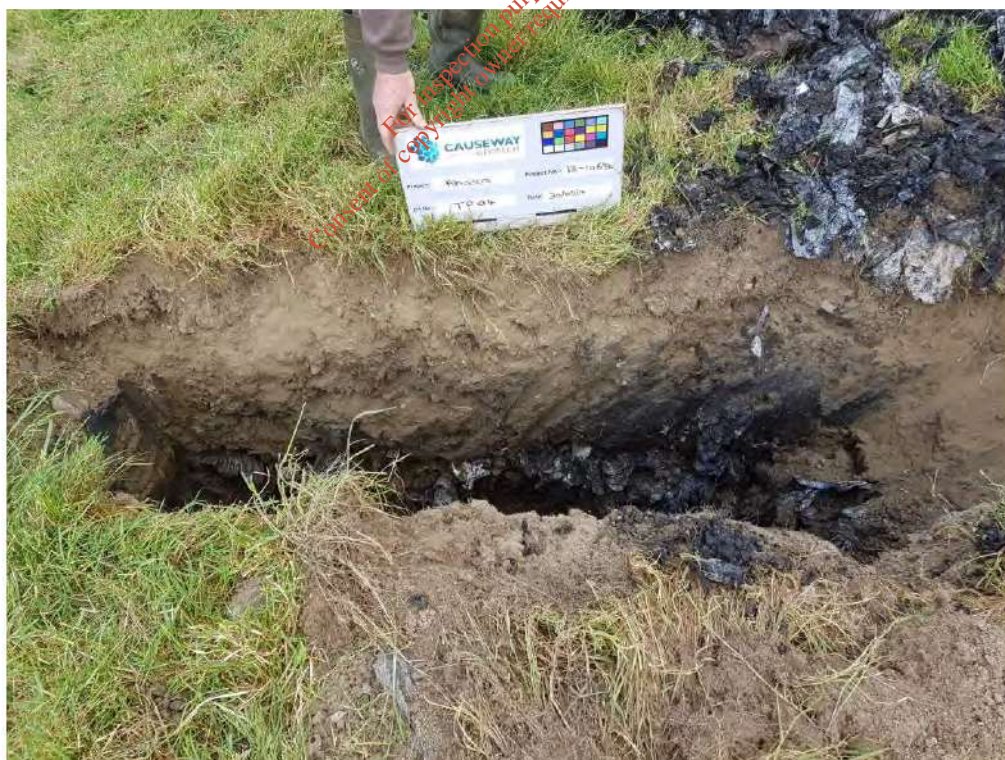
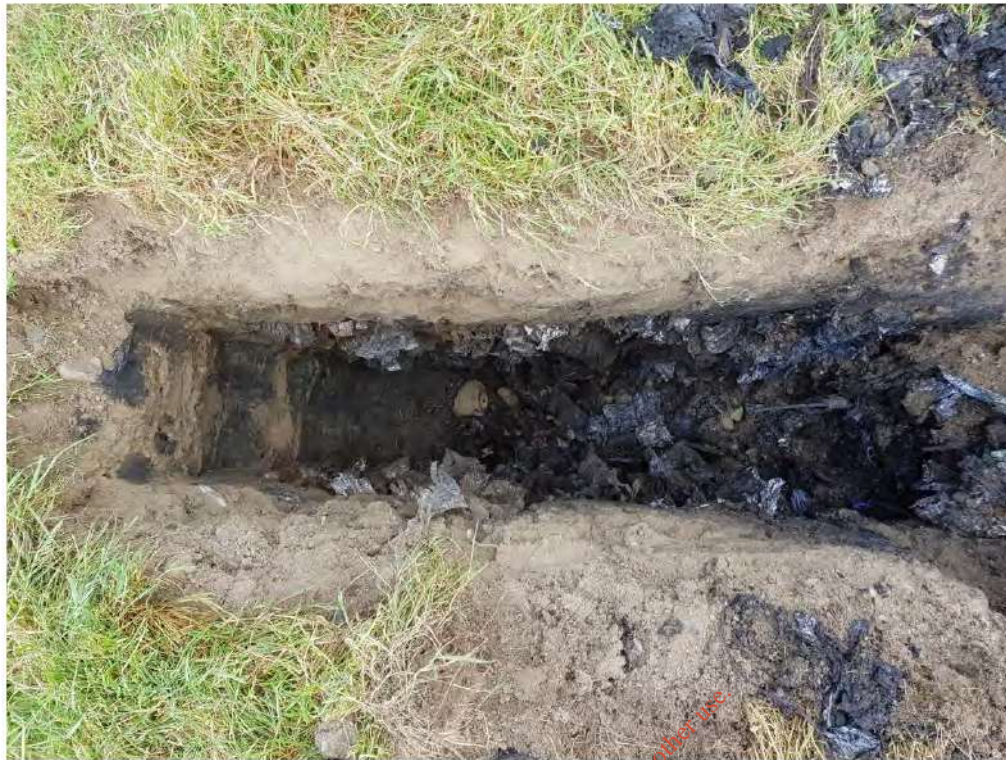
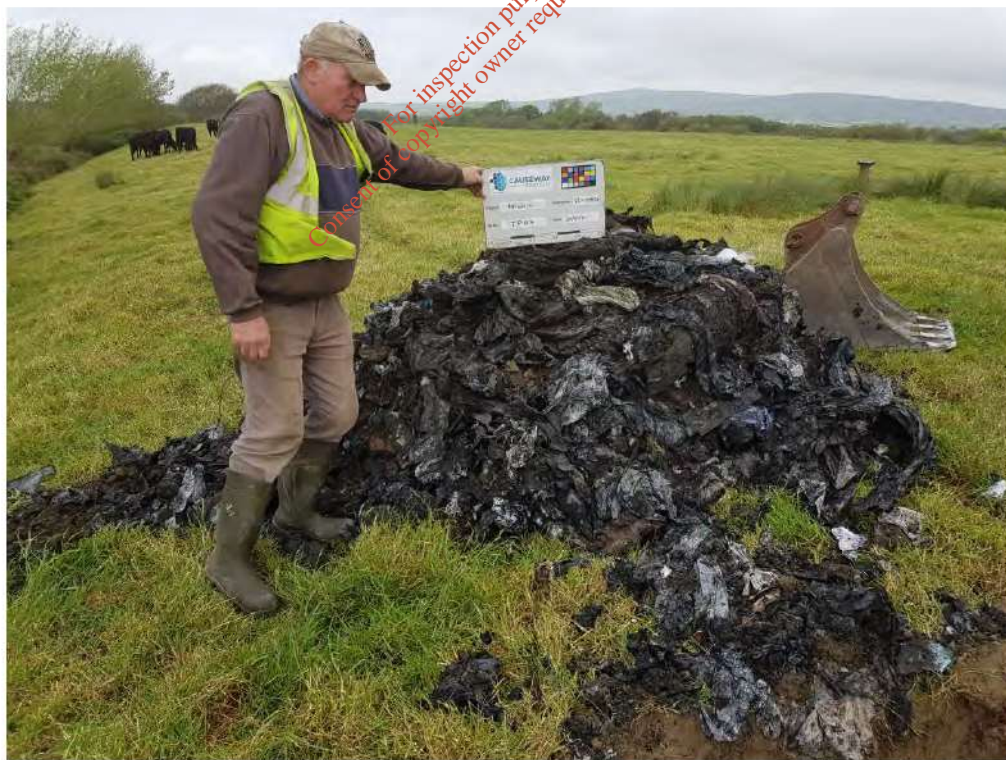
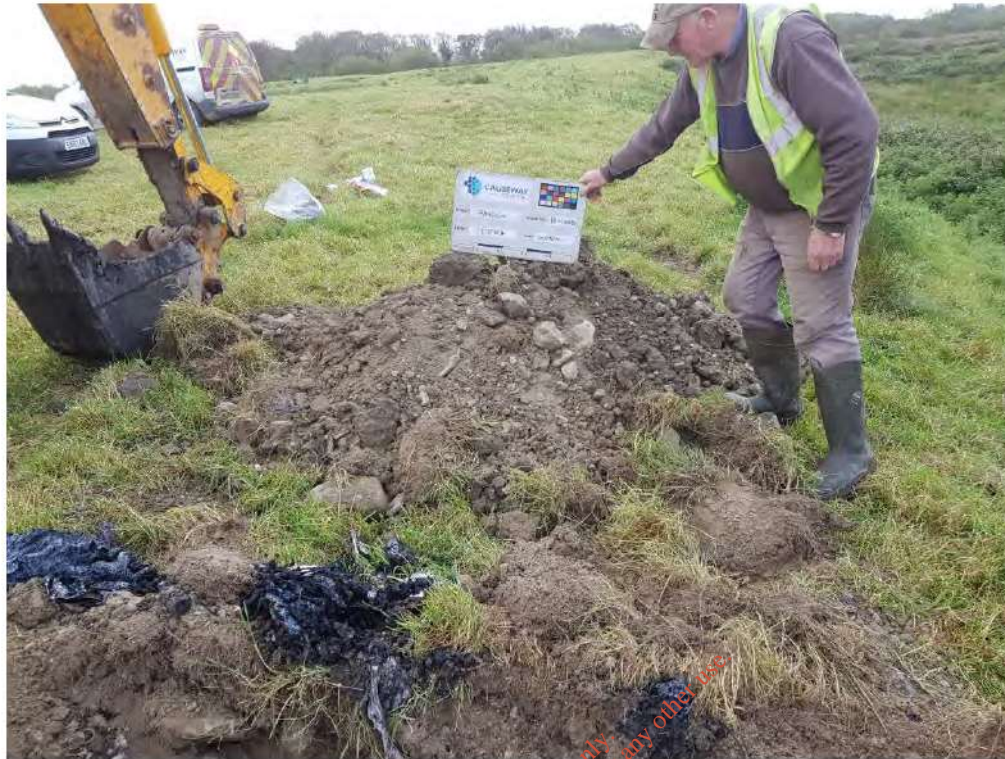
TP04 – ENE Face

Remarks No groundwater encountered. Terminated due to >1.50m landfill material present.	Water Strikes:		Stability: Stable
	Struck at (m):	Remarks:	
			Width: 0.70 Length: 2.90
