Causeway Geotechnical Reports

Historical Landfills in North Kerry - Ahascra

Report No.: 18-1068b

Date: September 2019

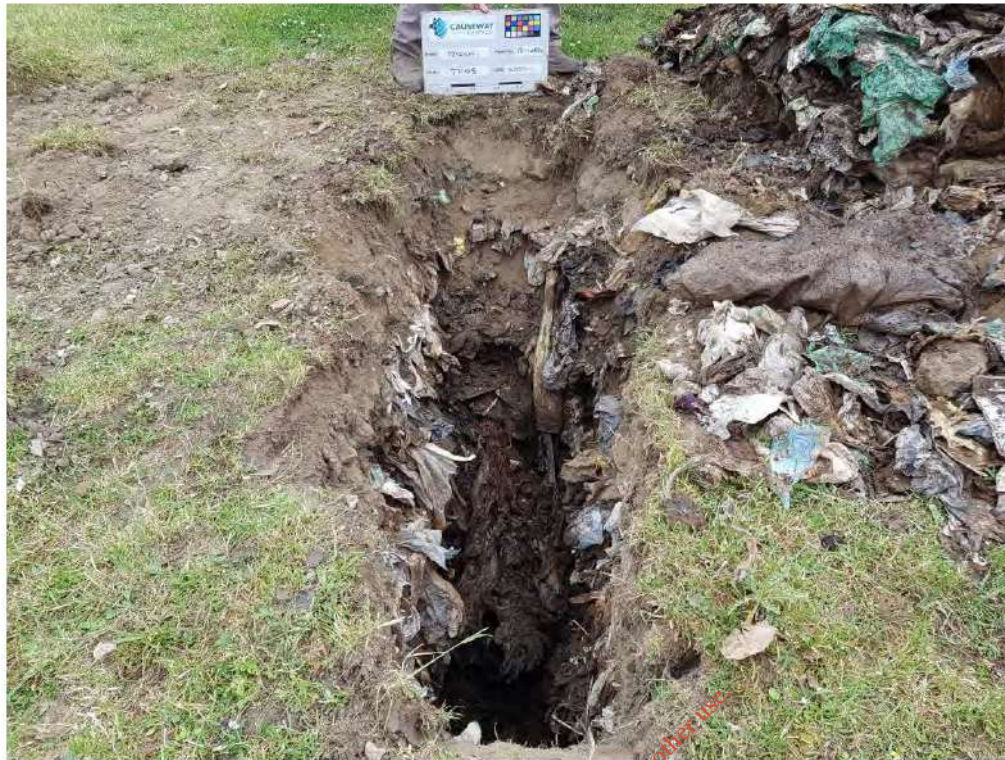
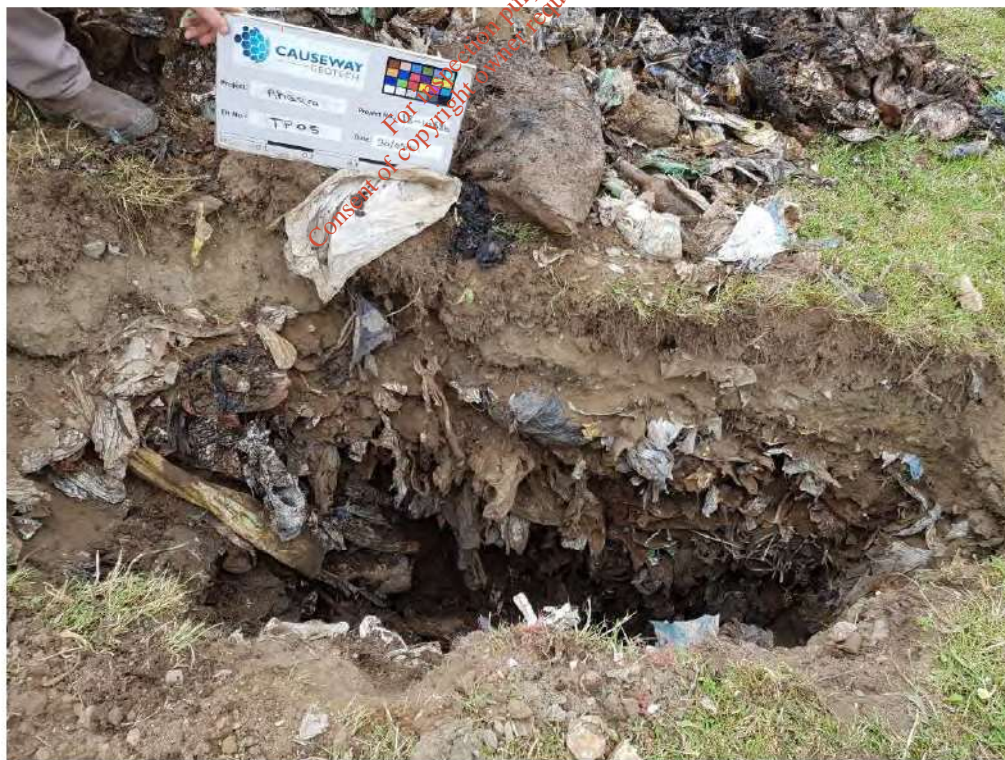
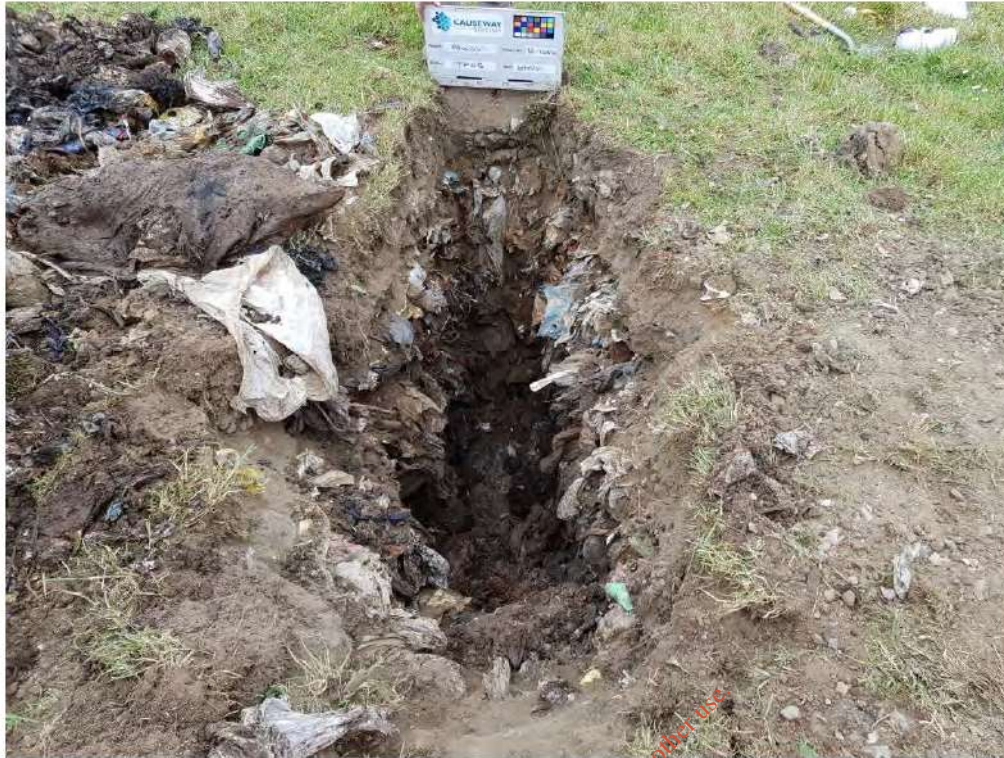
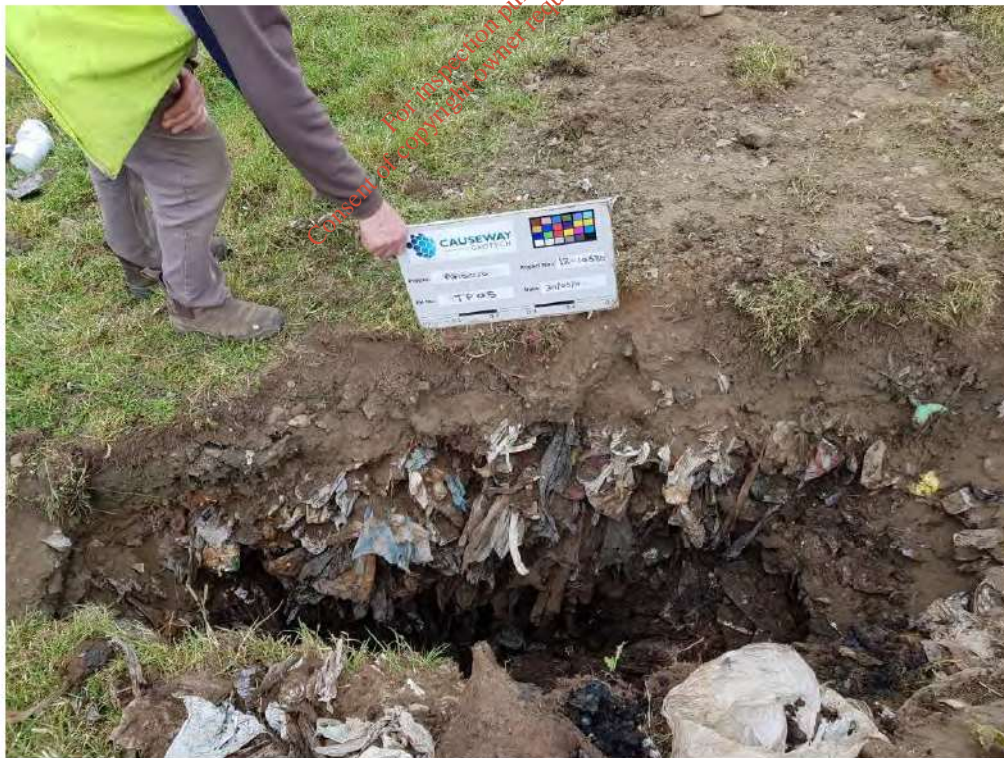
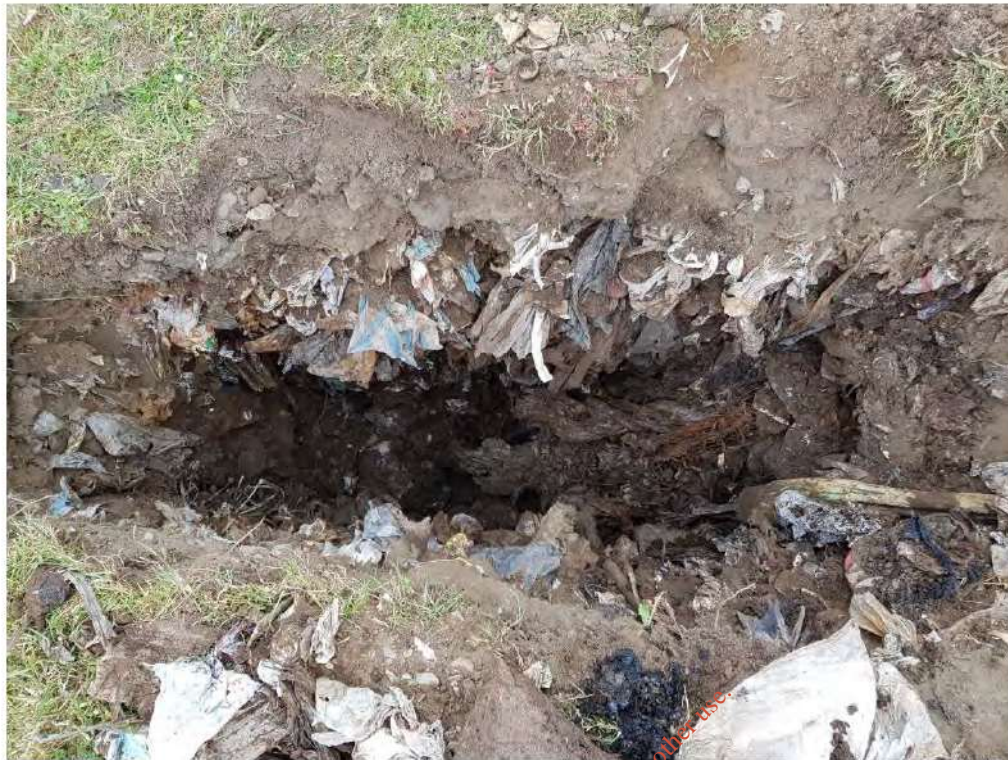
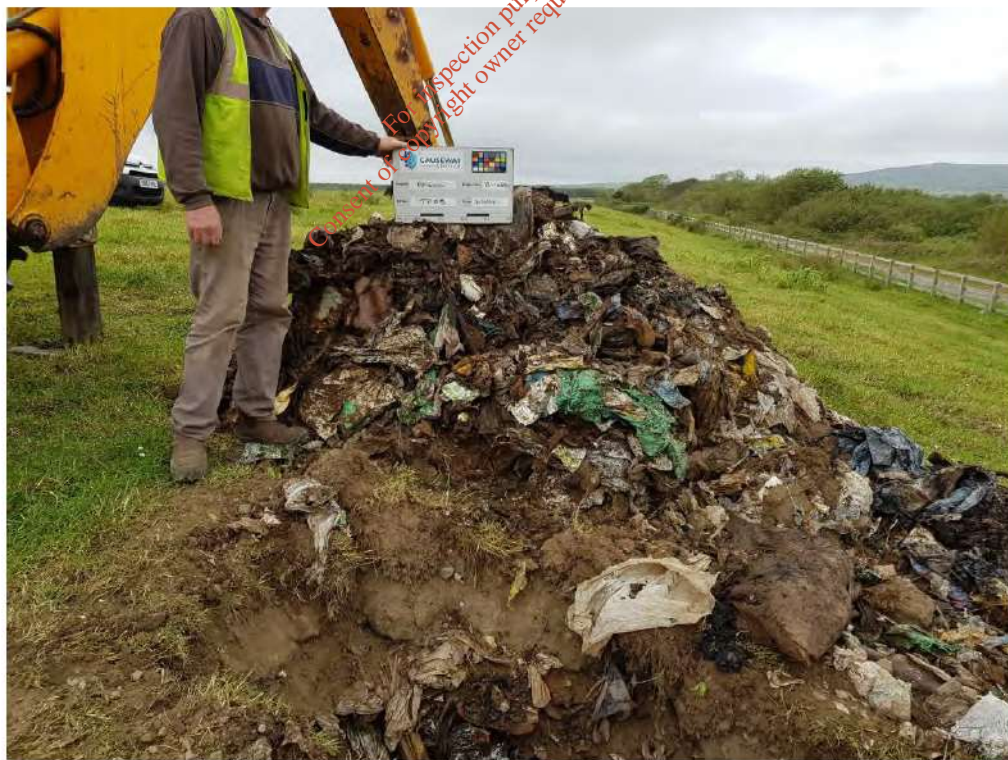
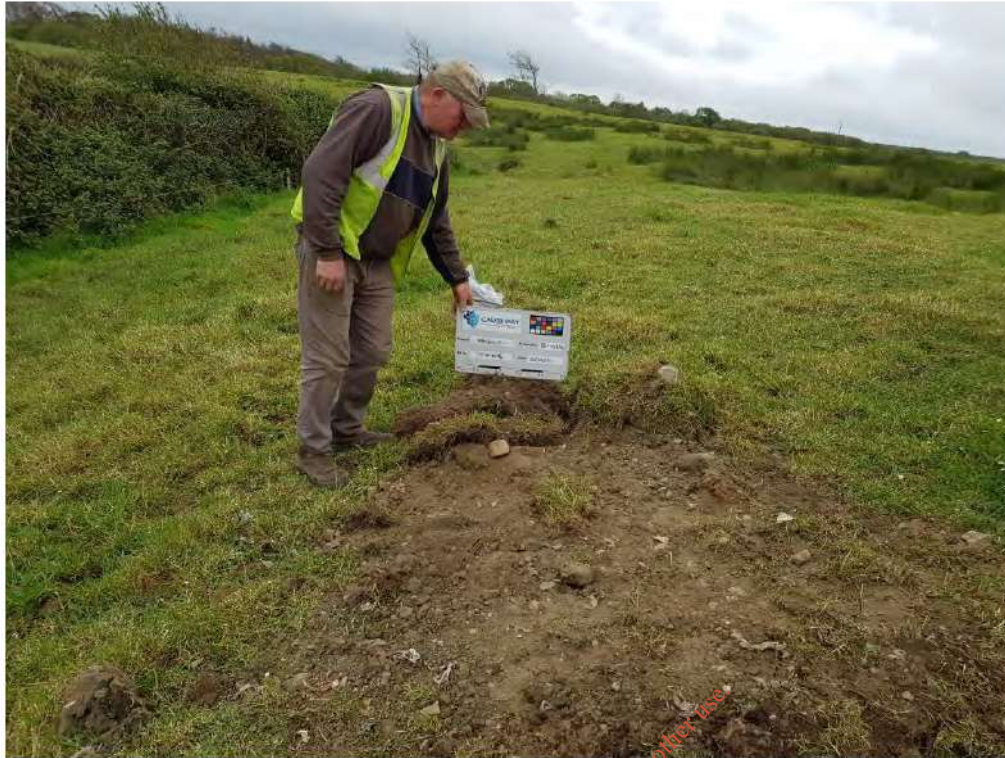
TP05 - W Face

Remarks No groundwater encountered. Terminated due to >1.50m landfill material present.	Water Strikes:		Stability:
	Struck at (m):	Remarks:	Slightly unstable
			Width: 1.10
			Length: 2.60
