TIER 2 RISK ASSESSMENT HISTORIC LANDFILL AT AHASCRA, CO. KERRY

Prepared for: Kerry County Council

Date: August 2021

Abstract: This report represents the findings of a Tier 2 risk assessment carried out at Ahascra Historic Landfill, Co. Kerry. The risk assessment was conducted in accordance with the EPA Code of Practice for unregulated landfill sites.

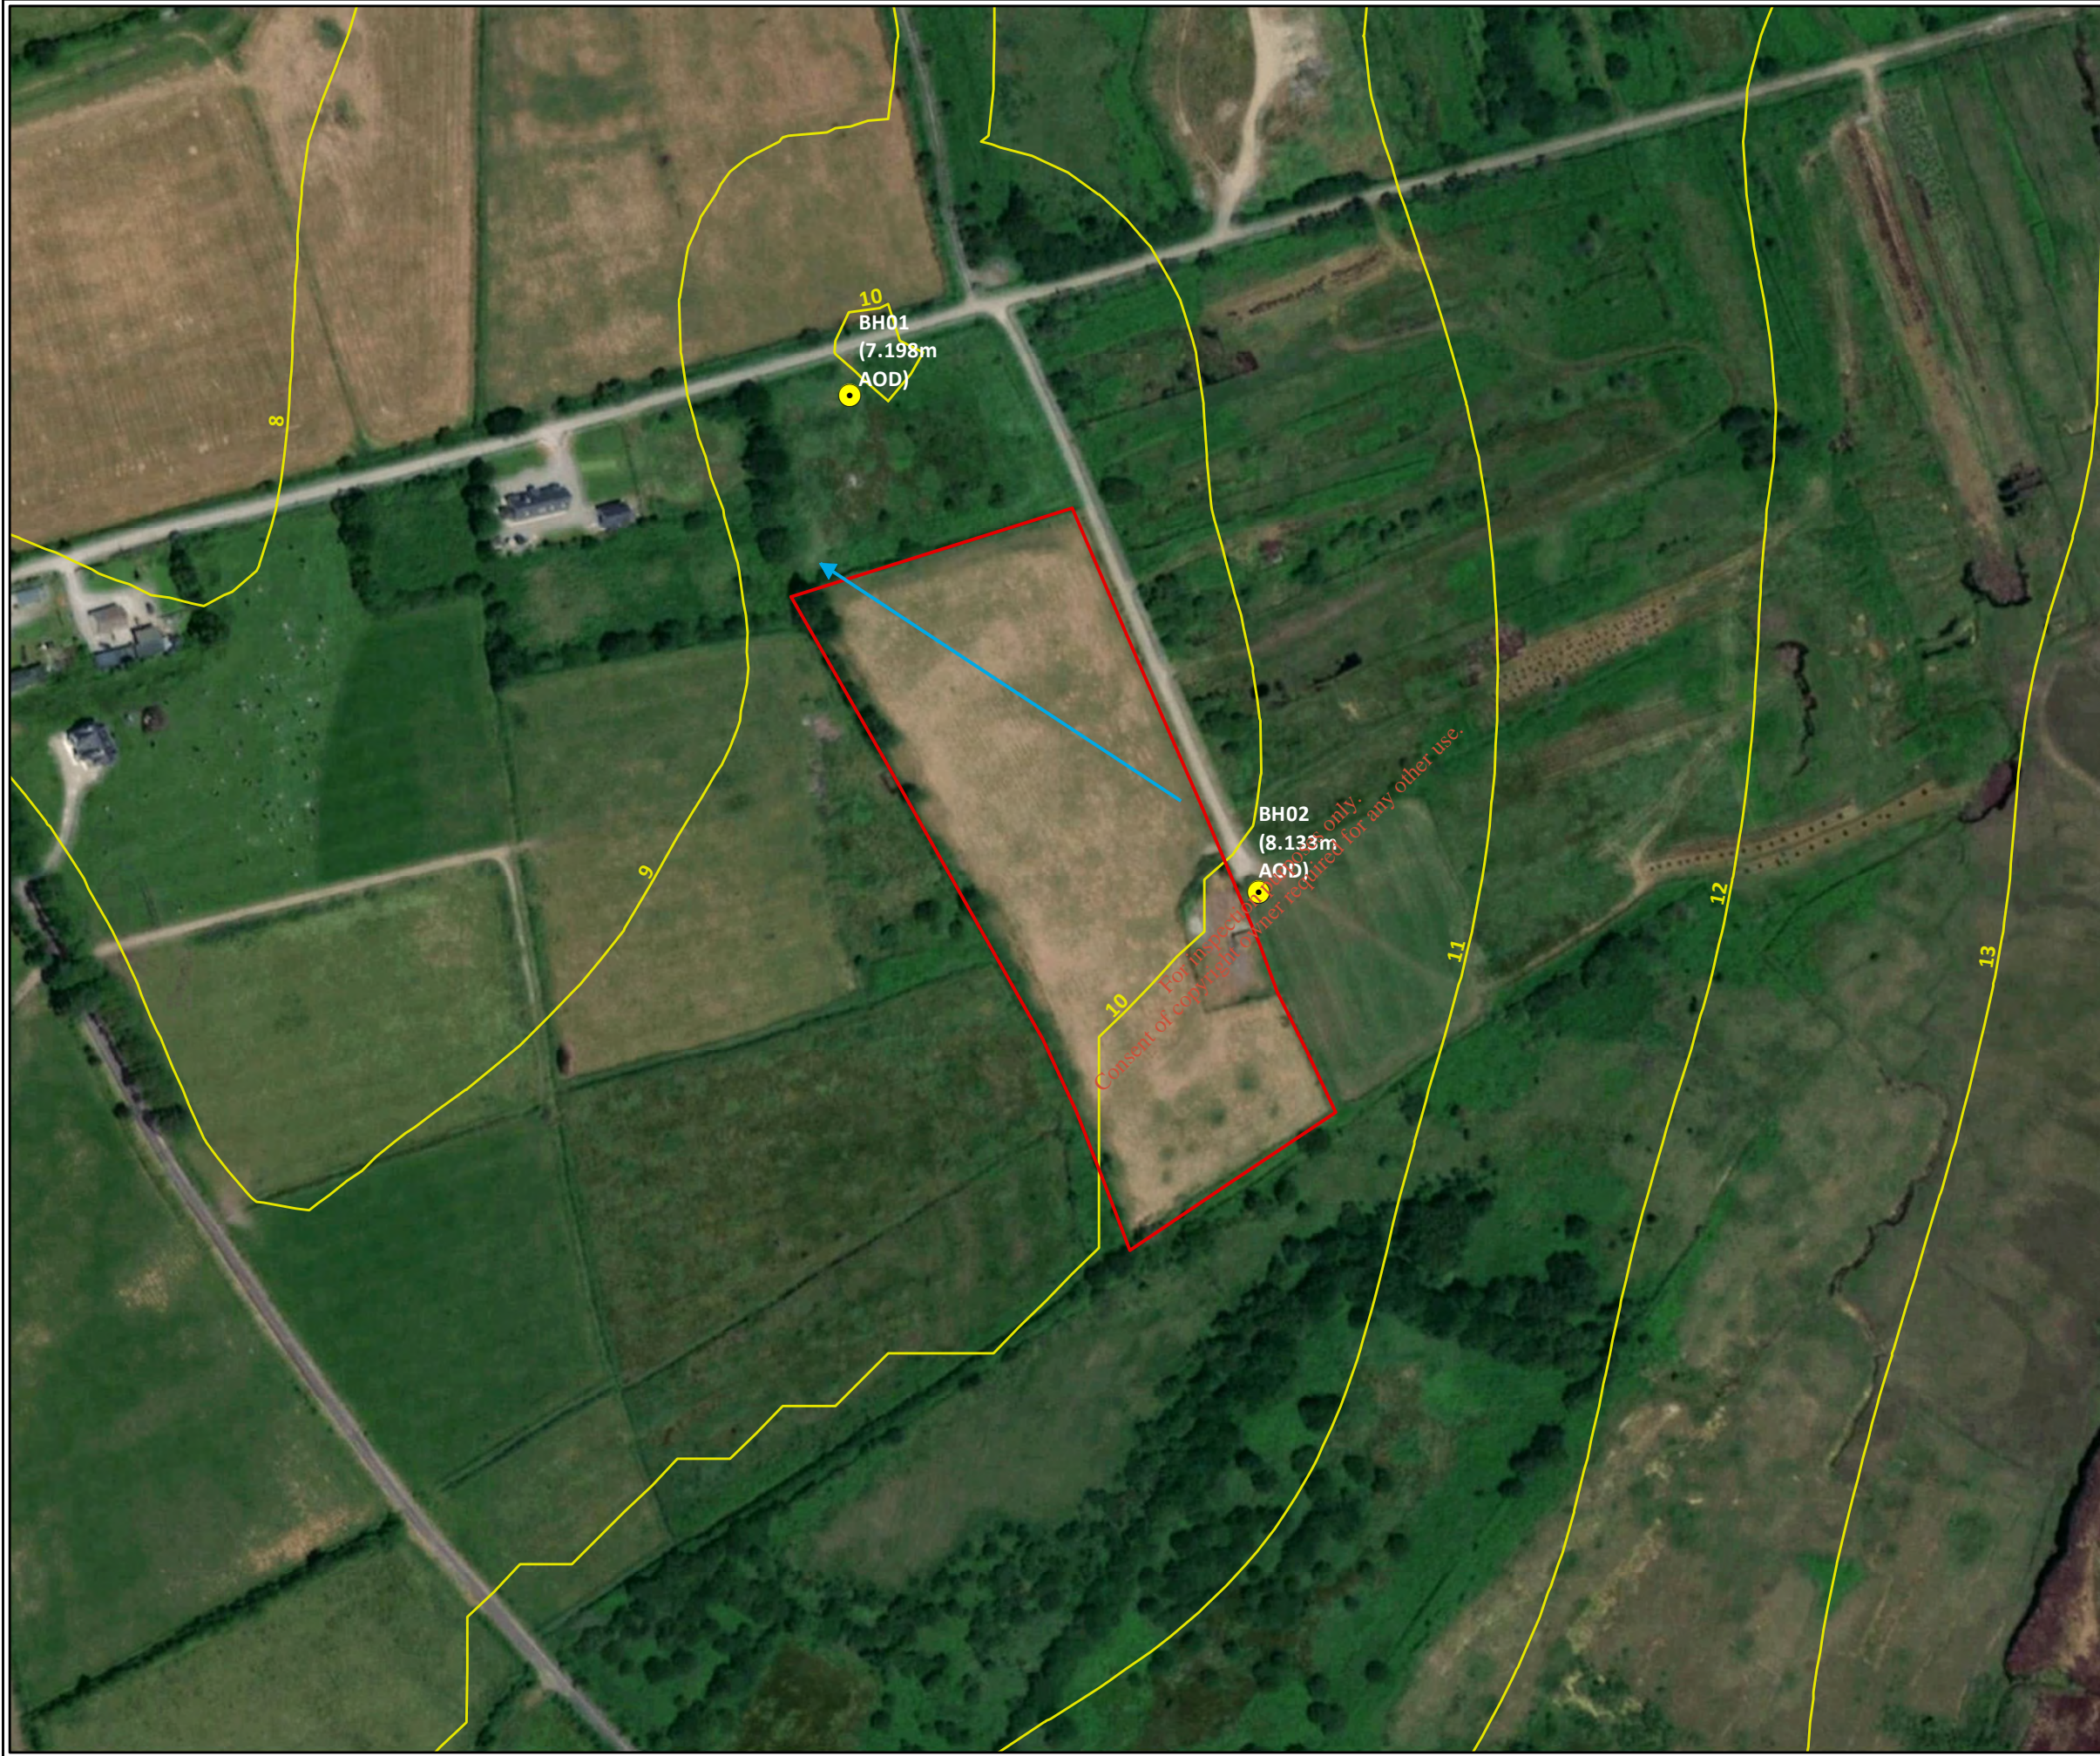
TITLE:	Groundwater Flow Direction	
PROJECT:	Ahascra Landfill, Co. Kerry	
FIGURE NO:	4.1	
CLIENT:	Kerry County Council	
SCALE:	1:2500	REVISION: 0
DATE:	31/10/2019	PAGE SIZE: A3

- Borehole Locations
- Groundwater Flow Direction
- Site Boundary
- 1m Contours

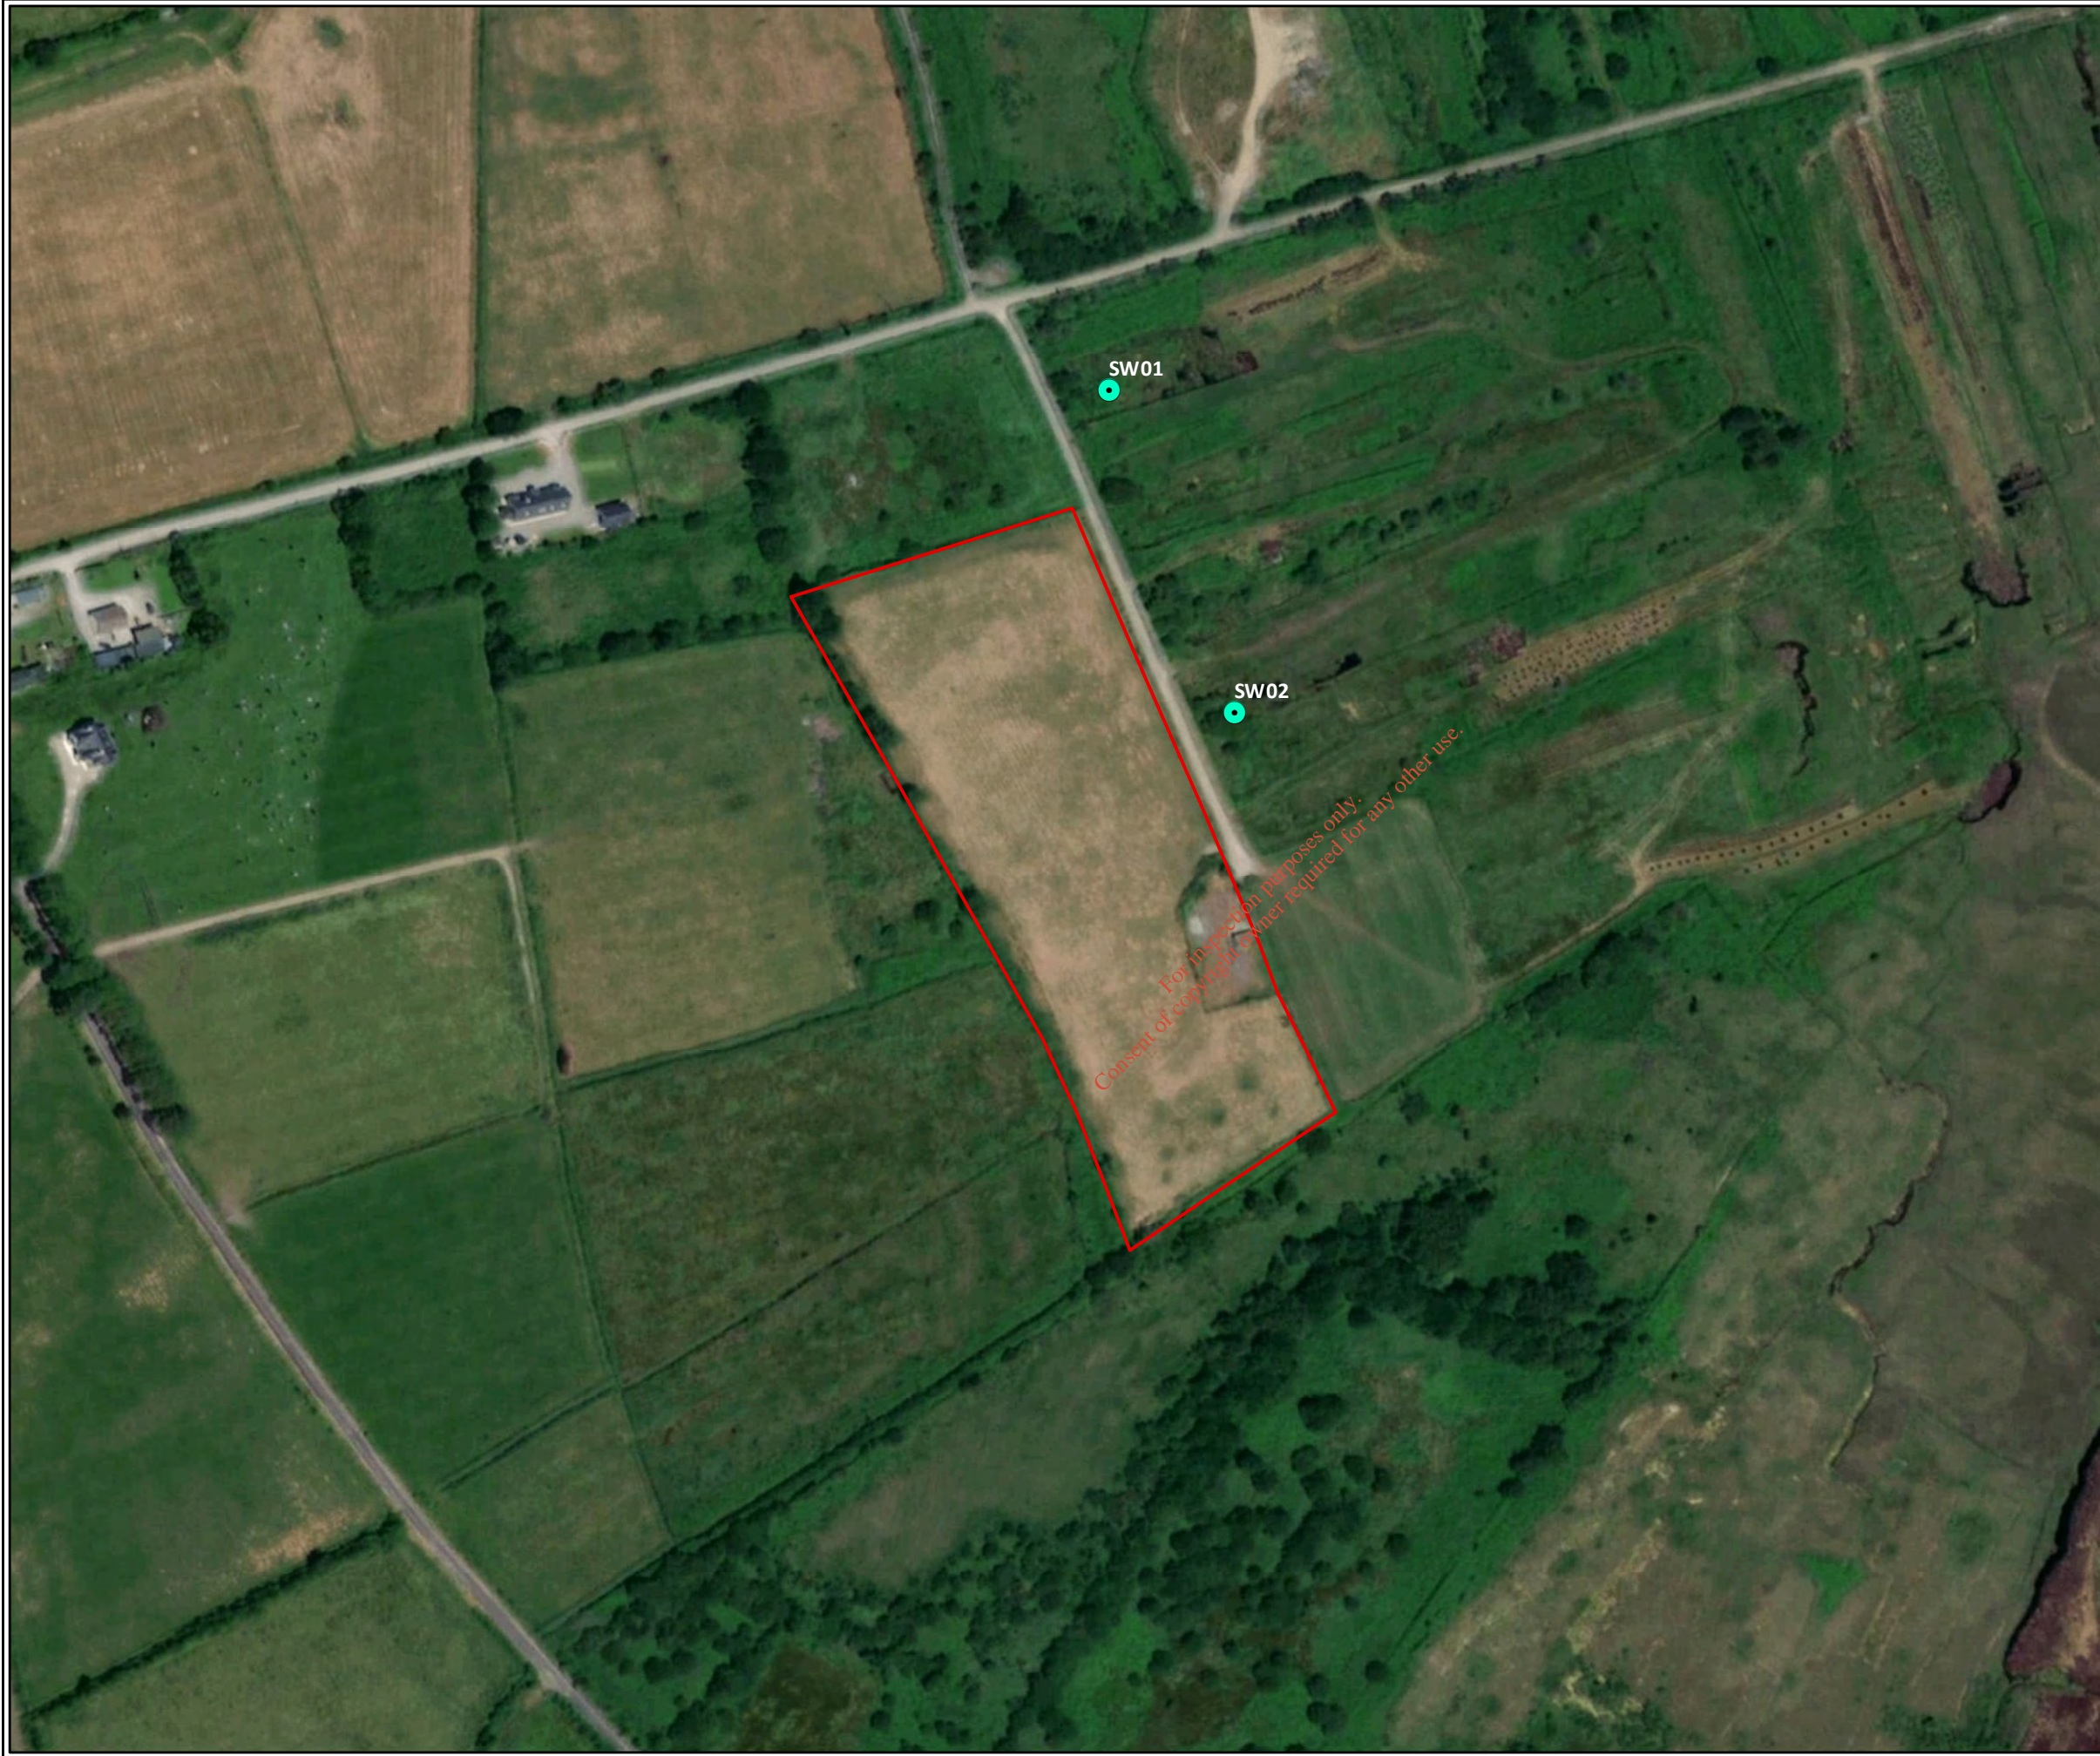
- Surface Water Sampling Locations
- Site Boundary

In the absence of a free-flowing surface waterbody near the site, surface water monitoring locations were selected within a man-made peatland drainage channel adjacent to the landfill footprint, as shown on Figure 4.2. Very low flow conditions were observed within the land drain during both monitoring rounds.
