**Tier 1 Risk Assessment
Kerry County Council**

► Tier 1 Review Report – Bawnluskaha (Castleisland), Killarney ◀

S22-02668

December 2011

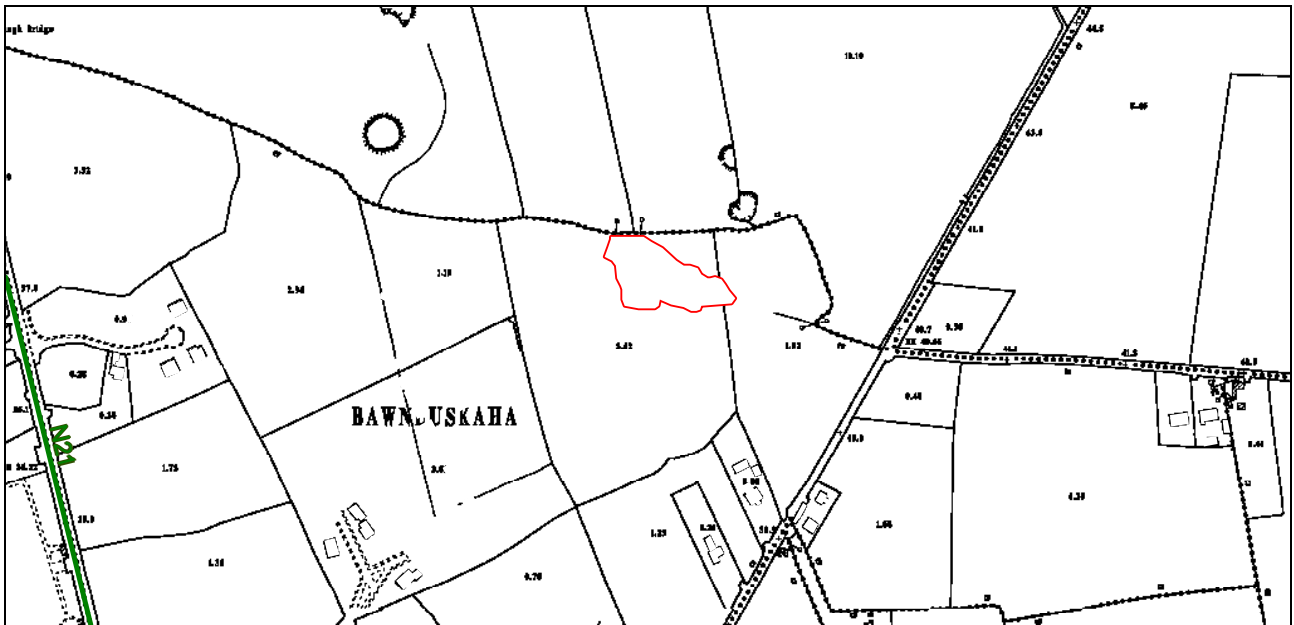
This overlain map indicates dwellings constructed since the map area was surveyed.

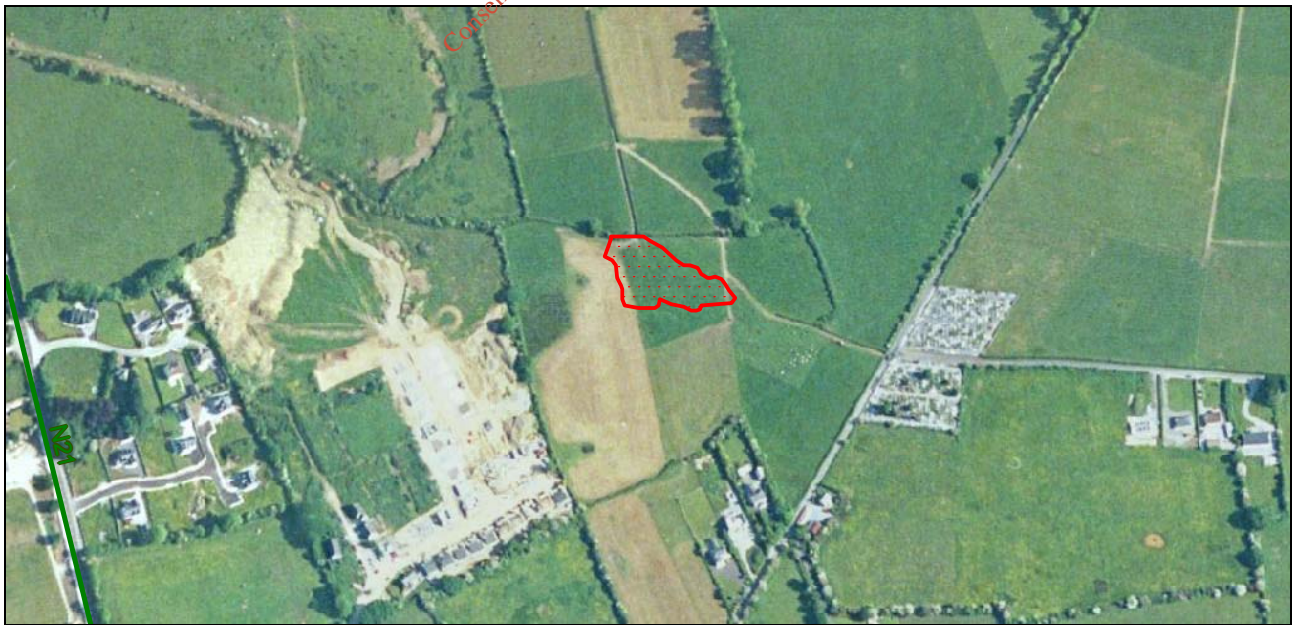
Aerial Photography (scale 1:5,000) – 2004

There are two sets of available aerial photography from 2000 and 2004. These are presented in the following pages

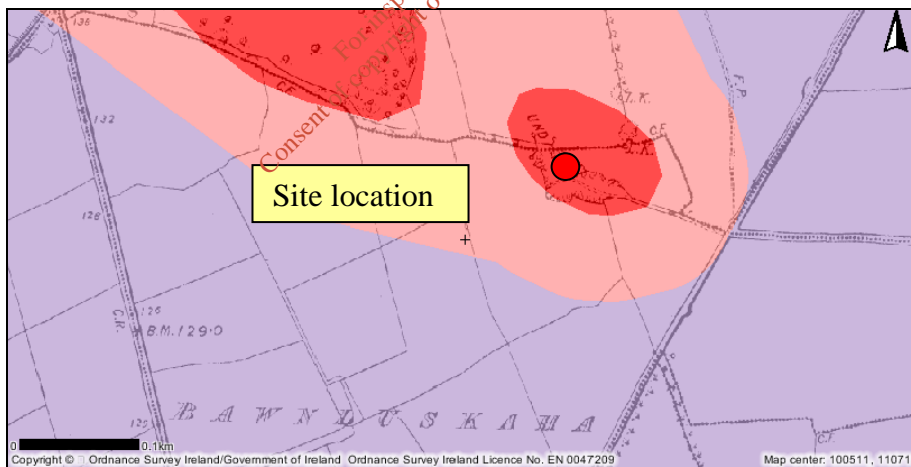
Groundwater vulnerability, scale 1:5,000

The site is located in an area that designated as X (Rock near surface) and surrounded by Extreme (E).

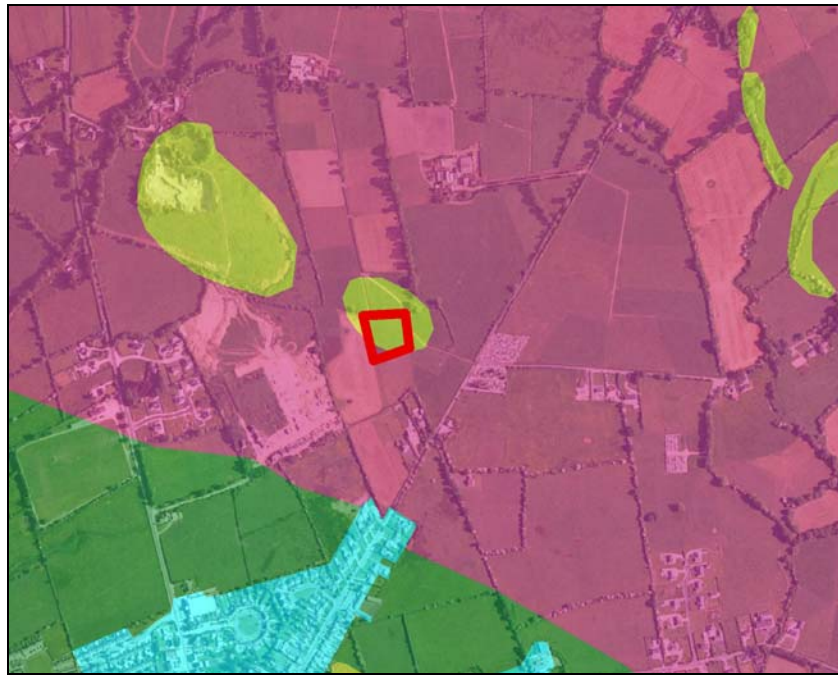
Sub-soil Categorisation

Reference to the location map indicates the presence of domestic dwellings within 100m of the western boundary of the site. The soils and sub soils are Tills.
