TIER 2 ERA REPORT FOR CASTLEISLAND HISTORIC LANDFILL

TIER 2 RISK ASSESSMENT

Prepared for: Kerry County Council

Date: August 2021

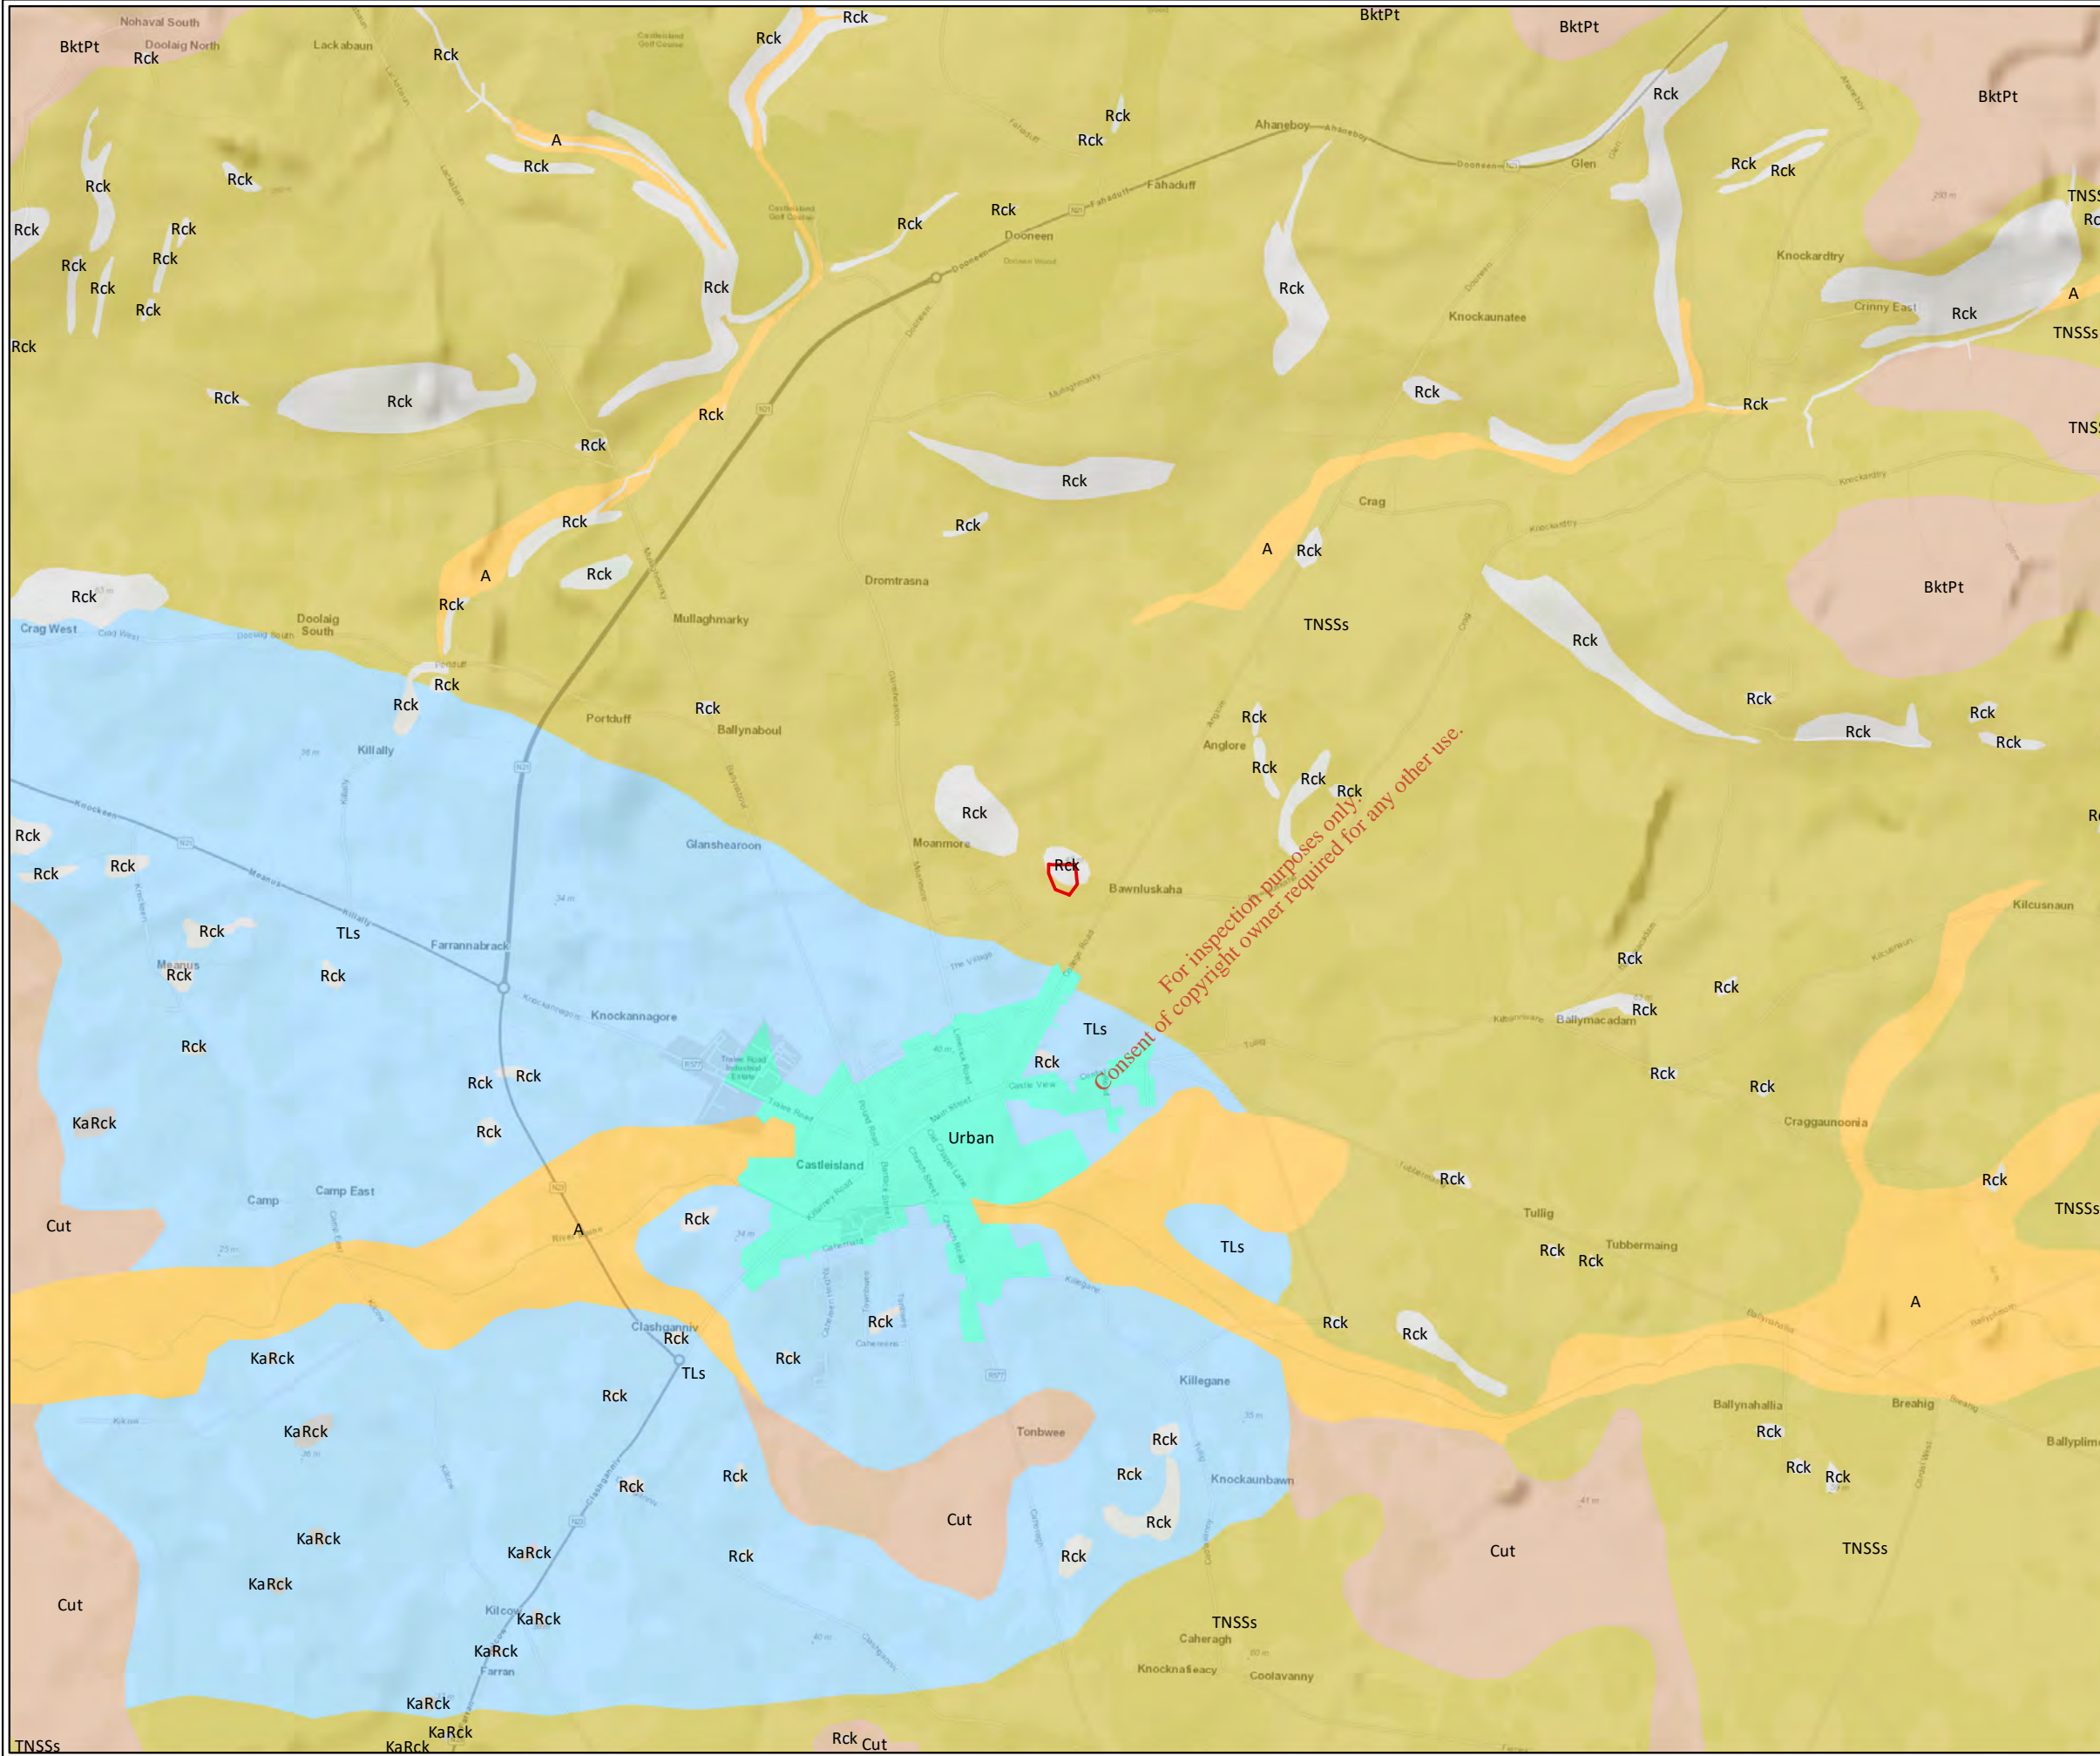
The quaternary Map provided by GSI Online identifies the quaternary sediments at the site as 'Quaternary Sediments: Bedrock outcrop or subcrop' and its surroundings as 'Till derived from Namurian sandstones and shales'. Quaternary sediments are shown in Figure 2.2.
