## CGL Site Investigation Report

## Historical Landfills in South and West Kerry - Dingle

Client: Kerry County Council

Report No.: 18-1123b

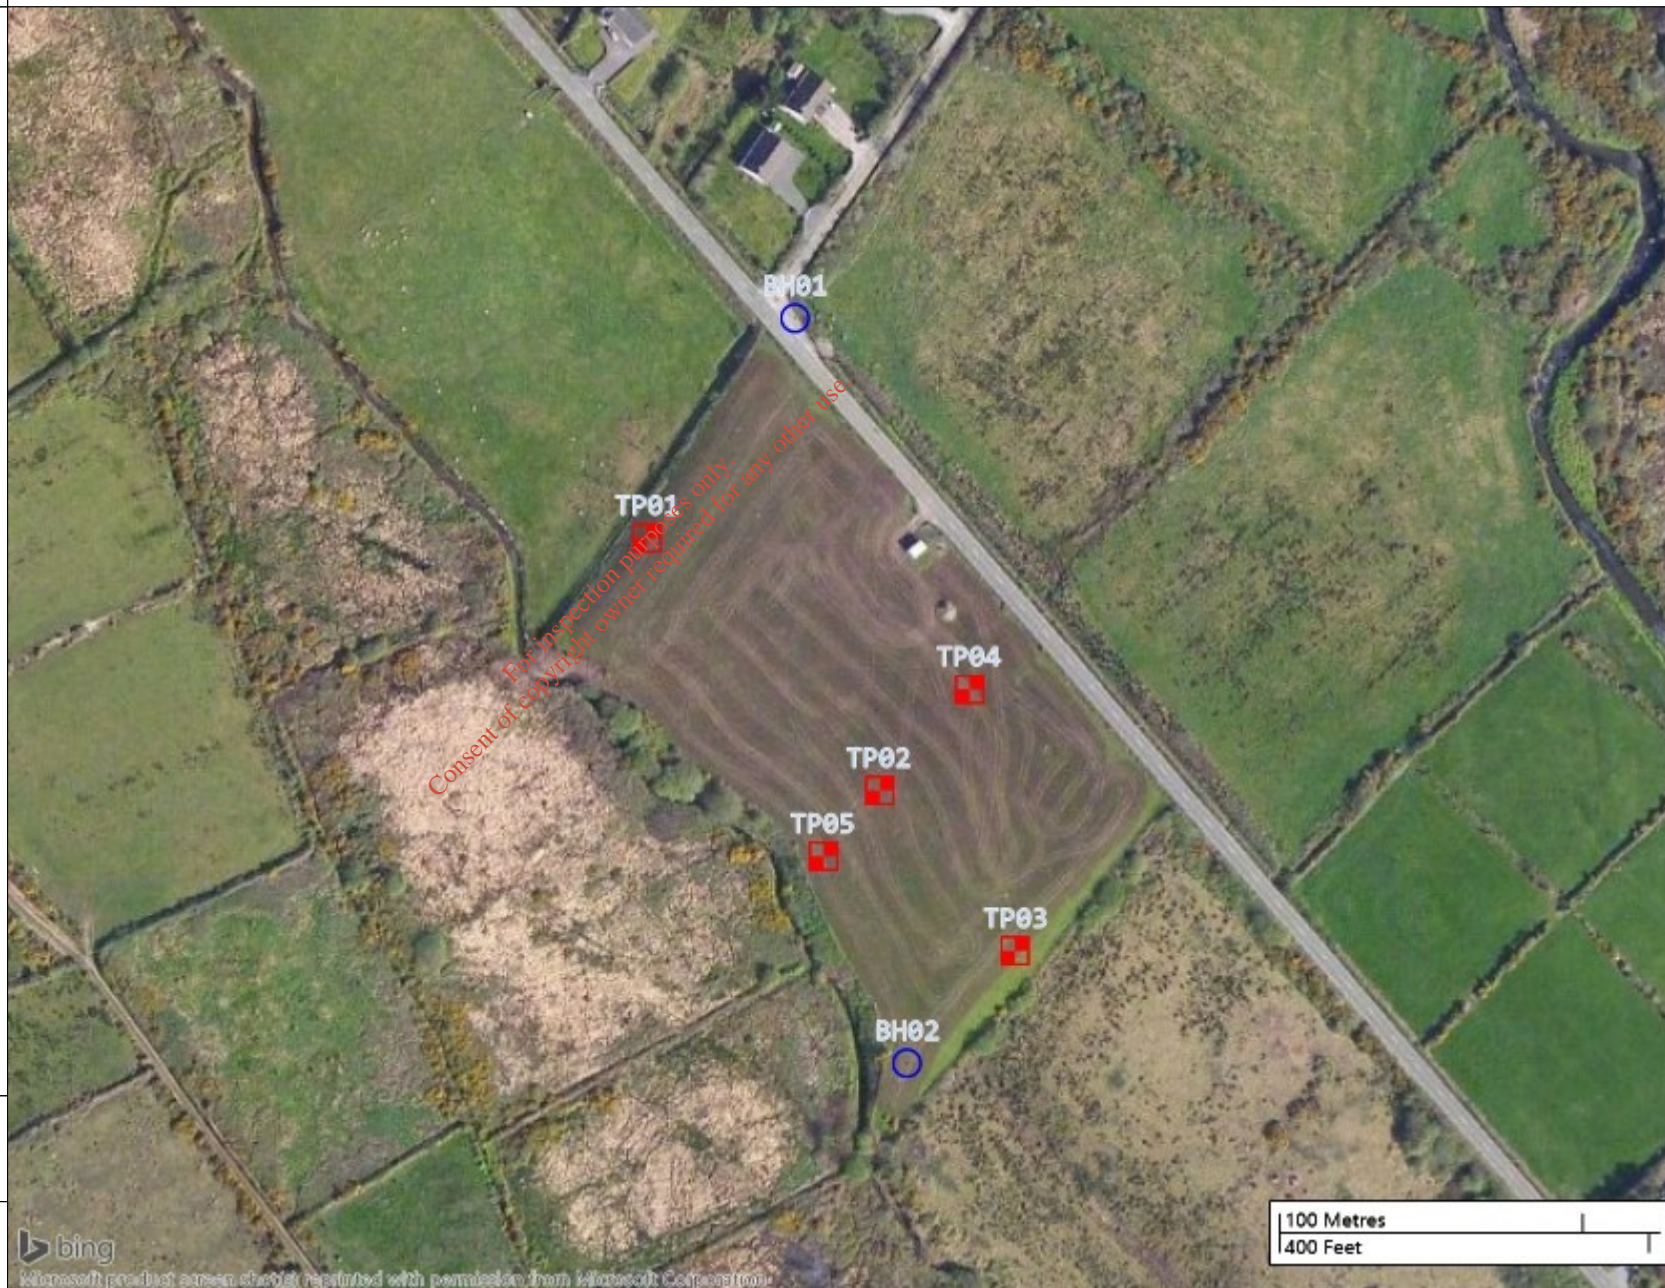
**Title:**  
Exploratory Hole Location Plan

The plan coordinates (Irish National Grid) and ground elevation (mOD Malin) at each location are recorded on the individual exploratory hole logs. The exploratory hole plan presented in Appendix A shows these as-built positions.

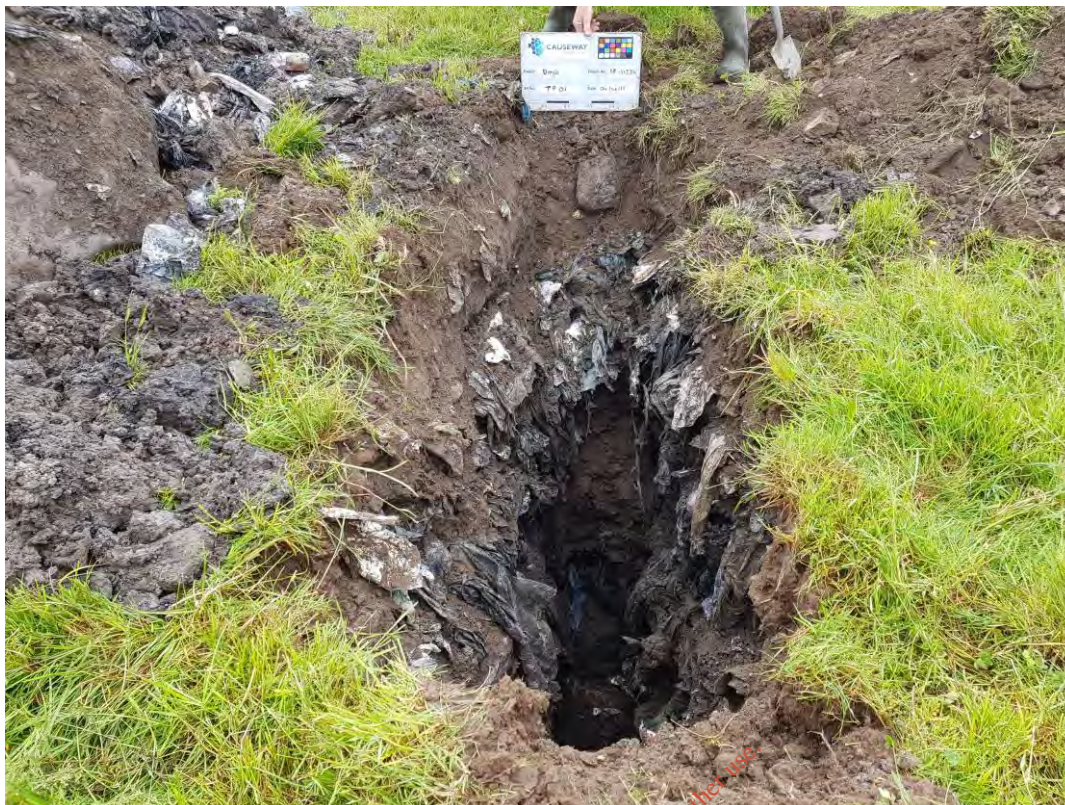
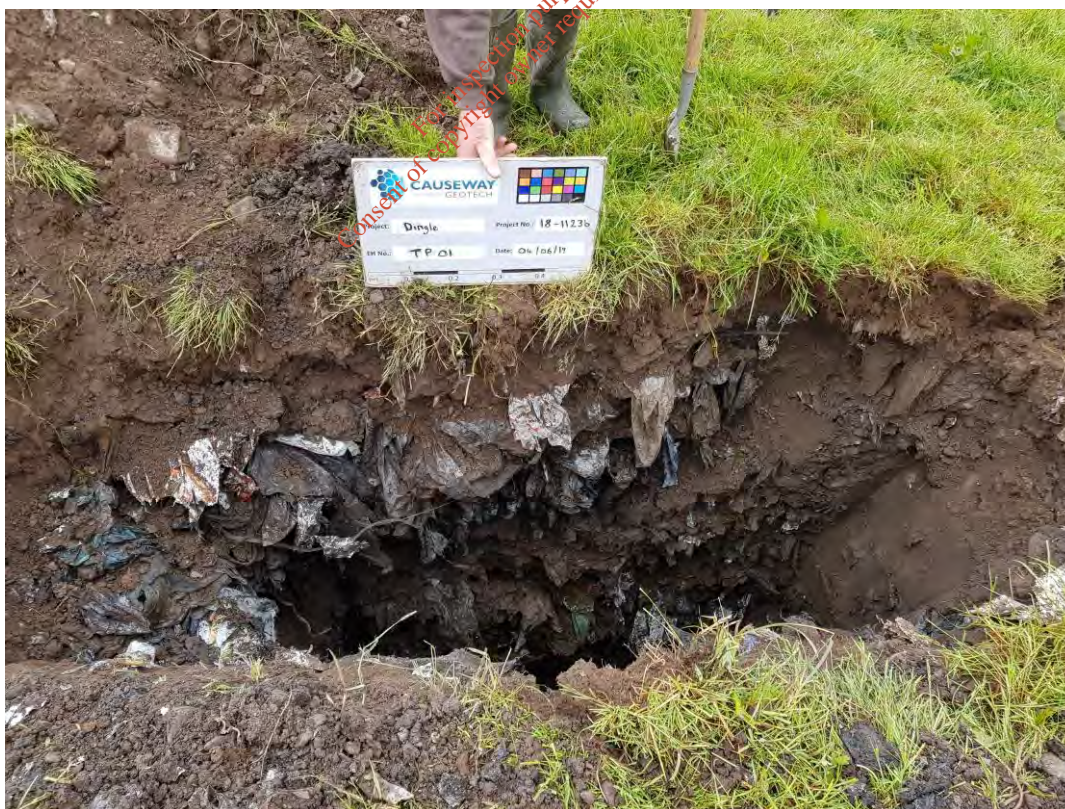
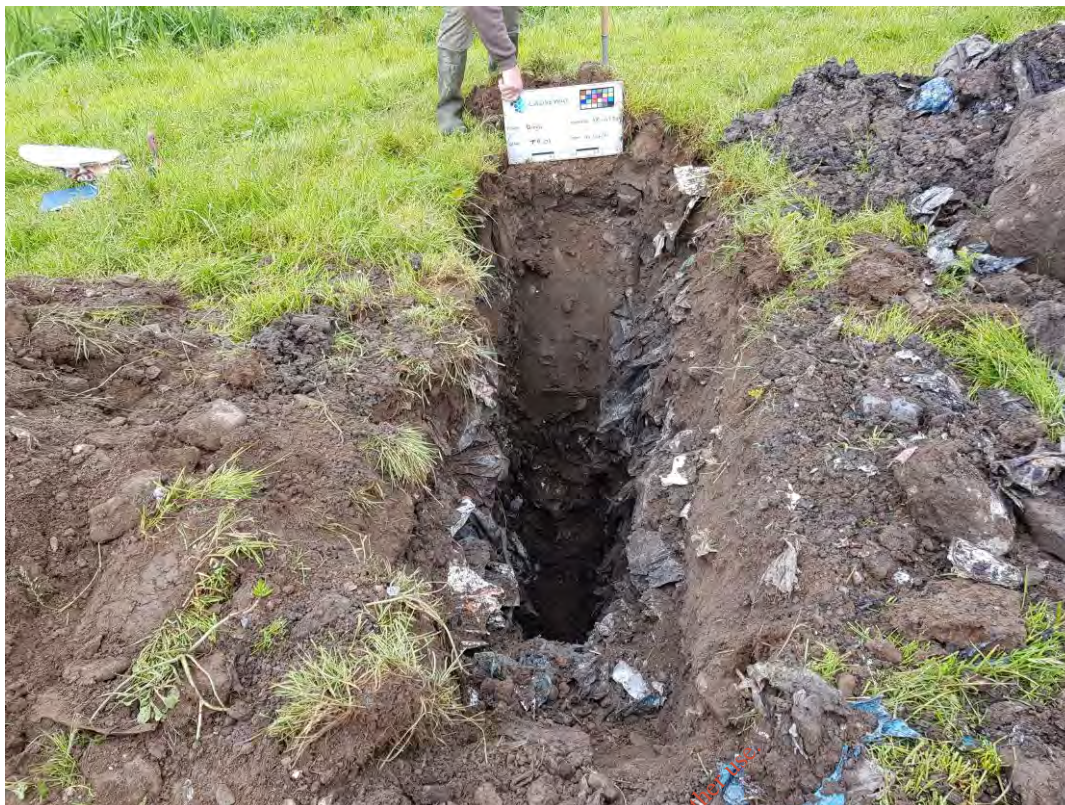
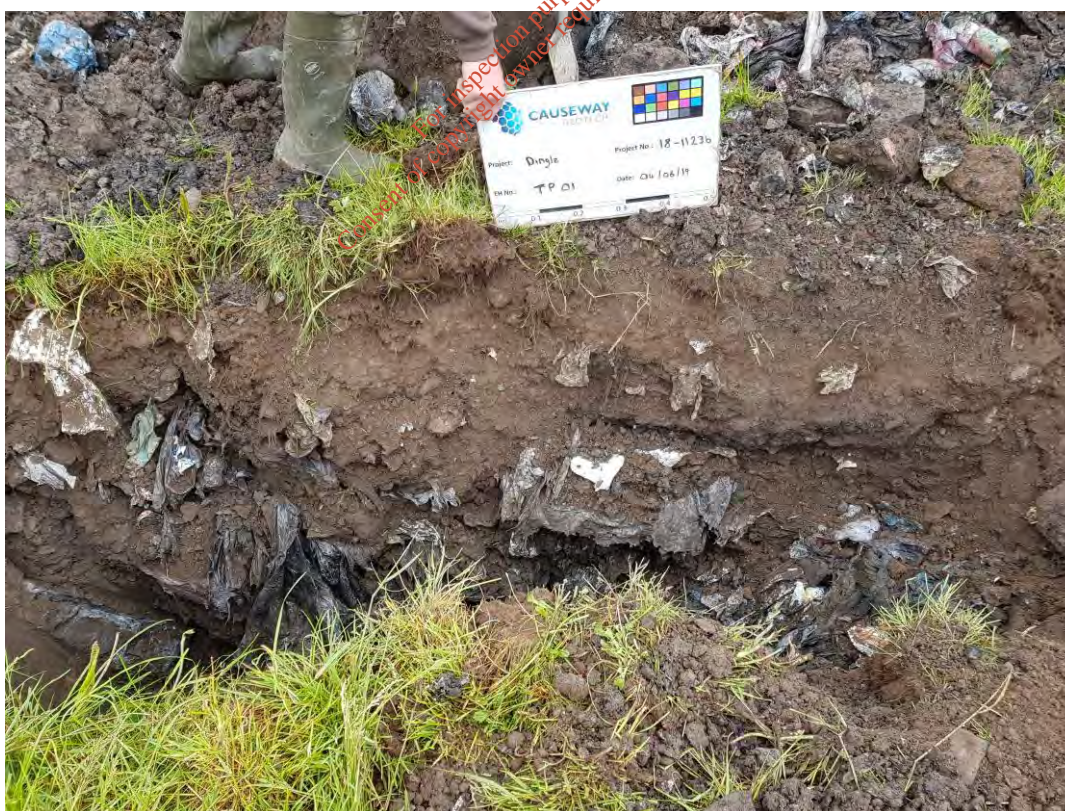
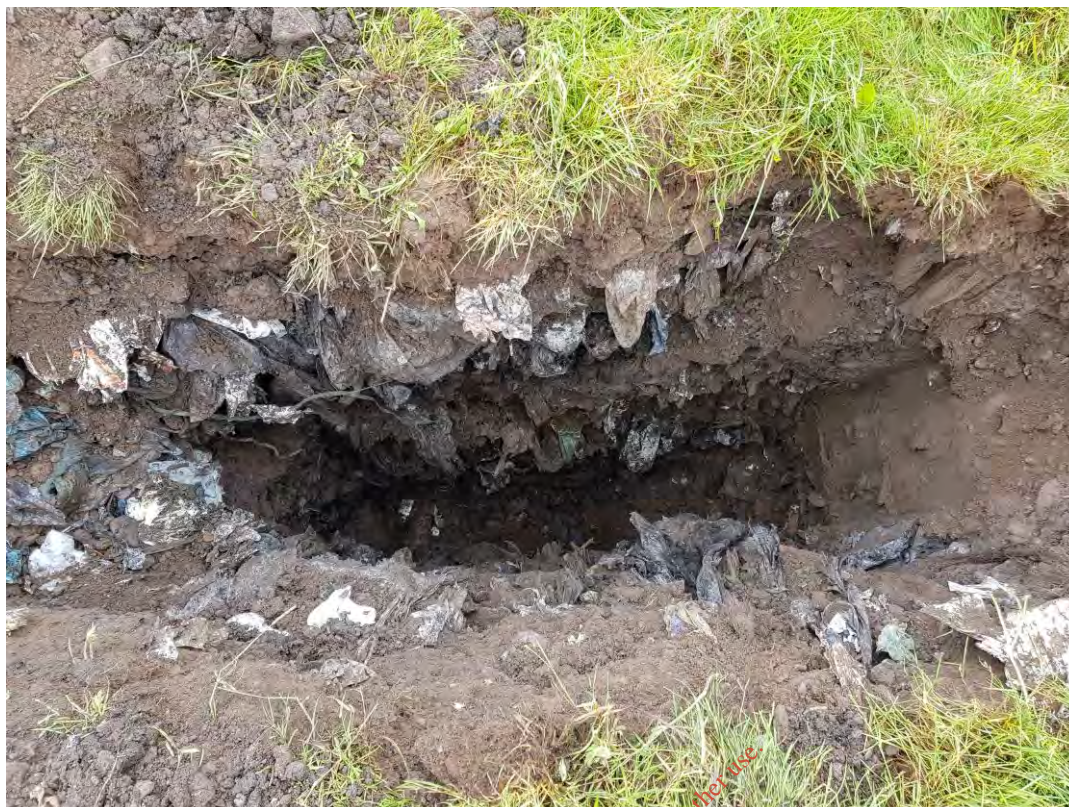
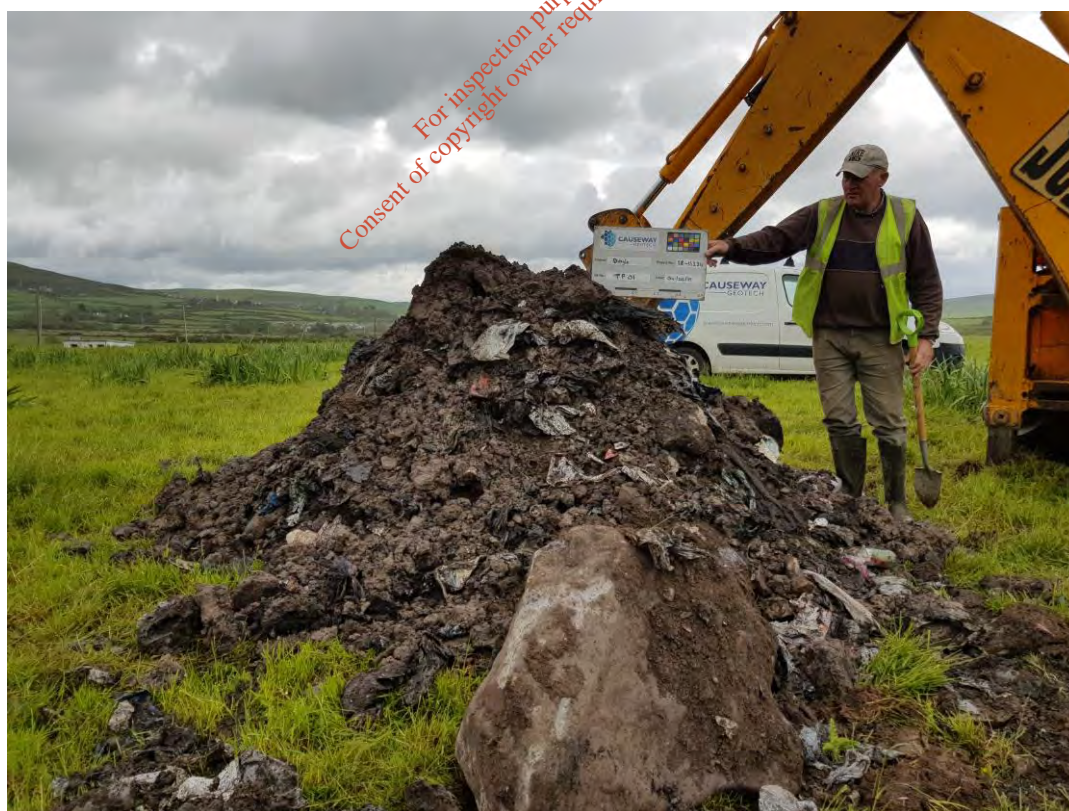
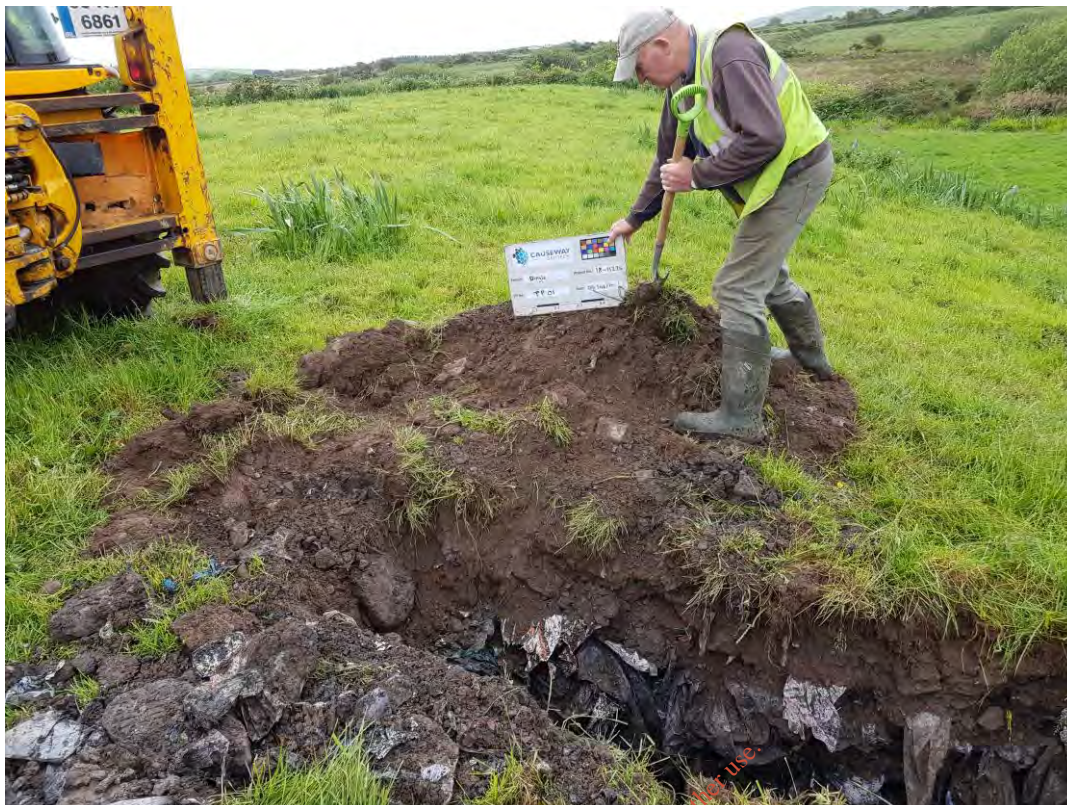
TP01 – SSE Face

TOPSOIL: Firm brown slightly sandy slightly gravelly silty CLAY with low cobble content. Sand is fine to coarse. Gravel is subangular to subrounded fine to coarse of limestone. Cobbles are subangular of limestone.	
				0.25

MADE GROUND: Firm greyish brown slightly sandy slightly gravelly silty CLAY with low cobble and low boulder content and some rubbish, including plastic bags and glass bottles. Sand is fine to coarse. Gravel is subangular to subrounded fine to coarse of limestone. Cobbles and boulders are subangular to subrounded of limestone.	
1.75	ES1			(2.75)			
			9.63	3.00		End of trial pit at 3.00m

<b>Remarks</b> No groundwater encountered.  Terminated due to >1.50m of landfill material present.	<b>Water Strikes:</b>		<b>Stability:</b> Stable
	Struck at (m):	Remarks:

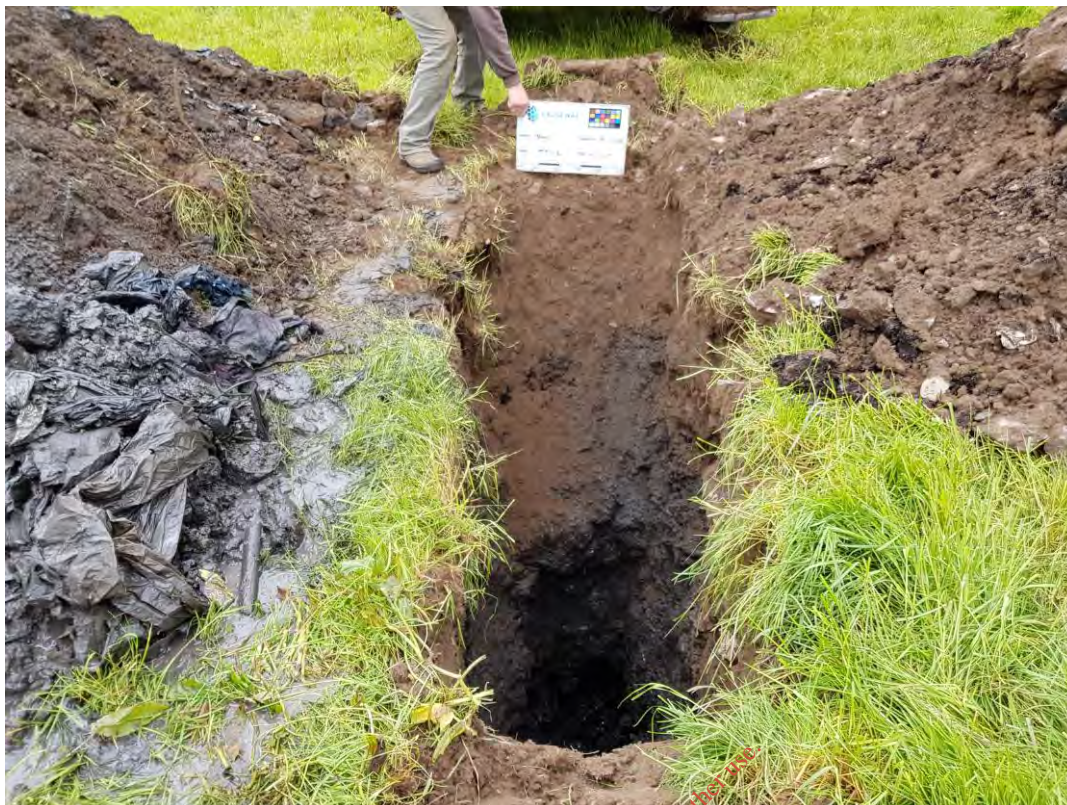
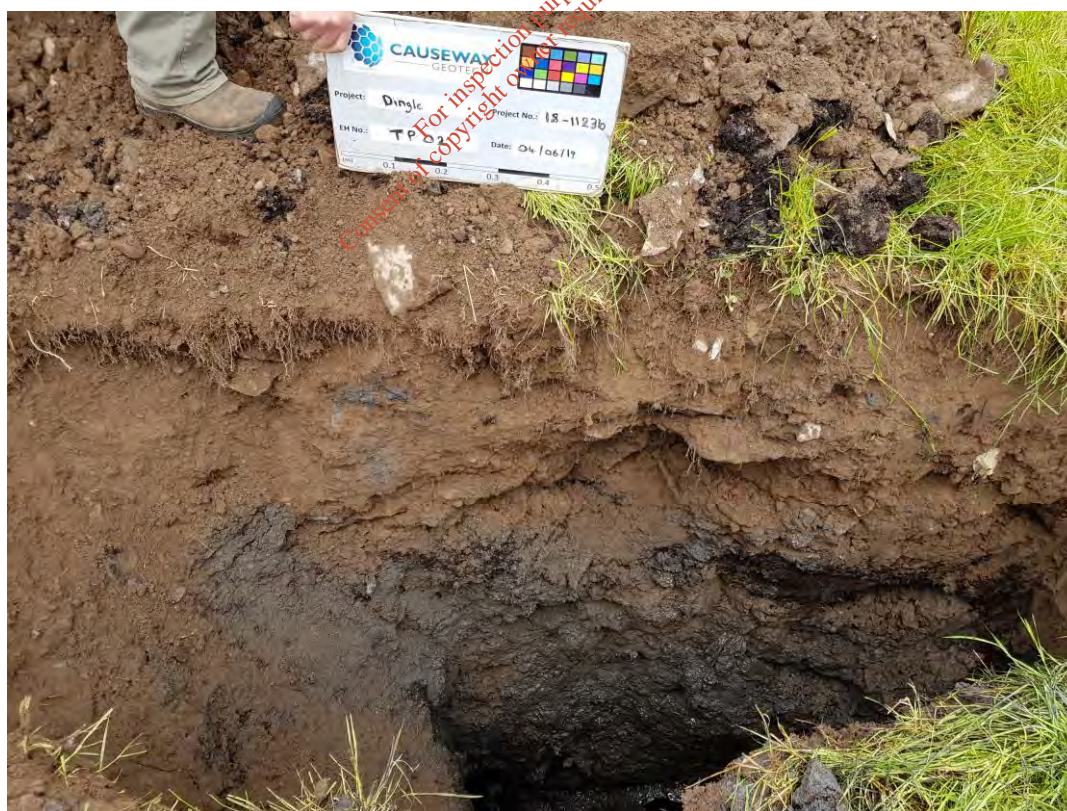
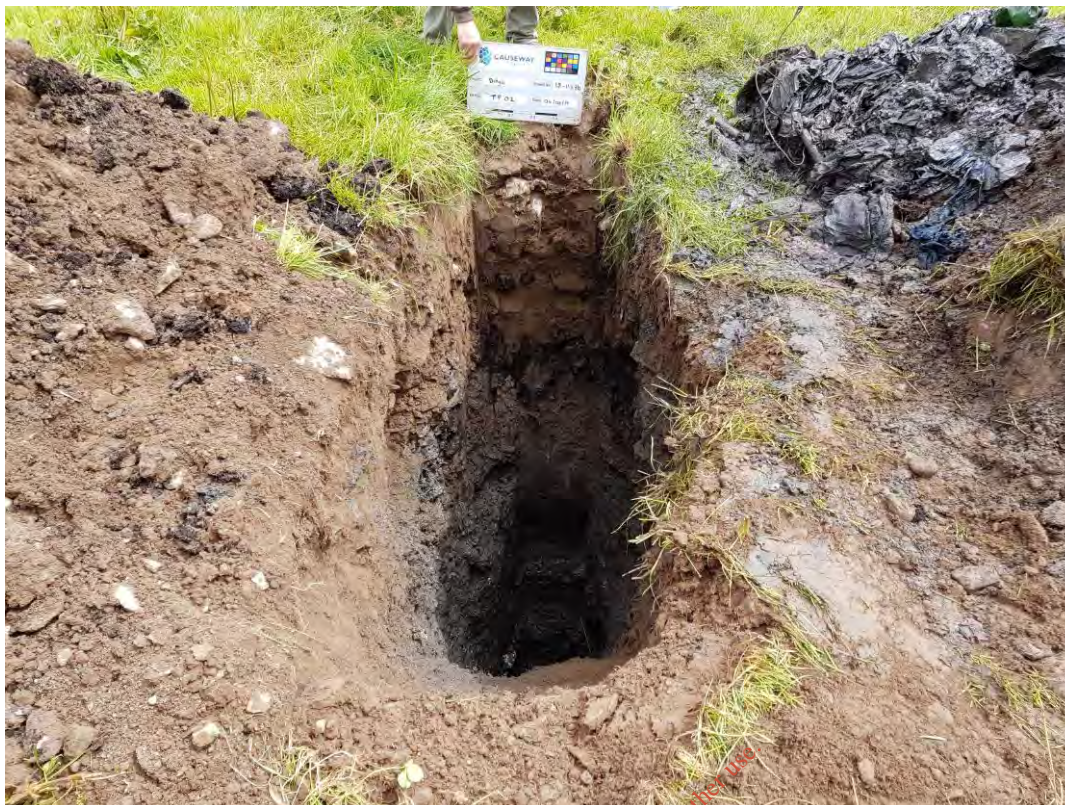
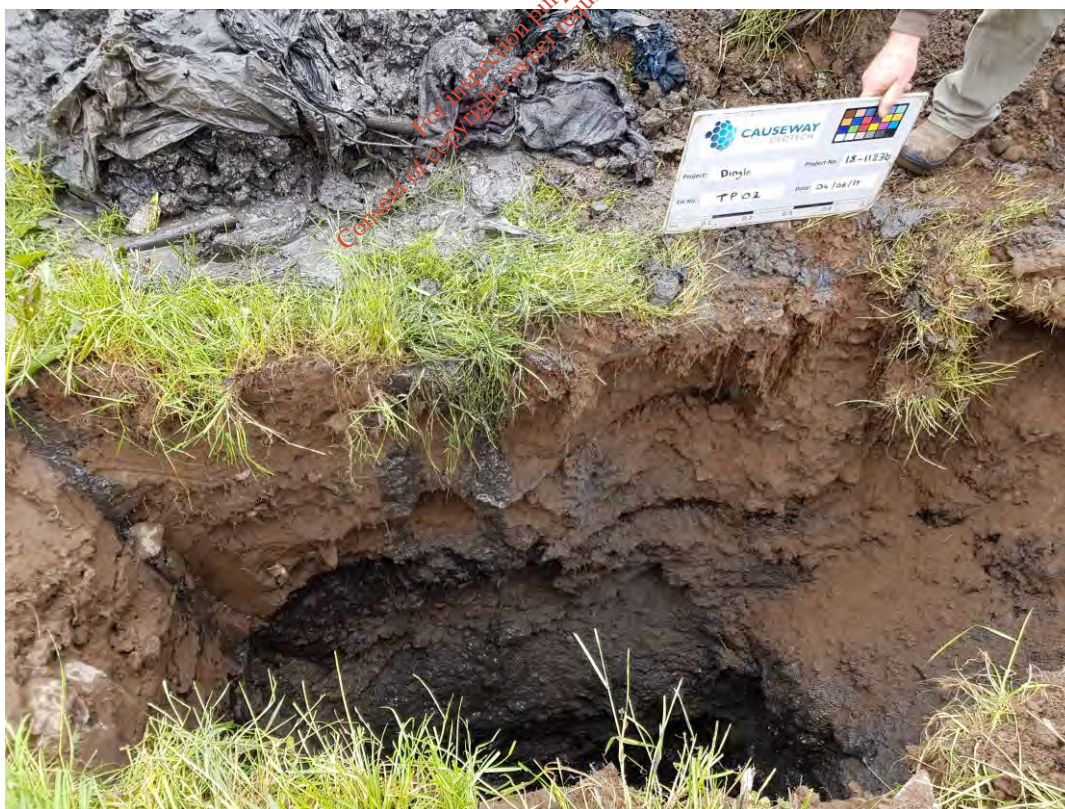
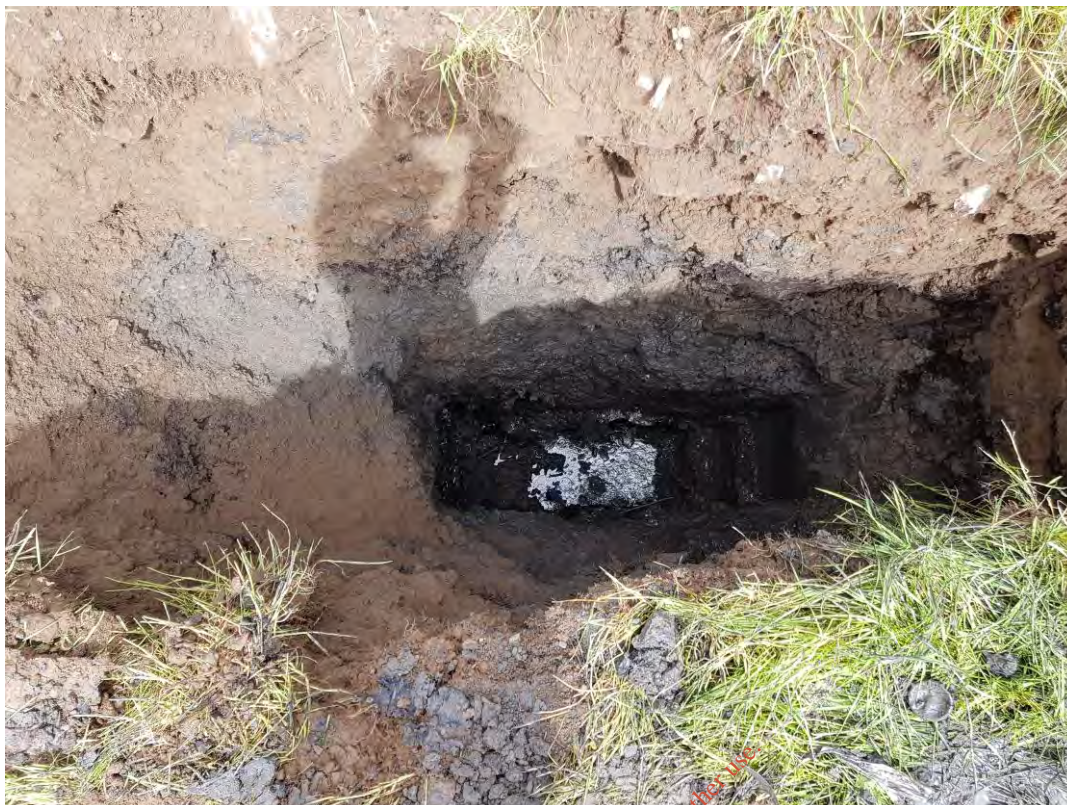
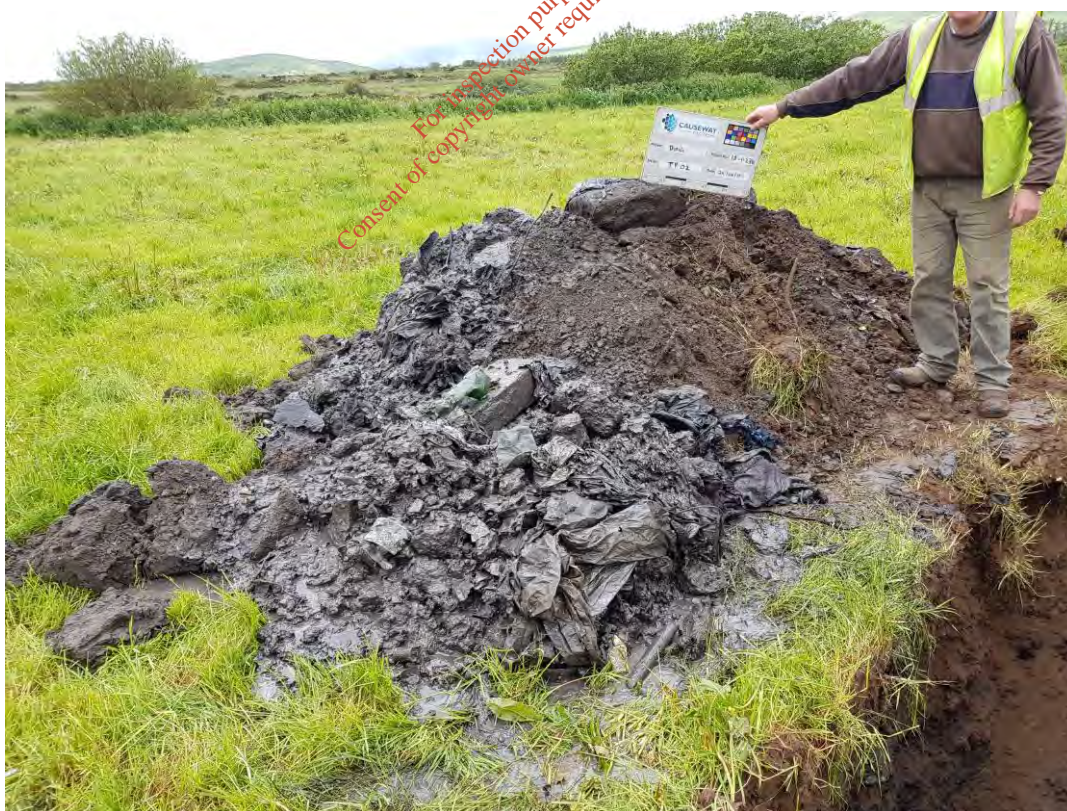
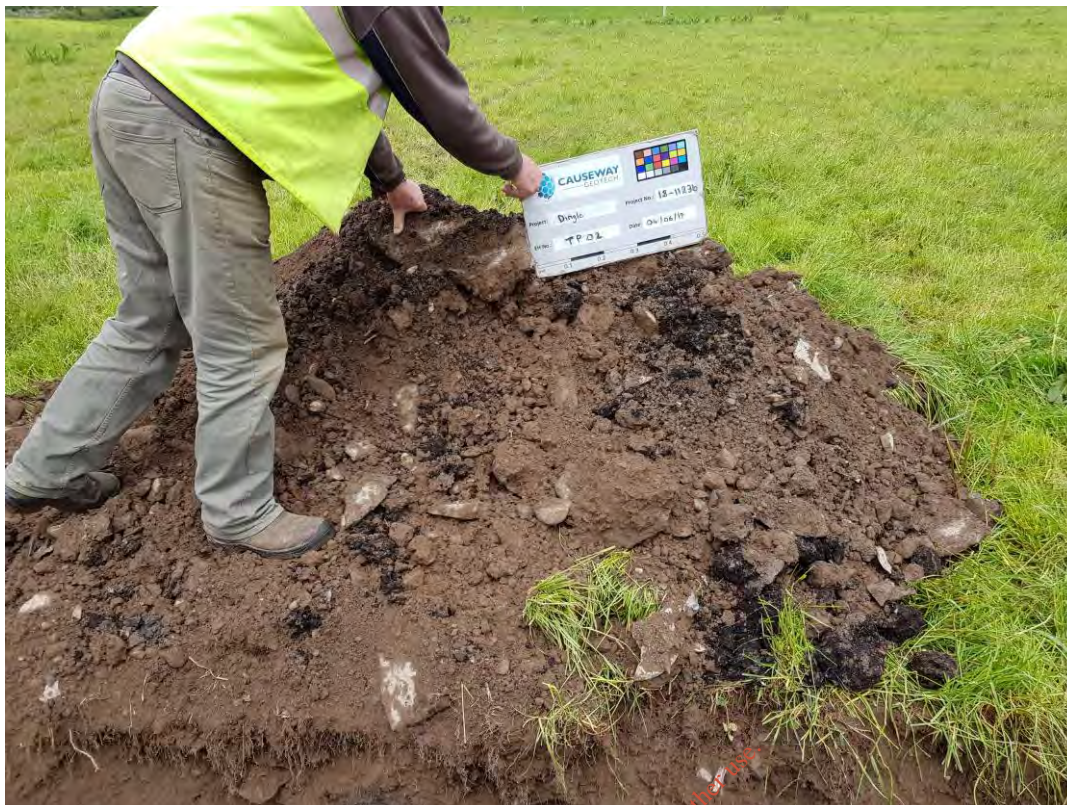
TP02 – WNW Face

MADE GROUND: Firm brown slightly sandy slightly gravelly silty CLAY with low cobble content and plastic bags. Sand is fine to coarse. Gravel is angular to subrounded fine to coarse of limestone. Cobbles are subangular of limestone.	0.5

MADE GROUND: Firm black pseudo-fibrous PEAT.	1.0
			10.82	1.30

MADE GROUND: Firm grey to greyish brown slightly sandy slightly gravelly silty CLAY with low cobble content and some rubbish including plastic bags, glass bottles, building blocks, and clothing. Sand is fine to coarse. Gravel is subangular to subrounded fine to coarse of limestone. Cobbles are subangular of limestone.	1.5

Remarks  Terminated due water ingress.	<b>Water Strikes:</b>		<b>Stability:</b> Stable
	Struck at (m):	Remarks:	
	3.50	Water strike at 3.50m.	<b>Width:</b> 1.00 <b>Length:</b> 3.40

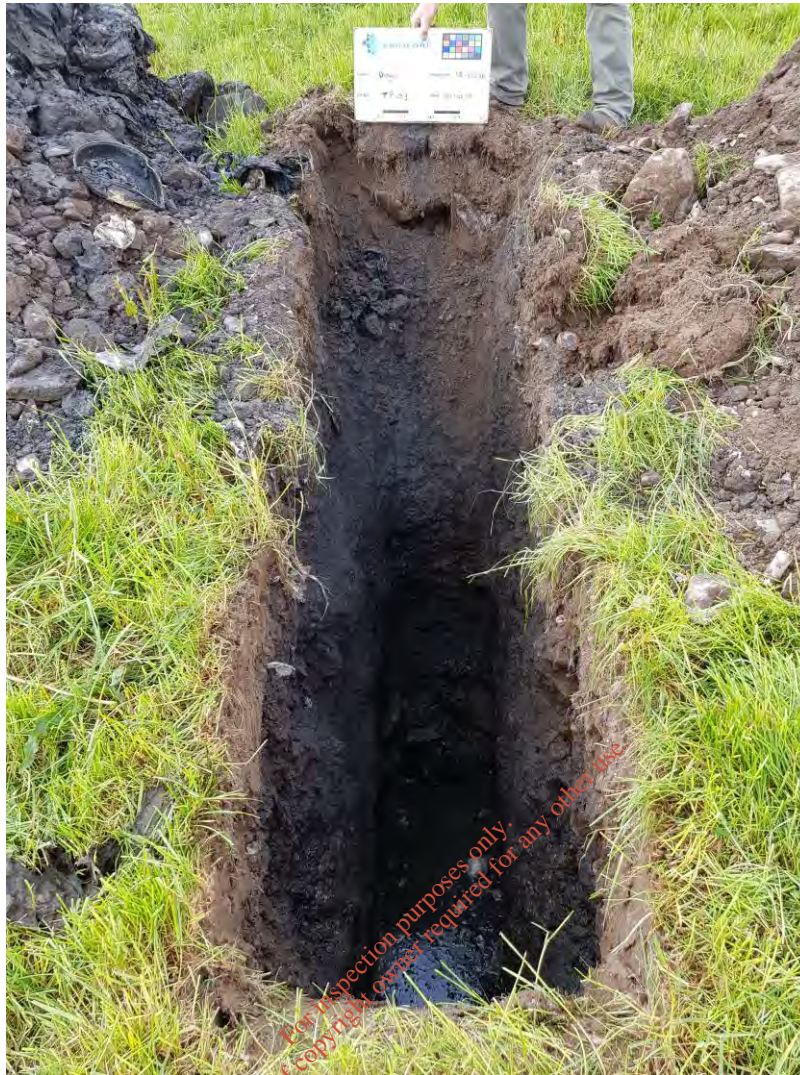
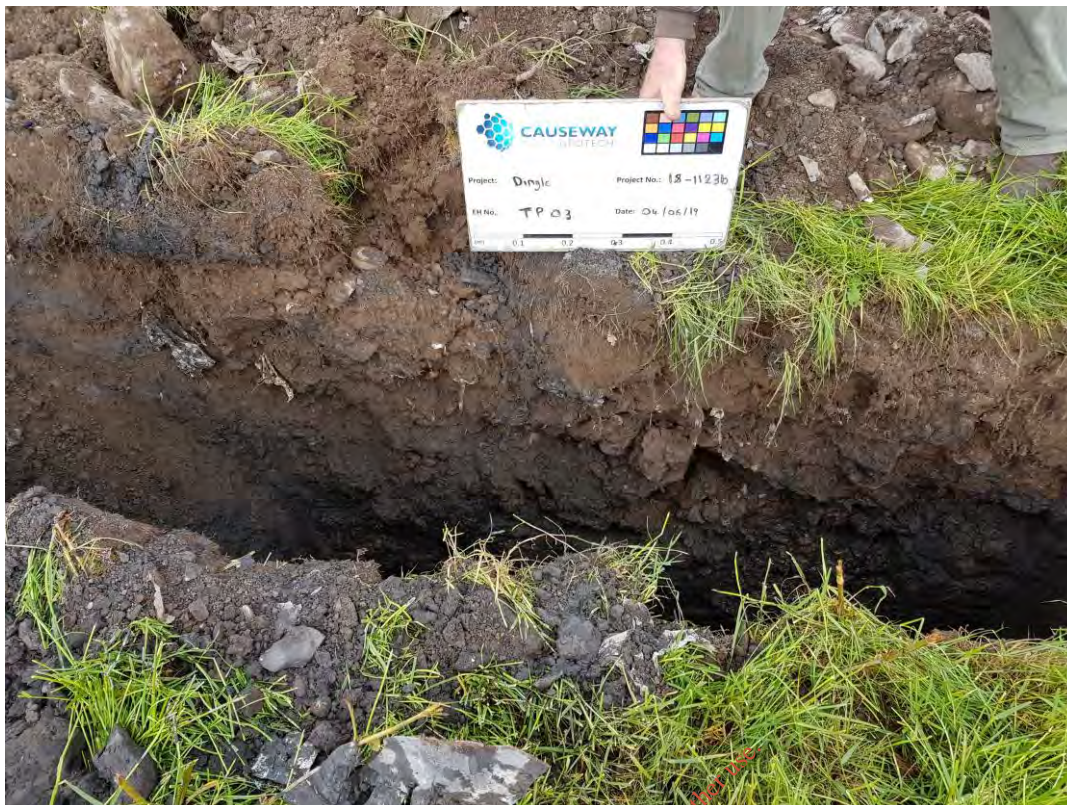
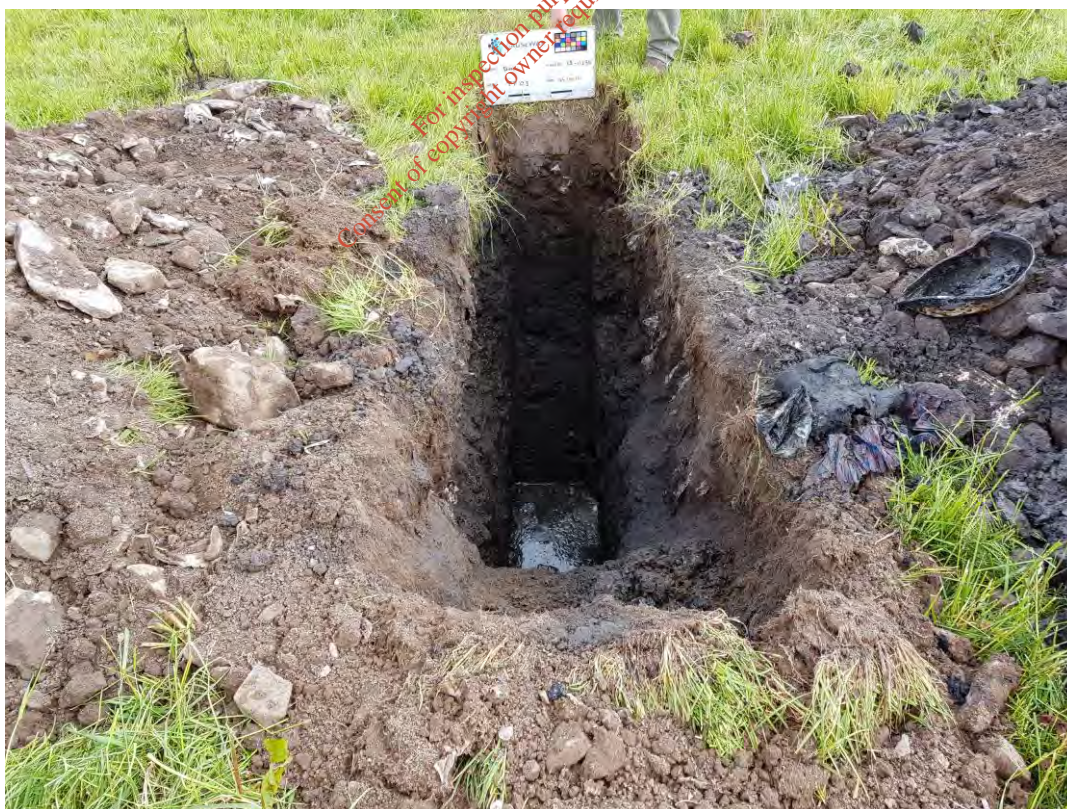
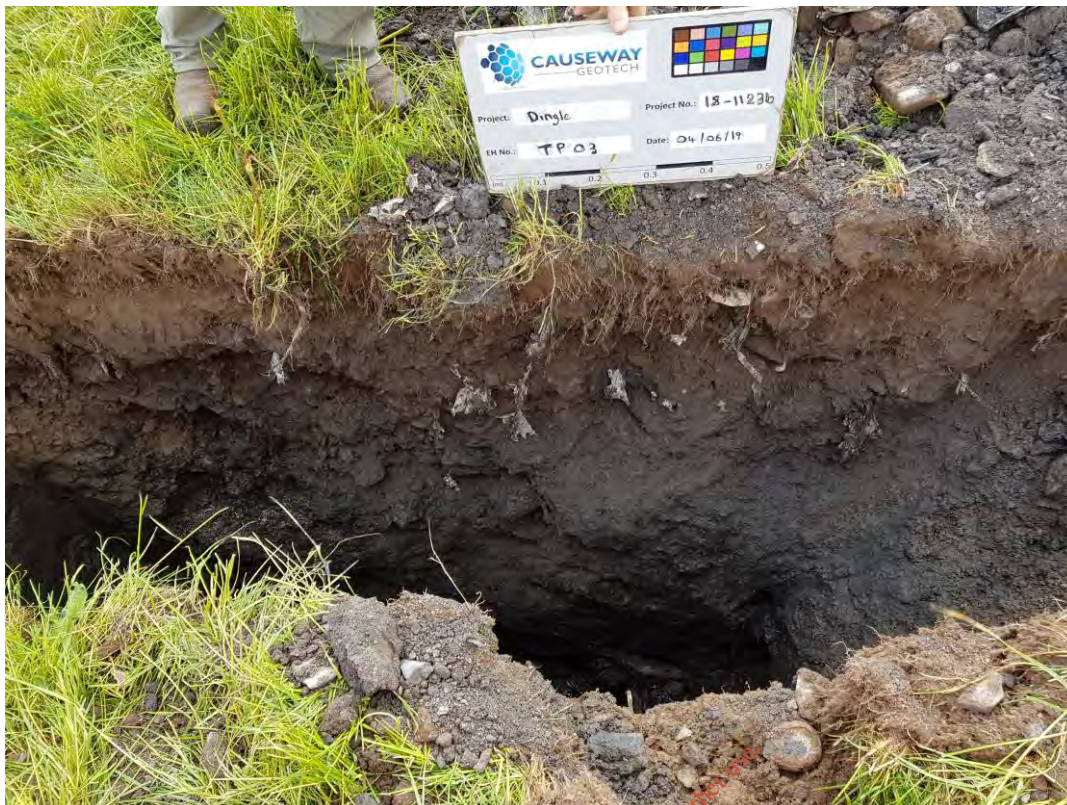
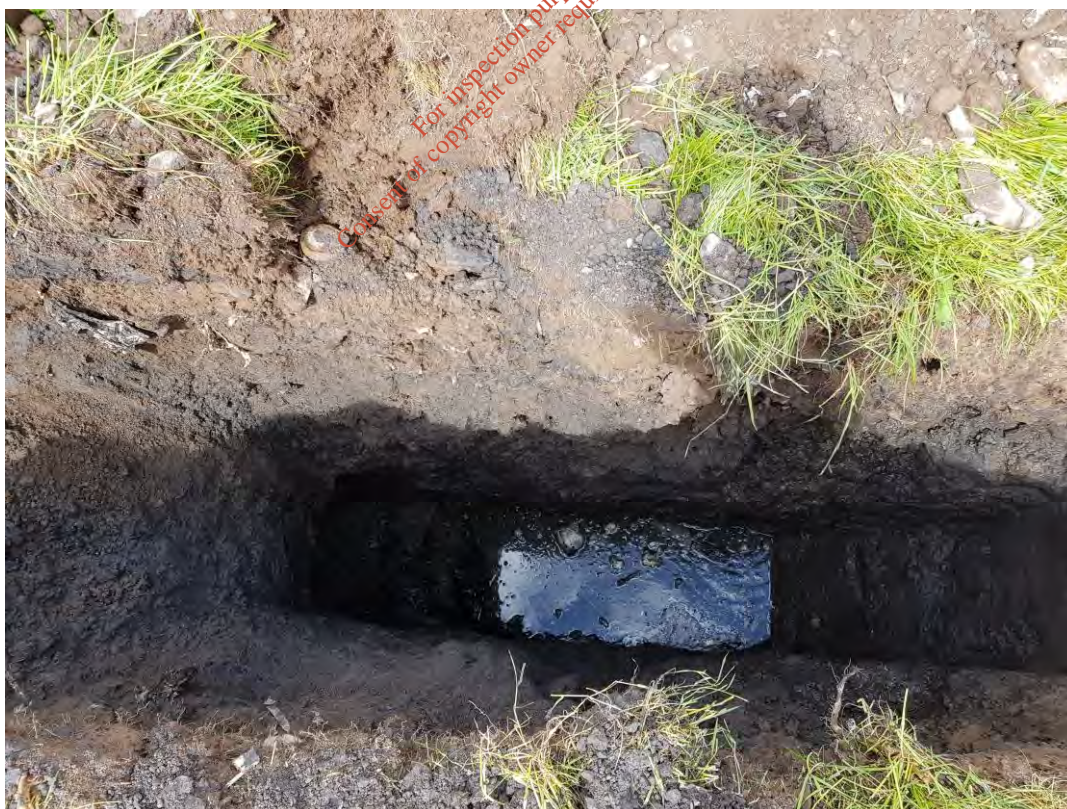
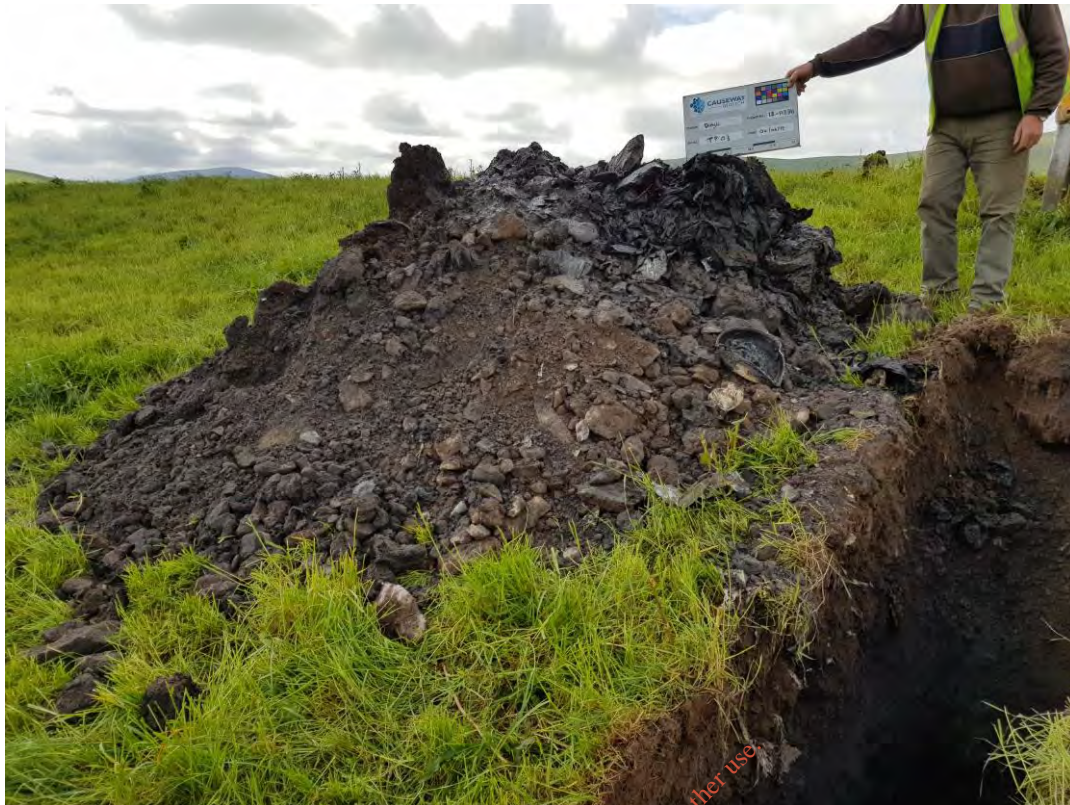
TP03 – NW Face

MADE GROUND: Firm brown slightly sandy slightly gravelly silty CLAY with low cobble content and plastic bags. Sand is fine to coarse. Gravel is subangular to subrounded fine to coarse of limestone. Cobbles are subangular of limestone.	
			9.26	0.75

MADE GROUND: Grey slightly sandy slightly gravelly SILT with low cobble content and rubbish including, plastic bags, shoes, and plastic bottles. Sand is fine to coarse. Gravel s subangular to subrounded fine to coarse of limestone. Cobbles are subangular of limestone.	
				(1.85)

2.30	ES1	Water strike at 2.40m	7.41	2.60
