## CGL Site Investigation Report

## Historical Landfills in South and West Kerry - Dingle

Client: Kerry County Council

Report No.: 18-1123b

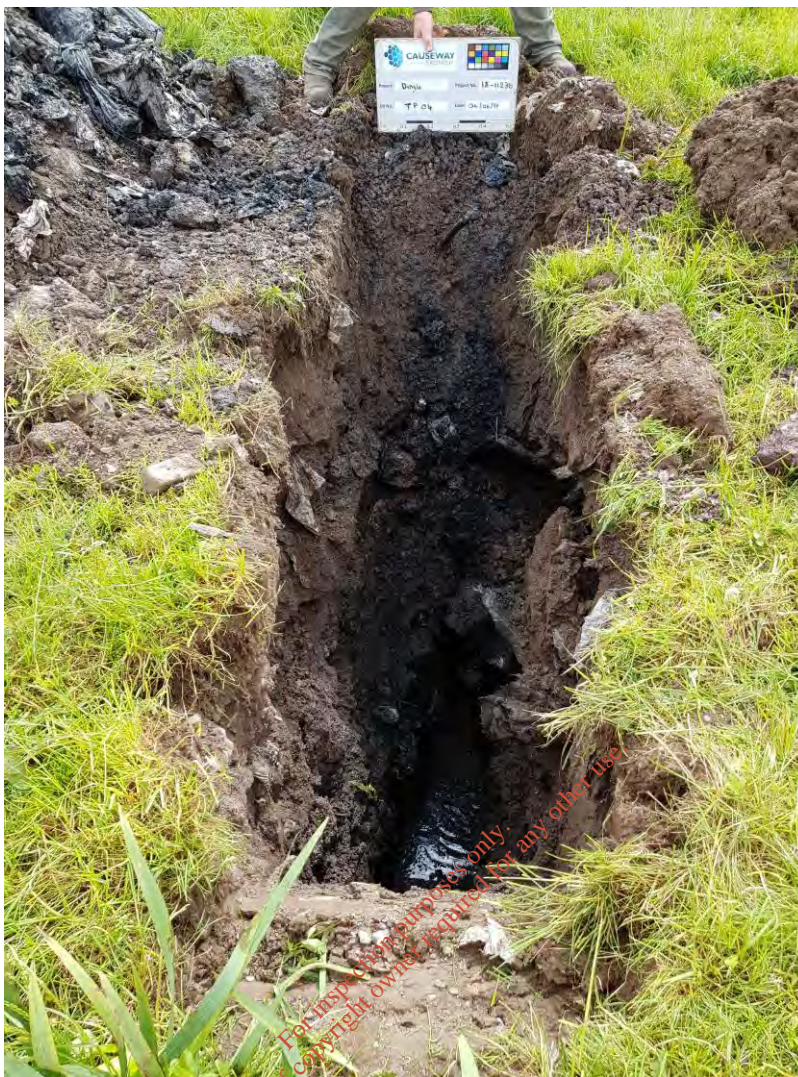
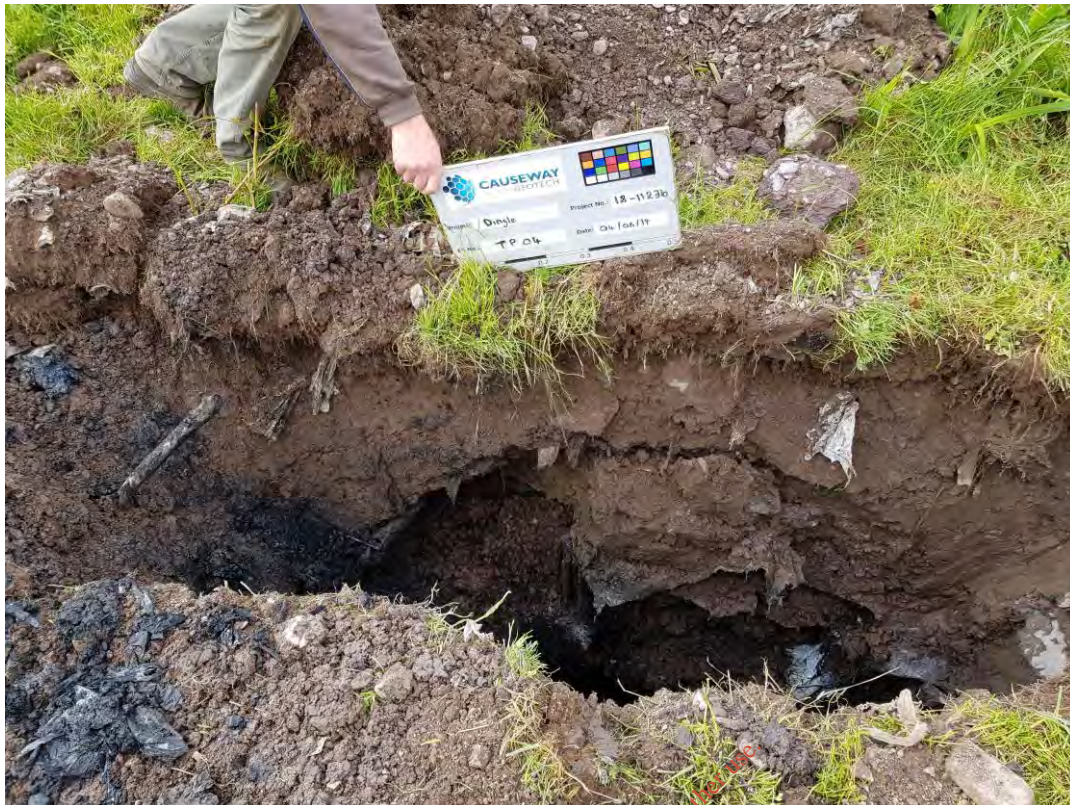
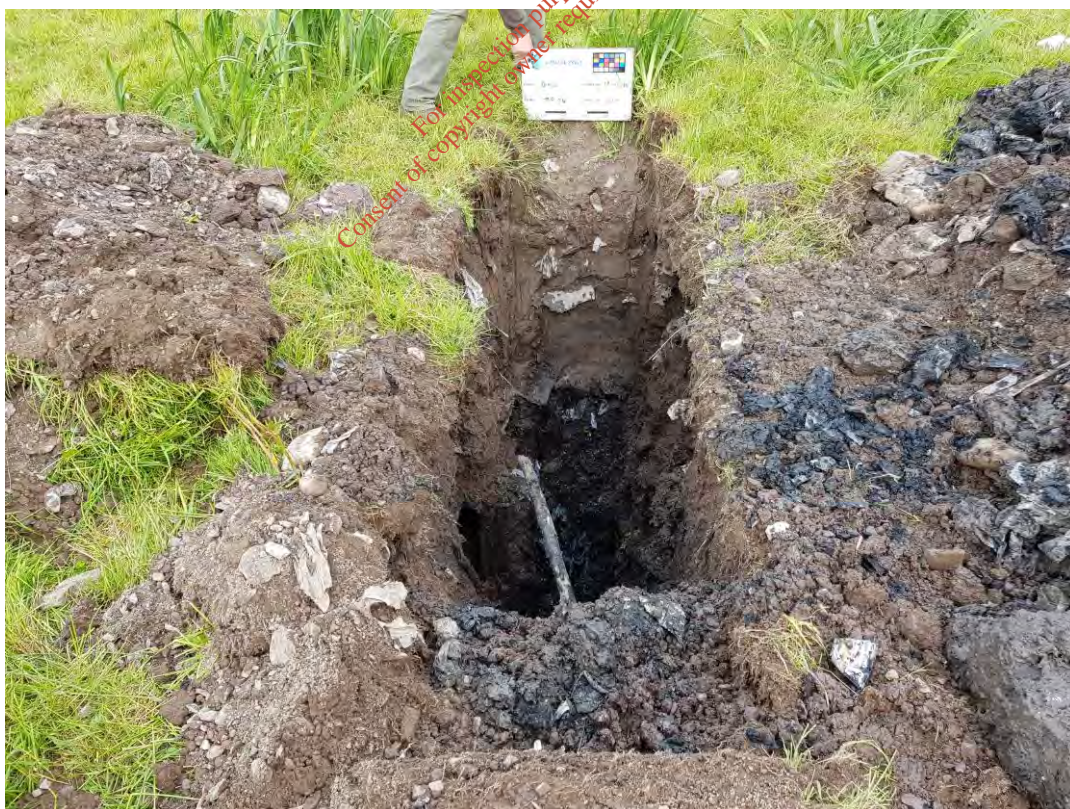
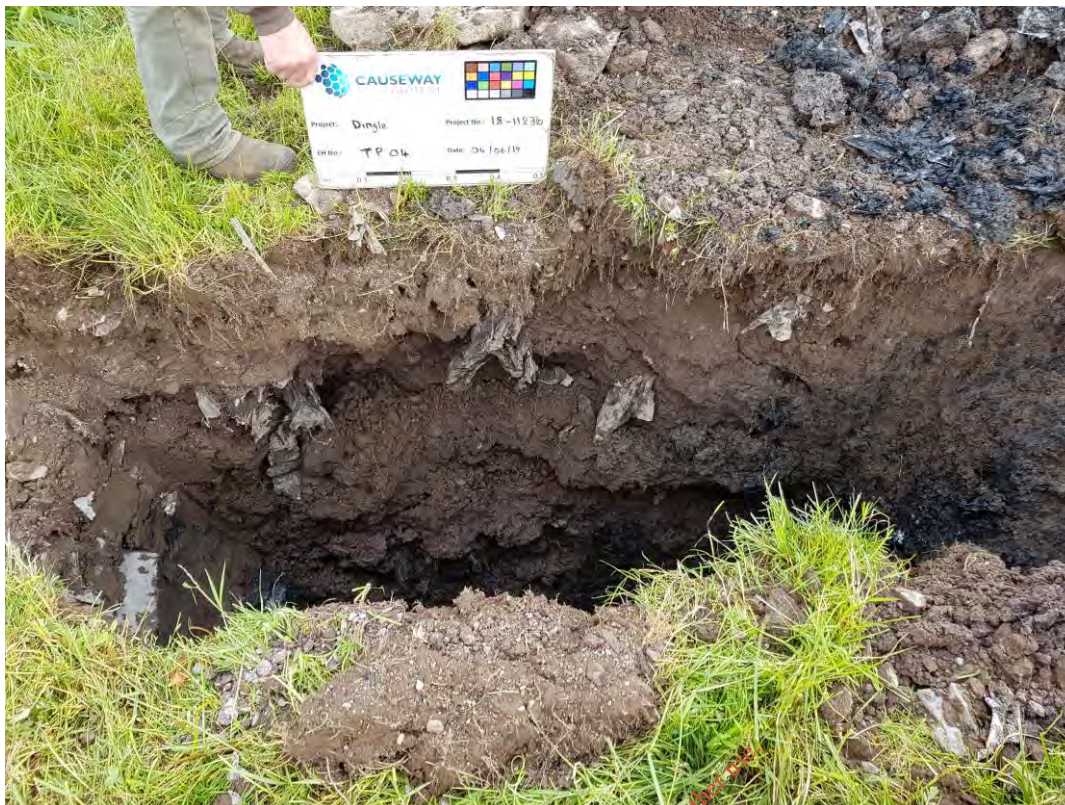
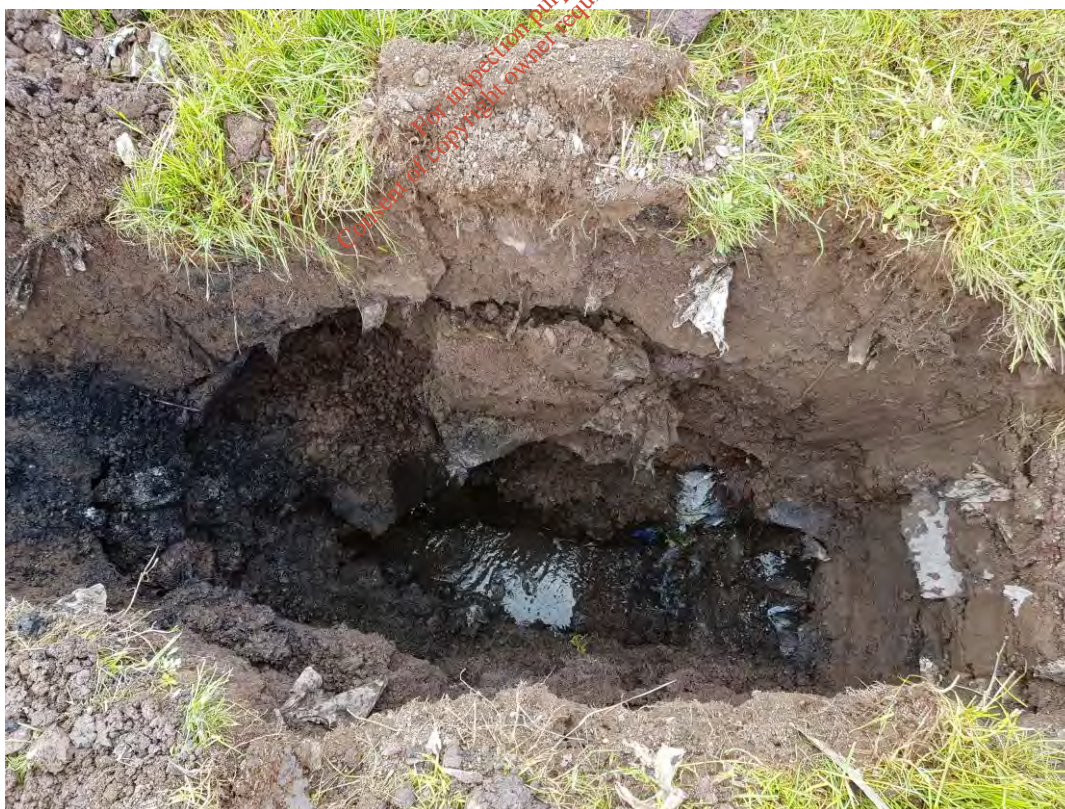
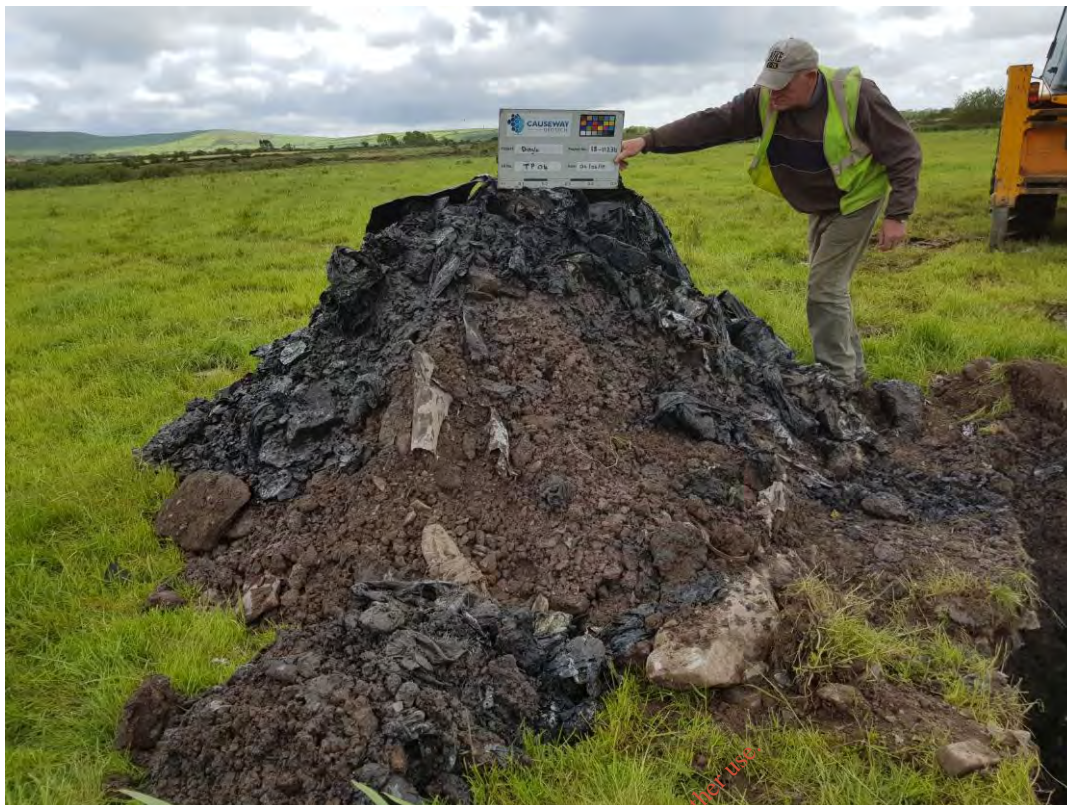
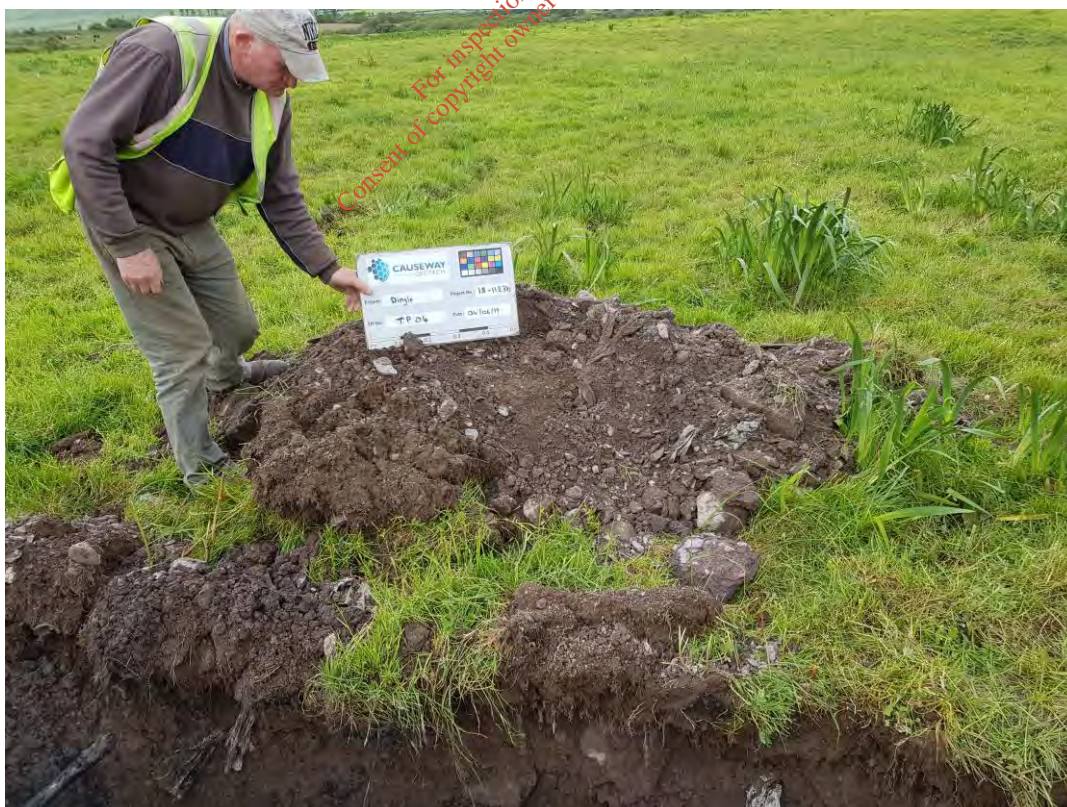
TP04 – SW Face

TOPSOIL	
				(0.80)

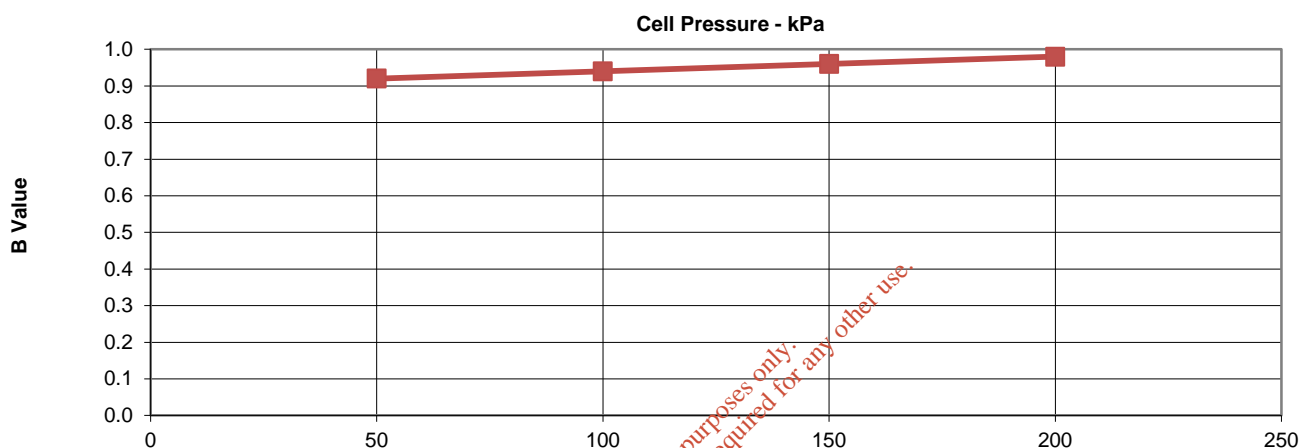
Specimen Details		
Hole Number		TP02
Sample Depth	m	0.50
Sample No.		1
Grid Reference		
Lift Number		
Saturation		
Cell Pressure Incr.	kPa	50
Back Pressure Incr.	kPa	50
Differential Pressure	kPa	10
Final Cell Pressure	kPa	200
Final B Value	-	0.98

Consolidation		
Effective Pressure	kPa	100
Cell Pressure	kPa	400
Back Pressure	kPa	300
Final PWP	kPa	301
PWP dissipation	%	99

Permeability Stage		
Cell Pressure	kPa	400
Mean Effective Stress	kPa	100
Back Pressure Diff.	kPa	20
Mean Rate of Flow	ml/min	0.0058
Average Temperature	'C	20
Vertical Permeability Kv	m/s	6.0E-10
