# APPENDIX 1

**► Tier 1 Review Report – Kilfountain (Dingle), Killarney ◀**

**S22-02662**

December 2011

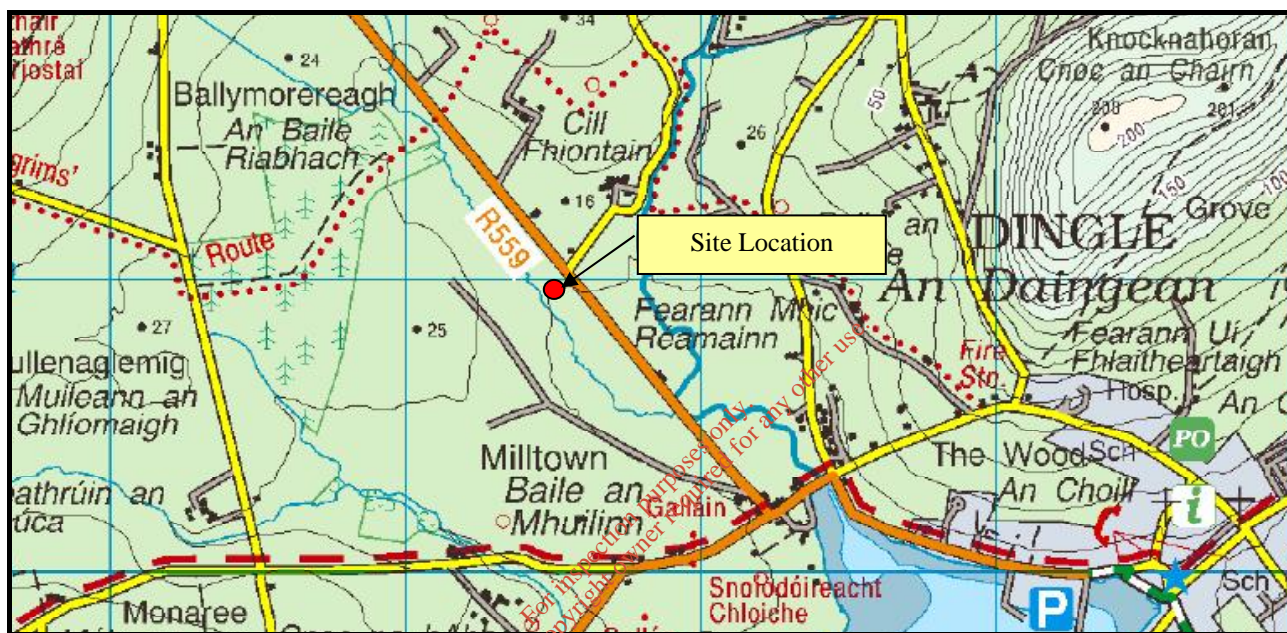
##### Site Location

The unregulated closed site is located in the townland of Kilfountain approximately \*\*km northwest of Dingle Town.

The site is bounded to the north and east by R559 Regional Road. The southwest edge is bounded by a local stream and the remain boundaries are with adjacent agricultural lands.

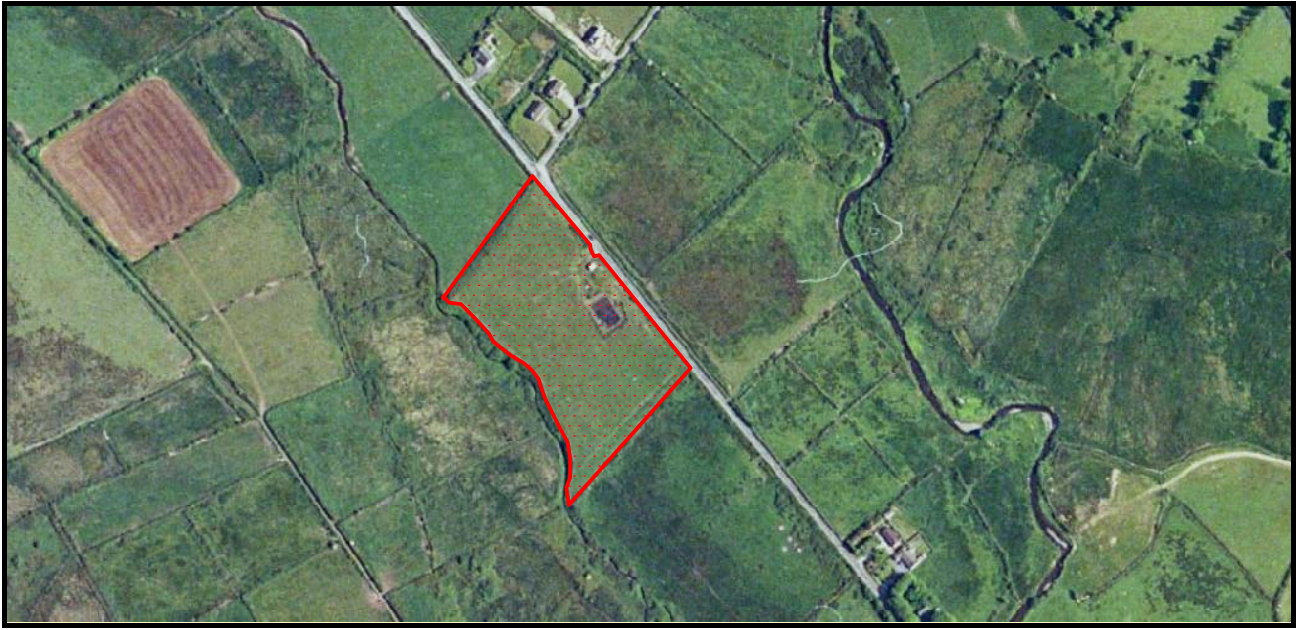
#### Aerial Photography (scale 1:5,000) - 2004

There are two sets of available aerial photography from 2000 and 2004. These are presented in the following pages

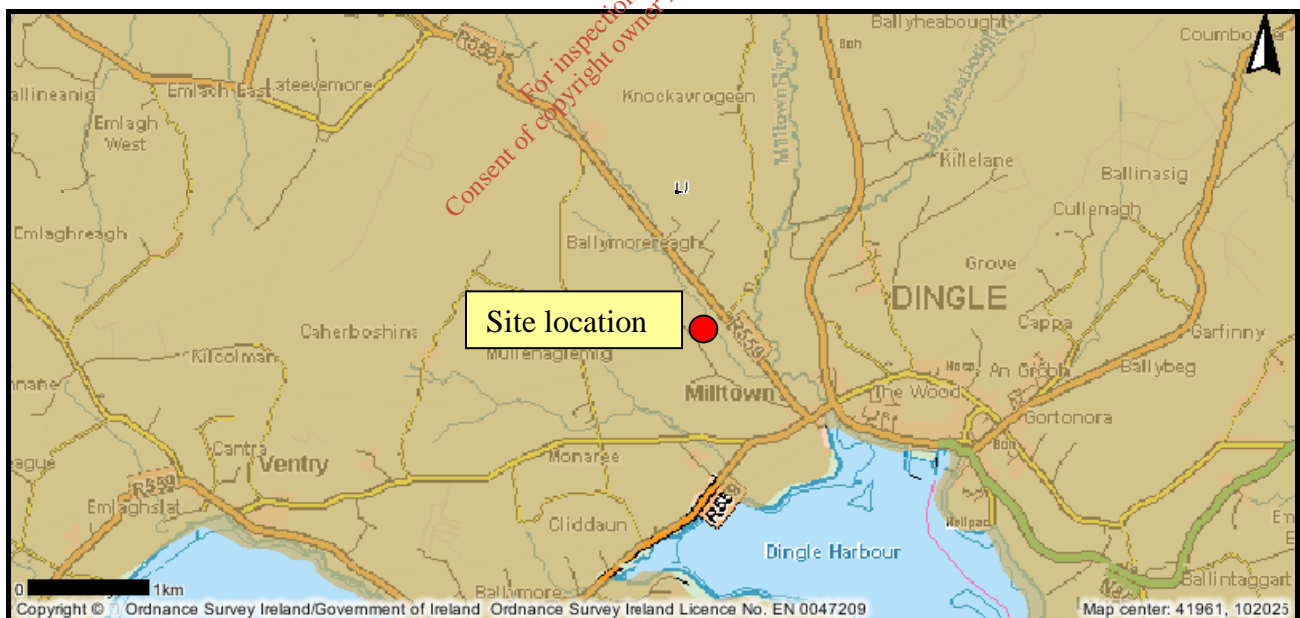
#### Aquifer status, scale 1:50,000

The LI status implied that the bedrock aquifer is moderately productive only in local zones.
