TIER 2 RISK ASSESSMENT HISTORIC LANDFILL AT LENAMORE, CO. KERRY

Prepared for: Kerry County Council

Date: August 2021

Abstract: This report represents the findings of a Tier 2 site environmental risk assessment carried out at Lenamore Historic Landfill, Co. Kerry. The risk assessment was conducted in accordance with the EPA Code of Practice for unregulated landfill sites.

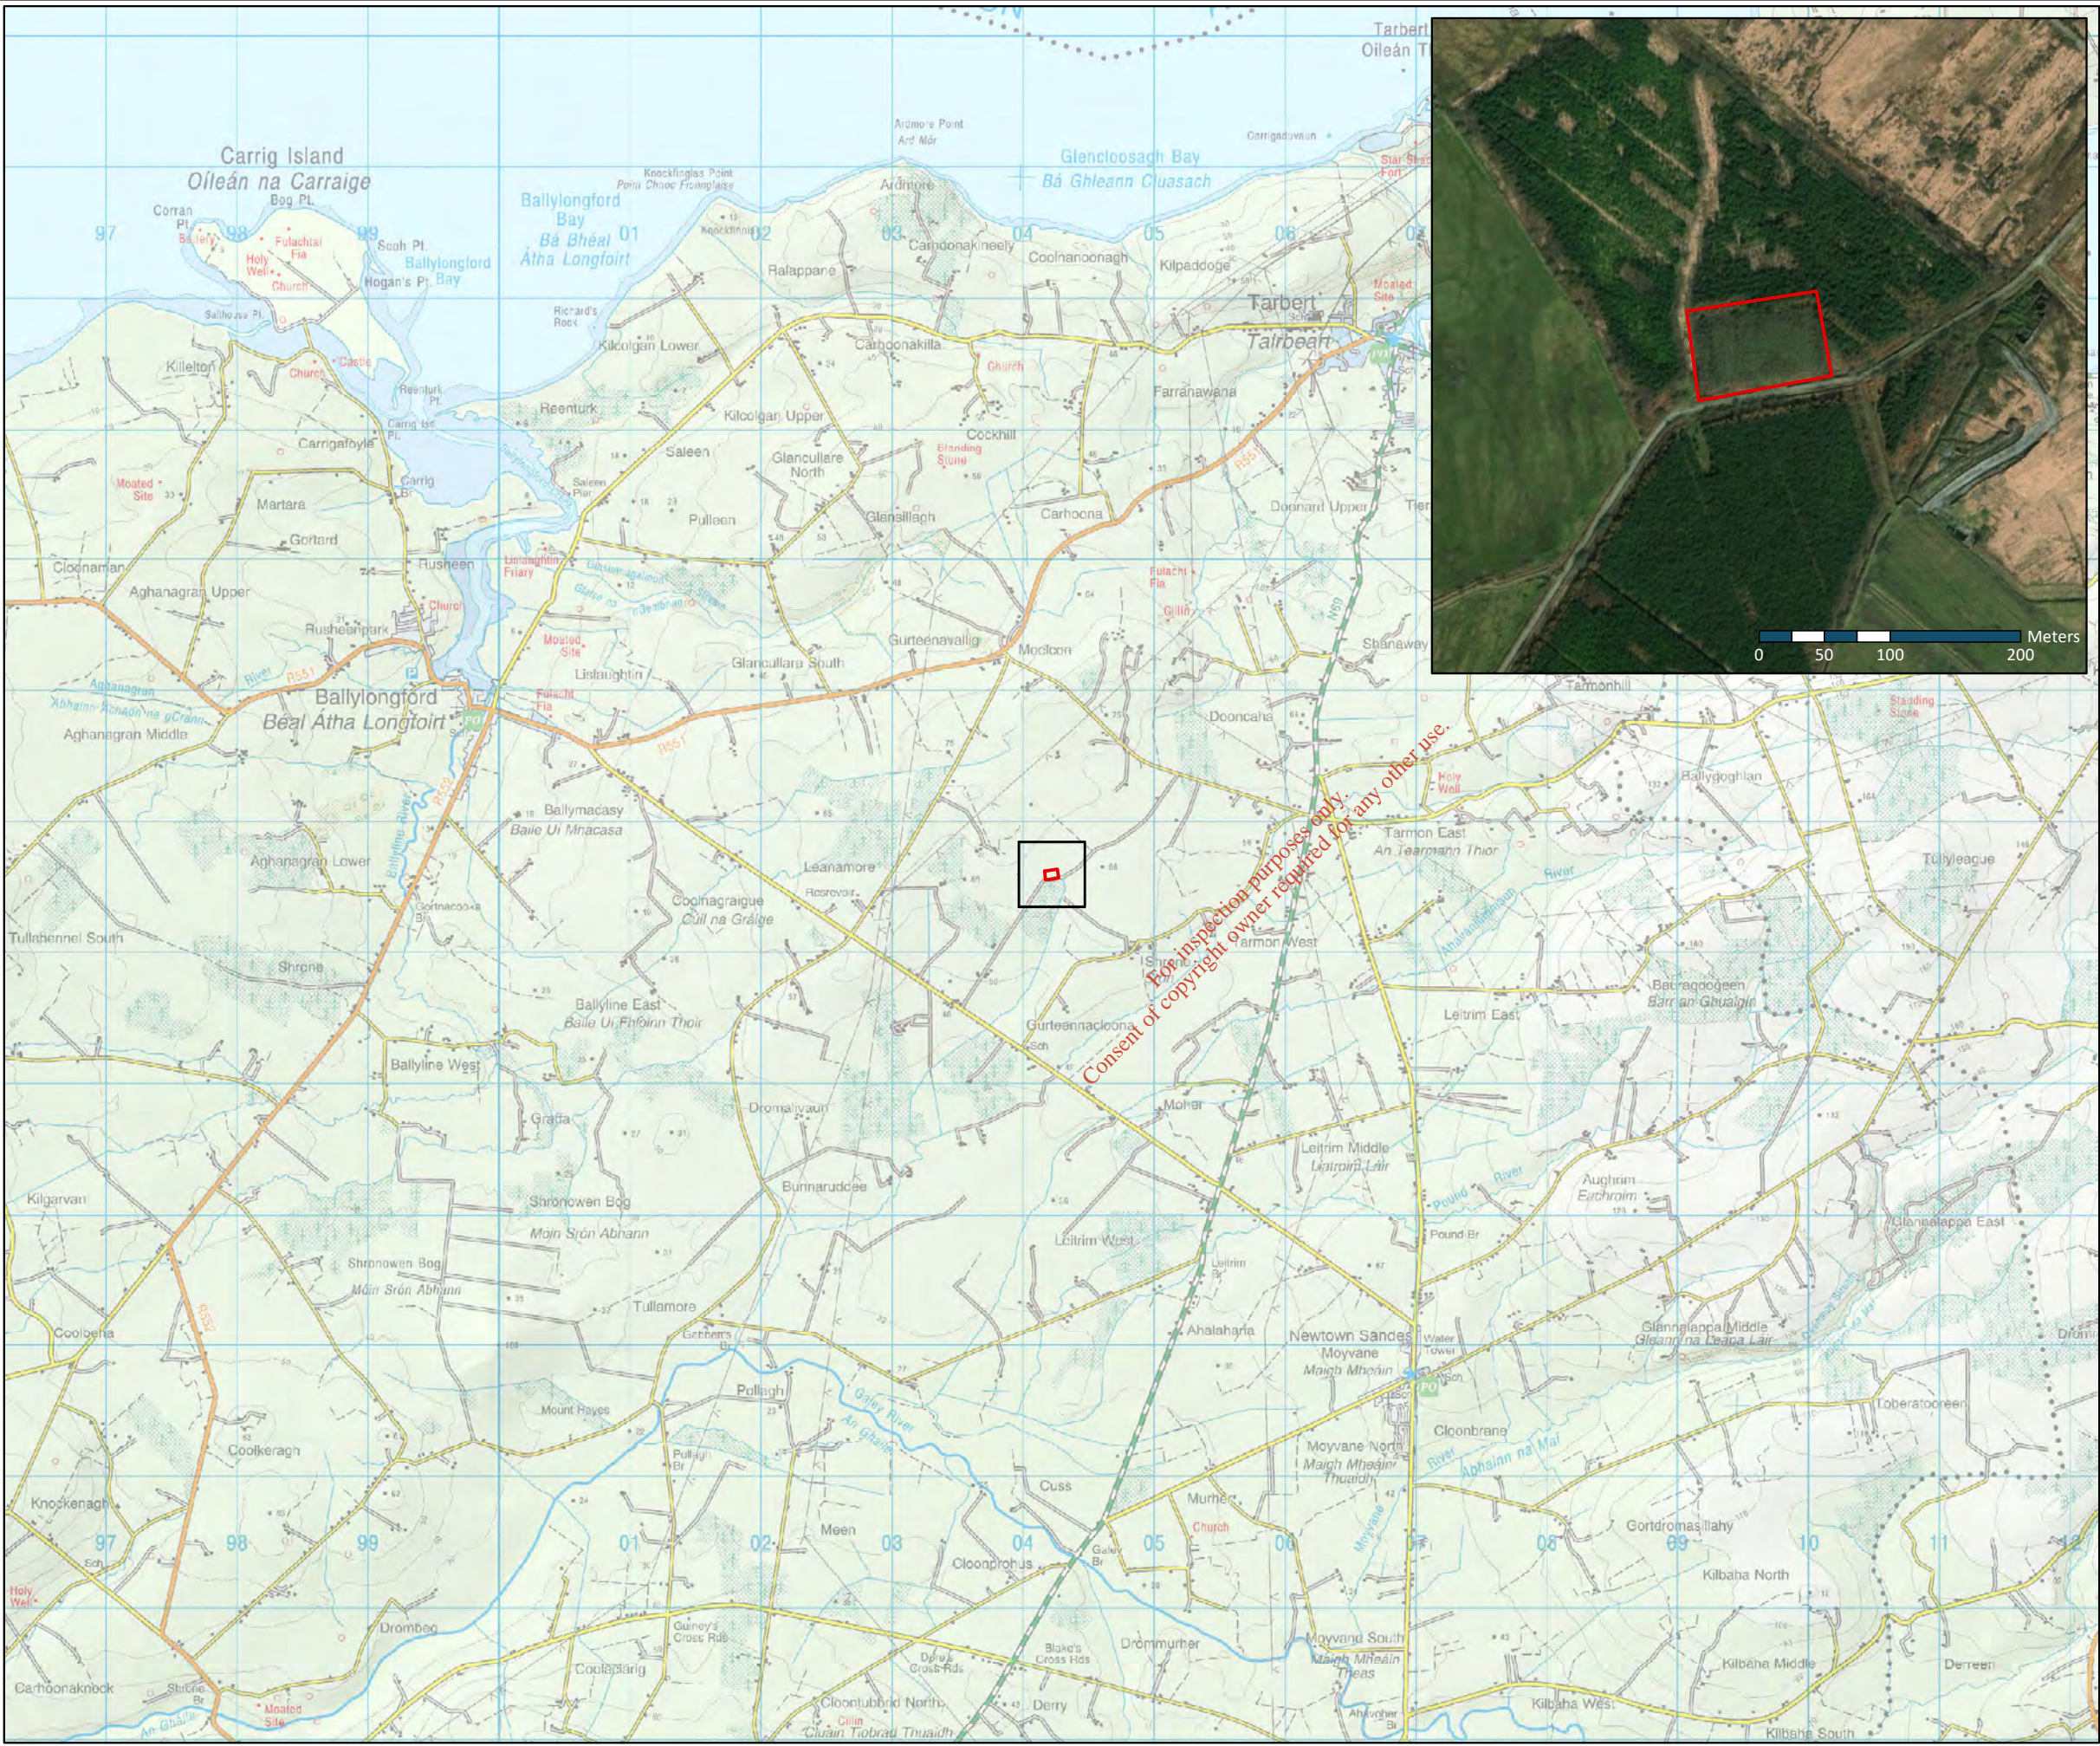
TITLE:		Site Location	
PROJECT:		Environmental Risk Assessment for Lenamore Landfill, Co. Kerry	
FIGURE NO:		2.1	
CLIENT:		Kerry County Council	
SCALE:	1:50000	REVISION:	0
DATE:	29/10/2019	PAGE SIZE:	A3

The site is bounded to the south by a small local road. All other sides are surrounded by agricultural land (forestry) and bog. There are no dwellings located within the site boundary or immediately adjacent to the site. The nearest dwelling is located approximately 400m north-west of the site.

The location of the site is shown in Figure 2.1.

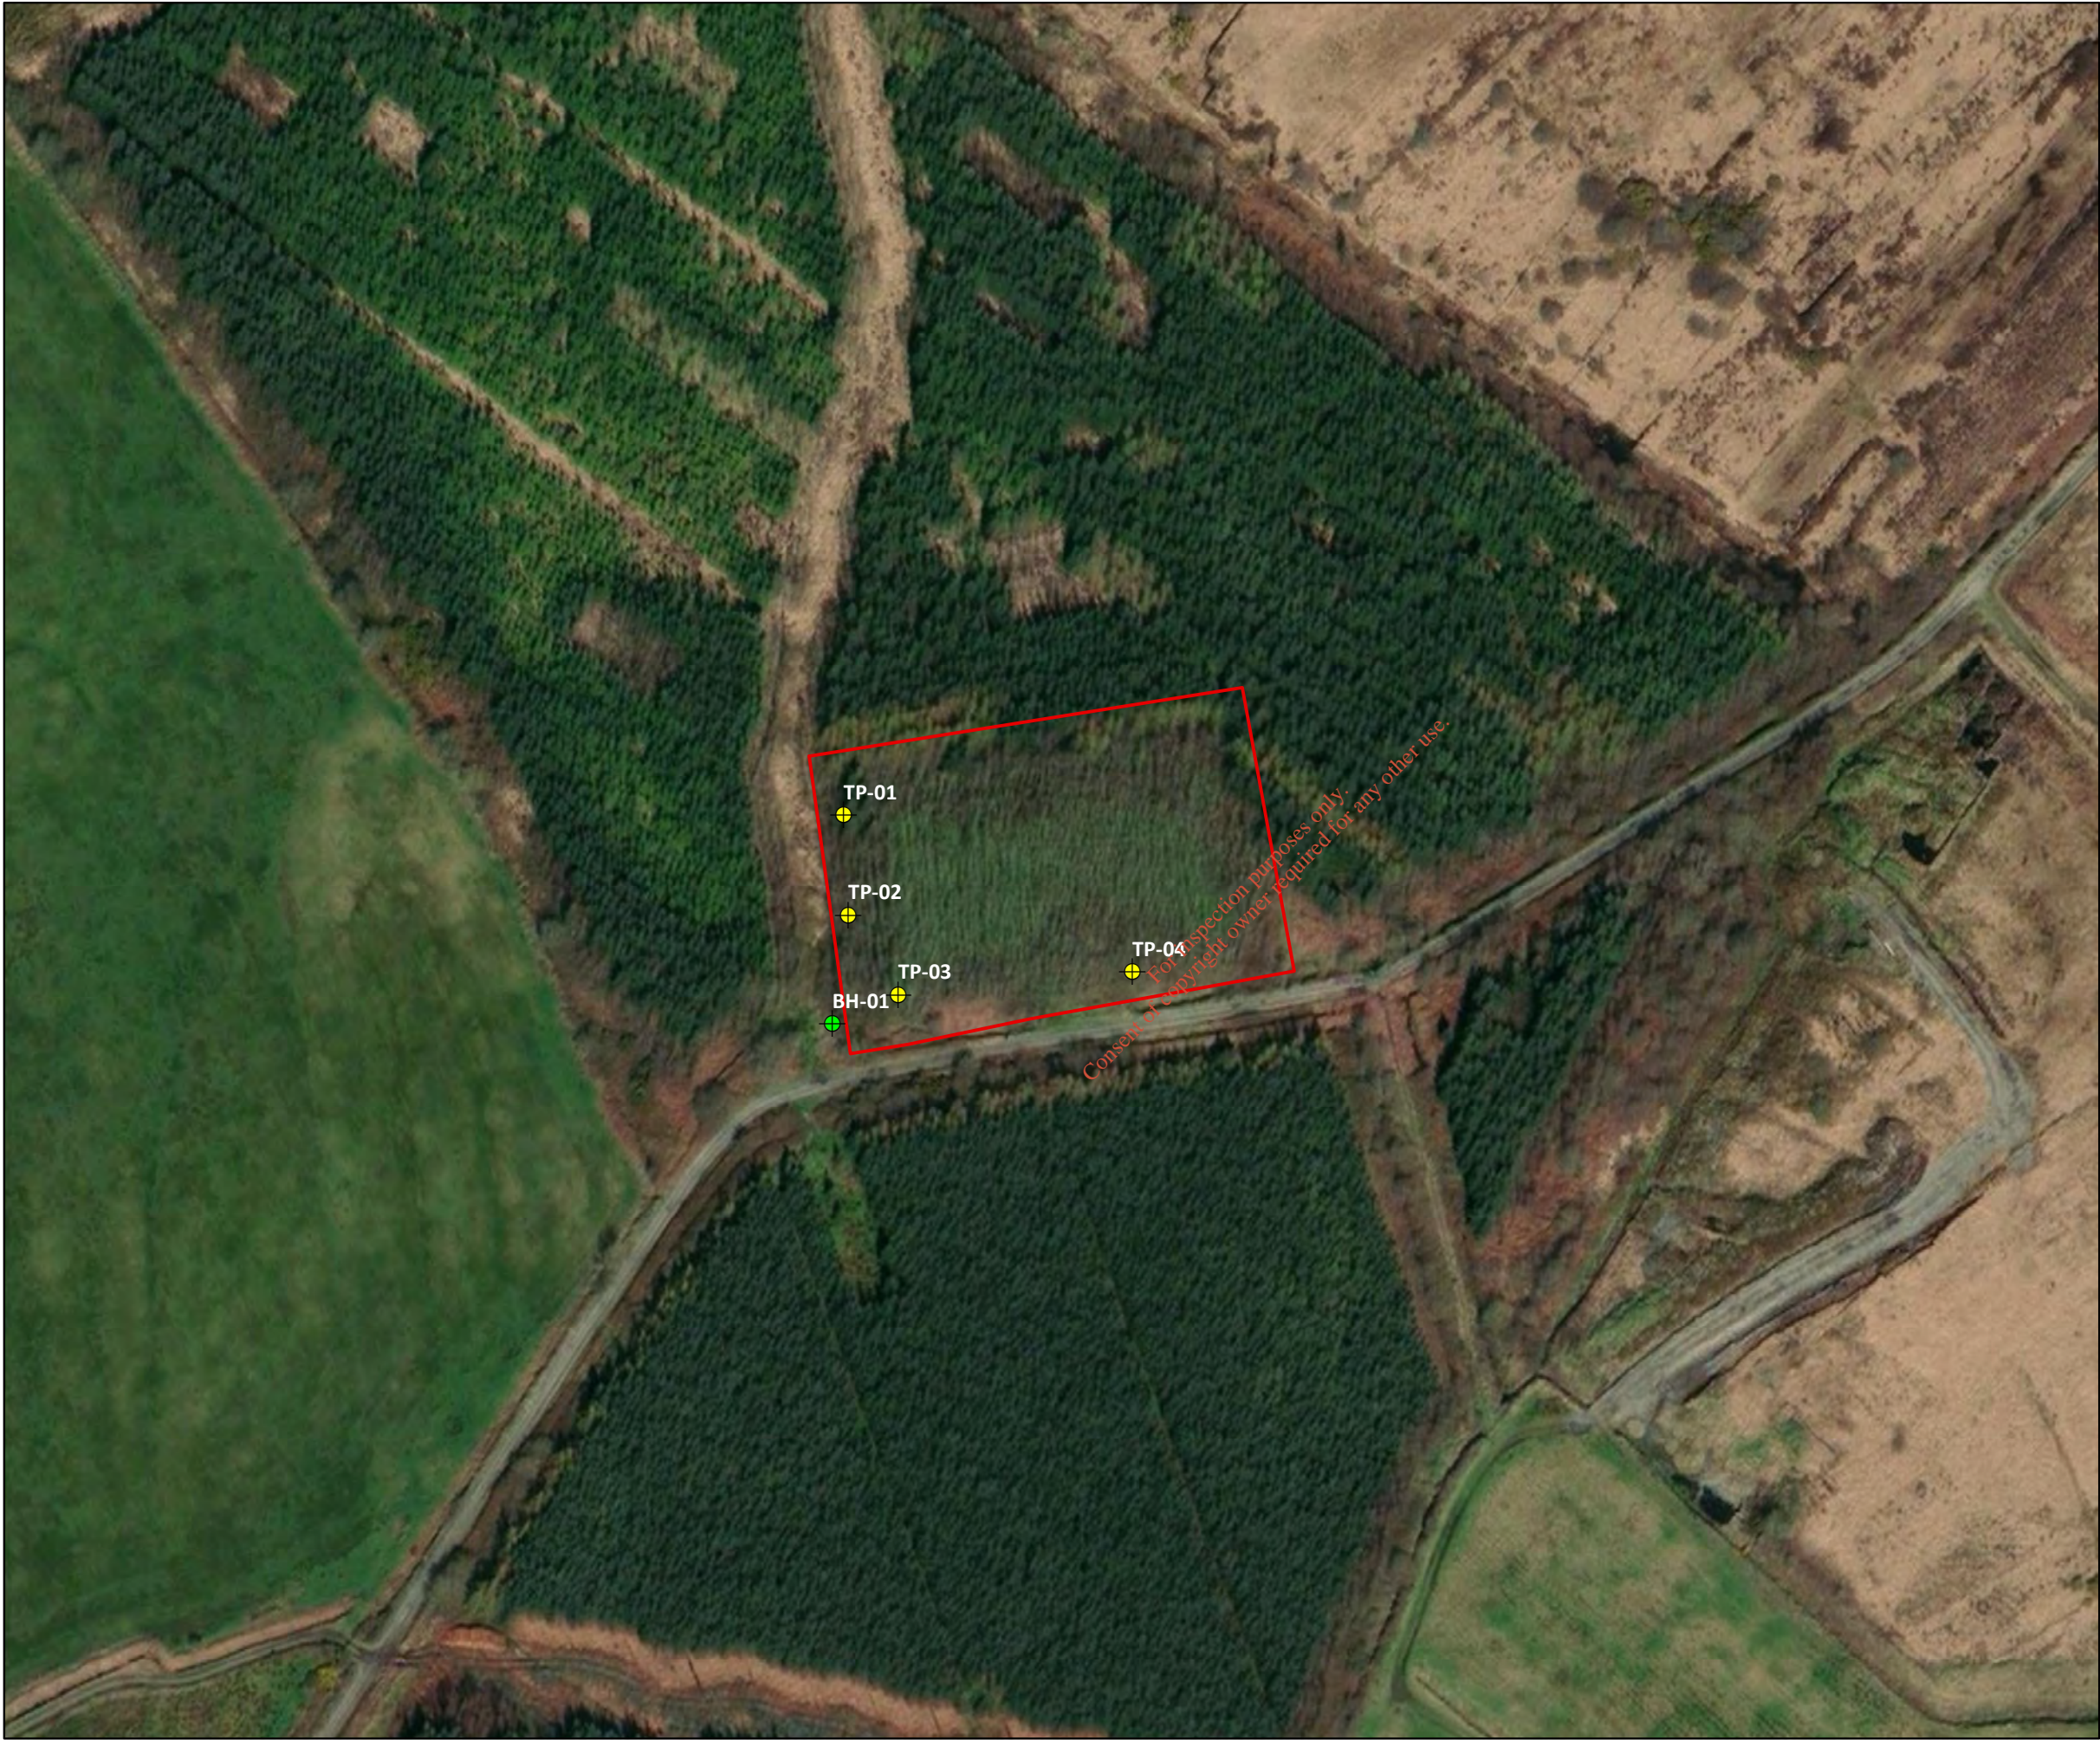
TITLE: Site Investigation Location Plan	
PROJECT: Lenamore Landfill, Co. Kerry	
FIGURE NO:	3.1
CLIENT:	Kerry County Council
SCALE:	1:1500
DATE:	13/11/2019
REVISION:	0
PAGE SIZE:	A3

A Causeway Geotech (CGL) Engineering Geologist supervised the advancement of 4 No. trial pits, shown in Figure 3.1, on the 6th June 2019.

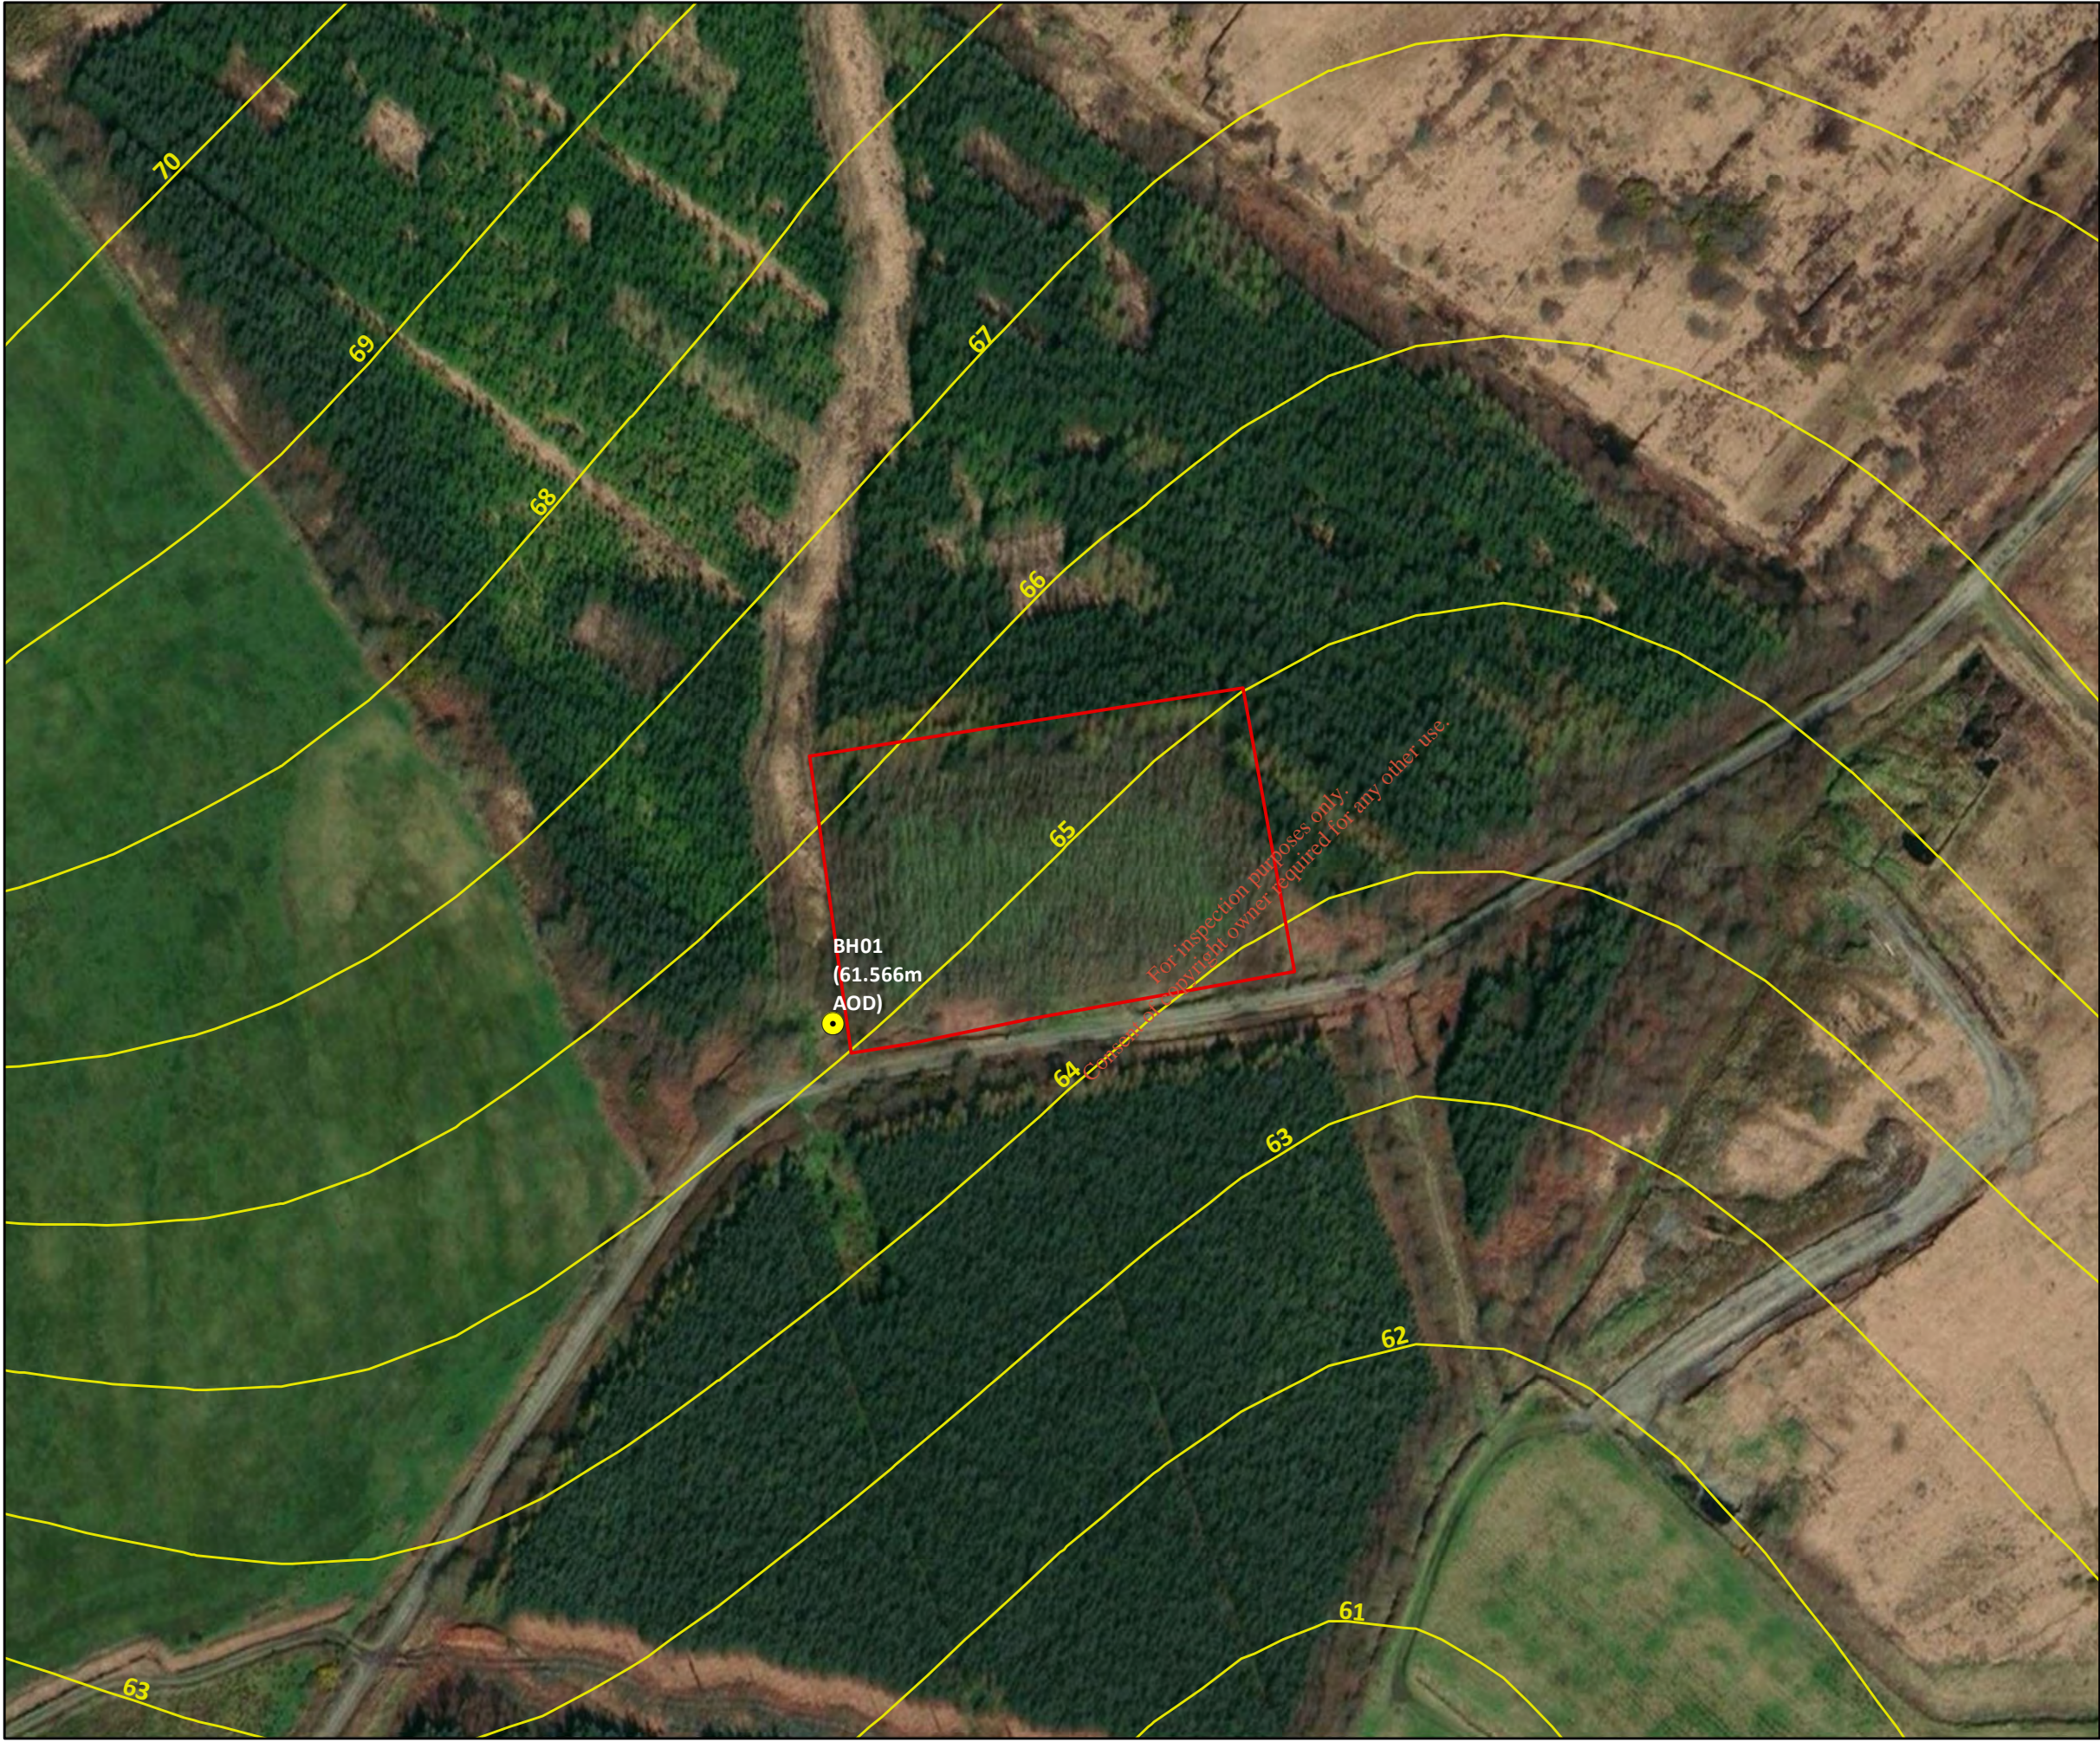
TITLE:		Groundwater Flow Direction	
PROJECT:		Lenamore Landfill, Co. Kerry	
FIGURE NO:		4.1	
CLIENT:		Kerry County Council	
SCALE:	1:1500	REVISION:	0
DATE:	31/10/2019	PAGE SIZE:	A3

Based on the above field survey measurements, groundwater levels were present below the surface at over 2.5m below ground level (m bgl). Therefore, based on this standalone measurement, it is assumed that the potentiometric groundwater surface intersects the waste body further upgradient. This was confirmed where shallow groundwater was encountered within trap pit TP04.

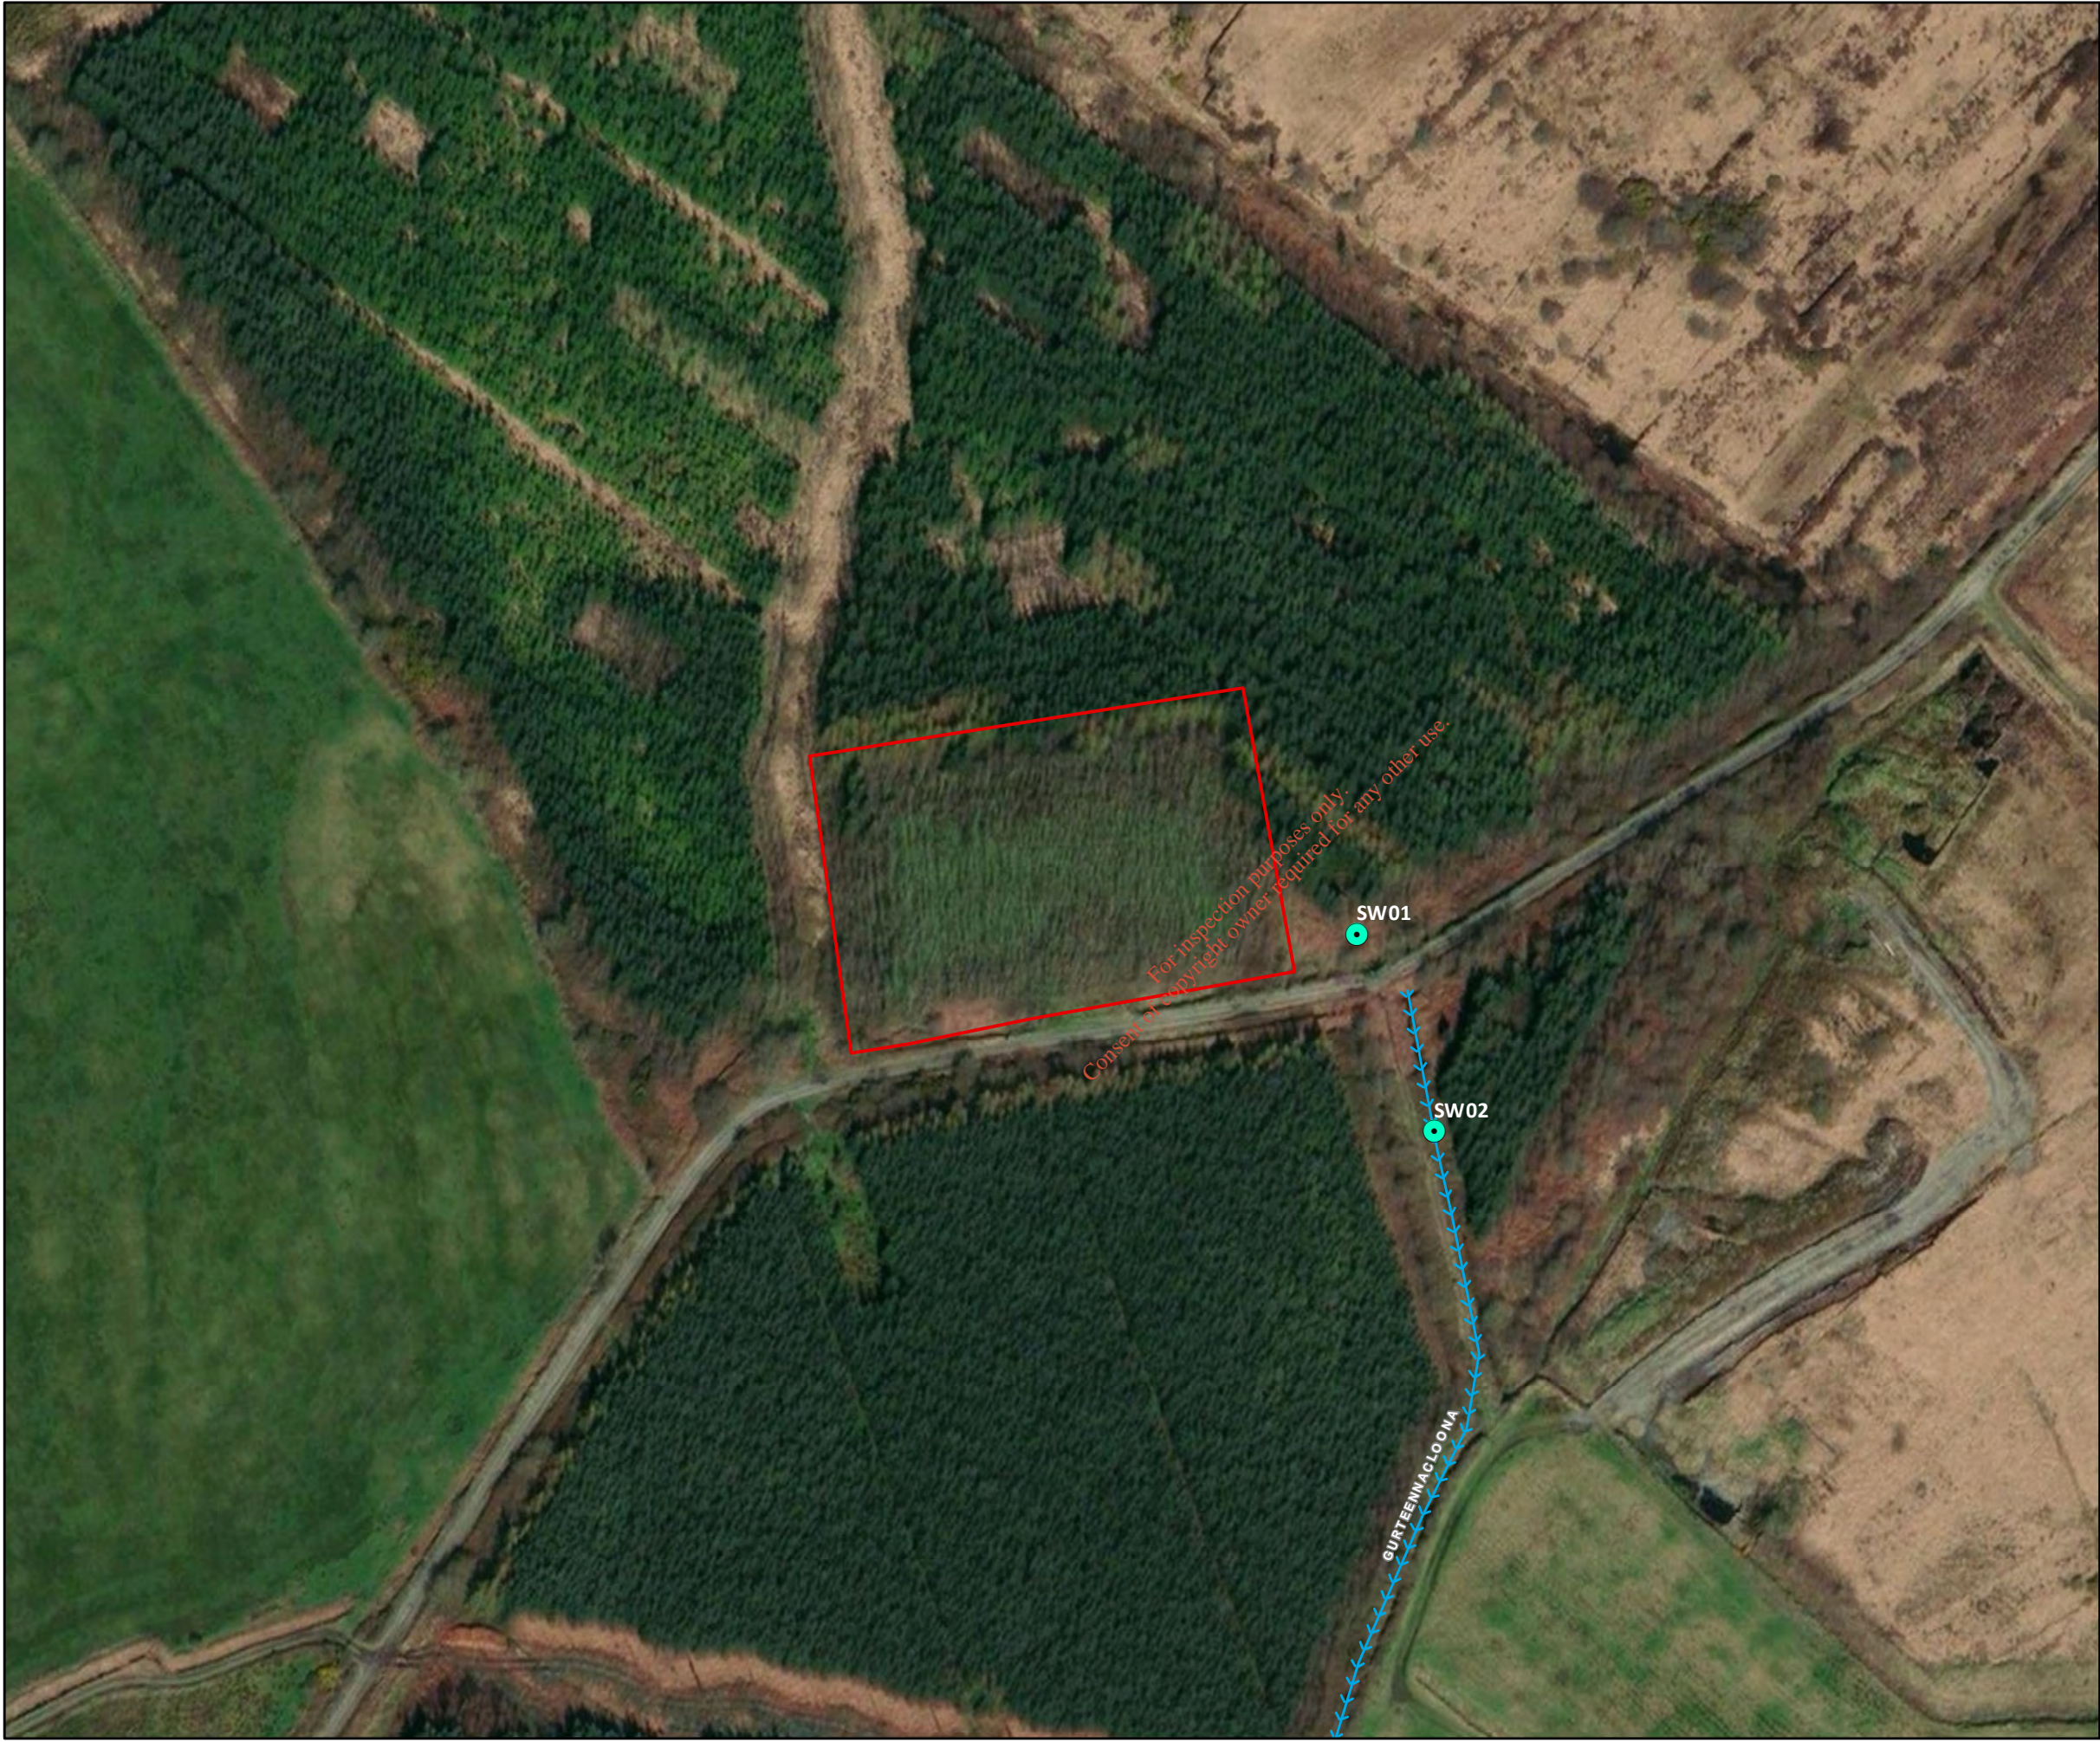
TITLE:		Surface Water Sampling Locations	
PROJECT:		Lenamore Landfill, Co. Kerry	
FIGURE NO:		4.2	
CLIENT:		Kerry County Council	
SCALE:	1:1500	REVISION:	0
DATE:	31/10/2019	PAGE SIZE:	A3

The EQS limit values for Iron were recorded at both surface water at SW2 during July 2019 and at SW1 during September 2019. The recorded exceedances of Phosphorus and Iron in surface water samples may be indicative of direct impact to surface waters from leachate generated within the waste body.
