# APPENDIX 1

**► Tier 1 Review Report – Listowel ◀**

**S22 - 02667**

November 2013

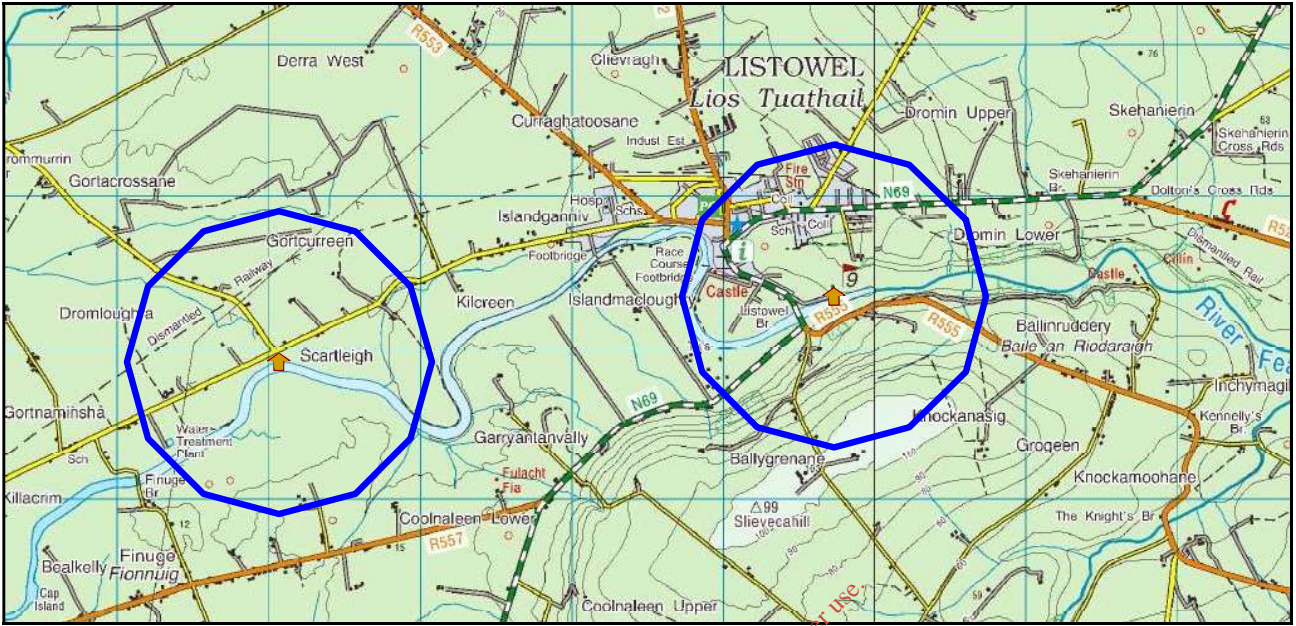
The site is located 3.59 km from the edge of Scartleigh surface water abstraction point and within 140m of the disused Listowel Town Source. As a precaution the Listowel Town Supply is taken as being in operation.

It should be noted that if a score of 3 was entered for 3D and all other scores remain the same the class of site would be calculated, based on the risk screening, as MODERATE in SPR 5 only

Based on the above this score is used in the Risk Assessment (see Appendix 1)	Table 3D	Score 7
---	----------	---------

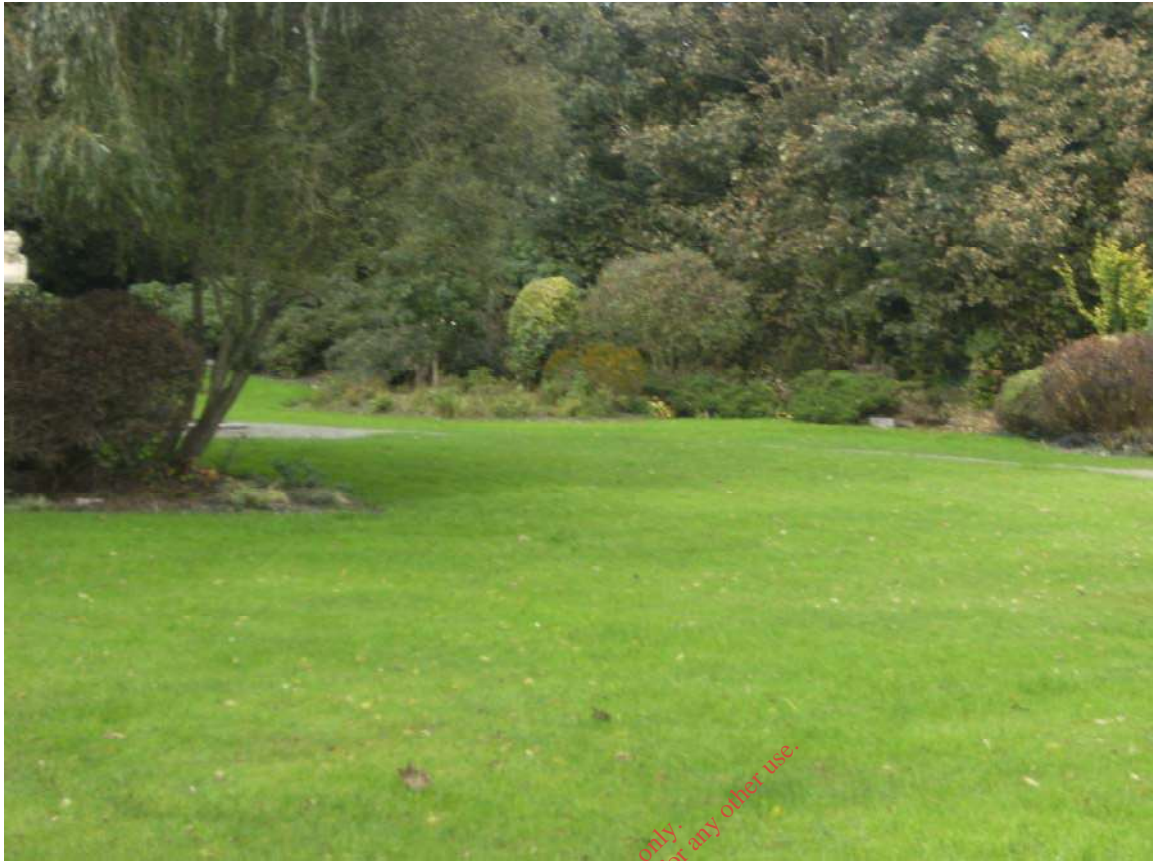
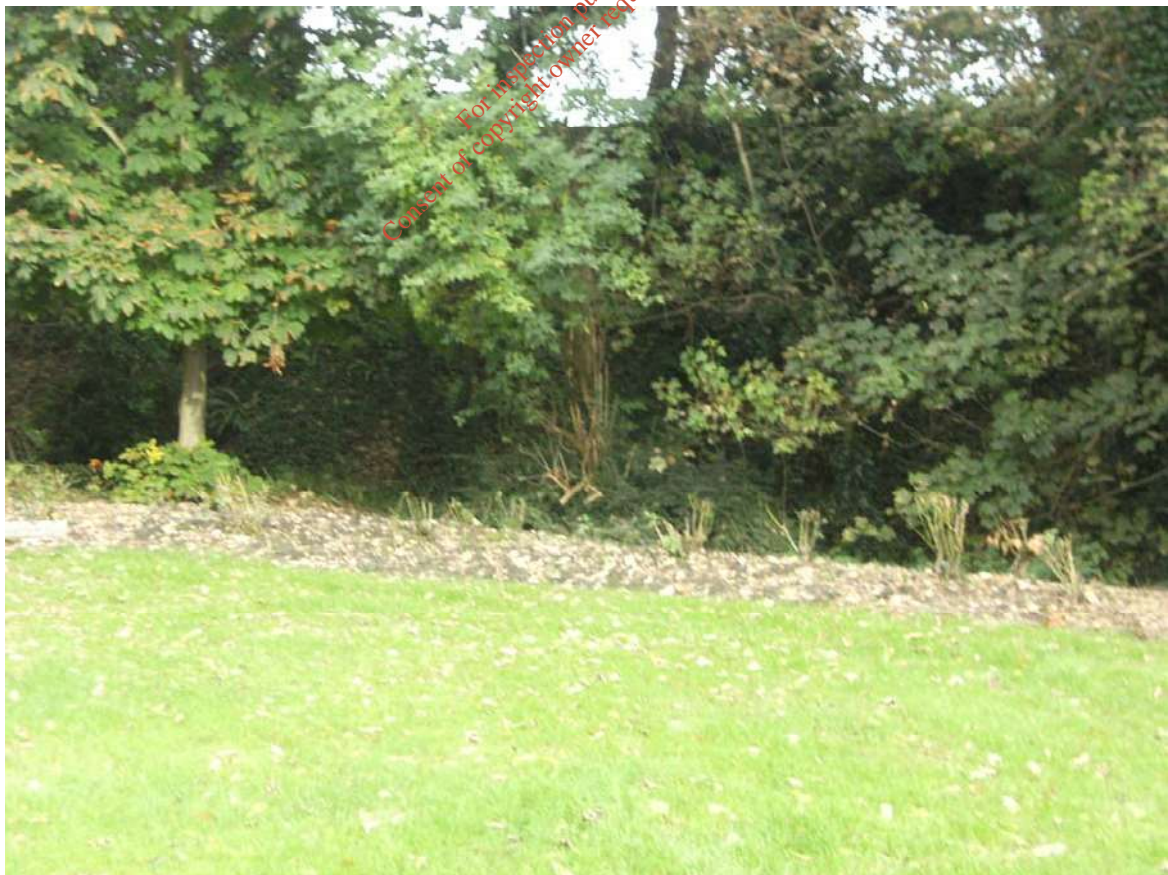
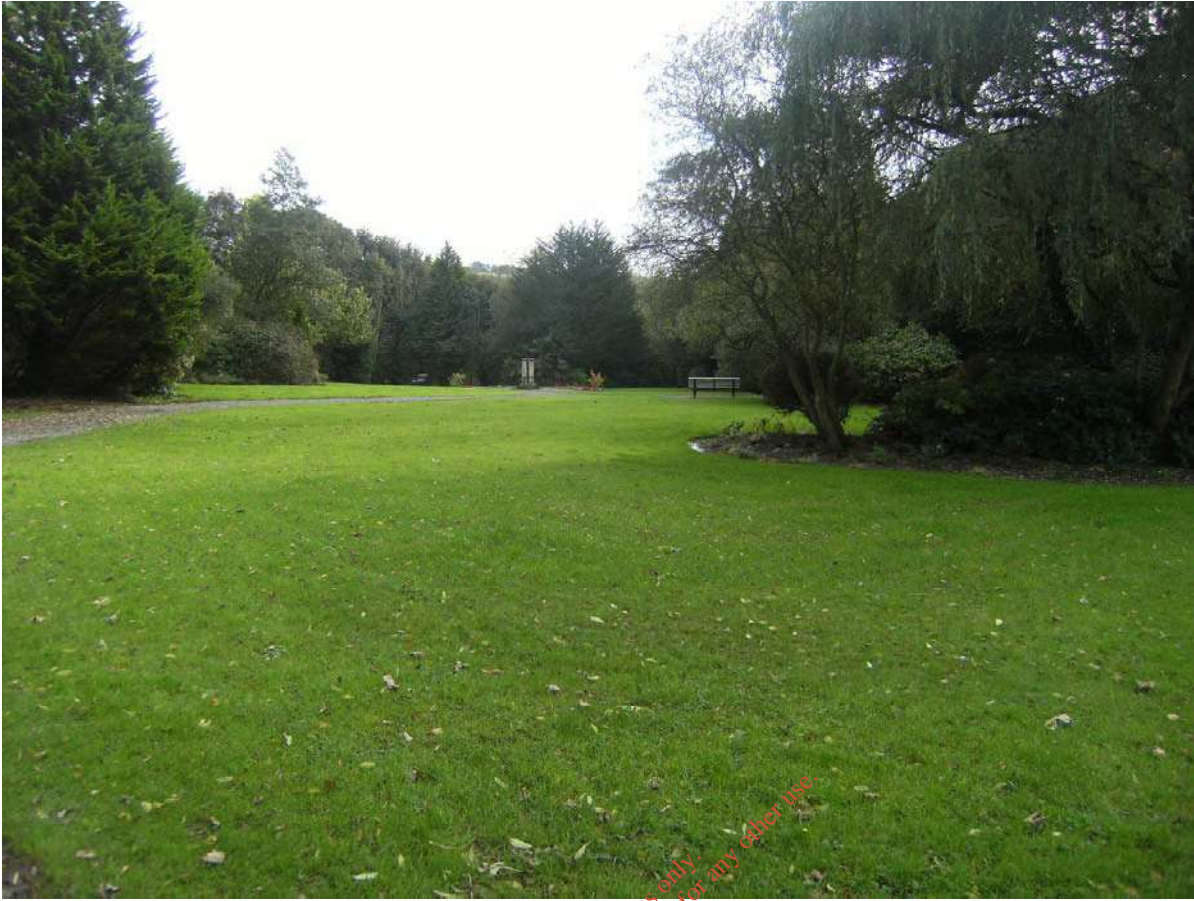
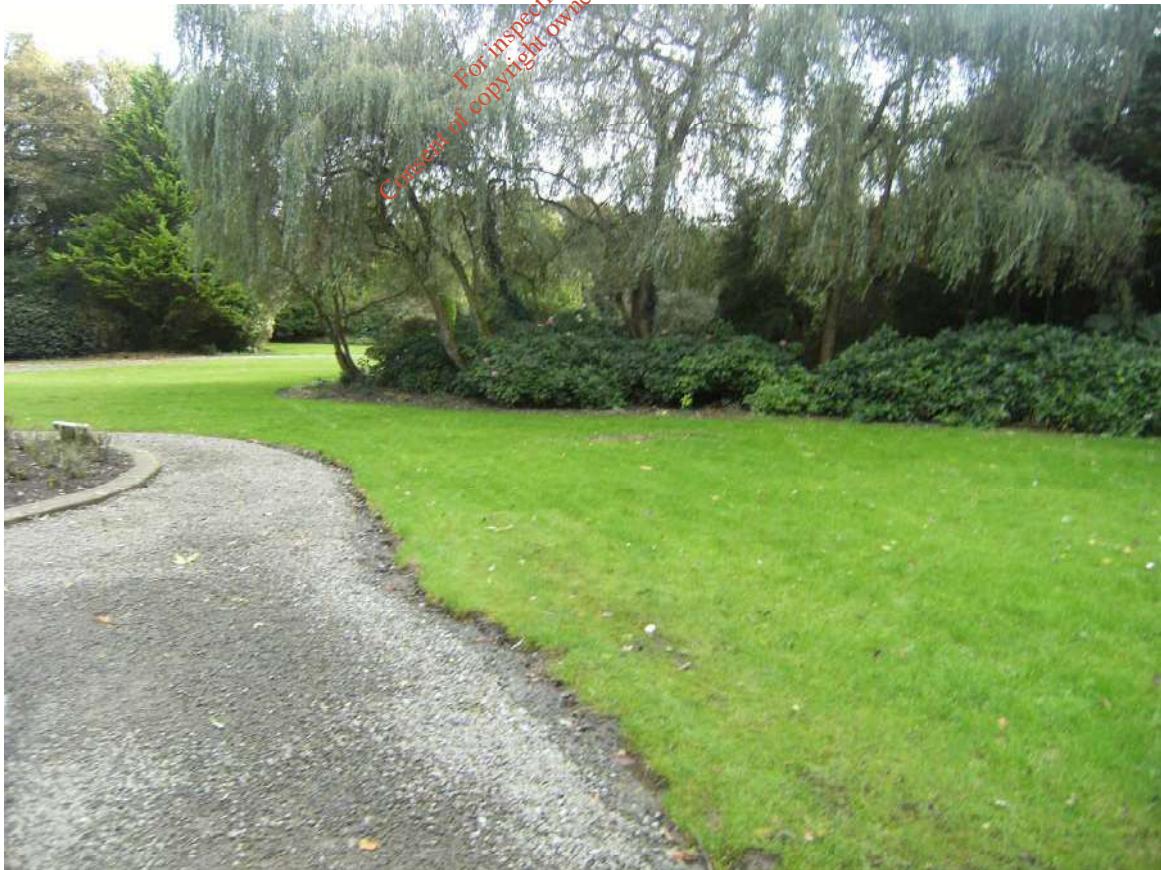
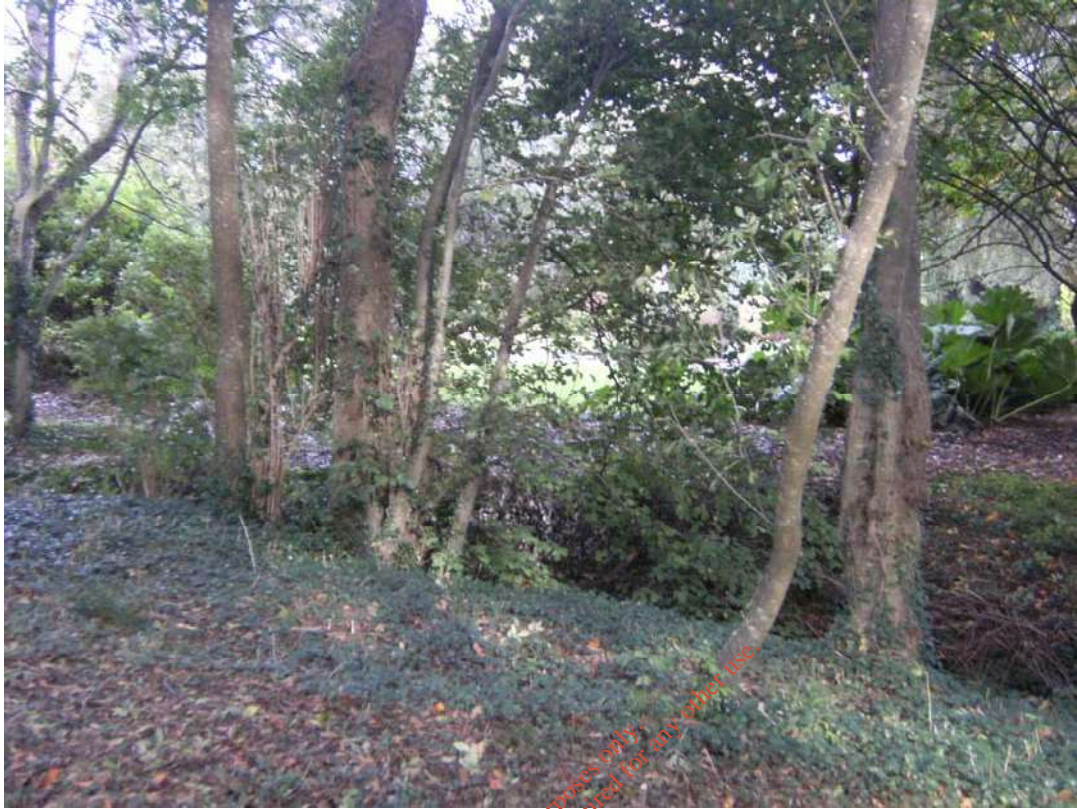
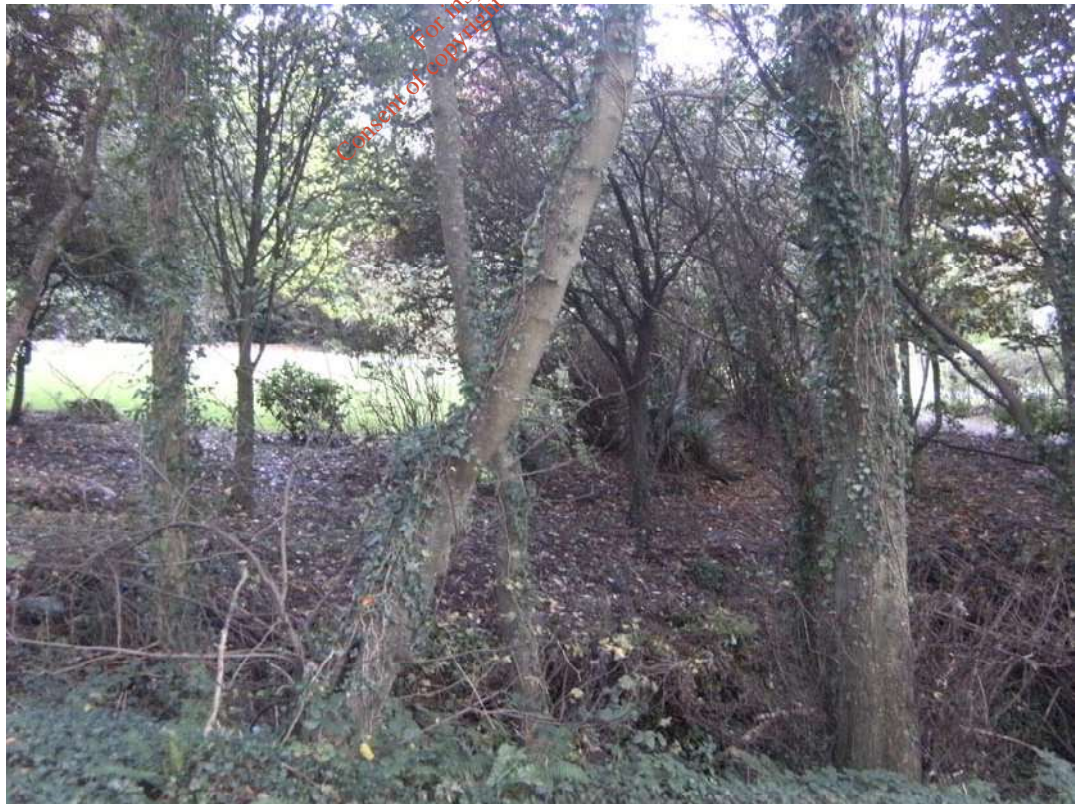
<b><i>Walkover Survey Checklist</i></b>	<b><i>Comment</i></b>
Site	Listowel
What is current landuse	Parkland
What are the neighbouring land uses	Amenity
What is the size of the site	Approx 1 Ha
What is the topography	Undulating
Are there potential receptors (if yes - details)	Yes
Houses	Approx 200m
Surface water features (if yes distance and direction of flow)	Yes - River Feale
Any wetland or protected area	Yes
Public water supplies	Yes - now closed
Private wells	No
Services	None visible
Other buildings	Storage yard
Other	
Are there any potential sources of contamination (if yes give details)	
Surface waste (if yes what type)	None
Surface ponding of leachate	None

Leachate seepage	None
Landfill gas odours	None
Are there any outfalls to surface water	None
Are there any signs of impact on the environment (if yes take photographic evidence)	
Vegetation die off, bare ground	None
Leachate seepage	None
Odours	None
Litter	None
Gas bubbling through water	None
Signs of settlement, subsidence water logged areas	None
Drainage or hydraulic issues	None
Downstream water quality appears poorer than upstream water quality	
Are there any indications of remedial measures (provide details)	Area has been filled in and landscaped
Capping	Yes - sub soil
Landfill gas collection	No
Leachate collection	None
Describe fences and security features (if any)	None, part of parkland
Any other relevant information	
Site name and reference;	Listowel, S22 - 02667
Date of inspection;	October 25th 2013
Walk over survey by;	Conor Culloo
