Historical Landfills in North Kerry - Listowel

Client: Kerry County Council

Report No.: 18-1068c

Date: September 2019

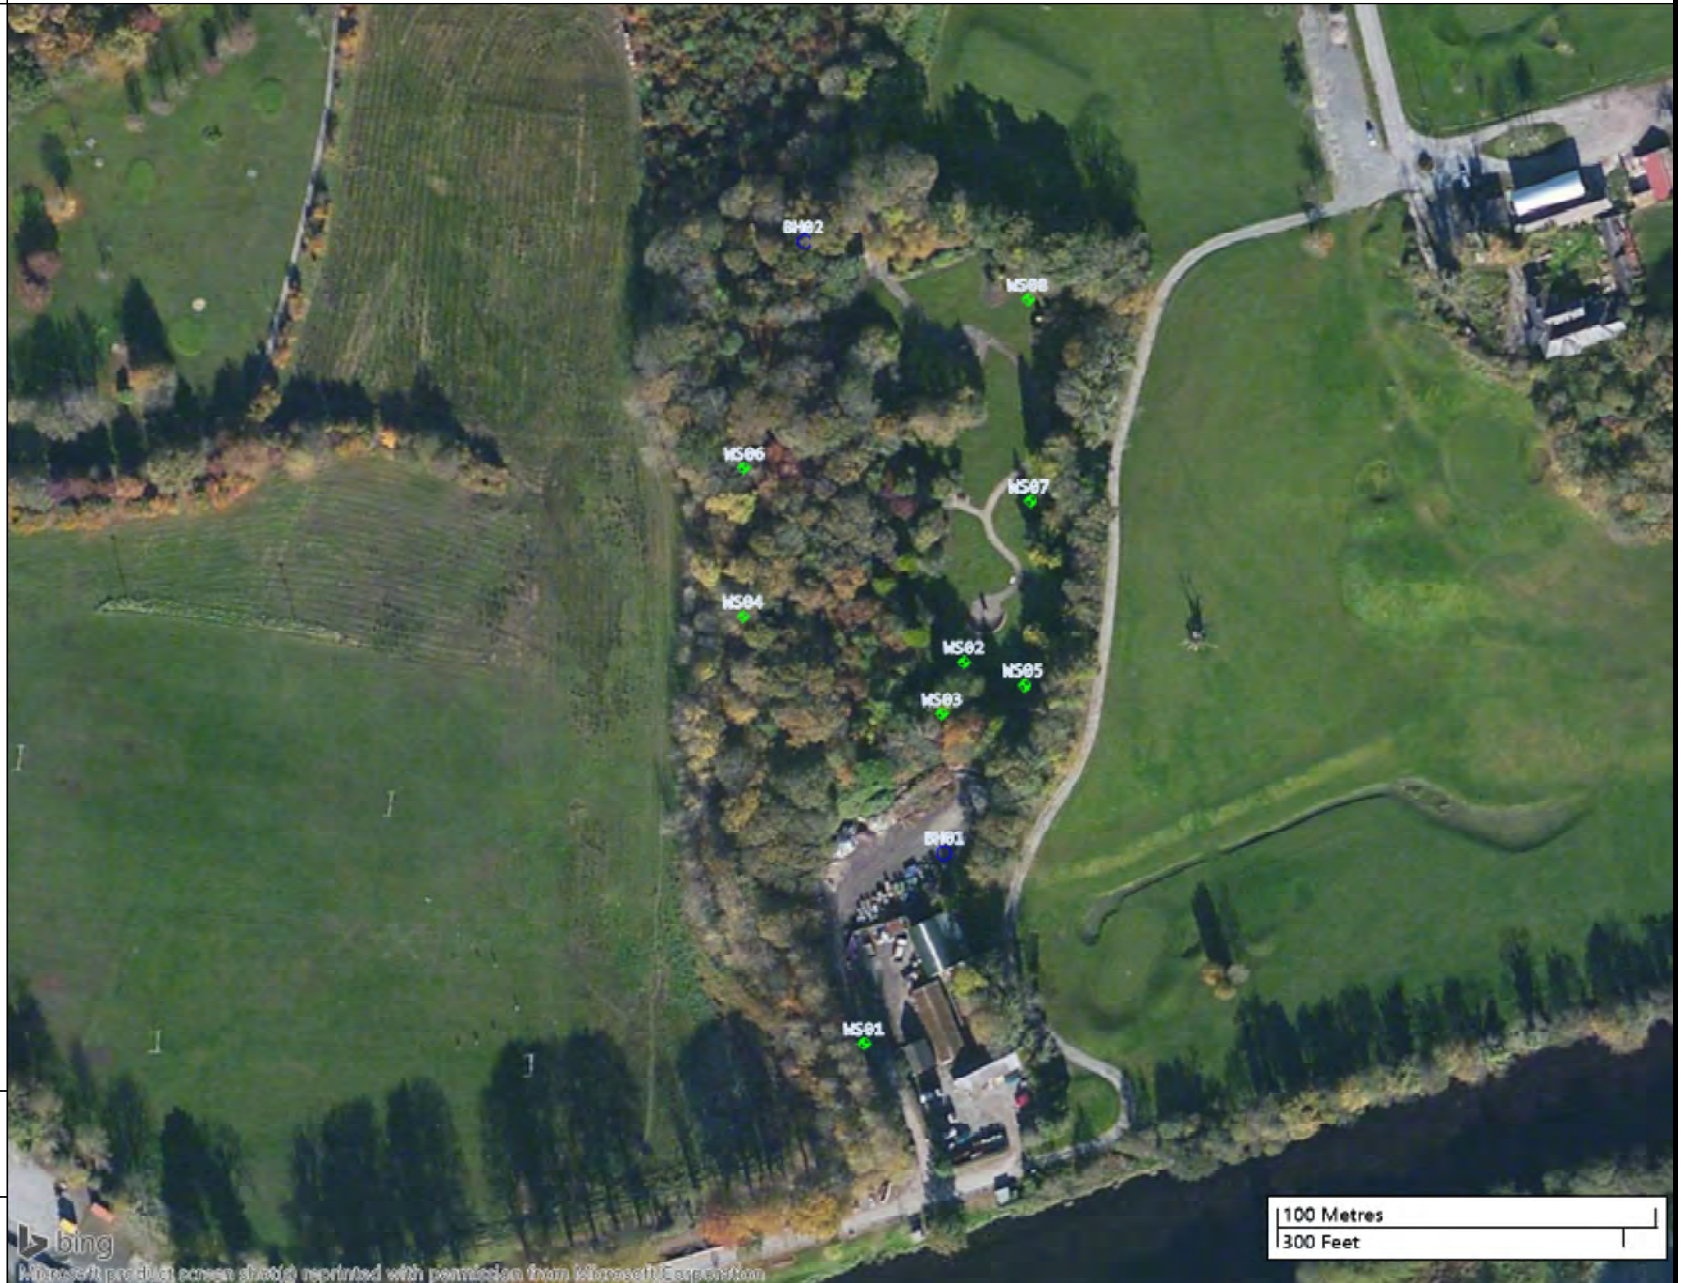
Title:
Exploratory Hole Location Plan

The exploratory holes and in-situ tests were located as instructed by the Client's Representative, as shown on the exploratory hole location plan in Appendix A.

The plan coordinates (Irish National Grid) and ground elevation (mOD Malin) at each location are recorded on the individual exploratory hole logs. The exploratory hole plan presented in Appendix A shows these as-built positions.

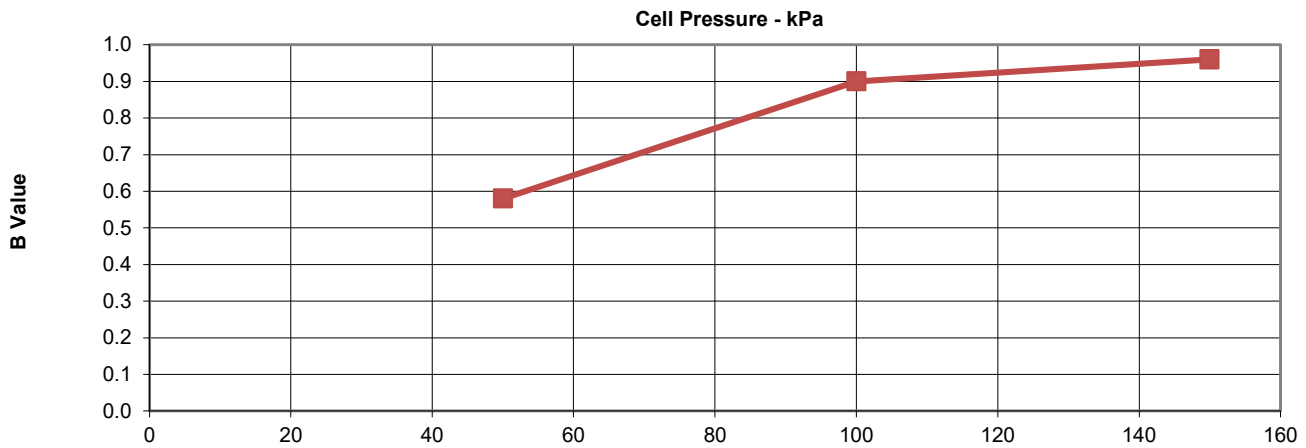
Specimen Details		
Hole Number		WS08
Sample Depth	m	0.10
Sample No,		1
Grid Reference		
Lift Number		
Saturation		
Cell Pressure Incr.	kPa	50
Back Pressure Incr.	kPa	50
Differential Pressure	kPa	10
Final Cell Pressure	kPa	150
Final B Value	-	0.96

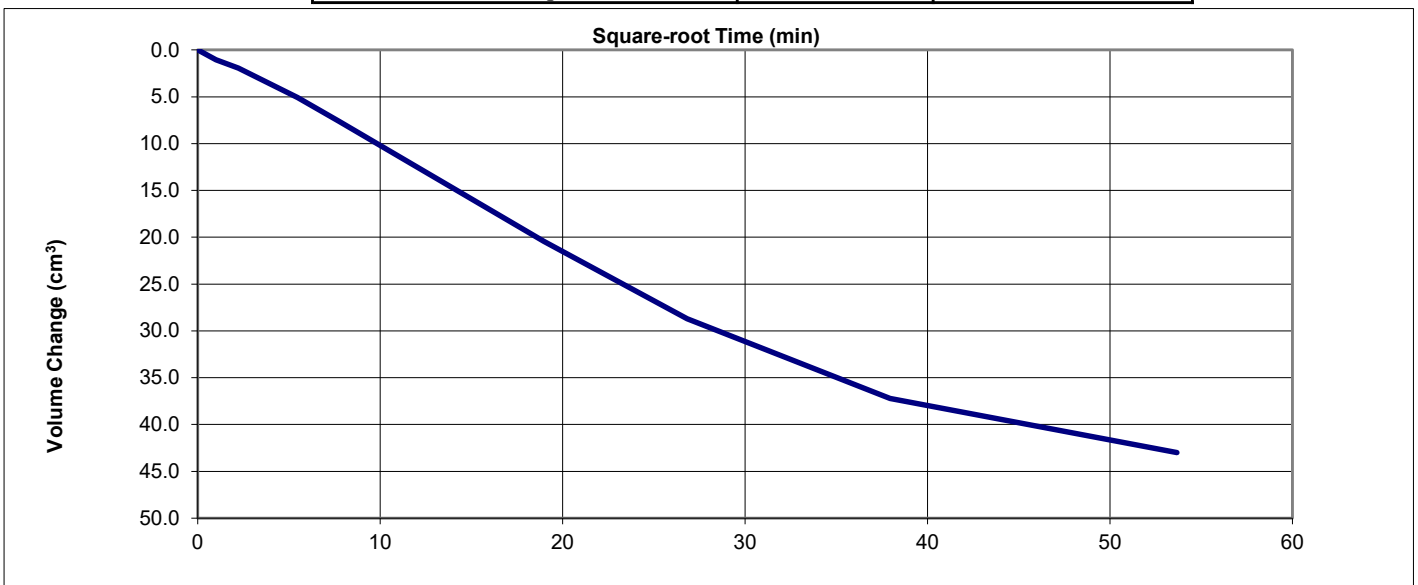
Consolidation		
Effective Pressure	kPa	100
Cell Pressure	kPa	400
Back Pressure	kPa	300
Final PWP	kPa	300
PWP dissipation	%	100
