► Tier 1 Review Report – Listowel ◀

S22 - 02667

November 2013

The site is known as Listowel closed landfill.

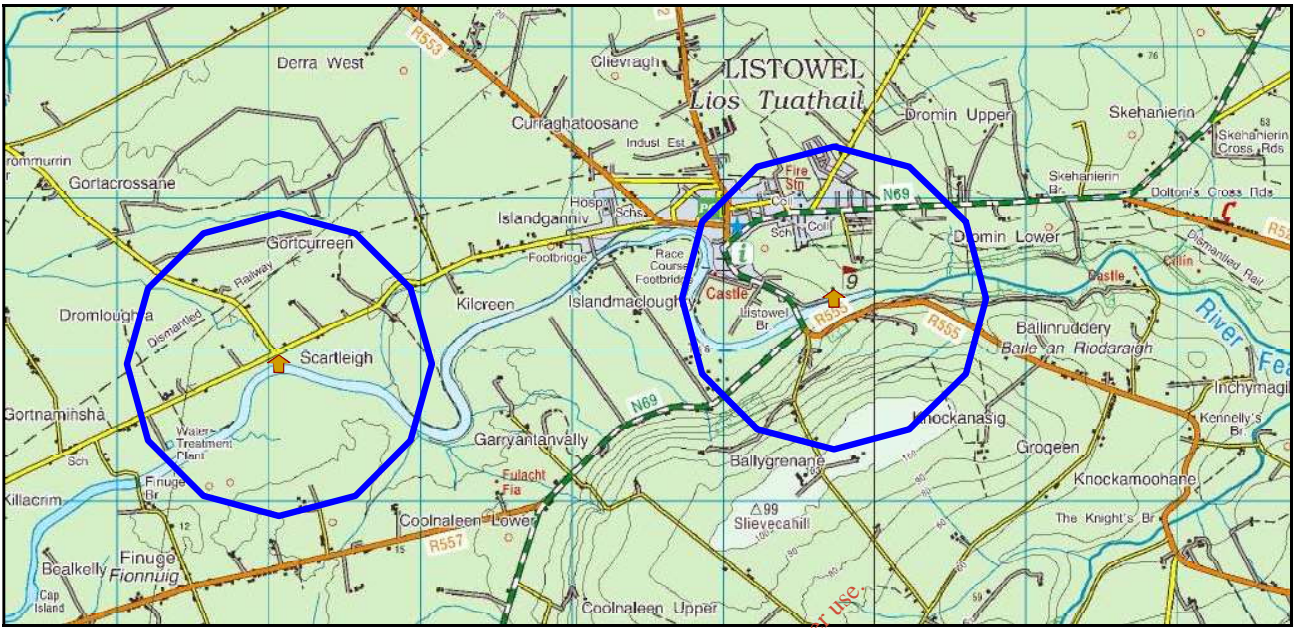
The site is located 3.59 km from the edge of Scartleigh surface water abstraction point and within 140m of the disused Listowel Town Source. As a precaution the Listowel Town Supply is taken as being in operation.

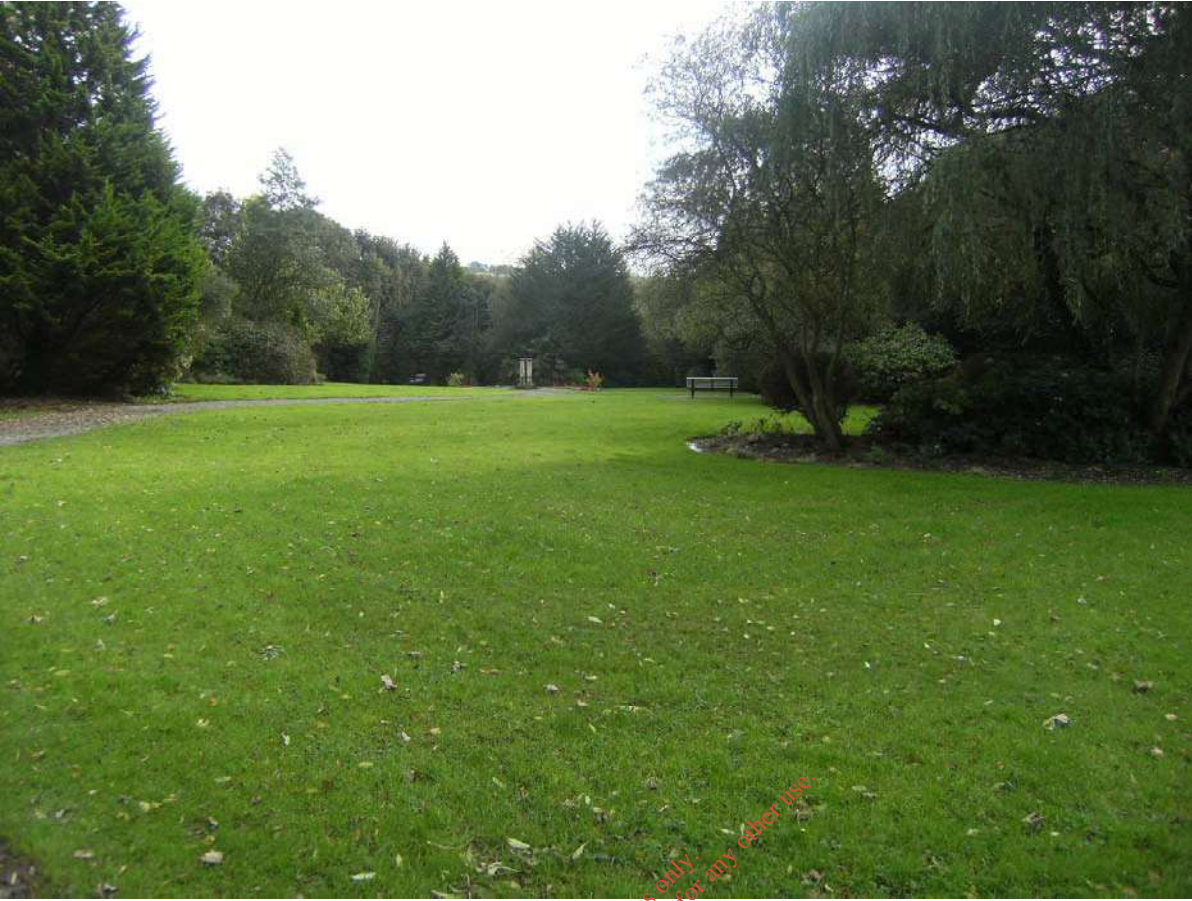
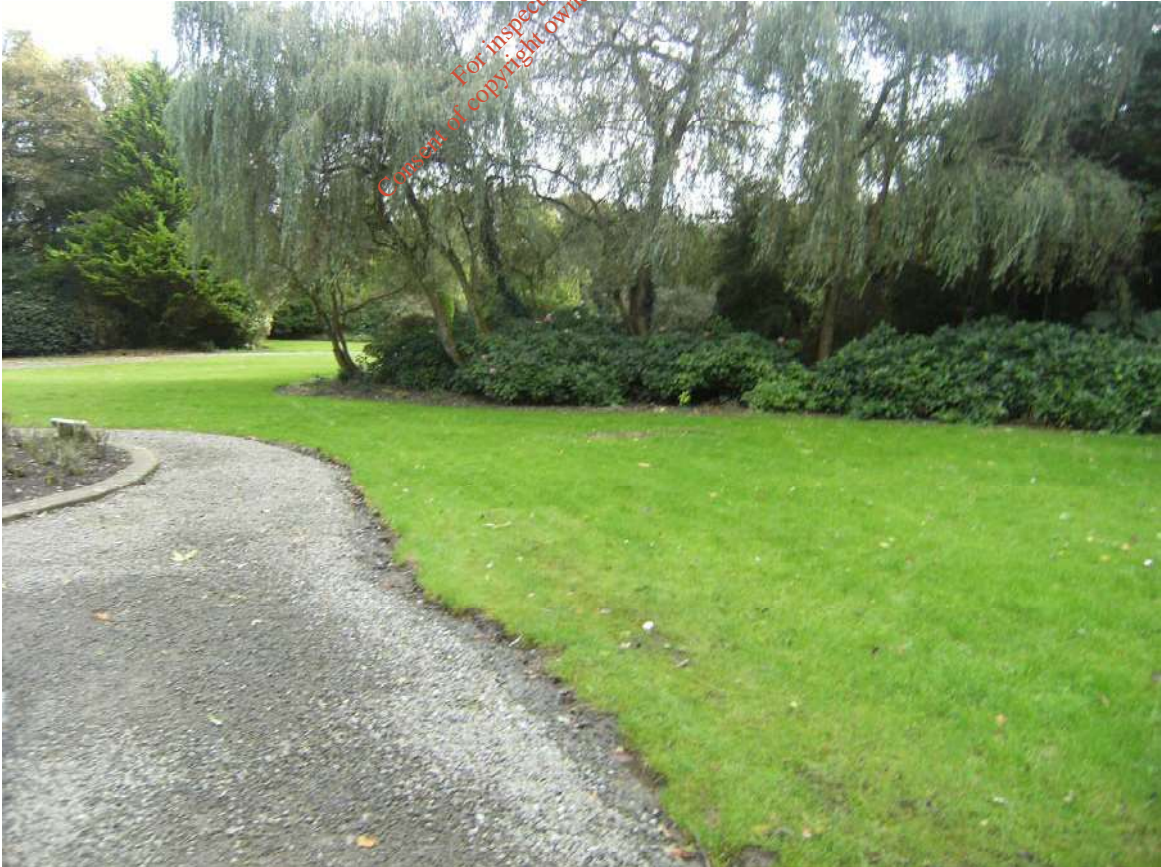
Typical photographs of the site are included in Attachment 6.2.
