## **APPENDIX 2**

## Historical Landfills in North Kerry - Listowel

Client: Kerry County Council

Report No.: 18-1068c

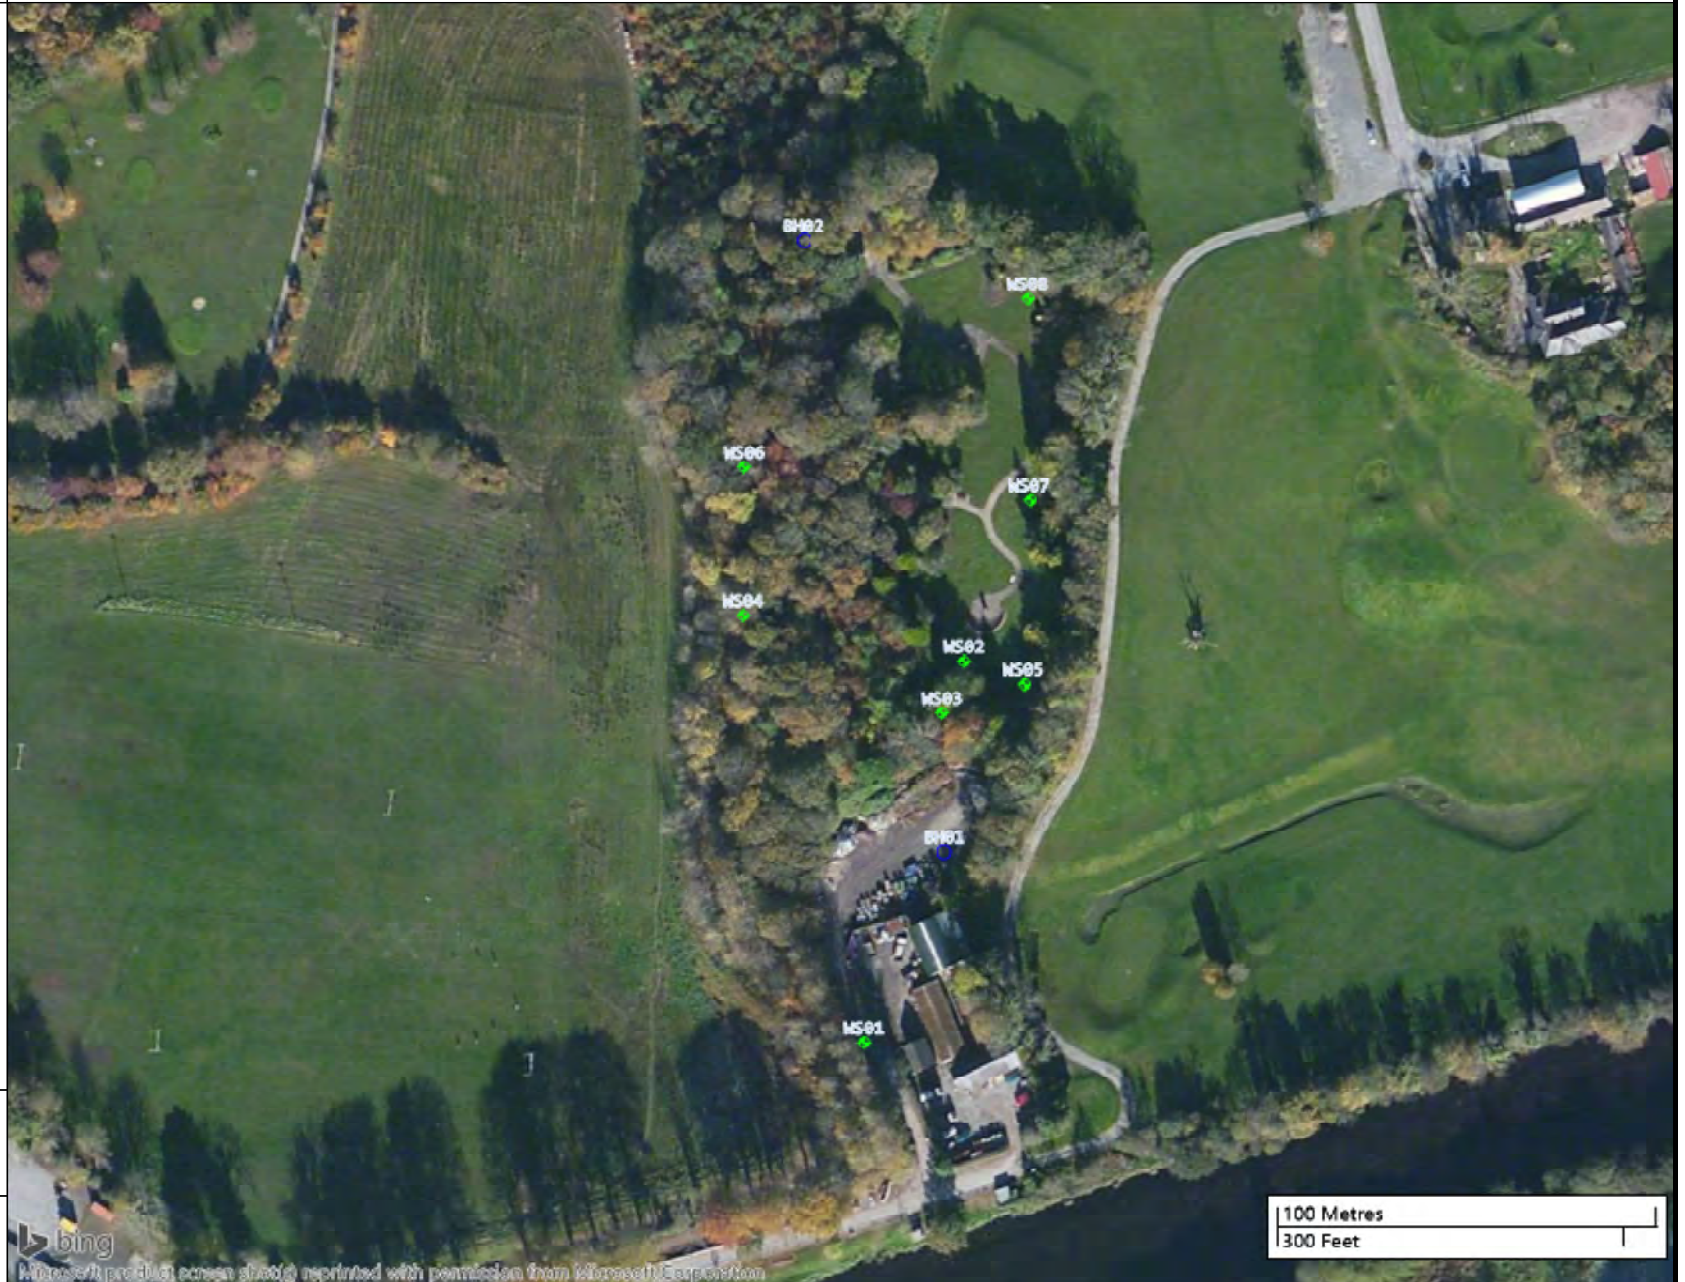
**Title:**  
Exploratory Hole Location Plan

The exploratory holes and in-situ tests were located as instructed by the Client's Representative, as shown on the exploratory hole location plan in Appendix A.

The plan coordinates (Irish National Grid) and ground elevation (mOD Malin) at each location are recorded on the individual exploratory hole logs. The exploratory hole plan presented in Appendix A shows these as-built positions.

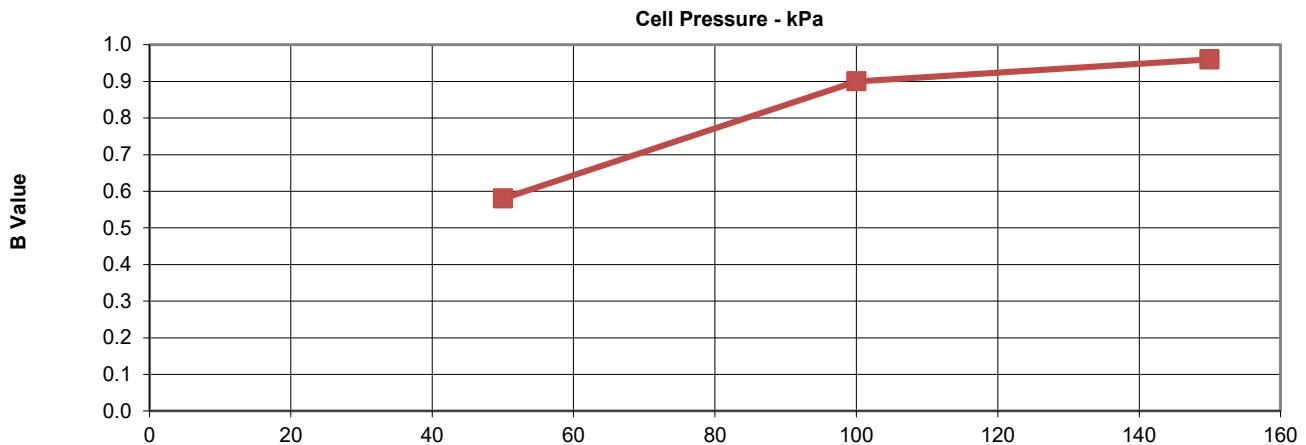
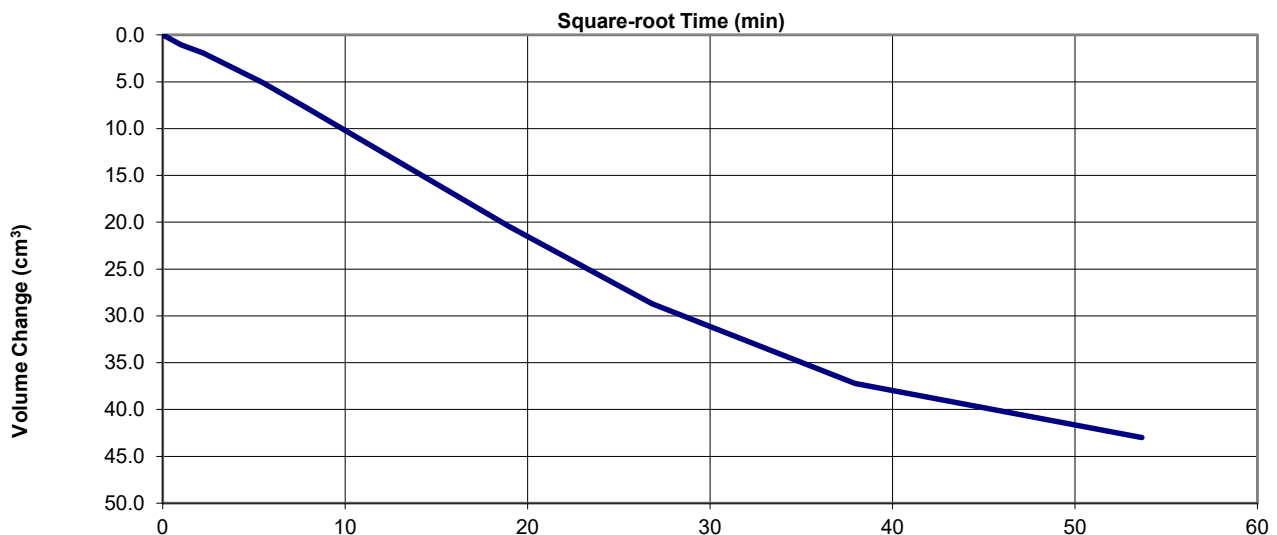
BS 1377 : Part 6 : 1990 Clause 6

Specimen Details		
Hole Number		WS08
Sample Depth	m	0.10
Sample No,		1
Grid Reference		
Lift Number		
Saturation		
Cell Pressure Incr.	kPa	50
Back Pressure Incr.	kPa	50
Differential Pressure	kPa	10
Final Cell Pressure	kPa	150
Final B Value	-	0.96

Consolidation		
Effective Pressure	kPa	100
Cell Pressure	kPa	400
Back Pressure	kPa	300
Final PWP	kPa	300
PWP dissipation	%	100

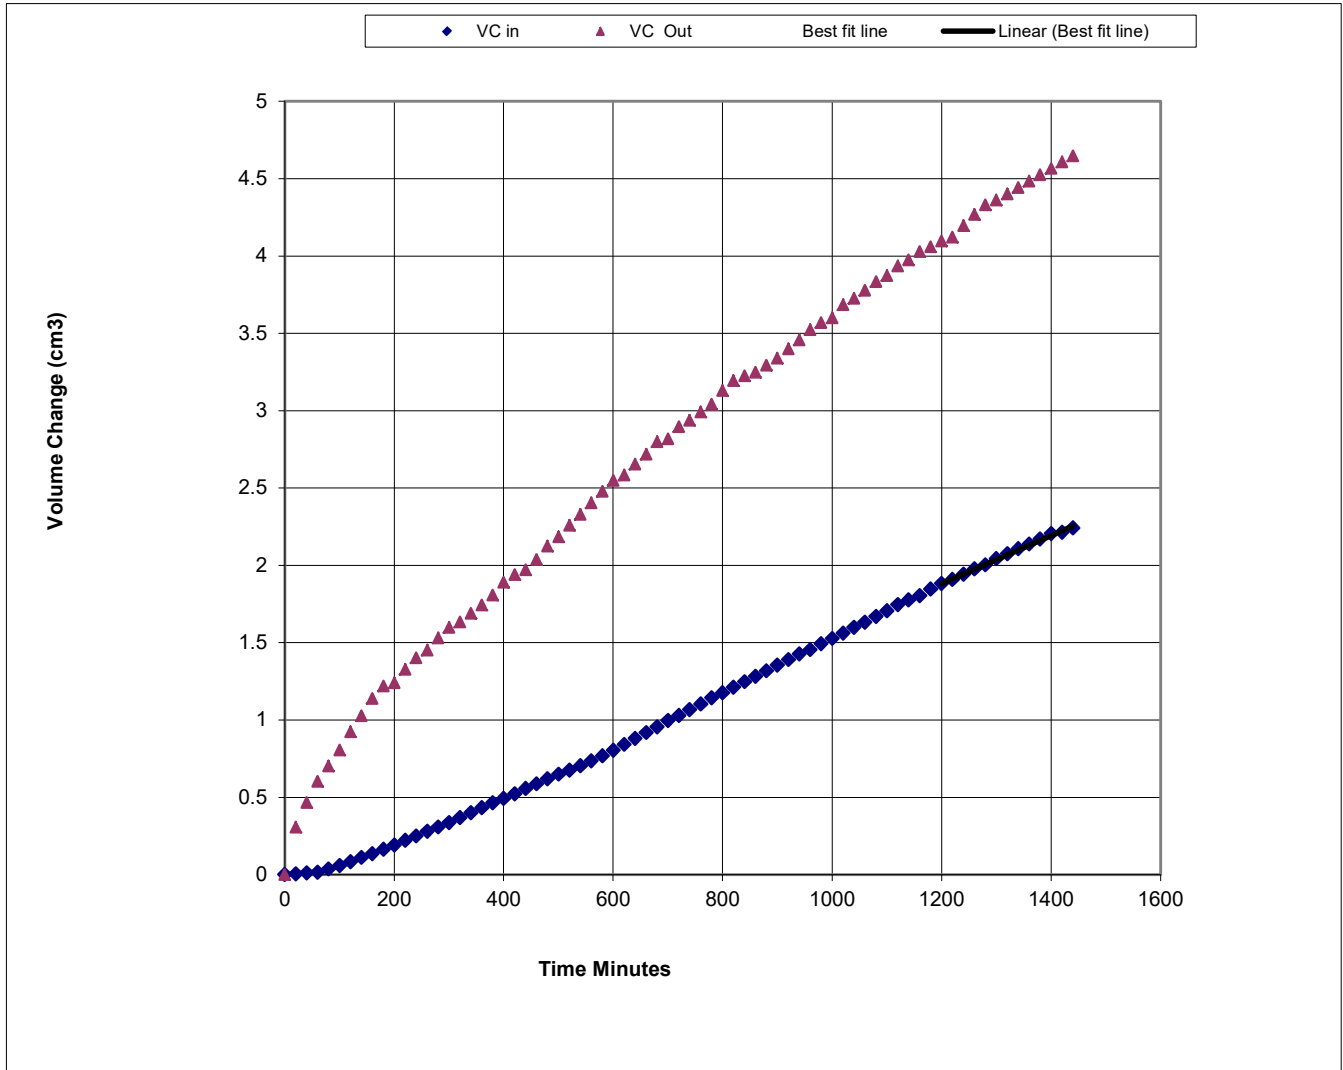
## Permeability Stage

Permeability Stage		
Cell Pressure	kPa	400
Mean Effective Stress	kPa	100
Back Pressure Diff.	kPa	20
Mean Rate of Flow	ml/min	0.0015
Average Temperature	'C	20
Vertical Permeability Kv	m/s	1.5E-10
