TIER 2 RISK ASSESSMENT HISTORIC LANDFILL AT LISTOWEL, CO. KERRY

Prepared for: Kerry County Council

Date: August 2021

Keywords: Site Investigation, environmental risk assessment, geophysical survey, waste, leachate, soil sampling, groundwater sampling

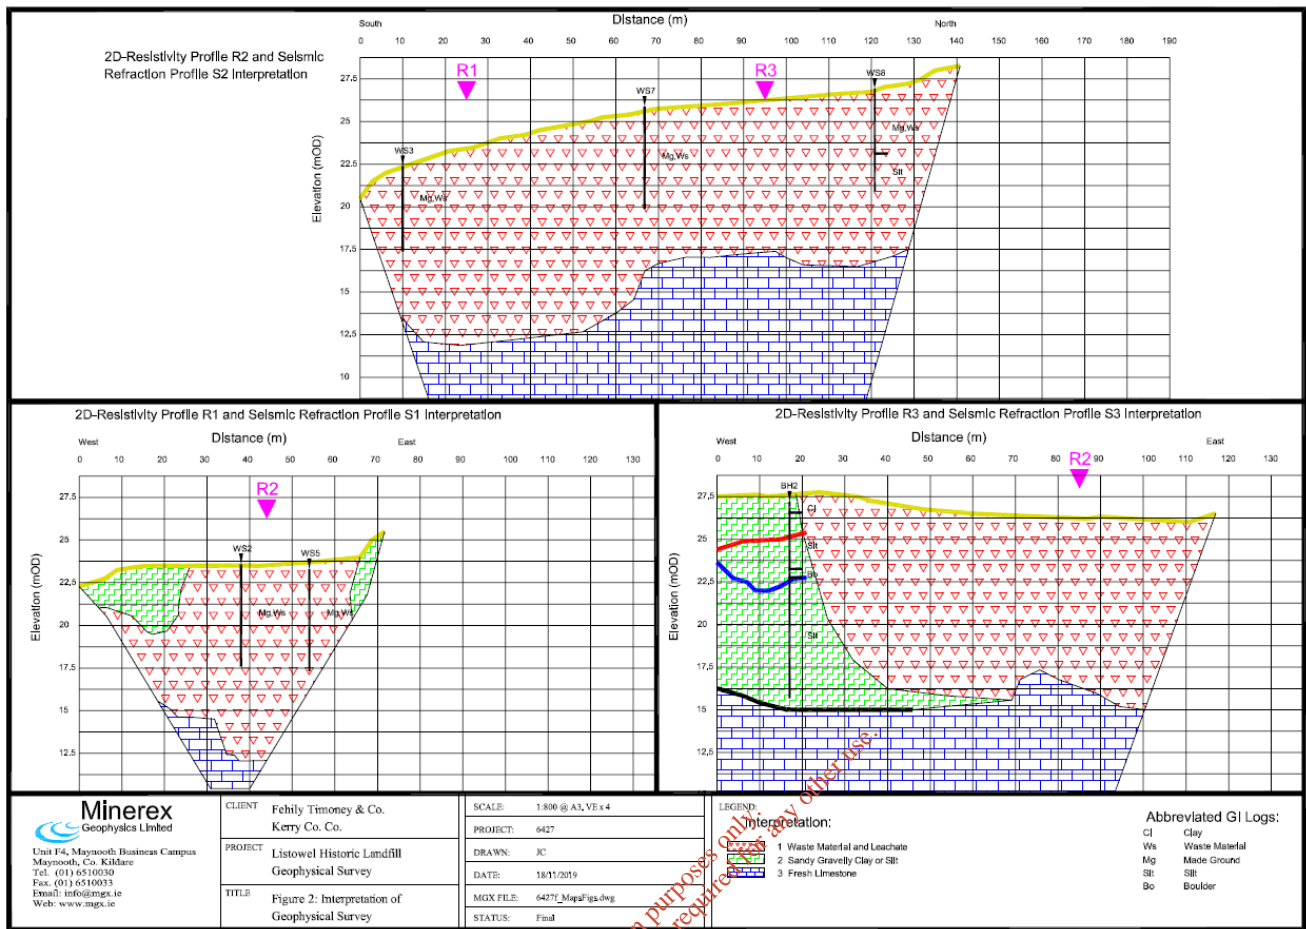
Figure 3.3: Integration of Geophysical Survey

Layer 1 has a seismic velocity range of 200 m/s and 250 m/s and is found in most of the survey area. This velocity would represent landfill material which has a lower velocity than the surrounding natural ground.

Layer 2 has a seismic velocity range of 400 and 2200 m/s. This layer is interpreted as natural overburden material, in this case sandy gravelly Clay or Silt and it is found only in some areas, such as start and end of profile R1 and start of profile R3.

Layer 3 is interpreted as fresh Limestone and is found in most of the survey area, under layers 1 and 2. This layer has N/A seismic velocity.

MGX note that possible leachate movement was identified at the start of profile R1 where low resistivities below higher resistivities were found.

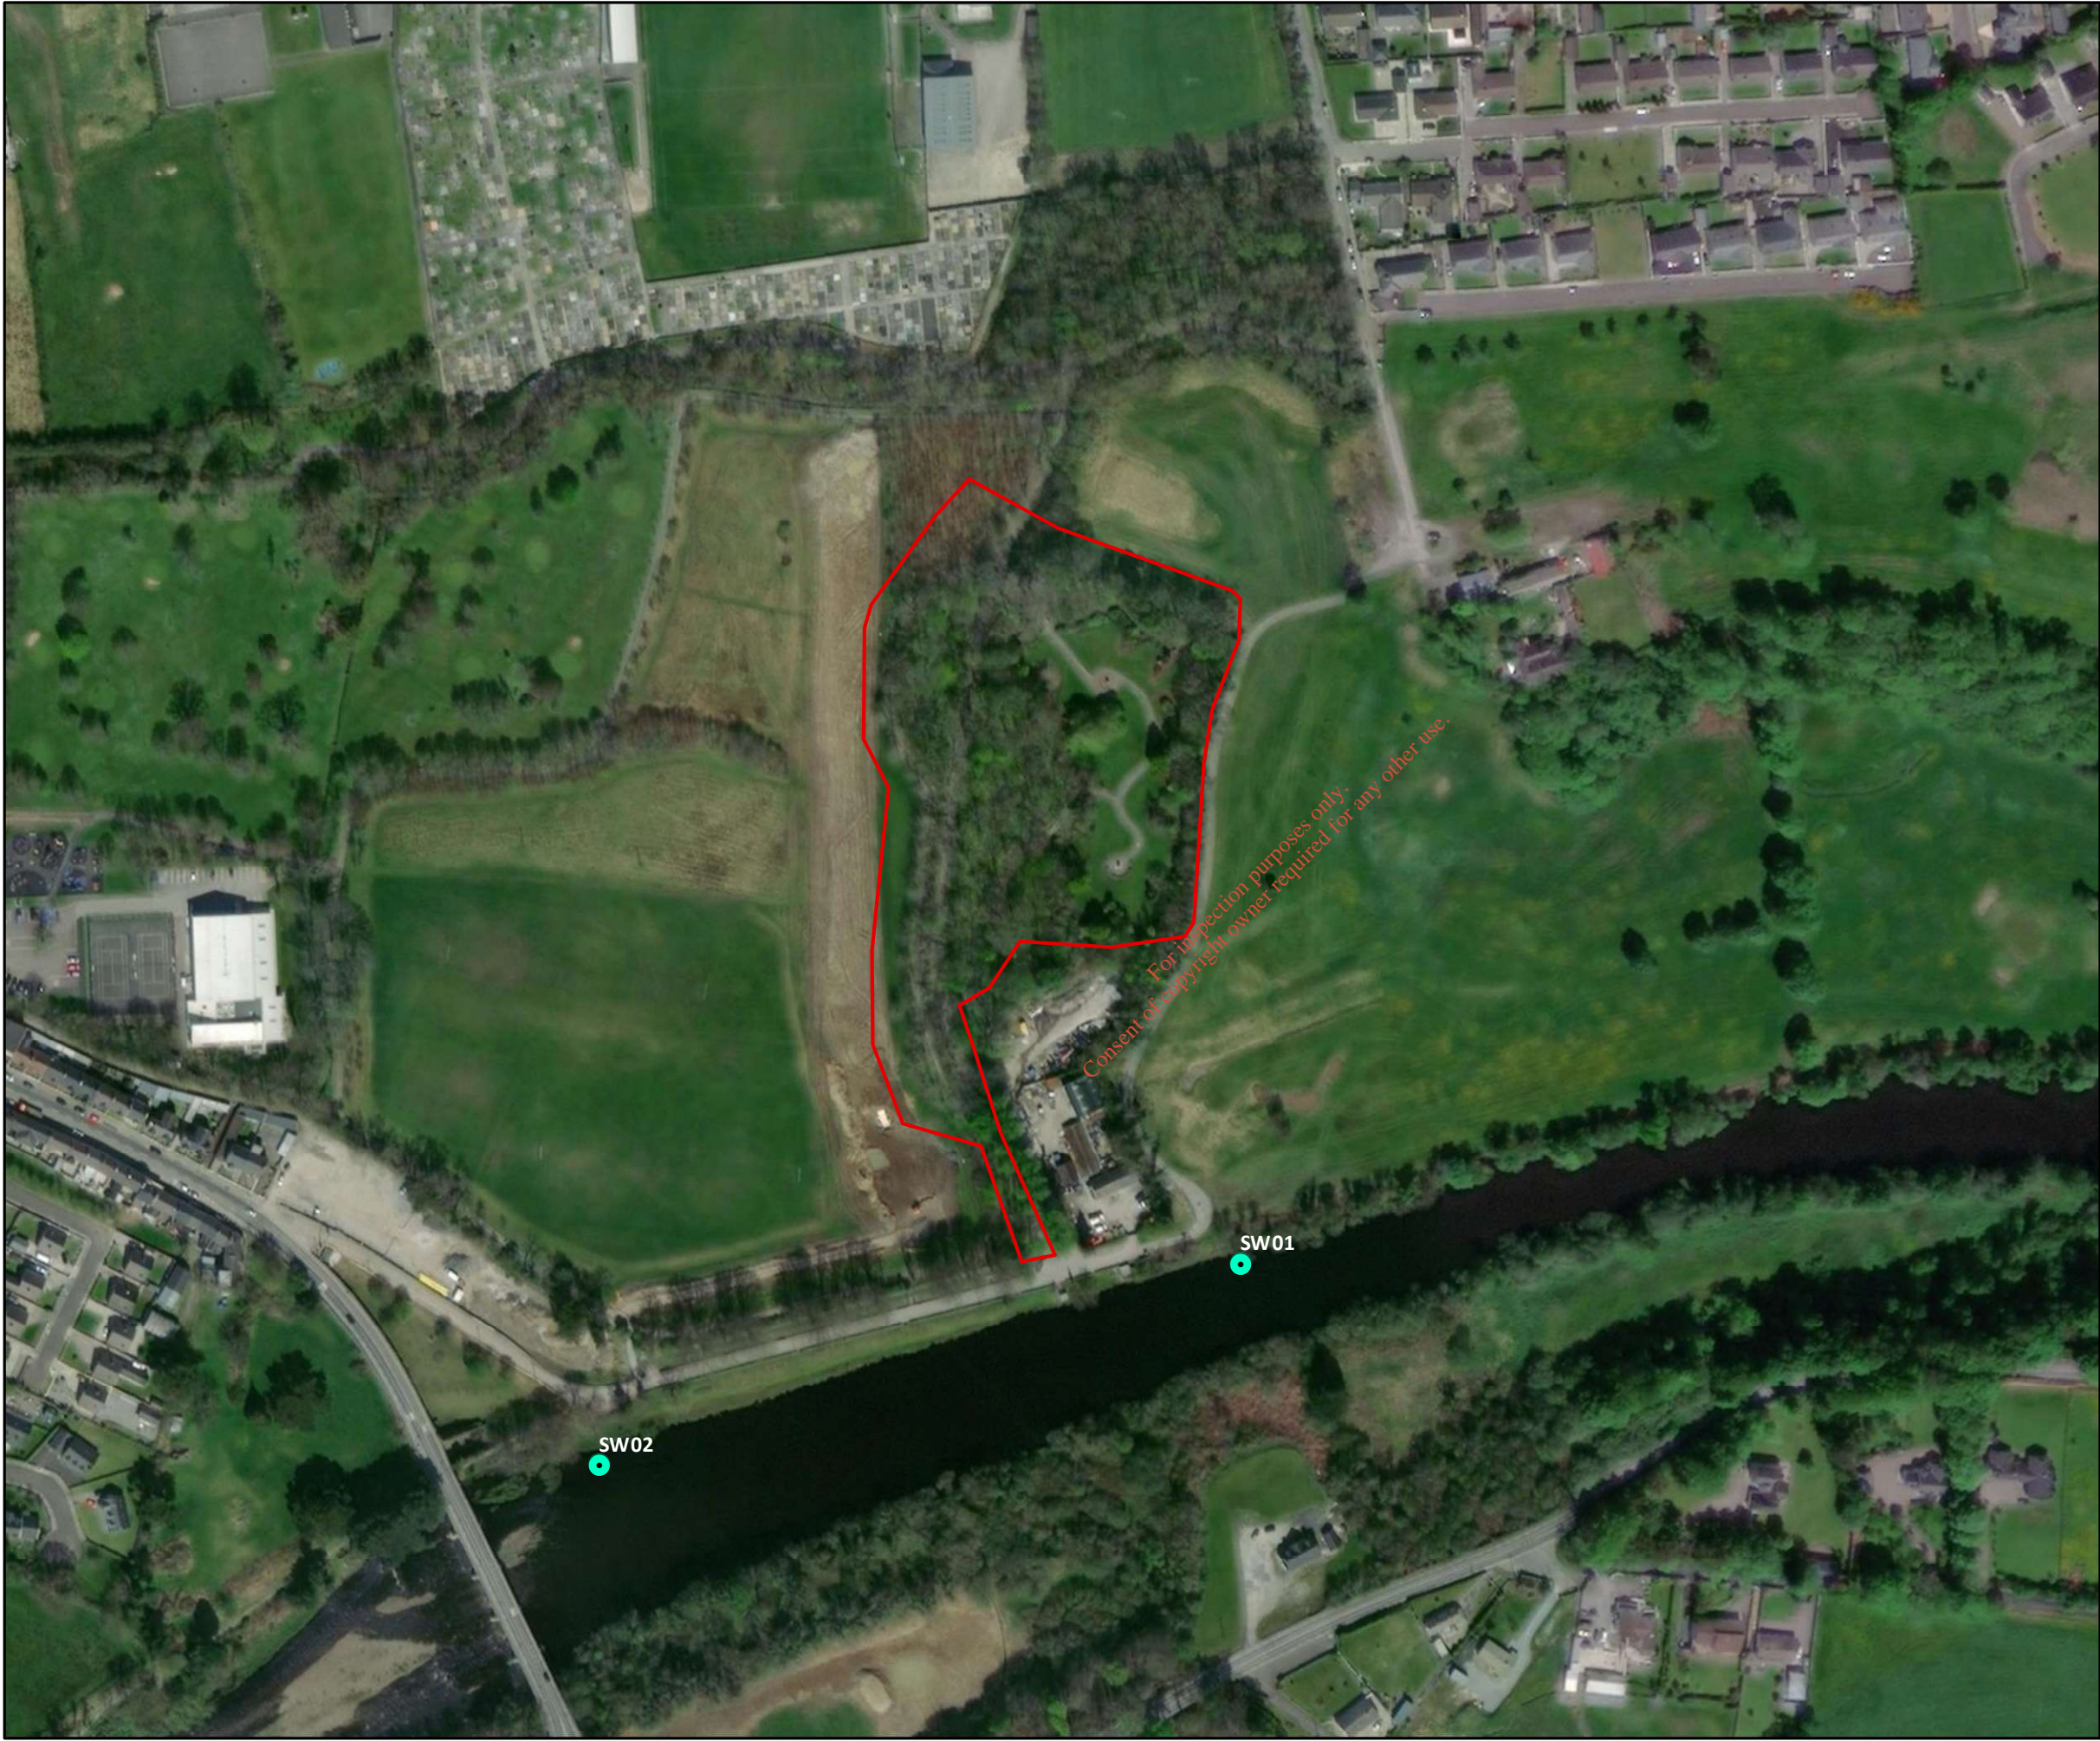
TITLE: Surface Water Sampling Locations	
PROJECT: Environmental Risk Assessment for Listowel Landfill, Co. Kerry	
FIGURE NO: 4.2	
CLIENT: Kerry County Council	
SCALE: 1:2500	REVISION: 0
DATE: 31/10/2019	PAGE SIZE: A3

The results of the surface water laboratory analysis as presented in Table 4.5, when assessed against the MAC (1989) and EQS (2009) quality standards were found to be below the guideline values in all assessments.

Results show very little variation in parameter levels was observed between upstream and downstream sampling locations.
