TIER 2 RISK ASSESSMENT HISTORIC LANDFILL AT ARDFERT, CO. KERRY

Prepared for: Kerry County Council

Date: August 2021

Abstract: This report represents the findings of a Tier 2 assessment carried out at Ardfert Historic Landfill, Co. Kerry, conducted in accordance with the EPA Code of Practice for unregulated landfill sites.

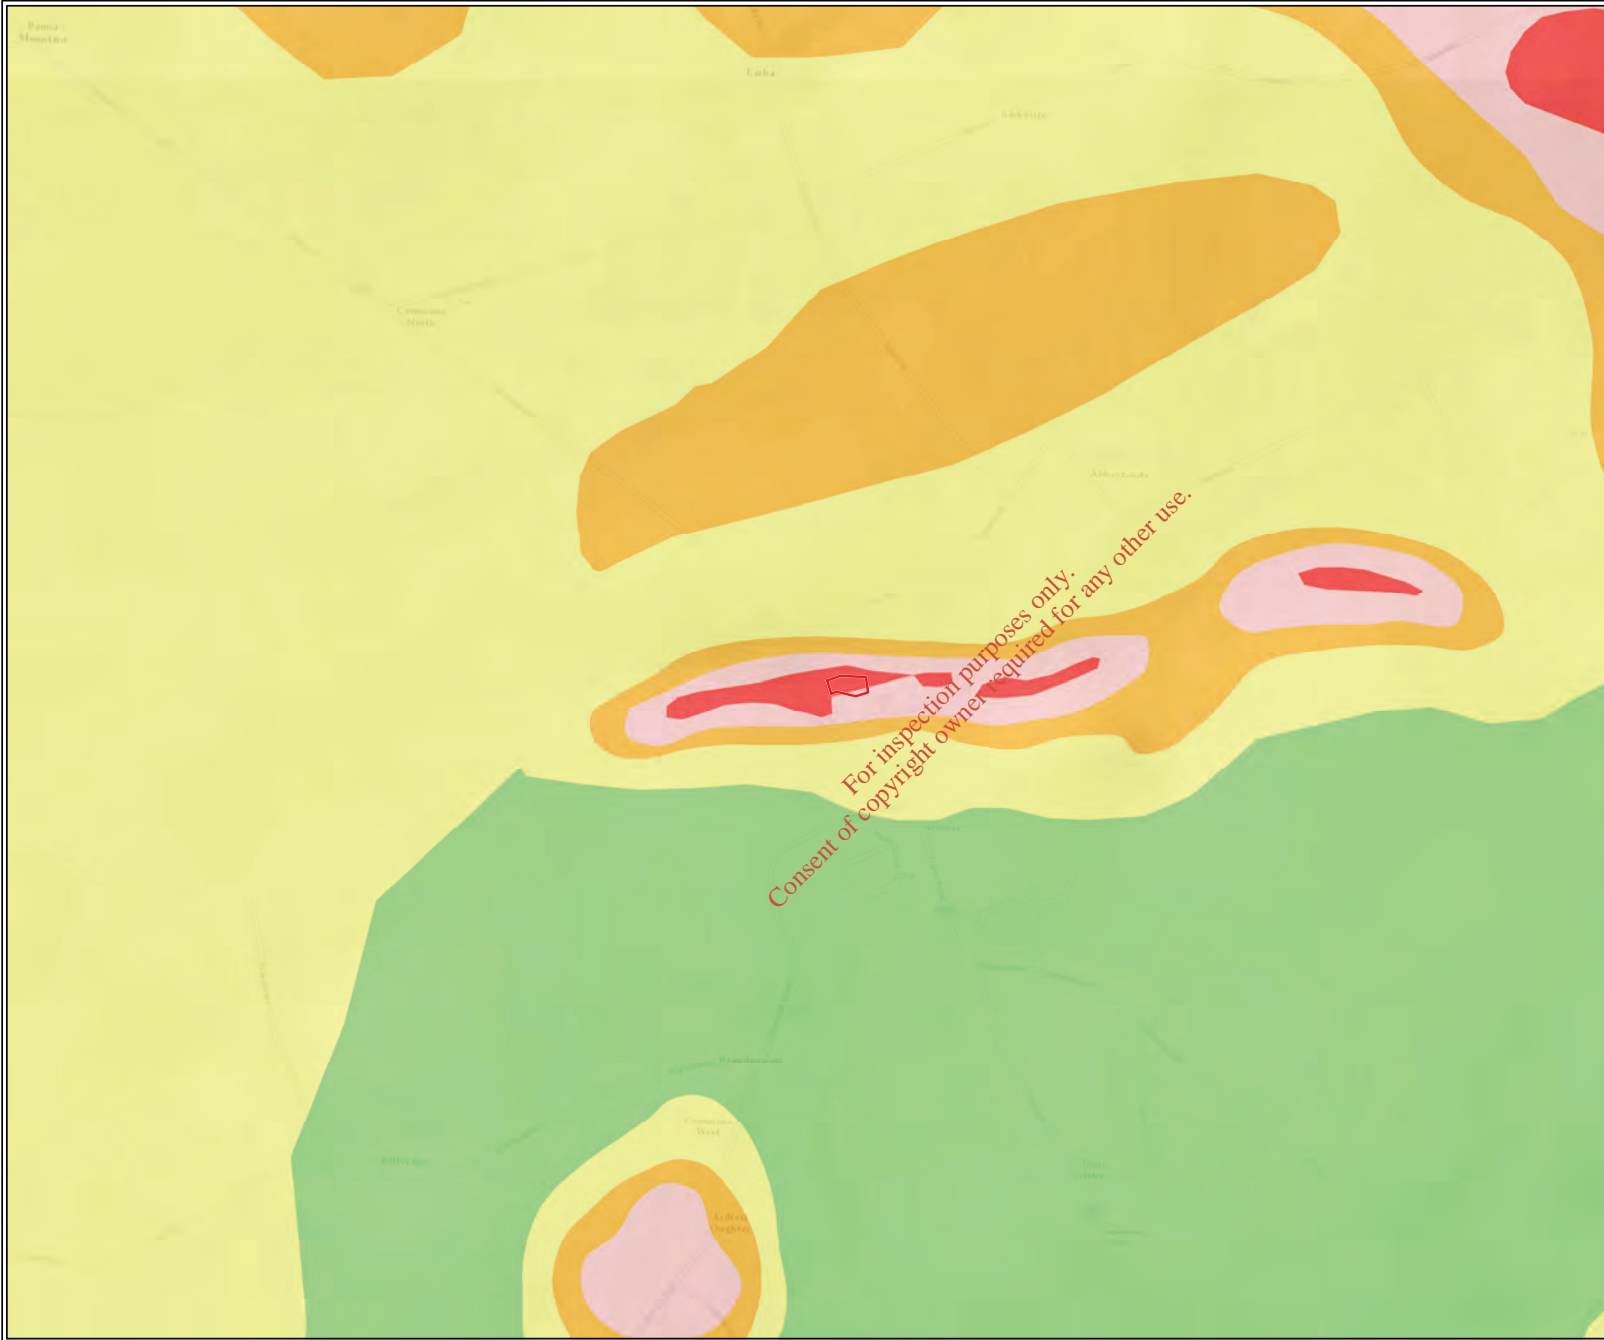
- Site Boundary
- Groundwater Vulnerability**
- E - Extreme
- H - High
- M - Moderate
- L - Low
- X - Rock Near Surface or Karst

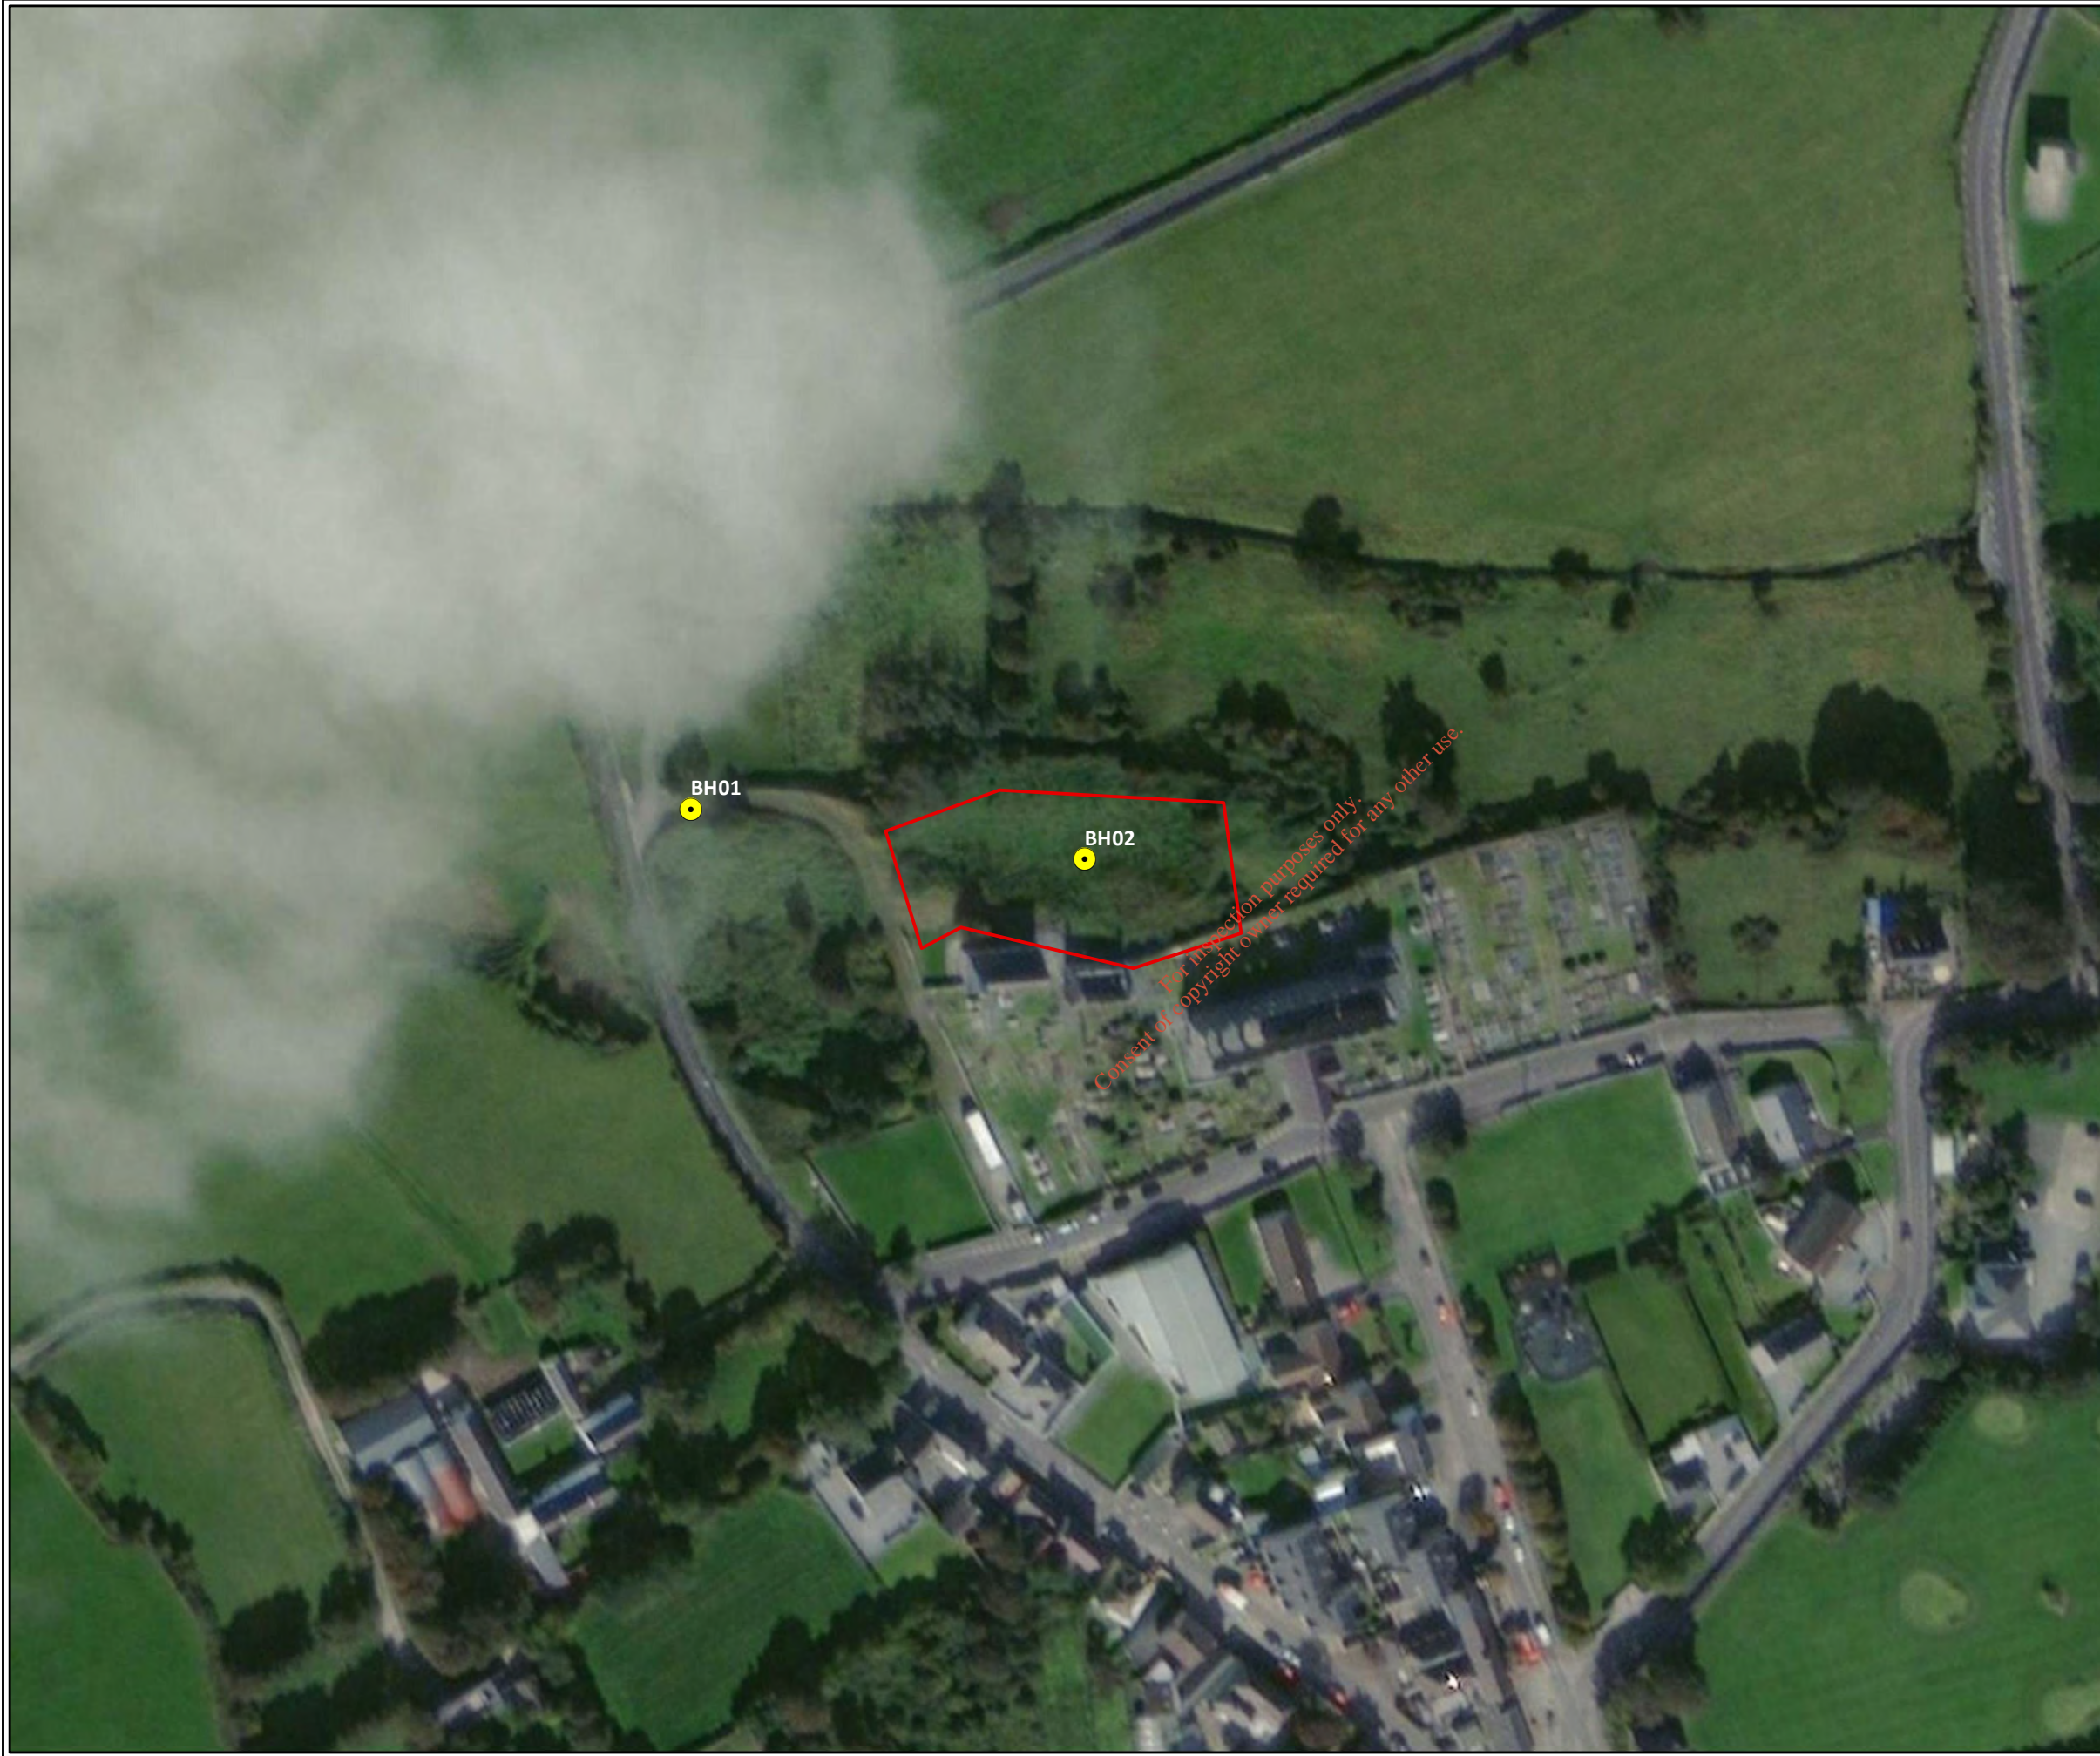
| TITLE: | Site Investigation Location Plan | | |

A Causeway Geotech (CGL) Engineering Geologist supervised the advancement of 4 No. trial pits, shown in Figure 3.1, on the 29th May 2019.

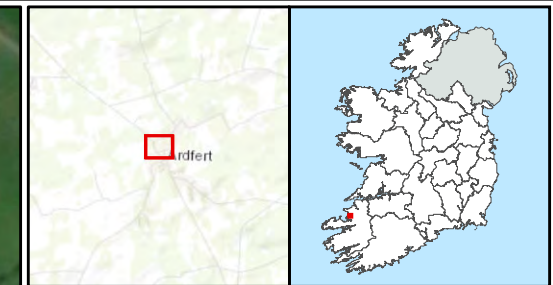
- Borehole Locations
- Site Boundary

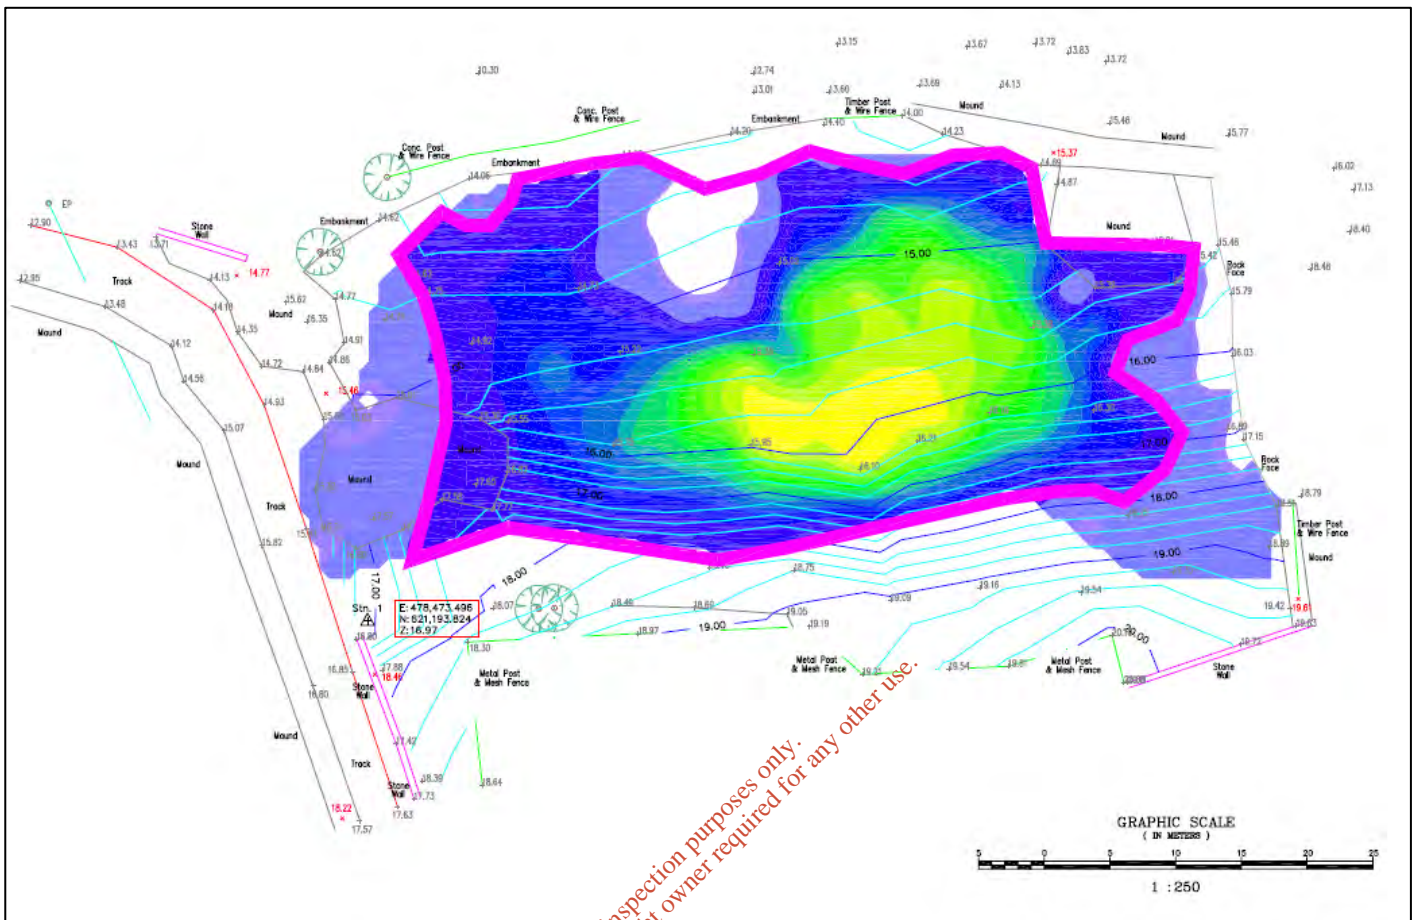
Figure 3.2: Delineation of the Waste Profile

Minerex interpreted the low resistivities and seismic velocities measured were consistent with industrial and domestic waste rather than C & D type waste.

An extract from the geophysical report showing a delineation of the identified waste body is presented in Figure 3.2. The map shows the EM31 ground conductivity contours. The low (light blue) conductivities indicate natural ground. The middle range (dark blue – green – yellow) values indicate interred waste material and the negative readings (blank) in the north indicate buried metal.

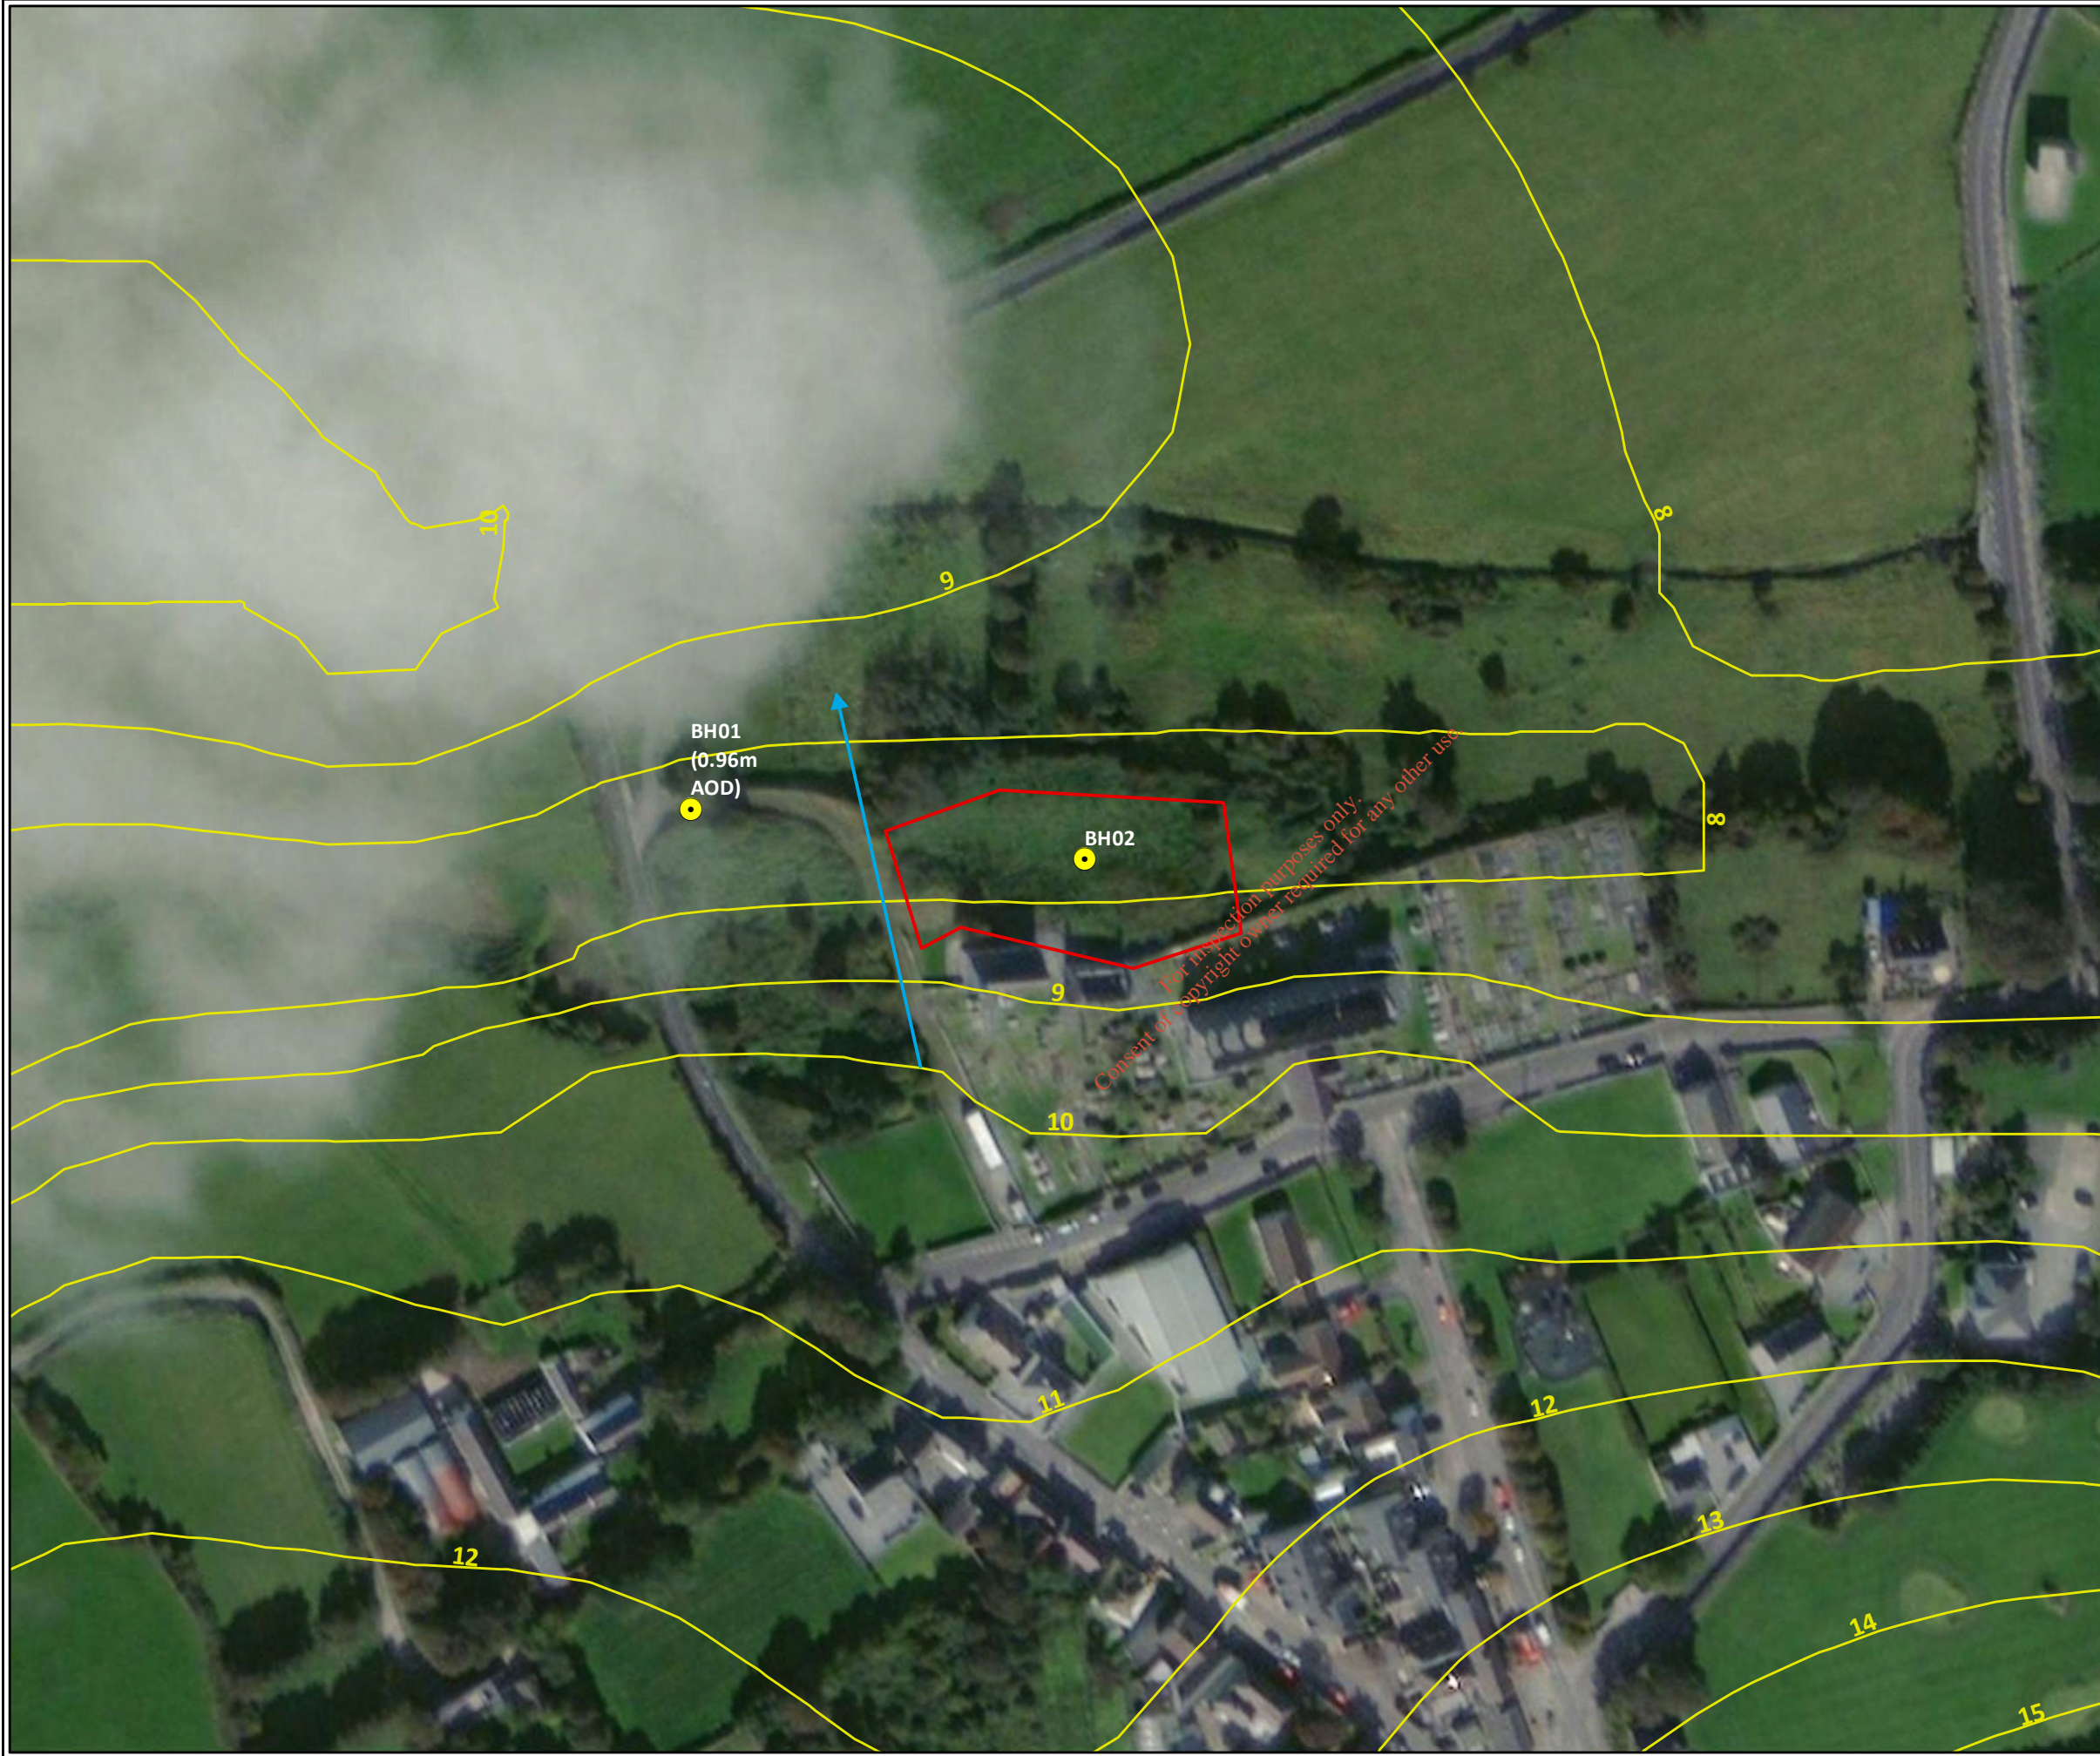
| TITLE: | Groundwater Flow Direction | | |

A review of the GSI groundwater flow contours indicates flow direction is due north/north-west. BH01 is therefore considered to be down or cross-gradient of the waste mass identified.

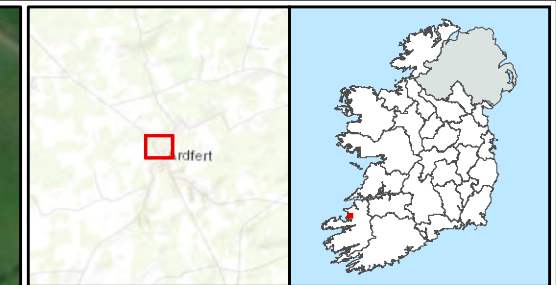
- Borehole Locations
- Groundwater Flow Direction
- Site Boundary
- 1m Contours

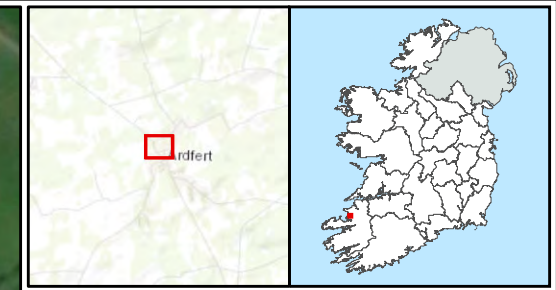
| TITLE: | Surface Water Sampling Locations | | |

- Surface Water Sampling Locations
- Rivers
- Site Boundary

Results show very little variation in parameter levels was observed between upstream and downstream sampling locations.

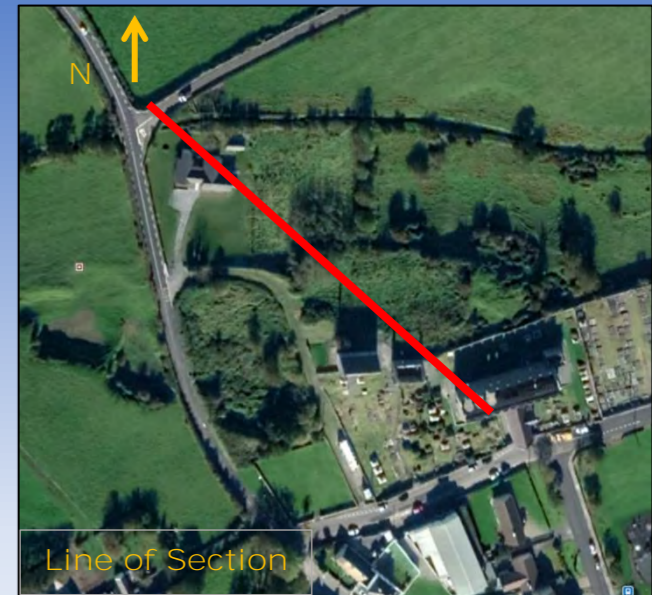
FIGURE 5.1 ARDFERT HISTORIC LANDFILL
CONCEPTUAL SITE MODEL

Based on the review of the Tier 1 assessment and site investigation works completed for Ardfert Historic Landfill, an assessment of the risk is made to confirm the source – pathway – receptor (S-P-R) linkages identified in the preliminary investigation. The results and analysis of the investigation has enabled a revised conceptual model to be produced for the site, which is presented in Figure 5.1, overleaf.
