3 TIER 2 SITE INVESTIGATION

Figure Title	Maximum Anticipated Waste Footprint		
Figure No.	3.2		
Project	Historical Landfills: Thorpes		
Client	Kilkenny County Council		
Scale	1:2,500	Page Size	A3
Revision	A	Date	28/01/2021

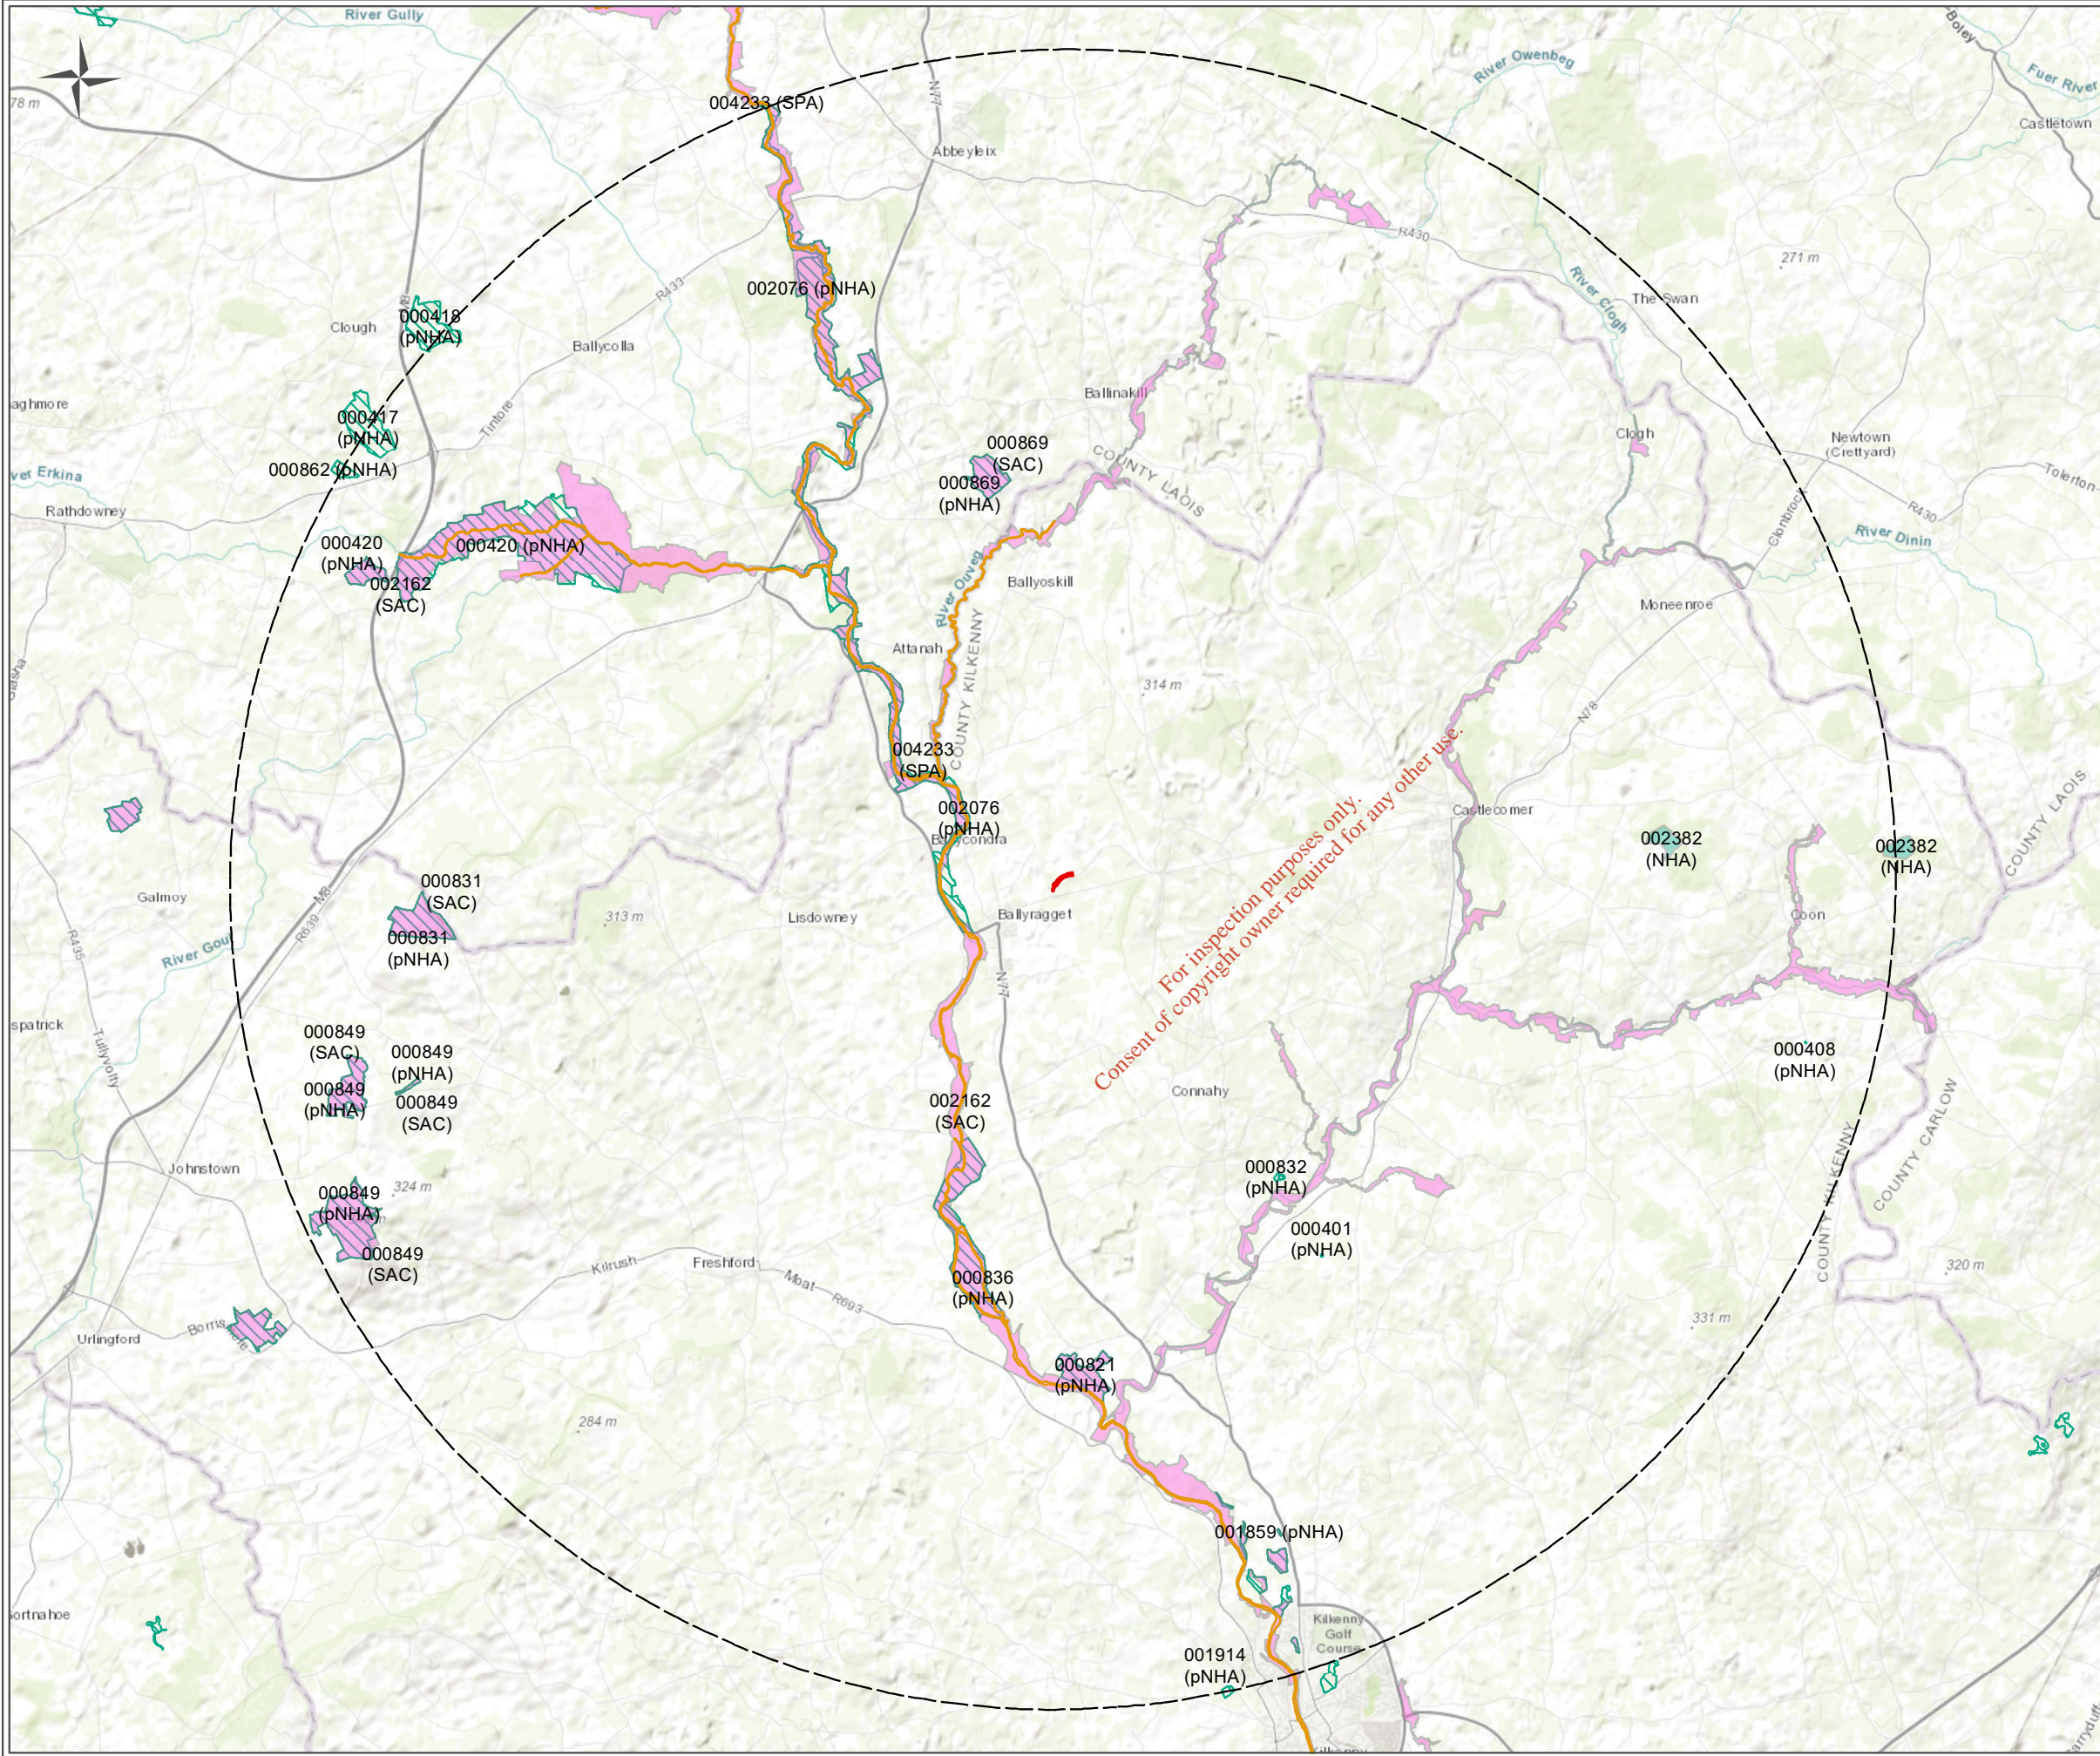
Figure Title	Ecology: Protected Sites
Figure No.	2.7
Project	Historical Landfills: Thorpes
Client	Kilkenny County Council
Scale	1:120,000
Page Size	A3
Revision	A
Date	28/01/2021

- Site Boundary
- 15km Distance from Site Boundary
- Special Protection Area (SPA)**
- Closest Site: 1.7km
- Special Area of Conservation (SAC)**
- Closest Site: 1.6km
- Proposed Natural Heritage Area (pNHA)**
- Closest Site: 1.7km
- Natural Heritage Area (NHA)**
- Closest Site: 10.5km

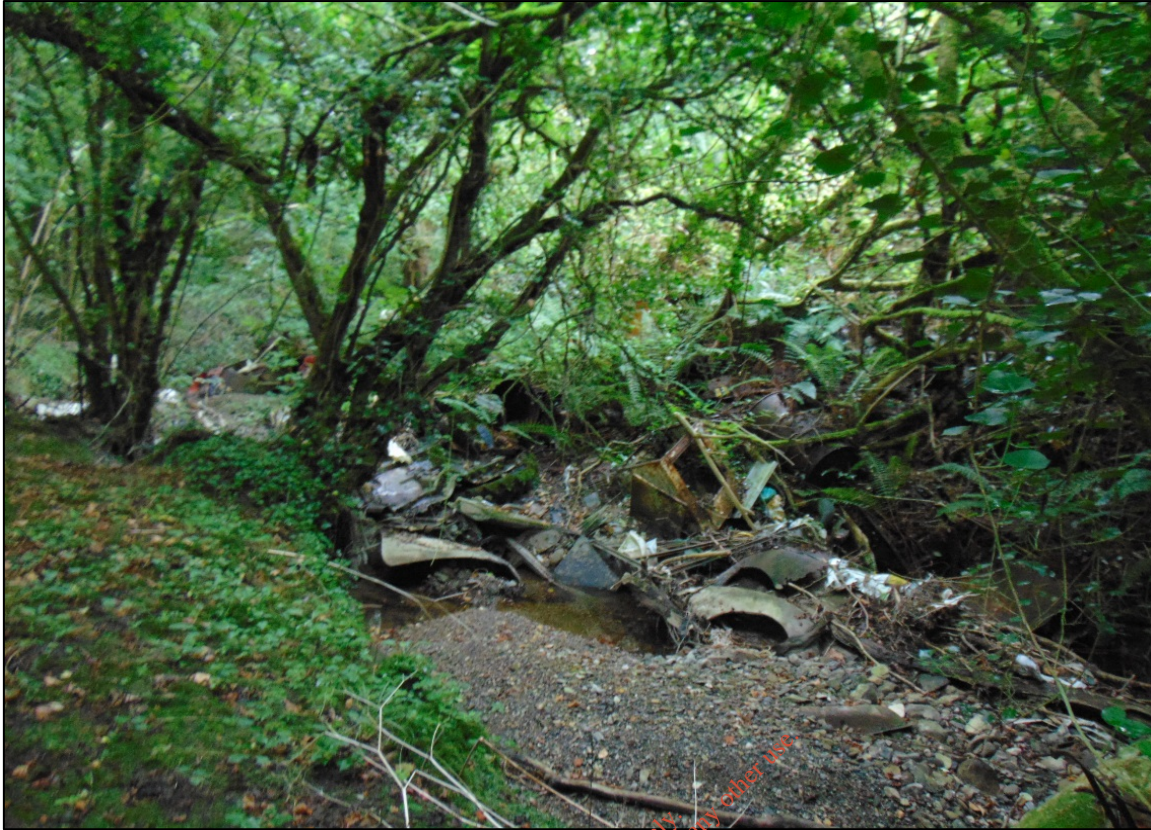
Figure 3-1: Loose discarded non putrescible waste material

The site walkover noted the presence of discarded waste within and along the banks of the Ballyragget stream within the site as can be seen in Figure 3.1 below.

Most of the waste encountered comprised of fragments of waste typical of non-putrescible commercial and industrial type waste e.g., tyres, plastic bottles, glass, car parts, timber, rubber, etc. No visual or olfactory evidence of putrescible / biodegradable waste was noted by FT during the site walkover.

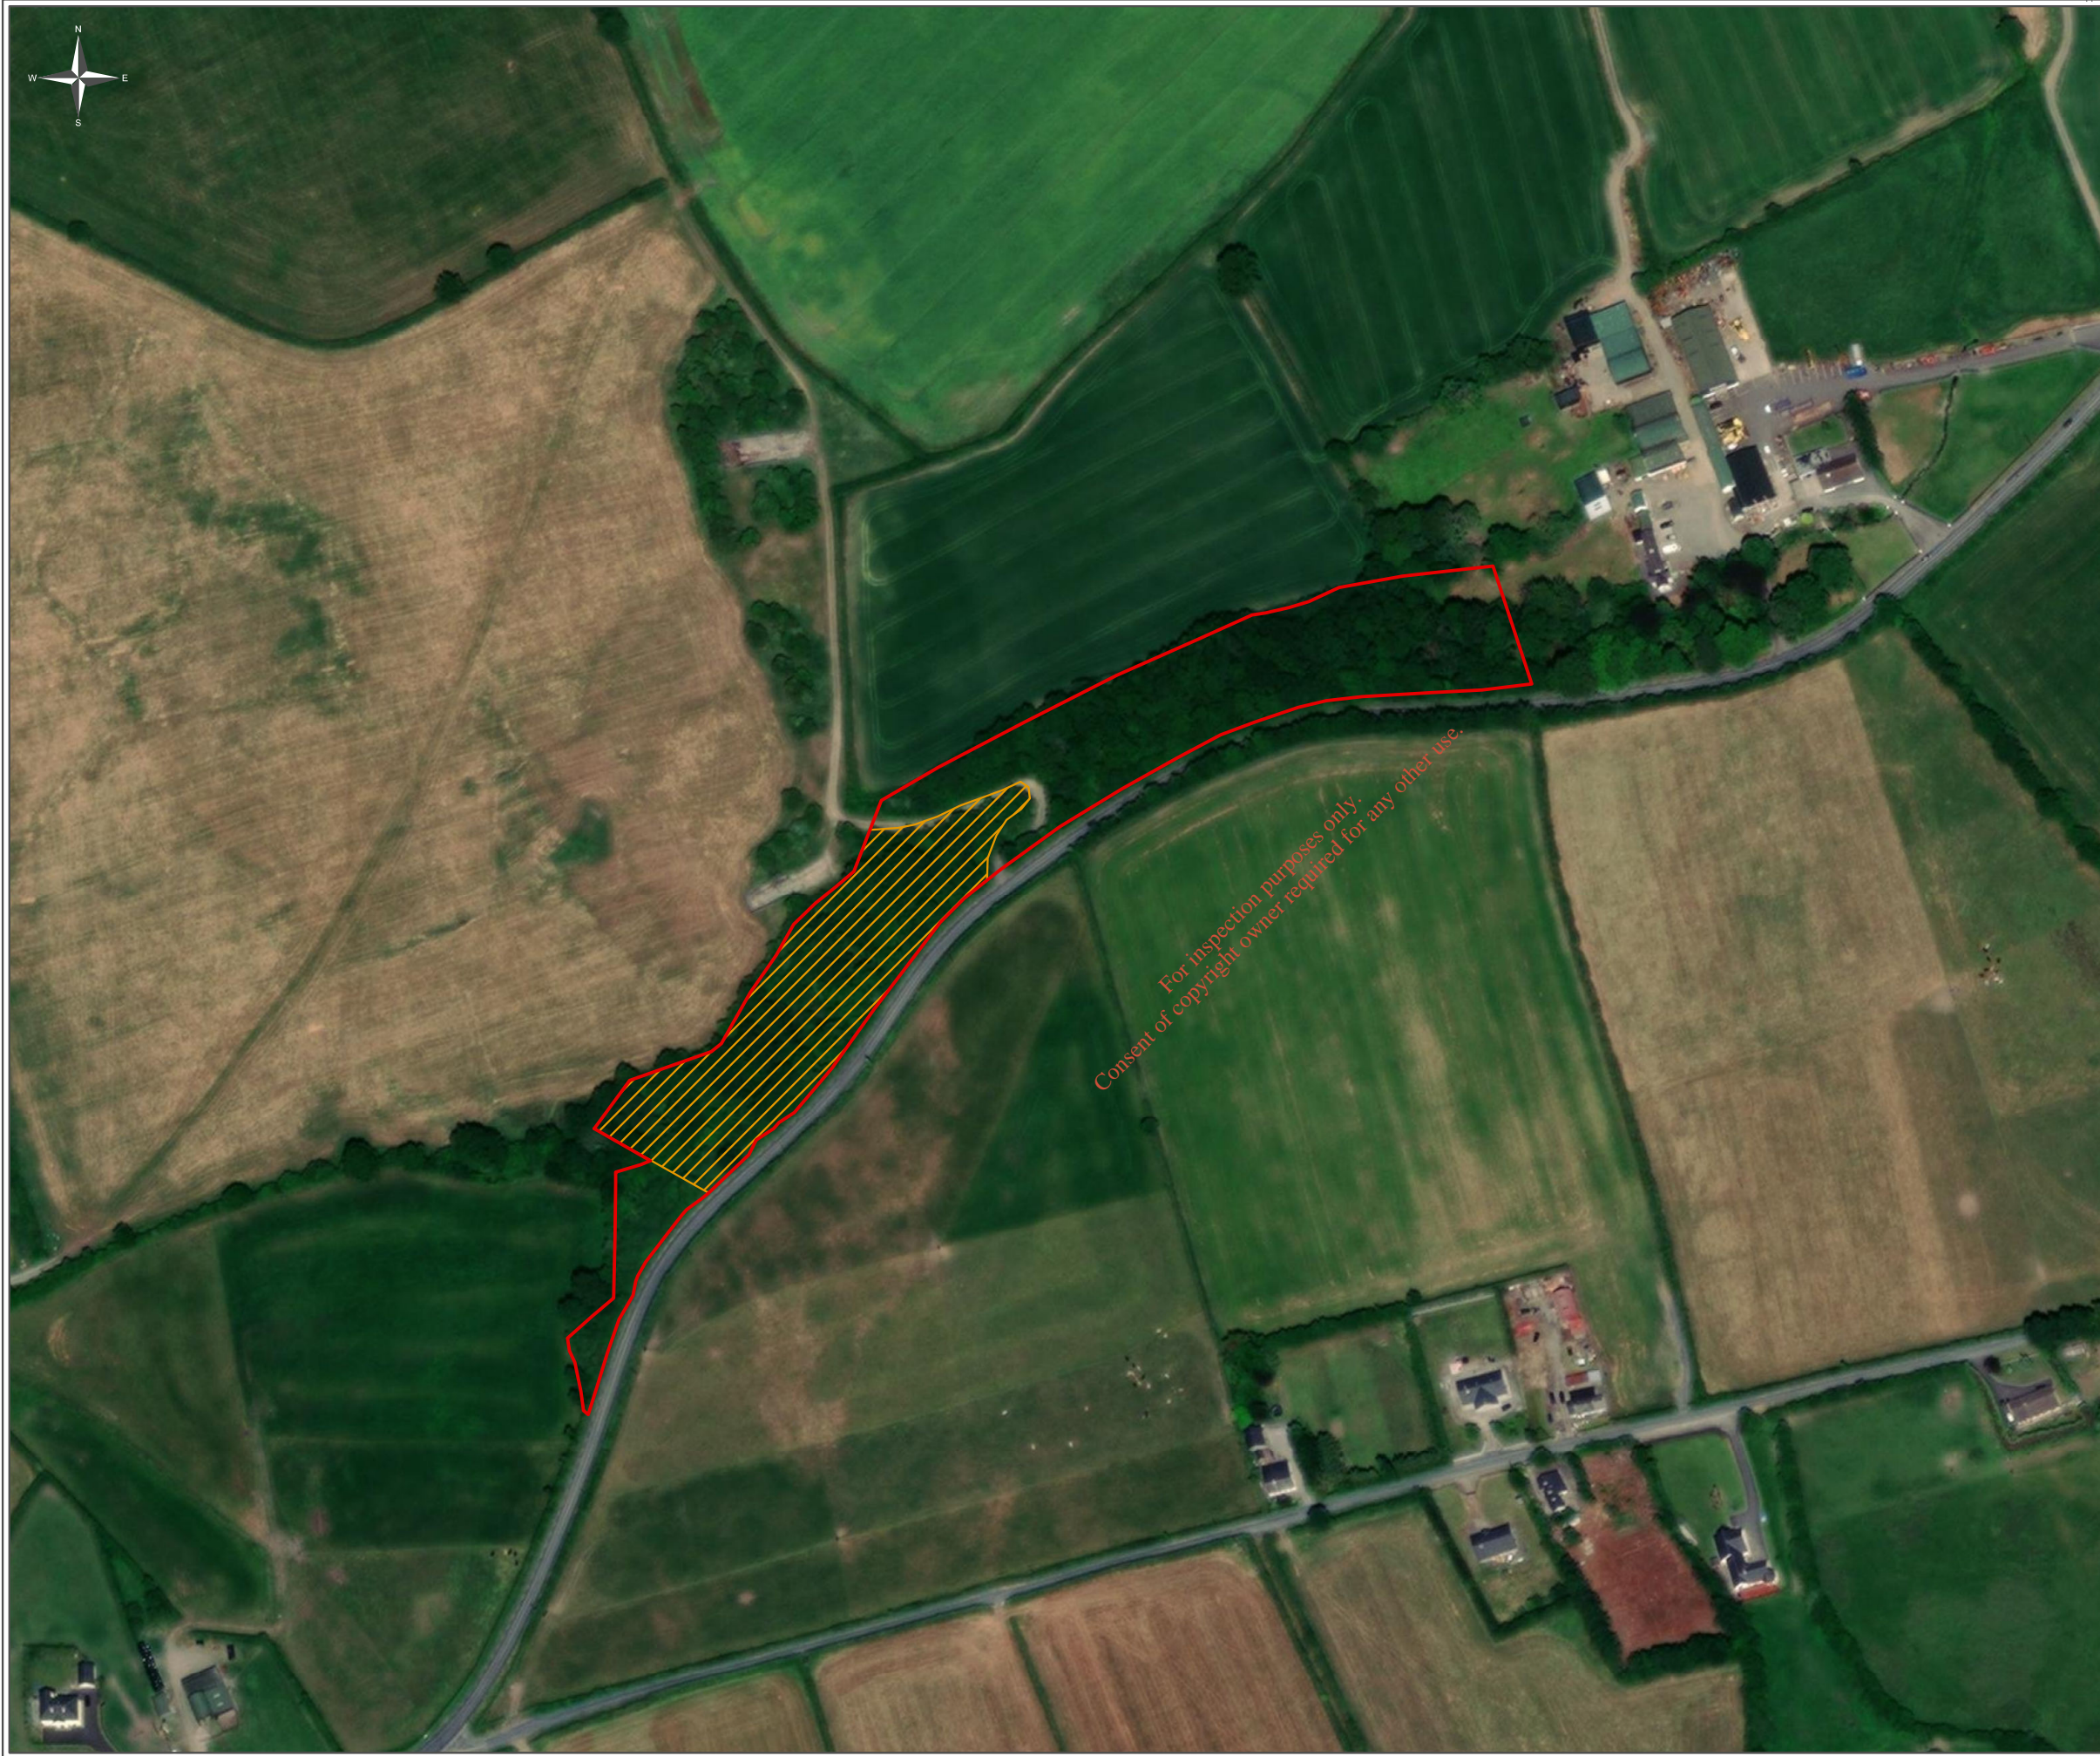
The findings of the site walkover suggest the waste material is deposited in a single infill area tending east to west, extending to maximum dimensions 210m in length and 40m in width.

Based on this interpretation, the maximum waste footprint is calculated to be approximately 0.84 hectares. The maximum anticipated waste footprint is presented in Figure 3-2.

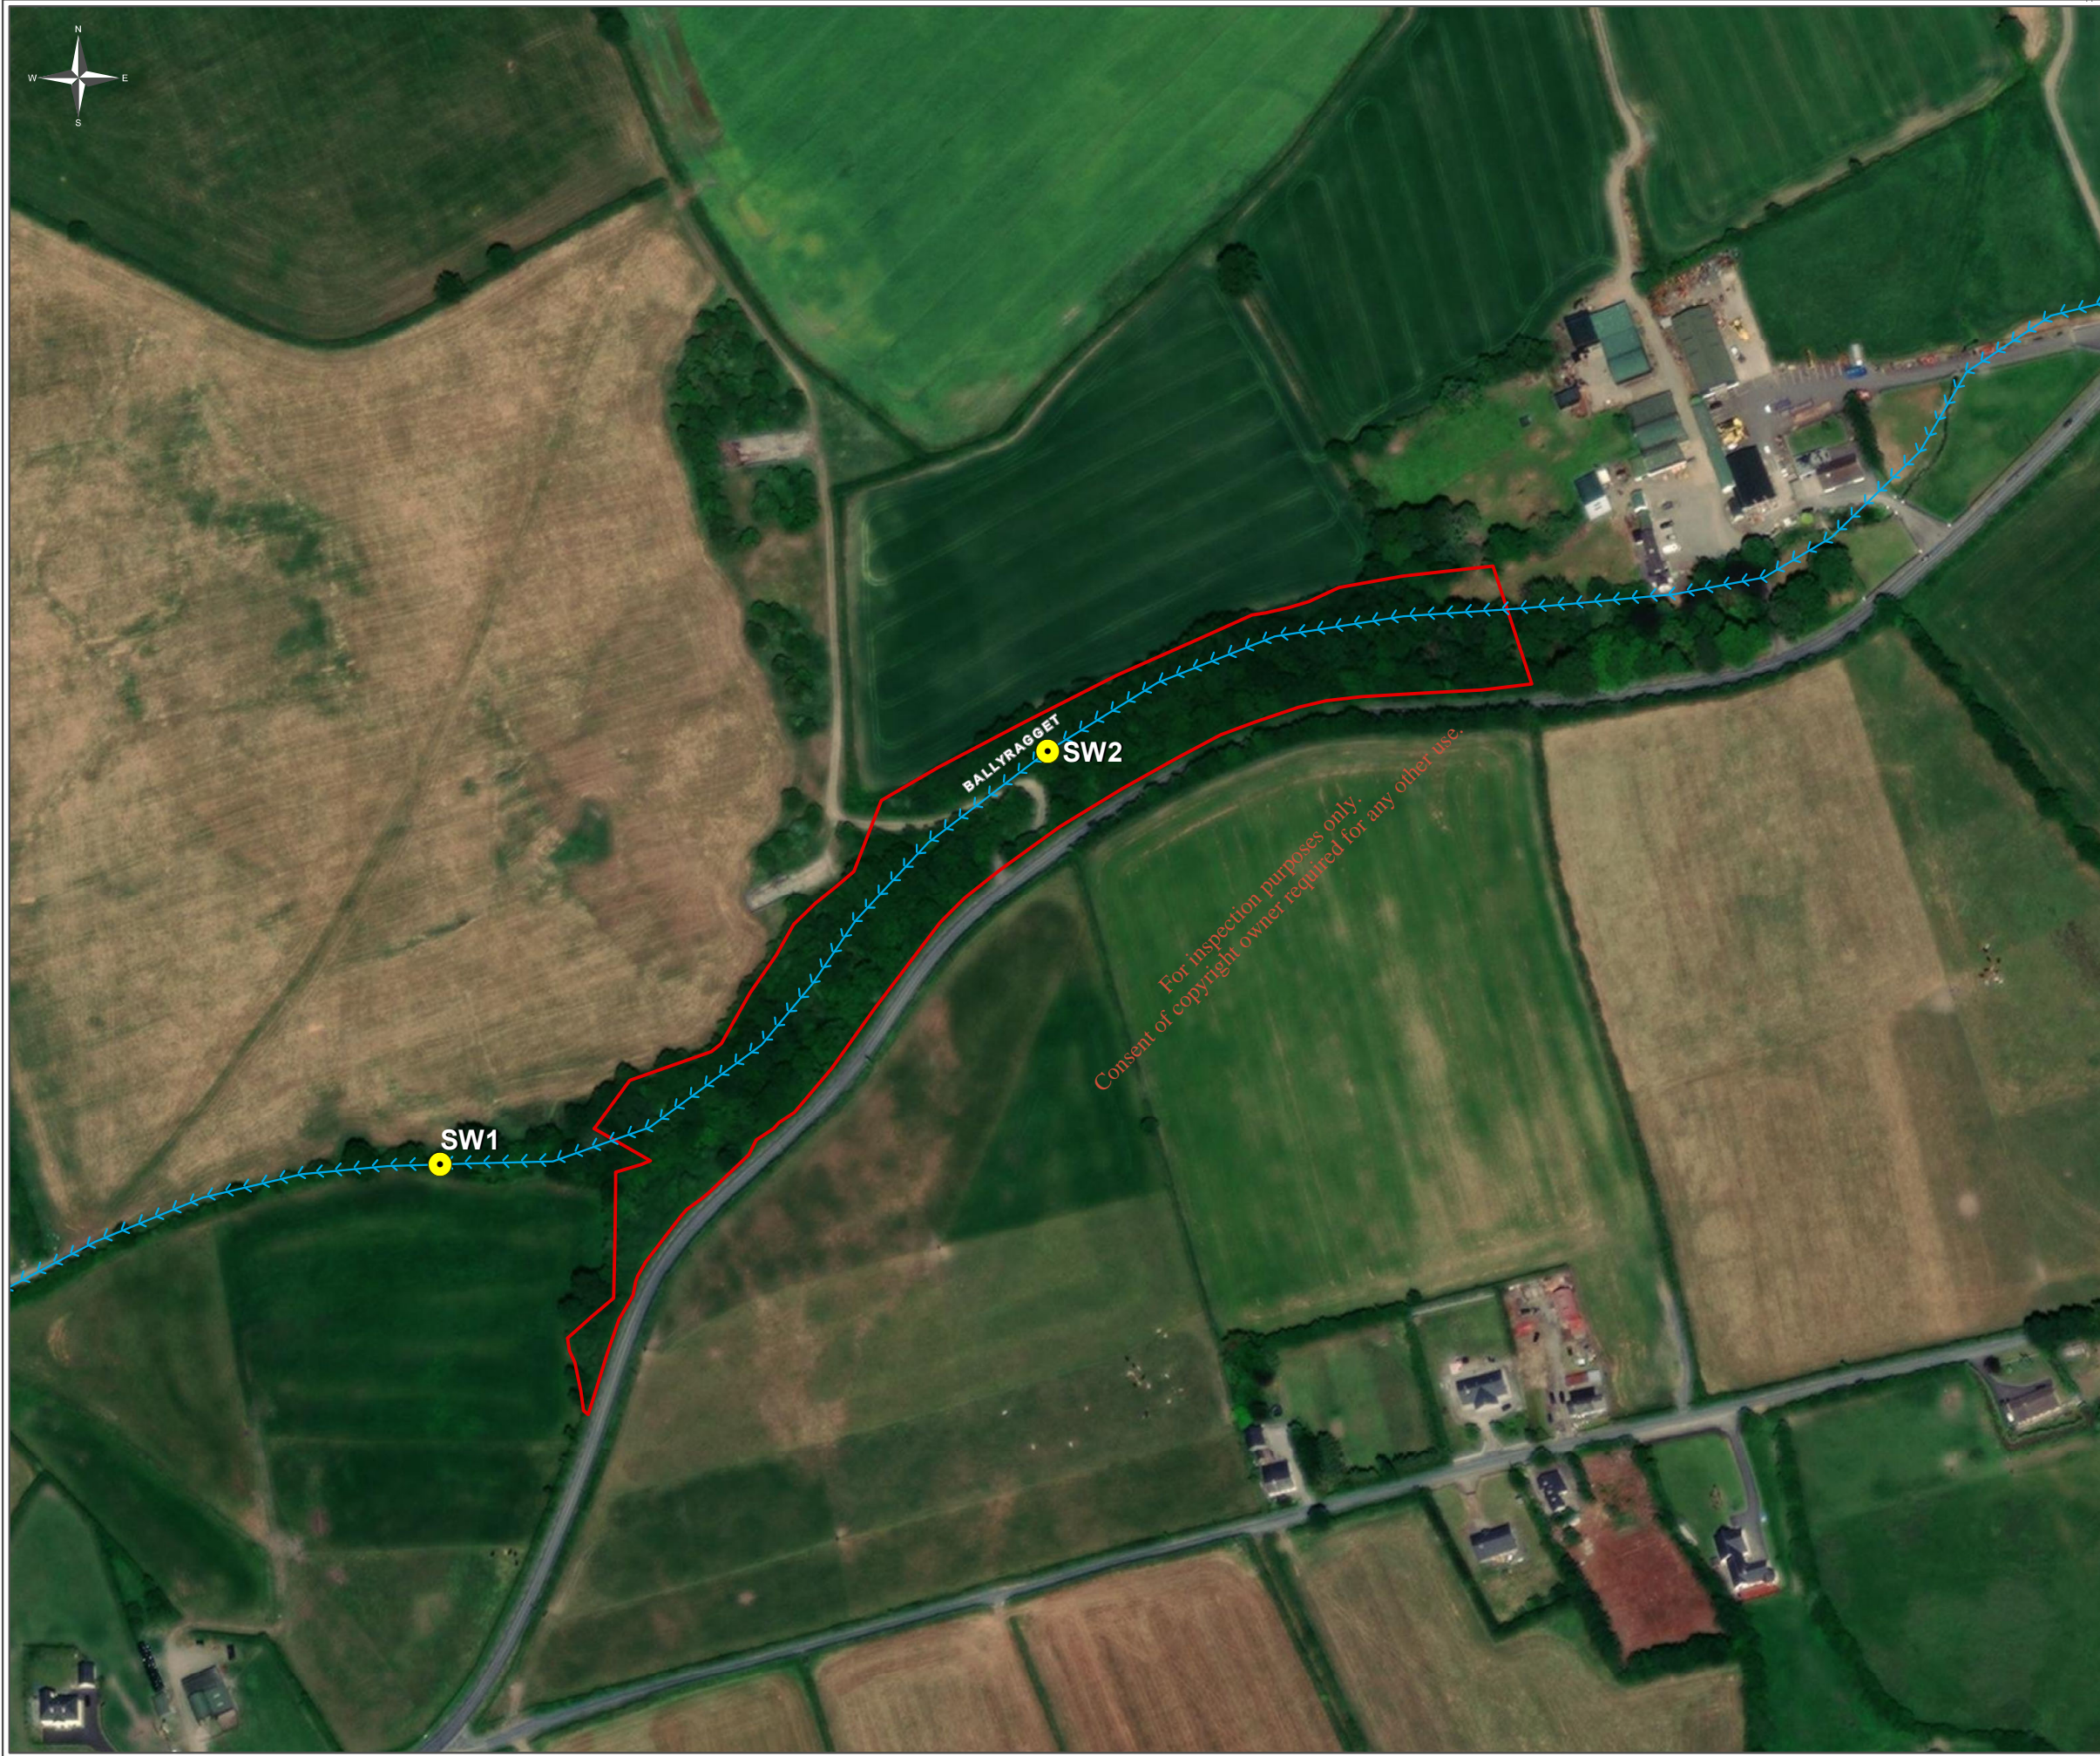
Figure Title	Surface Water Sampling Locations		
Figure No.	4.1		
Project	Historical Landfills: Thorpes		
Client	Kilkenny County Council		
Scale	1:2,500	Page Size	A3
Revision	A	Date	28/01/2021

The surface water monitoring locations were selected upstream and downstream of the landfill footprint, as shown on Figure 4-1. Monitoring location SW1 was selected as the furthest downstream location and samples the Ballyragget Stream to the west of the landfill. Monitoring location SW2 is located at a concrete culverted bridge to the east of the landfill and samples upstream of the landfill.

The results of surface water sampling analysed from the 2 No. sampling locations (SW1 and SW2) at the site have been assessed against the Maximum Admissible Concentration (MAC) Regulations (1989) and the Environmental Quality Standard (EQS) for Surface Waters Regulations (2009) assessment criteria.

The results of the surface water monitoring from SW1 and SW2 as presented in Table 4.1, when assessed against the MAC (1989) and EQS (2009) quality standards were found to be below the guideline values in all assessments.

It is recommended that surface water monitoring be undertaken at both monitoring locations, SW1 and SW2, monthly for three months prior to the Certificate of Authorisation application.

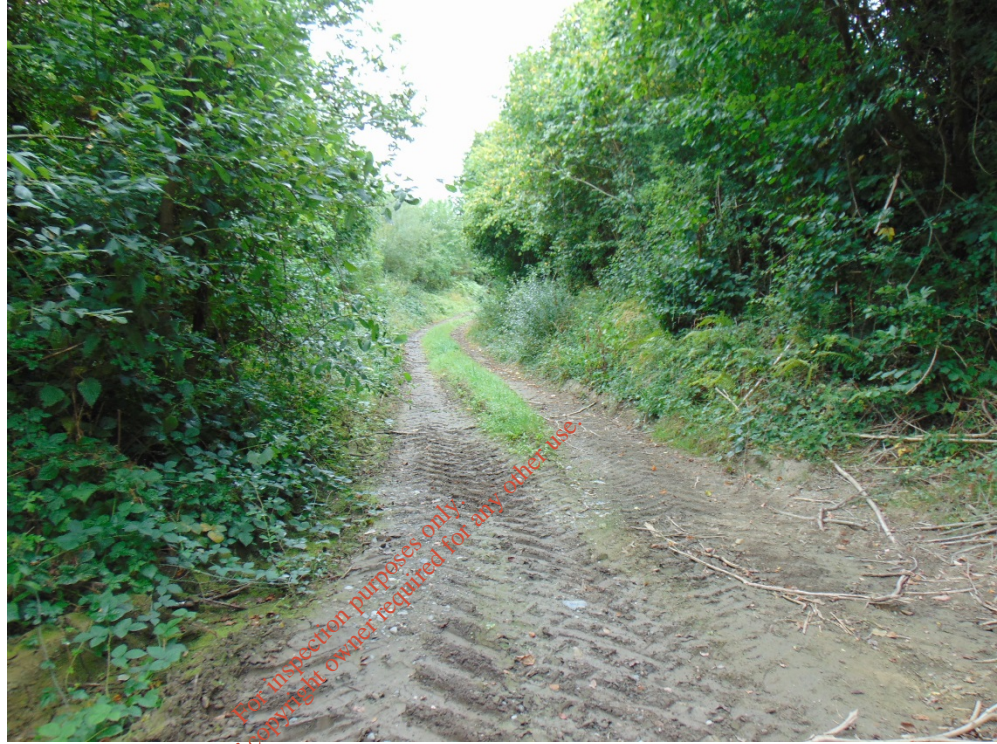
Photo
No.2

Thorpes access road

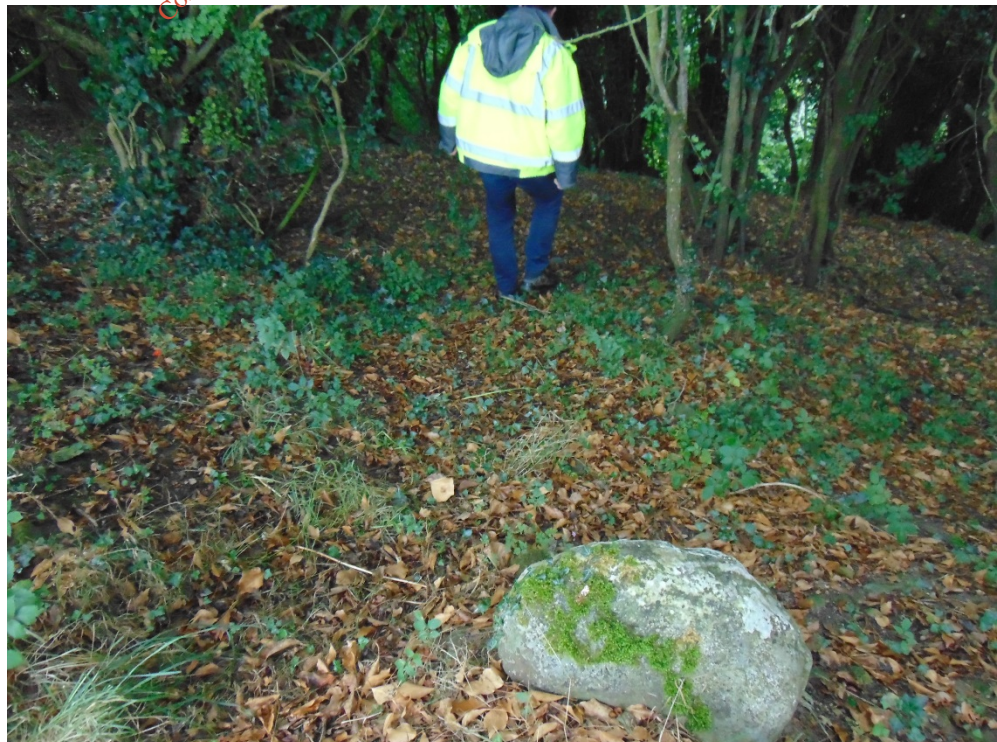
Access to site by foot,
sloping north west to
south east

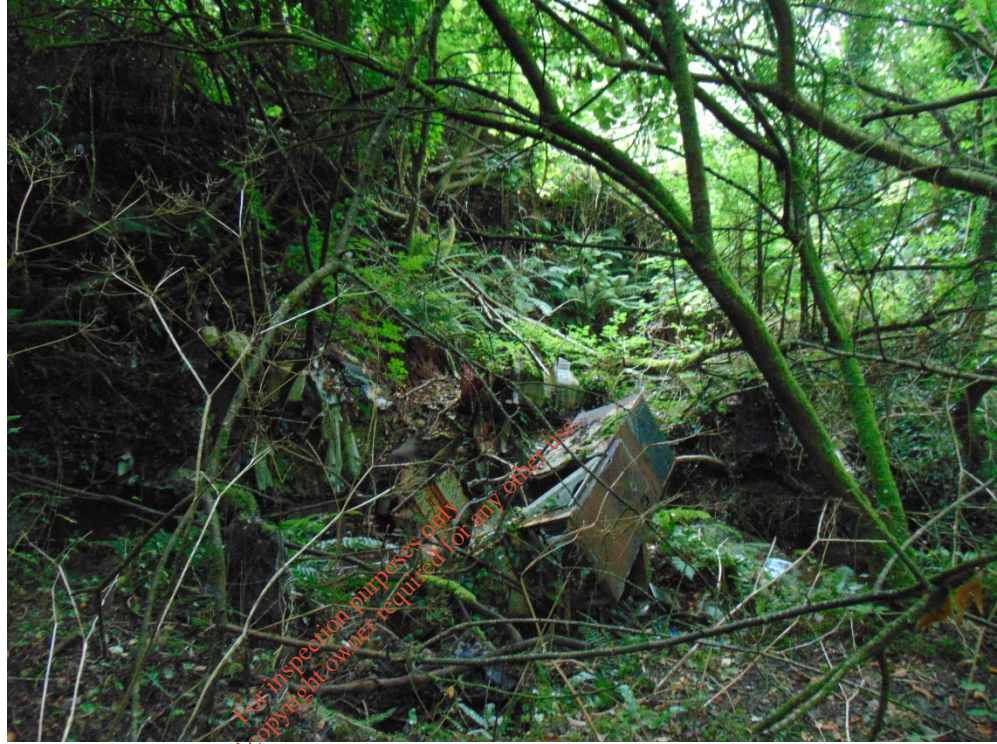
**Photo
No.3**

Large metal items
dump on slope face
sloping from road
adjacent to the
southern site
boundary down to
the stream within the
site

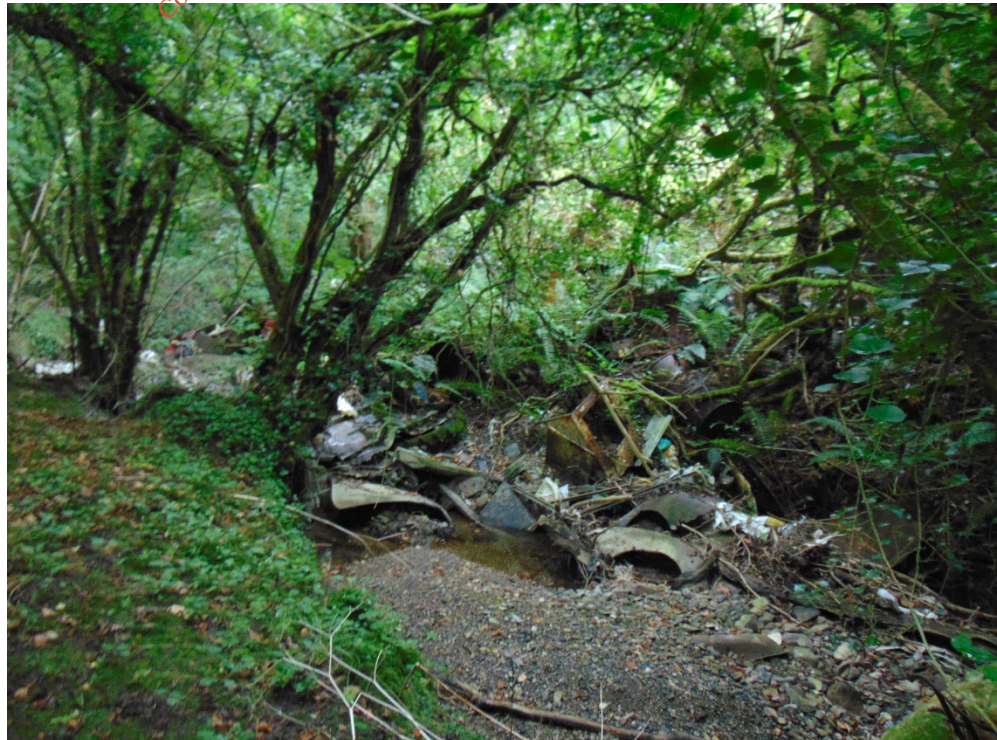
**Photo
No.4**

Large waste items on
slope adjacent to
road and in stream

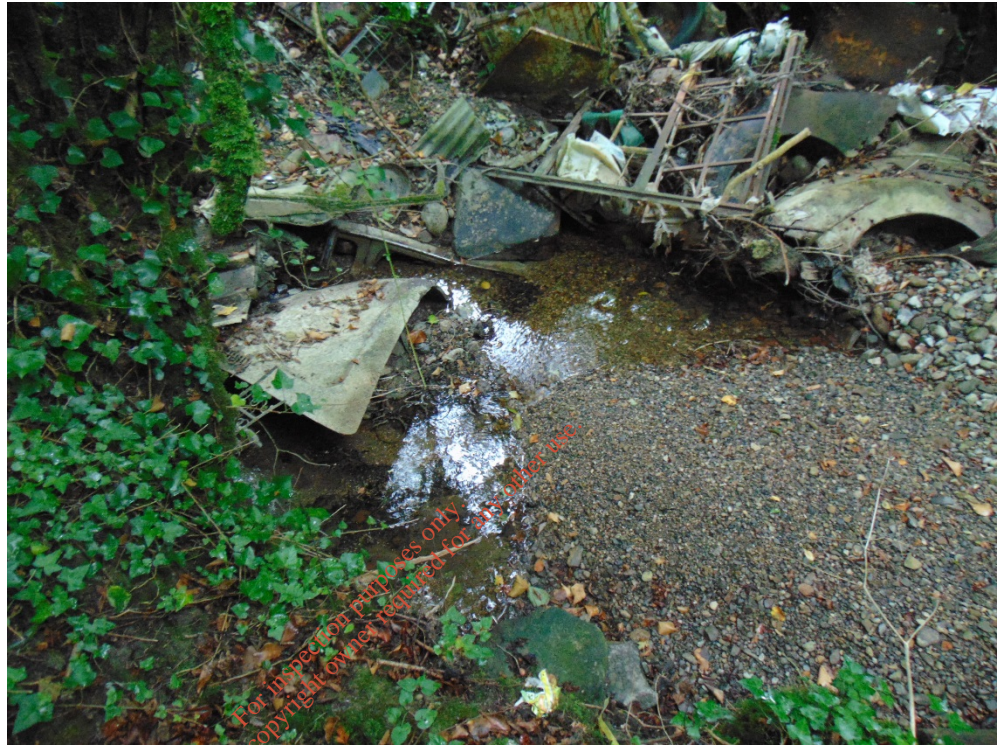
No.5

Waste in stream
running through site

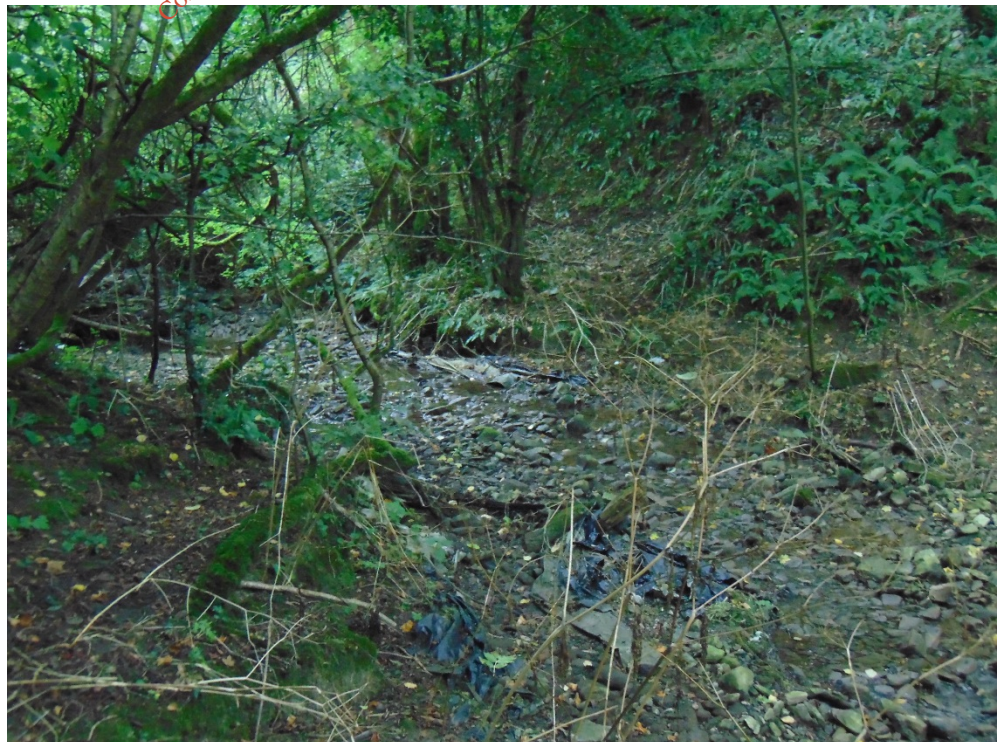
No.6

Plastic litter in stream,
upstream of main waste
deposits

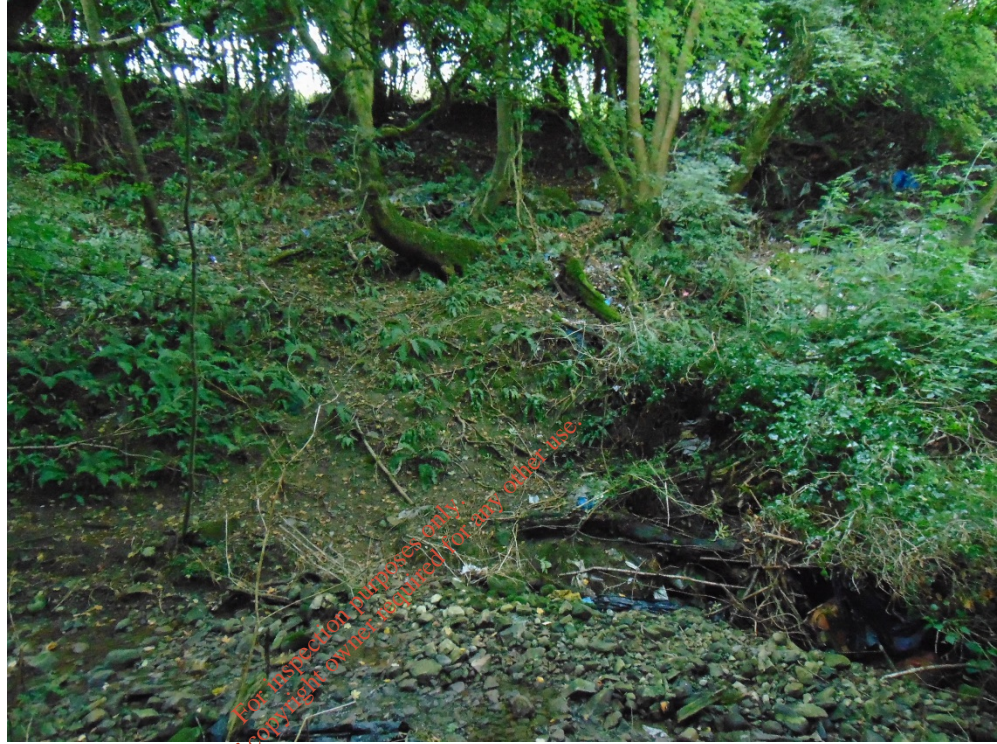
Slope up to road
adjacent to southern
sit boundary with
stream at base of
slope

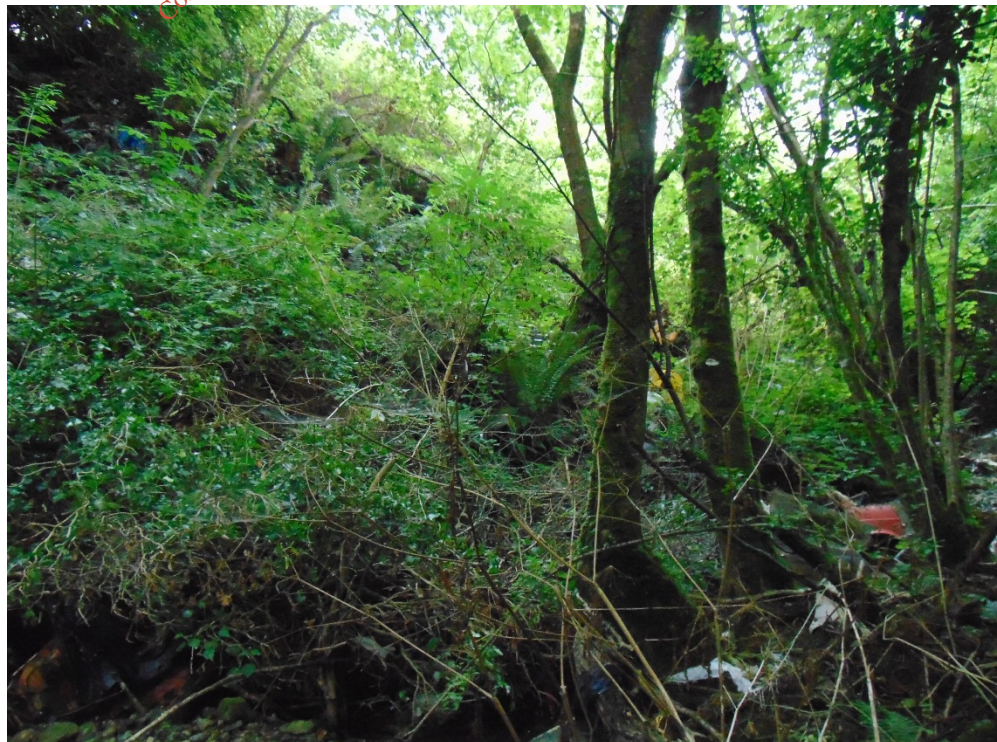
Photo No.
8

Vegetation on slope up
to road adjacent to
southern site boundary
