CHAPTER 12 TRAFFIC AND TRANSPORTATION

Appendix 12.1 Traffic movement counts

Survey Name: 221 19328 EIA/Grange Castle ATC & MCC Data
Date: Tue 01 Oct 2019

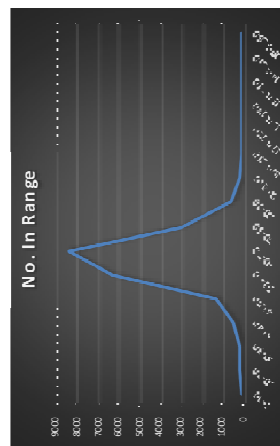
Speed (KPH)	No. In Range
0-10	1
10-20	39
20-30	112
30-40	357
40-50	1206
50-60	6251
60-70	8350
70-80	2927
80-90	538
90-100	106
100-110	29
110-120	7
120-130	2
130-140	6
140-150	5
150-160	3

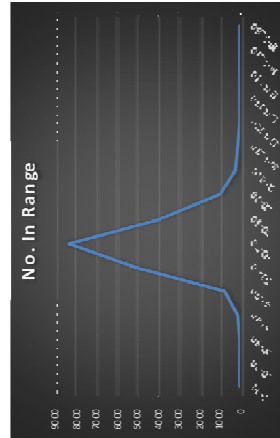
Southbound (B => A)

No. of Vehicles 19537
 85% Speed 73 KPH
 Minimum Speed 5 KPH
 Maximum Speed 155 KPH
 Average Speed 64.28 KPH

Speed (KPH)	No. In Range
0-10	2
10-20	4
20-30	30
30-40	130
40-50	726
50-60	3060
60-70	4233
70-80	4007
80-90	911
90-100	154
100-110	44
110-120	4
120-130	4
130-140	4
140-150	1
150-160	3

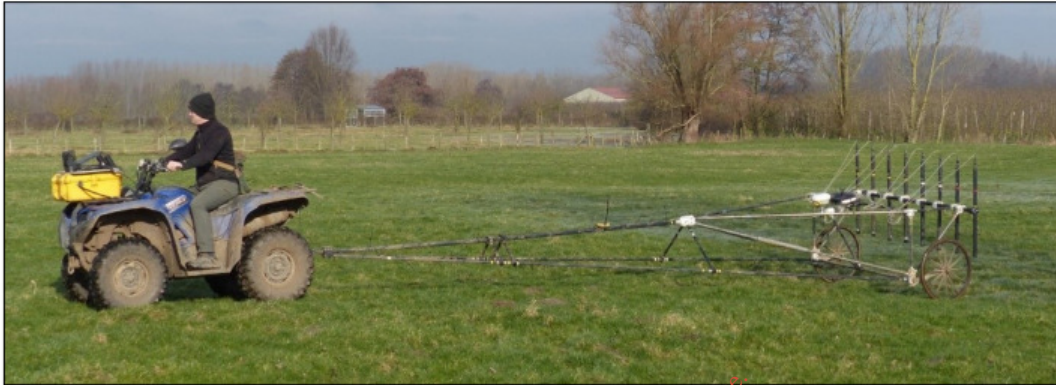
1. Advanced multi-channel magnetometer survey mapping the buried foundation of a 14th century castle (towed configuration with ATV).

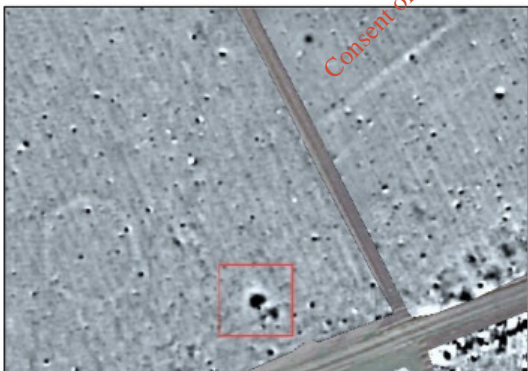
2. Results from magnetometer survey presented in greyscale format highlighting pit remains bordering an enclosure site and Roman villa.

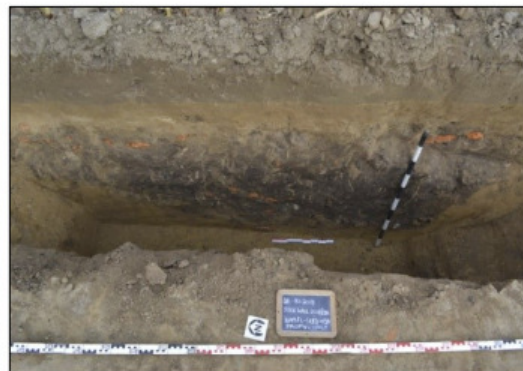
3. Burnt & fired debris revealed following excavation of pit remains bordering an enclosure site and Roman villa.

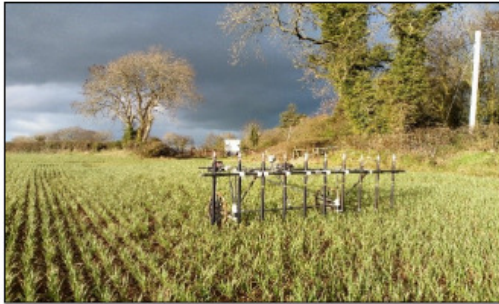
4. Advanced multi-channel gradiometer system for magnetometer survey (manual configuration).

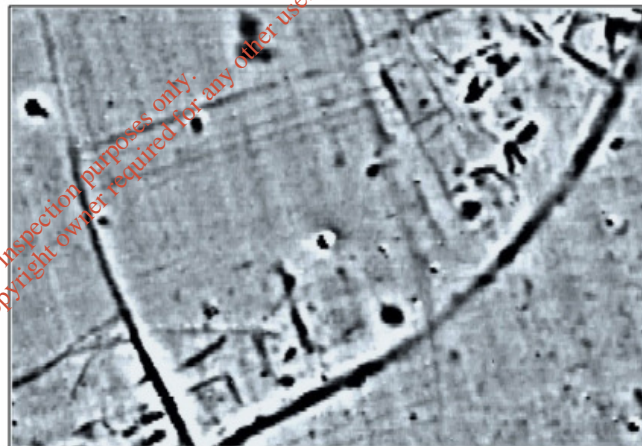
6. Greyscale from survey at the site of a deserted medieval village.

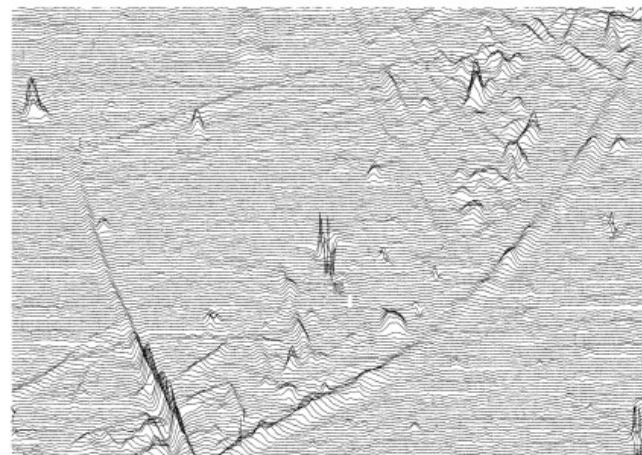
XY trace plots provide a near-perspective representation of measurements along individual lines of data recorded from each of the magnetometer sensors. The XY trace format is used as a conventional method for identifying responses which derive from modern ferrous debris. The XY trace display is particularly when identifying magnetically strong anomalies indicative of buried hearths, kilns and furnaces.

7. XY trace from survey at the site of a deserted medieval village.
