GALWAY HISTORIC LANDFILLS

TIER 2 RISK ASSESSMENT HISTORIC LANDFILL AT NEW INN, CO. GALWAY

Prepared for: Galway County Council

Date: November 2020

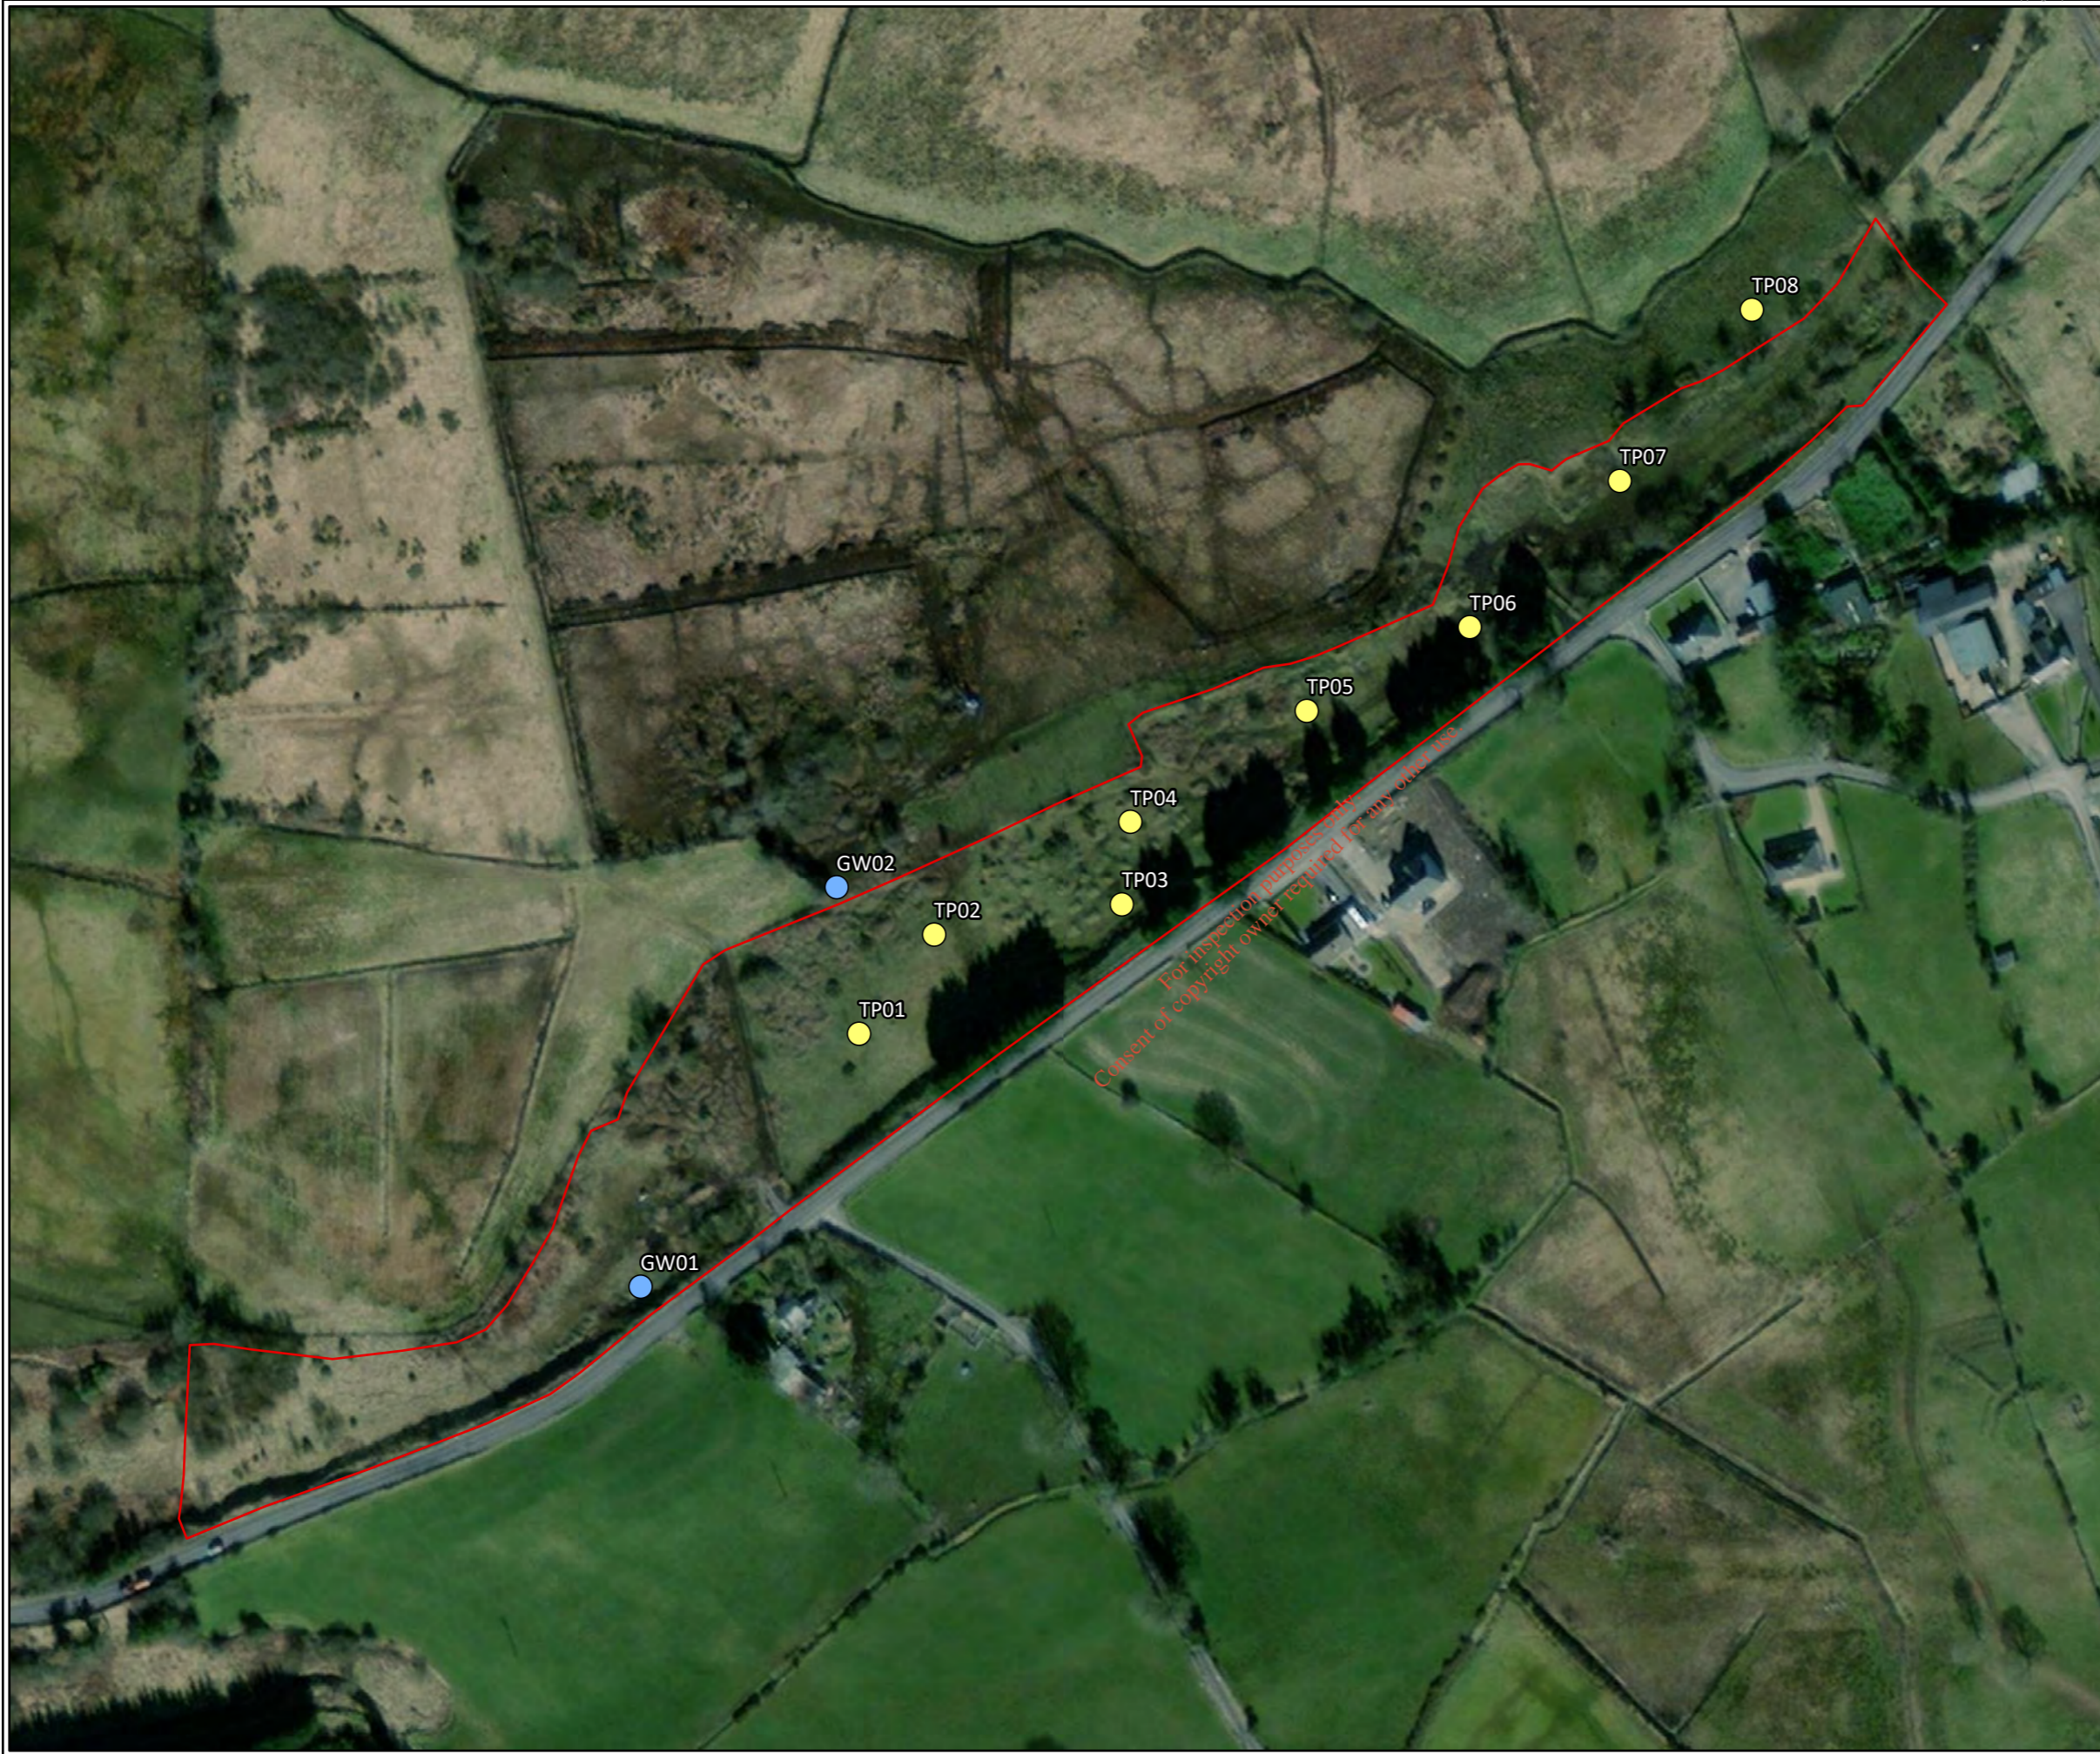
- Site Boundary
- Groundwater Well
- Trial Pit

A Causeway Geotech (CGL) Engineering Geologist supervised the advancement of 8 No. trial pits, shown in Figure 3.1, on the 6th July 2020. Trial pits TP01 to TP04 were excavated within the area, previously defined by GCC as being the area of historic landfilling. TP05 to TP08 were excavated within adjacent lands to the north-east to confirm if landfilling activity also occurred beyond the known historic landfill area.

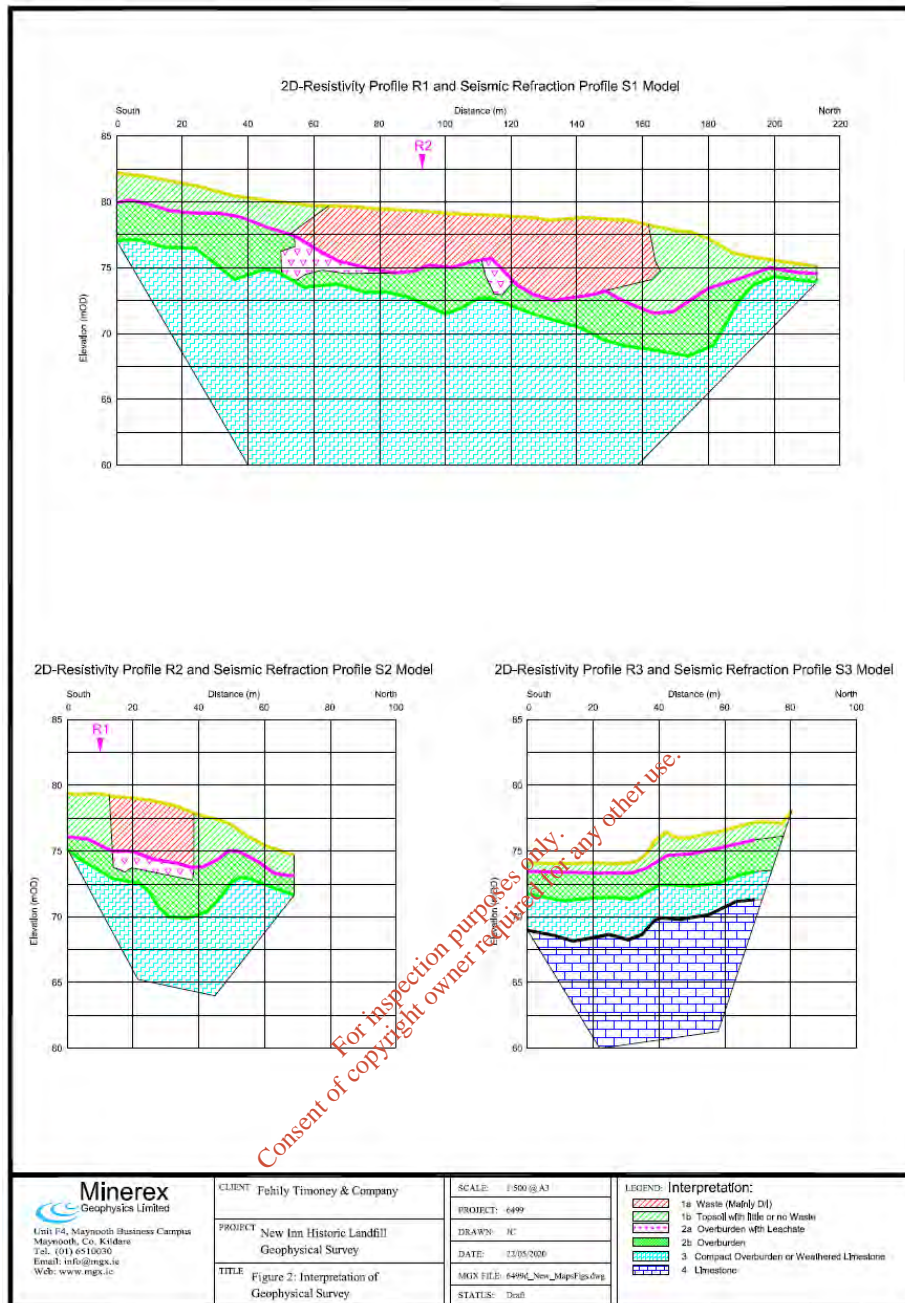
Figure 3-3: Integration of Geophysical Survey

Most of the survey area shows low conductivities (<20 mS/m) which indicates no waste or possibly C&D waste material. There is one area in the south where conductivities rise to generally 20 – 40 mS/m. These conductivities would indicate some waste material, but the conductivities do not increase to very high levels which are typically found over deep landfills.

Layer 1a has a seismic velocity range of 300 m/s and 400 m/s and is found in the South of the survey area. This velocity would represent landfill material, mainly MSW.

Layer 1b has a seismic velocity range of 300 m/s and 400 m/s and is found in most of the survey area. This velocity would represent topsoil with little or no waste material.

Layer 2a has a seismic velocity range of 900 and 1200 m/s. This layer is interpreted as overburden material with leachate, and it is found only in some areas below layer 1a.

Layer 2b has a seismic velocity range of 900 and 1200 m/s. This layer is interpreted as overburden material, and it is found in most of the survey area.

Layer 3 is interpreted as compact overburden or weathered Limestone, and is found in most of the survey area, under layers 2a and 2b. This layer has 2000 m/s seismic velocity.

Layer 4 is interpreted as fresh Limestone and is found only under profile R3, under layer 3. This layer has 4000 m/s seismic velocity.

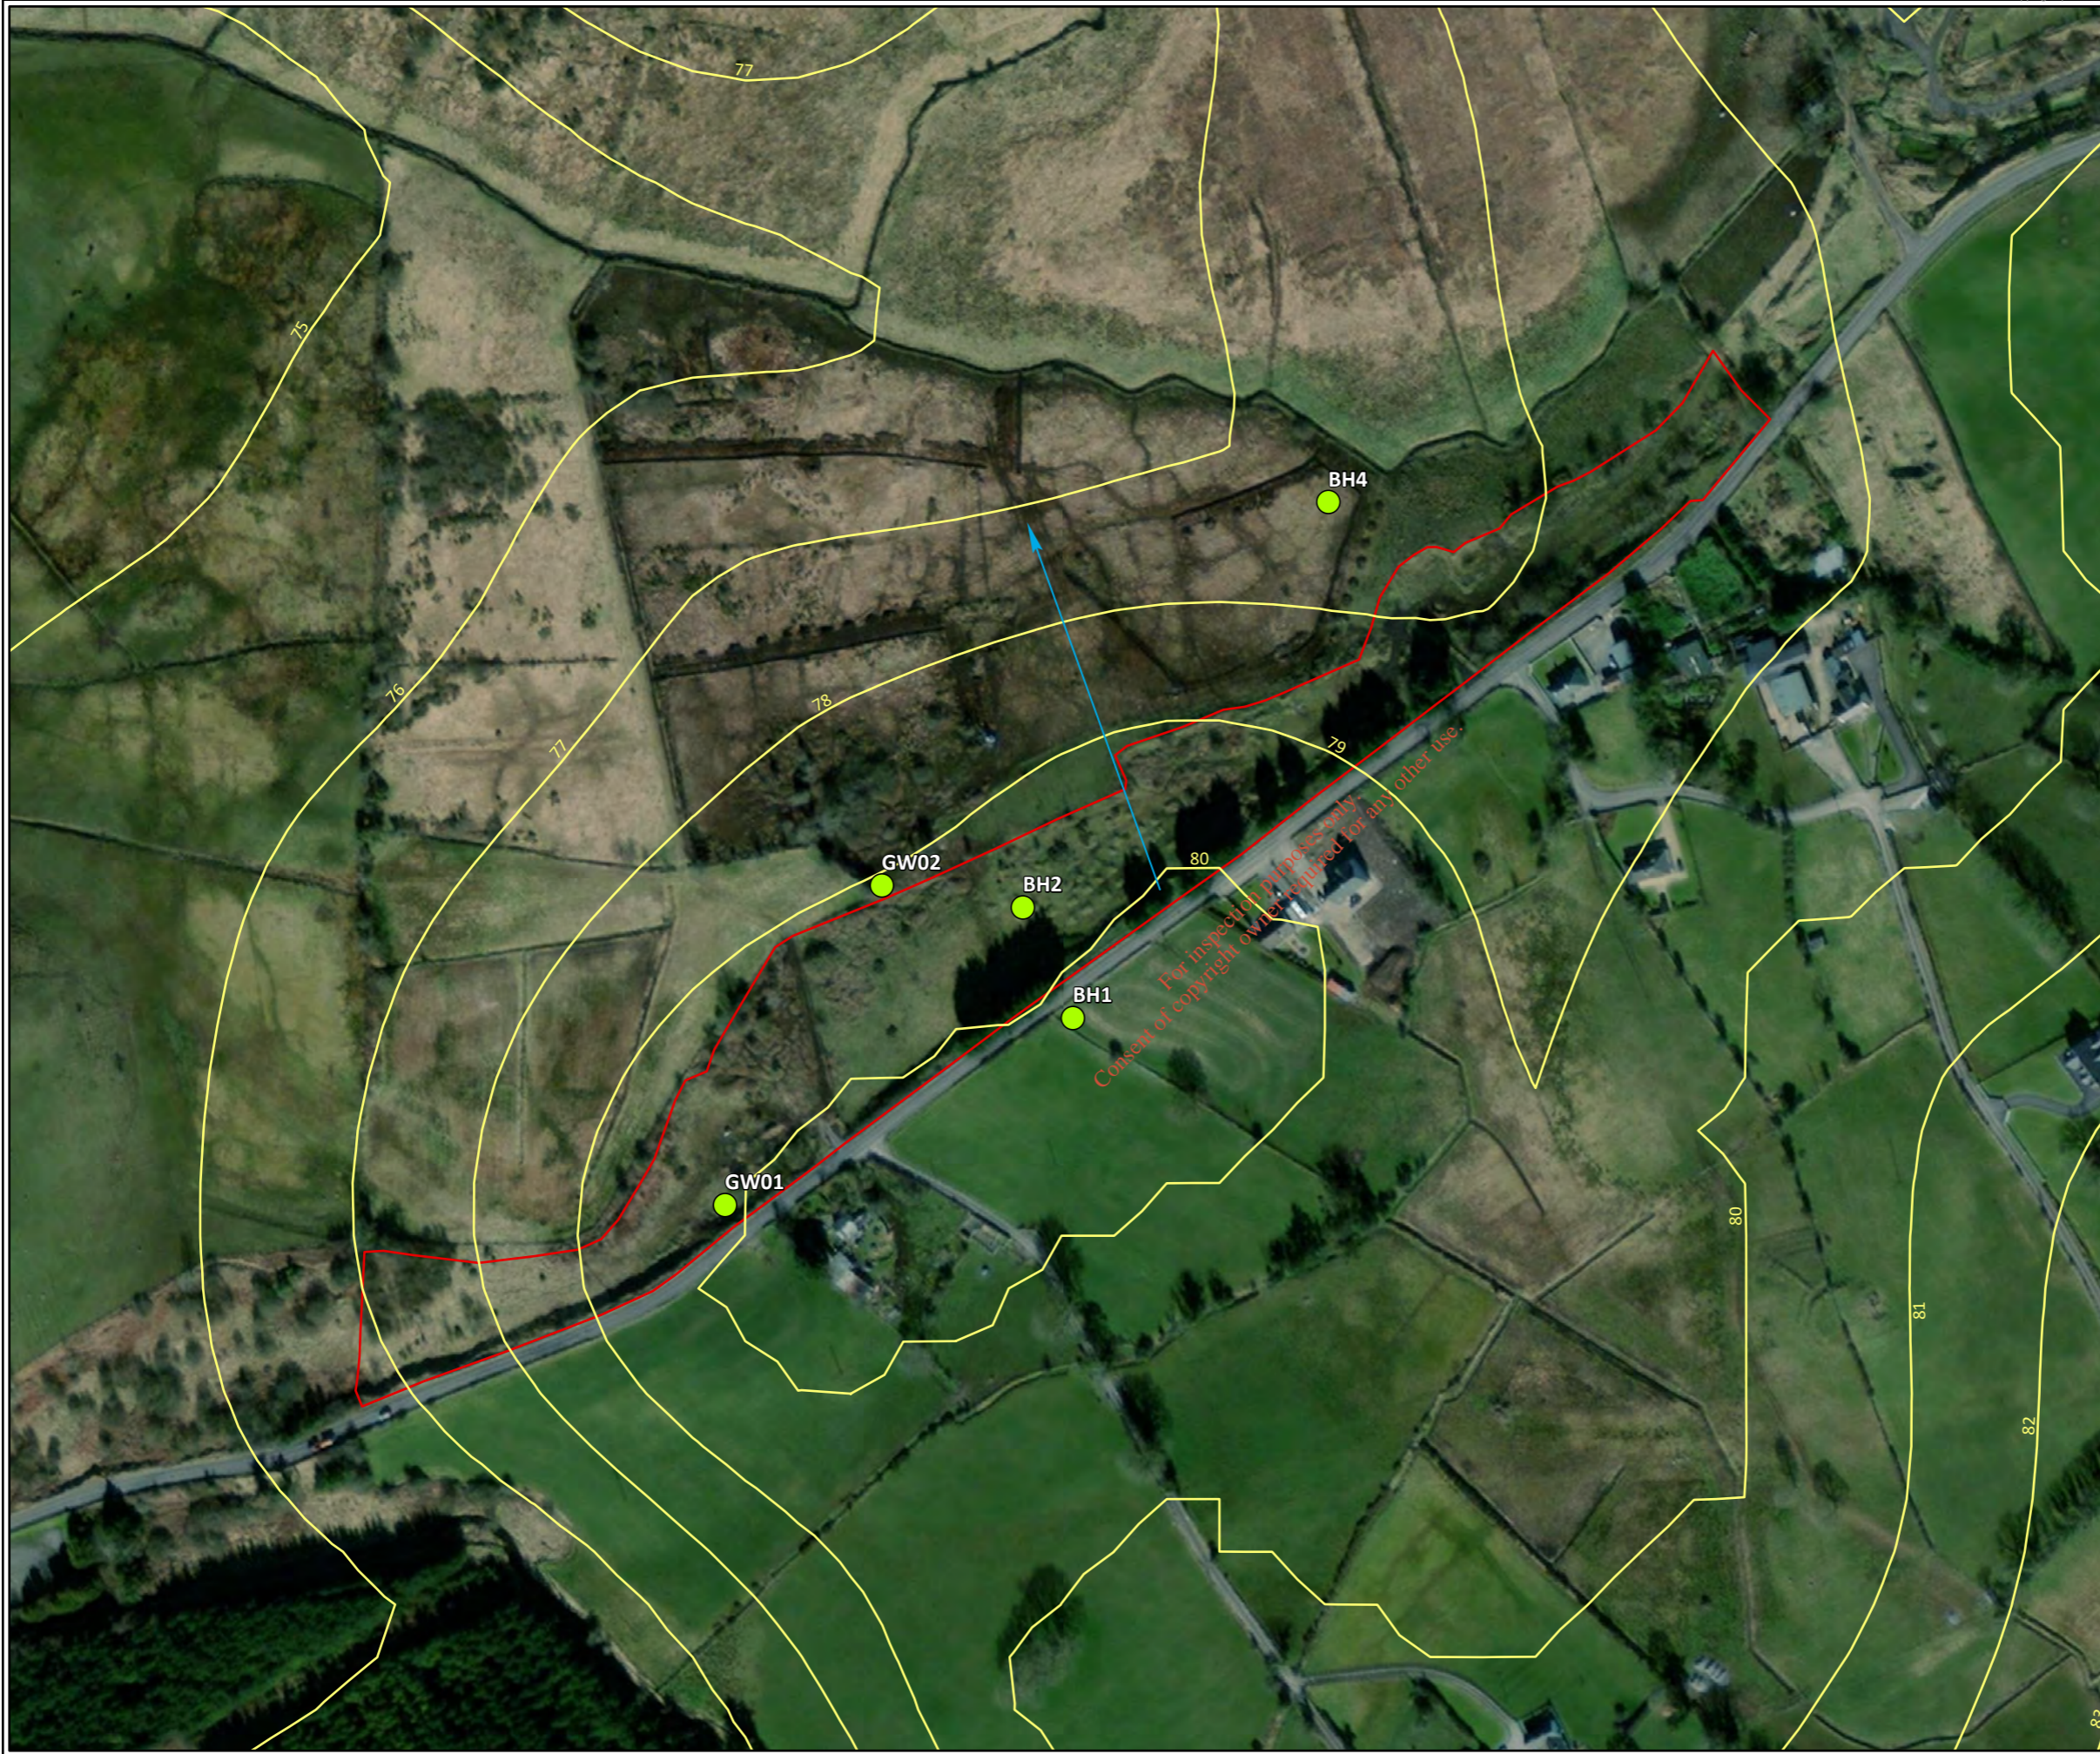
Based on the above field survey measurements, the groundwater flow direction is estimated to be south to north. This corresponds with the general local topography. Groundwater level measurements, when compared against waste depths as per trial pit logs, also indicate that the groundwater table is below the base of waste material. However, it is noted that groundwater levels fluctuate seasonally and depending on weather conditions the water table may on occasion transect the waste body. A potentiometric map illustrating the hydraulic gradient and the direction of groundwater flow is presented in Figure 4.1.

- Site Boundary
- Borehole Locations
- 1m Ground Elevation Contours
- ➔ Indicative Groundwater Flow Direction

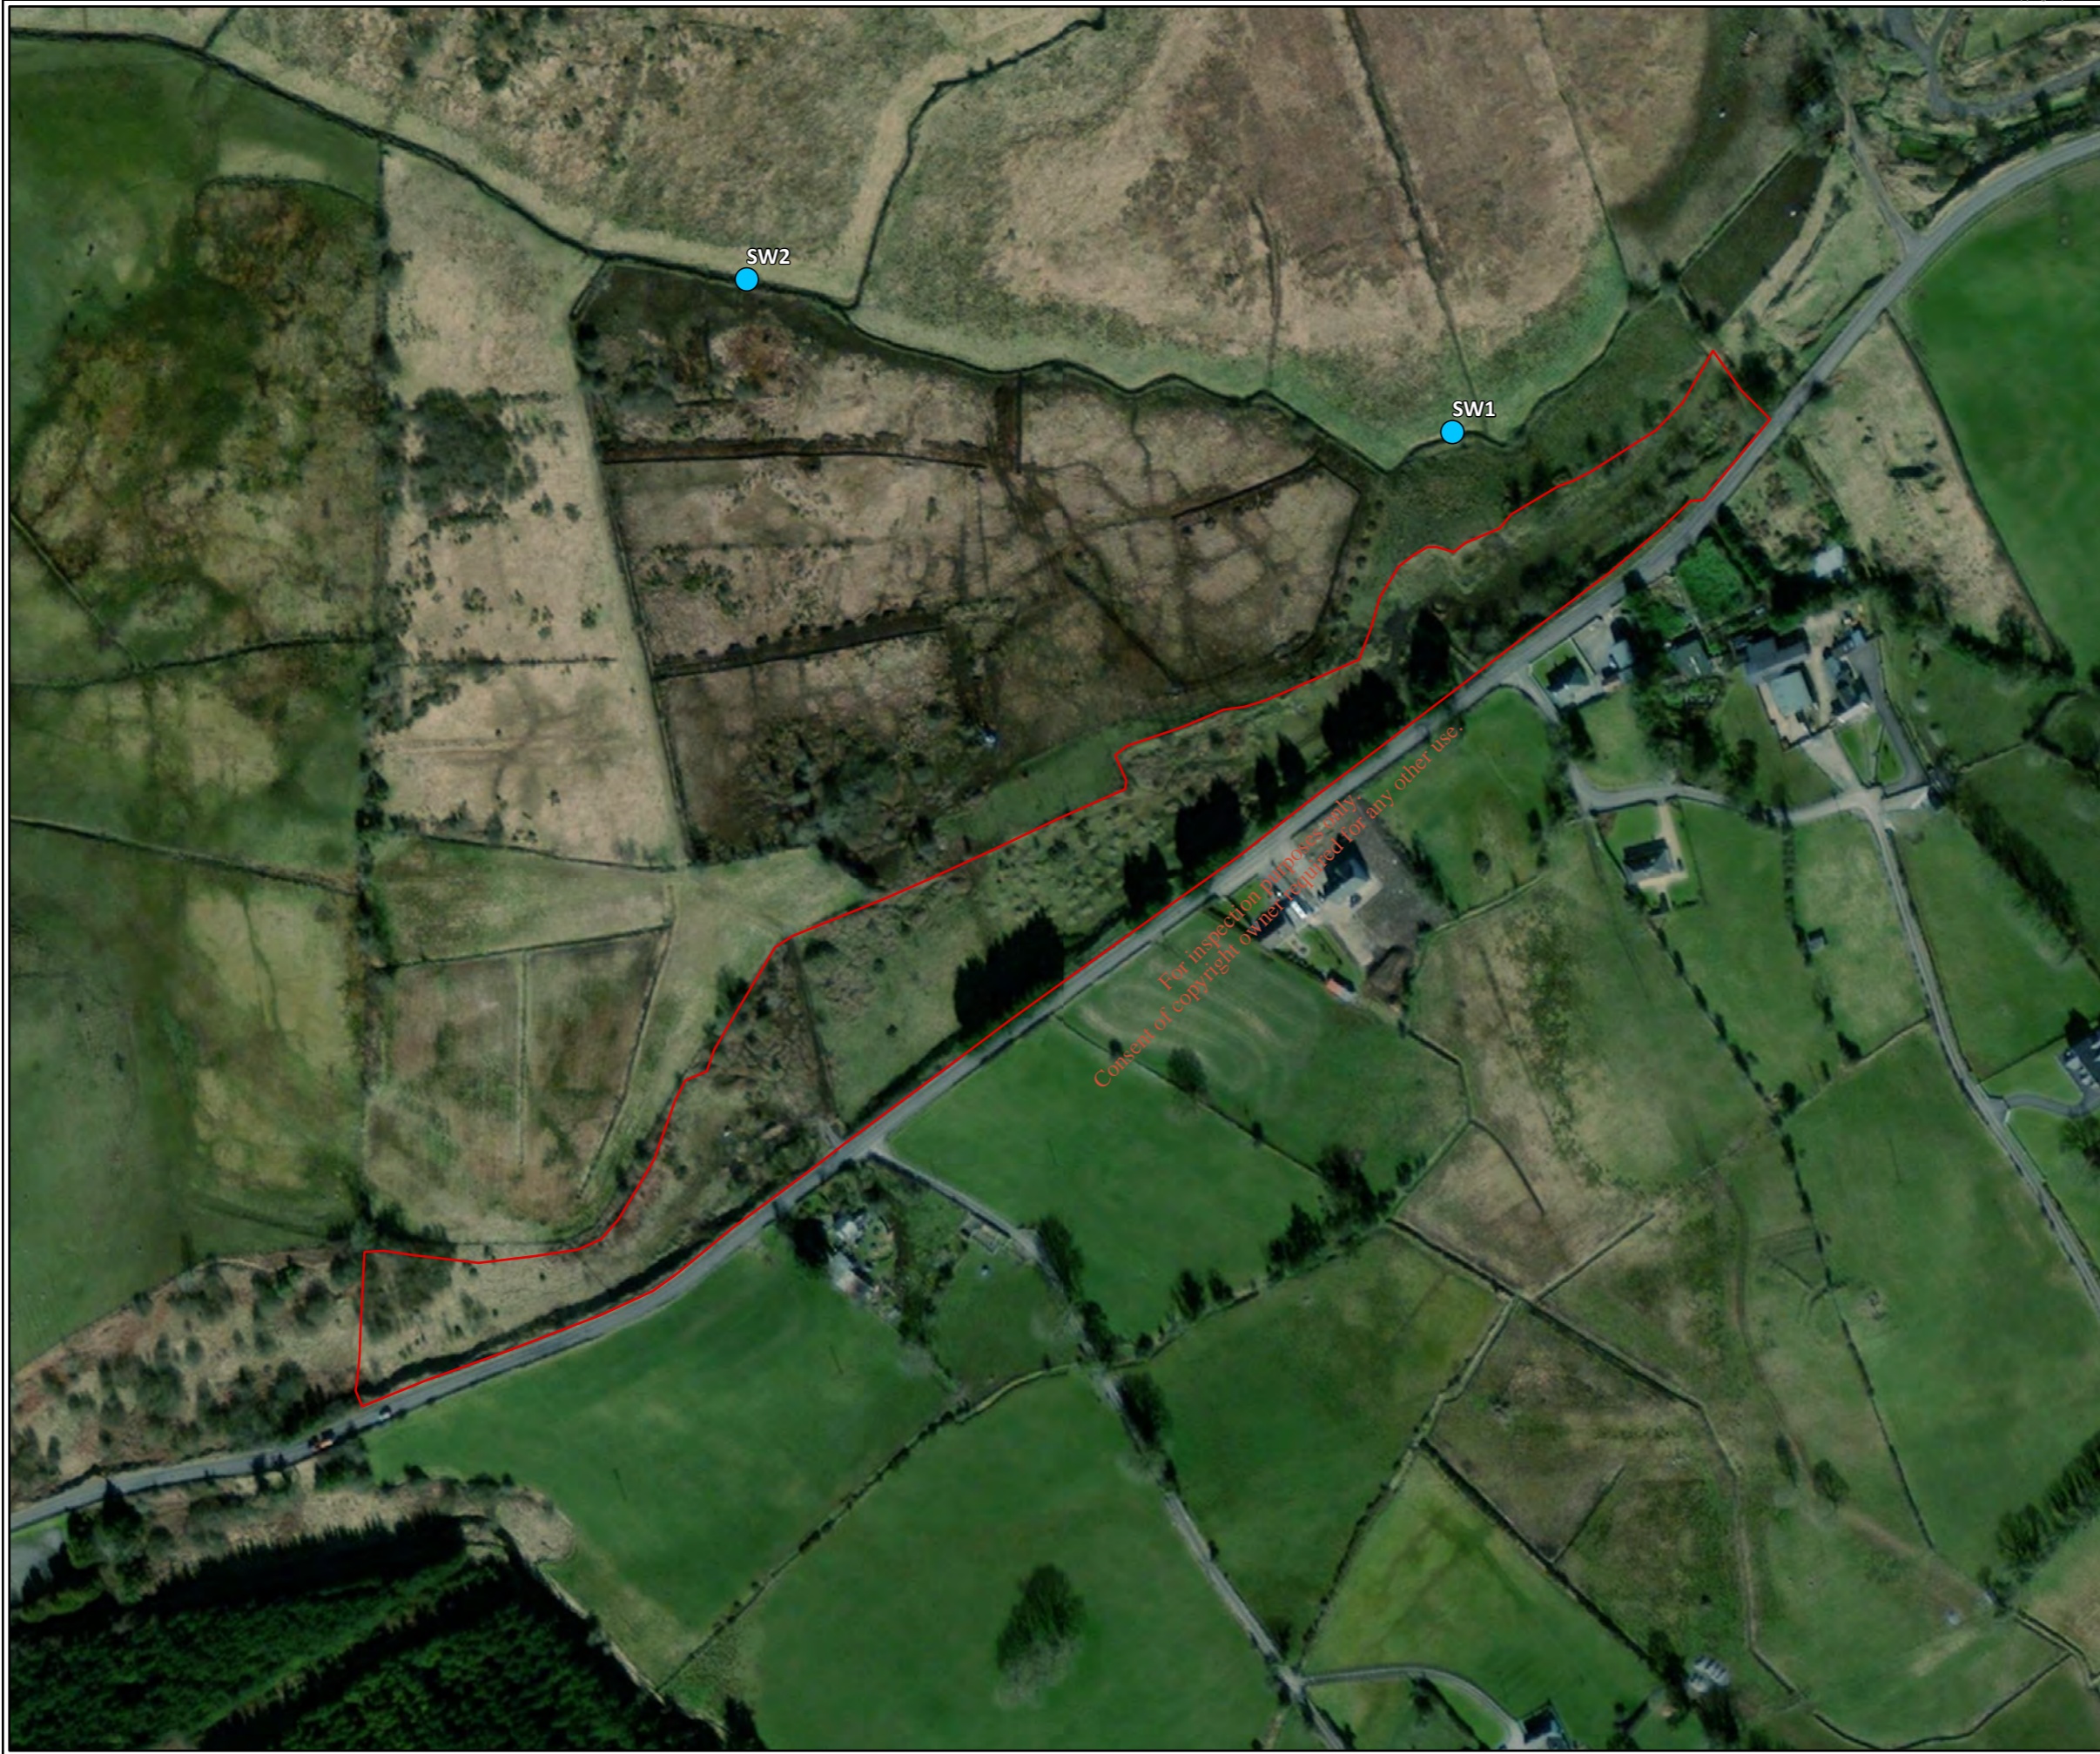
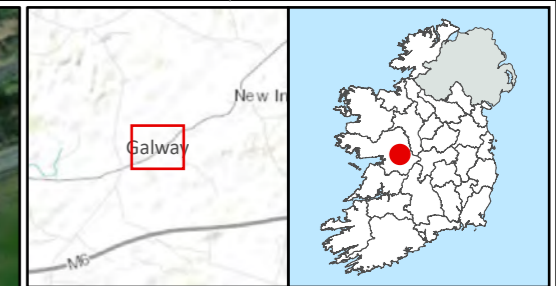
The results of surface water sampling analysed from the 2 No. sampling locations (SW1 and SW2) at the site have been assessed against the Maximum Admissible Concentration (MAC) and the Environmental Quality Standard (EQS) as per S.I. No. 77/2019 European Union Environmental Objectives (Surface Waters) (Amendment) Regulations 2019.

- Site Boundary
- Surface Water Monitoring Locations
