## Galway Historic Landfills – Tuam Ground Investigation

Client: Galway County Council

Report No.: 19-1465A

Date: September 2020

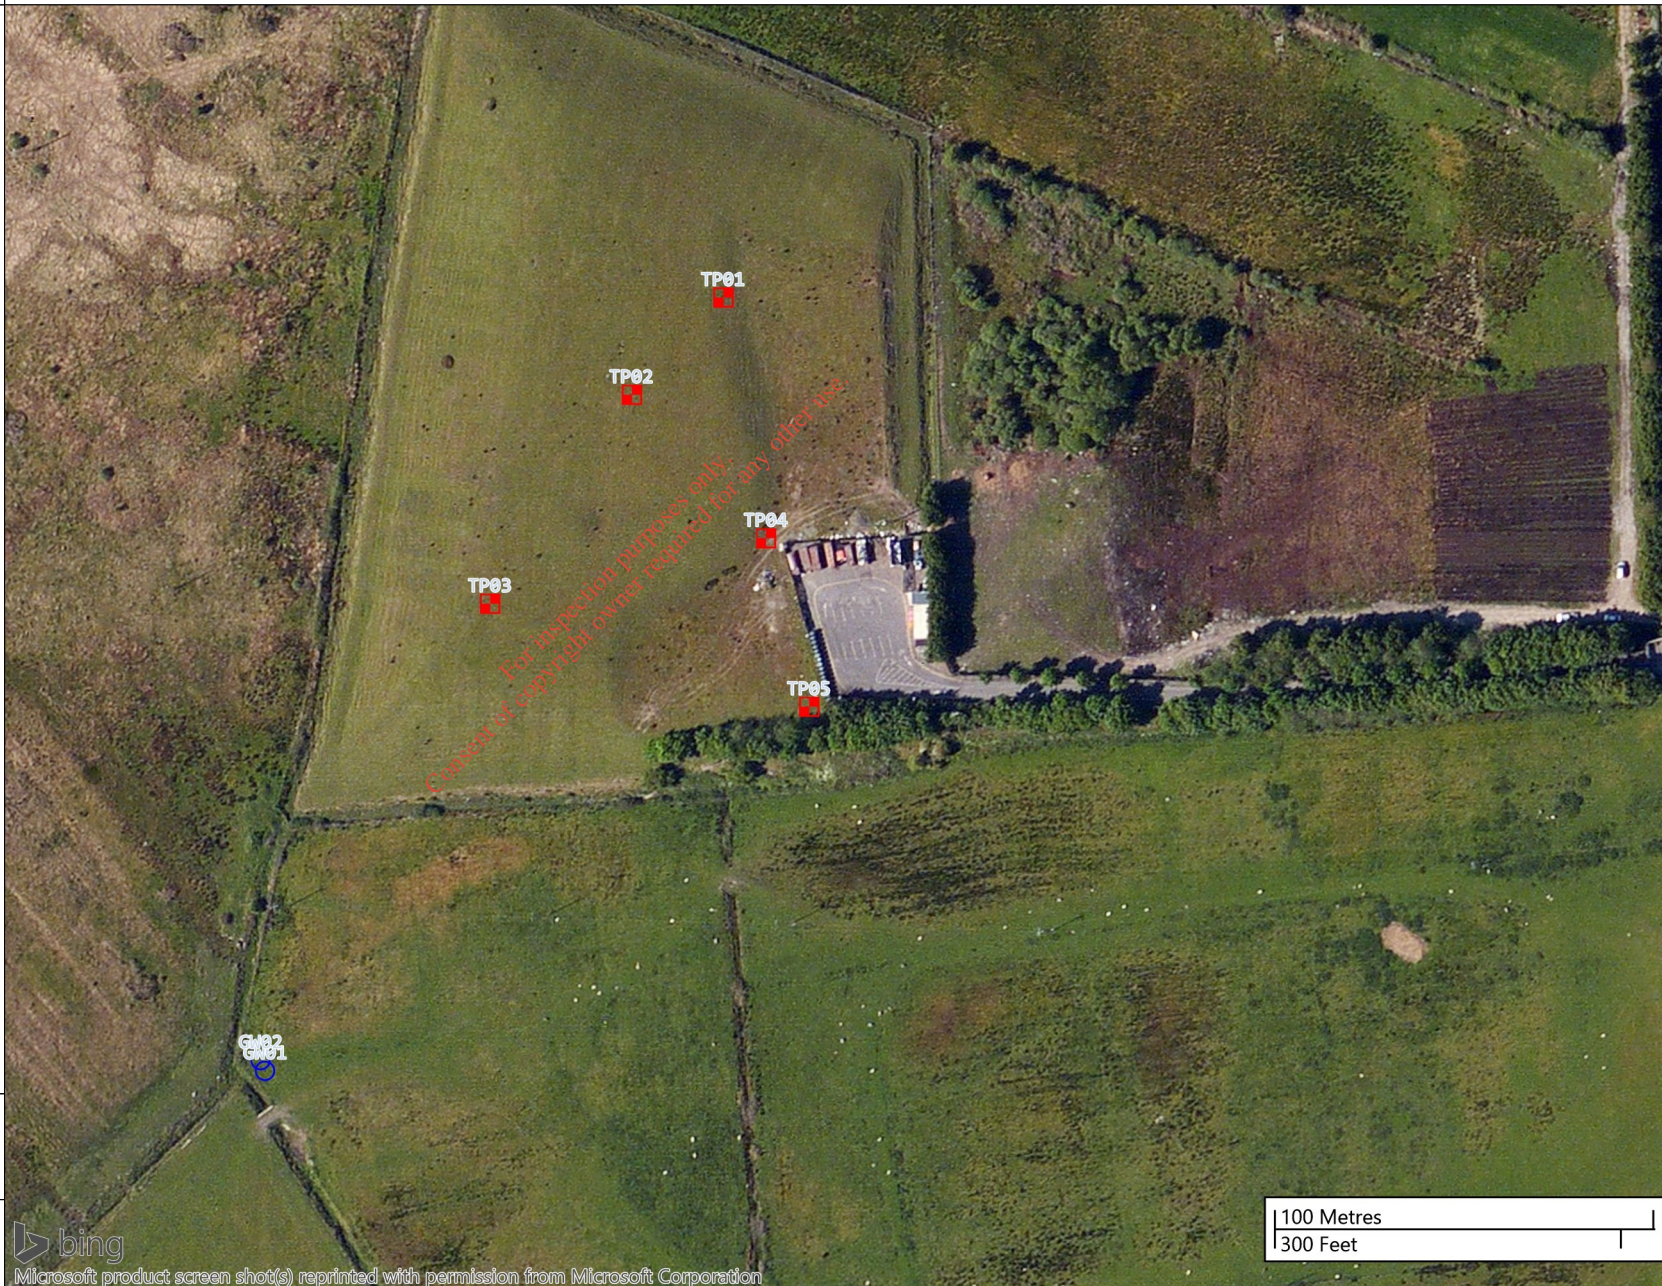
**Title:**  
Exploratory Hole Location Plan

The plan coordinates (Irish Transverse Mercator) and ground elevation (mOD Malin) at each location are recorded on the individual exploratory hole logs. The exploratory hole plan presented in Appendix A shows these as-built positions.
