GALWAY HISTORIC LANDFILL

TIET 2 RISK ASSESSMENT HISTORIC LANDFILL AT TUAM, CO. GALWAY

Prepared for: Galway County Council

Date: November 2020

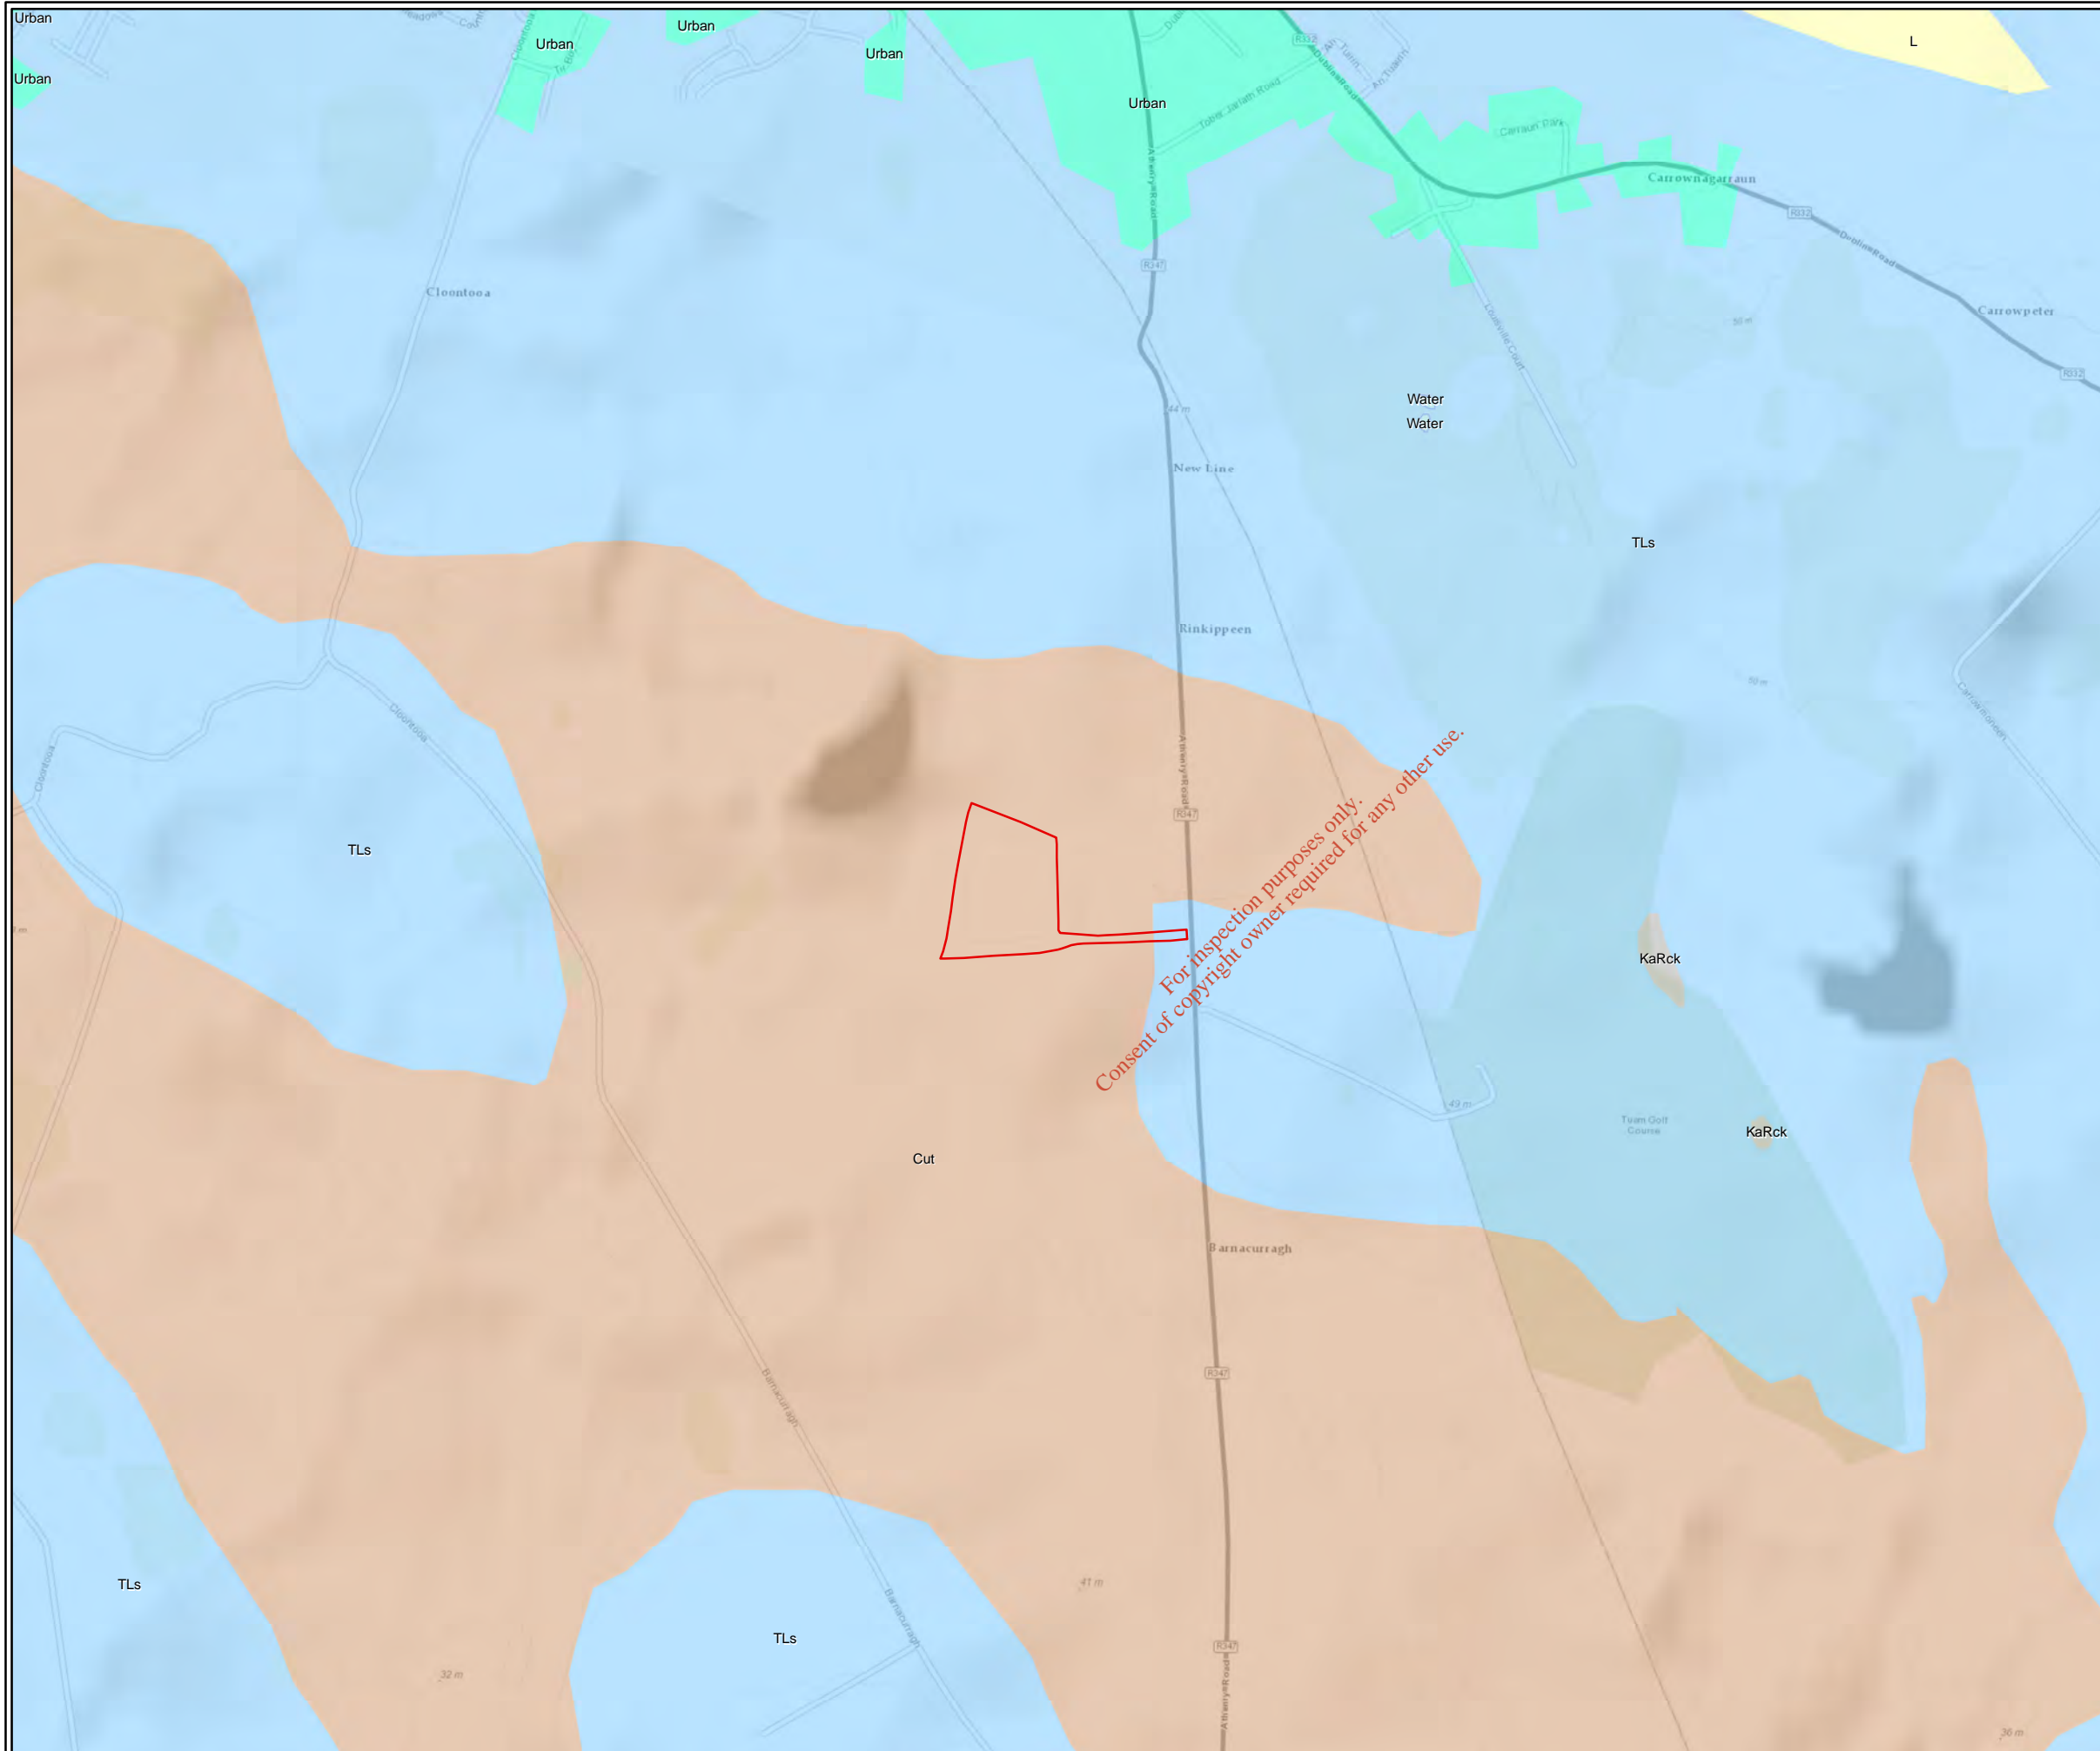
TITLE:	
Quaternary Geology	
PROJECT:	
Tuam Historic Landfill ERA	
FIGURE NO: 2.2	
CLIENT: Galway County Council	
SCALE: 1:10000	REVISION: 0
DATE: 18/10/2021	PAGE SIZE: A3

- Site Boundary
- Quaternary Sediments:**
- Cut, Cut over raised peat
- KaRck, Kartsified bedrock outcrop or subcrop
- L, Lacustrine sediments
- TLs, Till derived from limestones
- Urban
- Water

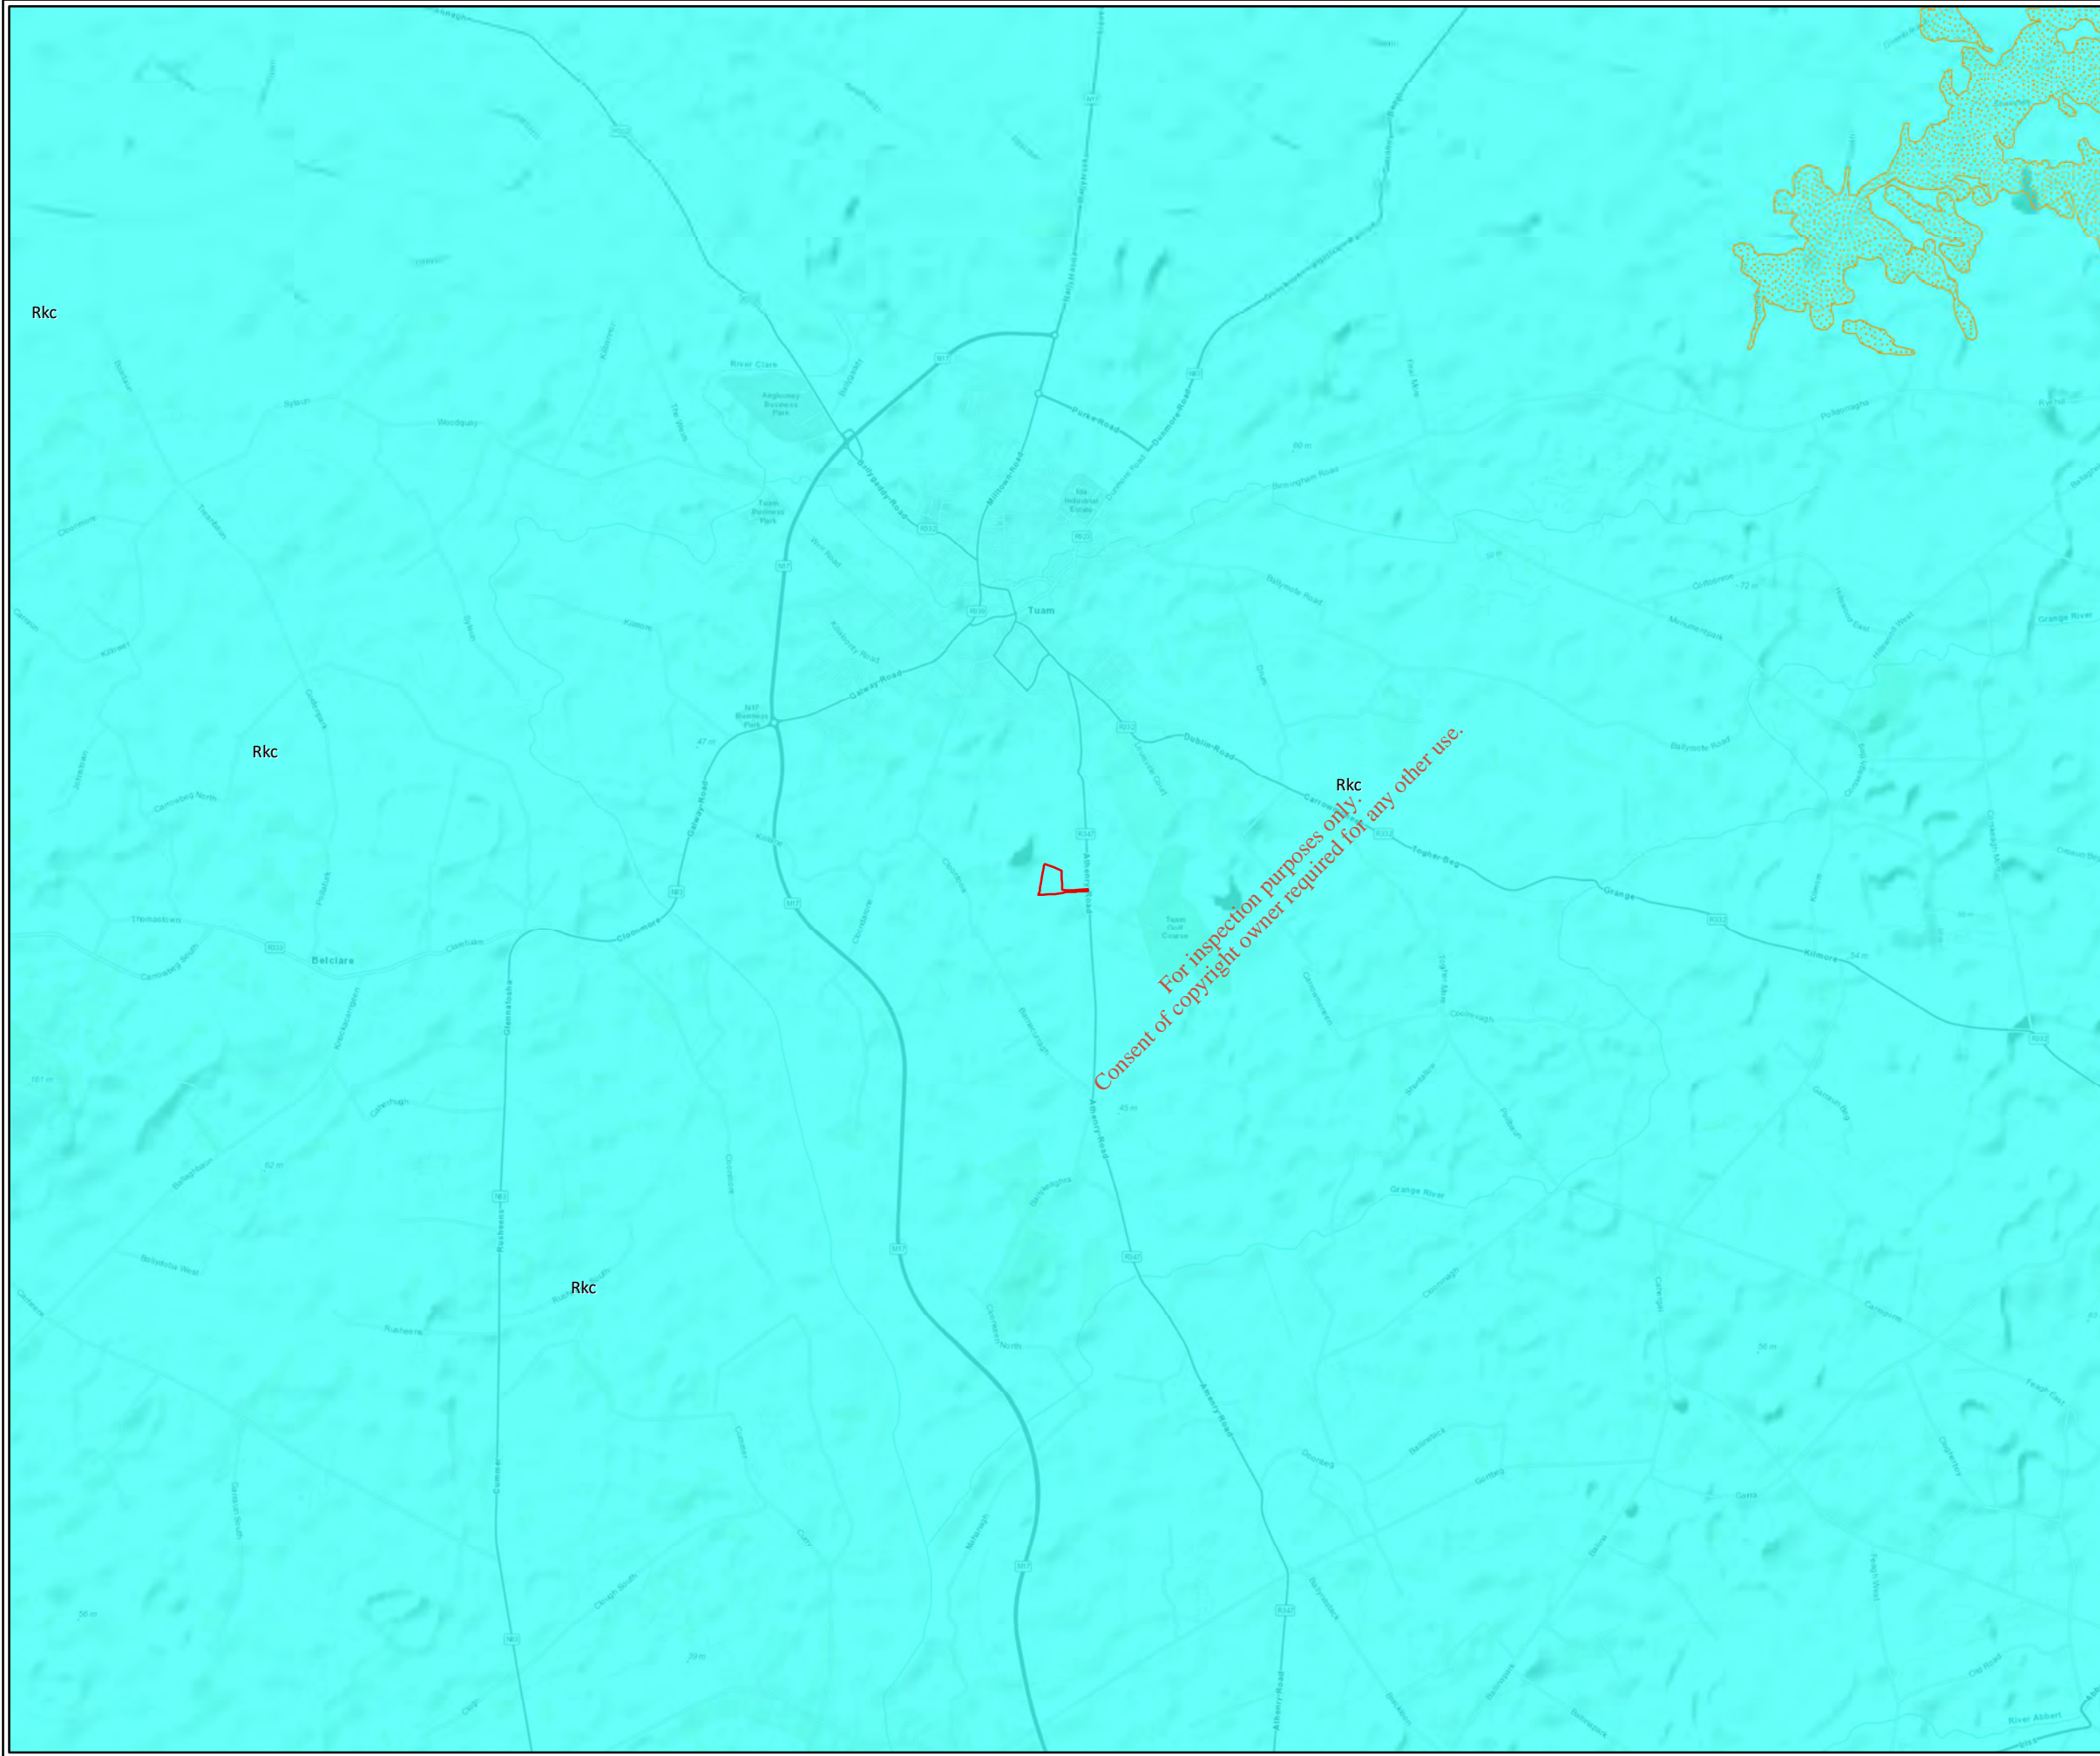
TITLE:	Aquifer Classification
PROJECT:	Tuam Historic Landfill ERA
FIGURE NO:	2.4
CLIENT:	Galway County Council
SCALE: 1:50000	REVISION: 0
DATE: 18/10/2021	PAGE SIZE: A3

- Site Boundary
- Sand and Gravel Aquifers:**
- Locally important gravel aquifer
- Bedrock Aquifers:**
- Rkc: Regionally Important Aquifer - Karstified (conduit)

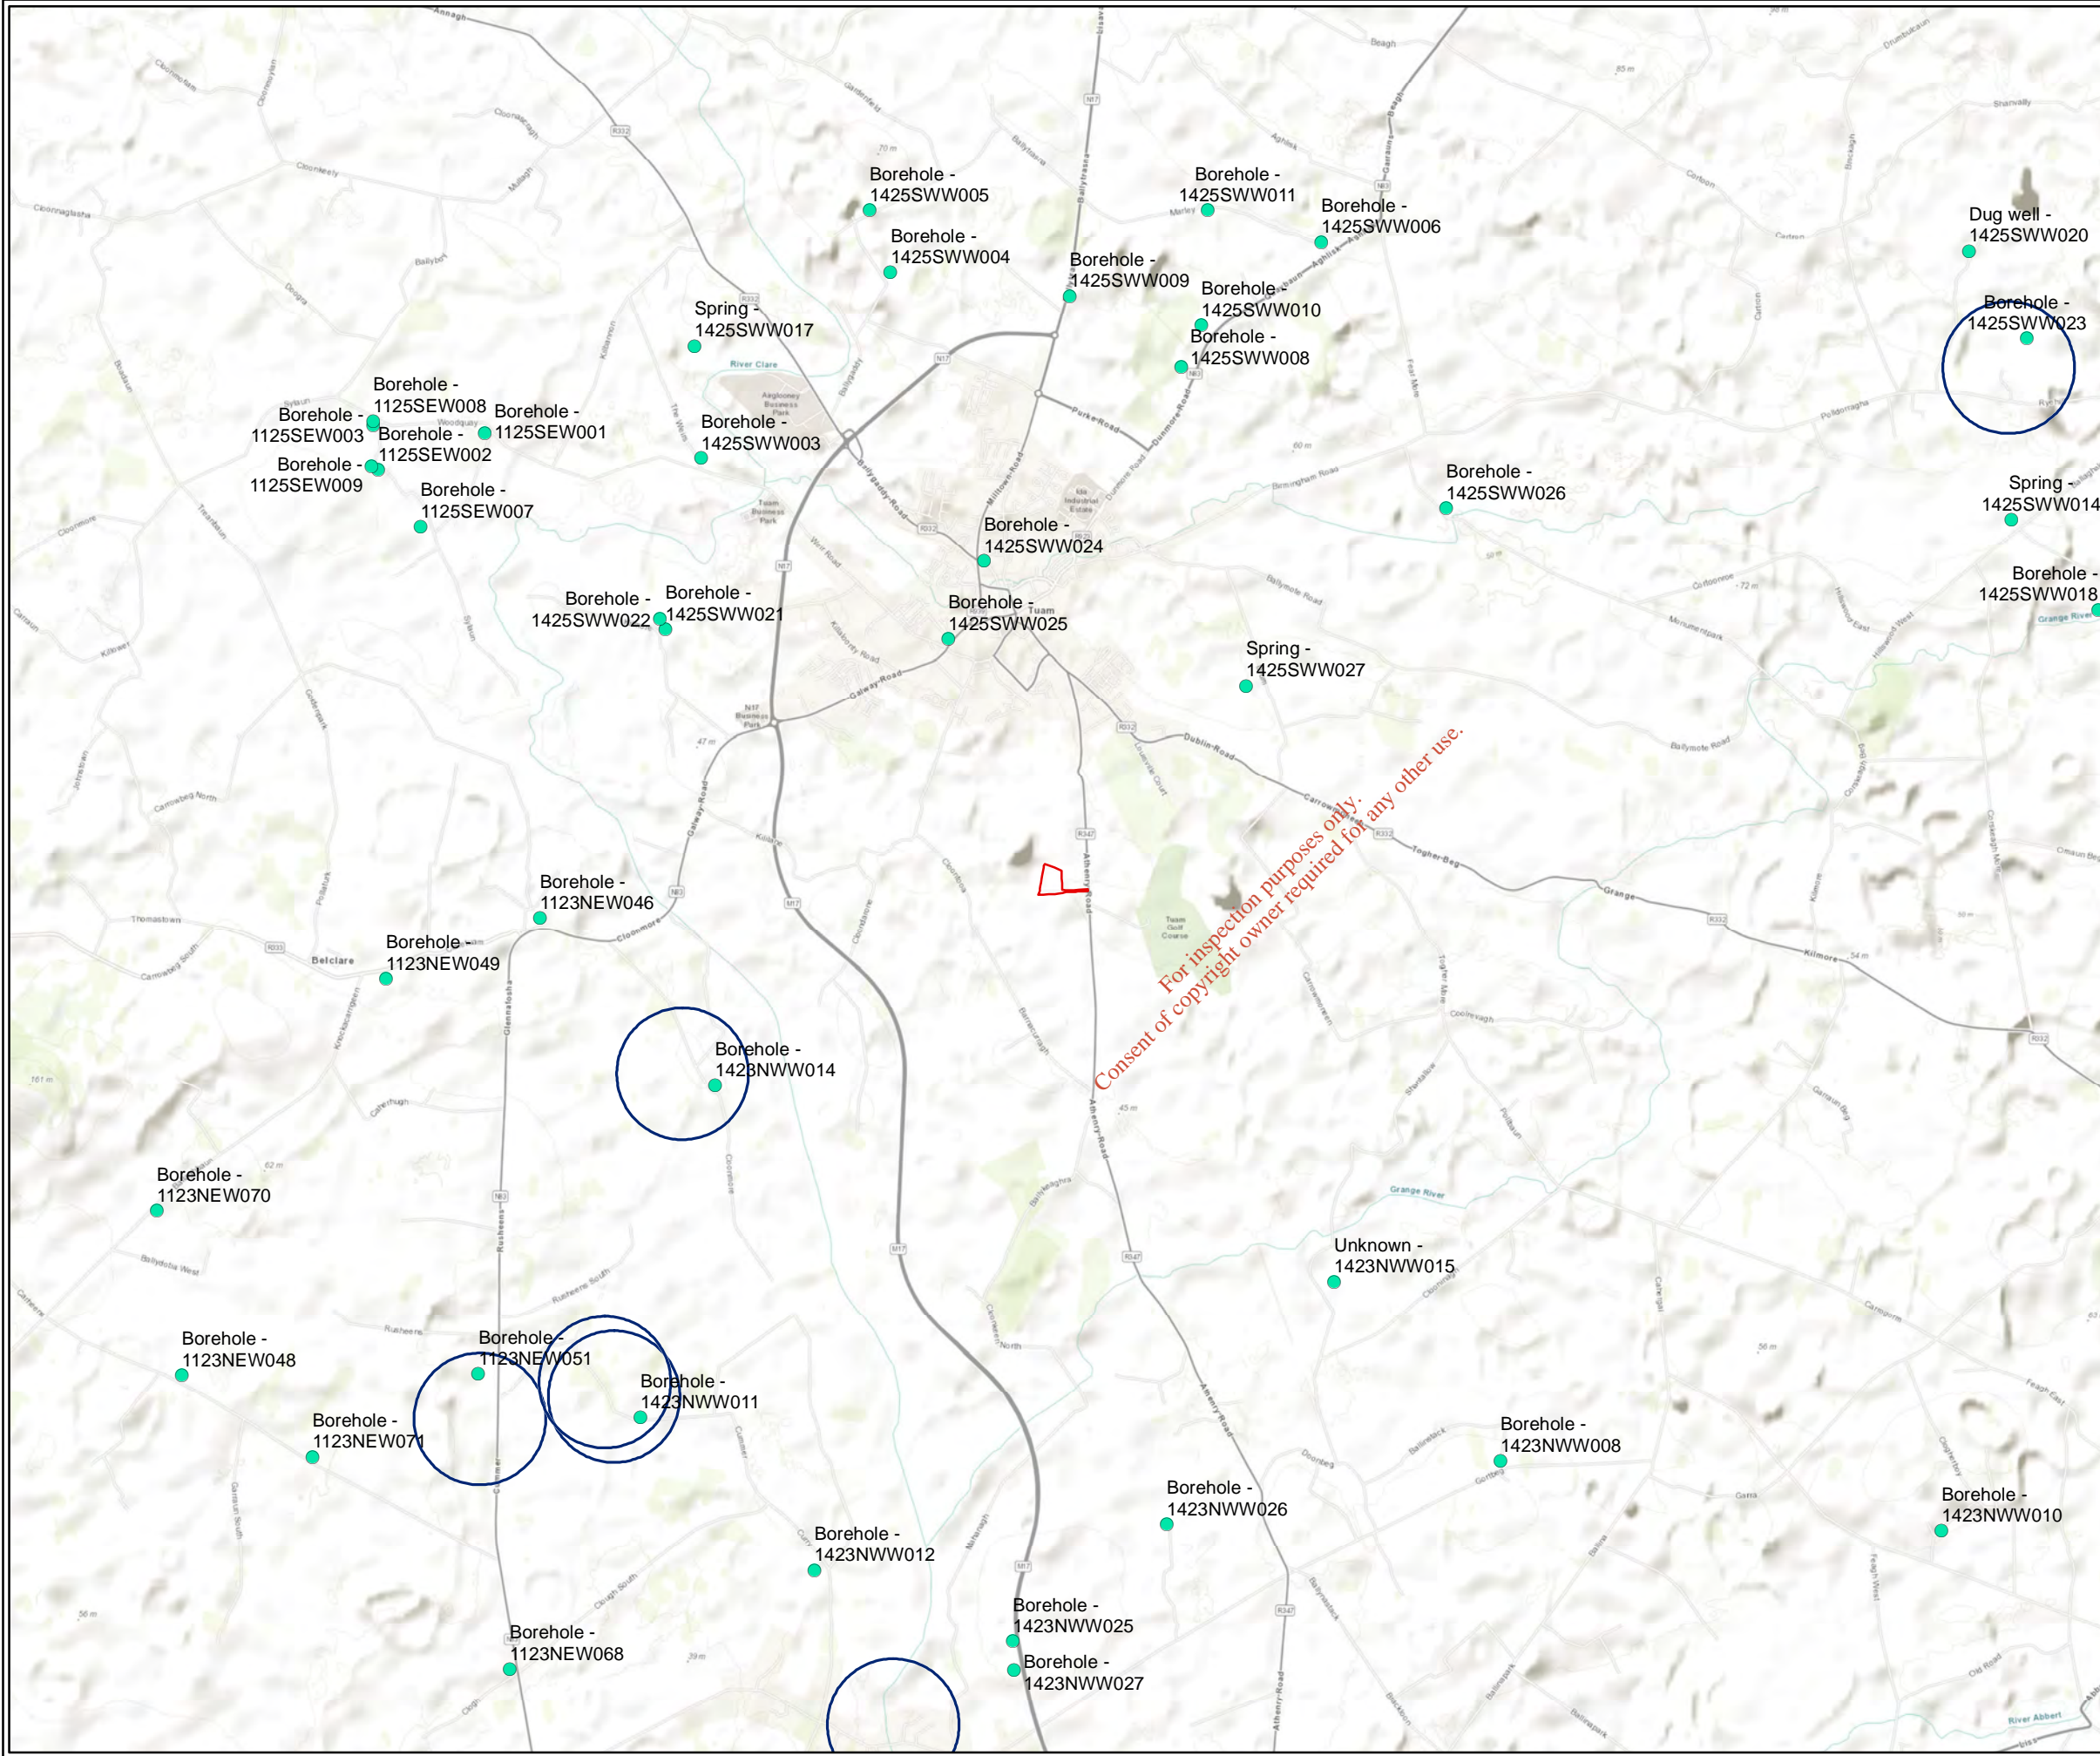
TITLE:	
Wells and Springs	
PROJECT:	
Tuam Historic Landfill ERA	
FIGURE NO: 2.5	
CLIENT: Galway County Council	
SCALE: 1:50000	REVISION: 0
DATE: 18/10/2021	PAGE SIZE: A3

- Site Boundary
- Groundwater Wells (10-50m Accuracy)
- Groundwater Well (500m-1km Accuracy)

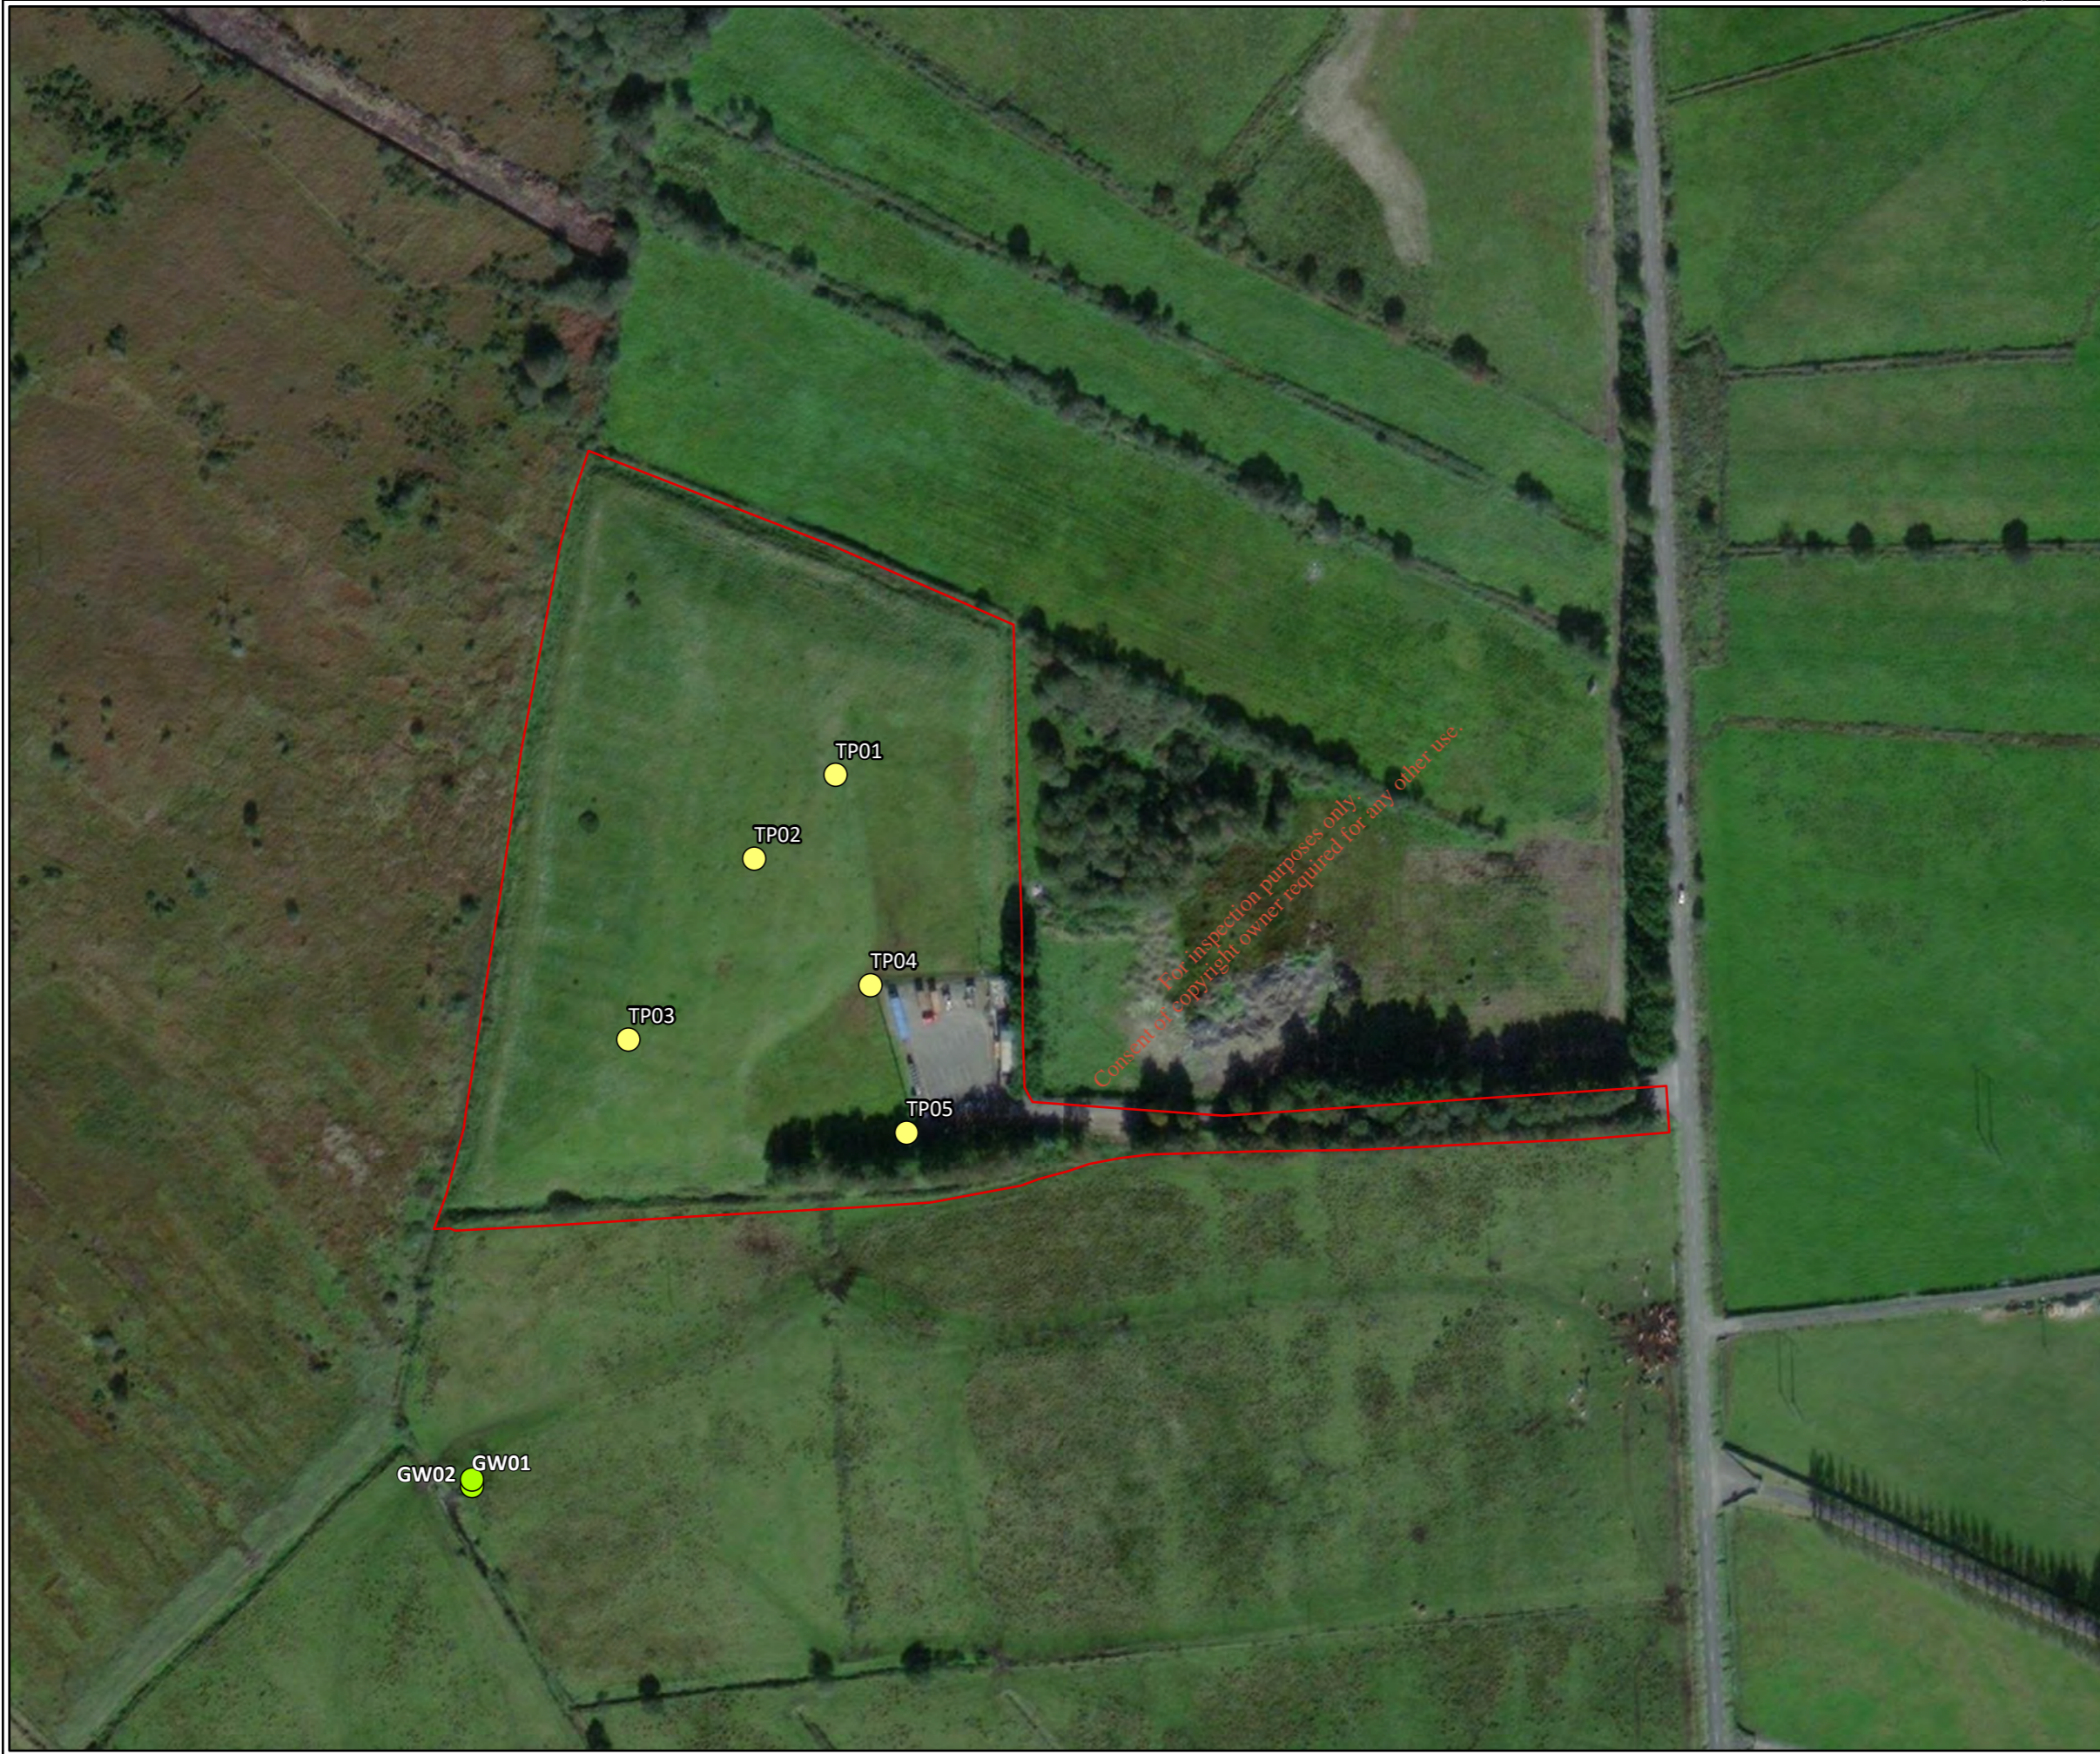
- Site Boundary
- Trial Pit
- Groundwater Well

A Causeway Geotech (CGL) Engineering Geologist supervised the advancement of 5 No. trial pits, shown in Figure 3.1, on the 7th July 2020.

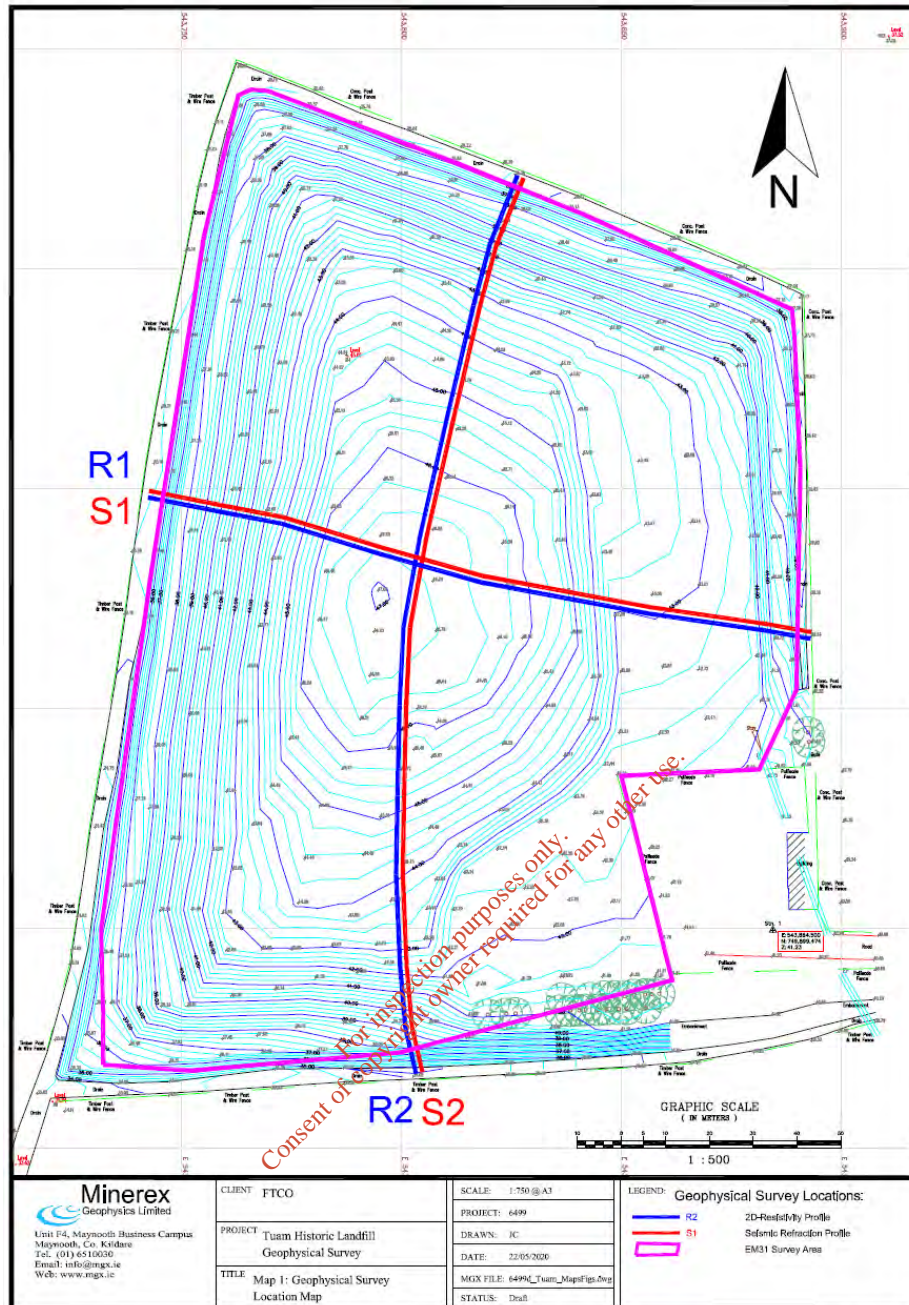
Figure 3-2: Geophysical Survey Location Map

MGX recorded RT profiles data along 2 designated profiles named R1 and R2, and two seismic refraction profiles (S1 and S2) were recorded across the site. See Figure 3.2.

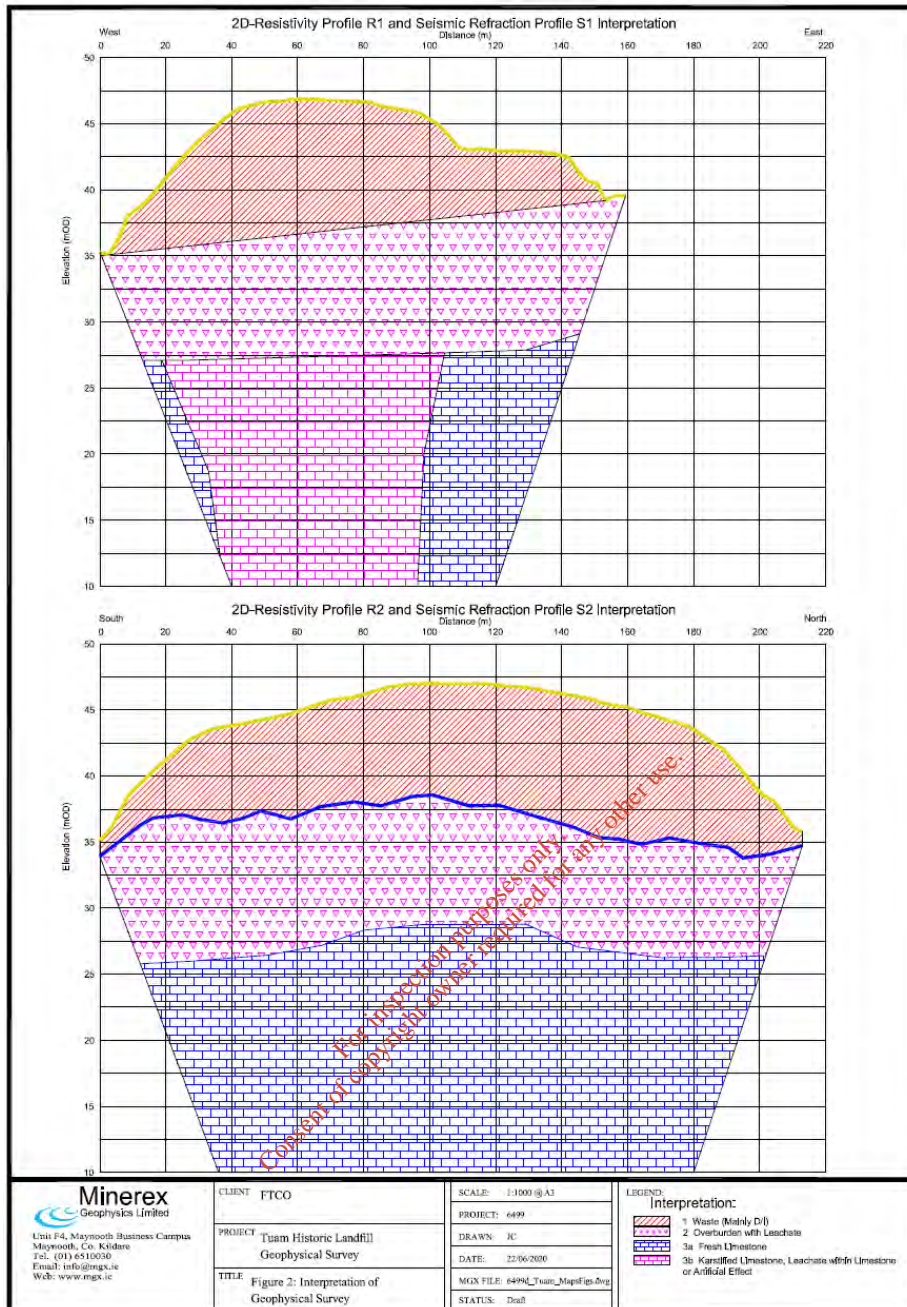
Figure 3-3: Integration of Geophysical Survey

Layer 1 has a seismic velocity range of 200 m/s and is found in most of the survey area. This velocity would represent landfill material, which has a lower velocity than the surrounding natural ground.

Layer 2 has a seismic velocity range of 700 m/s. This layer is interpreted as overburden material with leachate, and it is found in most of the survey area, below layer 1.

Layer 3a is interpreted as fresh Limestone and is found in most of the R2 profile and some areas of R1, under layer 2. This layer has N/A seismic velocity.

Layer 3b is interpreted as Karstified Limestone, Leachate within Limestone or Artificial Effect and is found in some areas of profile R1, under layer 2. This layer has N/A seismic velocity.

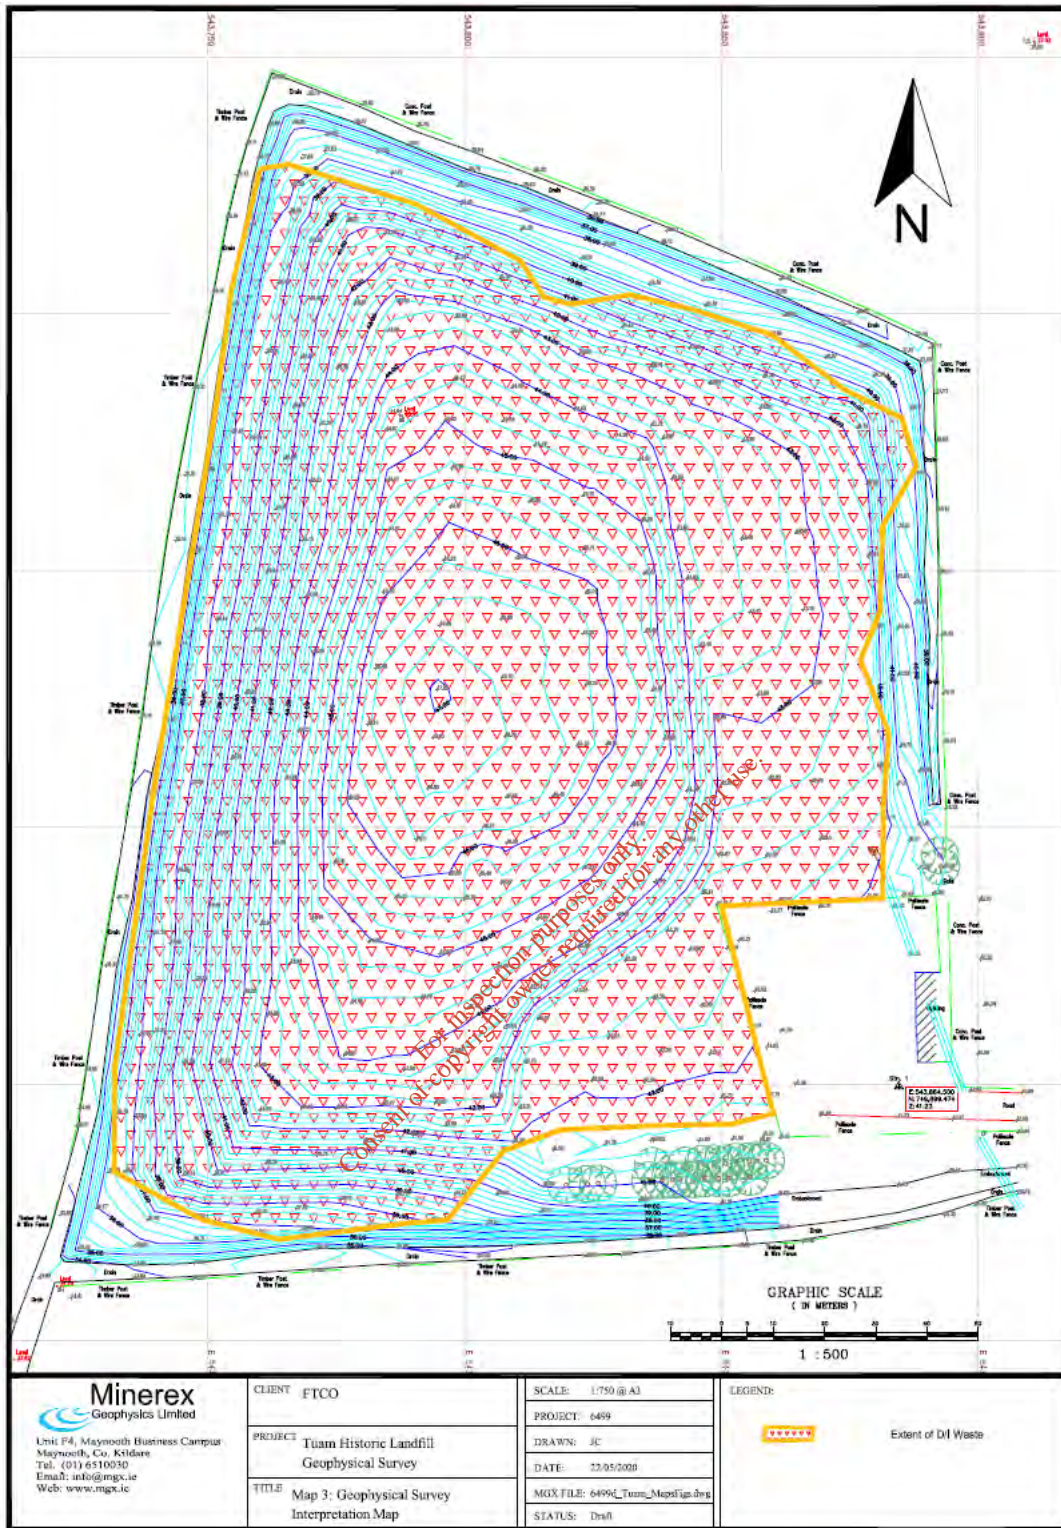
Figure 3-4: Geophysical Survey Estimated Waste Footprint

Examination of the borehole logs (included in the Closure and Remediation Plan) for the previously installed wells BH1, BH2 and BH3 record waste thicknesses of 4.8m, 4.8m and 9.0m respectively. Assuming an average waste thickness of 6.2m, based on these records and applying this thickness across the footprint of 27,700 m² as estimated by the geophysical survey, this yields a waste volume of 171,740 m³.

The maximum anticipated waste footprint (orange line) is presented in Figure 3.4.

MGX note that low resistivities below the waste body is interpreted as likely leachate. The fresh limestone below this layer should generally restrict the leachate movement but there may be leachate penetration into the rock along profile R1.
