GALWAY HISTORIC LANDFILL

TIET 2 RISK ASSESSMENT HISTORIC LANDFILL AT TUAM, CO. GALWAY

Prepared for: Galway County Council

Date: November 2020

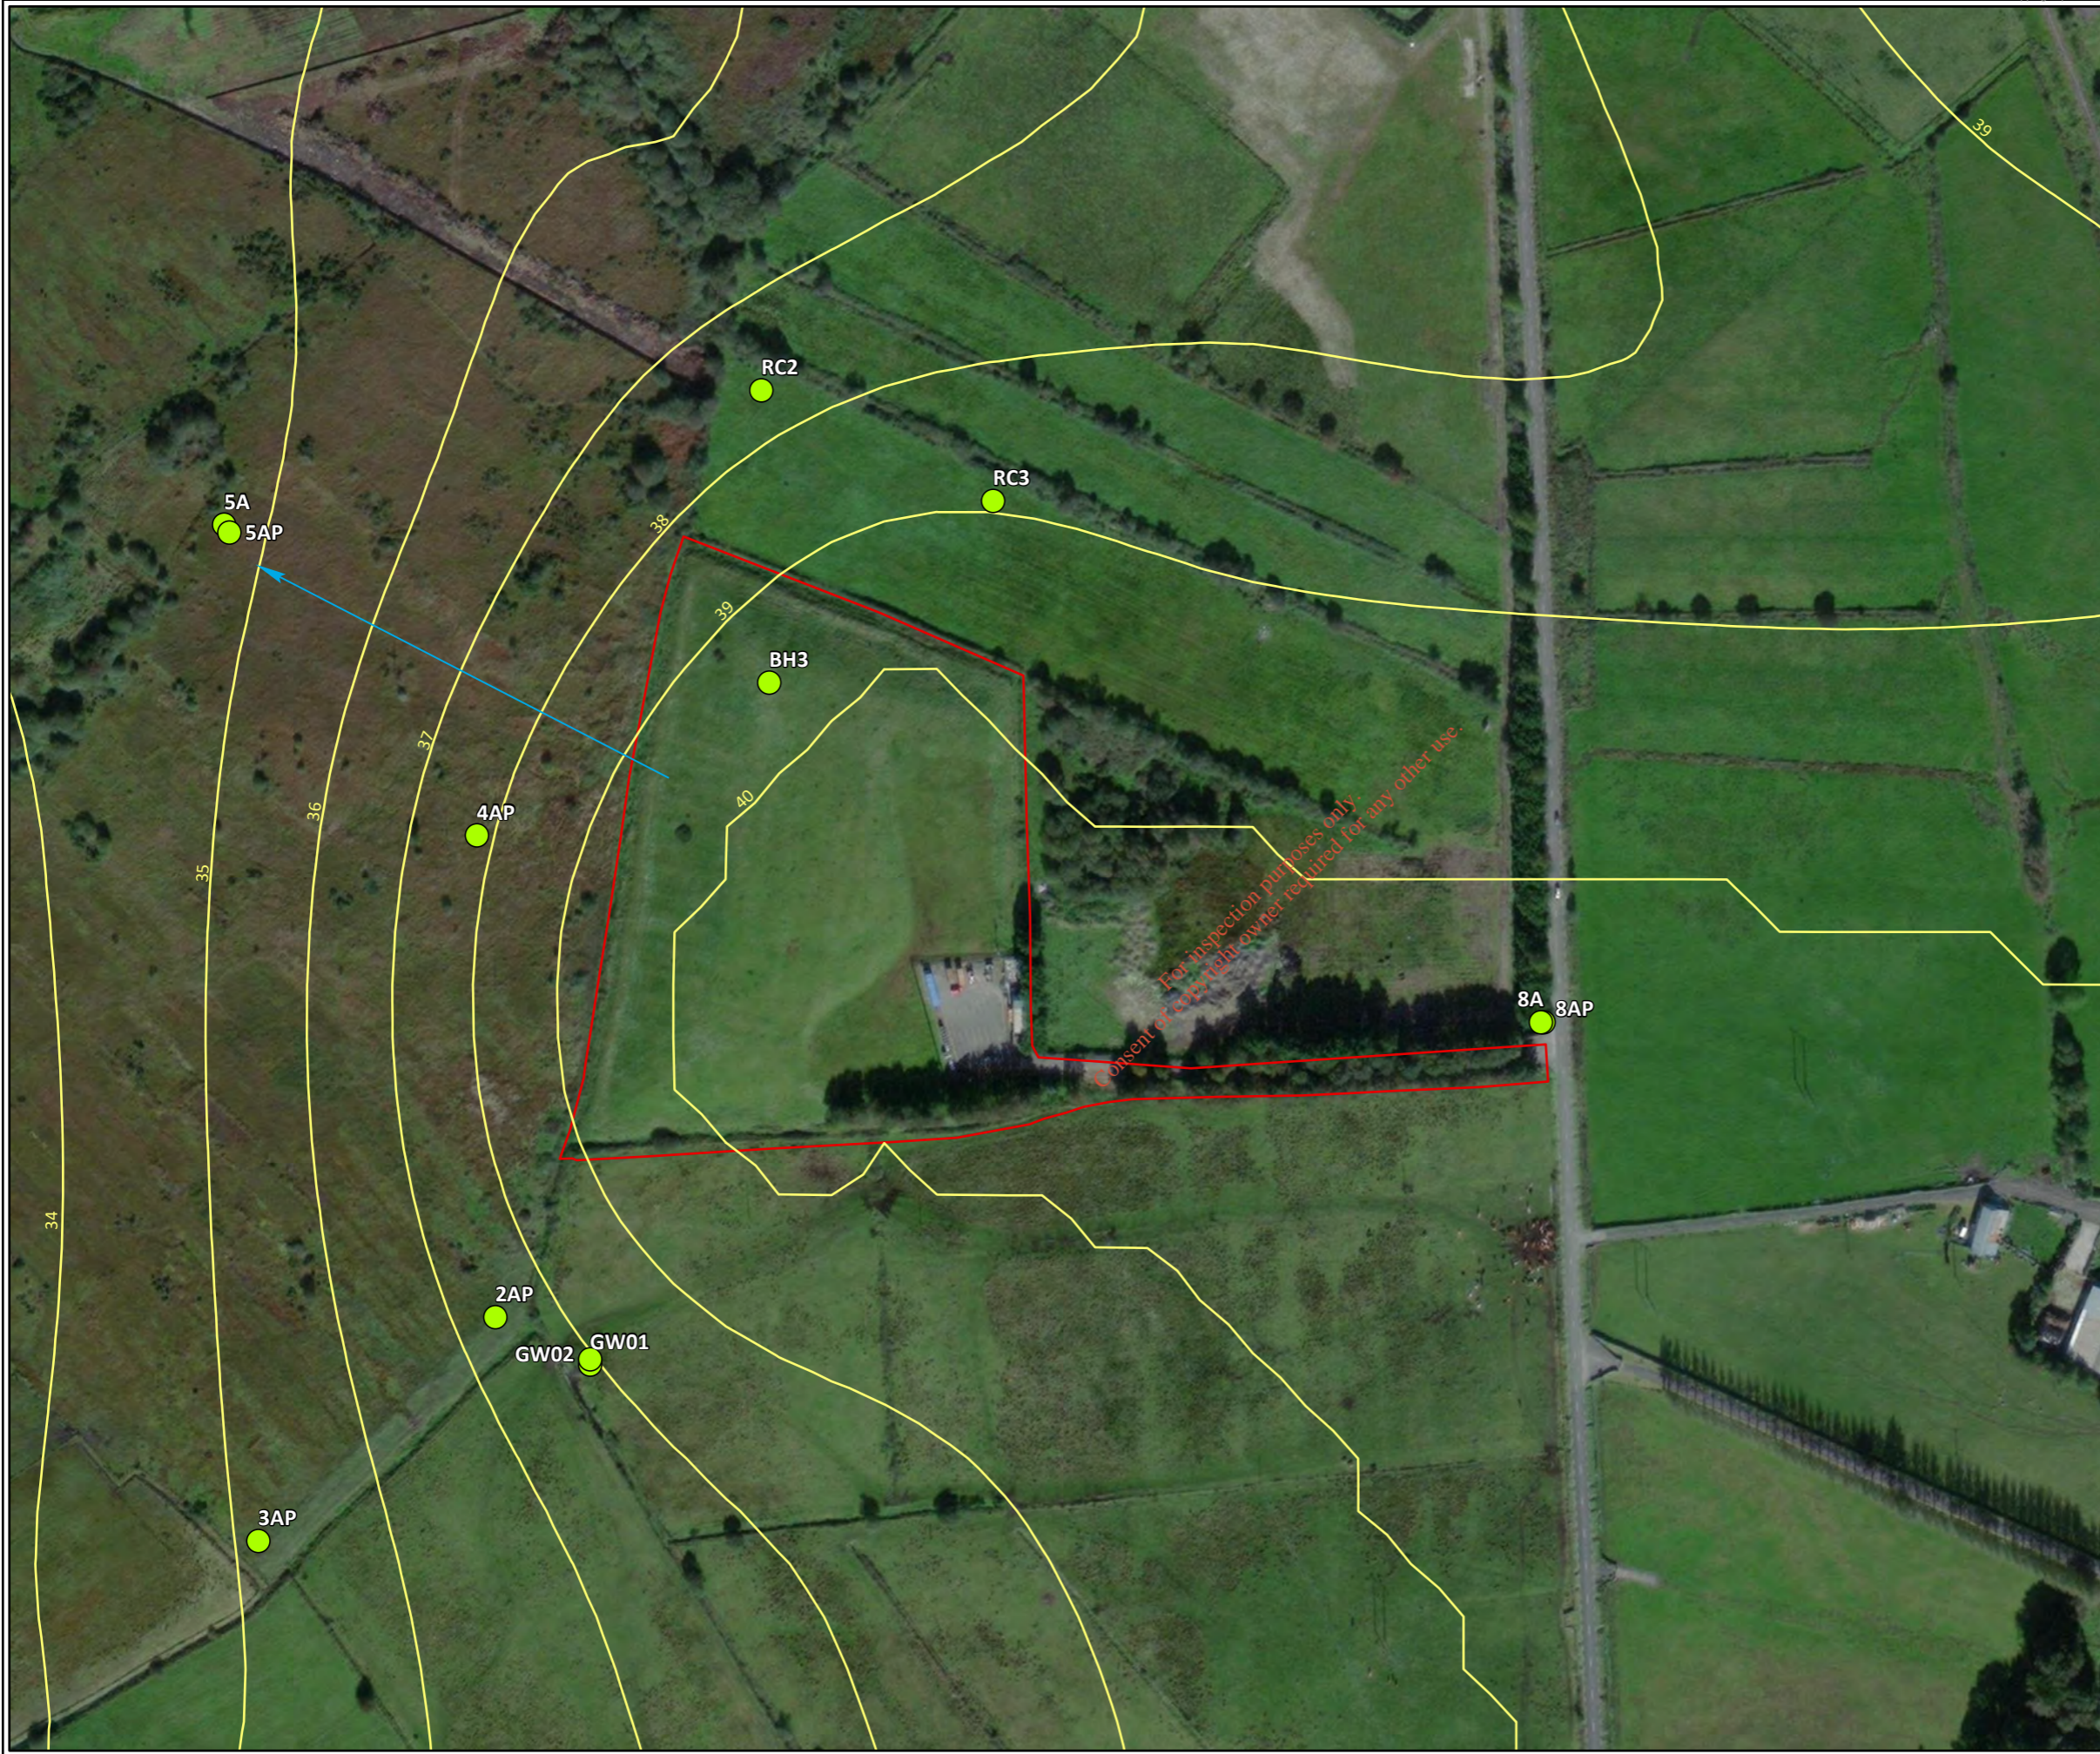
A potentiometric map illustrating the hydraulic gradient and the direction of groundwater flow is presented in Figure 4.1.

- Site Boundary
- Borehole Locations
- 1m Ground Elevation Contours
- ➔ Indicative Groundwater Flow Direction

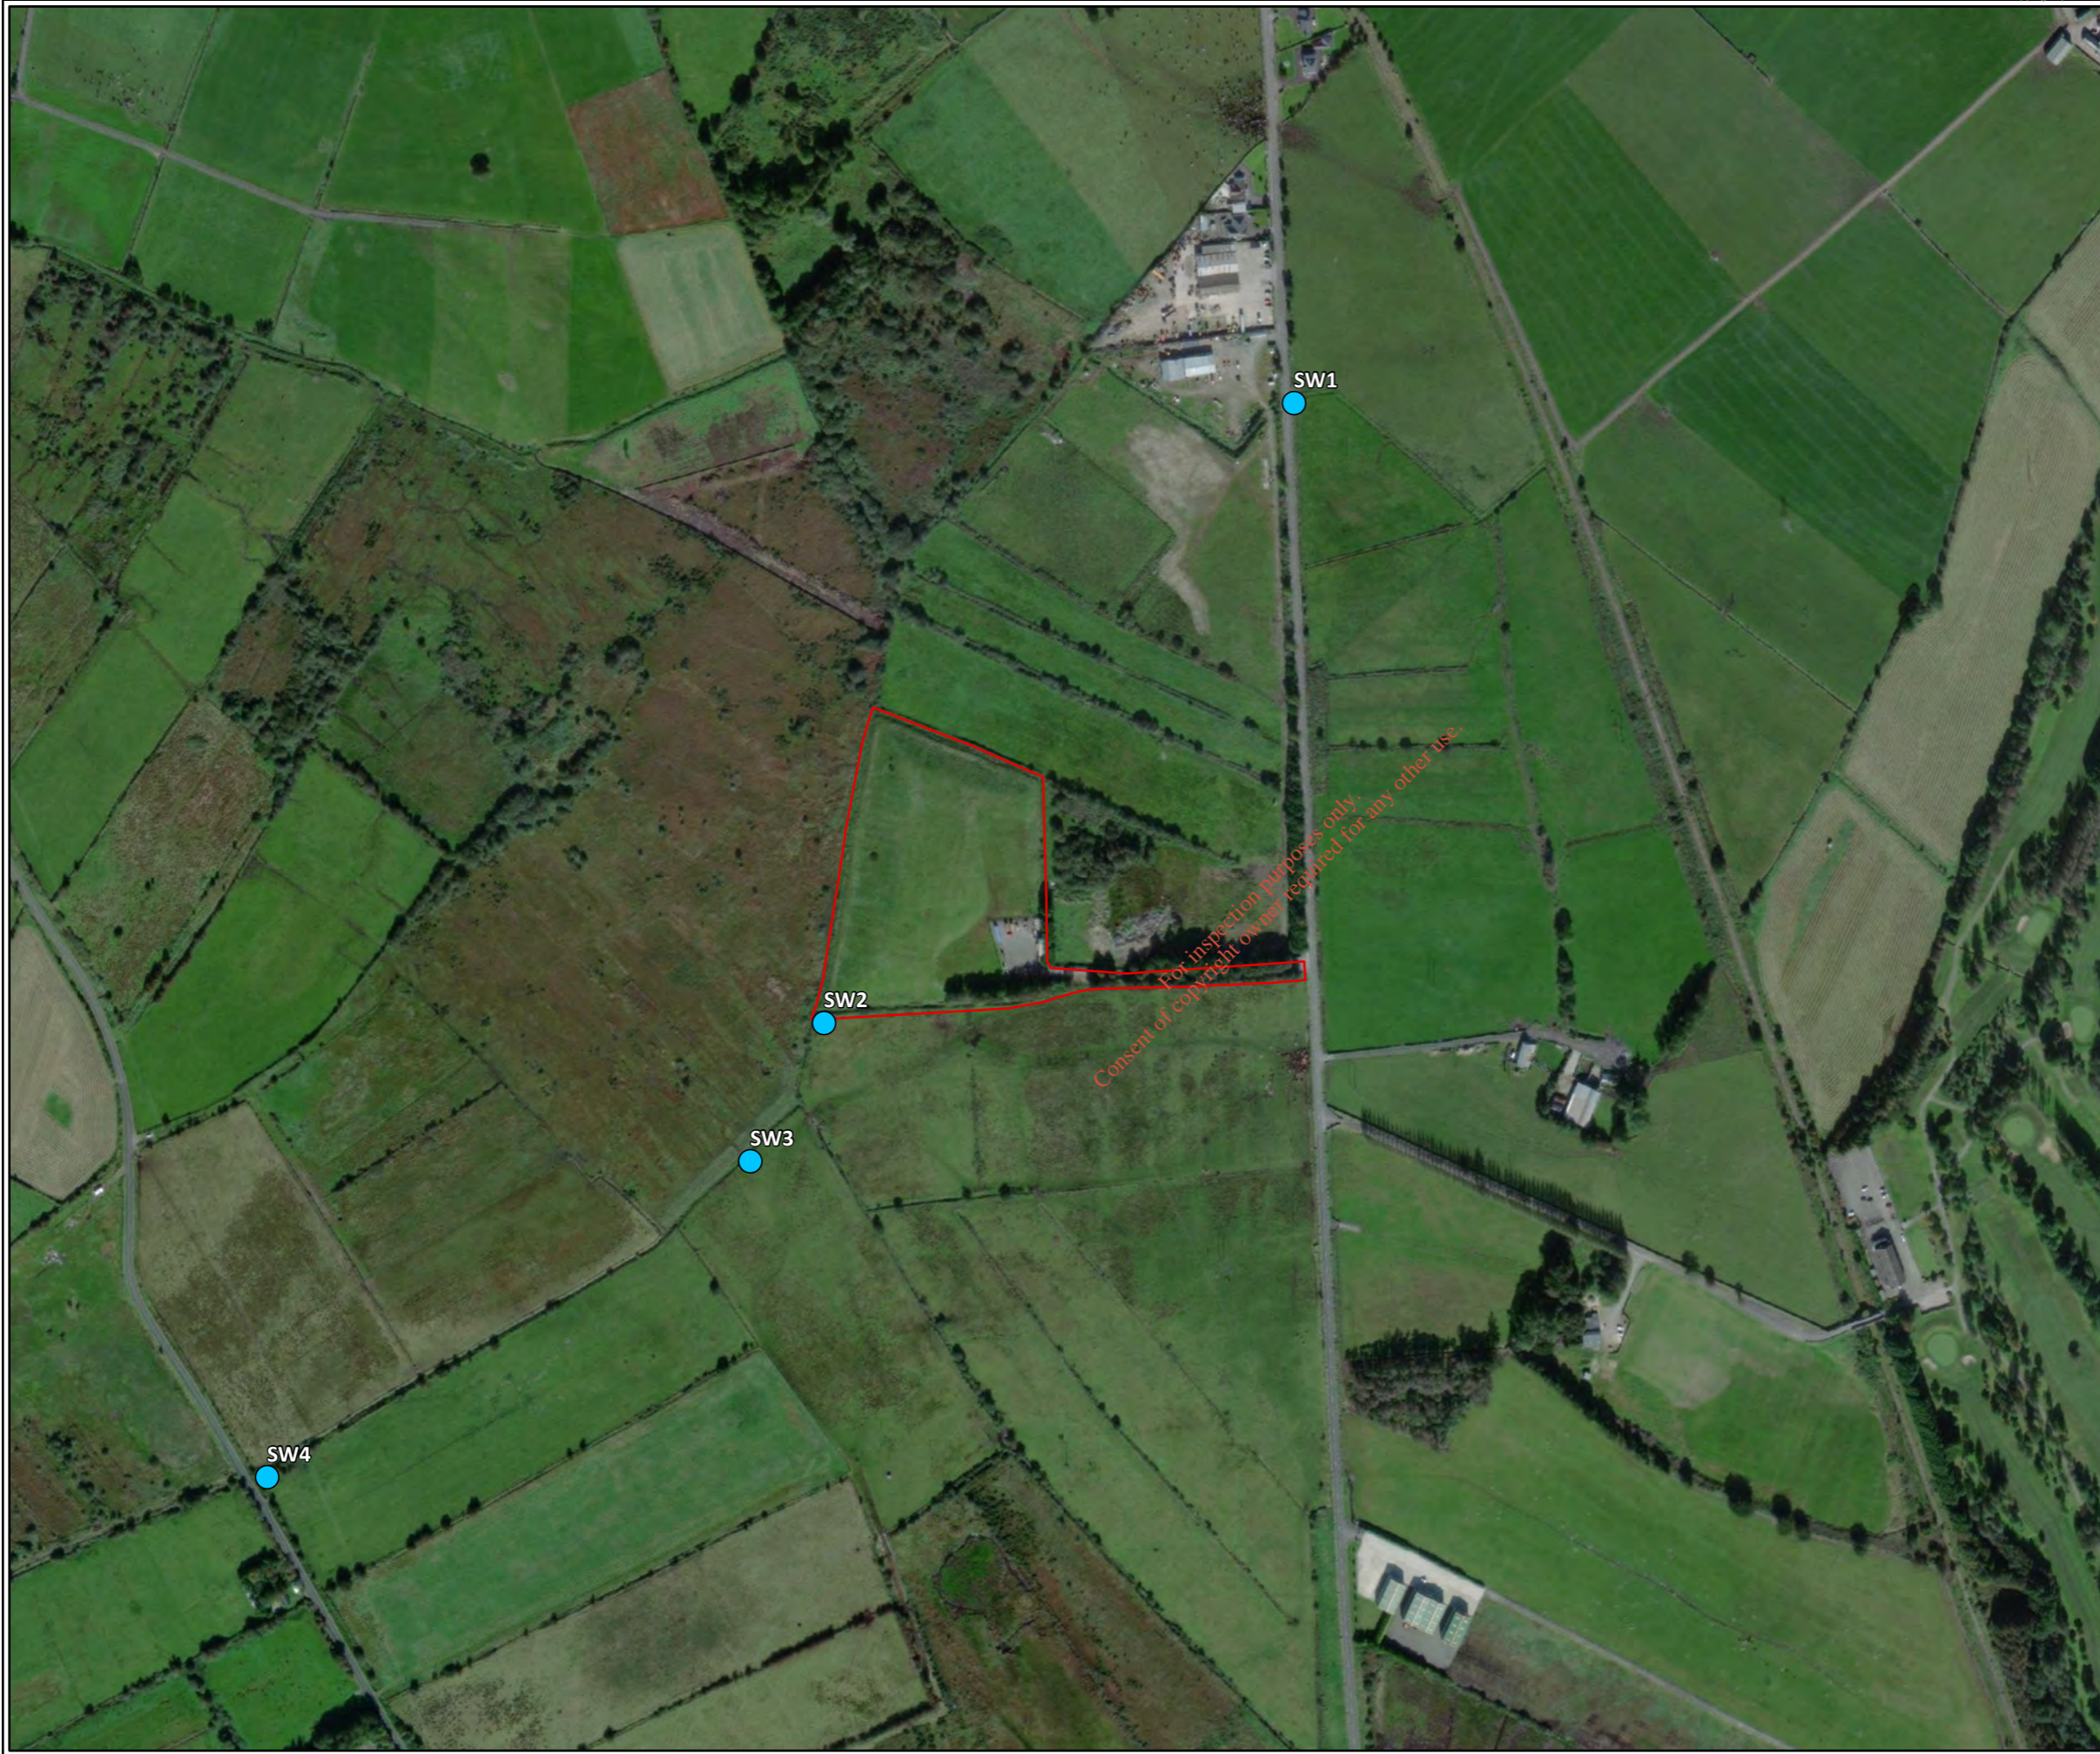
TITLE:	
Surface Water Sampling Locations	
PROJECT:	
Tuam Historic Landfill ERA	
FIGURE NO: 4.2	
CLIENT: Galway County Council	
SCALE: 1:5,000	REVISION: 0
DATE: 18/10/2021	PAGE SIZE: A3

- Site Boundary
- Surface Water Monitoring Locations

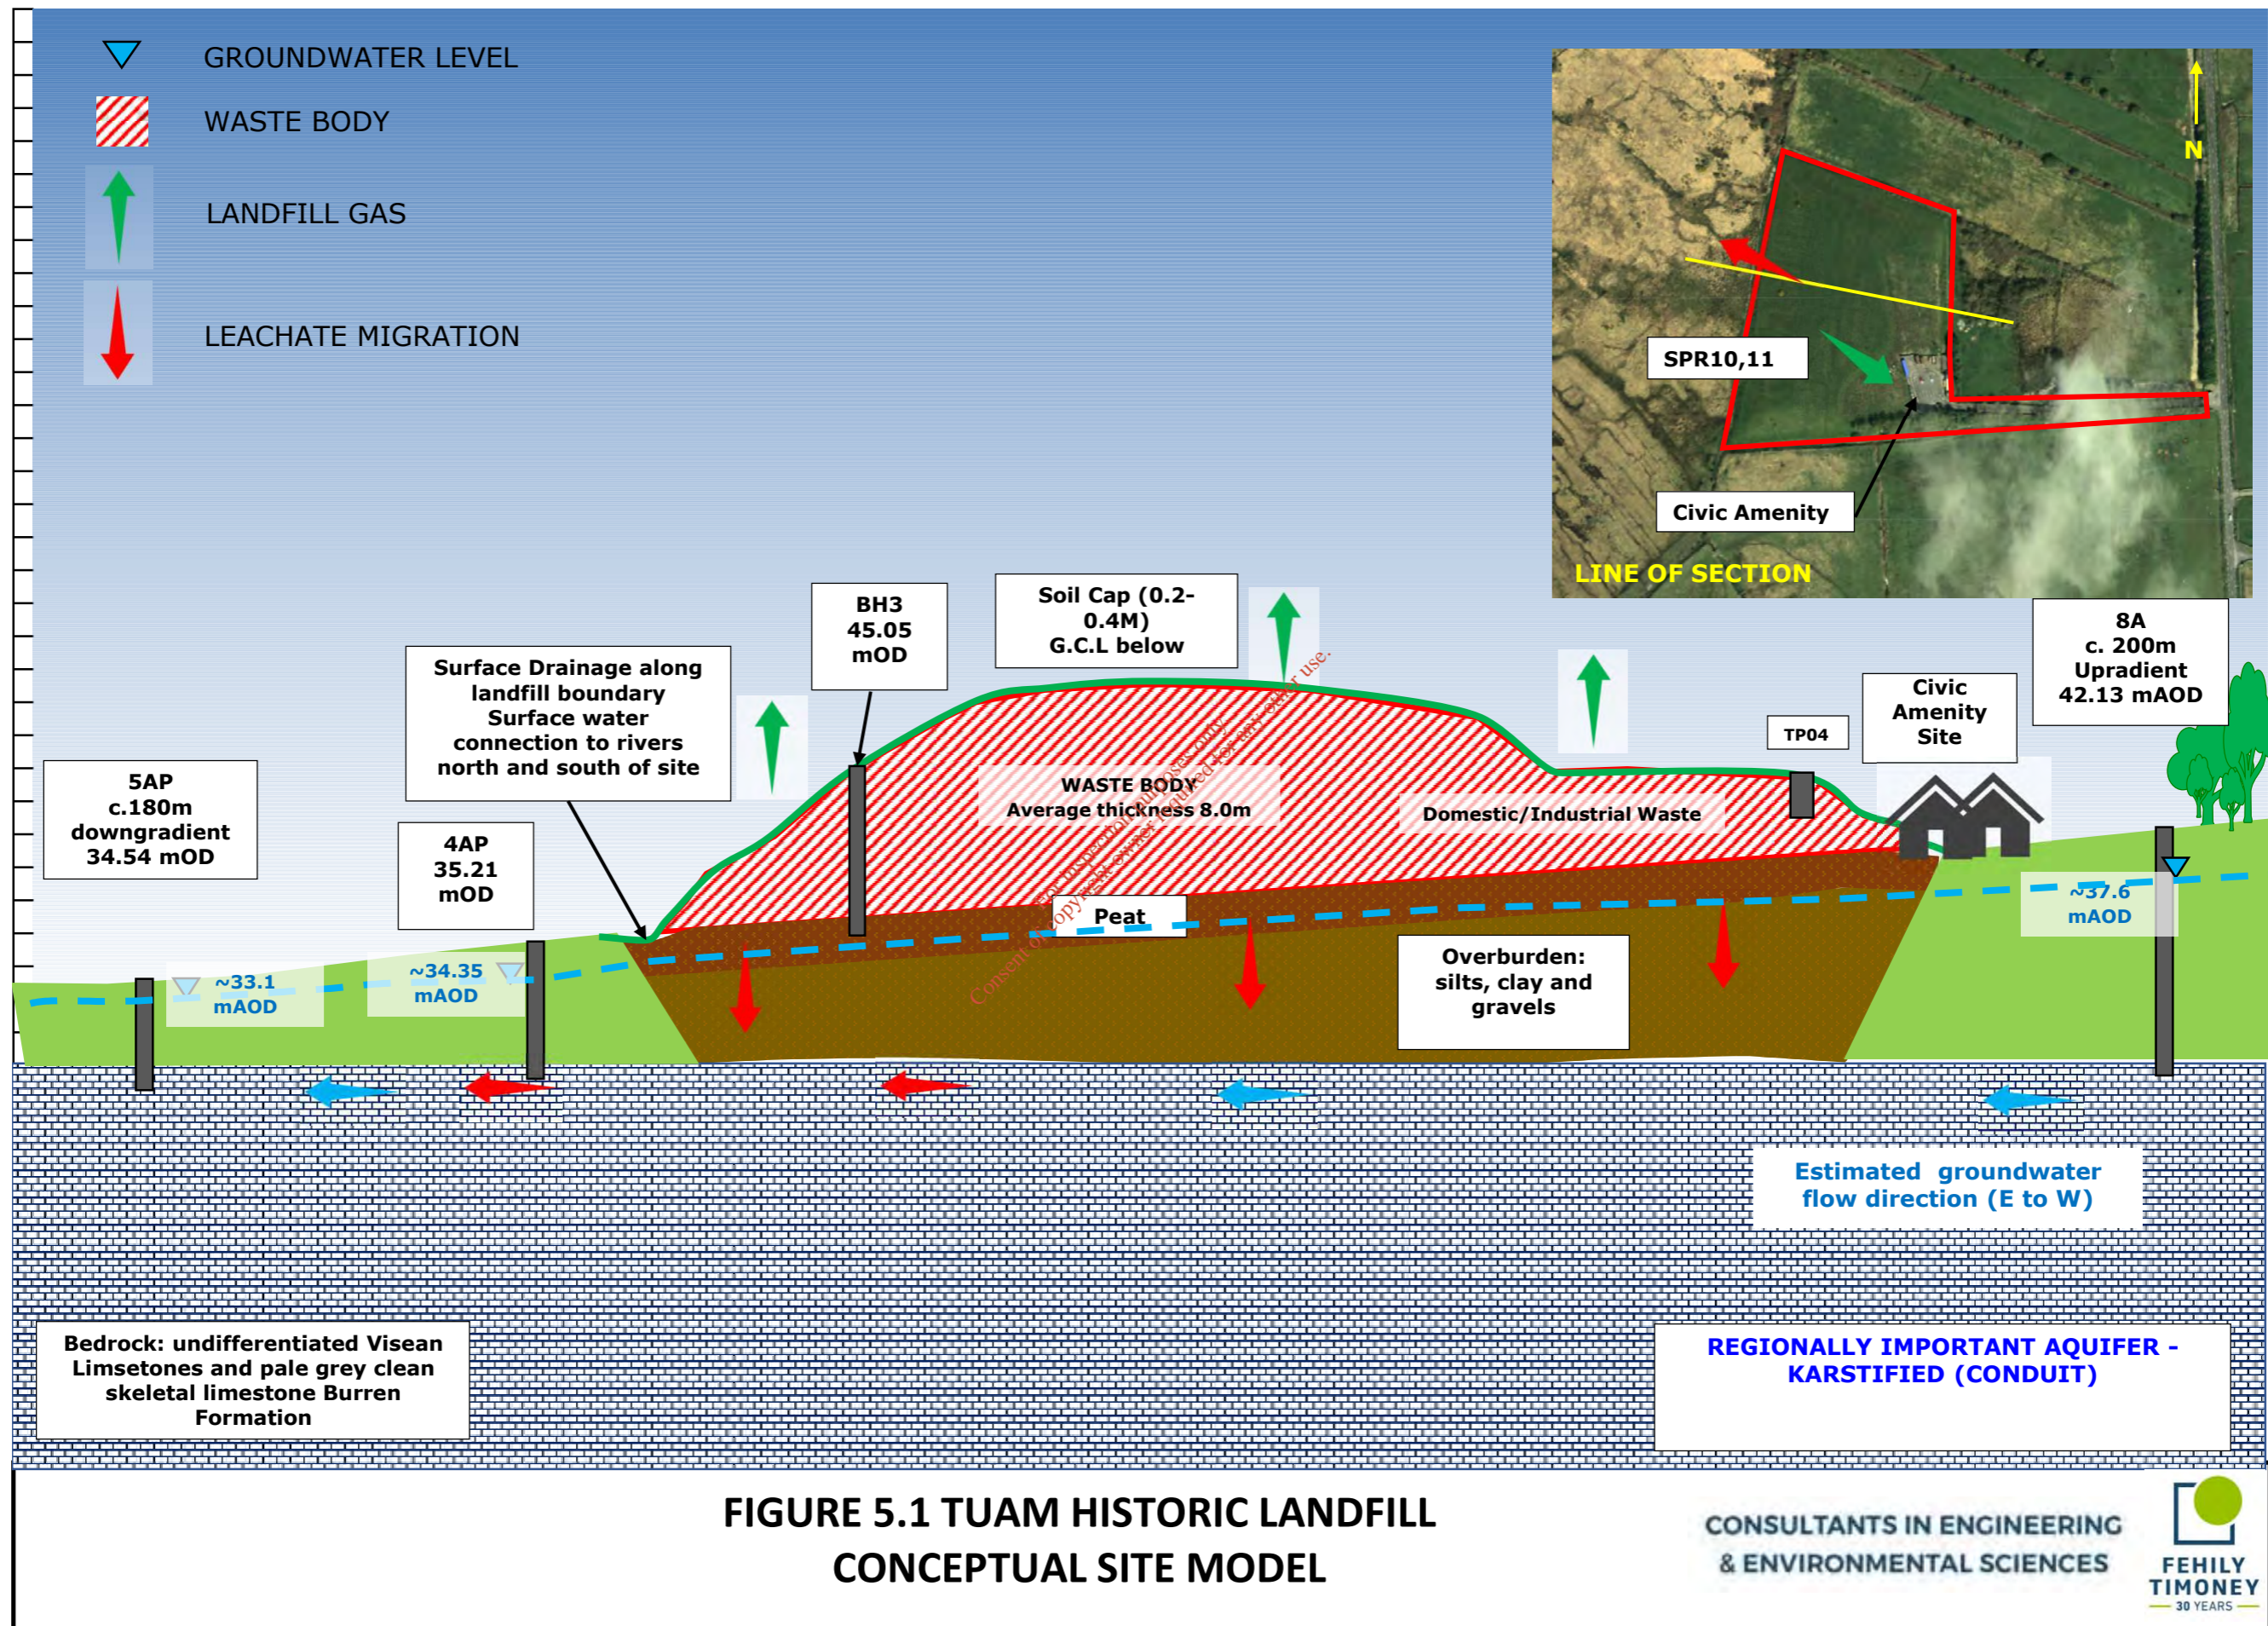
Based on the review of the Tier 1 assessment and site investigation works undertaken for Tuam Historic Landfill, an assessment of the risk is made to confirm the source – pathway – receptor (S-P-R) linkages identified in the preliminary investigation. The results and analysis of the investigation has enabled a revised conceptual model to be produced for the site, which is presented in Figure 5.1, overleaf.
