Causeway Geotechnical
Reports

Galway Historic Landfills – Gort Ground Investigation

Client: Galway County Council

Report No.: 19-1465B

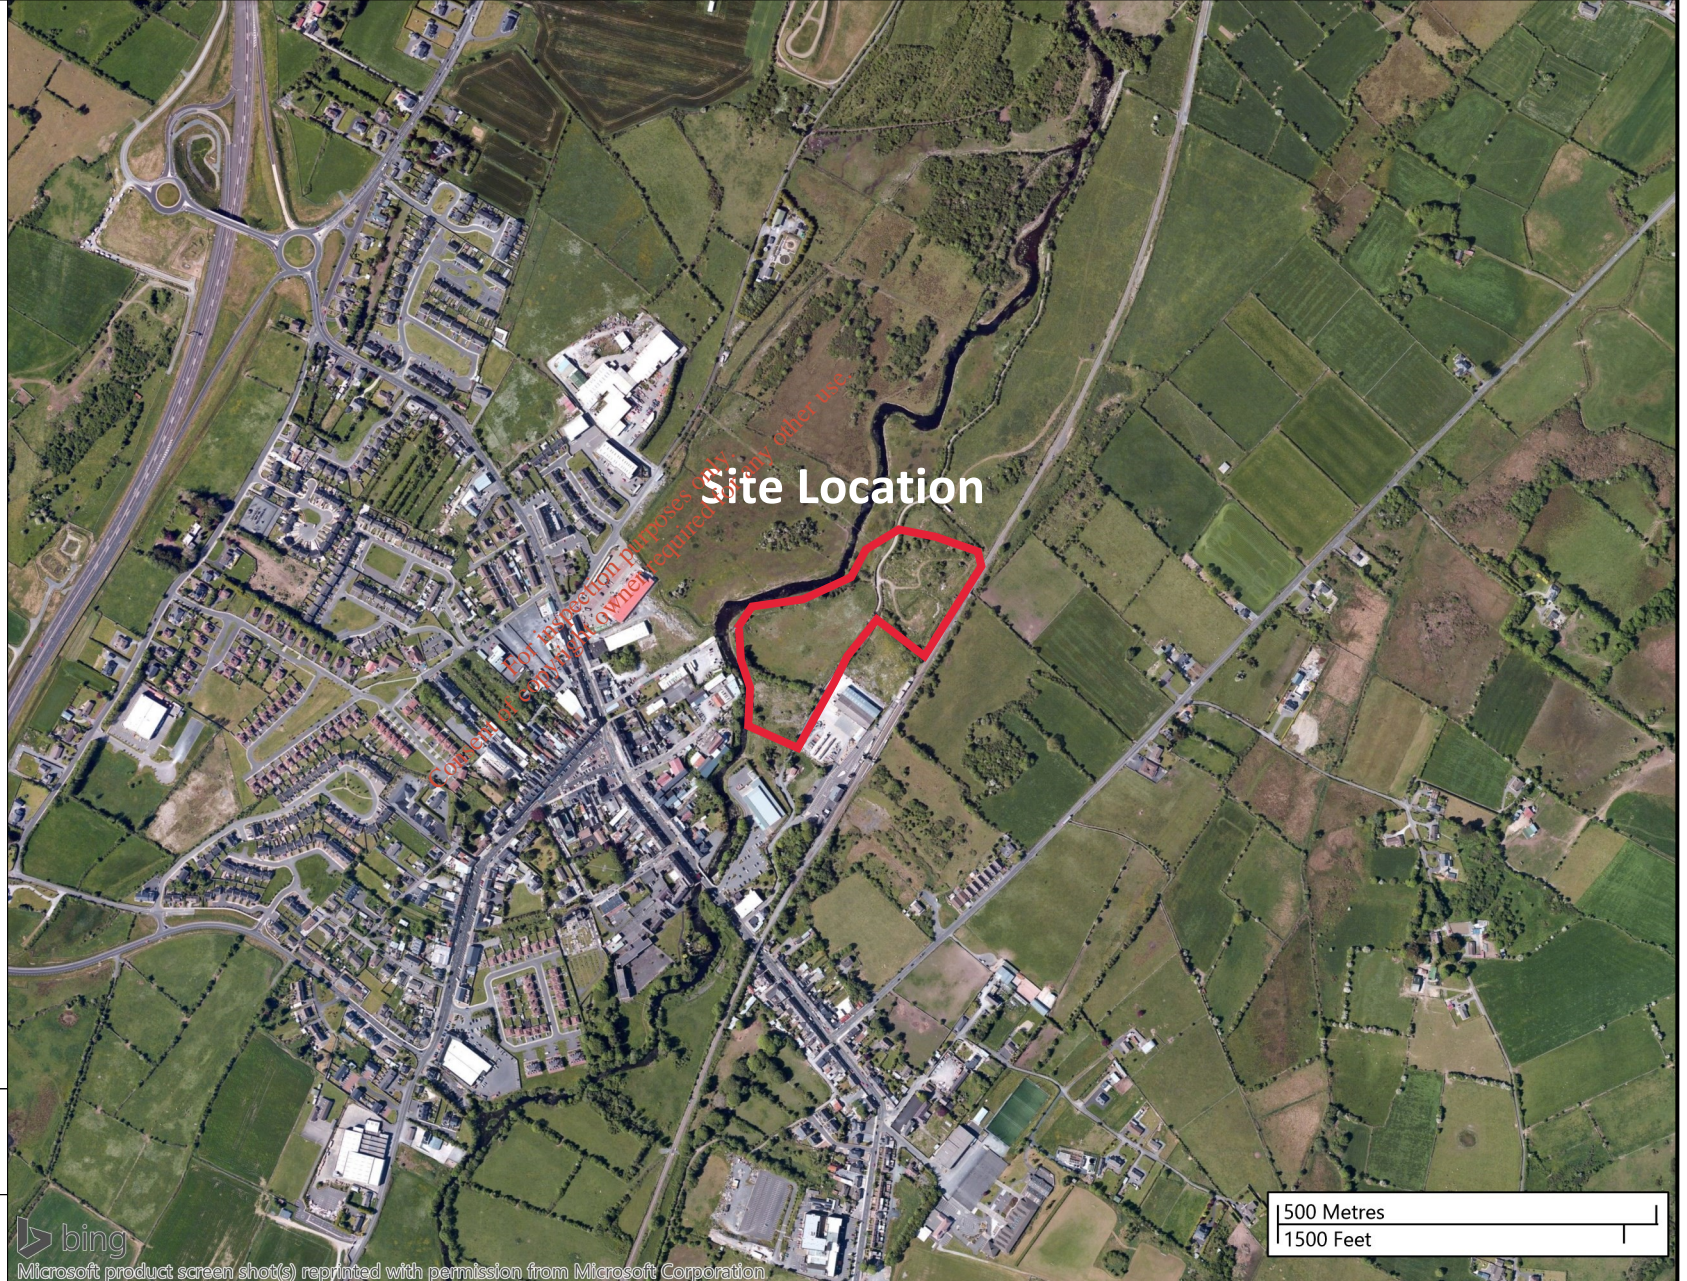
Title:
Site Location Plan

As shown on the site location plan in Appendix A, the works were conducted on a site located 100m north west of Gort town centre. The site is accessed off Station Road and is bounded by the Gort River to the north and west, a railway line to the east and by TJ O’Mahony Hardware store to the south. Works were conducted across three separate fields, which were relatively flat with a gentle fall in elevation towards the river.

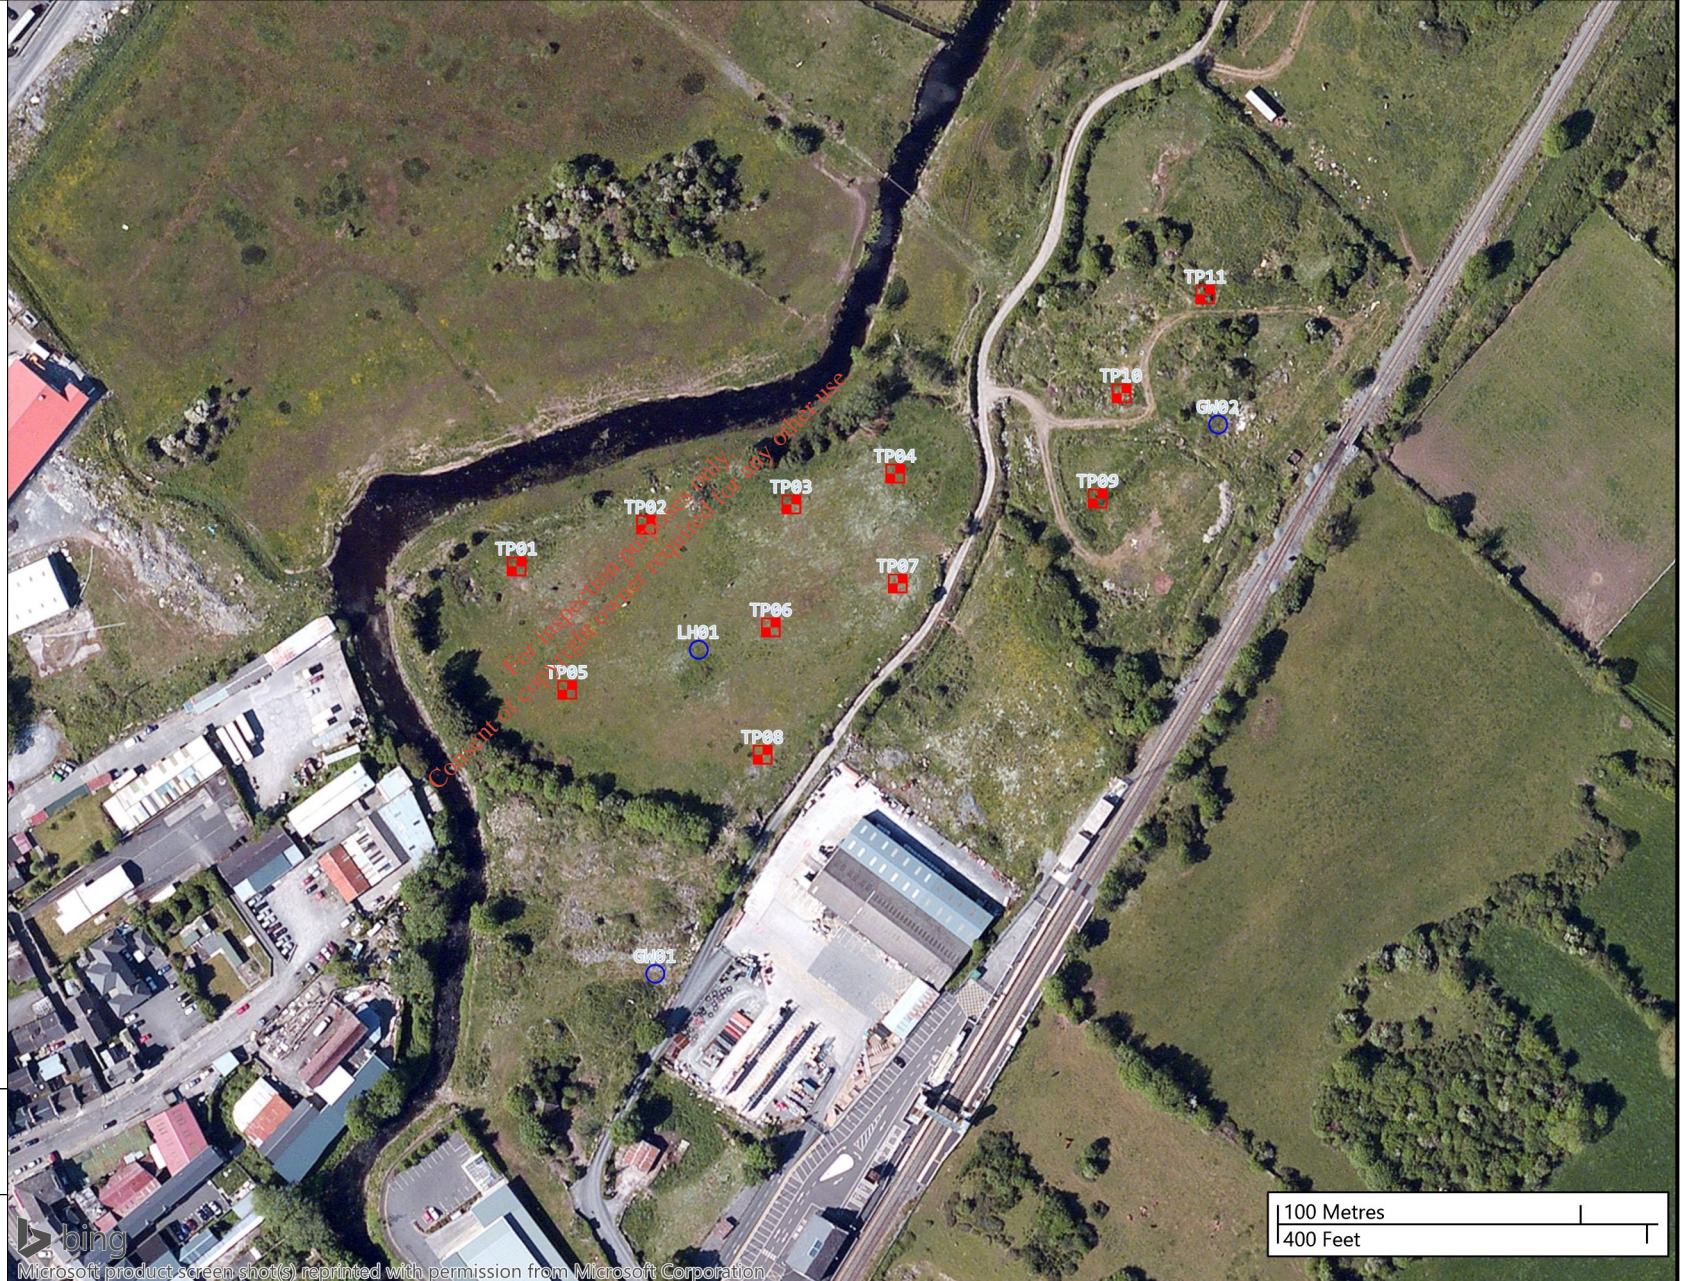
Title:
Exploratory Hole Location Plan

The exploratory holes and in-situ tests were located as instructed by the Client's Representative, as shown on the exploratory hole location plan in Appendix A.

The plan coordinates (Irish Transverse Mercator) and ground elevation (mOD Malin) at each location are recorded on the individual exploratory hole logs. The exploratory hole plan presented in Appendix A shows these as-built positions.

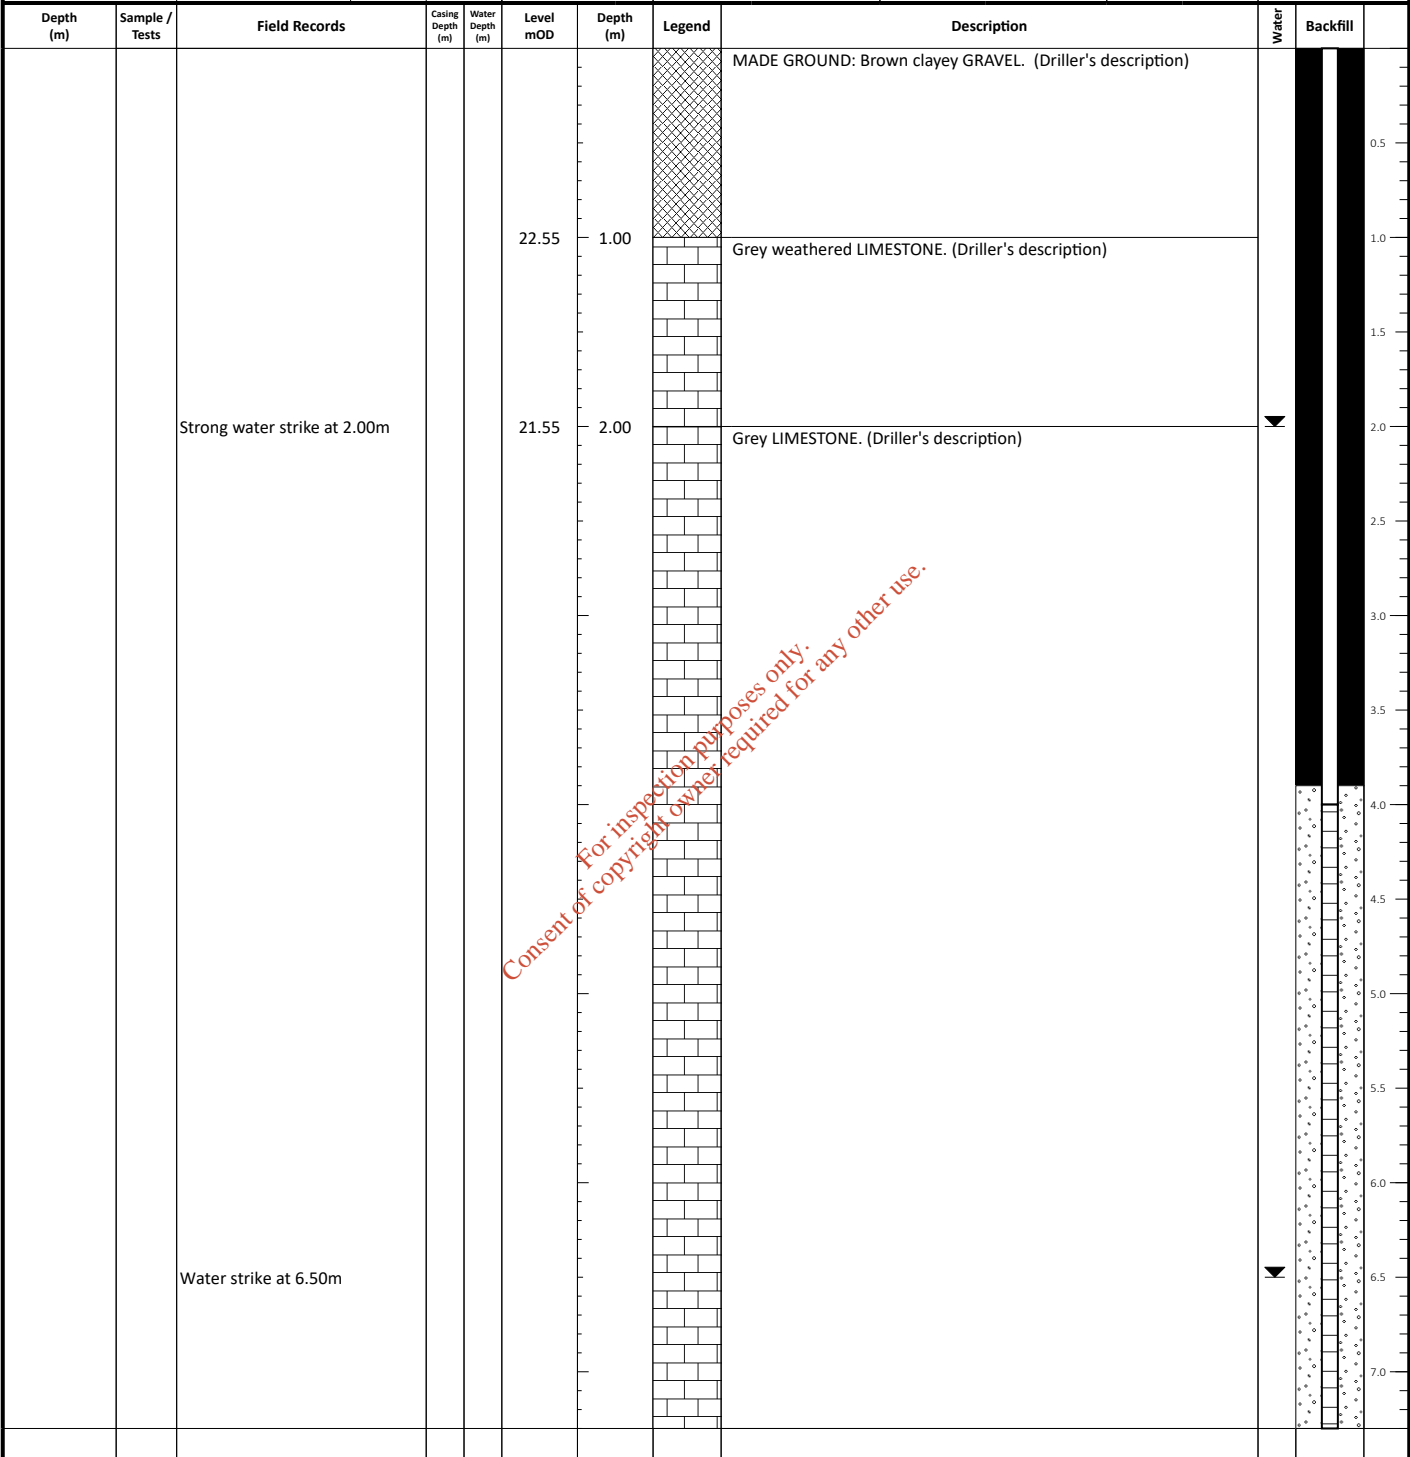
Borehole ID
GW02

Water Strikes				Remarks	
Struck at (m)	Casing to (m)	Time (min)	Rose to (m)		
2.00					
6.50					
Casing Details		Water Added			
To (m)	Diam (mm)	From (m)	To (m)		
2.50	200				
		Core Barrel	Flush Type	Termination Reason	Last Updated
				Terminated at scheduled depth.	13/08/2020

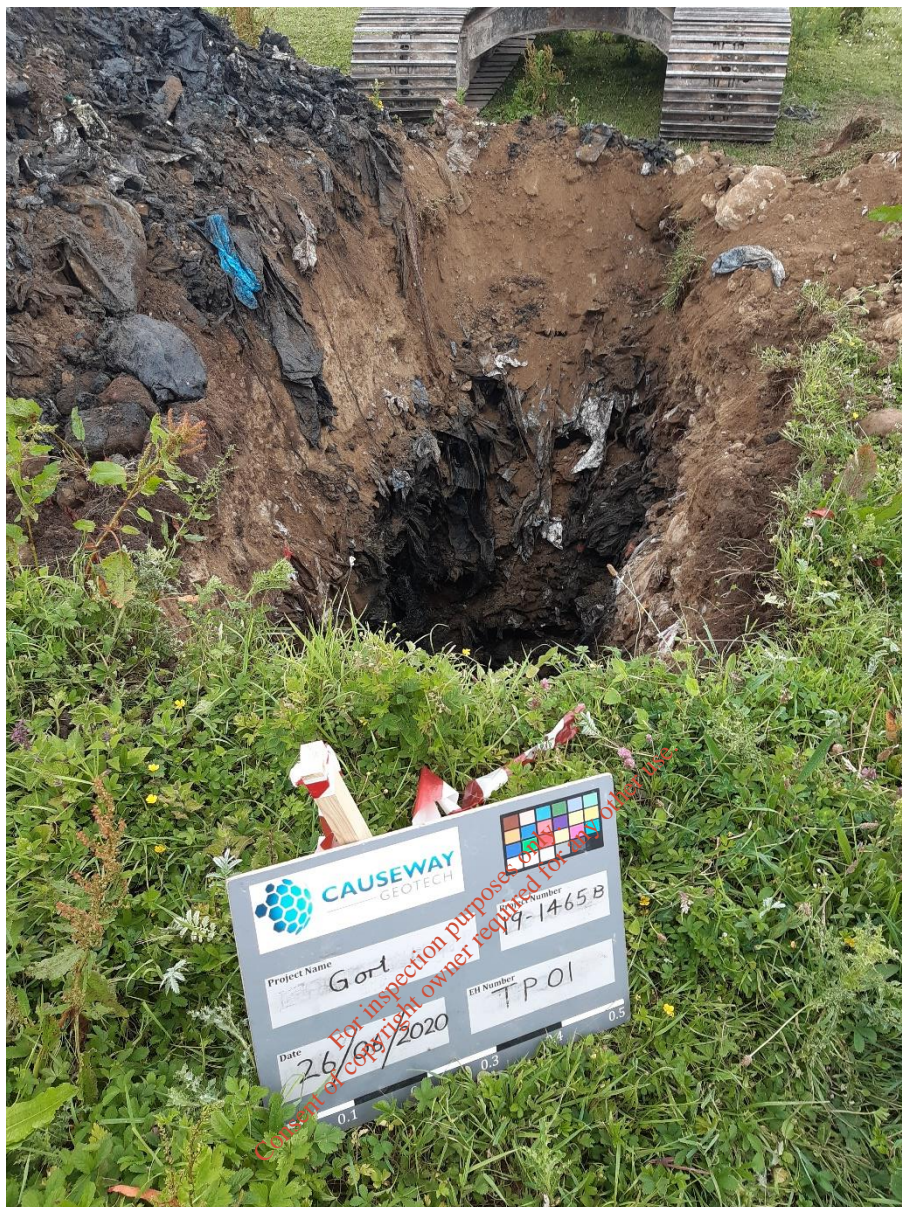
TP01

Depth (m)	Sample / Tests	Field Records	Level (mOD)	Depth (m)	Legend	Description	Water
			21.08	0.20		Reworked TOPSOIL	
						MADE GROUND: Brownish yellow sandy silty subrounded fine to coarse GRAVEL of limestone with low cobble content.	0.5
			20.48	0.80		MADE GROUND: Lenses of soft black clay with multicoloured sheets of plastic, plastic bottles, glass bottles, and pieces of wood.	1.0
						Soft grey CLAY	1.5
			18.28	3.00			2.0
		Slow seepage at 3.50m					2.5
							3.0
							3.5
							4.0
			16.78	4.50		End of trial pit at 4.50m	4.5

Water Strikes		Depth: 4.50 Width: 1.20 Length: 4.50	Remarks:
Struck at (m)	Remarks		
3.50	Slow seepage at 3.50m		
Stability: Stable		Termination Reason: Terminated at scheduled depth.	Last Updated 13/08/2020
