HISTORIC LANDFILL AT GORT, CO. GALWAY

TIER 2 RISK ASSESSMENT

Prepared for: Galway County Council

Date: November 2020

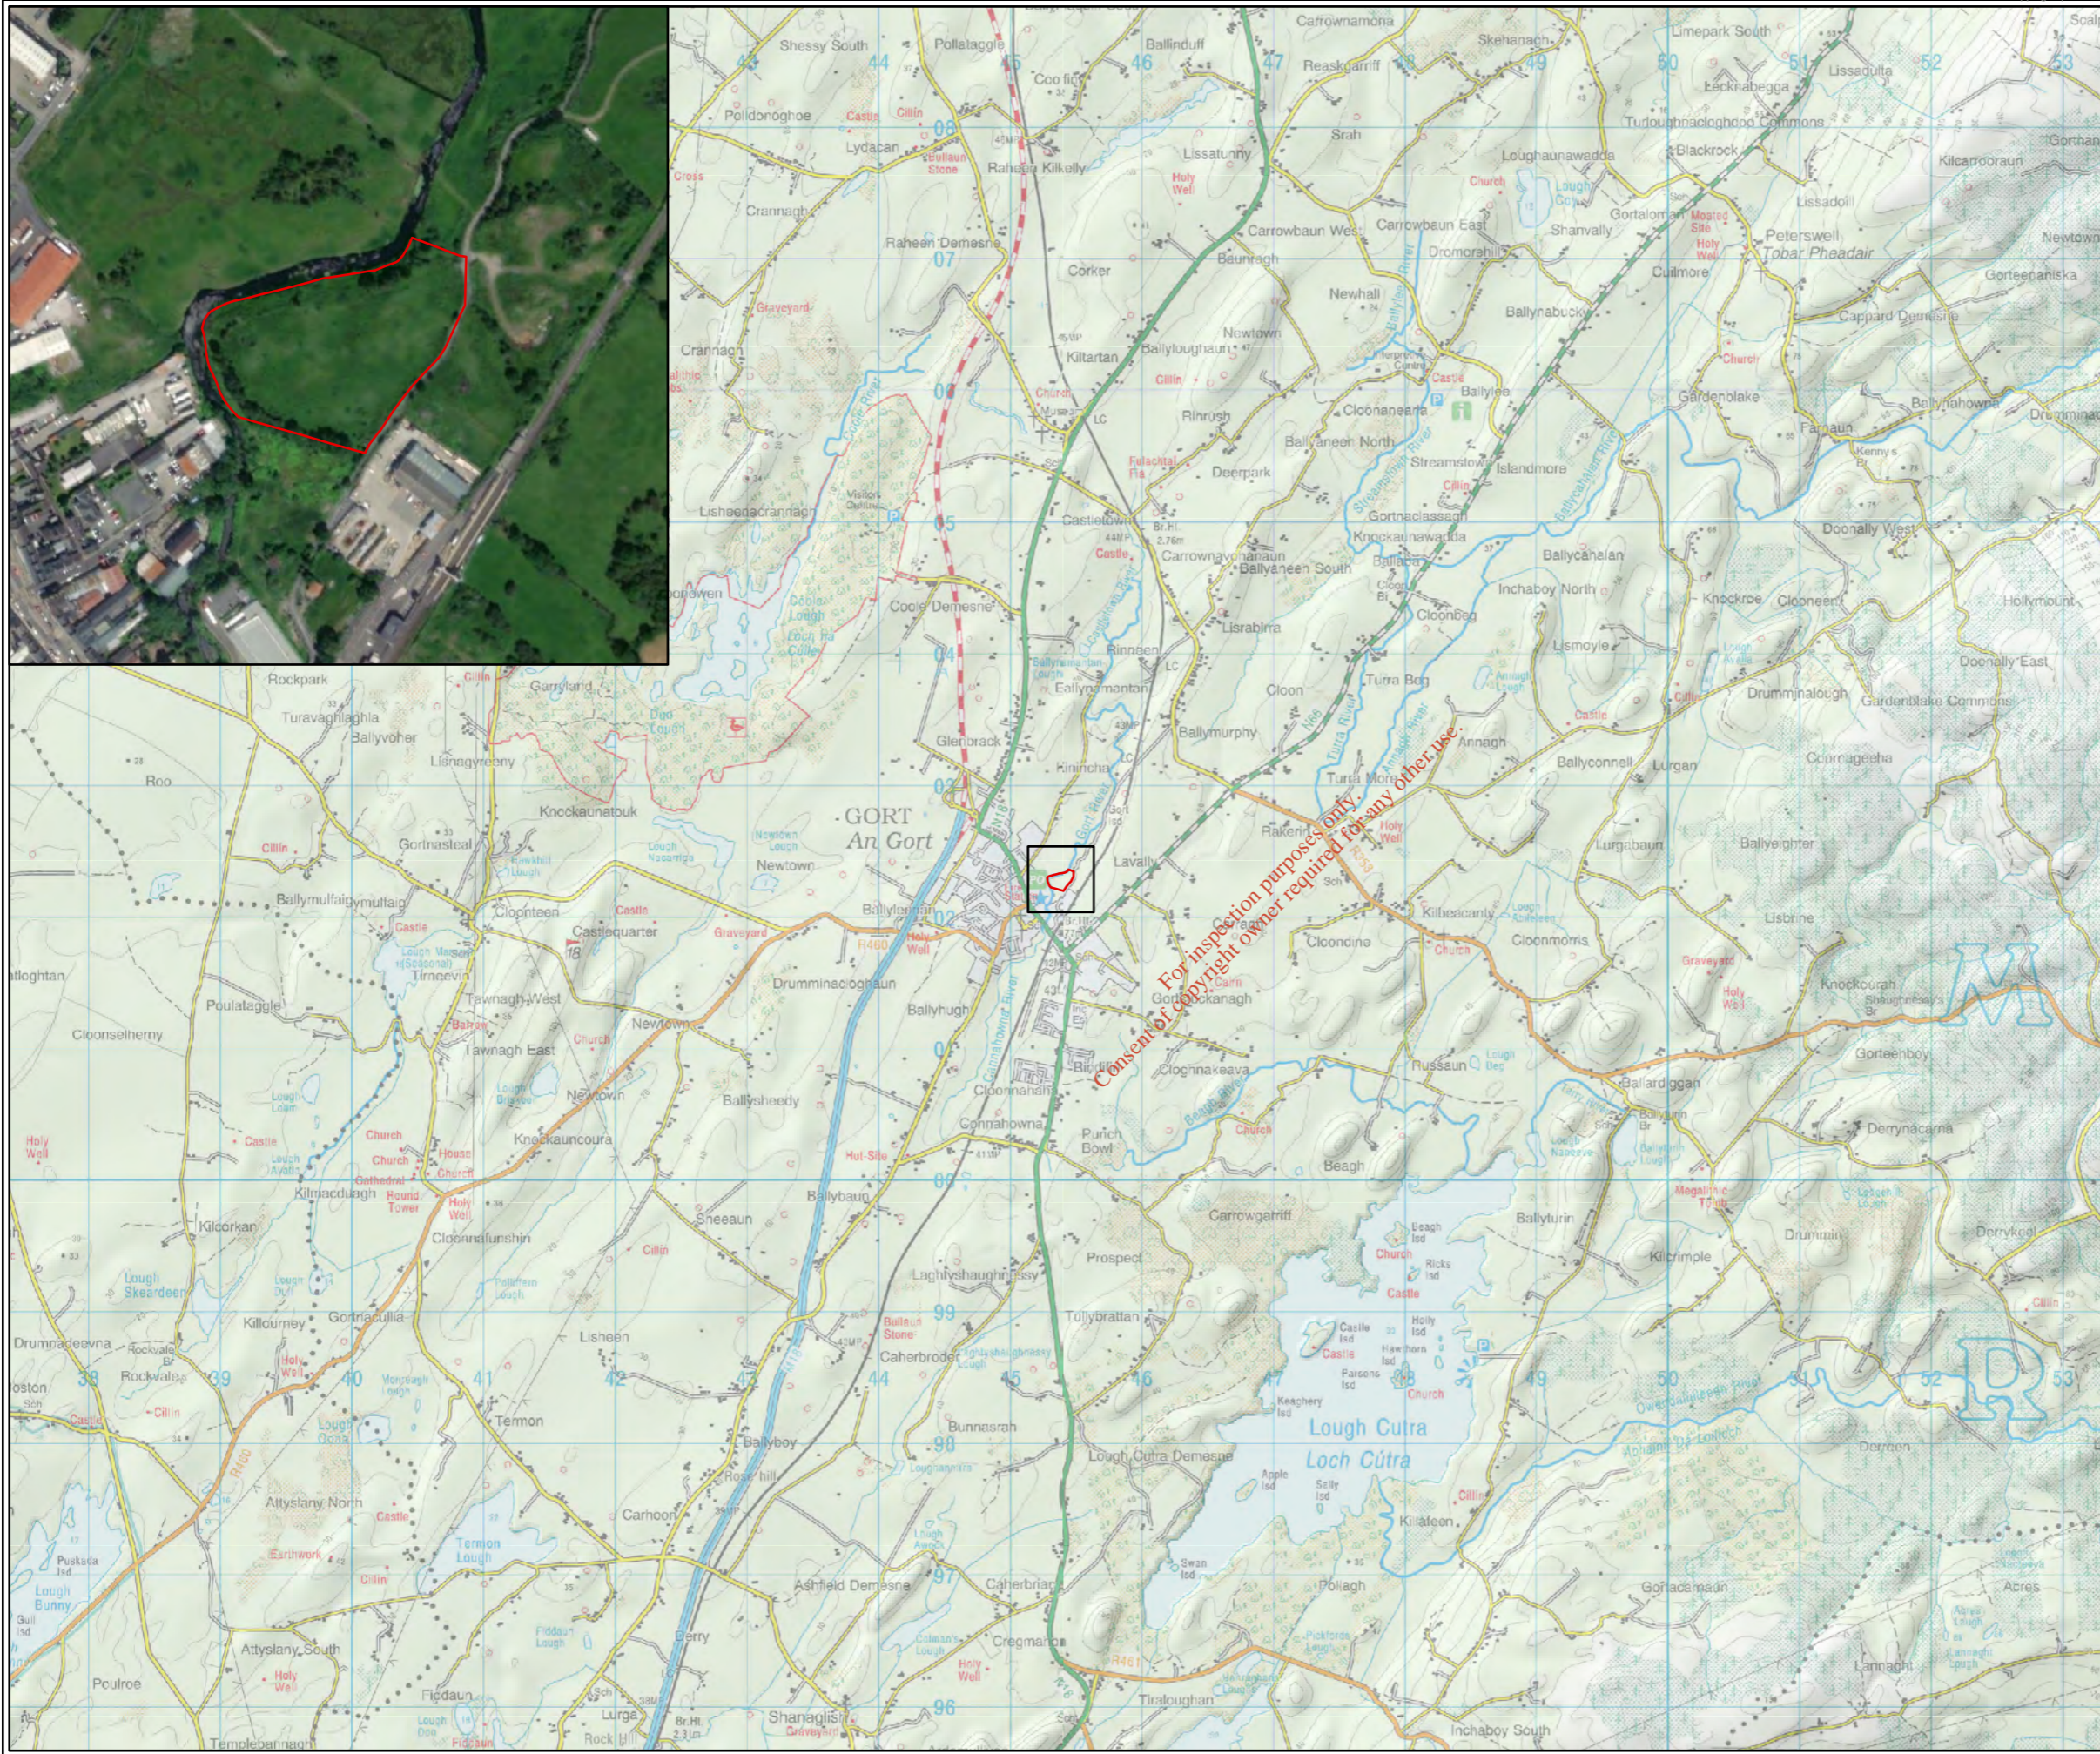
TITLE:	Site Location
PROJECT:	Gort Historic Landfill ERA
FIGURE NO:	2.1
CLIENT:	Galway County Council
SCALE:	1:50,000
REVISION:	0
DATE:	15/10/2020
PAGE SIZE:	A3

The location of the site is shown in Figure 2-1.

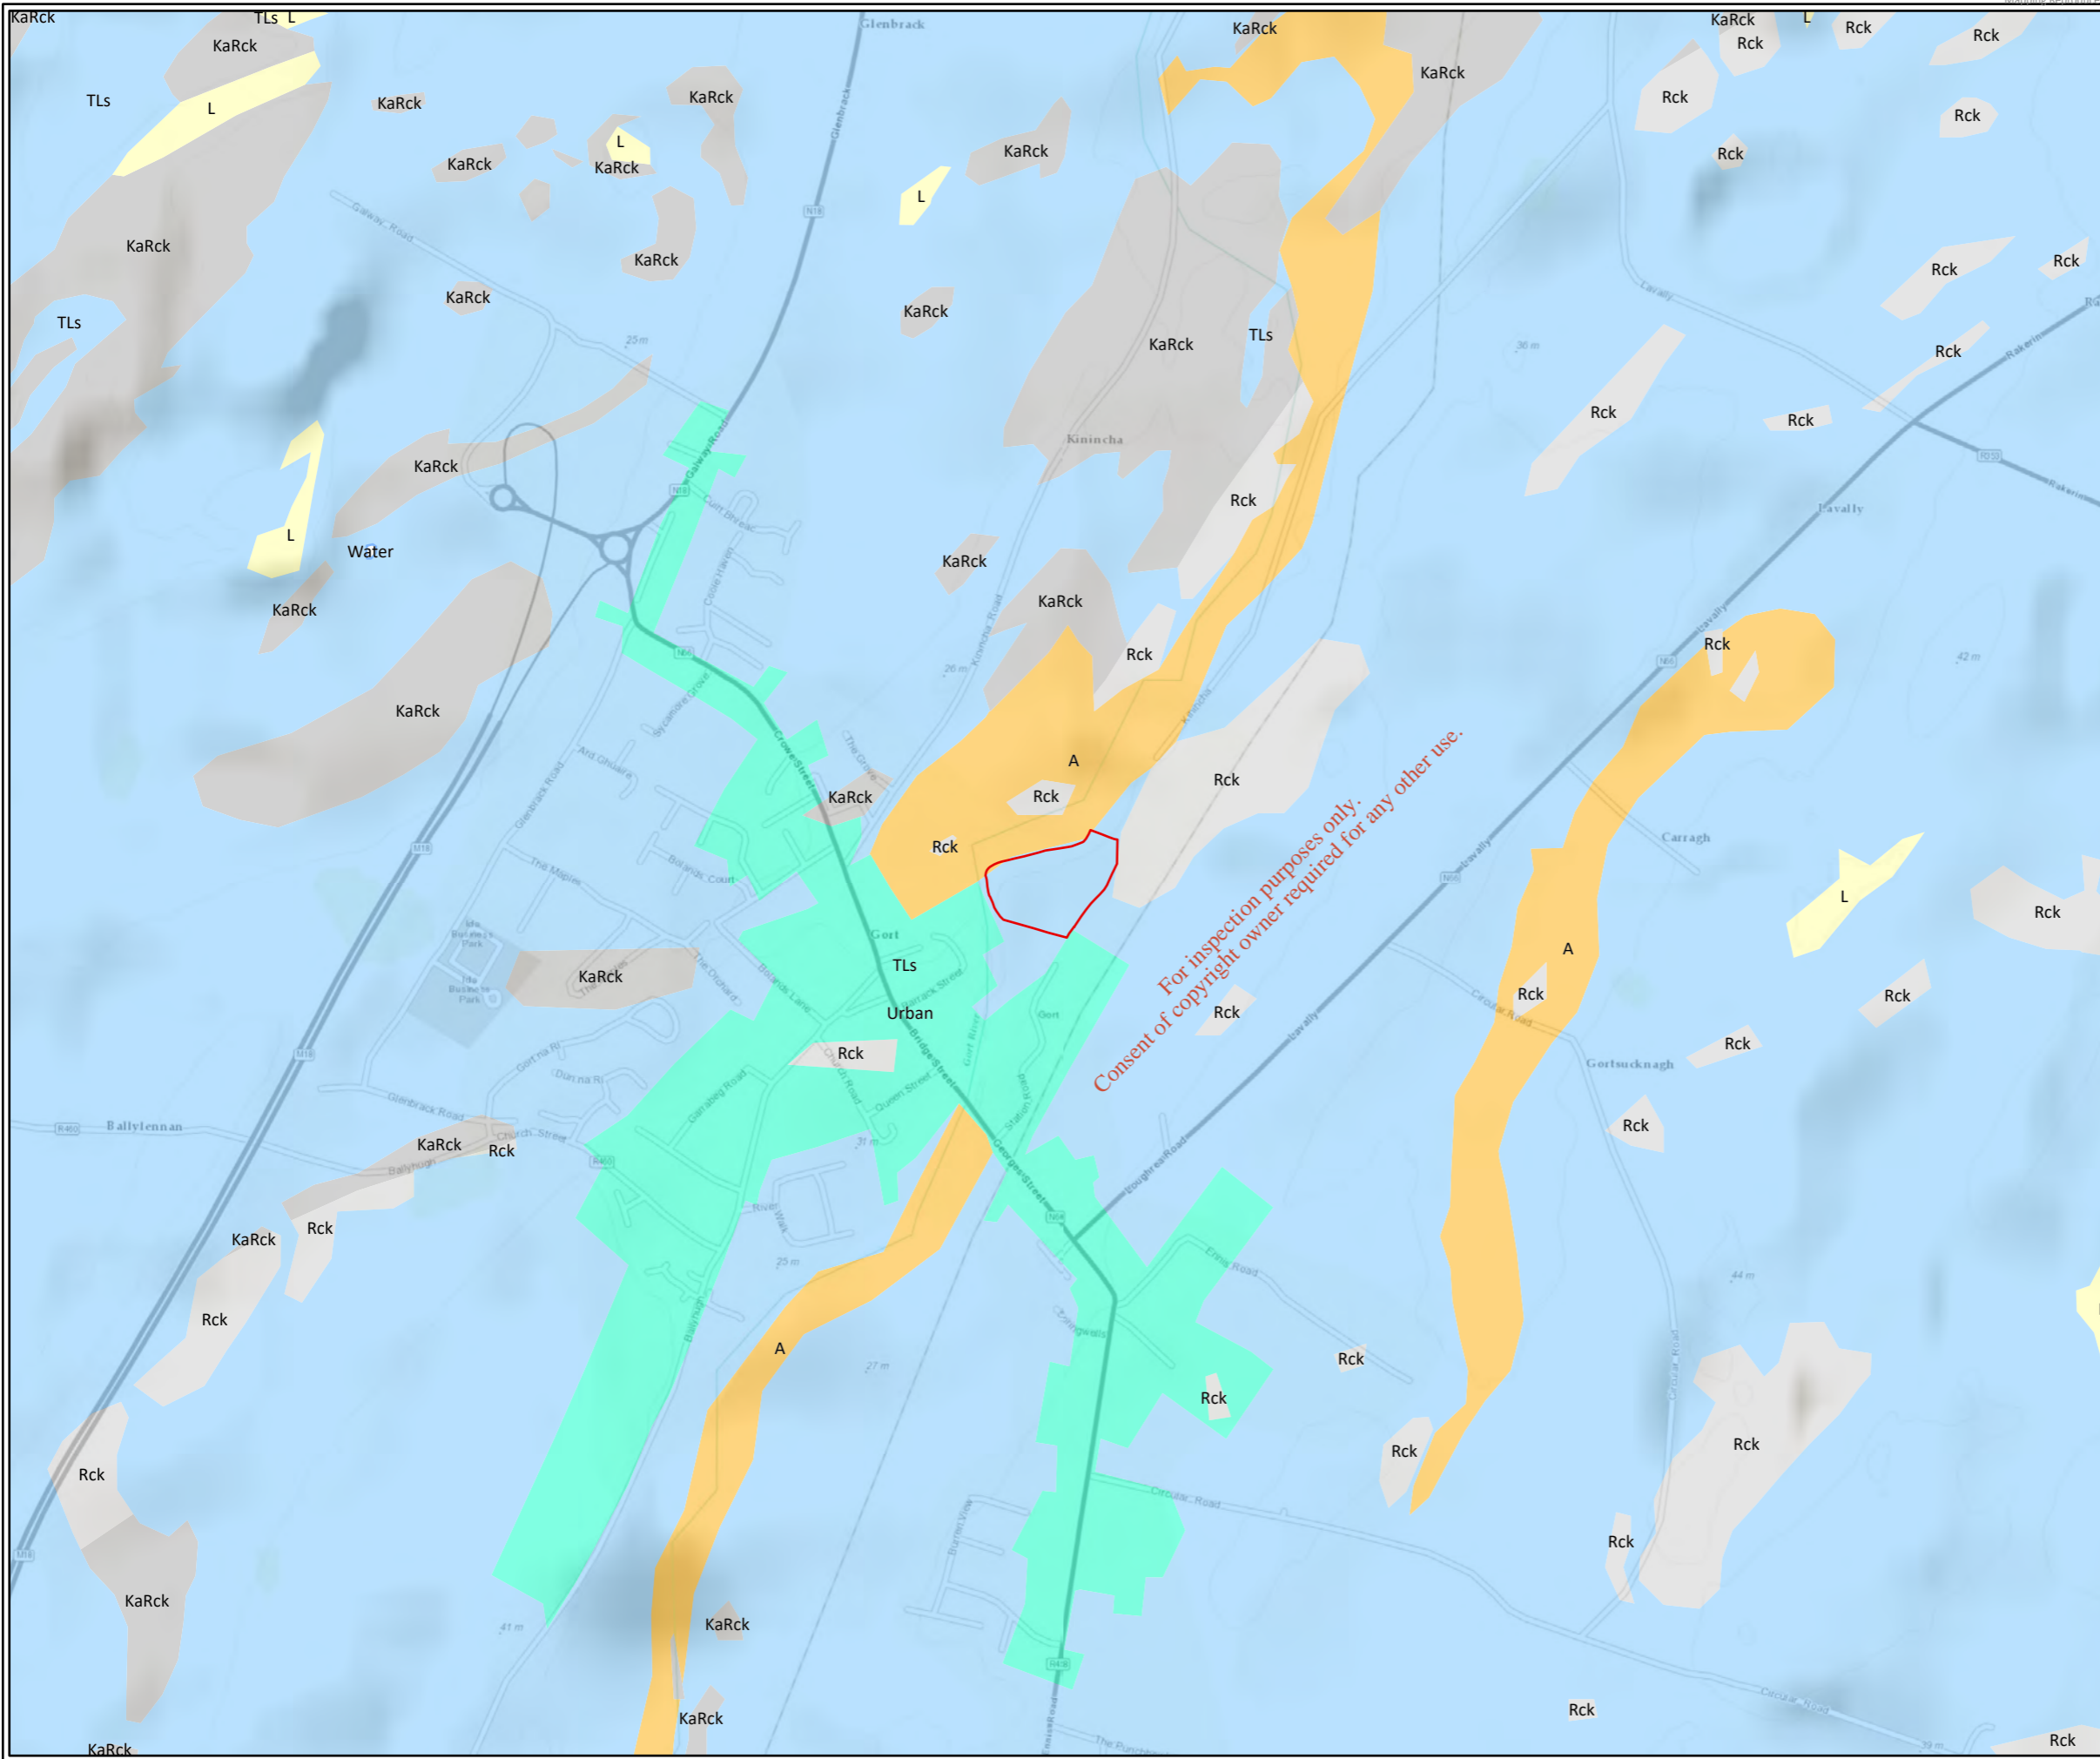
TITLE:	Quaternary Geology		
PROJECT:	Gort Historic Landfill ERA		
FIGURE NO:	2.2		
CLIENT:	Galway County Council		
SCALE:	1:10,000	REVISION:	0
DATE:	15/10/2020	PAGE SIZE:	A3
		Cork Dublin Carlow www.fehilytimoney.ie

Quaternary sediments at the site comprise a combination of tills derived from limestones (western area) and bedrock outcrop or subcrop (eastern area). Alluvium deposits are also shown to be present along River Gort. Drift/quaternary geology is shown in Figure 2-2.

- Site Boundary
- Quaternary Sediments**
- A, Alluvium
- KaRck, Kartsified bedrock outcrop or subcrop
- L, Lacustrine sediments
- Rck, Bedrock outcrop or subcrop
- TLS, Till derived from limestones
- Urban
- Water

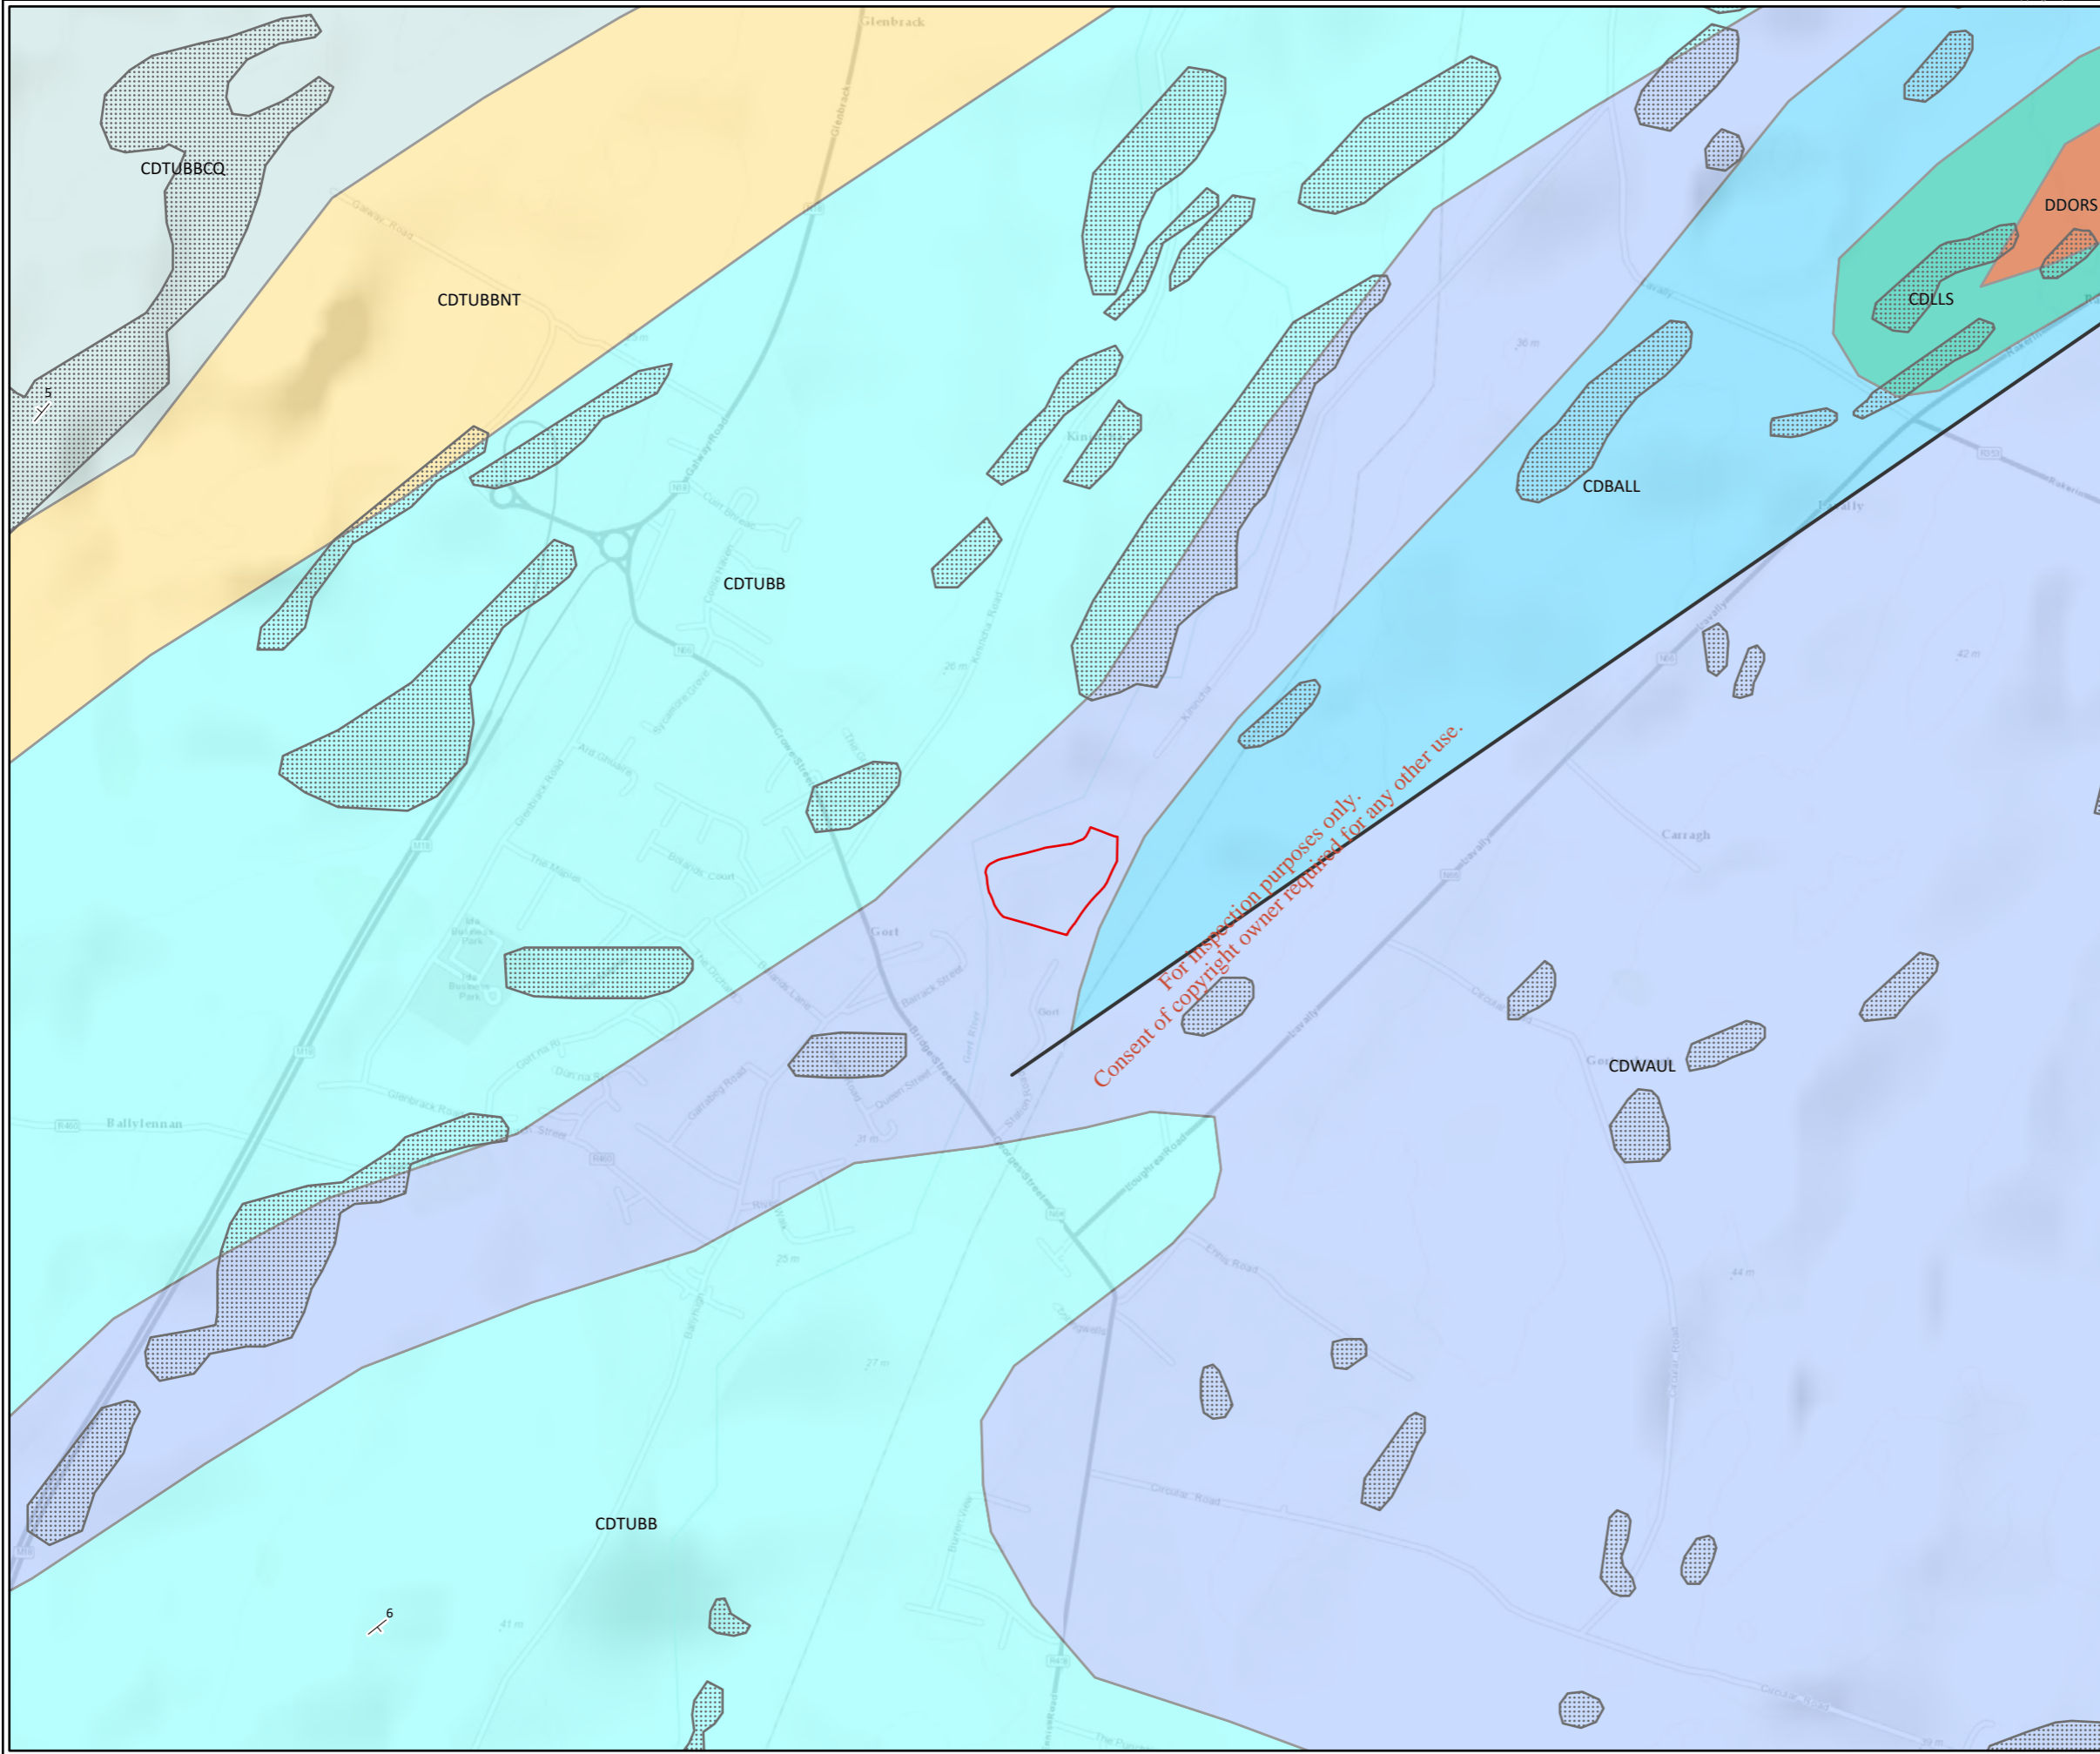
TITLE:	Bedrock Geology		
PROJECT:	Gort Historic Landfill ERA		
FIGURE NO.:	2.3		
CLIENT:	Galway County Council		
SCALE:	1:10,000	REVISION:	0
DATE:	15/10/2020	PAGE SIZE:	A3

The bedrock beneath the site comprises two different formations, Waulsortian Limestones (CDWAUL) and Ballysteen Formation (CDBALL). Further to the north, west and south of the site is the Tubber Formation.

GSI mapping also indicates the presence of bedrock outcrop within the wider area. A significant number of bedrock outcrops and karstified bedrock outcrops are also shown along the banks of the River Gort. Bedrock geology mapping is presented in Figure 2-3.

- Site Boundary
- Strike and dip of bedding, way up unknown
- Fault
- Bedrock Outcrop
- Bedrock Geology**
- Ballysteen Formation
- Lower Limestone Shale
- Tubber Formation
- Castlequarter Member
- Newtown Member
- Waulsortian Limestones
- Old Red Sandstone (undifferentiated)

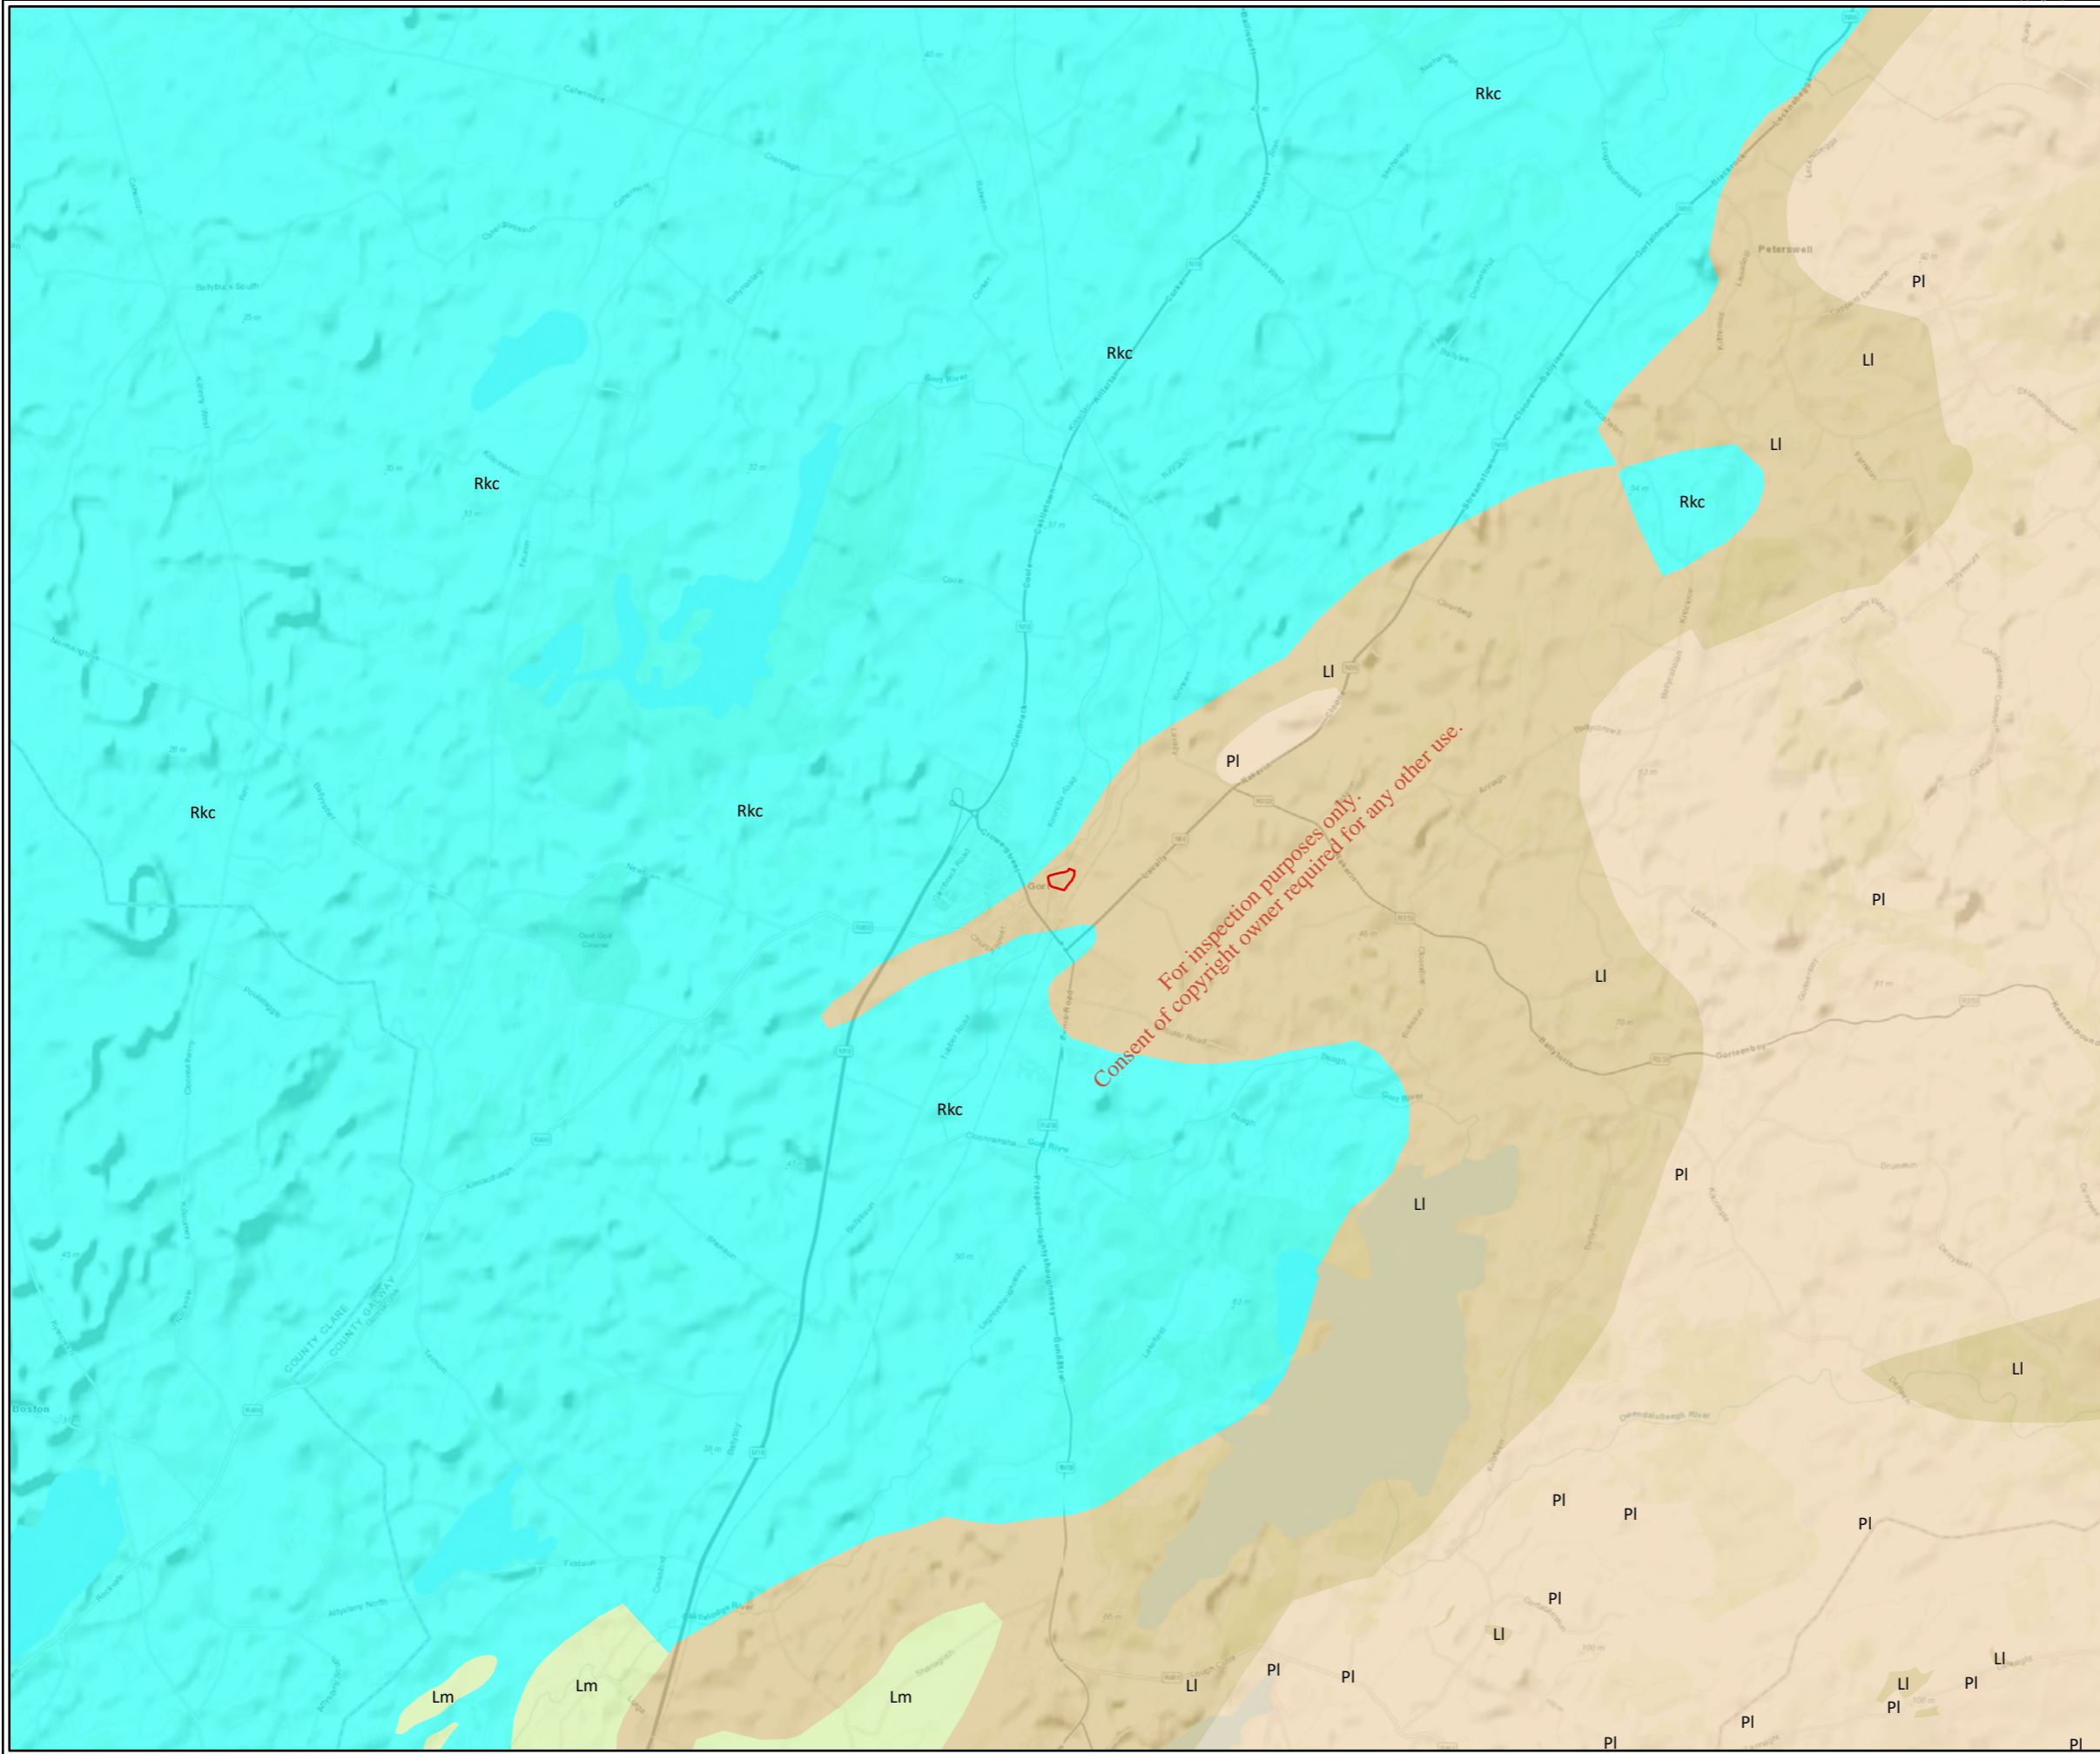
TITLE:	Aquifer Classification	
PROJECT:	Gort Historic Landfill ERA	
FIGURE NO:	2.4	
CLIENT:	Galway County Council	
SCALE:	1:50,000	REVISION: 0
DATE:	15/10/2020	PAGE SIZE: A3

An examination of the national bedrock aquifer mapping shows that the bedrock aquifer beneath site is classified as a ‘Locally Important Aquifer - Bedrock which is Moderately Productive only in Local Zones’. The bedrock aquifer mapping is presented in Figure 2-4.

- Site Boundary
- Bedrock Aquifers**
- LI: Locally Important Aquifer - Bedrock Mod Productive Locally
- Lm: Locally Important Aquifer - Bedrock Generally Mod Productive
- PI: Poor Aquifer Bedrock Generally Unproductive Except Locally
- Rkc: Regionally Important Aquifer - Karstified (conduit)

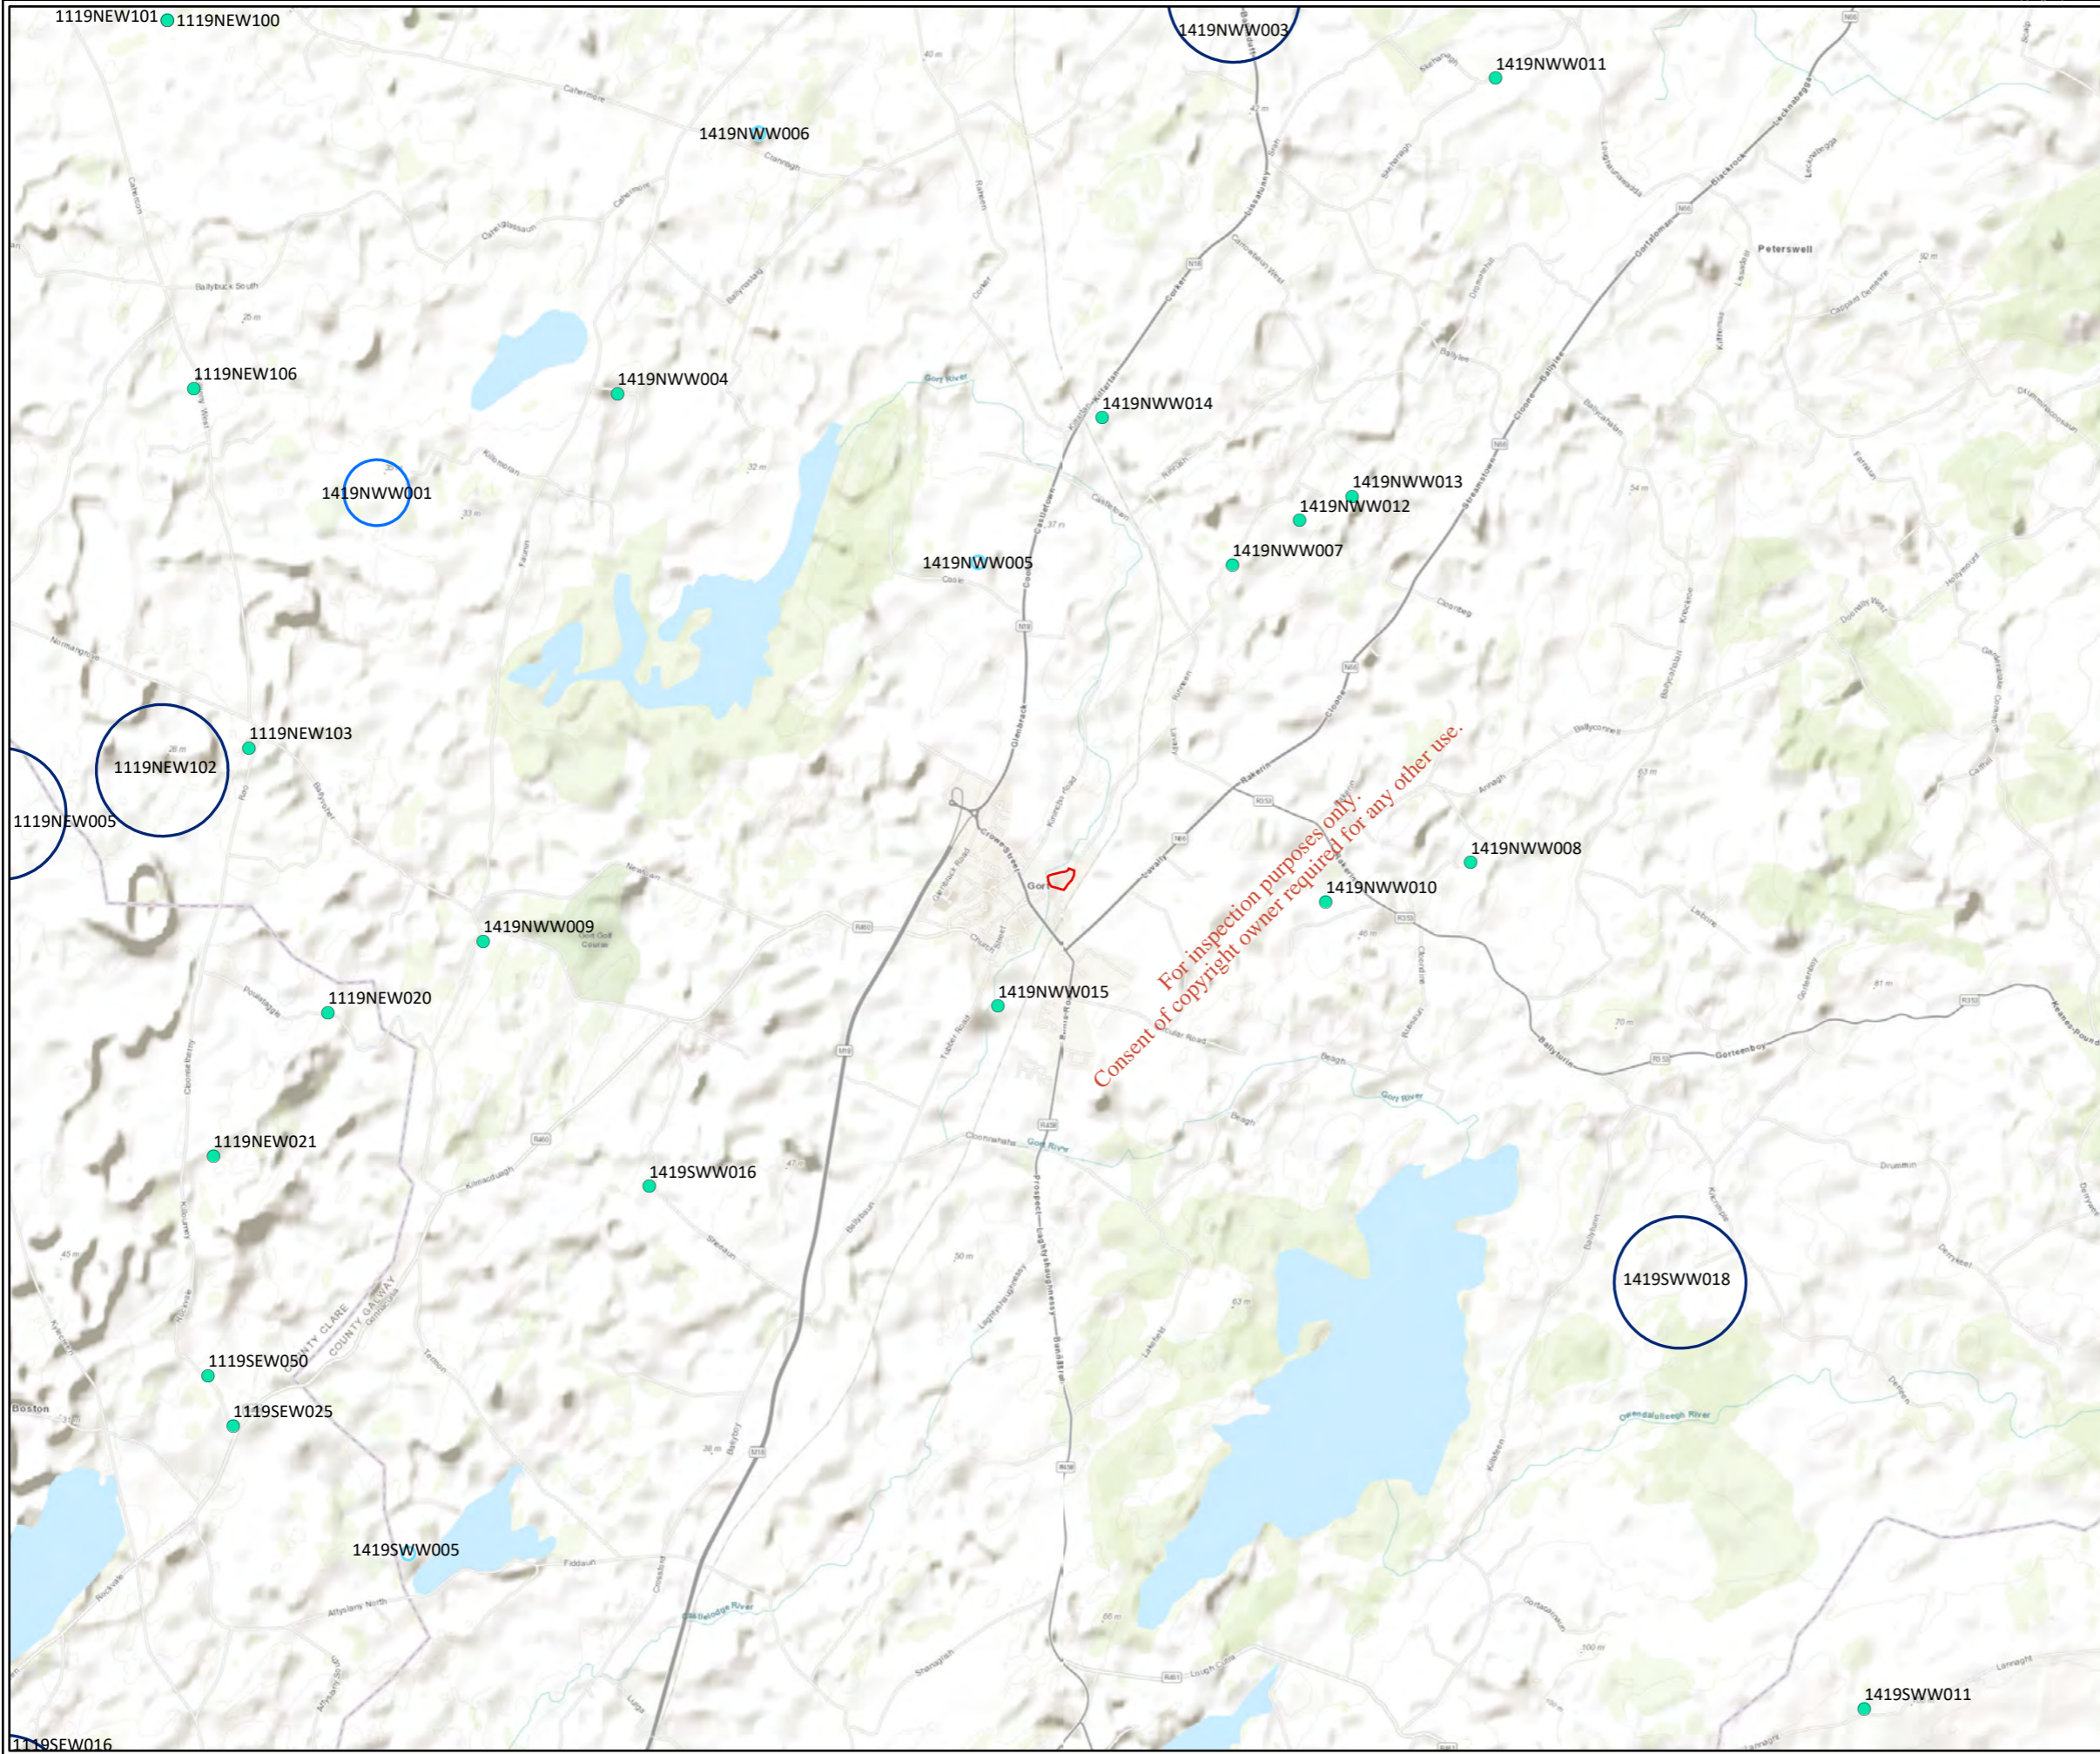
TITLE:	Wells and Springs
PROJECT:	Gort Historic Landfill ERA
FIGURE NO:	2.5
CLIENT:	Galway County Council
SCALE:	1:50,000
REVISION:	0
DATE:	15/10/2020
PAGE SIZE:	A3

The GSI mapping showing approximate locations of known wells and springs is included in Figure 2-5.

- Site Boundary
- Wells and Springs (10-50m Accuracy)
- Wells and Springs (50-100m Accuracy)
- Wells and Springs (100-200m Accuracy)
- Wells and Springs (200-500m Accuracy)
- Wells and Springs (500m-1km Accuracy)
