HISTORIC LANDFILL AT GORT, CO. GALWAY

TIER 2 RISK ASSESSMENT

Prepared for: Galway County Council

Date: November 2020

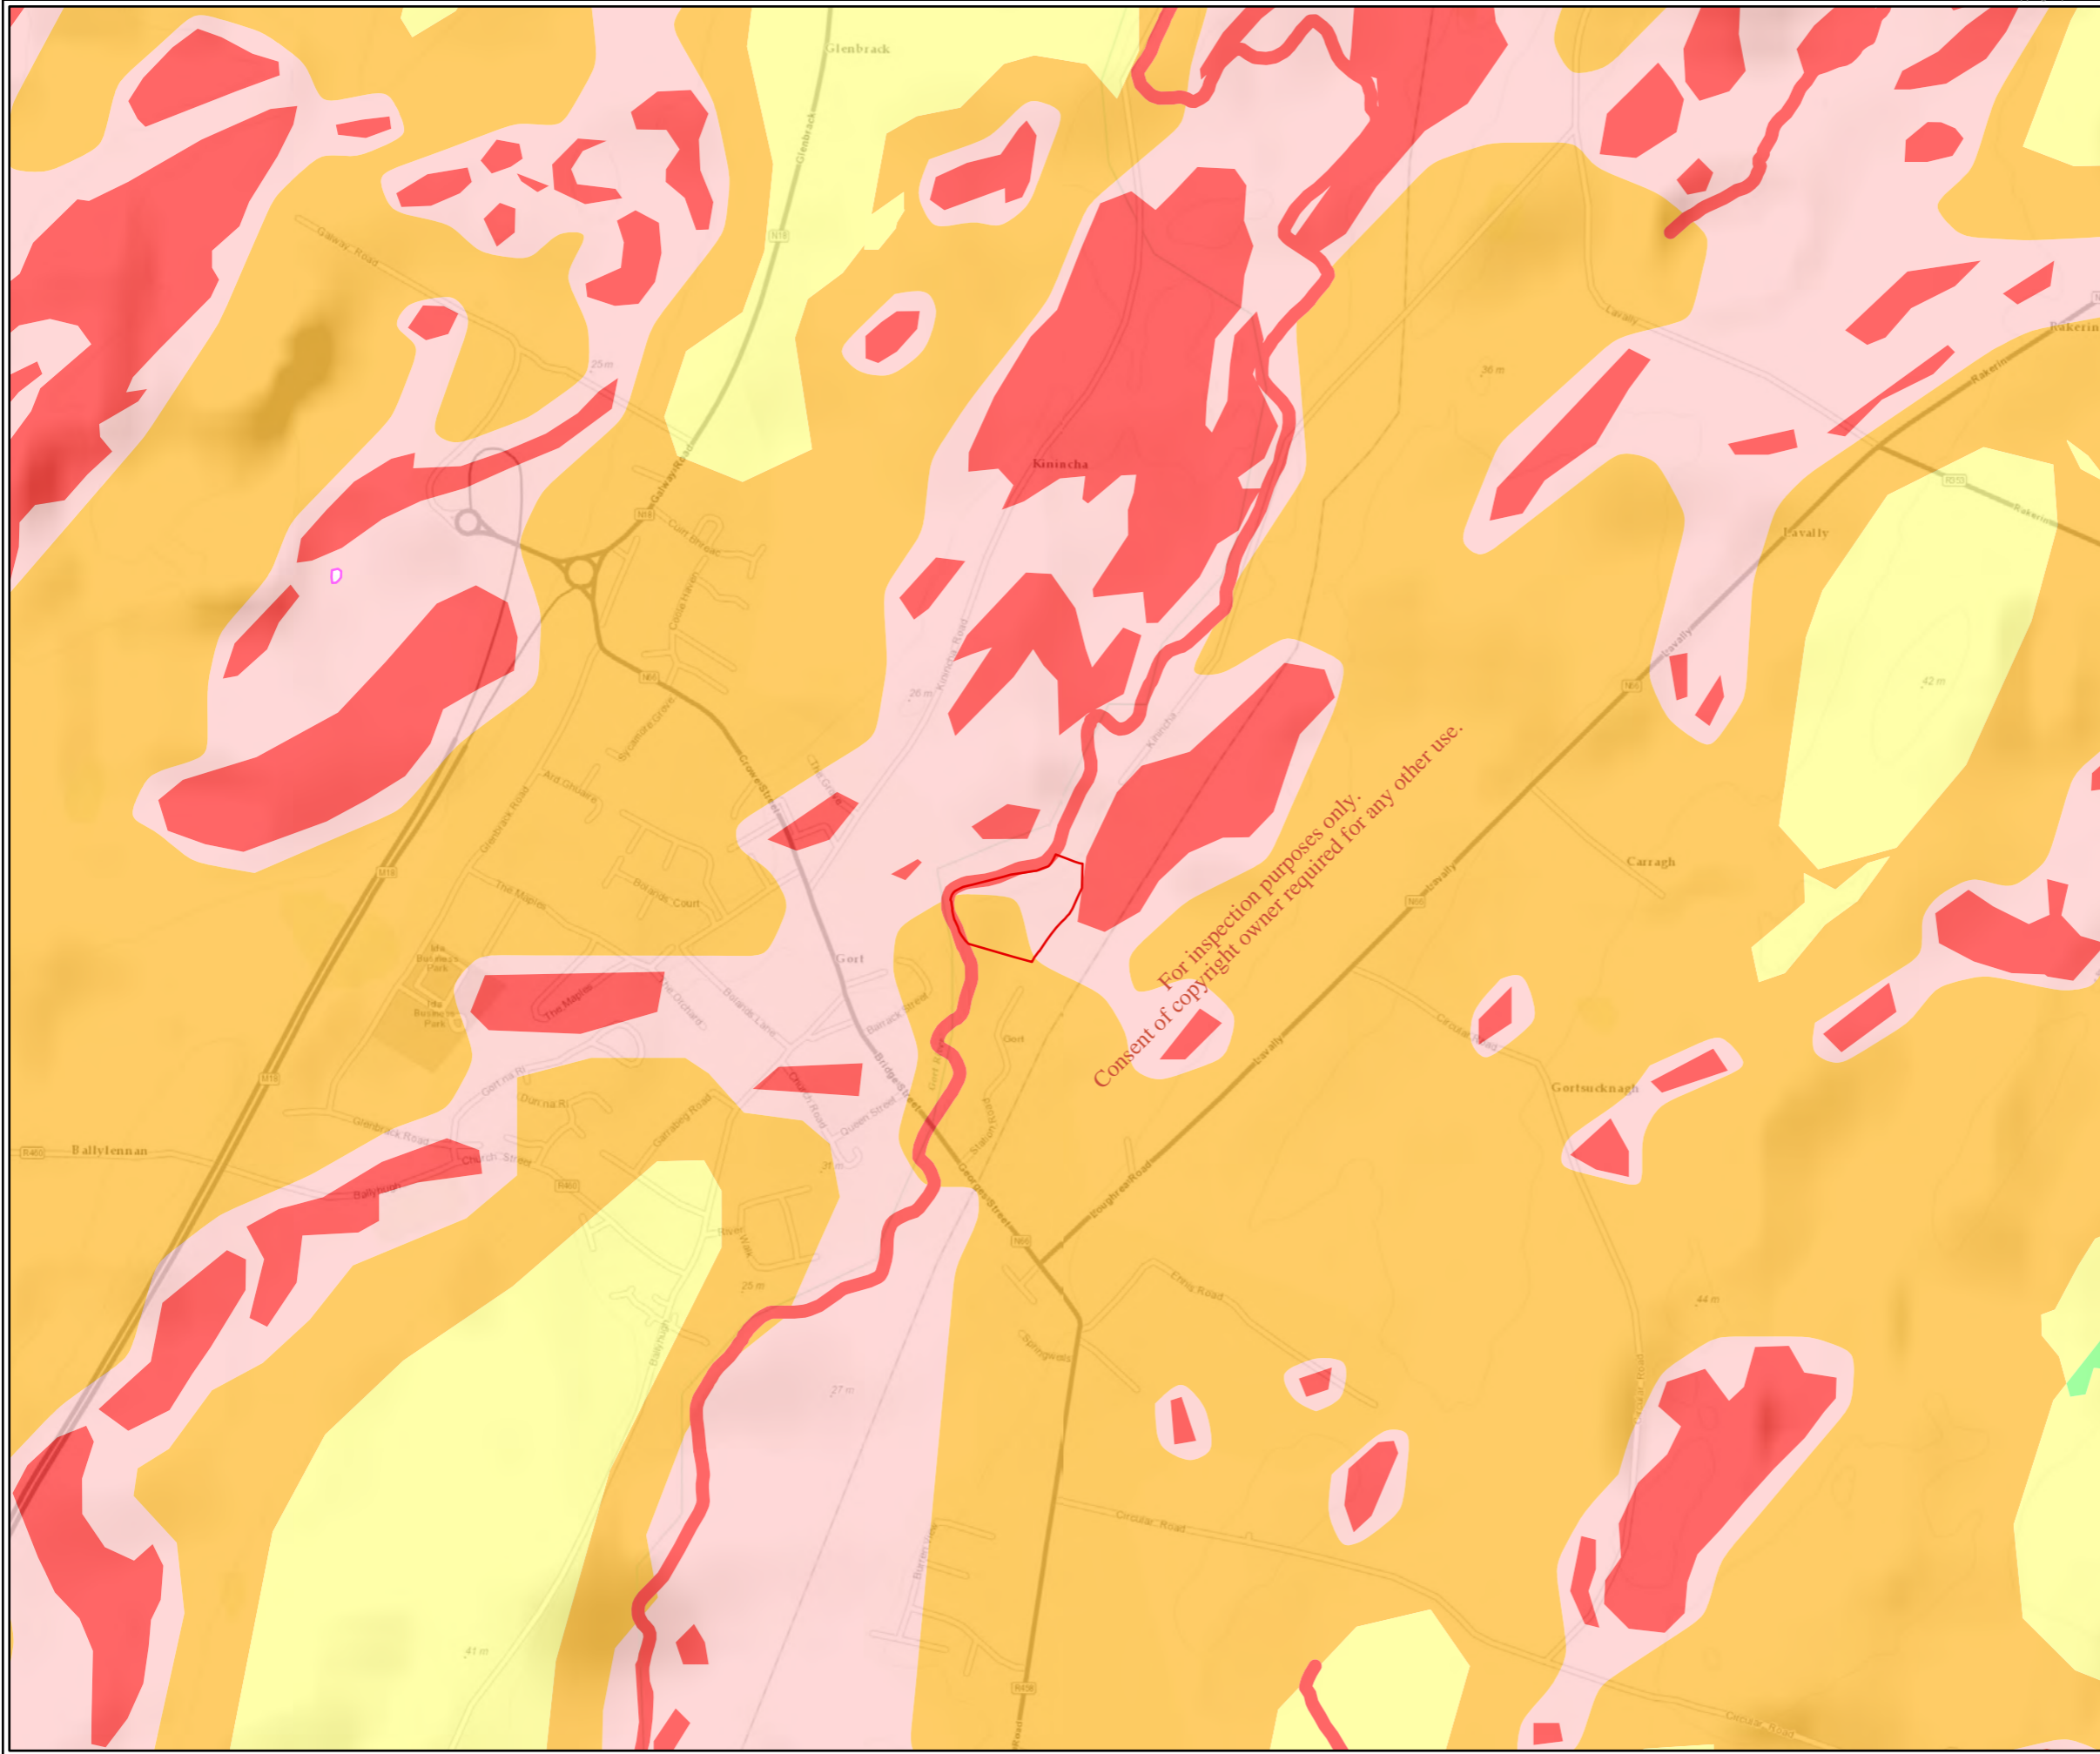
TITLE:	Groundwater Vulnerability		
PROJECT:	Gort Historic Landfill ERA		
FIGURE NO:	2.6		
CLIENT:	Galway County Council		
SCALE:	1:10,000	REVISION:	0
DATE:	15/10/2020	PAGE SIZE:	A3

The GSI Online mapping data set identifies the vulnerability of groundwater to contamination within the site area is classified as being primarily as ‘rock at or near the surface (X)’ and as ‘extreme (E)’. The groundwater vulnerability mapping is presented in Figure 2-6.

- Site Boundary
- E - Extreme
- H - High
- M - Moderate
- L - Low
- Water
- X - Rock Near Surface or Karst

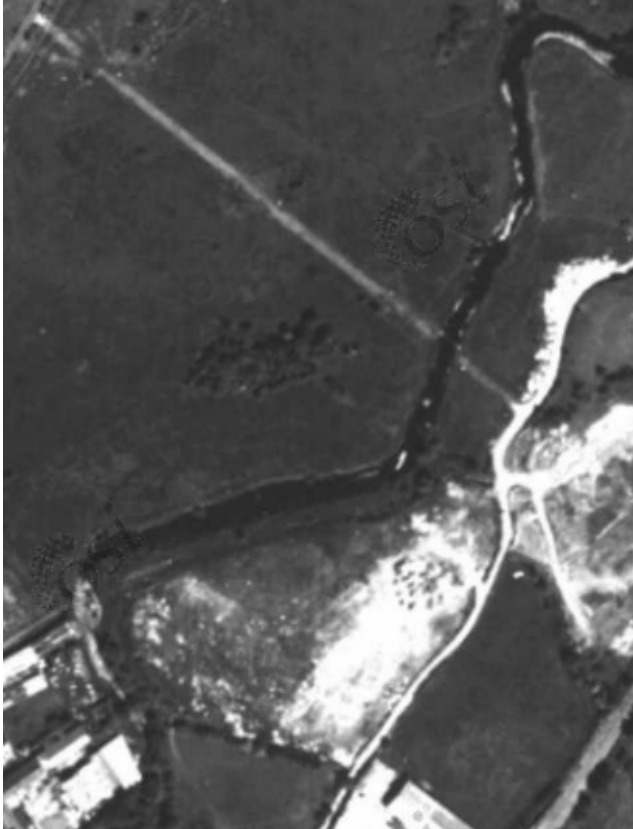
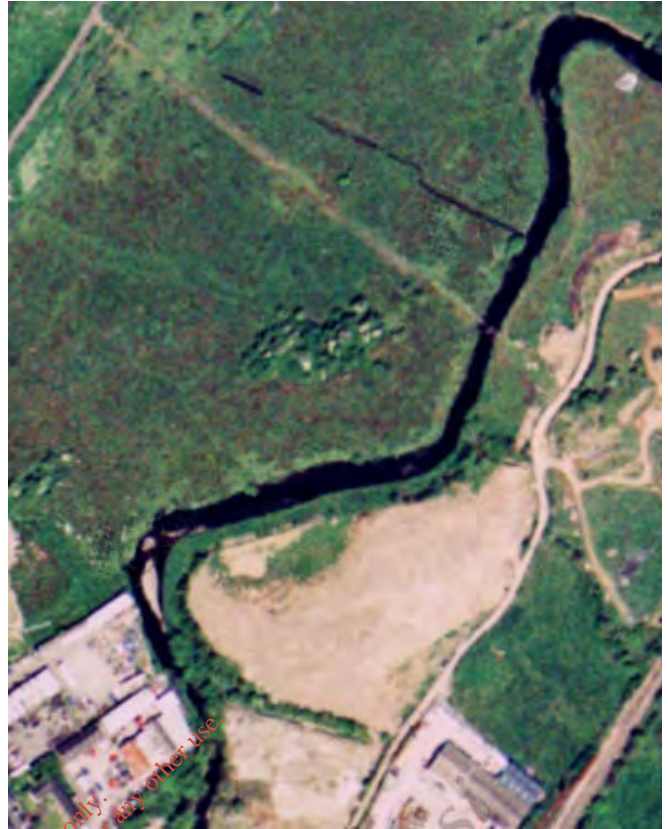
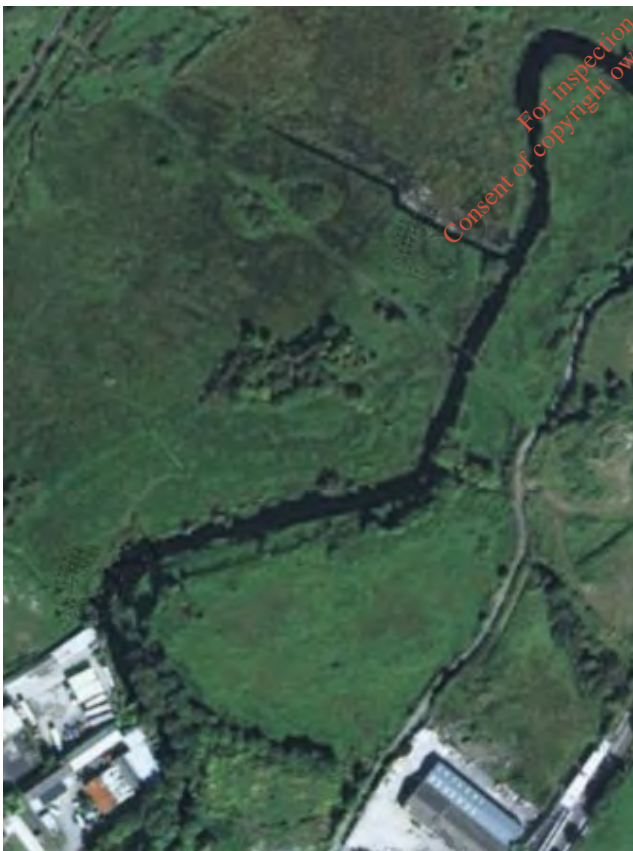
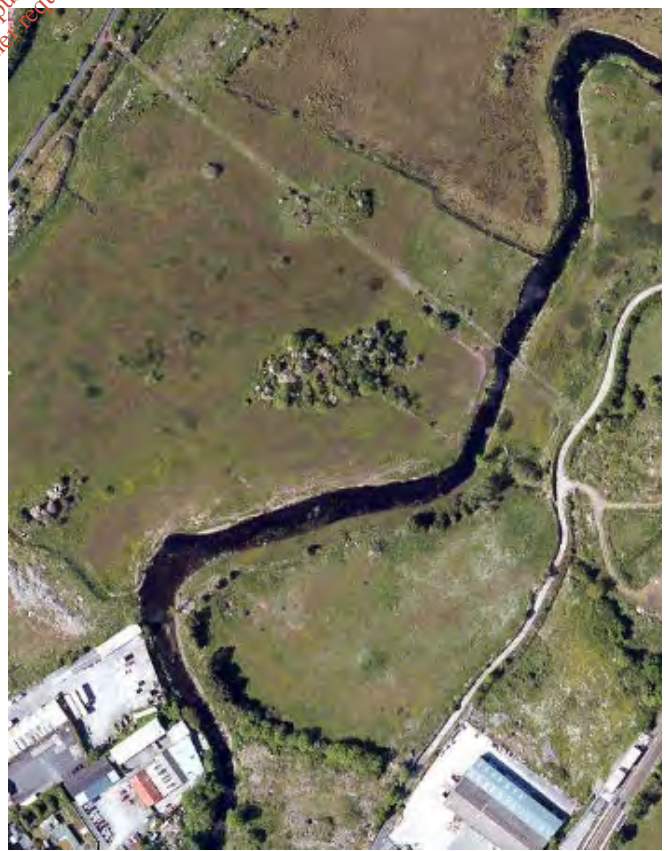
Figure 2-11: Historical Aerial Imagery¹

Historical Aerial Imagery (1995)

Historical Aerial Imagery (2000)

Historical Aerial Imagery (2005-2012)

Historical Aerial Imagery (2011-2013)

OSI historical mapping presented in Figure 2-10 and Aerial Imagery in Figure 2-11.
