## 3. TIER 2 SITE INVESTIGATION

<b>TITLE:</b>	
Site Investigation Location Plan	
<b>PROJECT:</b>	
Gort Historic Landfill ERA	
<b>FIGURE NO:</b>	3.1
<b>CLIENT:</b>	Galway County Council
<b>SCALE:</b> 1:2,000	<b>REVISION:</b> 0
<b>DATE:</b> 15/10/2020	<b>PAGE SIZE:</b> A3

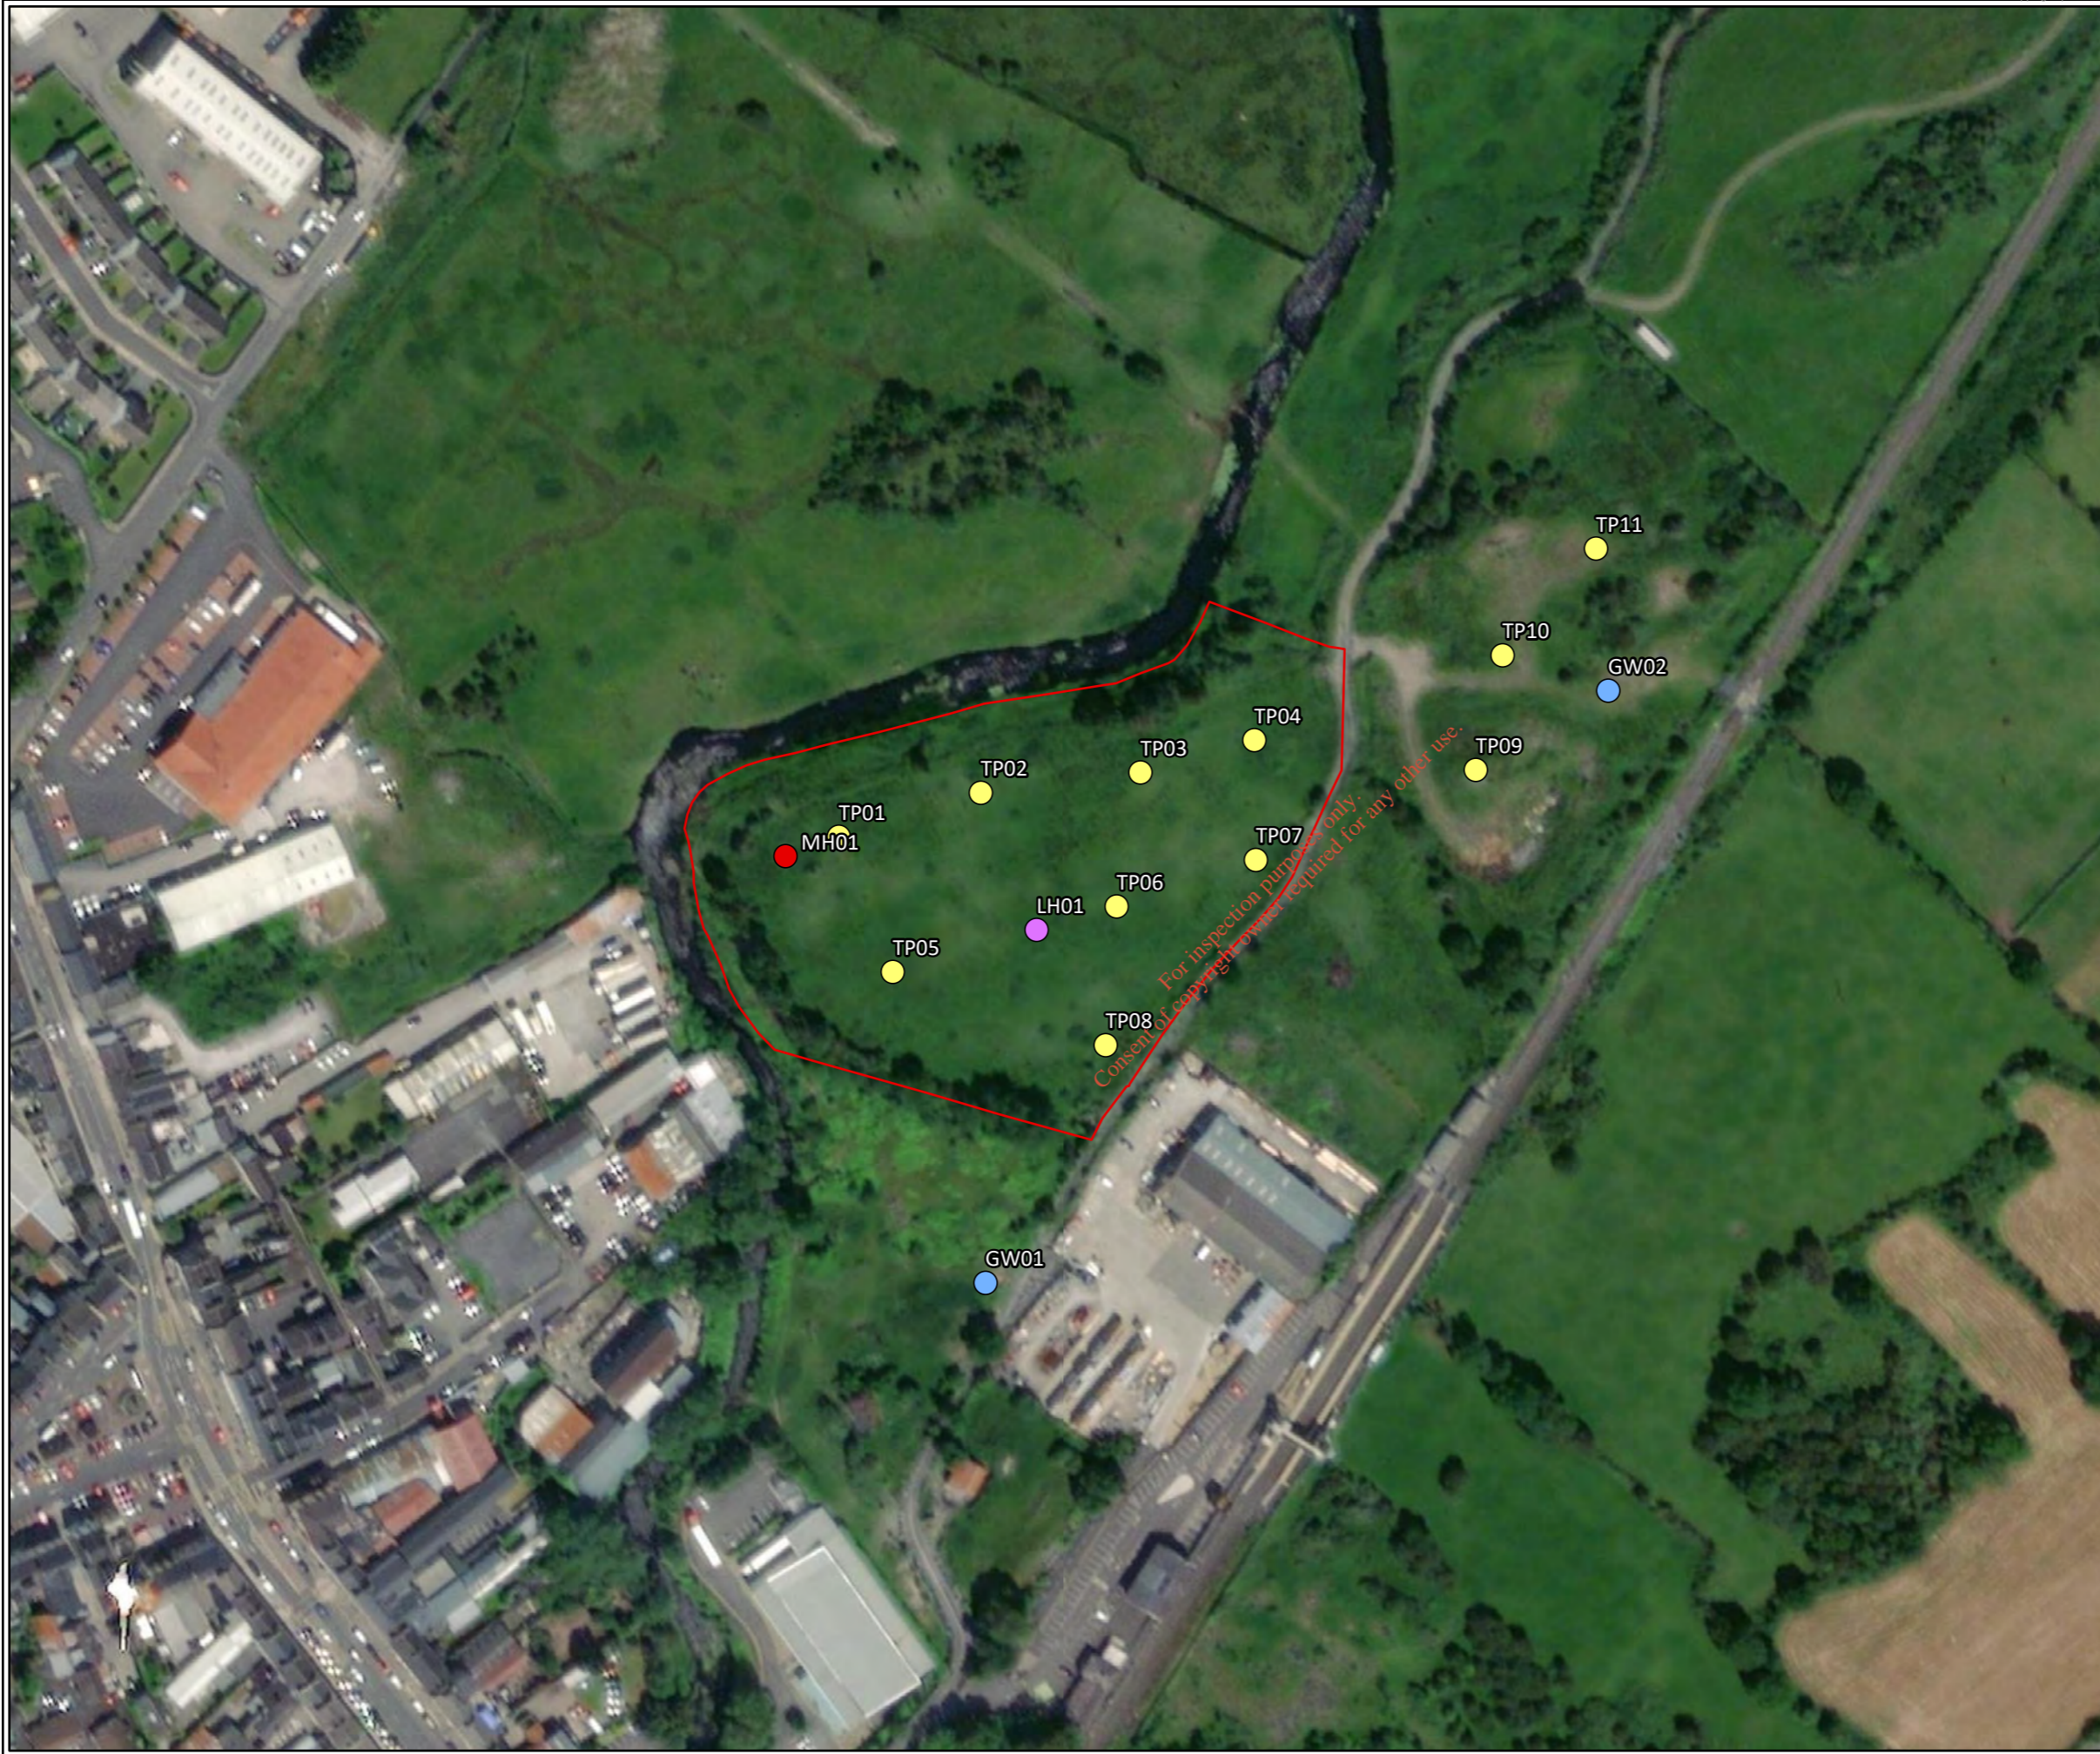
- Site Boundary
- Groundwater Well
- Trial Pit
- Leachate Borehole
- Existing Leachate Collection Manhole

The locations of the intrusive works conducted at the site are presented in Figure 3-1.

A Causeway Geotech (CGL) Engineering Geologist supervised the advancement of 11 No. trial pit, shown in Figure 3-1, on the 26<sup>th</sup> June 2020.

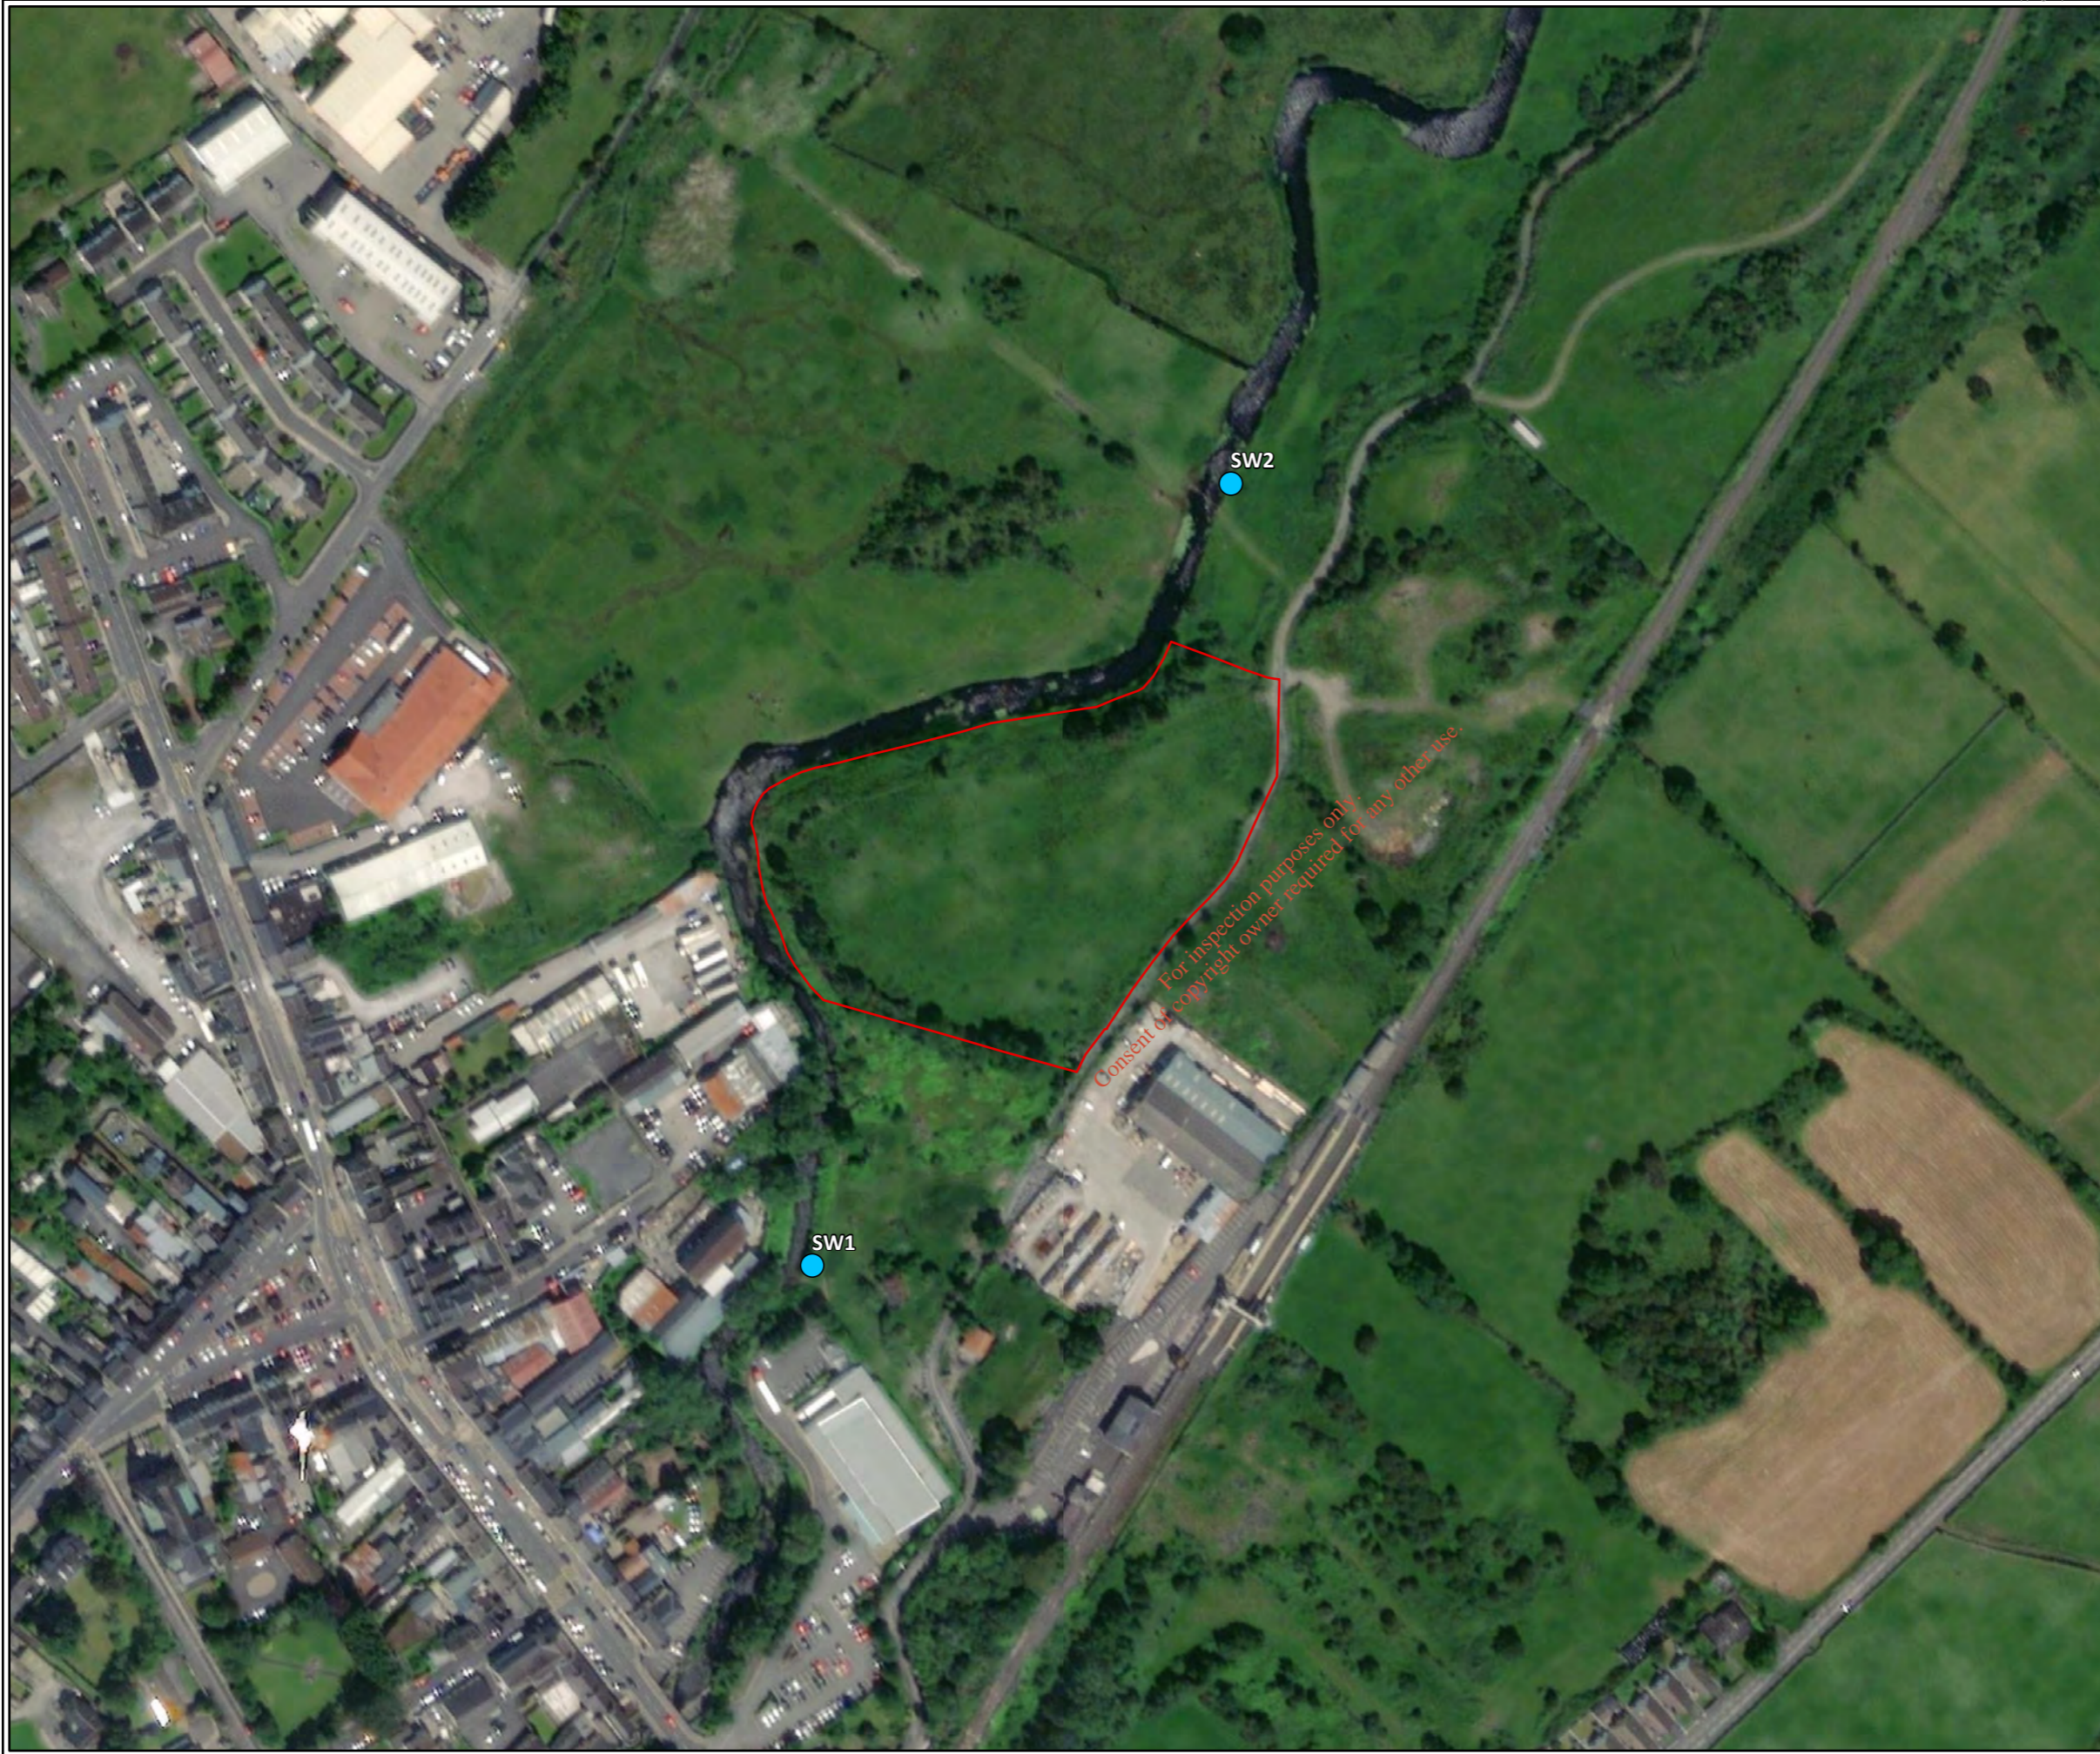
<b>TITLE:</b>	
Surface Water Sampling Locations	
<b>PROJECT:</b>	
Gort Historic Landfill ERA	
<b>FIGURE NO:</b> 4.2	
<b>CLIENT:</b> Galway County Council	
<b>SCALE:</b> 1:2,500	<b>REVISION:</b> 0
<b>DATE:</b> 15/10/2020	<b>PAGE SIZE:</b> A3

The surface water monitoring locations were selected upstream and downstream of the landfill footprint, as shown on **Error! Reference source not found.** Monitoring location SW1 was selected as the upstream location on Gort river to the south of the landfill. Monitoring location SW2 samples the Gort River downstream of the landfill.

- Site Boundary
- Surface Water Monitoring Locations
