**Environmental Survey in White Bay,
Whitegate, County Cork
September 2020**

AQUAFAC International Services Ltd

**DixonBrosnan Environmental Consultants.
Issued September 2020**

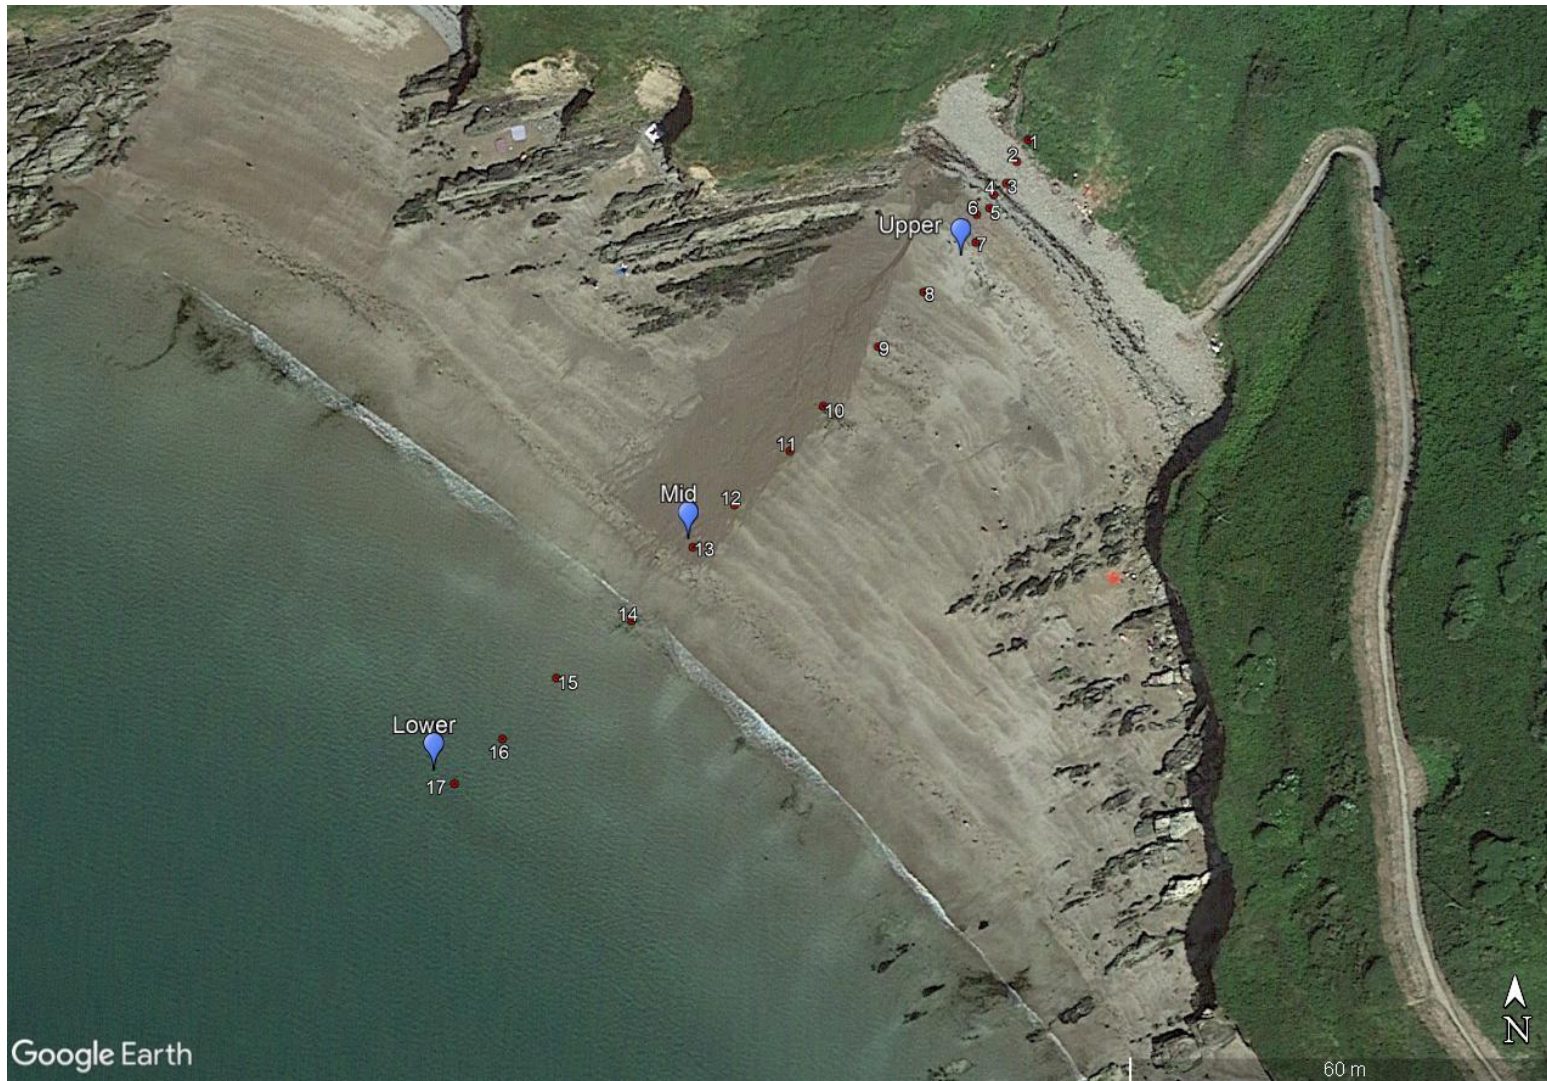
The slope of the shore from the upper splash zone to the water's edge was recorded by means of an engineer's level and metered staff. Levels were taken at regular intervals along the shore where the slope was even with additional levels taken where sudden drops or inclines occurred (Figure 2-1).

An 18 cm diameter core was used to collect faunal samples at the upper, mid and lower shore areas along the transect route. The coordinates of each location are presented in Table 2-1 and their location shown in Figure 2-1. Three replicate cores, to a depth of 15cm were collected at each of the stations for faunal analysis. The content of each core was stored in a labelled container and the core washed down to avoid any loss of the sample.

Figure 2-1 Beach transect and core station locations, White Bay, Cork Harbour, 1st September 2020.

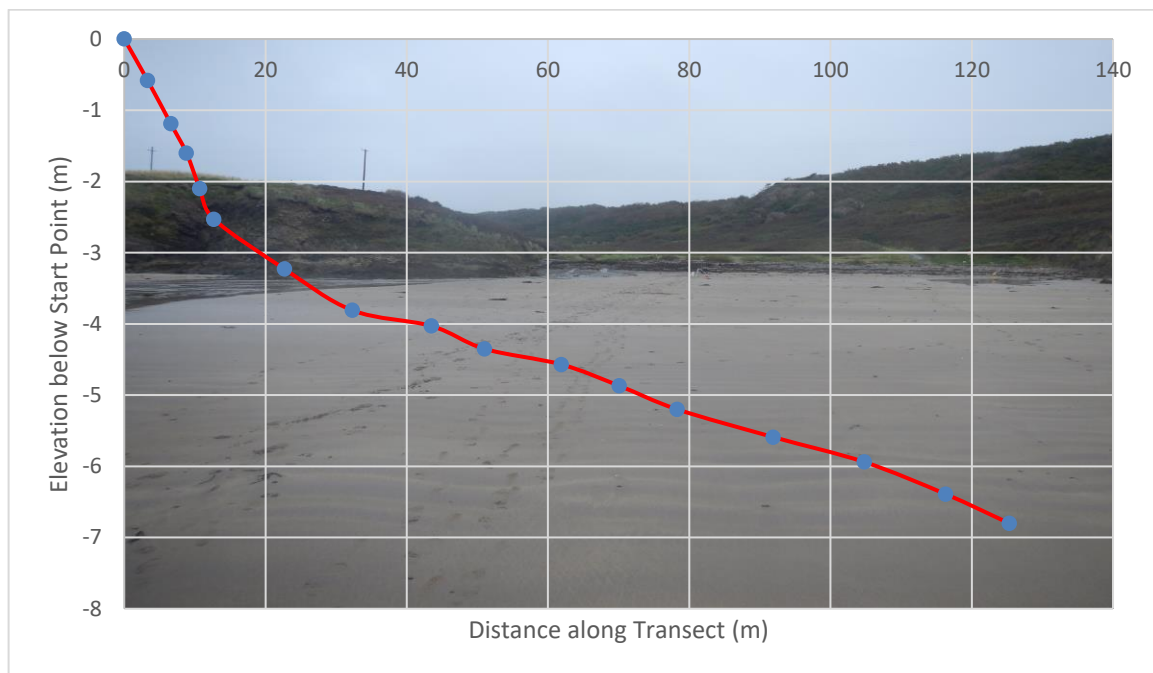
The profile of the upper splash zone and intertidal area exposed at low water on the 1st September 2020 is presented in Figure 3-1.

Figure 3-1 Profile of the shore transect at White Bay Beach, 1st September 2020

The shore transect began on an upper grass plateau that overlooked the beach (see Plate 3-1). Adjoining this was a short cobble bank that made up the upper splash zone, which continued on to a medium sand beach that continued down to the water's edge. A small stream flowed through the cobble bank and continued across the beach to enter the Bay at this location. The overall length of the transect was 125 m of which the sand beach was 115 m in an even slope dropping approximately 4m over its length.

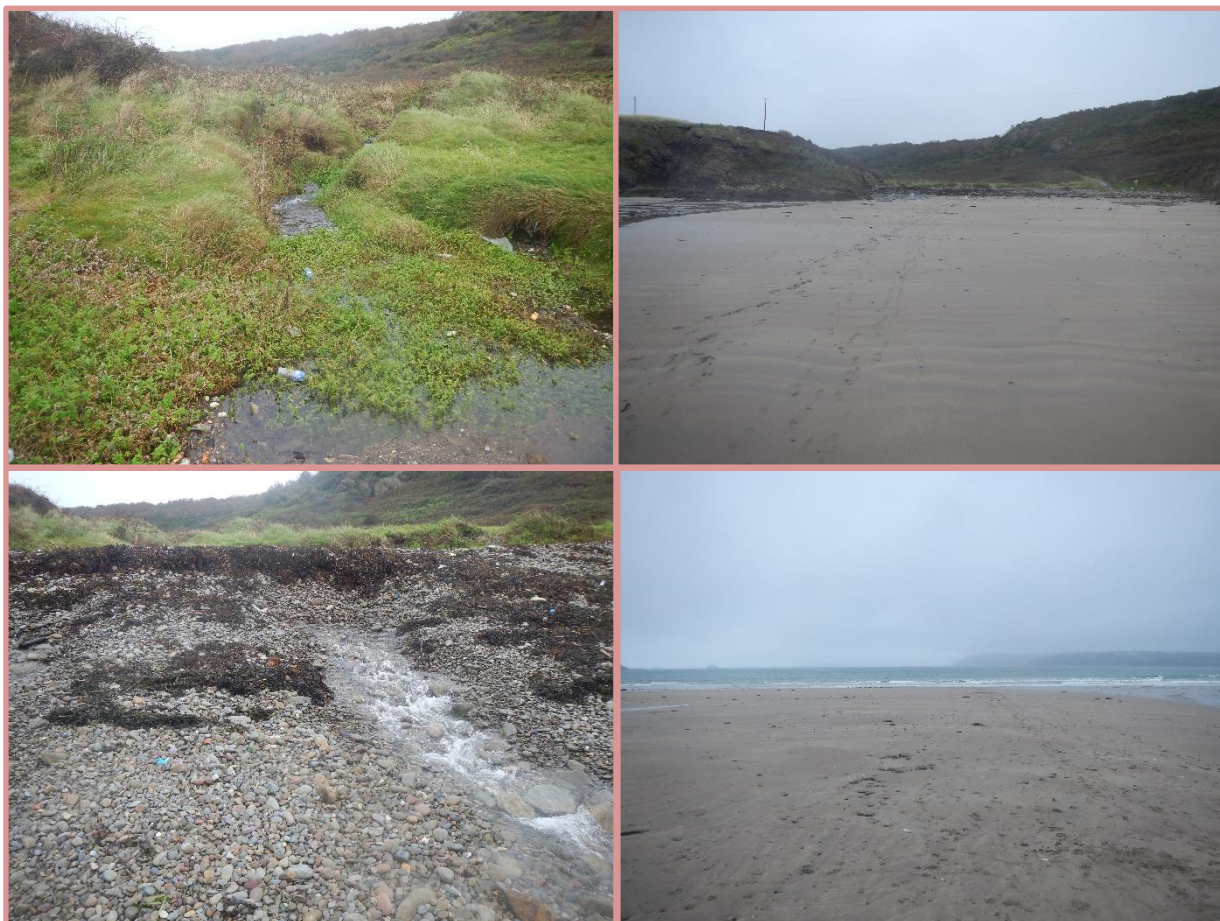
Plate 3-1 Images along the proposed route of the outfall pipe, White Bay.

Apart from the relatively gently sloping sand beach composed of clean medium sand, there were no other features along the proposed pipe route of note.

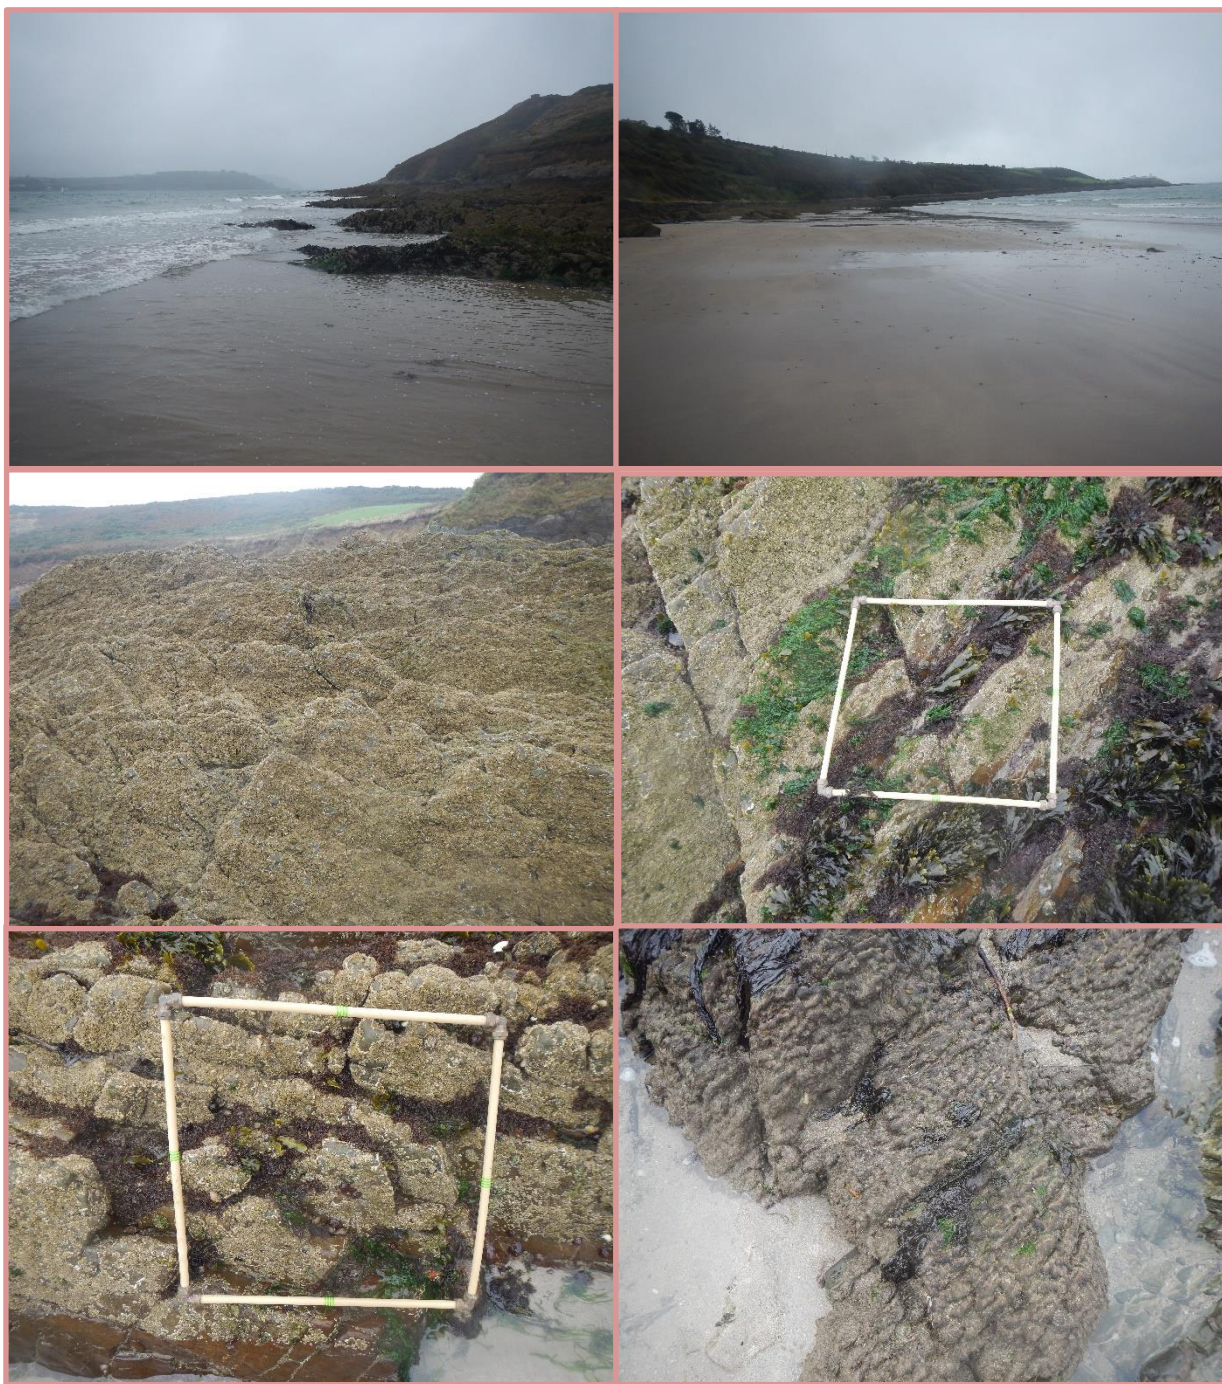
Jagged rock outcrops, extensions of the surrounding sedimentary rock cliffs, were located to the north and south of the beach (see Figure 2-1 and Plate 3-2) The rock surface was covered with barnacles, with some weed cover attached, predominantly at their base and in sheltered crevices at their base (Plate 3-2). In general, the weed was typical of rocky substrata influenced by sand scour with the inclusion of species such as *Rhodothamniella floridula*, *Ulva* sp., and brown weed such as *Fucus serratus* and *F. ceranoides*. In addition to barnacles, the main faunal species observed on the rock were Patellid limpets, Beadlet anemones (*Actinia equina*) and dog whelks, *Nucella lapillus*.

Plate 3-2 Rock outcrops, White Bay, 1st September 2020.

(the quadrat in the images is 25cm x 25cm)

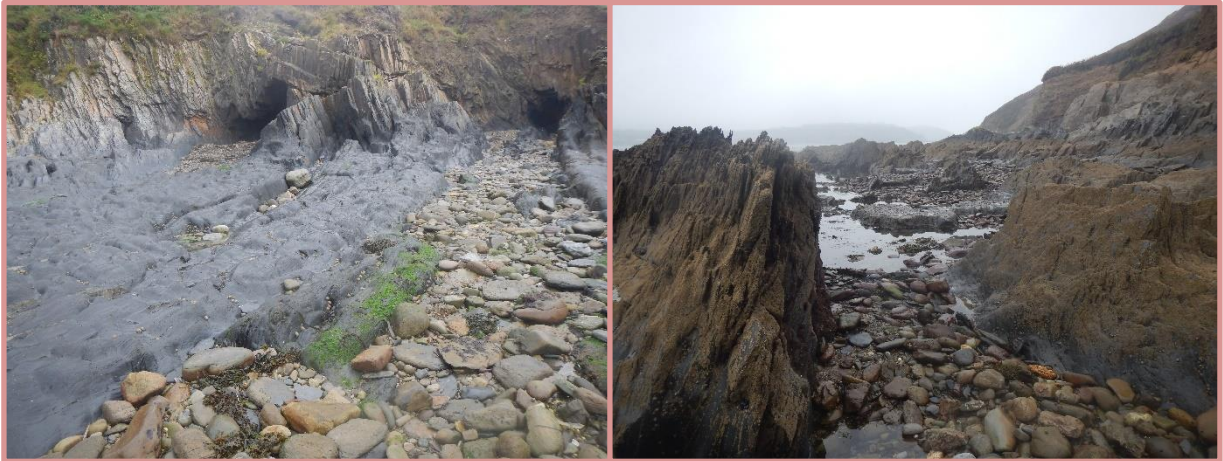
Plate 3-4 Rock and mobile cobble shore, Whiter Bay, 1st September 2020

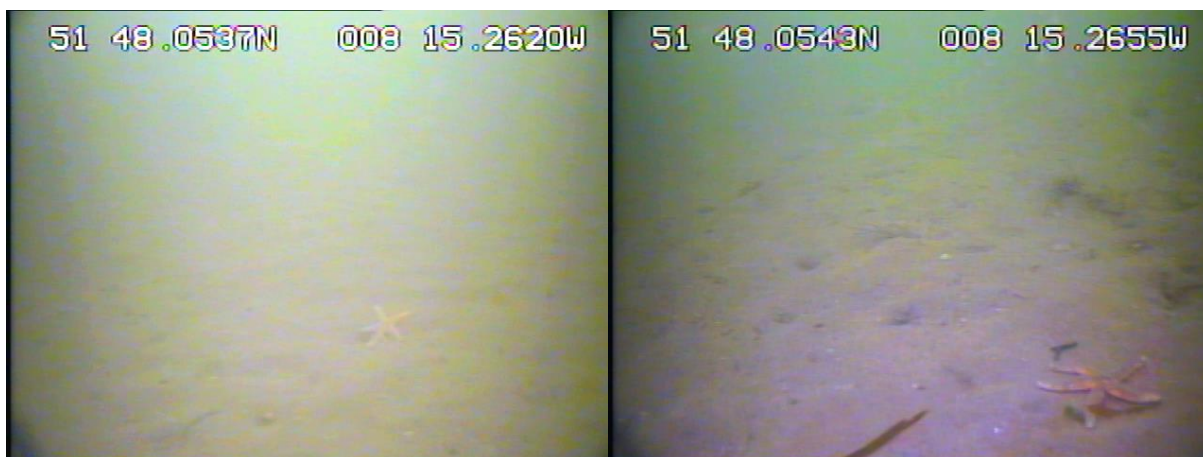
The seafloor along Transect 3 consisted of clean medium sand formed into small waves with shell and drift algae scattered over its surface. Starfish, *A. rubens*, were imaged foraging on the bottom.

Plate 3-7 Transect 3, White Bay, 1st September 2020

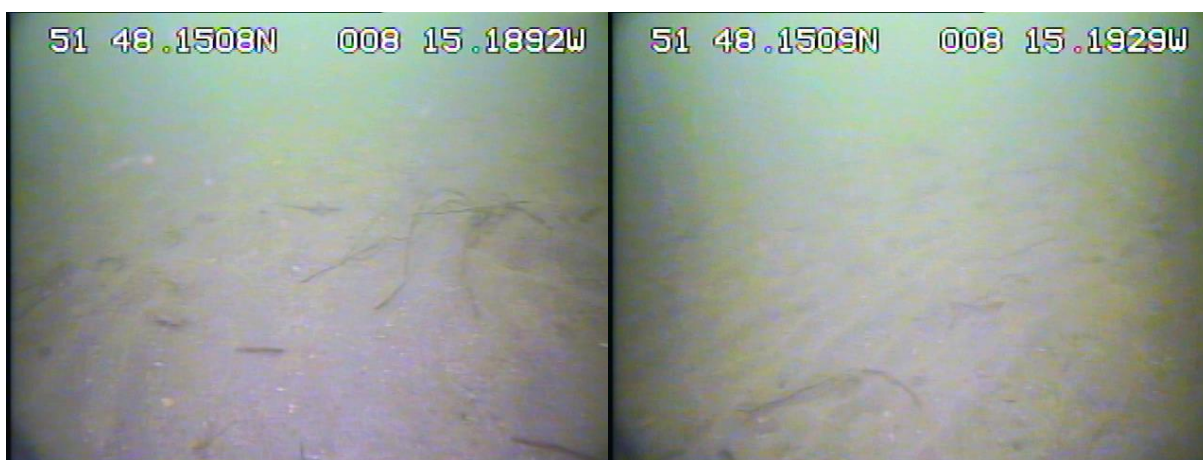
Plate 3-8 Transect 4, White Bay, 1st September 2020

The seabed along Transect 4 consisted of clean medium sand formed into small waves. Sparse individual clumps of seagrass, *Zostera marina*, were recorded growing in the sand.

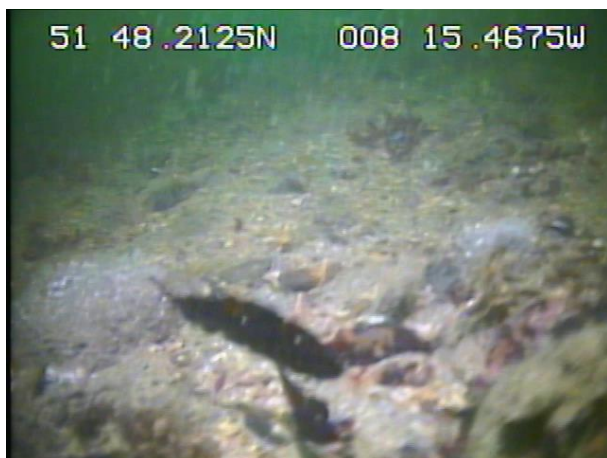
Plate 3-11 Transect 7, White Bay, 1st September 2020

The seafloor along Transect 7 consisted of coarse sand, cobble, and boulder. Numerous starfish (*A. rubens* and *Marthasterias glacialis*) were imaged along with hydroid tufts and red algae attached to the rock surface.

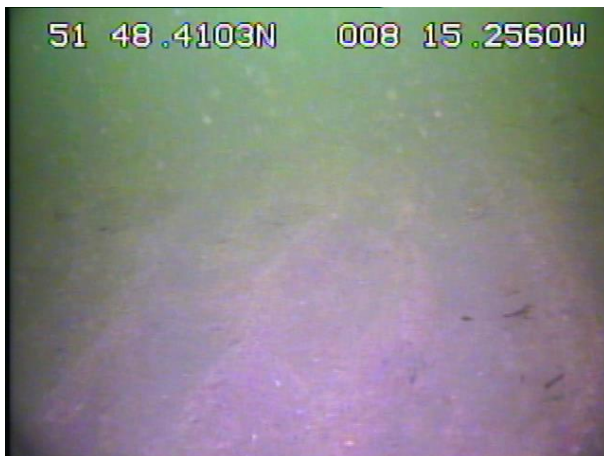
Plate 3-14 Transect 10, White Bay, 1st September 2020

The seabed along Transect 10 consisted of clean medium sand formed into small waves.

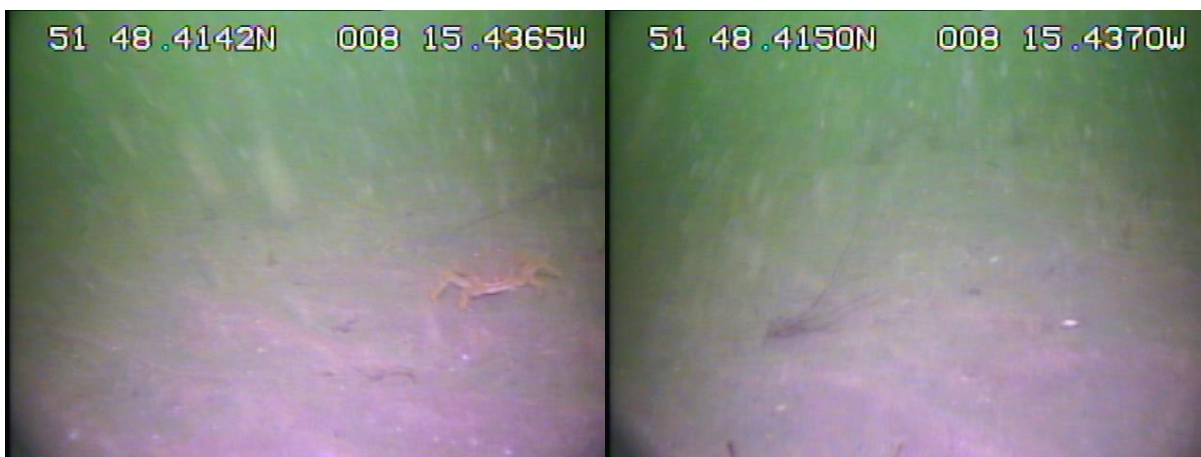
Plate 3-16 Transect 12, White Bay, 1st September 2020

The seafloor along Transect 12 consisted of clean medium sand formed into small waves. A Swimming crab, *Liocarcinus depurator*, was imaged on the sand.

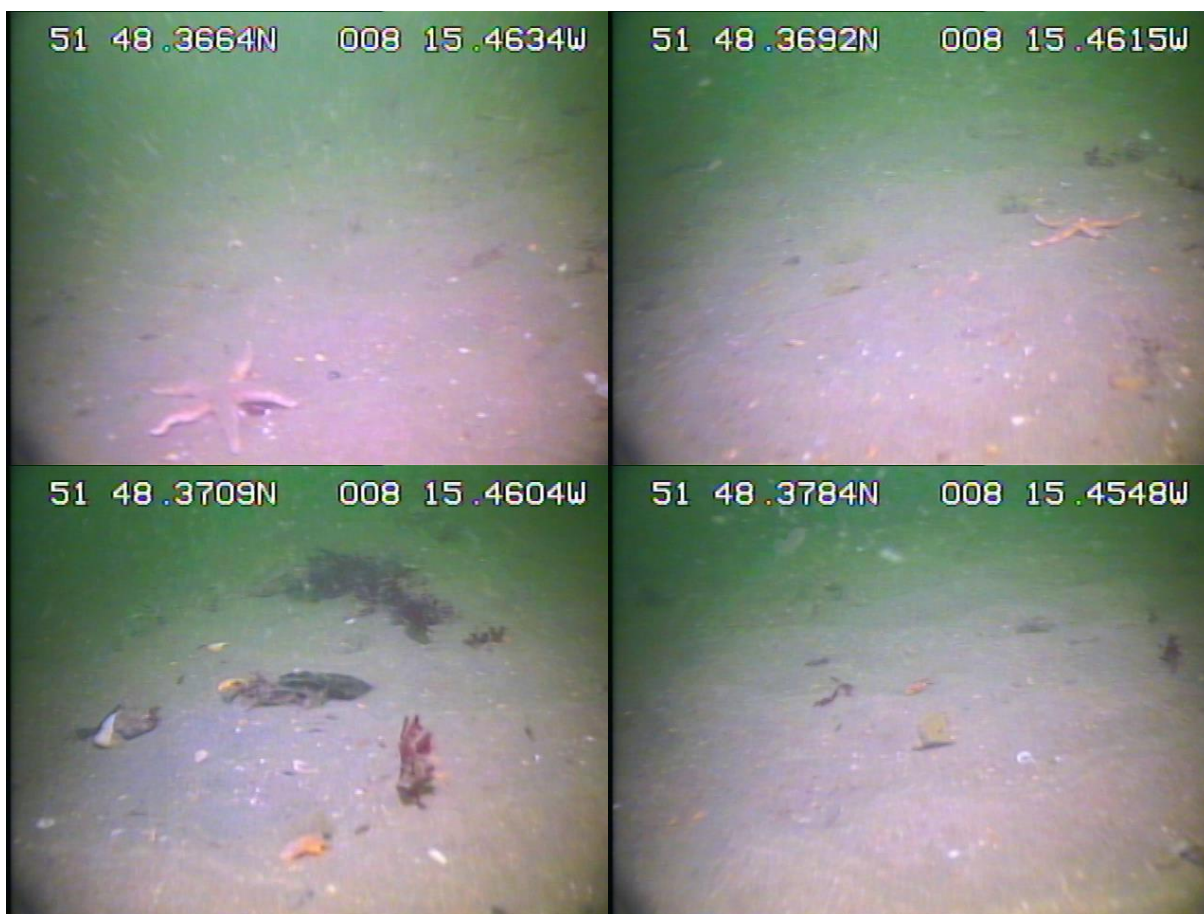
Plate 3-17 Transect 13, White Bay, 1st September 2020

The seafloor along Transect 13 consisted of clean medium sand formed into small waves with a scattering of broken shell and drift algae on its surface. Several starfish, *A. rubens* were imaged.

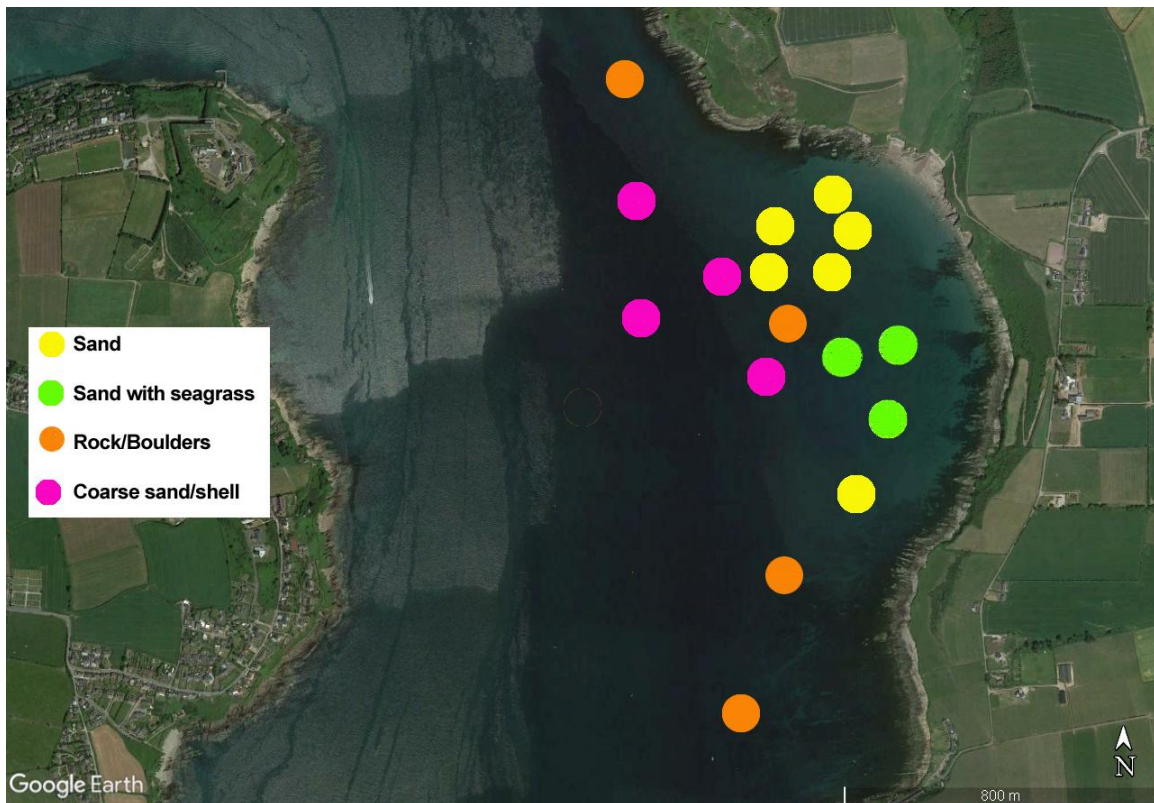
A number of habitats were recorded during the drop-down video survey of the sublittoral area in the vicinity of the outfall location and greater White Bay area (Figure 4-1). The seafloor at the proposed location of the outfall consisted of medium to fine sand sea formed into small waves by the action of the tidal currents. This is a continuation of the sand shore intertidal and it is likely the habitat can be described as Infralittoral mobile clean sand with sparse fauna- SS.SSa.IFiSa.IMoSa (JNCC 2015, EUNIS A5.231). Typically, this has medium to fine sandy sediment in shallow water, often formed into dunes, on exposed or tide-swept coasts that often contain very little infauna due to the mobility of the substratum. Some opportunistic populations of infaunal amphipods may occur, particularly in less mobile examples in conjunction with low numbers of mysids such as *Gastrosaccus spinifer*, the polychaete *Nephtys cirrosa* and the isopod *Eurydice pulchra*. Sand eels *Ammodytes* sp. may occasionally be observed in association with this biotope (and others). Common epifaunal species such as *Pagurus bernhardus*, *Carcinus maenas*, *Asterias rubens* and *Liocarcinus depurator* may be encountered and are the most conspicuous species present (JNCC, 2015).

Outside the sand habitat, the seafloor was predominantly composed of boulder, cobble and coarse sand. There were two main biotopes recorded from here and mainly differentiated by the percentage cover of rock and boulders. The rockier biotope can be described as CR.MCR.EcCr.AdigVt – *Alcyonium digitatum* and faunal crust communities on vertical circalittoral bedrock (JNCC 2015, EUNIS A4.215).

The other biotope recorded was Sublittoral coarse sediment (SS.SCS, JNCC 2015), that is difficult to determine without a description of the faunal component that requires a grab sampling effort. There was a strong tidal current along these stations at the time of recording.

Figure 4-1 Habitat distribution, White Bay, 1st September 2020.
