- 5.1 This Environmental Impact Statement (EIS) evaluates the regional and local geological conditions, and assesses the impact that quarrying will have on the geology of the area and any other geological aspects of the further development of the quarry. It is based on detailed examination of the existing quarry and its surroundings and was prepared by EurGeol Dr. John Kelly PGeo, MIMMM, MIQ in accordance with the guidelines on Geology in Environmental Impact Statements issued by the Institute of Geologists of Ireland.

**ROADSTONE WOOD LTD.  
ENVIRONMENTAL IMPACT STATEMENT**

**HUNTSTOWN QUARRY,  
NORTH ROAD, FINGLAS, DUBLIN 11**

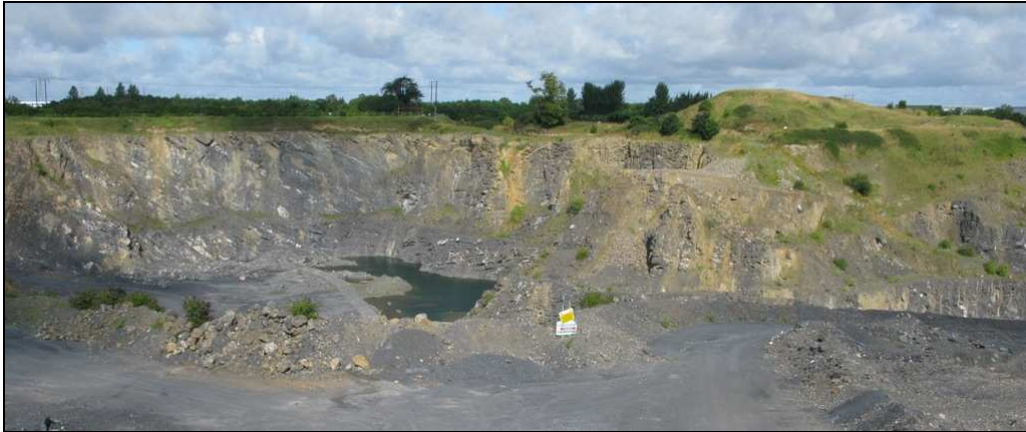
Plate 5-1. Typical limestones exposed in the western face of the North Quarry. Note steep dip to northwest and well-bedded nature of the limestones.

- 5.13 The North Quarry is developed in a sequence of well-bedded limestones and academic research on the fossil fauna of the sequence exposed indicates that this quarry is also developed within sub-Waulsortian limestones of the Malahide Formation. The sequence becomes shale dominated to the northwest as seen in borehole GW04 and in the upper part of the faces in the extreme northwest corner of the quarry.

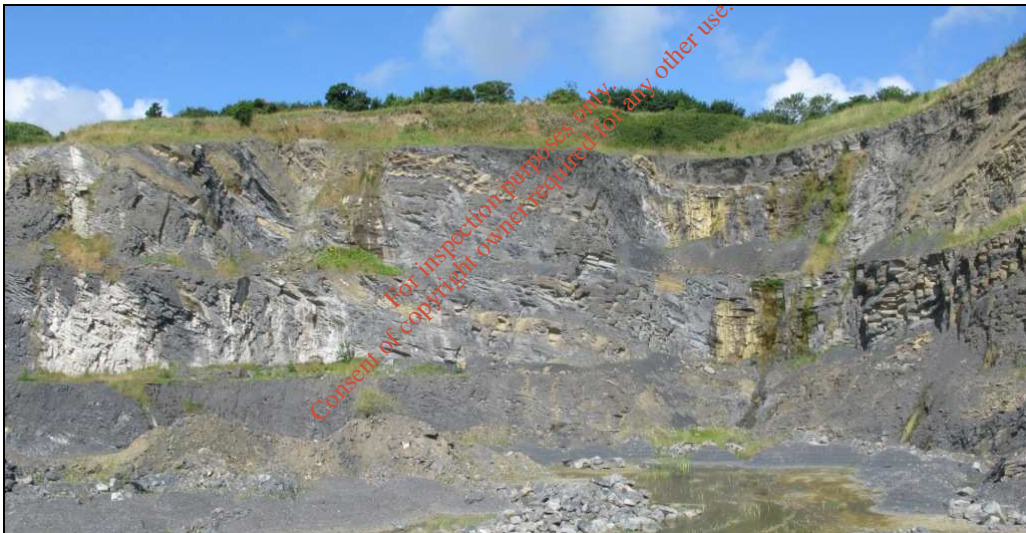
Plate 5-2. Northwestern area of North Quarry immediately northeast of borehole GW04. Note shales dominating sequence in upper part of quarry face.

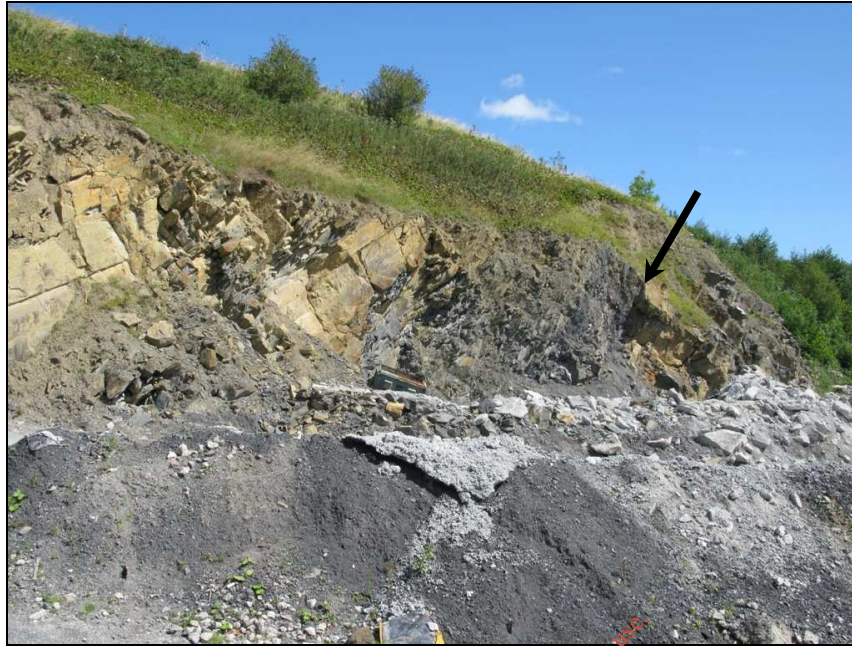
Plate 5-3. Huntstown Central Quarry. Exposure of the contact between the Waulsortian limestones of the Feltrim Limestone Formation to right and Tober Colleen Formation to left. Contact marked by arrow.

- 5.12 The Central Quarry is not currently being worked and is used as a construction and demolition recycling facility. The quarry is developed in pale micritic Waulsortian limestones of the Feltrim Limestone Formation. The contact between the Waulsortian limestones and the overlying Tober Colleen Formation is exposed in the sides of the roadway accessing the Central Quarry from the north

- 5.20 Consultations have been made with the Geological Survey of Ireland in relation to the geological heritage aspects at Huntstown. The contact between the Waulsortian Limestones of the Feltrim Limestone Formation and the Tober Colleen Formation, exposed in the roadway into the Central Quarry, has been listed as part of Irish Geological Heritage Programme 8.
- 5.21 The IGH Programme staff have visited the relevant parts of Huntstown Quarry and their comments are presented in Appendix 5-A. Roadstone Wood Ltd. will ensure that the relevant geological section and rock exposure will be maintained.

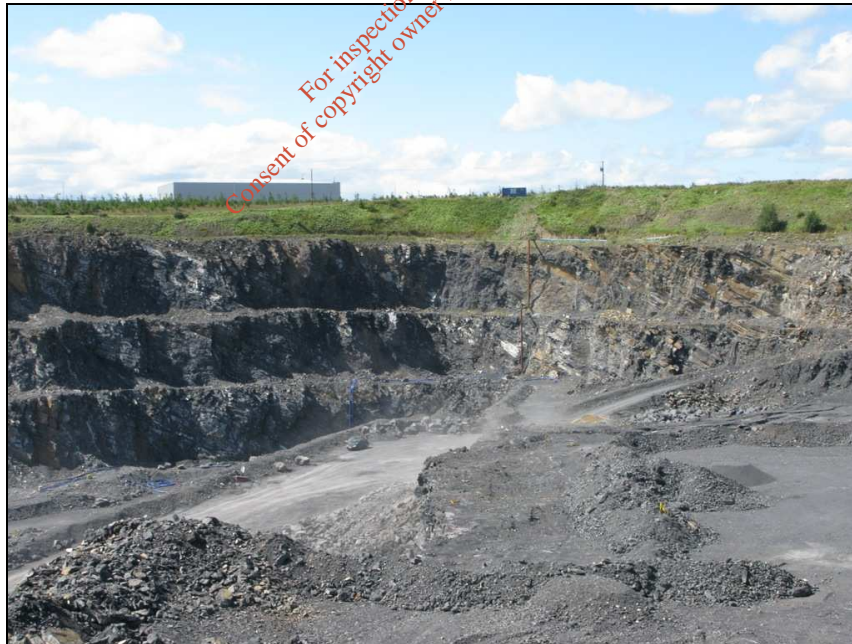
Plate 5-4. Typical limestone sequence exposed in southwestern part of the South Quarry

- 5.11 The South Quarry is developed within limestones of the Malahide Formation which dip steeply to the north in the eastern part of the quarry and to the northwest in the western part of the quarry. The limestones are dominated by well-bedded limestones with minor shales. Banded, interbedded limestones and shales are exposed in the northwestern corner of this extraction area.
