SURFACE WATER AND GROUNDWATER 6

- 6.1 This Environmental Impact Statement (EIS) is prepared to accompany a planning application for the continuance of use of the existing quarry at Huntstown, County Dublin submitted to Fingal County Council by Roadstone Wood Ltd. This EIS has been prepared by SLR Consulting Ireland for Roadstone Wood Ltd.
- 6.2 The site is a large operational limestone rock quarry situated in north county Dublin. The quarry is operated by Roadstone Wood Ltd. (hereafter referred to as RWL).
- 6.3 The planning application area of the quarry is approximately 167.5 hectares, and there have been four discrete areas of excavation at the site, with a total extraction area of 55.9 hectares. The remaining area within the landholding is used for value-added activities (e.g. concrete batching, tar plant, etc.), a power station, and agricultural land.

ROADSTONE WOOD LTD.
HUNTSTOWN QUARRY,
NORTH ROAD, FINGLAS, DUBLIN 11
**GROUNDWATER MONITORING
LOCATIONS AND GROUNDWATER
LEVEL CONTOURS**

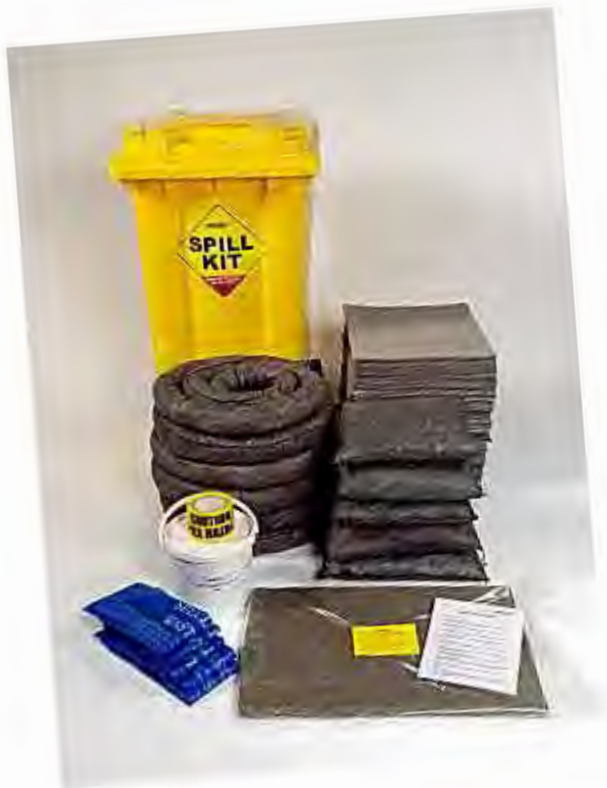
250 Litre Spill Kit

- 1 250 Litre Wheeled Bin
- 4 Socks (3m x 8cm)
- 20 Cushions
- 140 Pads (Double Weight)
- 1 Plug Rug (61cm X 40cm)
- 1 5Kg Plugging Granules
- 1 Caution Tape
- 4 Disposal Bags and Tie
- 1 Instruction Sheet
