Figure 6-1 Regional Soils Map
Figure 6-2 Regional Subsoils Map
Figure 6-3 Regional Geology Map
Figure 6-4 Detailed Geology Map
Figure 6-5 Geoheritage Map

INTRODUCTION

- 6.1 This Chapter of the Environmental Impact Assessment (EIA) Report addresses the potential impacts on land, soils and geology of the soil and stone waste recovery activities on the western side of Huntstown South Quarry. These activities will facilitate backfilling of the quarry to surrounding ground level and its ultimate long-term restoration to grassland.

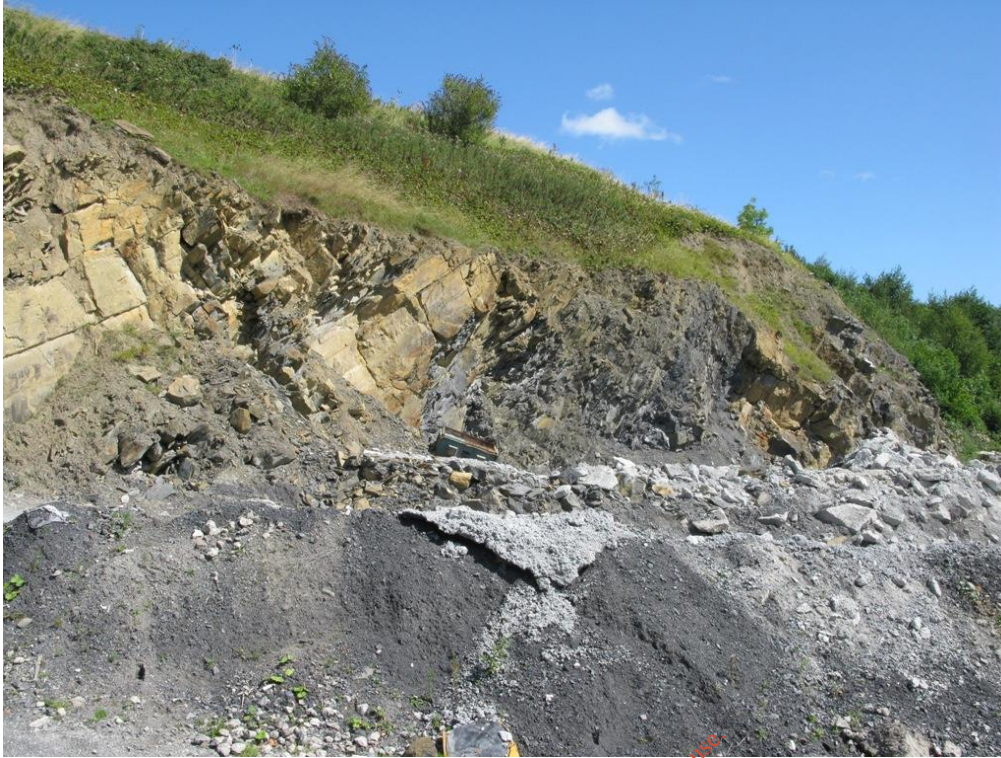
Waulsortian – Tober Colleen contact east side of central quarry access road, Huntstown Quarry, Dublin. (Photo: J.Kelly)

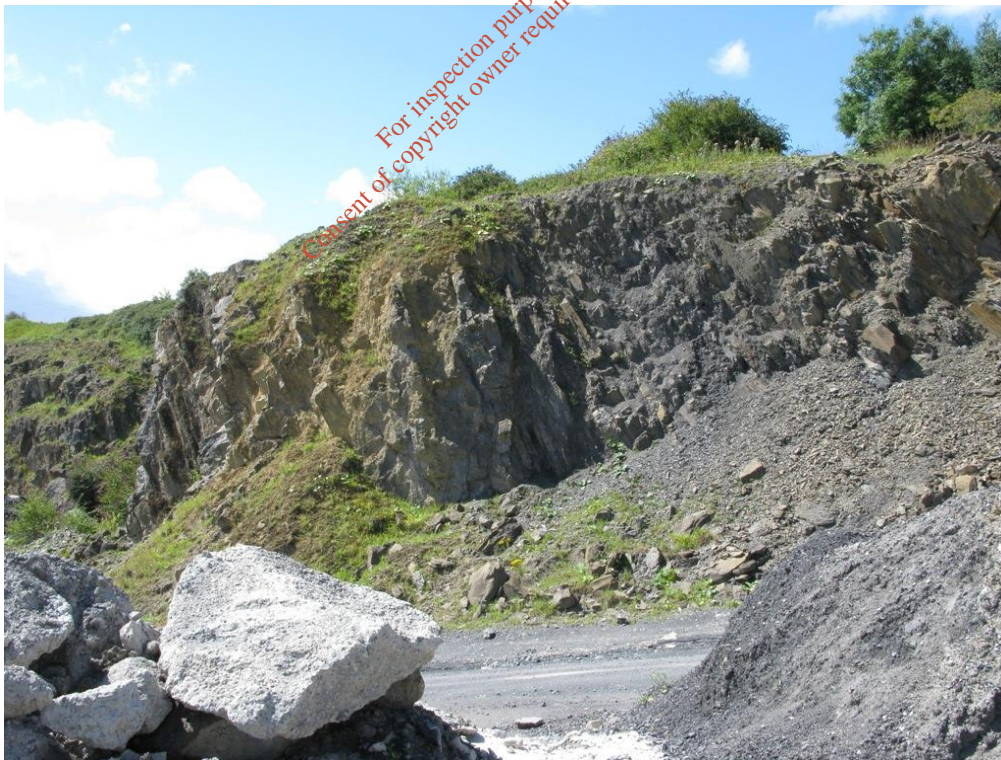
Waulsortian – Tober Colleen contact west side of central quarry access road, Huntstown Quarry, Dublin. (Photo: J.Kelly)
