ATTACHMENT-4-8-3 COMPLETE BASELINE REPORT

Technical Report Prepared For
Amazon Data Services Ireland Limited

CMK/21/1056WR01

23 February 2022

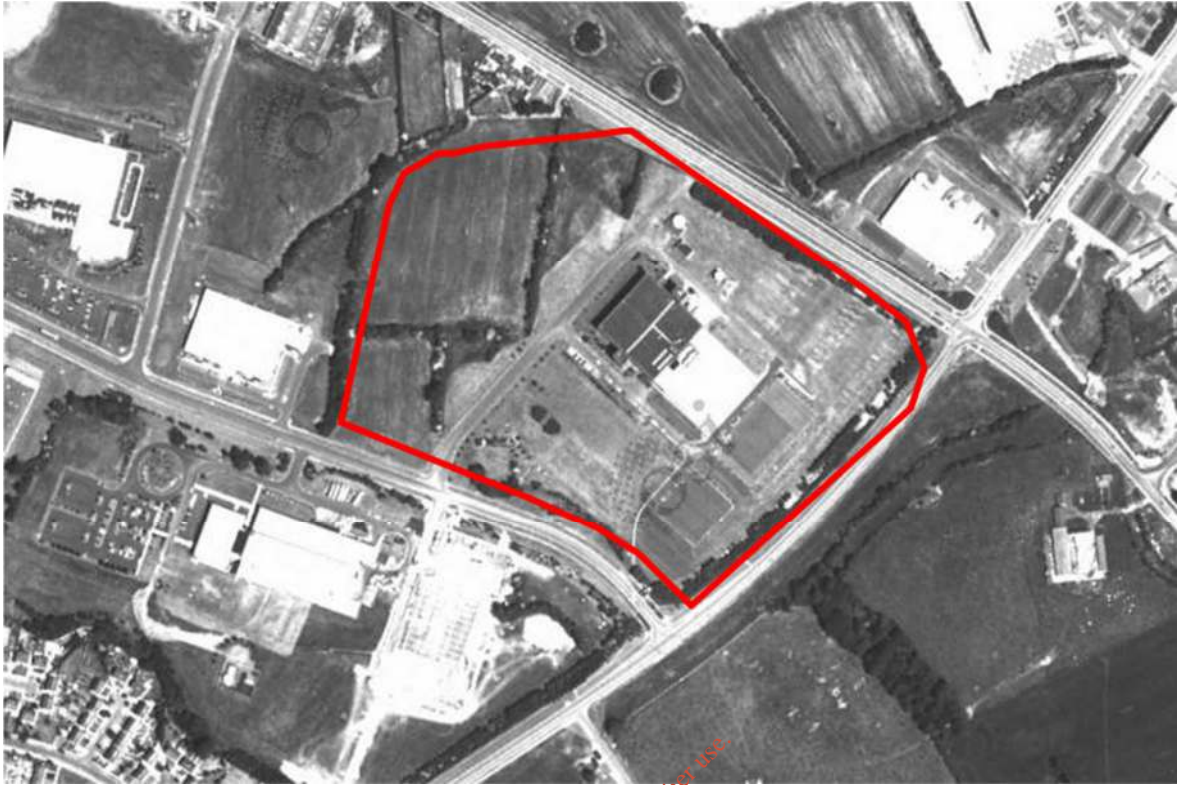
Insert 6.3 Aerial Image (1995) (source www.osi.ie) (Indicative site boundary shown in red)

The most notable changes occur on the 1995 aerial imagery (Insert 6.3) with the construction of the Snugborough Road and the expansion of the Ballycoolin Road to the east and north of the site. Industrial premises are present both on the site and the sites to the north, northeast, east and south. Residential estates are now present to the southwest of the site. The building located on the site is the hexagon building. Most of the current site remains greenfield.

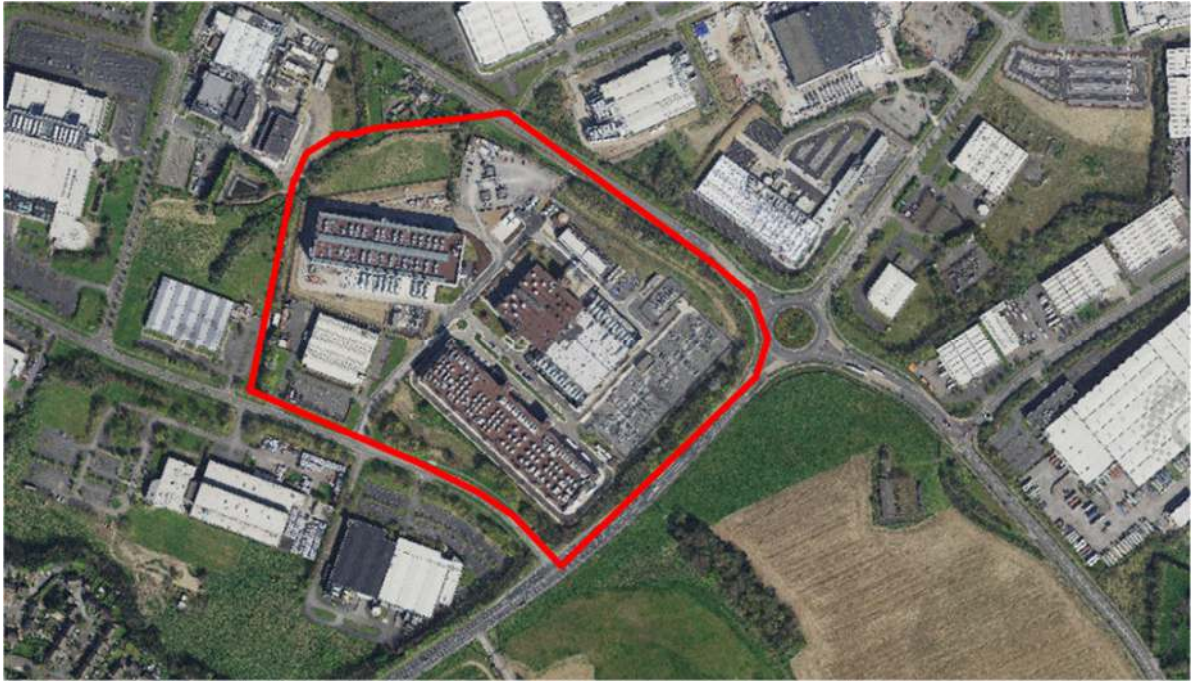
Insert 6.3 OSi Aerial Map (2012-2018) (source www.osi.ie) (Indicative site boundary shown in red)

The imagery dated 2012-2018 (Insert 6.6) shows the further expansion of the site with the addition of the buildings to the southeast and northwest of the site and the expansion of a hardstanding areas to the north and east of the site.

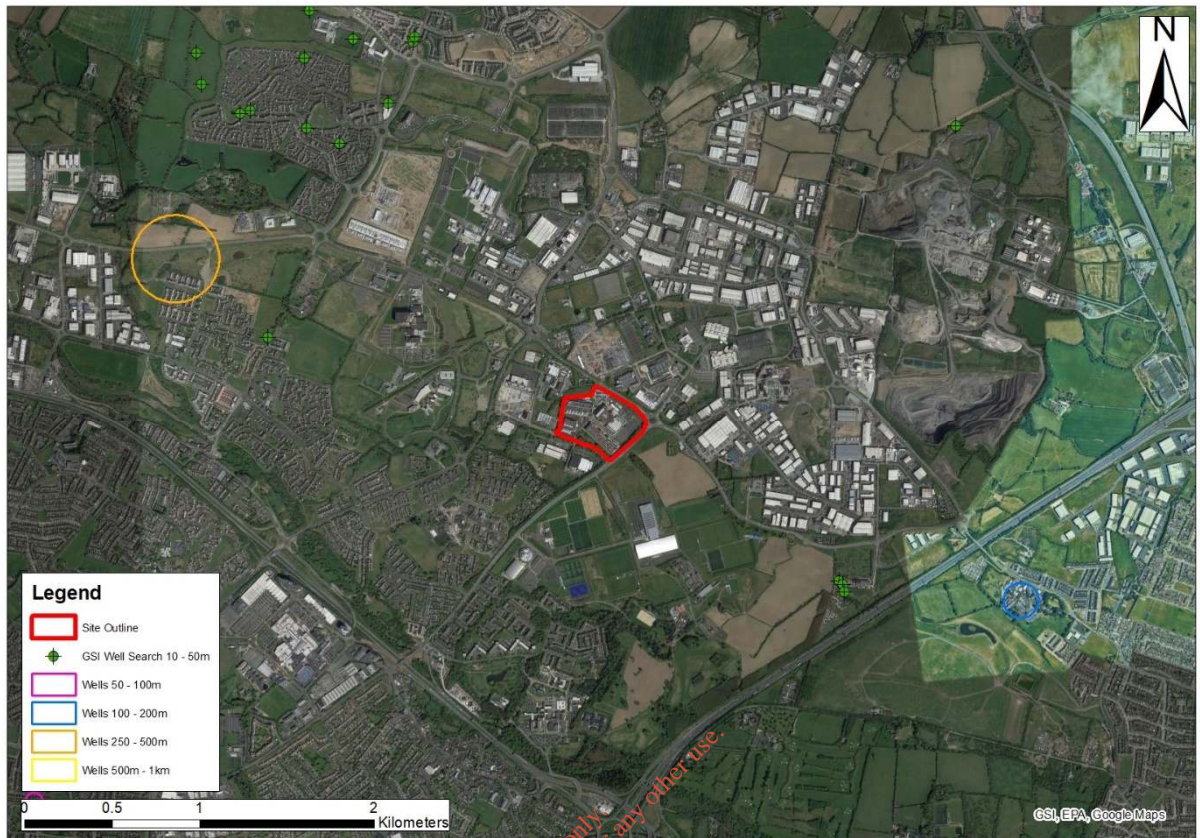
Insert 7.4 GSI Well Search (GSI, 2020)

Insert 7.4 below presents the GSI well search for the area surrounding the site (Note this source does not include all wells) and Table 7.1 below summarises the details of some of the wells present within this search area.

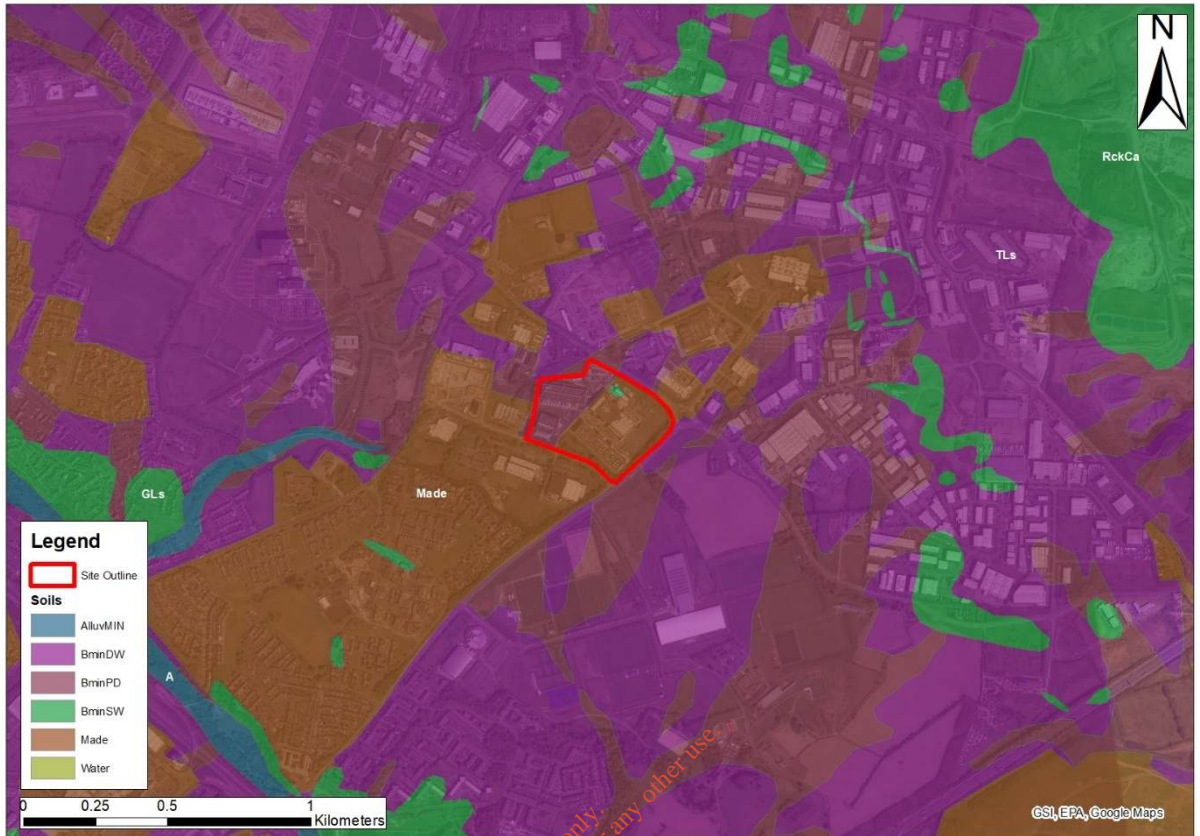
Insert 7.6 Soils map (boundary indicated in red) (Source: www.gsi.ie)

The GSI geological web viewer shows the site primarily underlain by till derived from limestone with local area (0.1 km²) of gravels derived from limestone within the northern part of the site. There is a bedrock outcrop or subcrop in the southwestern part of the site.

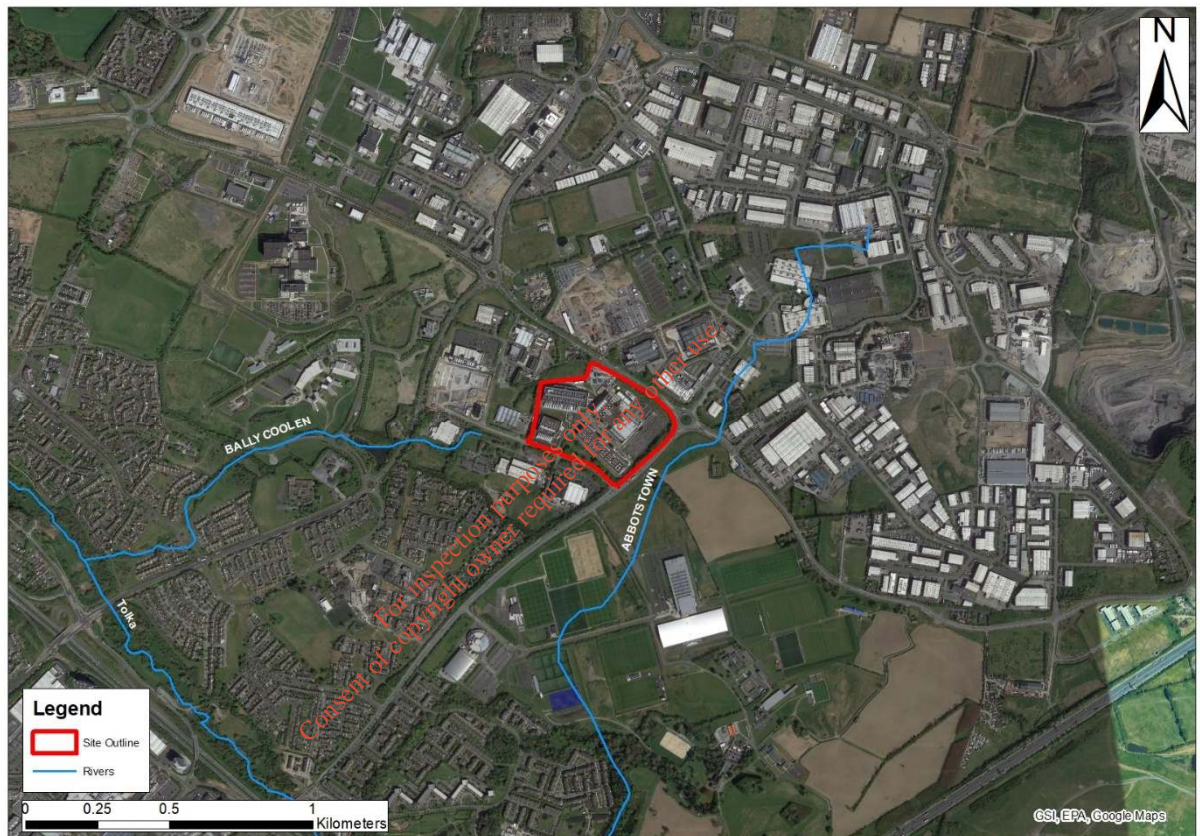
Insert 7.8 Hydrological Environment (Source: [EPA Maps](#))

The site is drained by the Ballycoolen River approximately 150 meters to the southwest of the site and the Abbotstown River approximately 60 meters to the east of the site. The Ballycoolen river flows southwest, the Abbotstown River flows to the southeast, both rivers drain into the River Tolka at Mulhuddart and Abbotstown respectively. The River Tolka lies 1.7km south of the site and discharges to Dublin Bay.

Storm water drainage from the site currently discharges to the attenuation ponds on site prior to discharge to the existing storm water system along the Business Estate Road via Class 1 hydrocarbon interceptors and flow control devices. This eventually discharges into the Ballycoolen stream to the west of the site.

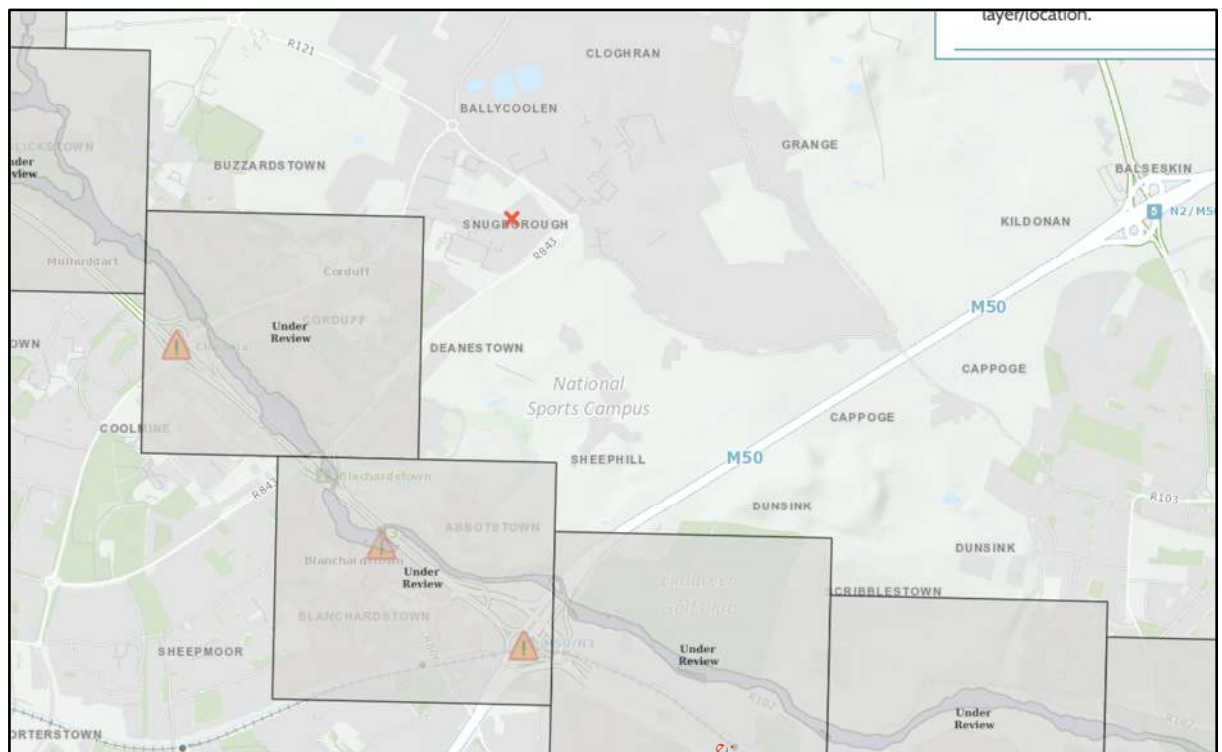
Insert 7.11 OPW Historical Flood Map (source: www.floodmaps.ie)

There are no historic flood events recorded for the proposed development site and the surrounding area. The nearest flood event occurred 1.85km south west of the development site along the N3 at Blanchardstown. The flooding occurred along the Tolka River in April 2002.

It is concluded that the site is located in an area which is not liable to flooding and will not in and of itself result in any additional flood risk.

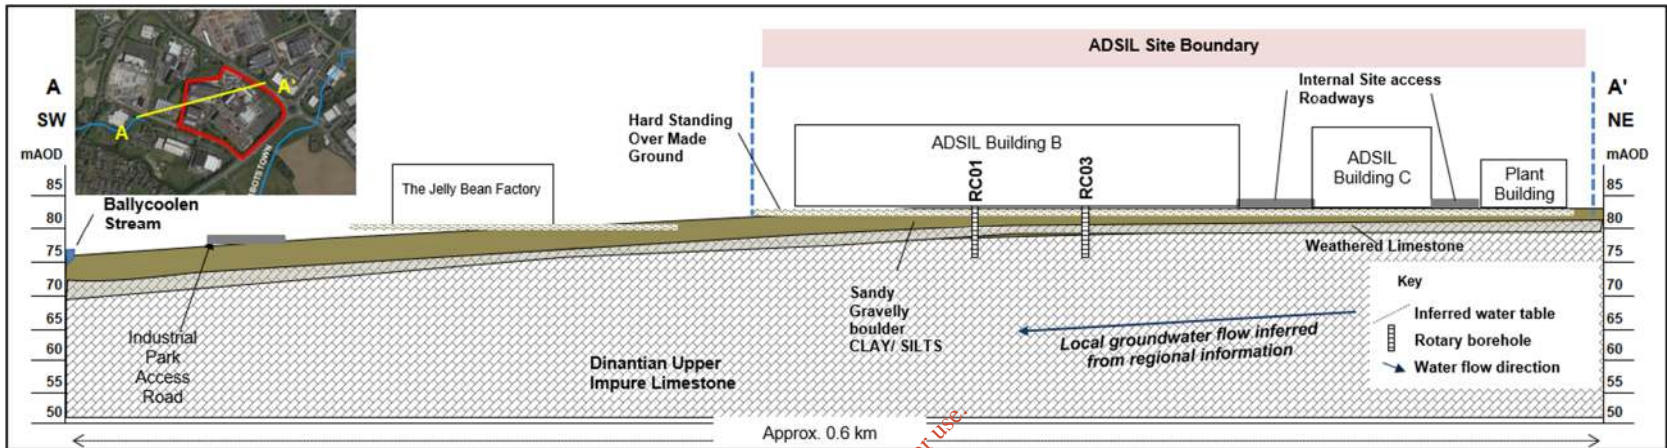
- Groundwater flows are expected to be in a south direction towards the River Tolka and regionally in a south easterly direction towards Dublin Bay.
- Based on the Institute of Geologists of Ireland (IGI) the criteria for rating the importance of hydrogeological features, the importance of the hydrogeological features at this site is rated as **Low Importance**. This is based on the assessment that the attribute has a low quality significance or value on a local scale. The aquifer is a *poor* bedrock aquifer, unproductive expect in local zones and it is unlikely to be used for public water supply or widely used for potable use.

Insert 8.1 A-A' Schematic local cross section showing the ADSIL site

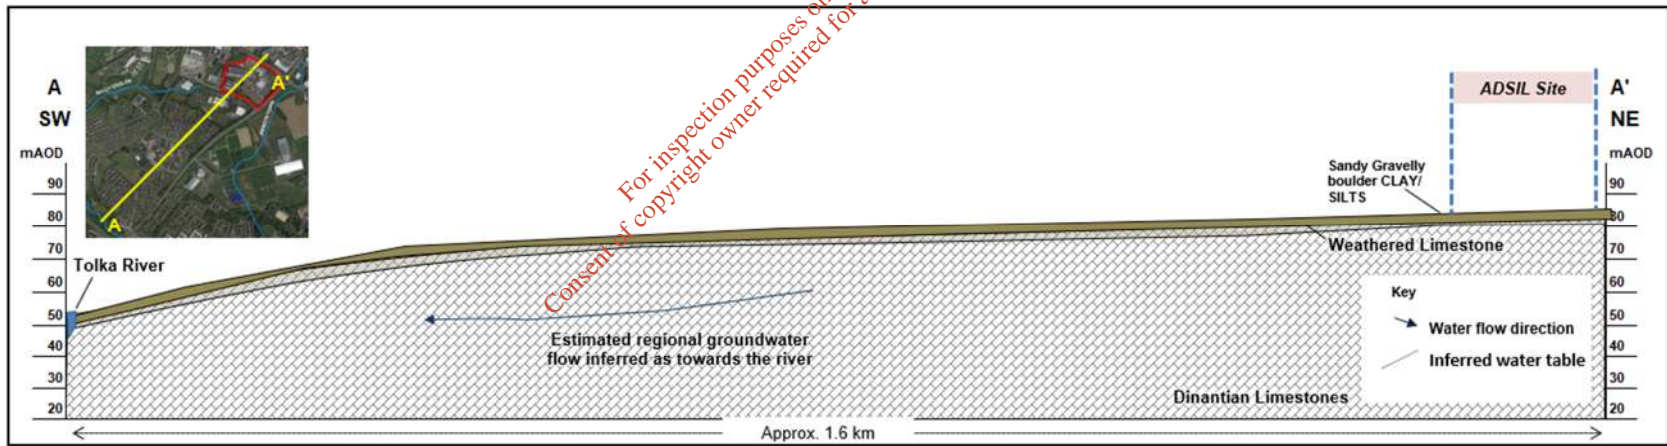
Insert 8.2 A-A' Schematic regional cross section showing the ADSIL site
