An Daingean Small Craft Harbour
Supporting Information for Screening for Appropriate
Assessment and Natura Impact Statement
Volume 2 – Appendices

Produced by
AQUAFAC International Services Ltd

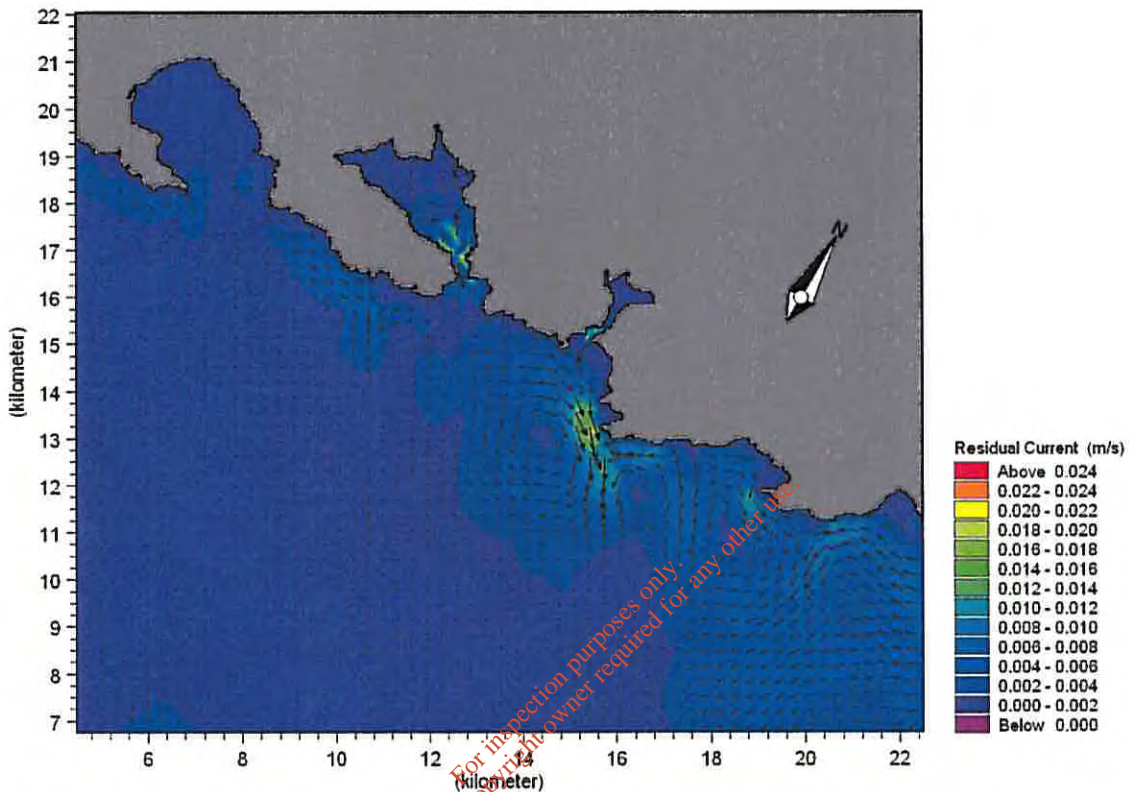
Figure 3.5 Lunar month residual tidal flow around An Daingean

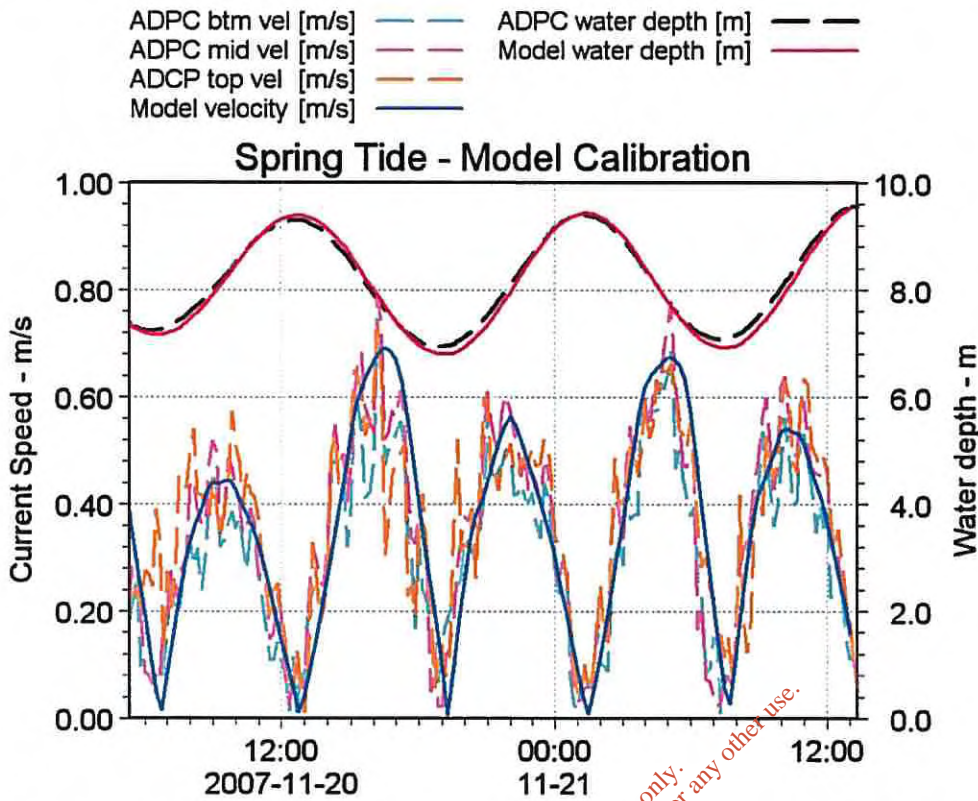
Figure 3.6 Spring tide model and ADCP data at entrance to An Daingean Harbour

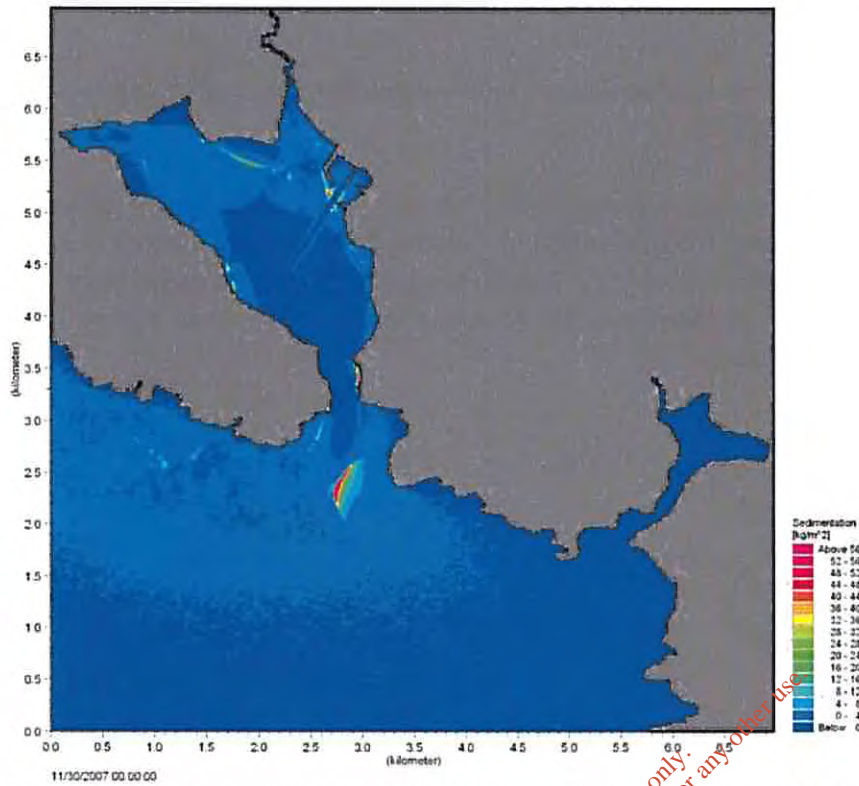
Figure 3.17 Deposition of sediment at end of dredging operations (Calm conditions)

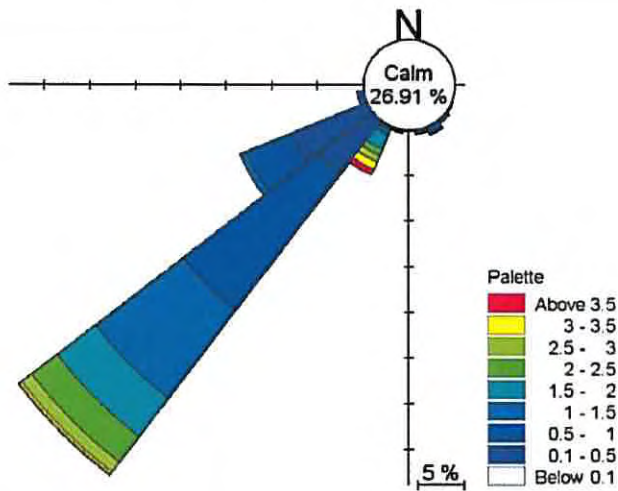
Figure 3.21 Inshore annual wave rose at centre of proposed disposal site

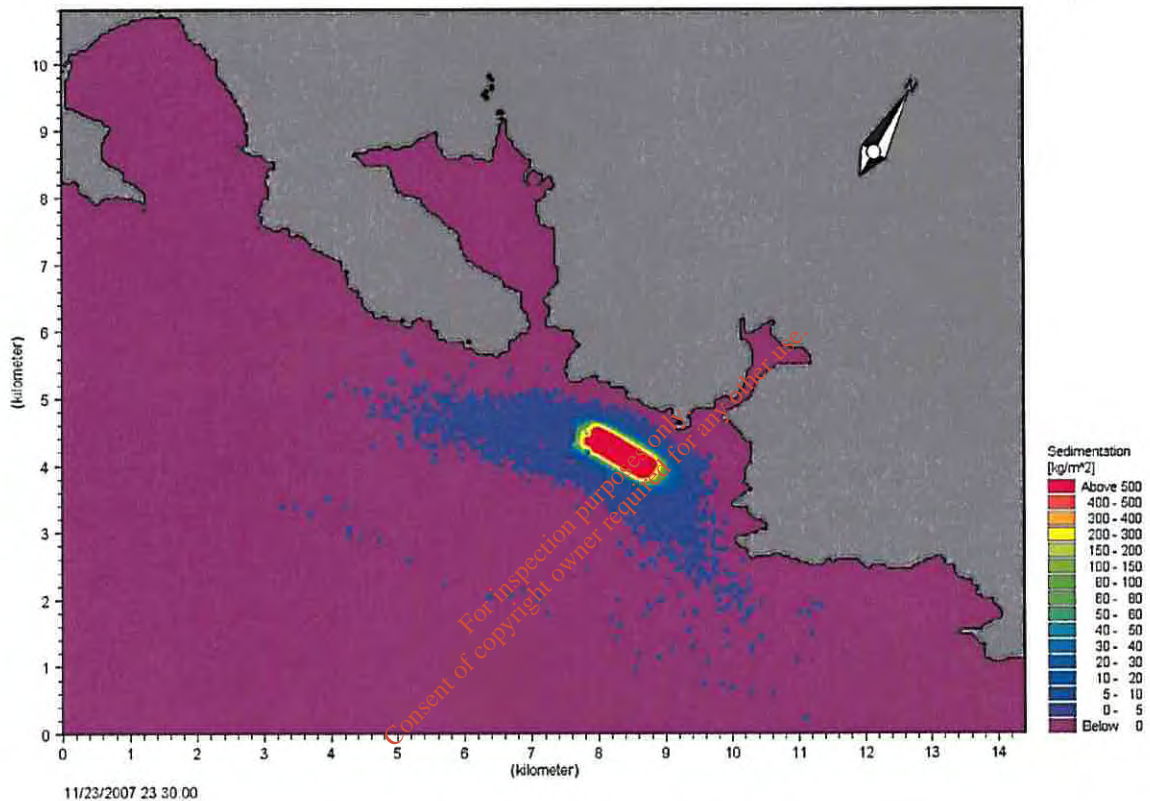
Figure 3.23 Deposition depths at completion of the dumping of the dredged spoil with calm conditions during the 6 month dumping period

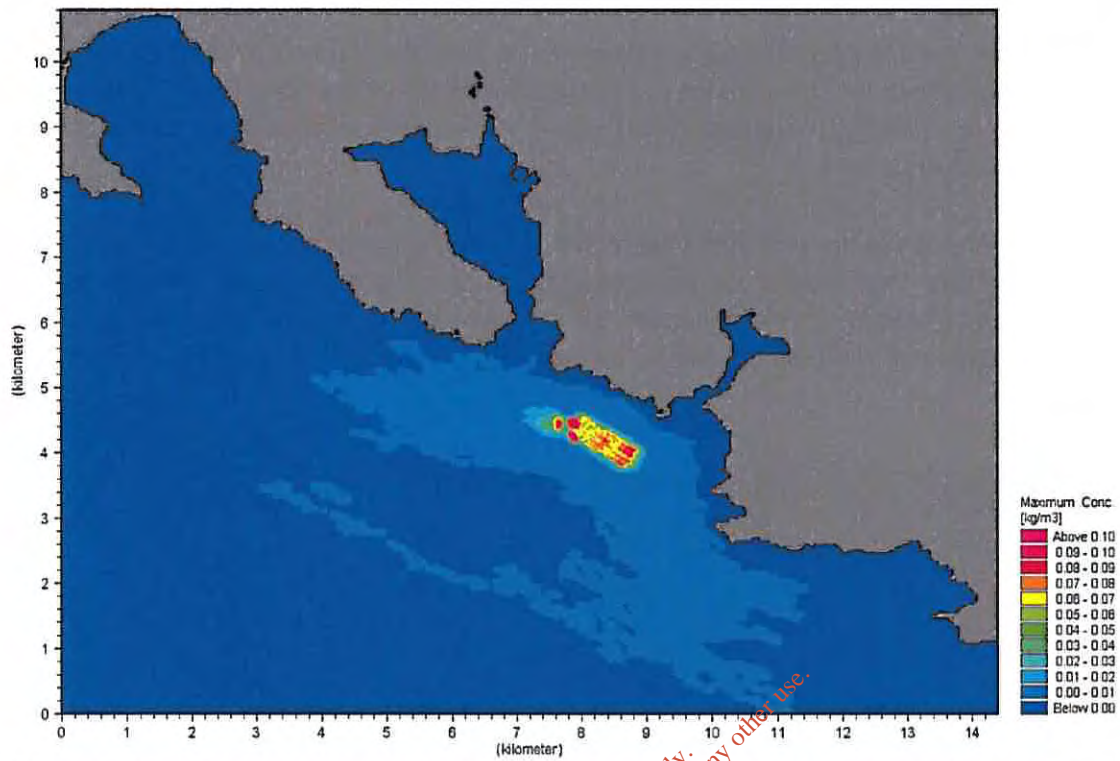
Figure 3.24 Maximum suspended sediment concentration in water column during the 6 month dumping operations

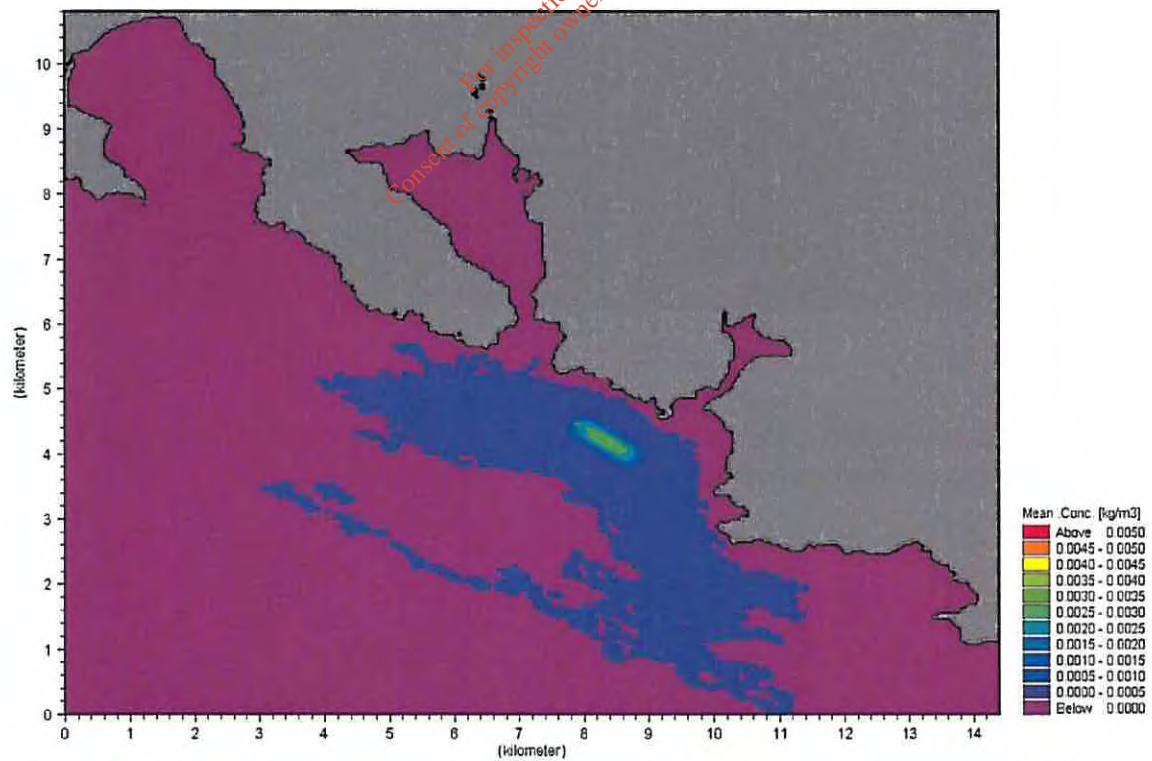
Figure 3.25 Average suspended sediment concentration in water column during the 6 month dumping operations

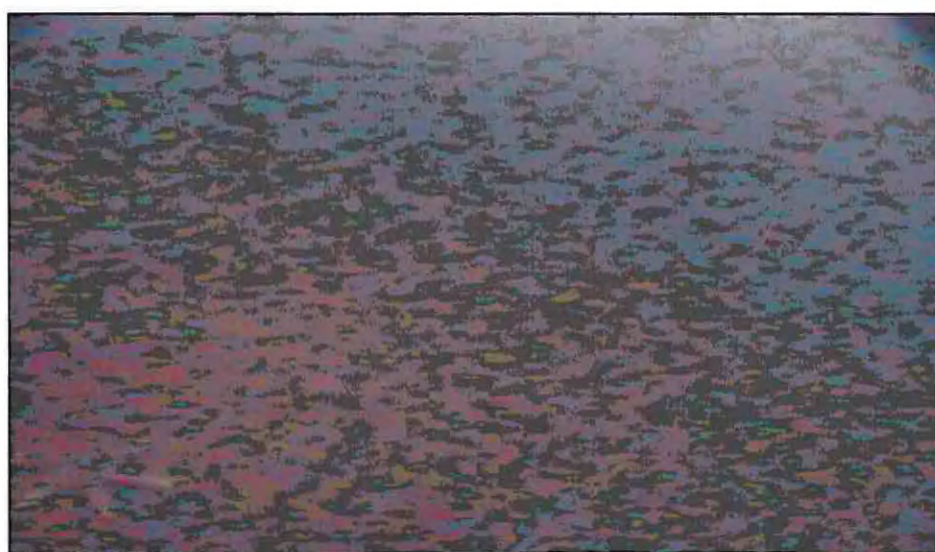
Figure 38 Sandy ground with common starfish (*Asterias rubens*) present in lower left corner of image along Dive 32.
