<b>OFFICE OF ENVIRONMENTAL SUSTAINABILITY</b>
<b>INSPECTOR'S REPORT ON AN APPLICATION FOR A CERTIFICATE OF AUTHORISATION FOR A CLOSED LANDFILL</b>	
<b>TO:</b>	Eimear Cotter, Director
<b>FROM:</b>	Ewa Babiarczyk, Inspector. Environmental Licensing Programme
<b>DATE:</b>	7 <sup>th</sup> June 2022
<b>RE:</b>	Application by <b>Clare County Council</b> for a Certificate of Authorisation for a closed landfill at <b>Dysert, Kilrush, County Clare</b> . Certificate of Authorisation Register Number <b>H0030-01</b> .

## 1. Application details

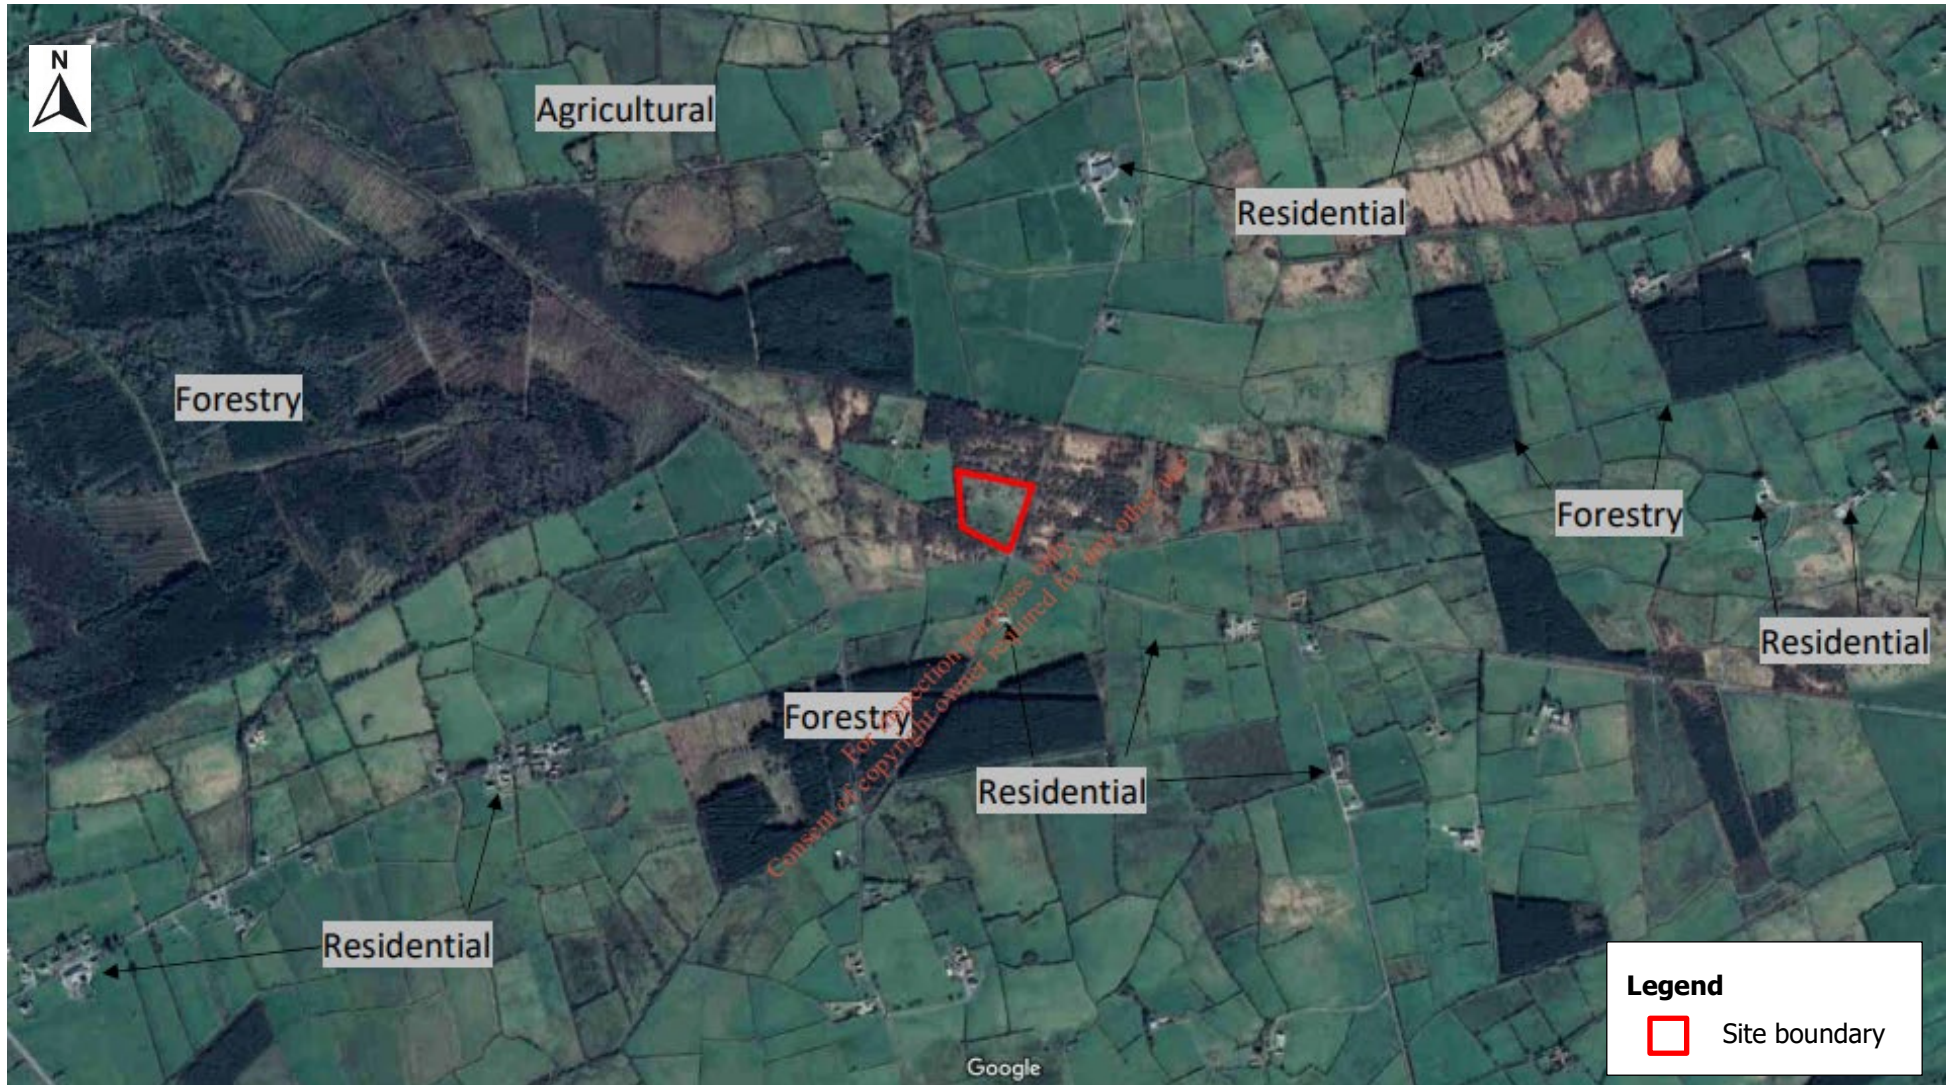
**Figure 2: Site boundary & site surroundings**

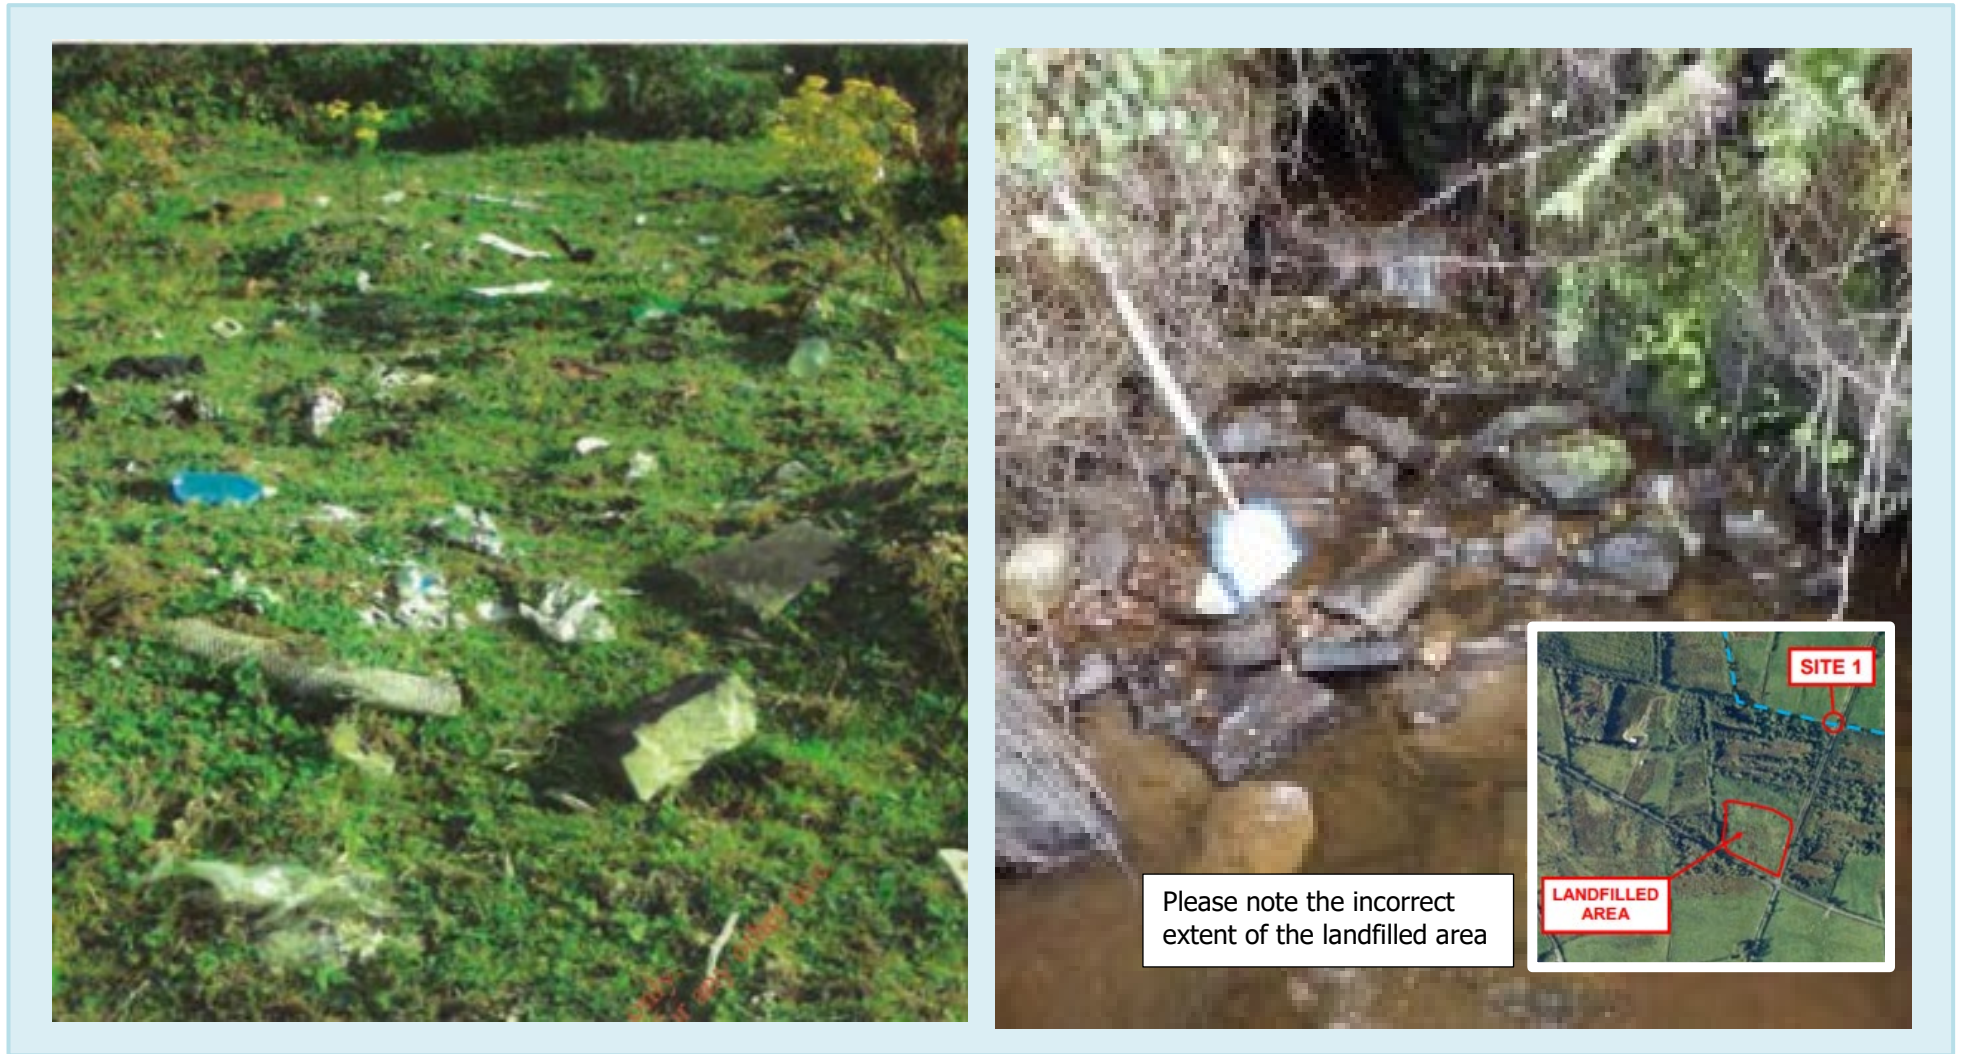
Current condition and appearance of closed landfill:	<p>The site rises by approximately 4m above the surrounding lands and gently slopes from south to north and east to west. There is exposed waste on the landfill surface and waste in a few locations in the adjacent ditches, as shown in Figure 3. Condition 3.1(b) requires that the local authority removes this waste for disposal or recovery at an appropriate facility. Condition 3.1(c) provides for appropriate capping of the landfill, as outlined in Section titled <i>Proposed remedial actions</i> below.</p>
Site investigations	<p>The site investigations carried out as part of Tier 1, 2 and 3 assessments established the following facts:</p> <ul style="list-style-type: none"> <li>• The site is underlain by peat which lies over the bedrock;</li> <li>• The waste body is unlined;</li> <li>• Waste is deposited above groundwater table.</li> <li>• The average waste thickness is 3.5m;</li> <li>• The maximum depth of waste measured during a trial pit investigation is 4.5mbg;</li> <li>• The waste body is partially covered with a 0.2m layer of soil;</li> <li>• Landfill gas is being generated;</li> <li>• The rainwater infiltrates through the cover material into the waste body;</li> <li>• Landfill leachate is being generated and there are perched tables of leachate and infiltrated rainwater within the waste body; and</li> <li>• The leachate is migrating into the nearby drainage ditches.</li> </ul>

**Figure 3: Waste on the landfill surface and in the nearby drainage ditch (Site 1)**

- (a) Minimise the disturbance of deposited waste to the extent possible;
- (b) Remove, for disposal or recovery at an appropriate facility, waste from the adjacent ditches or any area outside the waste body, and waste resulting from remediation works, within three months of the date of grant of this Certificate of Authorisation or the date of generation of waste from remediation works where applicable;
- (c) Install a low permeability landfill cap over the waste body, minimum 1m with 1mm thick low permeability geomembrane, or equivalent, to achieve a hydraulic conductivity of less than or equal to  $1 \times 10^{-9} \text{m/s}$ ;
